CRASH INJURY EVALUATION

SUMMARY EVALUATION

FLIGHT SAFETY FOUNDATION, Inc.

AVIATION CRASH INJURY RESEARCH
A Division of Flight Safety Foundation, Inc.
2871 Sky Harbor Blvd., Phoenix, Arizona

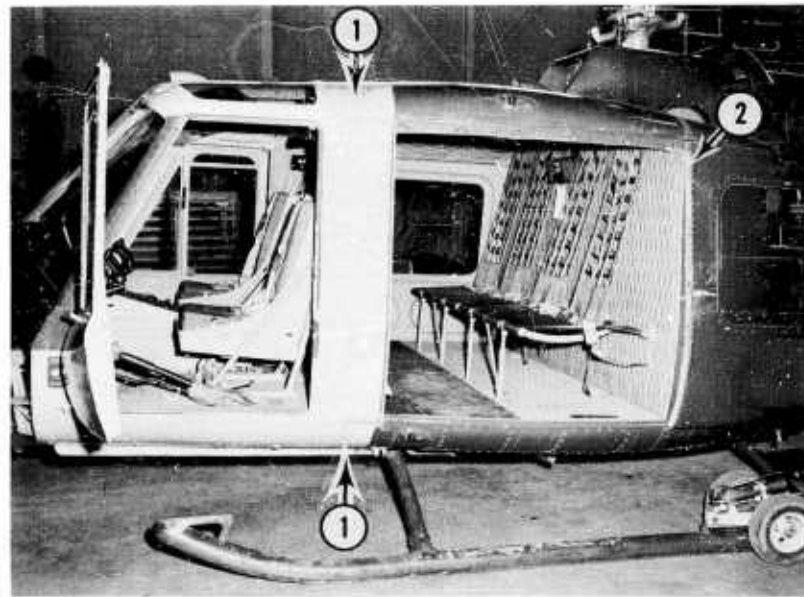
Figure 2. View of the vertical side supports. Arrow 1 denotes the vertical side support; arrow 2 depicts the aft firewall roof support.

The lower attachment points of the vertical support members on the right and left side of the cabin consists primarily of two "L" stringers, one fore and one aft. The outer skin of this support extends into the roof structure and is attached to the longitudinal roof support. At the present time, according to the Military Specification, this vertical support is required to carry only a normal air load.

Failure of these main side supports plus the failure of the aft bulk-head support permits the roof structure to lower sufficiently to strike the occupants or the seat backs in the occupiable crew and cabin areas. This is clearly demonstrated by the accident experience where the side vertical supports failed in every one of the five accidents, ranging from partial failure in Accident "C" and Accident "E" to complete failure in Accidents "A" and "D" (Figures 3 through 18). The aft end of the roof also failed in all but one of the five accidents (Figures 19 through 24). Only the absence of forward deceleration probably precluded any forward movement of the aft roof supporting structure in Accident "E".

It is evident, therefore, that the strength requirements of both the main side supports and the aft bulkhead support are inadequate. They should be able to withstand impact forces and conditions of a survivable nature without gross failure. This apparently has been recognized recently by both the military and the manufacturer. "Requests for Alteration" have been studied by the Bell Helicopter Corporation on each of these two features.

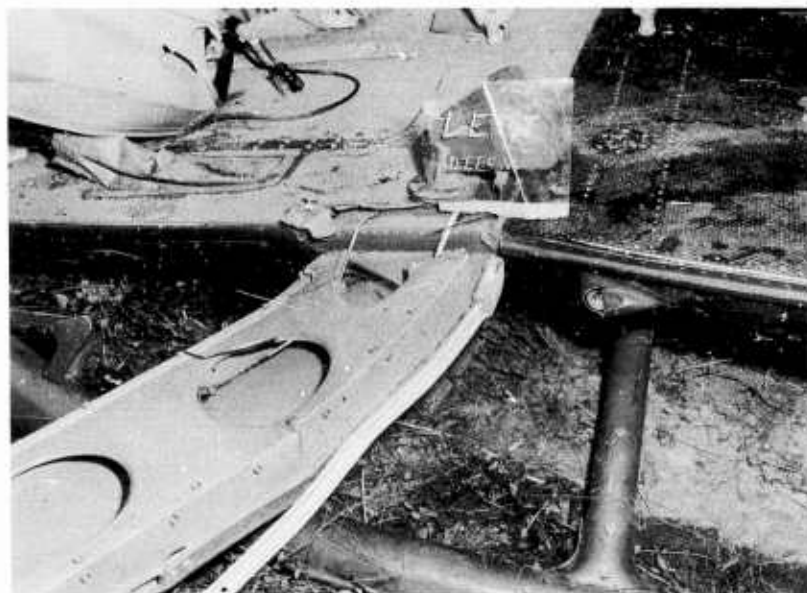
Figure 13. The entire left side support in Accident "D" was torn free with the exception of the wiring.

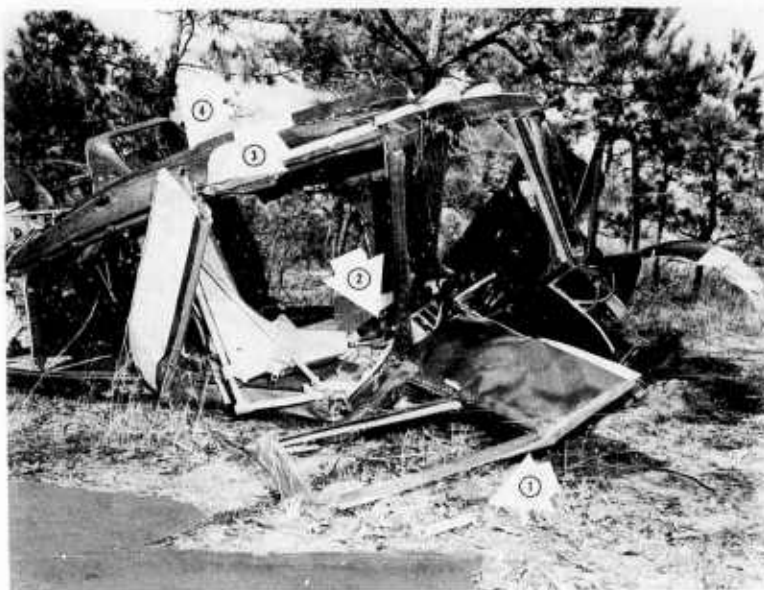
Figure 20. The collapse of the aft bulkhead allowed the roof structure to impinge into the occupiable area in Accident "B".

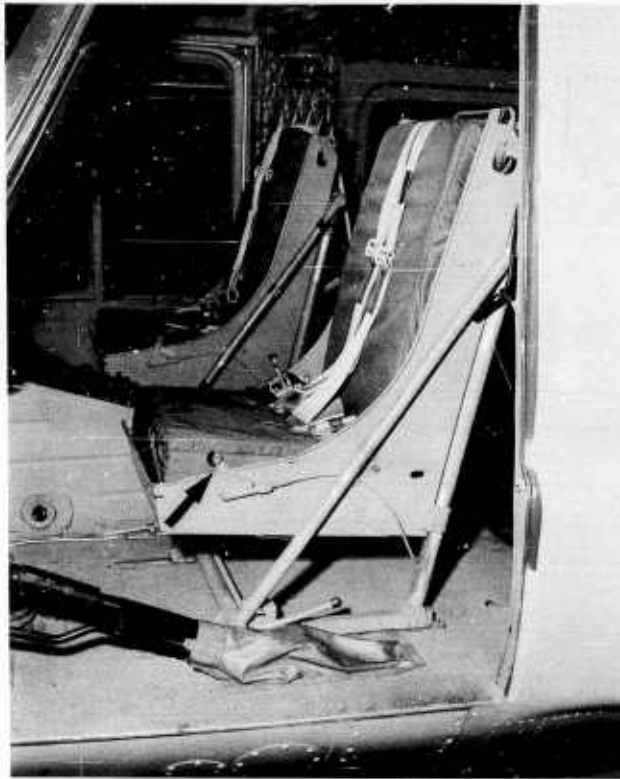
Figure 35. A side view of the pilot's seats. The inertia reel manual locking lever is conveniently located on the side of the seat pan (arrow).

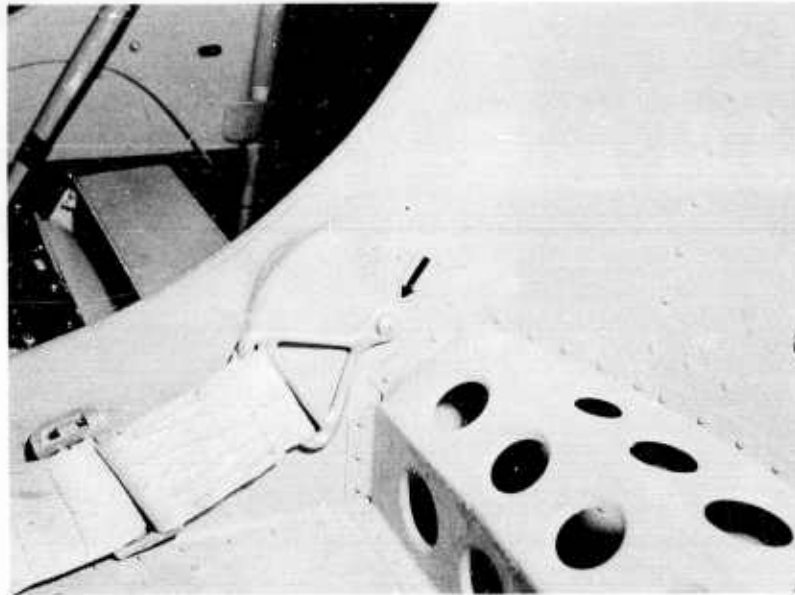
The safety belts on the crew members' seats are attached to the sides as depicted in Figure 36. A reinforcing plate is attached to the outside of the seats for additional strength. It should be noted that this safety belt attachment is not an omni-direction attachment. Helicopters frequently encounter side loads during an accident, and this type of anchorage would have a prying effect on the attachment with possible end attachment failure. It is suggested that the end attachments incorporate a self-aligning omni-directional anchorage.

Figure 36. Close-up of the safety belt end attachment (arrow). The metal baffle type structure is also depicted.

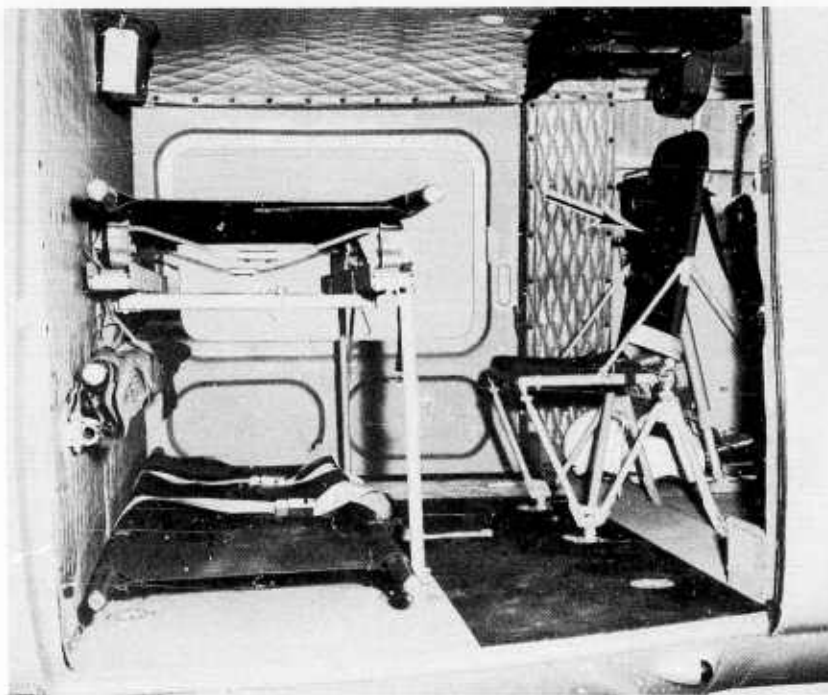
This seat is located just aft of the pedestal and was primarily designed as an aft facing Medical Attendant seat (Figure 47). In some cases the seat is reversed, forward facing, and is utilized by the crew chief. The safety belt is attached at the junction of the seat back and the seat pan and is stressed for 5.0G aft and 10.0G side loads when utilized in the aft facing position.

Out of the five accidents, this seat was installed and occupied only in Accident "D". In this case, the seat was attached facing forward and occupied by the Crew Chief. Upon impact the seat tore free from its leg attachments and permitted the Crew Chief and seat to be hurled out through the windshield.

Figure 47. View of the Crew Chief/Medical Attendant seat mounted in an aft facing position (arrow).

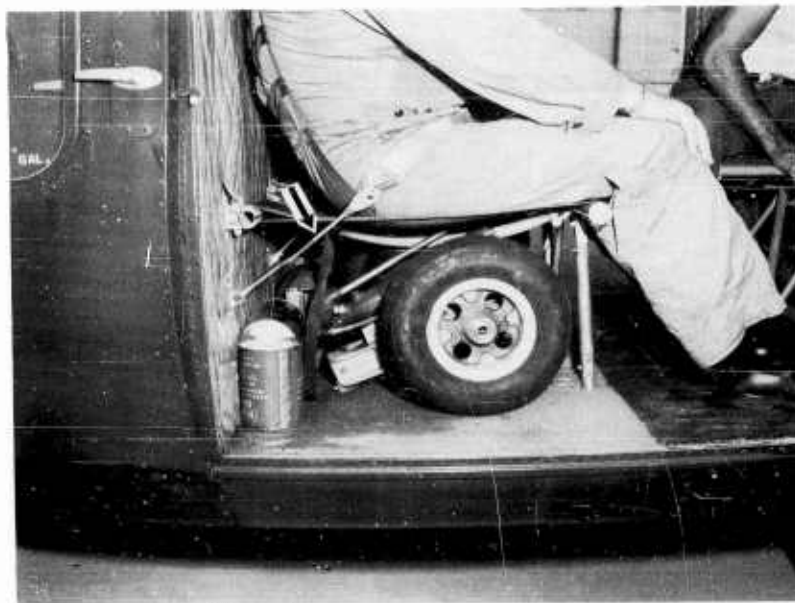
Numerous investigations and evaluations have shown that the cabin occupants' seat belts are being attached to an "O" ring which is attached to a rear longitudinal seat support. The correct and incorrect manner of attaching the seat belts in this aircraft is depicted in Figures 53 and 54.

Figure 54. The correct manner in which the safety belt should be installed in the HU-1 and the HU-1A is depicted by the arrow. Note that the belt crosses the hips at approximately 45°.

The belts are stressed to withstand 11.0G at a 45-degree angle upward, forward, and inboard. The seat belts should be attached to the cables which are tied directly into primary structure (Figure 54).

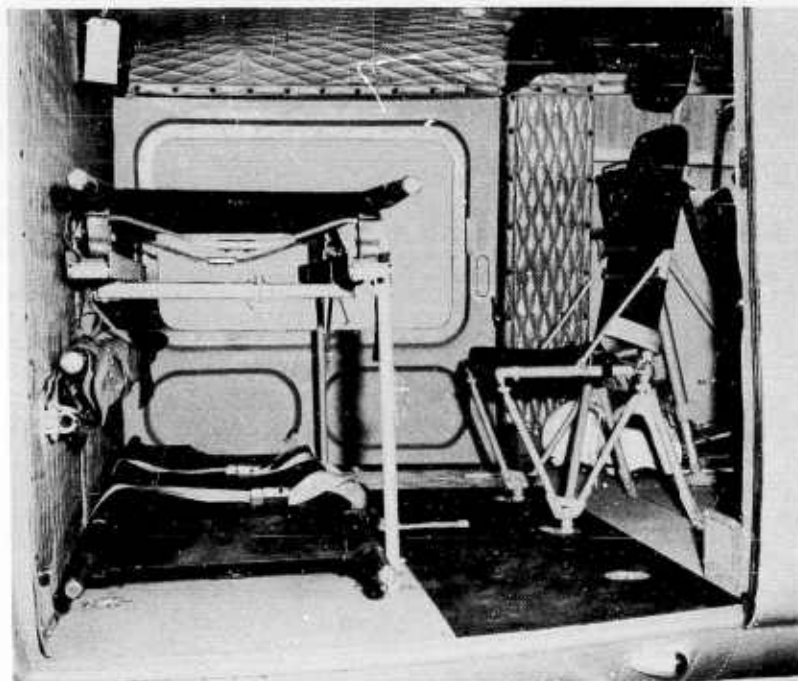
Figure 55. Over-all view of the litters and supporting frame.

The current litter configuration and installation should be dynamically tested with full-scale anthropomorphic dummies under force magnitude, direction, and time history conditions associated with survivable crash loads sustained in helicopter accidents. The results of these tests should be utilized in the development of a more suitable specification.

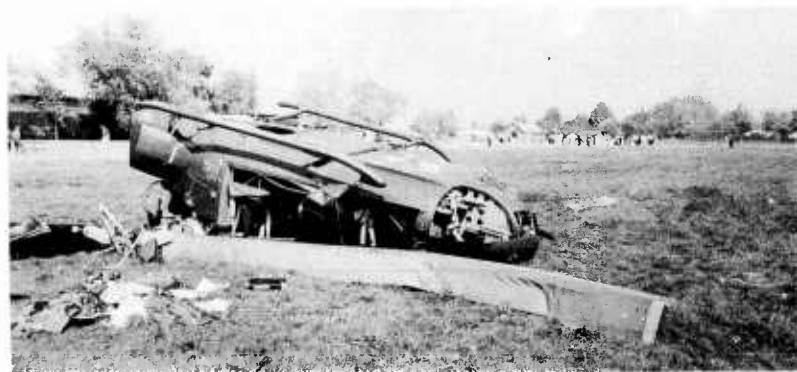
The helicopter had completed a high-speed run parallel to and in front of the spectators when the pilot initiated a cyclic climb to approximately 500 feet above the terrain to prepare for an autorotative descent. Upon arriving at the desired altitude with a velocity of 30 to 40 knots, he made an 180-degree turn, reduced power, lowered the nose of the aircraft, and entered autorotation. Immediately after entering the maneuver, the pilot noted an unusually high rate of descent, at a point estimated to have been 200 feet above the terrain. He leveled the aircraft, applied full power and collective pitch, but was unable to decrease the high rate of vertical descent. He continued application of power and pitch, and just prior to the crash, succeeded in partially reducing the high "sink" rate. At impact the tail boom began shearing loose and tore completely free as the aircraft rebounded into the air. The aircraft struck the ground two more times, finally coming to rest in an inverted position approximately 420 feet from the point of initial impact. During this sequence the engine tore free from its mounts and rolled far to the right of the crash path. Cargo and cabin doors were torn free. The main transmission, mast, and rotor assembly tore free during the rolling of the aircraft near the end of the crash path. The roof failed in compression, collapsing against the seat backs of the pilot and crew chief's seats. (It is reasonable to assume that the vertical side supports failed at initial impact. This is substantiated by the four other accidents that did not become inverted.) The forward deceleration was approximately 3.9G; the vertical load sustained was approximately 9.8G upon impact.

Over-all view of the East St. Louis, Illinois accident

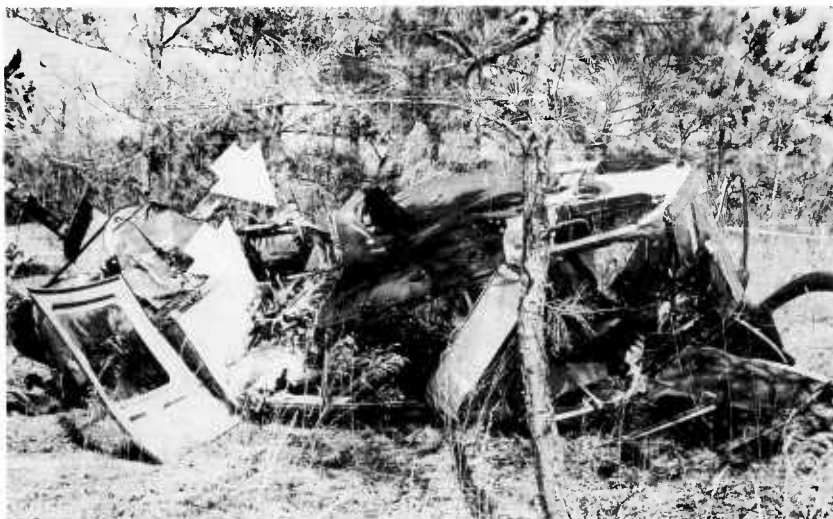
During a climbing right turn with approximately 60 knots indicated air speed and at about 250 feet above the ground, the pilot thought he smelled something burning. He reached up with his left hand to the overhead panel and turned off the aircraft heater, at the same time looking up to make sure he had the right switch. As a normal reaction to the outstretching of his left arm, he involuntarily applied a small amount of right forward cyclic, not realizing it because of the servo flight control system and the absence of force trim. This put the aircraft in a nose low attitude, increasing the air speed and allowing a rate of descent to build up to approximately 1,300 feet per minute. It also turned the aircraft downwind and picked up a 12-knot tail wind. By the time the pilot got his attention back and realized the attitude the aircraft was in, he was descending rapidly into a patch of trees which he reported were only about 50 feet away when he first saw them. His ground speed was in the neighborhood of 95 knots and with the rate of descent near 1,300 feet per minute, the aircraft had no time to respond to his control before hitting the trees and the ground. Just prior to ground contact the main rotor blade wrapped around an oak tree and pulled the transmission free of the aircraft. The aircraft continued on, striking the ground, bounced, and came to rest 20 feet from initial contact. The decelerative forces in this accident were estimated to be in excess of 14G's.

The HU-1 accident, Fort Rucker, 4 March 1960

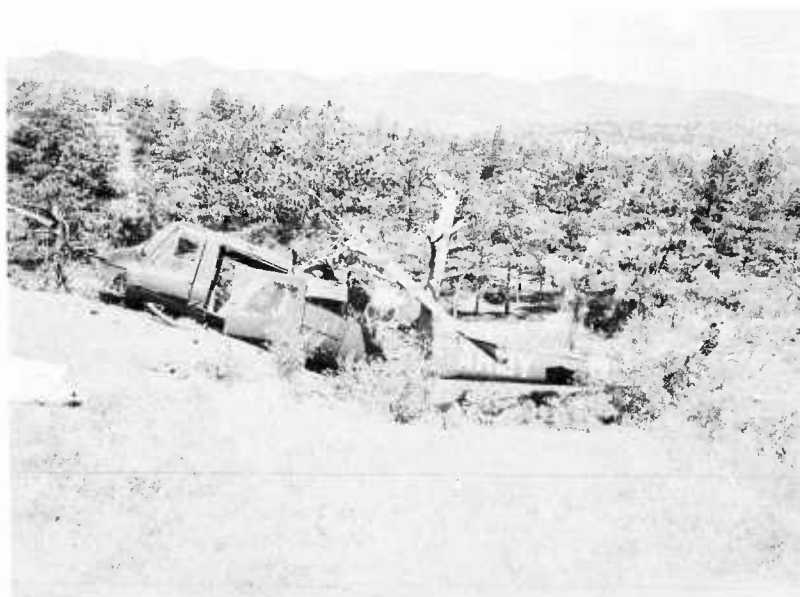
During approach to an intended landing site, the pilot observed an obstruction and initiated a climbing turn to the right. At approximately 270° of the turn and 300 feet of altitude, a partial power failure occurred. The pilot immediately actuated the increase power switch; power increased momentarily and then decreased between partial and full loss of power. The pilot lowered the nose of the aircraft, entered autorotation, and committed the aircraft to a forced landing. Upon entry into autorotation, the pilot noted a very steep angular approach and an unusually high rate of descent. Just prior to the crash, he succeeded in reducing this high "sink-rate" by one-half, to approximately 1,500 feet per minute, and then executed a full flare. During the full flare the main rotor blades contacted a large pine tree causing sudden stoppage of the rotor system as the aircraft forcibly contacted the ground. Due to the sudden stoppage of the rotors, transmission mounts failed, allowing the transmission and its components to penetrate the aft bulkhead into the occupiable area. The decelerative forces in this accident were computed to be approximately 13G.

Side view of the Fort Carson accident.

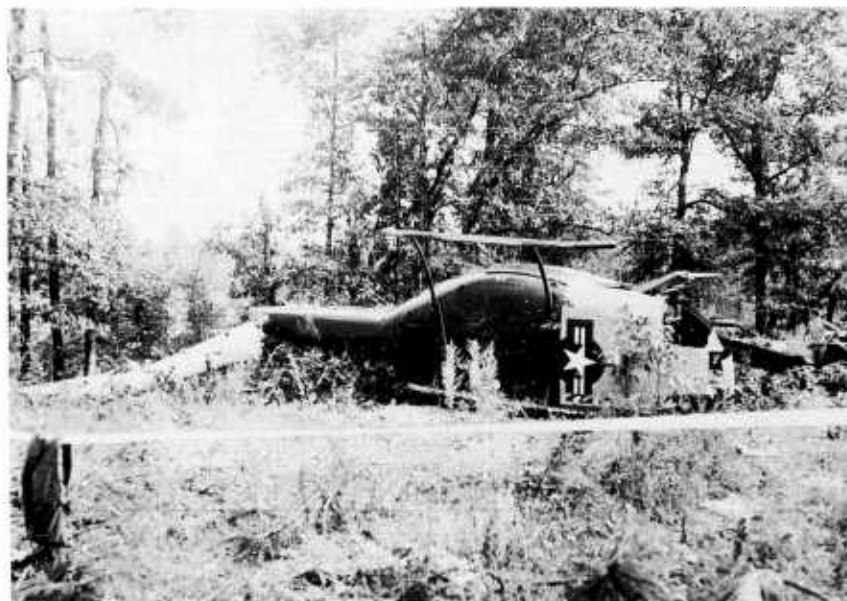
While in level flight at cruise power, the crew heard loud banging noises followed by moderate oscillation of the aircraft through all axes. Upon increasing collective pitch and power the helicopter started to yaw. The pitch control was immediately reduced to minimum and the pilot checked his anti-torque pedals. When no response was forthcoming, he then realized he had lost his tail rotor. He turned toward the runway which also placed the clearest available area in his flight path. Yaw control could only be maintained with the pitch bottomed. The pilot, realizing he could not make the runway, elected to head for the clearest area available. When approaching touchdown, a flare was executed to reduce touchdown speed. As the speed was reduced, the yaw increased to the left. The aircraft hit the top of several oak trees moving forward and downward through the trees. The initial impact with the trees was about 50 feet above the ground. The aircraft stopped its forward motion after about 110 feet while 15 feet above the ground. At this point it rolled over on its left side and fell vertically, coming to rest on its left side. Accurate gouge marks were unobtainable although evidence indicates the load sustained in this accident was between 5G and 10G.

View of the HU-1A accident which occurred at Fort Rucker, Alabama, 26 August 1960.
