OCTOBER 1964

# QUARTERLY TECHNICAL PROGRESS REPORT No. 1

XV-5A LIFT FAN  
FLIGHT RESEARCH AIRCRAFT.

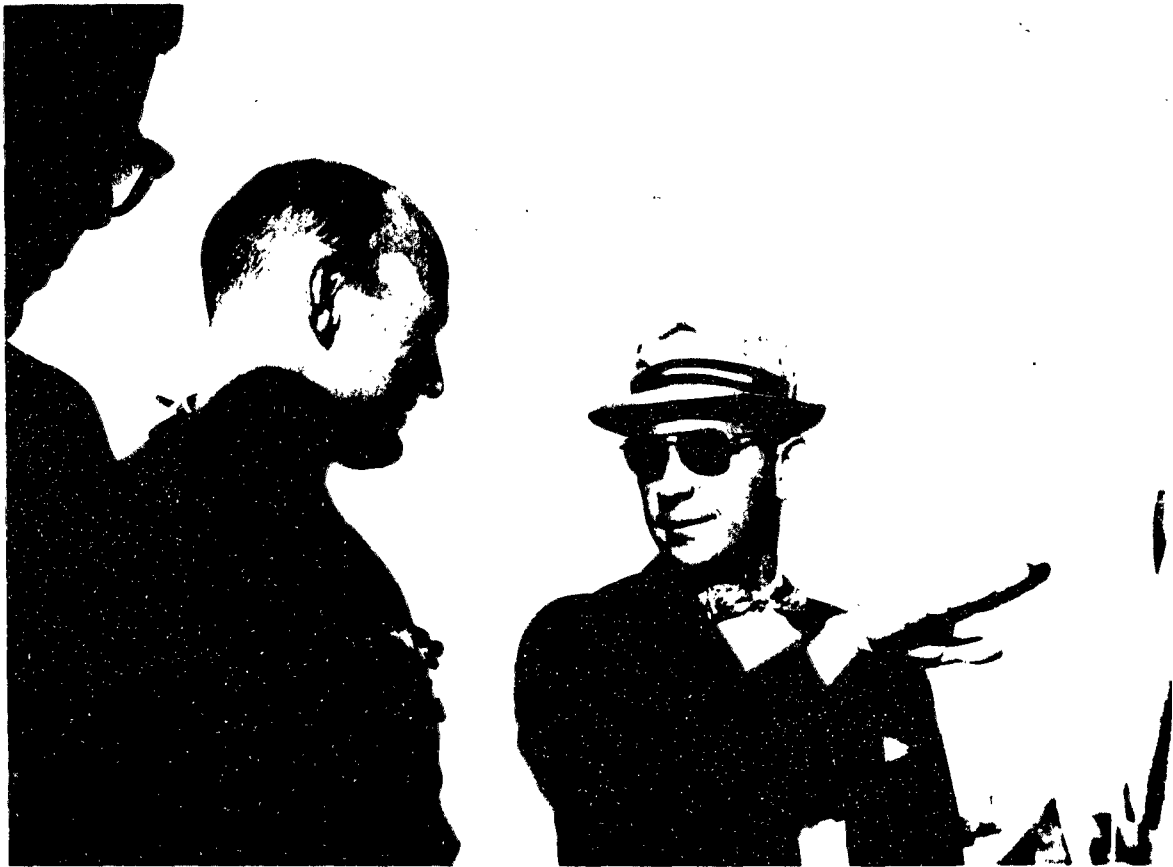
Figure 36. Post Flight Briefing.

- 5) As the aircraft was approaching touchdown, and while in ground effect at a height estimated at 2.5-3 feet, the compressor stall on the No. 2 engine was encountered. The engine power decreased instantaneously and the aircraft landed heavily, but without bottoming the gear struts. Due to an increased EGT condition, the engine was shut down immediately and no other damage was sustained by the aircraft. The engine will be removed for teardown inspection. The investigation of the stall problem is continuing.

After pilot and engineer discussions, see Figure 36, the flight operations were halted and further compressor stall investigation started. Details of the stall investigation and resulting aircraft configuration are described in Section V-B, page 113.

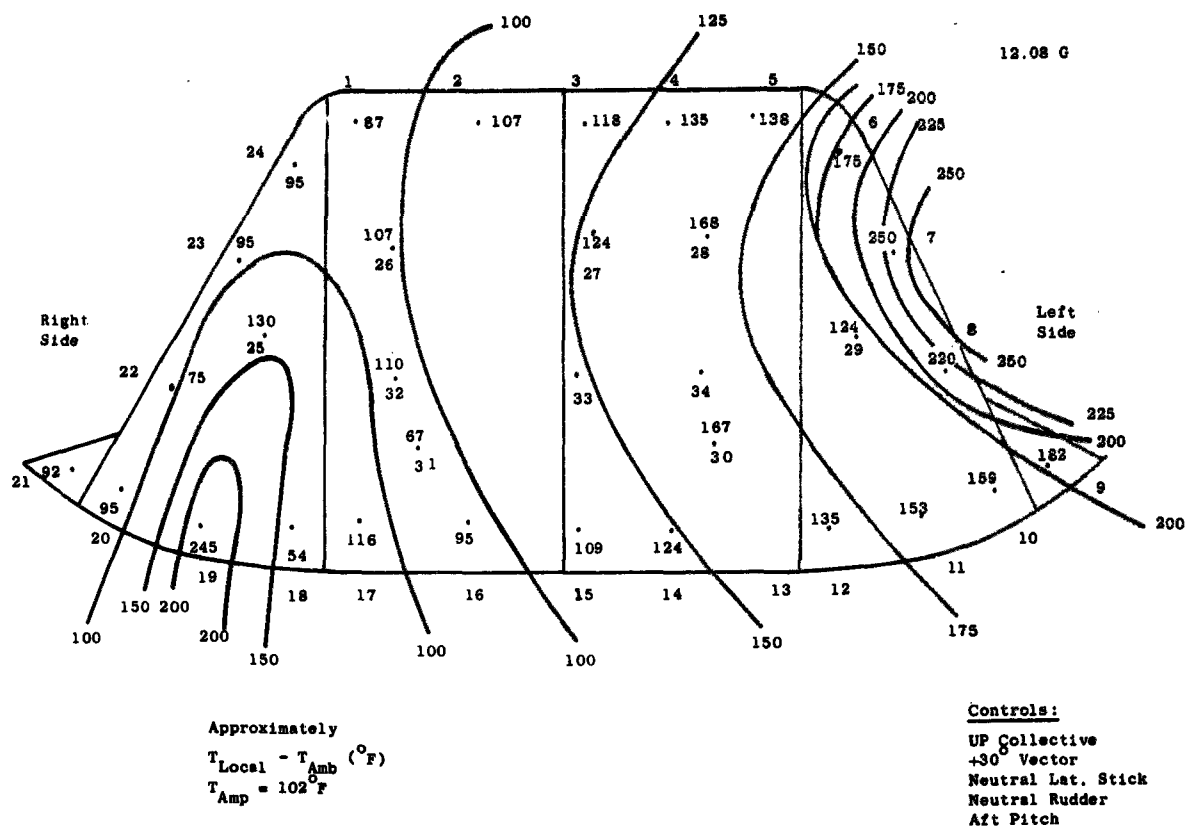
Figure 39. J85 Inlet Screen Temperatures.

Control combinations were determined which would induce temperature rise of up to 200°F in four to six second time intervals (and would also cause compressor stalls). Additional temperature measurements were made through a screen over the J85 inlets. A typical distribution of temperatures is shown in Figure 39. Other instrumentation was added to determine compressor casing temperatures ( $\Delta t$  giving an indication of change in compressor rotor/stator clearance), compressor and turbine gas pressures, bleed port pressures, bleed valve positions, fuel control  $T_2$  sensor air temperature and others.

Problem areas leading to decreased stall margin were:

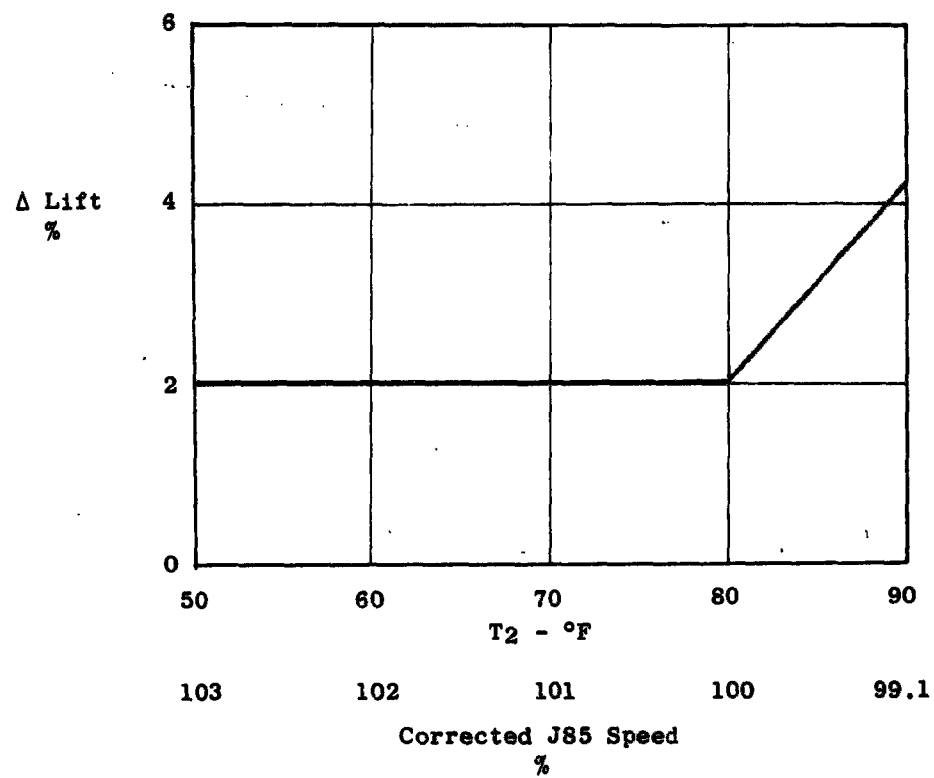
Figure 43. VG Adjustment - Effect on Performance - Predicted Decrement Based on SAED Engine 100-A.  
 $T_5 = 680^\circ\text{C}$  - Max. Power.

- 1) Engine trim at 102% - - -
- 2) Variable geometry adjustment -2.0%\*
- 3) Ejector for compressor case cooling  $\frac{-2.2\%}{-2.2\%}$

\*Below 80°F  $T_{t_2}$  - See Figure 43.

- 4) Adjusted variable geometry for 5% open bleeds or more during all operations, plus adjusted bleed valve schedule for cold drag response (see Figures 42 and 43).
