**XC-142A  
V/STOL TRANSPORT  
TRI-SERVICE  
LIMITED CATEGORY I  
EVALUATION**

**TECHNICAL REPORT No. 65-27  
JANUARY 1966**

**AIR FORCE FLIGHT TEST CENTER  
EDWARDS AIR FORCE BASE, CALIFORNIA  
AIR FORCE SYSTEMS COMMAND  
UNITED STATES AIR FORCE**

FTC-TR-65-27

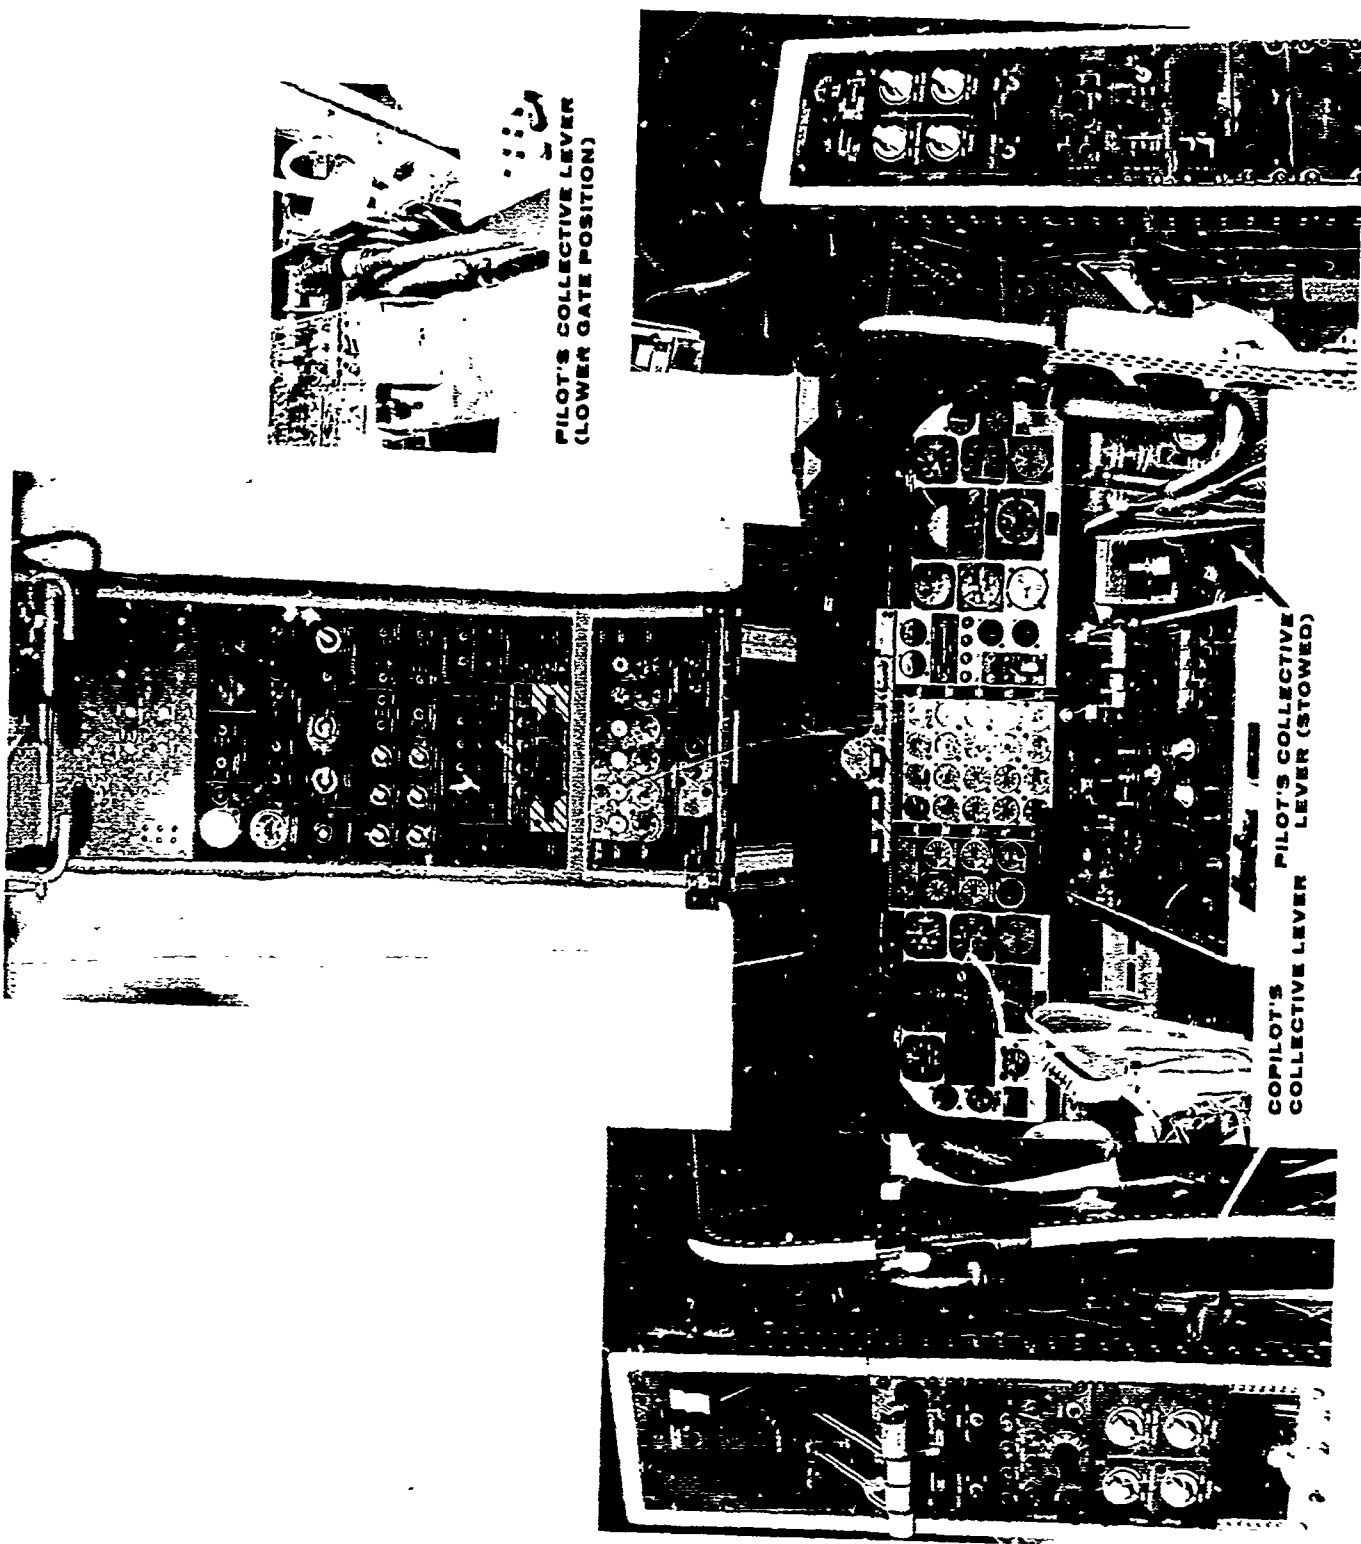
Two steps were provided to gain access to the flight deck from the cargo compartment. The pilot and copilot were supplied with zero-zero rocket type ejection seats which were not scheduled to be installed in production models. Zero-zero ejection seats should be provided in production aircraft. Normal pilot ejection was to be through the overhead plexiglass panels. Entry and egress from the seats was awkward and could not be accomplished without bumping into cockpit switches or controls. The seat had an electrically-actuated adjustment for vertical movement, but no fore and aft adjustment

was possible to bring the pilot to a comfortable position in relation to the aircraft controls. Fore and aft adjustment should be provided in production aircraft as recommended in AFSCM 80-1, Volume III, drawing AD3. The rudder pedal adjustment was adequate and rapid and was controlled by means of a twist knob on the rudder pedal pedestal between the rudders. (D 52, D 53)

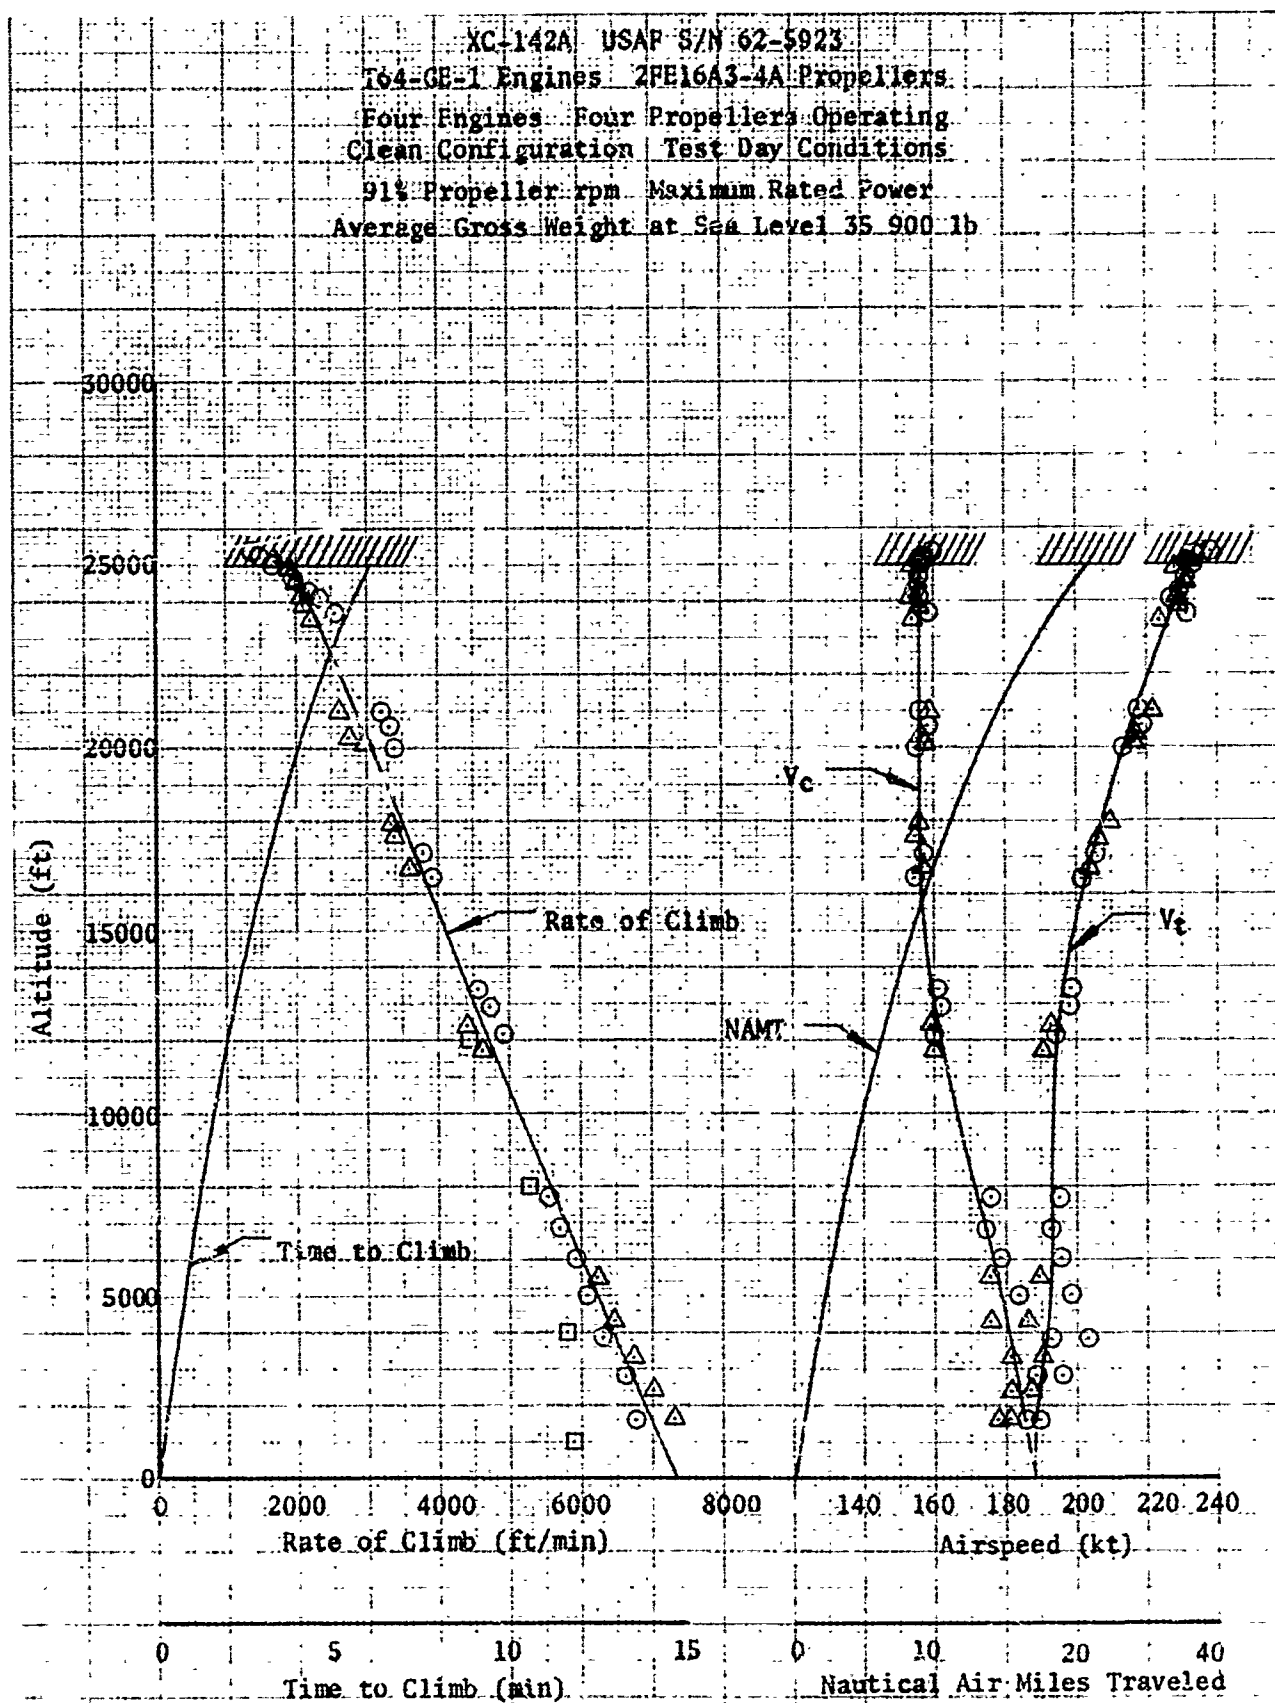
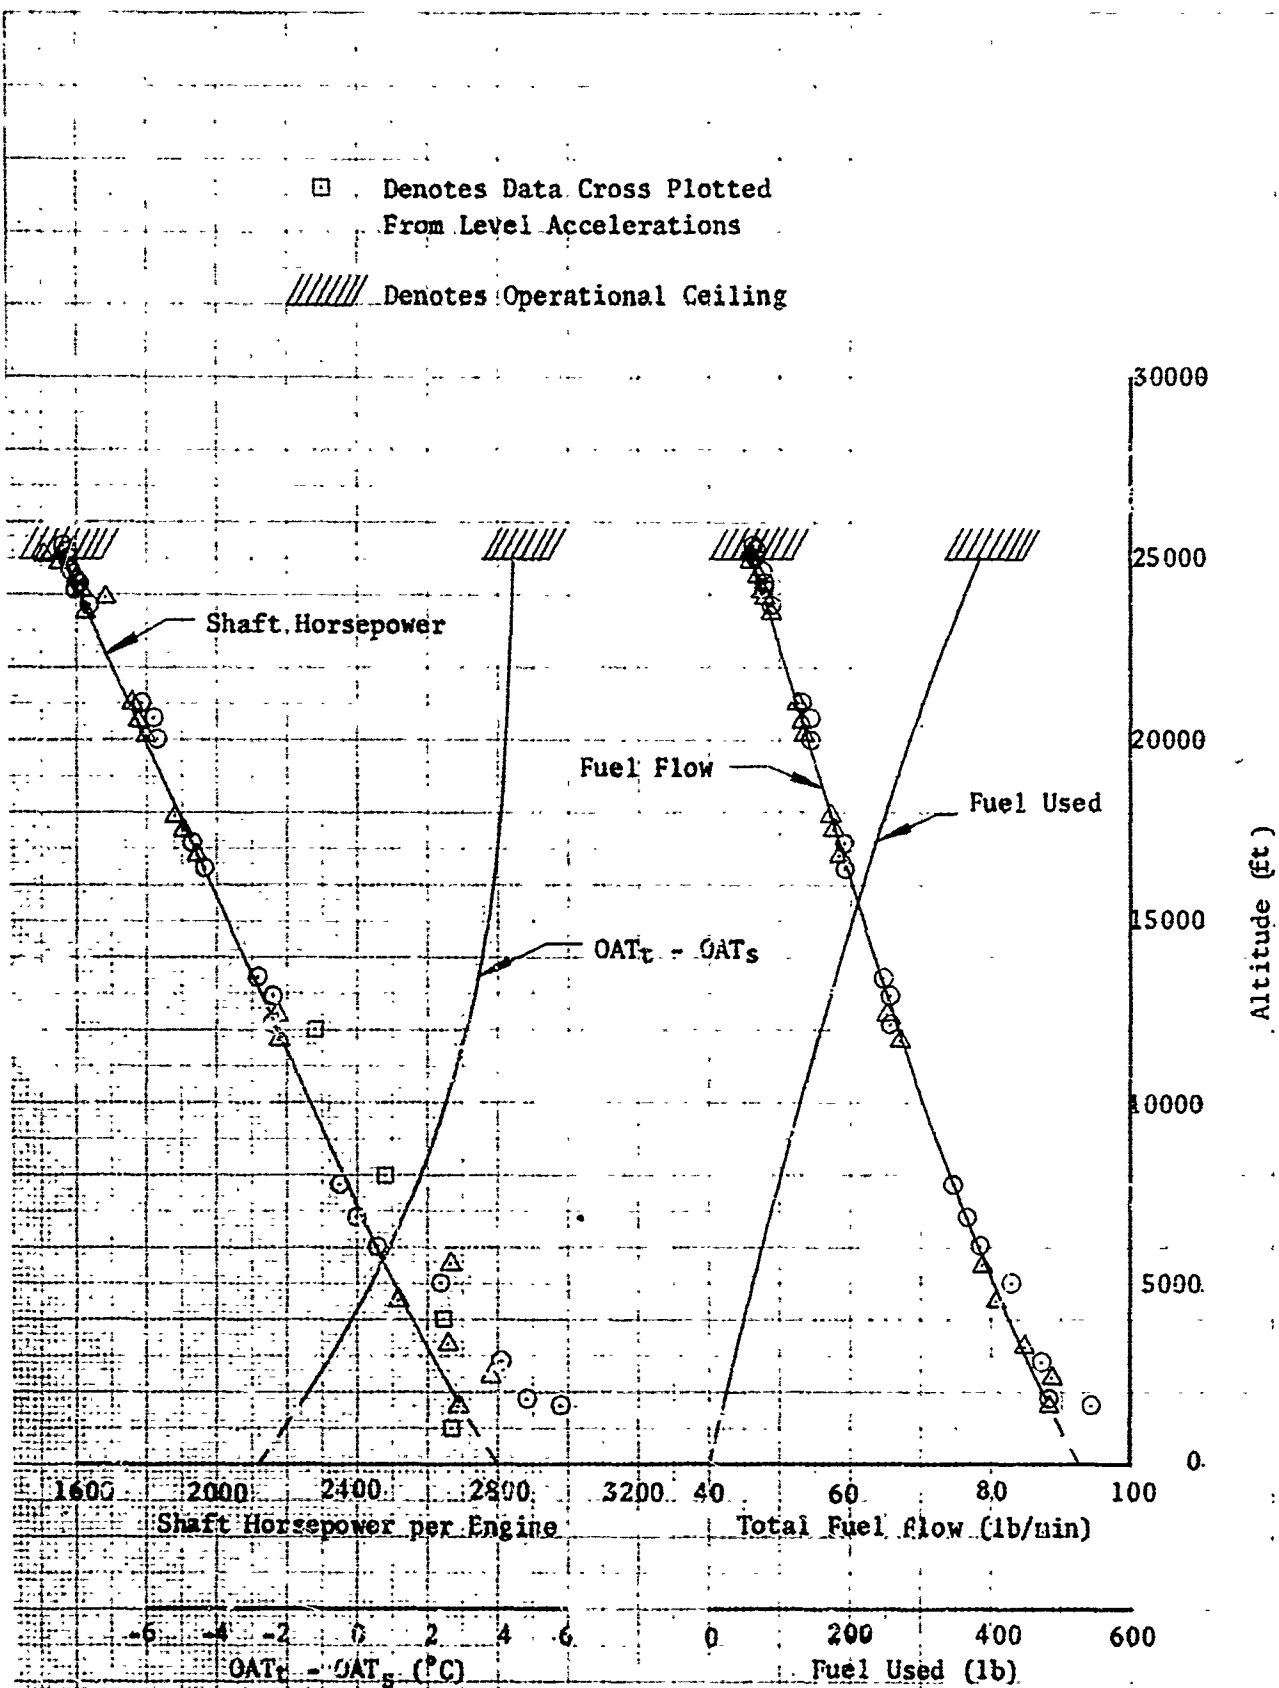
Figure 4. Climb Performance

of maximum power was rapid. Brisk rotation to the climb attitude was required to avoid exceeding the climb speed. For the 4-engine climbs, the initial fuselage attitude was about 26 degrees noseup; however, this did not adversely affect forward visibility. The climb data are presented in figure 4, appendix I.

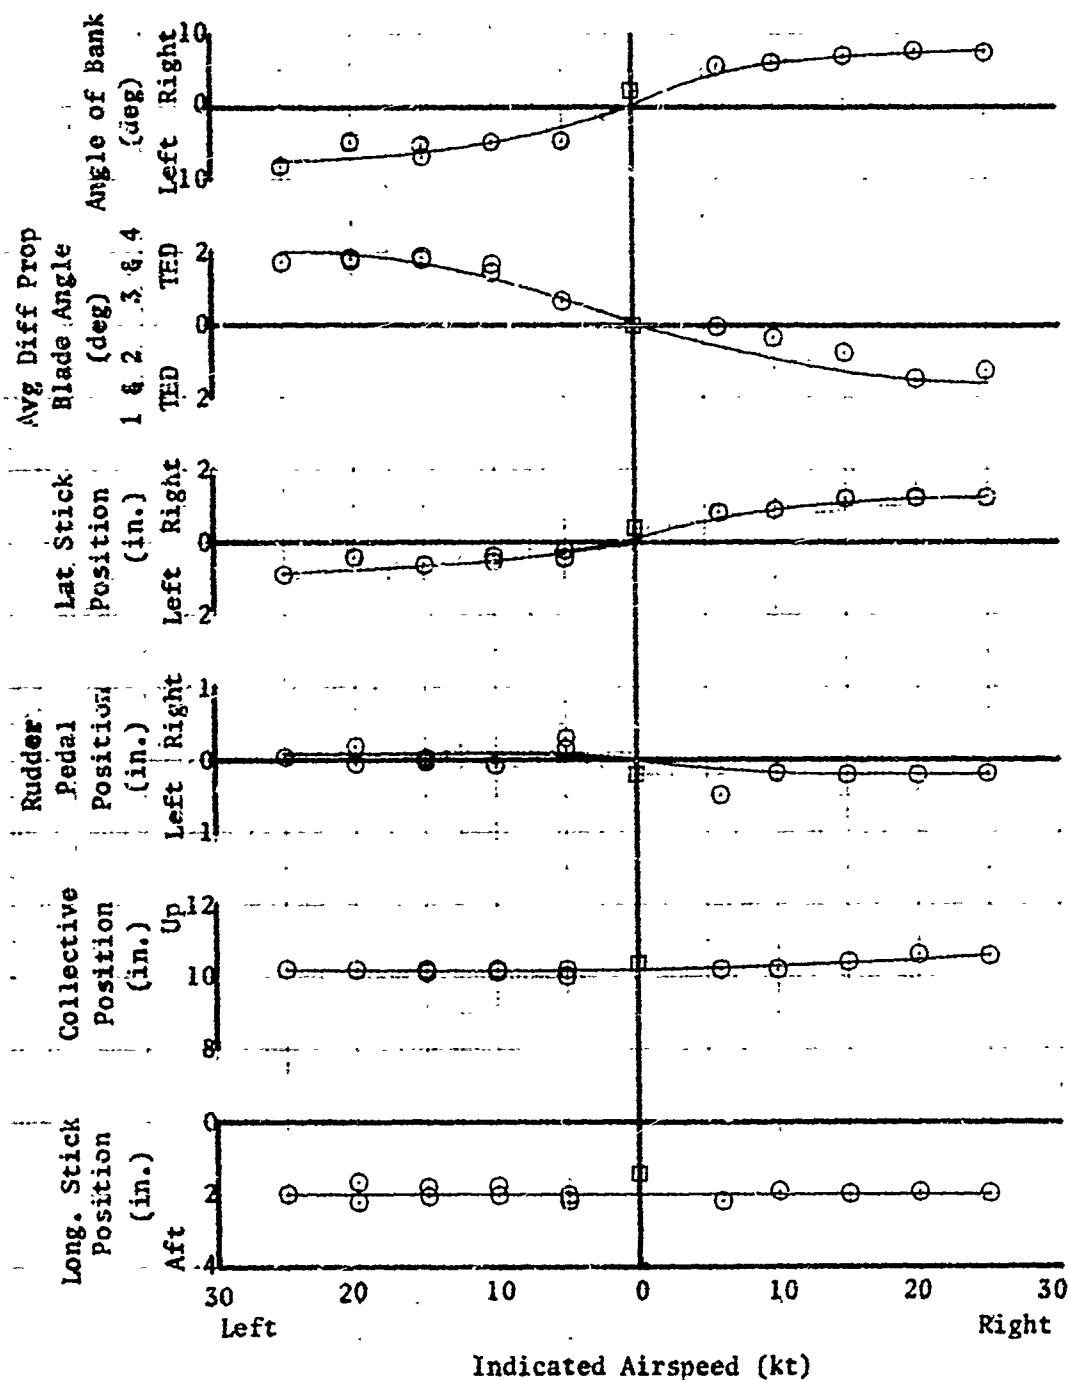
Figure 16. Control Positions in Sideward Flight

results in sideward flight are shown in figure 16, appendix I. (C 11)

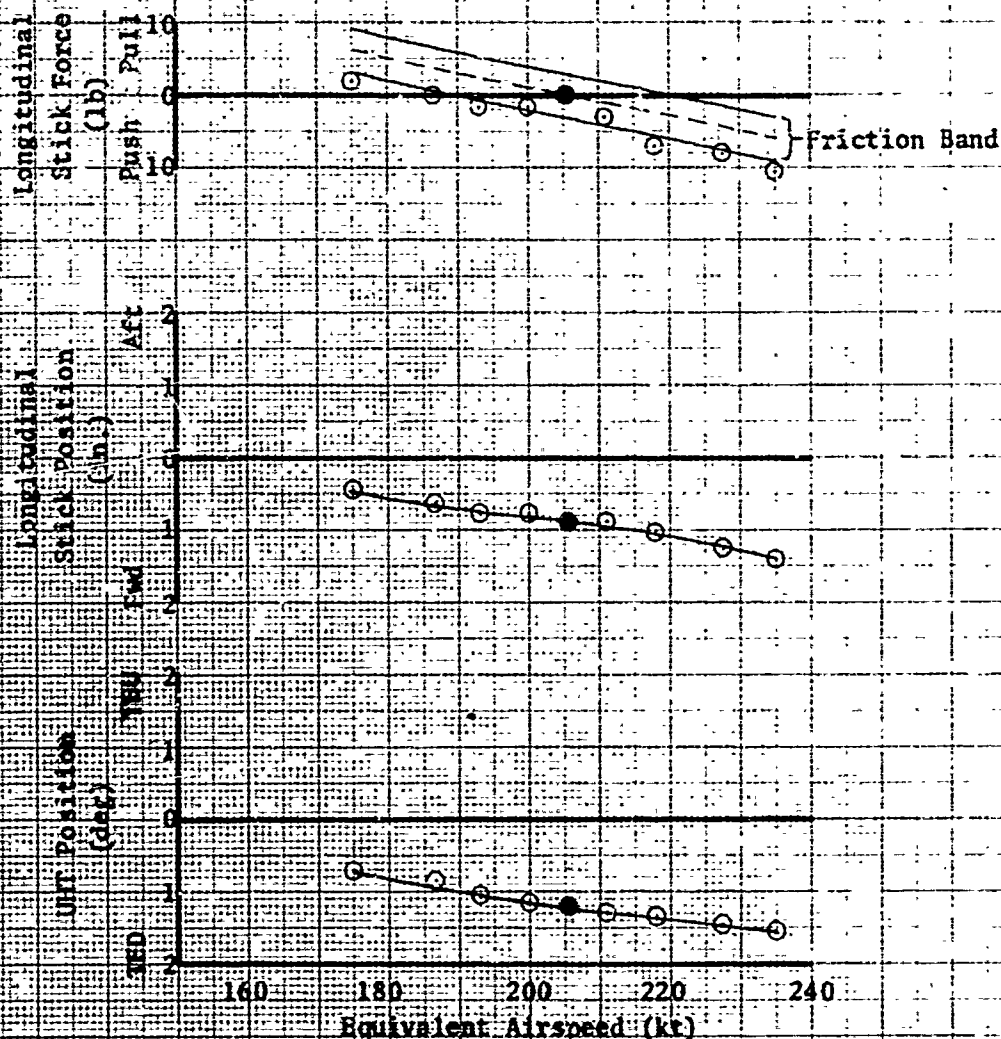
Figure 19. Static Longitudinal Stability

Static longitudinal stability tests were conducted at a mid cg of 20.7-percent MGC in the cruise configuration from a trim speed of 205 KEAS at 10 710 feet. The test technique used was to stabilize at airspeeds above and below the trim airspeed at a constant power setting. The static longitudinal stability, as indicated by the variation of UHT position and longitudinal stick force, was positive but low. Test results are presented in figure 19, appendix I.

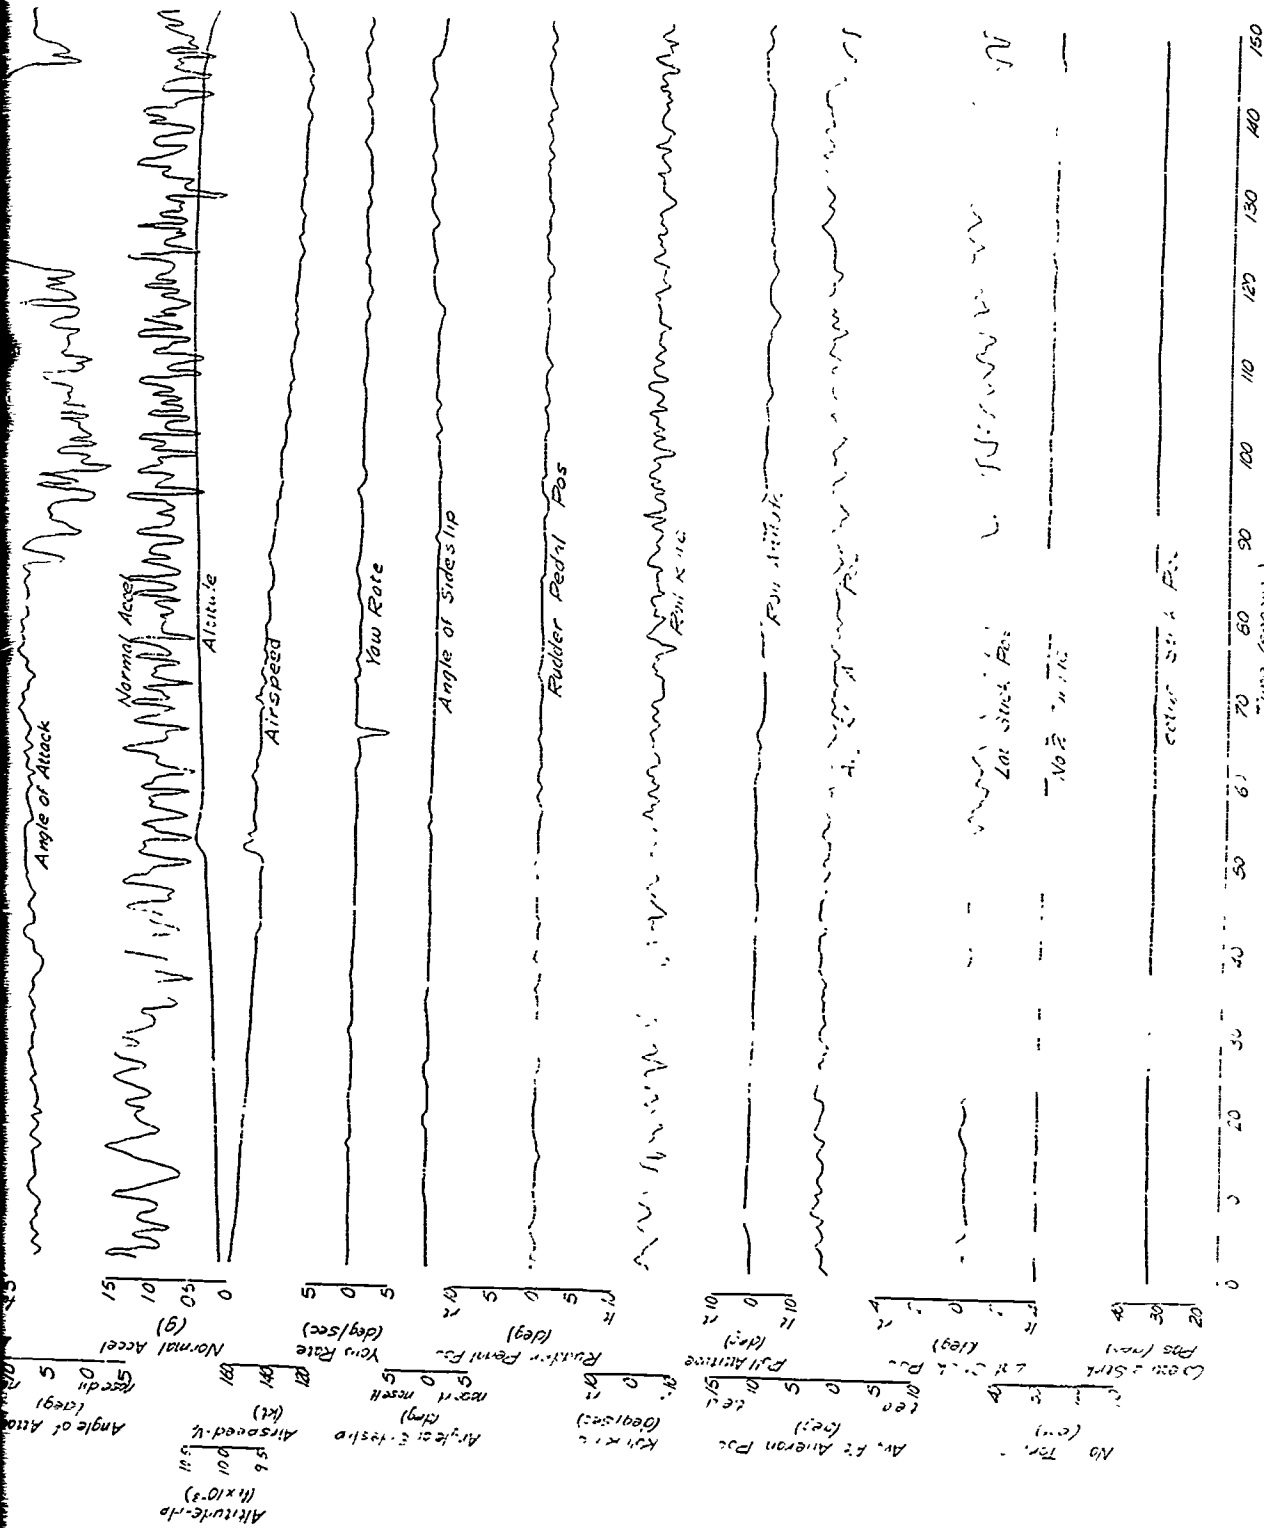
Figure 25 Bound On Stall-0.0°

In the cruise configuration, buffet onset occurred at 147 KIAS and increased to heavy buffet at 122 KIAS. Stability and controllability were good throughout. There was a slight deterioration in roll control at 122 KIAS. The stall approach was terminated at this speed because of the buffet intensity. A time history of this stall approach is presented in figure 25, appendix I.
