# ARMY AVIATION SAFETY

- CRASH INJURY
- CRASHWORTHINESS

Final Report  
U. S. ARMY  
TRECOM Contract  
DA 44 177 TC 624  
TREC Technical Report  
60 77  
AvCIR 70 0 128  
30 December 1960

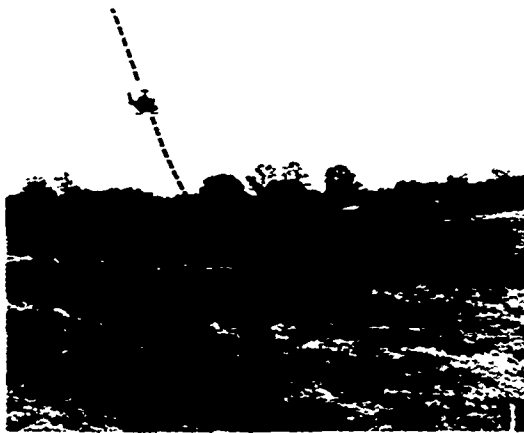
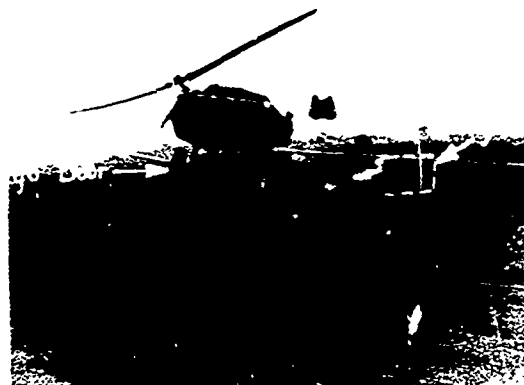
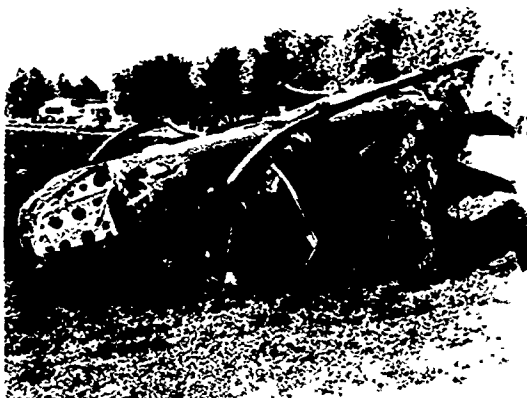
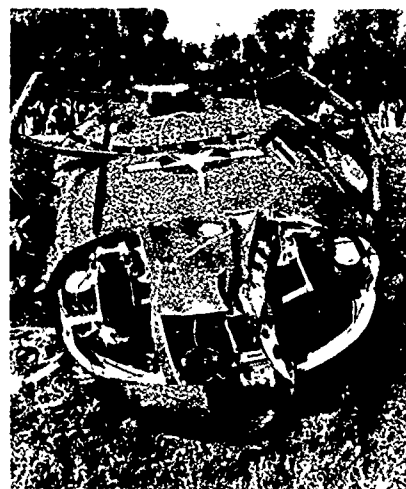
### U. S. ARMY HU-1A BELL IROQUOIS HELICOPTER ACCIDENT EAST ST. LOUIS, ILLINOIS 21 OCTOBER 1959

At impact the tail boom began shearing loose and tore completely free as the aircraft rebounded into the air. The aircraft struck the ground two more times finally coming to rest approximately 420 feet from the point of initial impact. During this sequence, the engine tore free from its mounts and rolled to the right of the crash path.

of the crash path. When the aircraft came to rest inverted, it was found that the roof had failed in compression collapsing against the seat backs of the pilot's and copilot's seats.

The investigation on 23-24 October 1959 revealed that the seat and cushion contributed to amplification of the crash force imposed on the pilot causing the spinal injury. It was revealed that the structure supporting the roof failed under relatively moderate crash forces per-

mitting the roof structure to crush into the cockpit and cabin under survivable crash force conditions.

The investigation found also that the skids and cross tubes absorbed a considerable amount of energy during the crash, that the doors broke off and allowed large exits for escape, and that the fuel cells are located in an area not highly subject to impact damage.

As a result of these findings, it was recommended: (1) that immediate steps be taken toward increasing the integrity of the roof supporting structure of this helicopter, and (2) that seats utilized in this aircraft should be so designed as to offer occupants a higher degree of energy absorption.

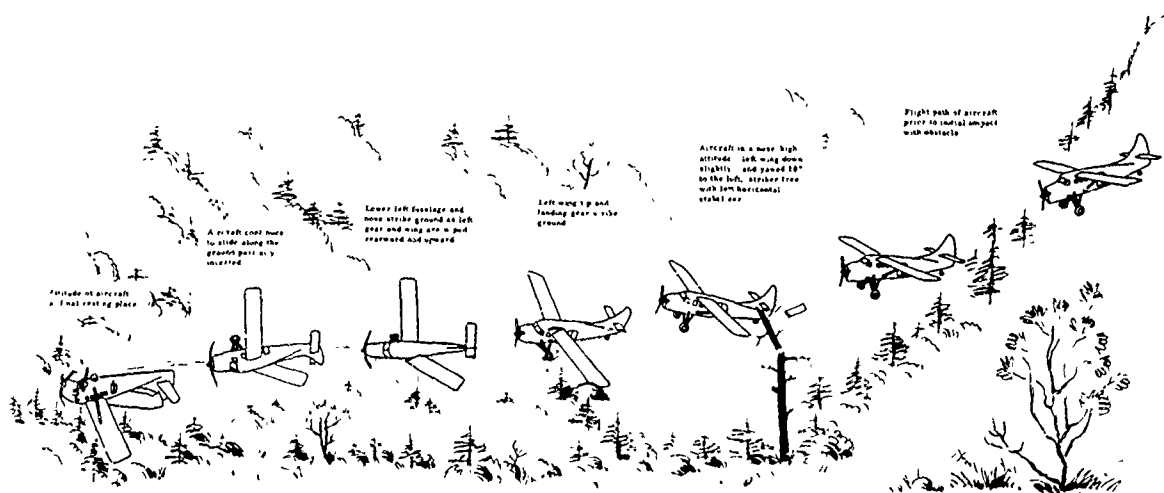
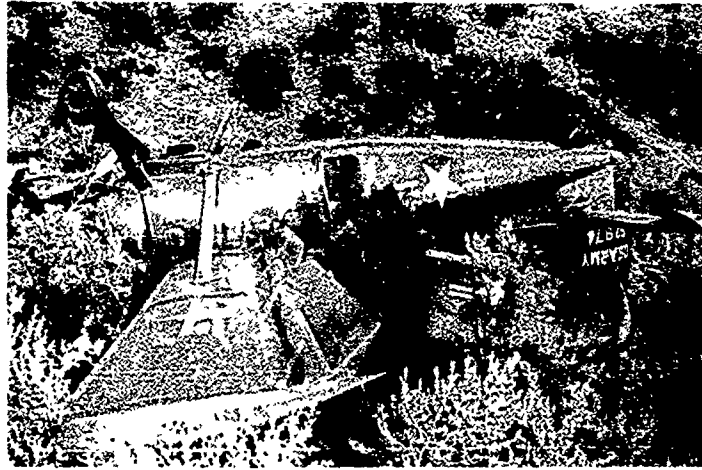
During this descent, the left horizontal stabilizer struck the trunk of a dead tree. The aircraft then struck the side slope of the canyon in extremely rugged terrain impacting on its left wing, nose, and left side

The cockpit and cabin remained reasonably intact. Major damage was sustained by the left wing, the left landing gear, the left lower side of the fuselage, and the engine and nose section. All occupied cabin seats except two were either torn free, broken, or distorted.

The crash injury investigation conducted on 18-20 June 1959 revealed that the injuries experienced were the result of the occupants' being thrown free due to the seat and/or seat belt failures or striking interior structure and rifles. The analysis of the injury causation factors resulted in recommendations for: (1) increased strength of seats and tie-downs; (2) a more suitable restraint system for occupants; and (3) a method of storing hand-carried weapons.

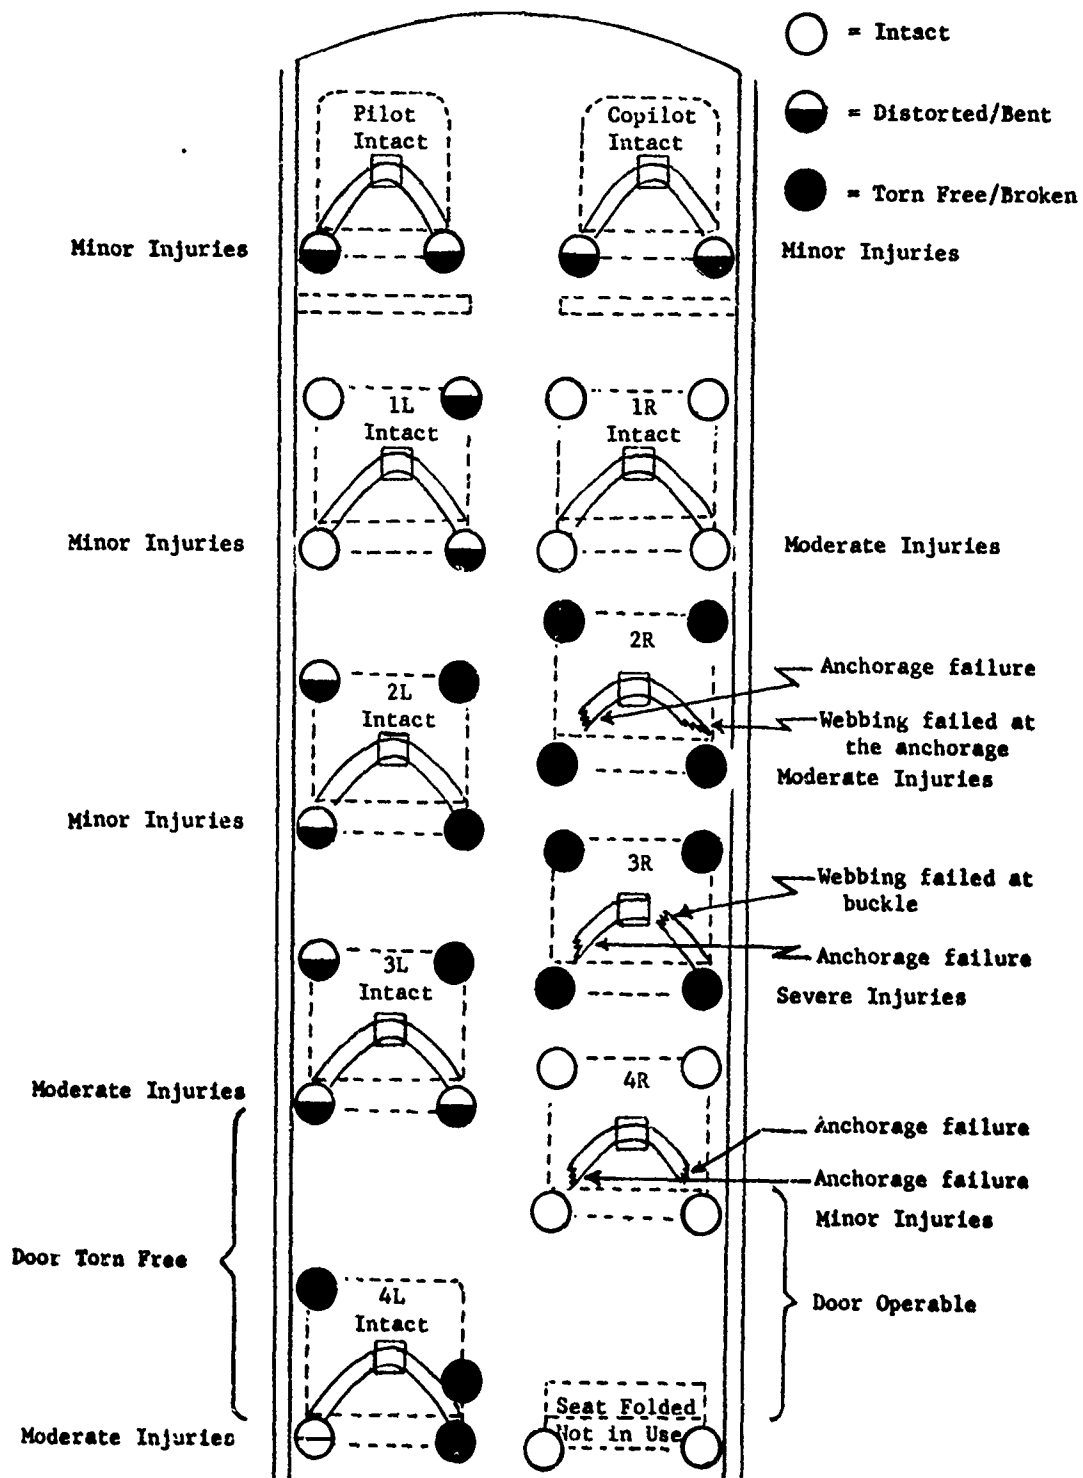
SEAT AND SEAT BELT DAMAGE  
OCCUPANT INJURIES

The pilot and scout leader (in the copilot's seat) were wearing safety belts and shoulder harnesses. Troops in the cabin were provided with seat belts, some of which failed in the crash.

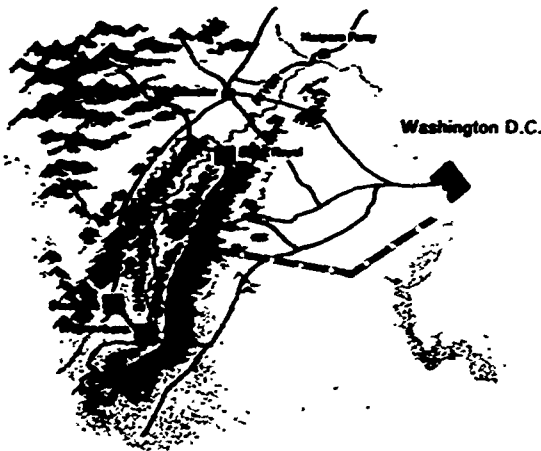
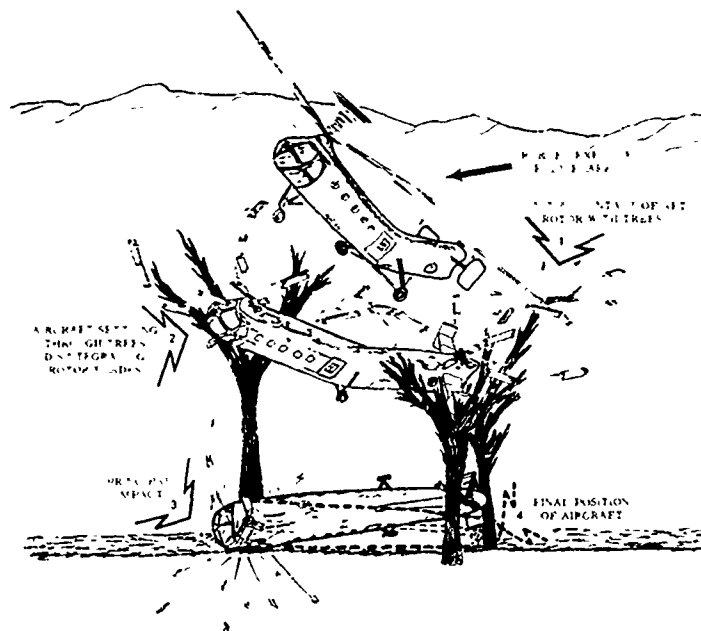
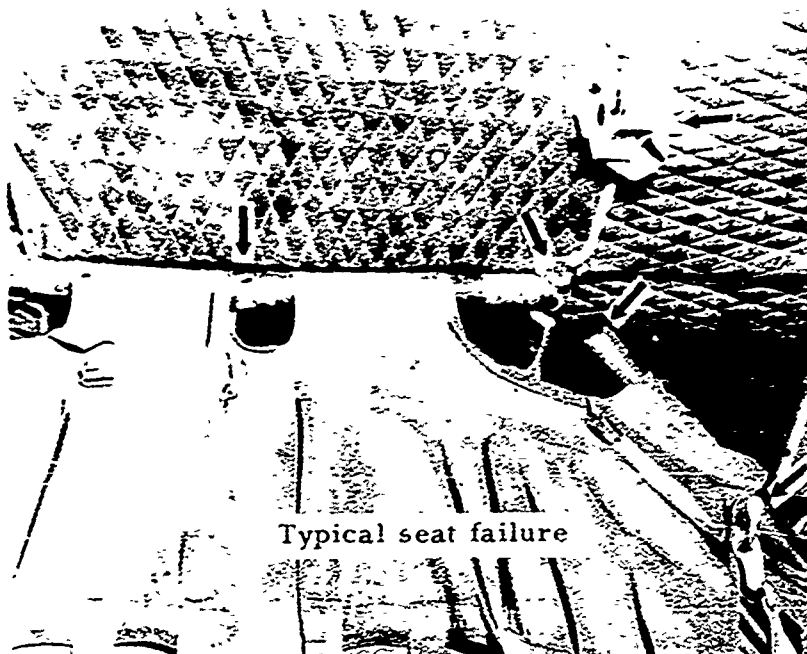
### U. S. ARMY H-21C SHAWNEE HELICOPTER ACCIDENT BIG MEADOWS, VIRGINIA 2 DECEMBER 1959

During the crash sequence, the aircraft rolled approximately 90 degrees to the left scraping down the sides of the trees approximately 40 feet in height. The aircraft impacted on its left side. Initial ground contact occurred

revealed that the predominant causes of injuries were failures of seats and seat belts. The investigation found also that relatively minor damage to the basic aircraft structure resulted from the crash and that the occupiable area of the aircraft,

with the exception of the seats and restraining devices, was almost completely intact.

As a result of the findings, it was recommended: (1) that immediate steps be taken toward increasing the integrity of both cockpit and cabin seats and

(2) that consideration be given to attachment of all restraining devices to the basic structure of the aircraft.

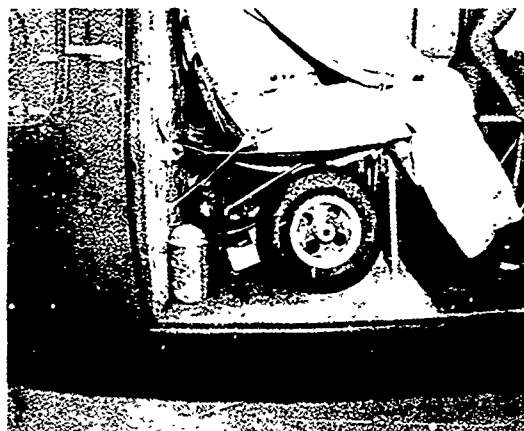
From this point the aircraft settled in a tail low attitude until striking the ground. During this latter sequence, the cabin area just aft of the pilot's seat on the right side was impaled on a stump approximately 10 inches high which penetrated into the inhabitable area.

The investigation conducted on 22-24 August 1960 revealed that the predominant causes of injuries were failures of the seat anchorages and partial collapse of the aft bulkhead supports. A contributing factor was loose gear stowed under the troop seats.

The investigation also found that the occupiable area of the aircraft received extensive damage due to the partial collapse of the aft bulkhead supports, cabin roof, and complete collapse of the side supports.

1. Immediate steps be taken toward increasing the integrity of both cabin structure and seats;

2. Adequate restraining devices be employed for all loose equipment that must be carried or to eliminate the carrying of potential injury producing items in the aircraft.

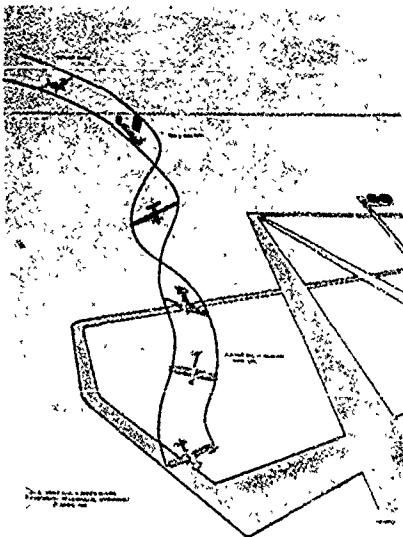
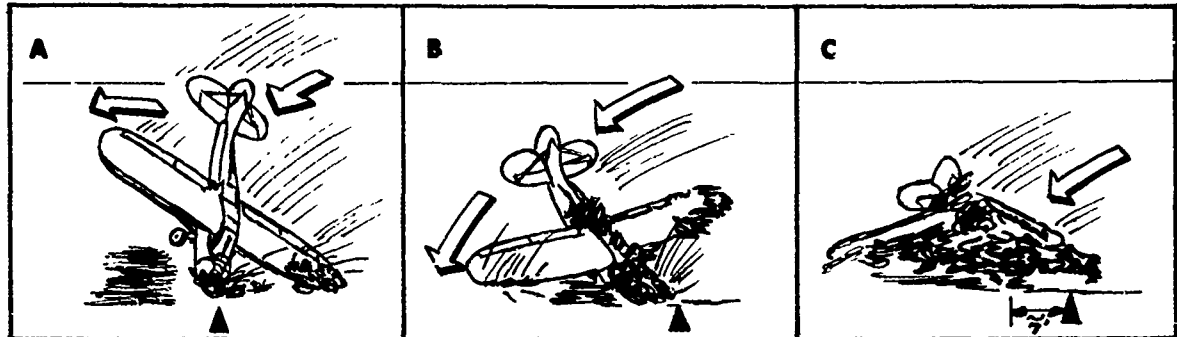
The aircraft was examined at the crash site on 29-30 April 1960. Photographs of the wreckage and of essential components and equipment were made during the course of the investigation. There were no witnesses to the accident; however, gouges in the ground and aircraft damage details, together with a graphic plotting of wreckage distribution, made it possible to reconstruct the kinematics of the crash sequence - basically a low altitude stall-

In view of both crash force magnitude and direction, as well as the extent of aircraft damage, this accident was considered non-survivable.

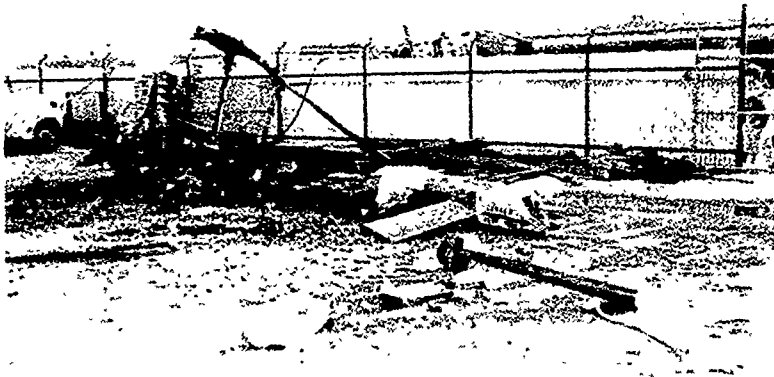
U. S. ARMY YH-41  
CESSNA HELICOPTER ACCIDENT  
PHOENIX, ARIZONA  
8 MAY 1960

The pilot experi-  
enced failure of the tail  
rudder just after take-off, the aircraft went out of control, crashed, and burned.

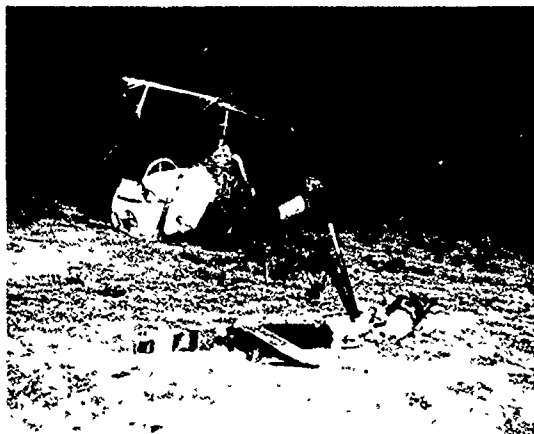
### U. S. ARMY NATIONAL GUARD H-23C HILLER HELICOPTER ACCIDENT PHOENIX, ARIZONA 8 DECEMBER 1960

With position and landing lights on, the aircraft struck the ground slightly nose-down in a gentle left turn at 50 to 60 knots forward velocity. The left skid hit first, followed by the left front underside of the cockpit. The rotors appeared to have flexed down into the tail boom, shattering the blades and tearing the tail boom into two main sections.

Investigation conducted on 8-9 December 1960 indicated that the latch on the safety belt did not hold throughout the crash sequence, for reasons still undetermined. During the initial impact, the belt held just long enough to allow the pilot to flex forward, at which point the buckle opened, allowing the pilot to go head down, backwards, through the upper portion of the bubble out of the aircraft.

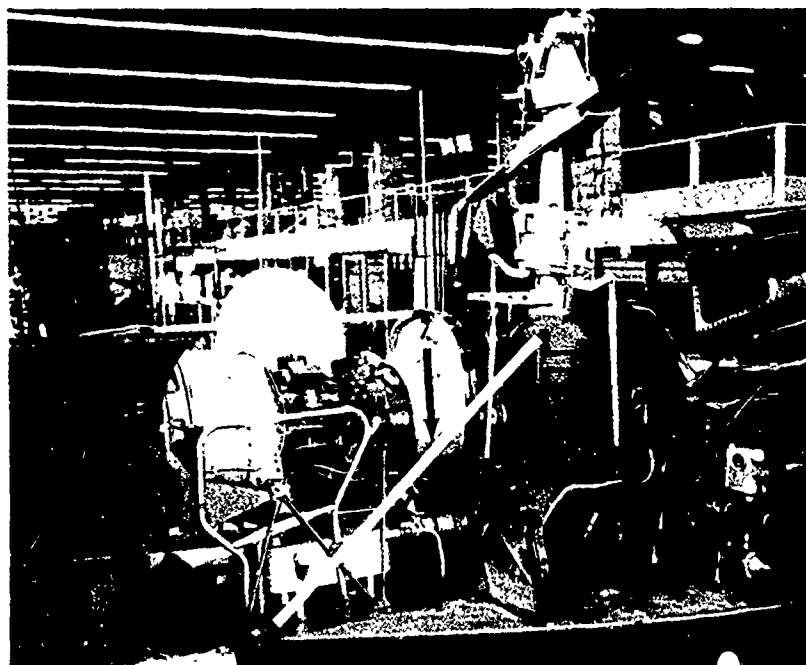
"It appears that crash loads will cause the transmission unit to break free and pass downward through the cabin bulkhead into the cabin, thereby crushing the occupants."

During the second evaluation by USABAAR, many of the same points were made with specific mention of the failure of the transmission mount in the wrecked YH-40. There also was transmission

failure in all five (5) accident cases with the transmission going into the cabin area with serious results in one of the accidents.

A suggestion of a tension tie (cable or tube), as illustrated below, was made.

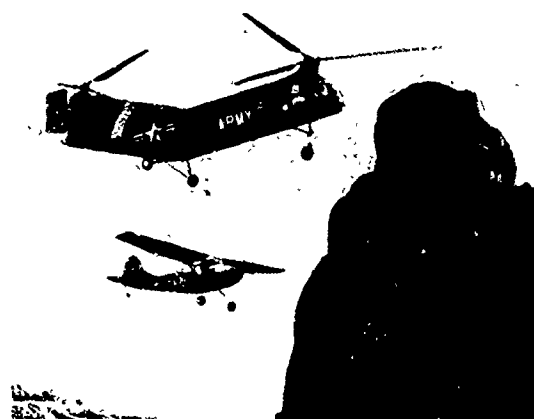
with an attempt to recover at low altitude. The actual drop was made at 35 knots, but the altitude was approximately 40 feet instead of 60 feet above the terrain.

- (3) Impact was to be on a relatively level terrain with the impact angle being 30 degrees nose down with no roll or yaw. Due to the low altitude at actual drop (40 feet) and a slightly

premature release, the aircraft impacted against the side of a ravine just ahead of the level terrain selected for the impact area.

This made an impact angle of 60 degrees with reference to the terrain (aircraft nose down 30 degrees and impact slope 30 degrees).

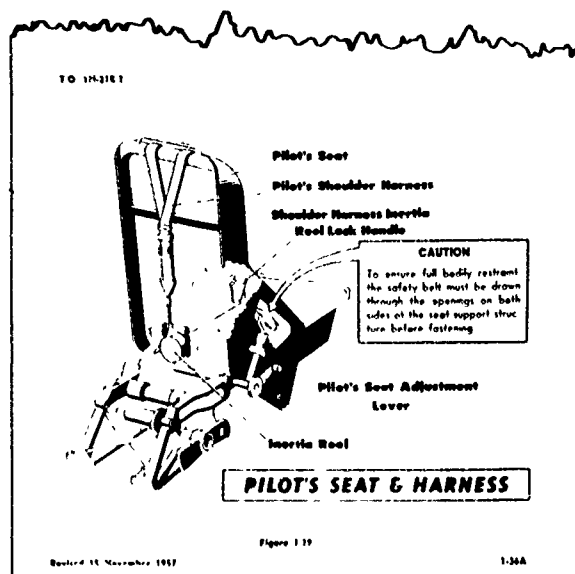
During an investigation of an accident involving an H-21 helicopter in which one crew member in the cockpit was fatally injured, it was noticed that the safety belt was improperly positioned on both seats.

In the medical report of this accident, and in one other H-21 accident on file at AvCIR, the medical investigators called attention to positioning of the safety belts as being a probable source of rib-cage and internal injuries.

The AvCIR accident investigation, plus the medical doctors' comments, led to an examination of the Technical Manual covering the safety belt installation. It was found that a 15 November 1957 revision carried a caution note on the proper installation of the belts and a subsequent revision (1 February 1959) deleted the caution note and illustrated

an improper installation.

The preceding information was presented in a Crash Injury Prevention Bulletin with a recommendation that the discrepancy be brought to the attention of all units utilizing H-21 helicopters and that the Technical Manual be revised to eliminate the discrepancy.

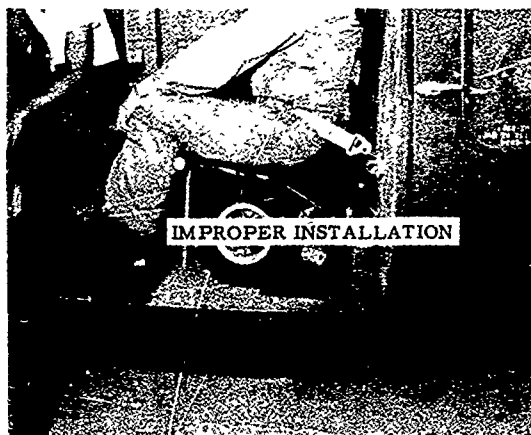
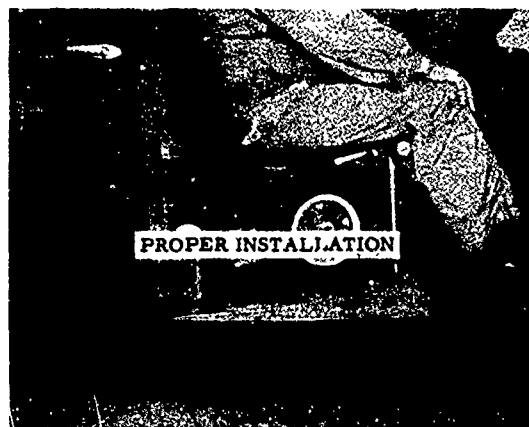
Part I - Attachment of Seat Belts in the HU-1A Helicopter

During investigations of several HU-1A accidents, it was noted that the safety belts utilized by occupants of the troop seat of this aircraft were anchored to the rear seat support member rather than to the cables provided in the aircraft for this purpose.

Anchoring of the seat belts to the rear seat support member causes the belt to ride across the occupant at an undesirable angle and introduces a potential cause of internal injuries. Further, this attachment does not have the seat belt anchor strength obtained when the belts are attached to the cables provided, which are anchored to basic aircraft structure.

Part I of this bulletin recommended that the units operating this aircraft be instructed to attach the troop seat belts to the cables provided in the aircraft.

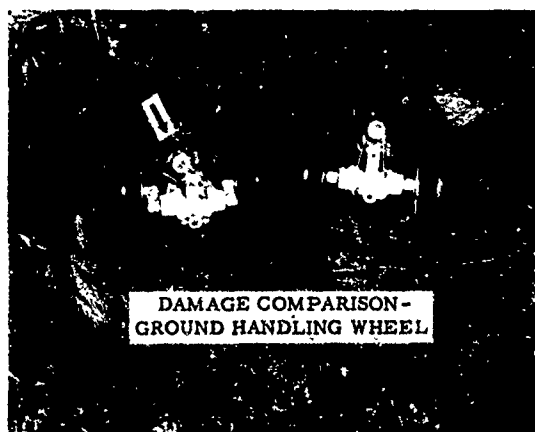
Part II - Stowage of Equipment under Troop Seats

Part II of the bulletin discussed and illustrated the manner in which certain items of loose equipment were stored under the troop seat during operation of the aircraft.

This information resulted from the investigation of an accident in

which one occupant of the troop seat was seriously injured when the troop

seat failed and the occupant bottomed out on a set of ground handling wheels stowed beneath his seat.

It was recommended that the area beneath the troop seats be kept free of loose equipment, and if non-rigid equipment is stored underneath the

seat that it be securely anchored to prevent its being thrown through the aircraft in the event of an accident.

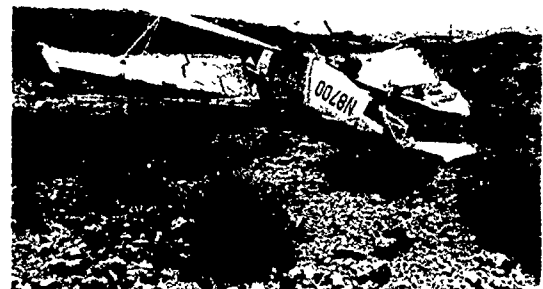
The aircraft settled down in a normal landing attitude, striking a pile of large rocks, sliding for approximately 60 feet, nosing over, and then sliding an additional 17 feet inverted. The aircraft was demolished.

The pilot was uninjured with the exception of being covered with toxic materials. However, the insecticide was not of the Parathion or Malathion type where fatality would have been certain.

Investigation revealed that the pilot had been wearing a crash helmet, shoulder harness, and safety belt, the combination of which is believed to be the life saving factor in this accident.

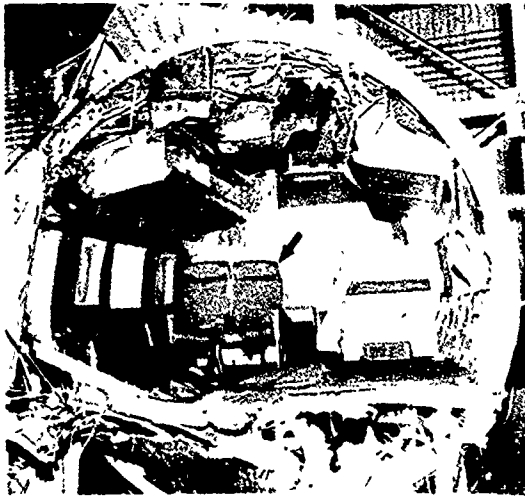
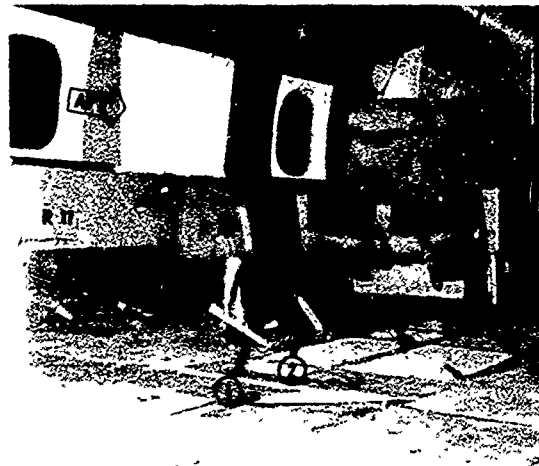
### LOCKHEED ELECTRA ACCIDENT LOGAN AIRPORT BOSTON, MASSACHUSETTS 4 OCTOBER 1960

Immediately after take-off, a Lockheed Electra L-188 struck a water surface in a near-vertical attitude. The forward and center fuselage sections were completely destroyed. The tail section, which included the lounge and part of the main cabin, remained remarkably well intact. Of the 72 persons aboard the aircraft, 10 survived the accident.

From the standpoint of crash survival, the tail section was of interest since only in this area were impact conditions of a possible survivable nature. The three side-facing occupants of the lounge survived, although one of them experienced seat belt attachment failure. One occupant of the only passenger seat that remained in place in the cabin - the aft-most seat on the right - is known to have survived. His seat belt held. The fate of the occupants of the other double seats in this intact cabin area is not exactly known. It is known, however, that at least seven (7) of them did not survive.

The seat failures were the result of inertia forces acting almost parallel to the longitudinal axis of the aircraft. Typical seat anchorage failures consisted

of pulled-out wall fittings and sheared-off leg plates. In that respect, this accident proved convincingly that the present occupant tie-down criteria are well below survivable human G tolerances and are no longer consistent with the apparent strength of modern fuselage structure.

Lack of reliable medical data, especially on the survivors, made it impossible to accurately determine the effect of occupant environment on impact survival. There are indications, however, that the integrated service trays were a potential source of head injuries while the aft beam of the seat frame undoubtedly caused numerous leg fractures. This confirms past accident experience showing that the full benefit of seat belt restraint can be realized only in combination with a non-injurious occupant environment.

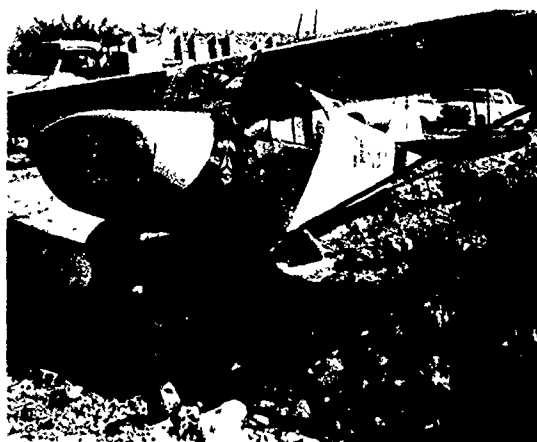
The aircraft was dispatched for an aerial message pick-up in conjunction with a Civil Defense maneuver. Due to an erroneous emergency signal from the ground party, an intermediate landing was attempted on rock strewn single lane road, the only suitable area in the mountainous terrain.

During the attempted landing, the aircraft bounced, became airborne a short distance, and then touched down again. During the second touchdown, the left landing gear struck a large rock causing the left gear to fail. This, in turn, caused the nose area to drop sufficiently to damage the propeller and the aircraft slid to a stop.

No injuries were sustained by the two occupants.
