U. S. NAVAL AIR TEST FACILITY (SI)

Report NATF-EN-1086

DEVELOPMENT AND EVALUATION
OF THE
TC13 MOD 1 STEAM CATAPULT
(30 Jan 1964 to 19 Oct 1965)

Periodic Report No. 1
22 March 1966

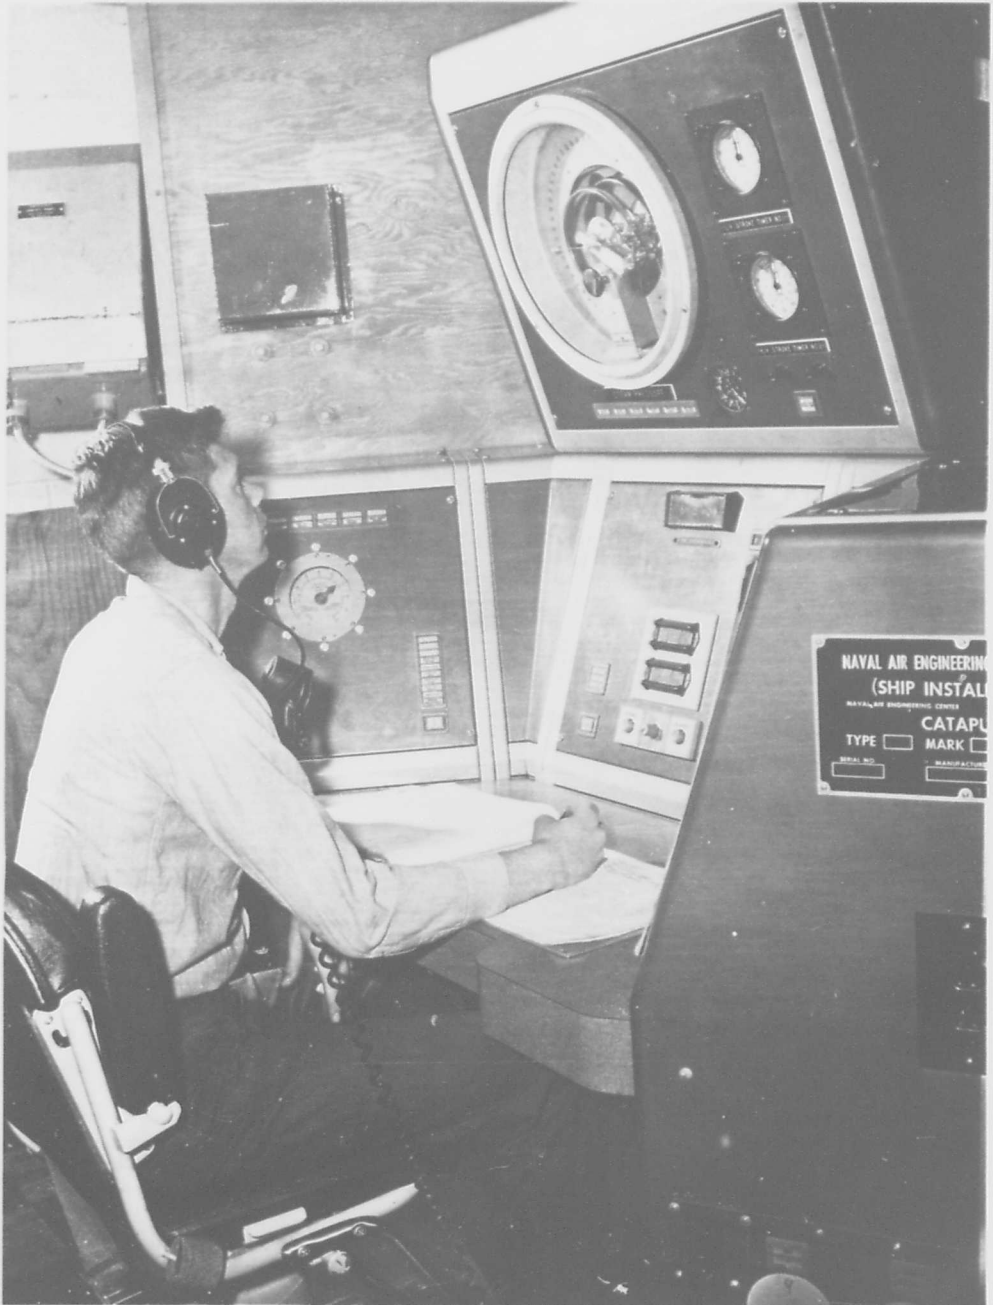
Figure 6 - CVA67 Wrap-Around Control Console (NAEL(SI) PN 612619-1)
Installed in TC13 Mod 1 Control Room

b. The console was installed in the TC13 Mod 1 control room in accordance with NAEL(SI) Drawing 612816. Figure 6 shows the completed installation. The console was wired and piped in parallel with the existing standard console so that control could be executed from either unit. Upon completion of the installation, the wrap-around console was functionally checked, and after correction of minor discrepancies, the system operated satisfactorily. Special tests will be conducted to determine the effectiveness of this new-type console.
