AIRCRAFT GROUND-FLOTATION INVESTIGATION
PART III. DATA REPORT ON TEST SECTION 2

U. S. ARMY ENGINEER WATERWAYS EXPERIMENT STATION

TECHNICAL REPORT AFFDL-TR-66-43, PART III

APRIL 1966

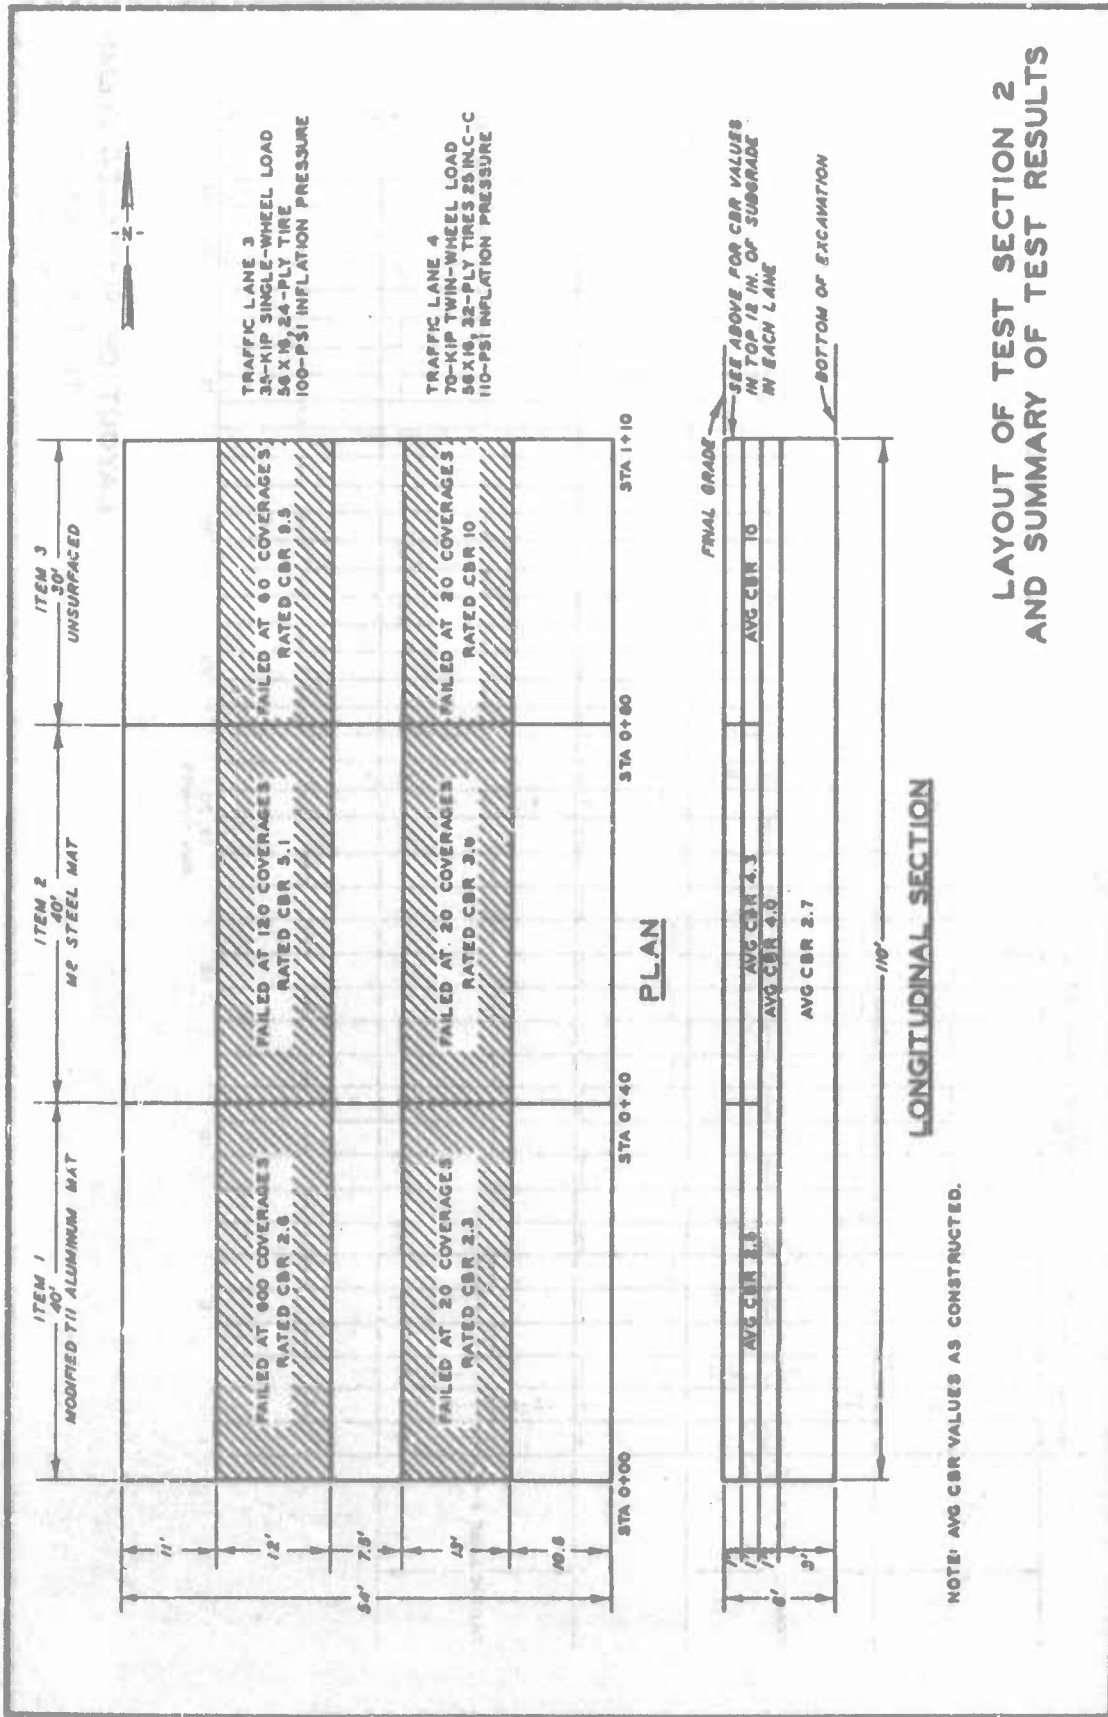
Figure 26

Two traffic lanes divided into three items each were constructed in the section. Different subgrade strengths were obtained in the items (**Fig 26**) by controlling the water content and compaction effort. Items 1 and 2 were surfaced with modified T11 aluminum and M8 steel landing mats, respectively (see **Fig 27**). Item 3 remained unsurfaced. The landing mats used are described and illustrated in Part I.

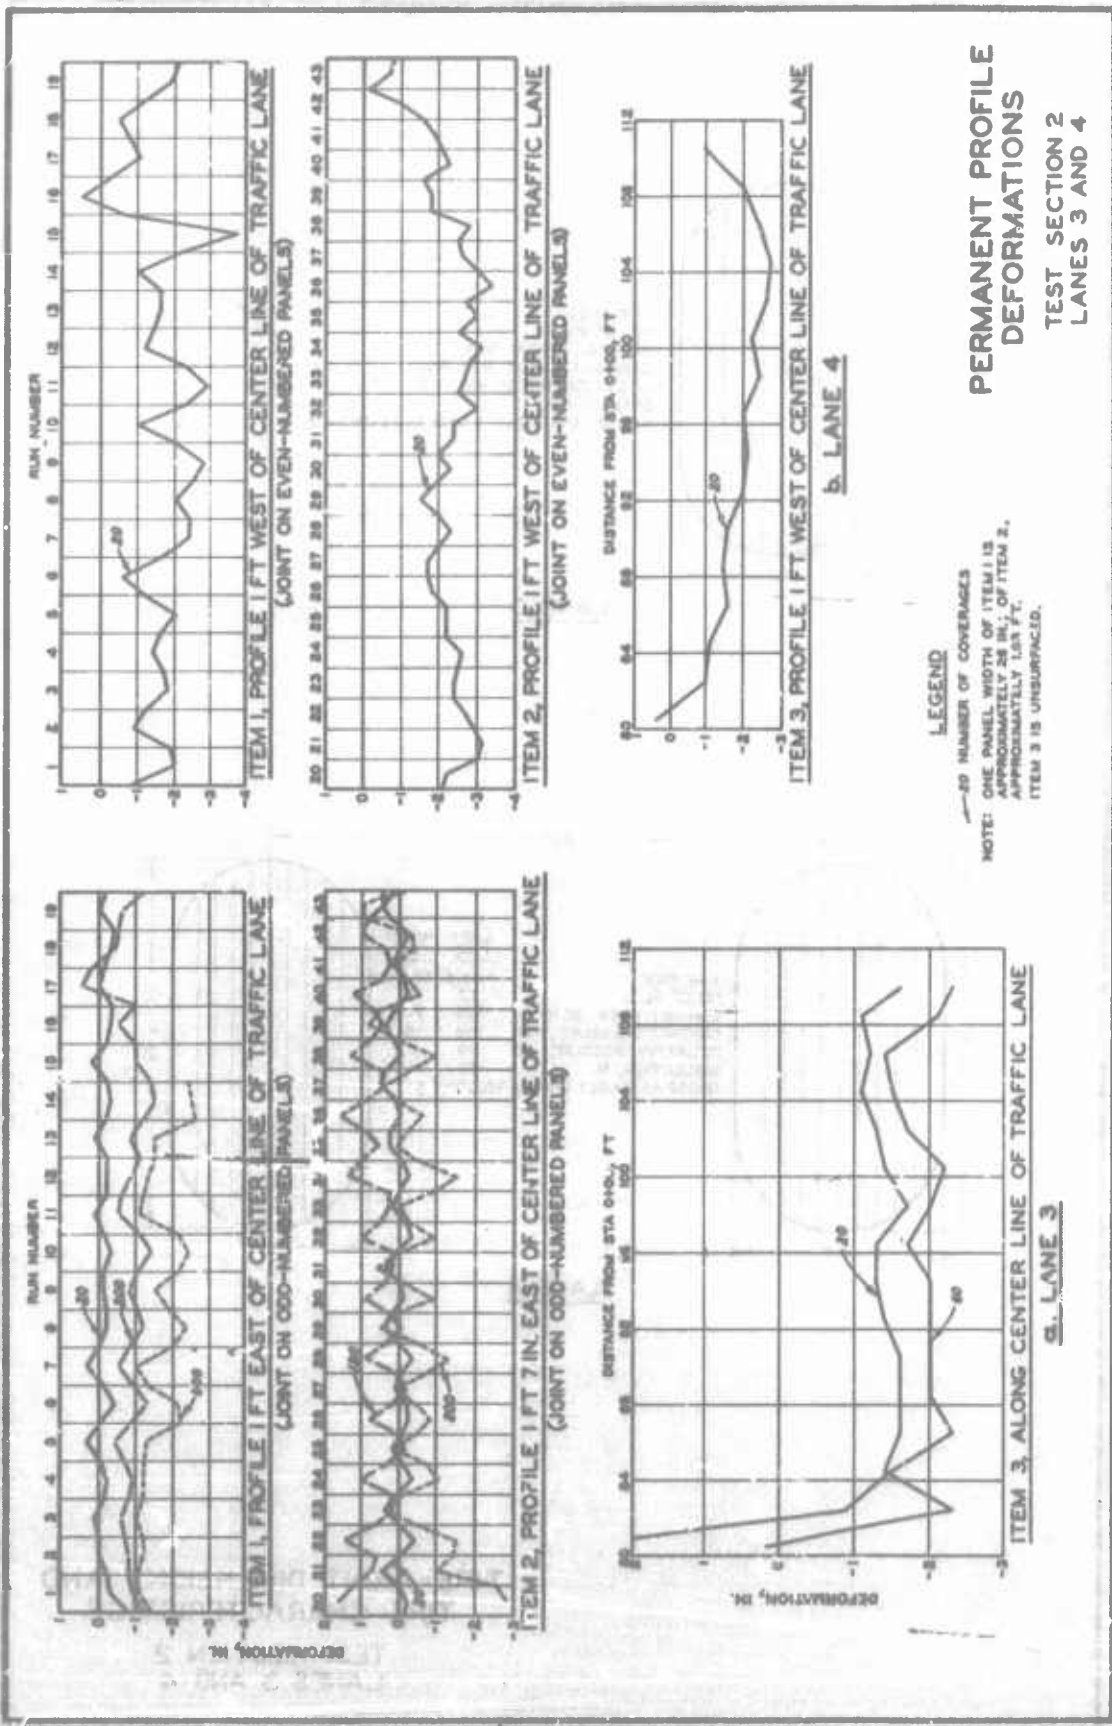
Figure 29

- b. Deformation. Average profile and cross-section deformations are shown in Figs 29 and 30, respectively. The maximum deformations occurred along the joint line 1 ft west of the center line. Fig 30 shows a maximum cross-section deformation of 1.9 in. for the item. The profile plots in Fig 29 illustrate the severe deformation and roughness that occurred along the direction of traffic.

b. Deformation. Average profile and cross-section deformations are shown in Figures 29 & 30, respectively. Maximum deformation occurred along a line near the end joints on the west side of the lane.

b. Deformation. Average cross-section deformations are plotted in Fig 30 for the 20-coverage level. Significant changes in the cross section occurred with each pass of the load vehicle due to severe rutting beneath the load wheels. The profile plot in Fig 29 indicates a general subsidence along the longitudinal direction of the traffic lane.
