20 June 1966

Subject: Final Report Investigation and Recovery Program for Nozzle Port  
Flange Snap Ring Groove Cracking Problem of the Minuteman Stage III  
Motor, Report No. MTO-752-50

FINAL REPORT  
INVESTIGATION AND RECOVERY PROGRAM  
FOR  
NOZZLE PORT FLANGE SNAP RING GROOVE CRACKING PROBLEM  
OF THE  
MINUTEMAN STAGE III MOTOR

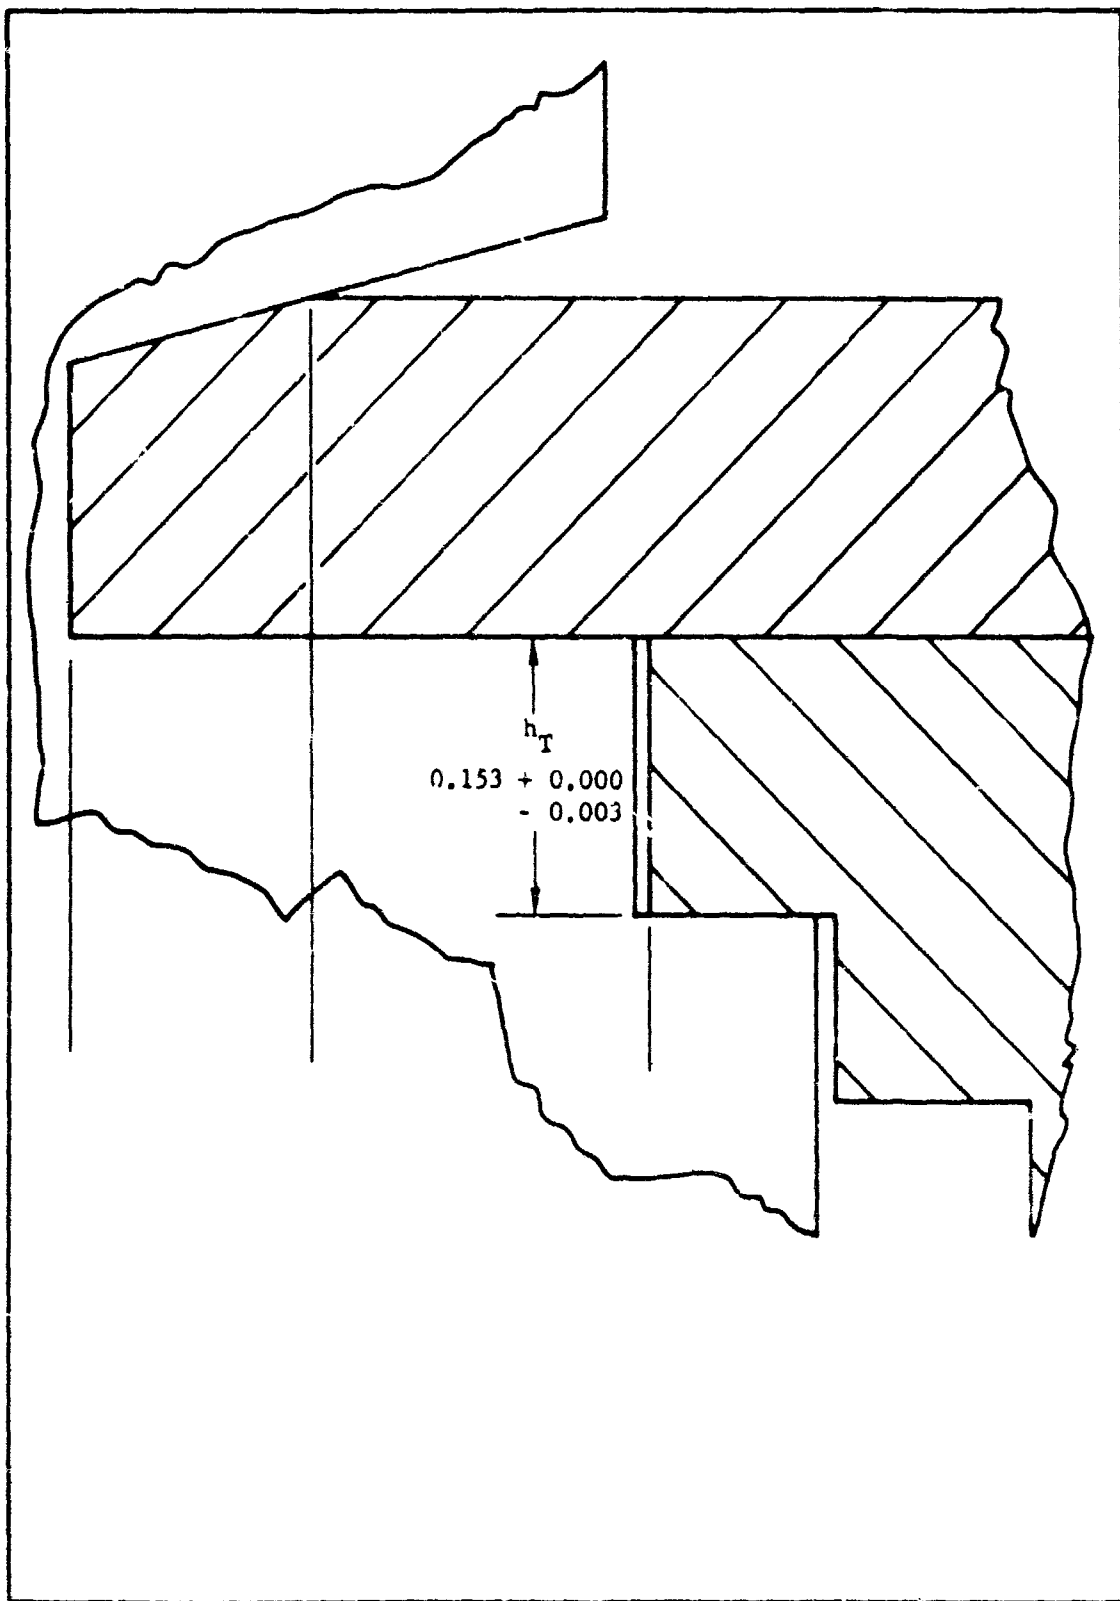
Figure 11. Original Hydroproof Closure Installation

During inspection of the hydroproof closures used for production case testing, it was discovered that the nominal thickness of the closure lip was 0.150 in. This dimension was 0.025 in. thinner than the nominal thickness of the lip on an operational nozzle. Figures 11 and 12 show that the snap ring does not seat as deeply into the snap-ring groove with the operational nozzle as it does with the hydroproof closure.

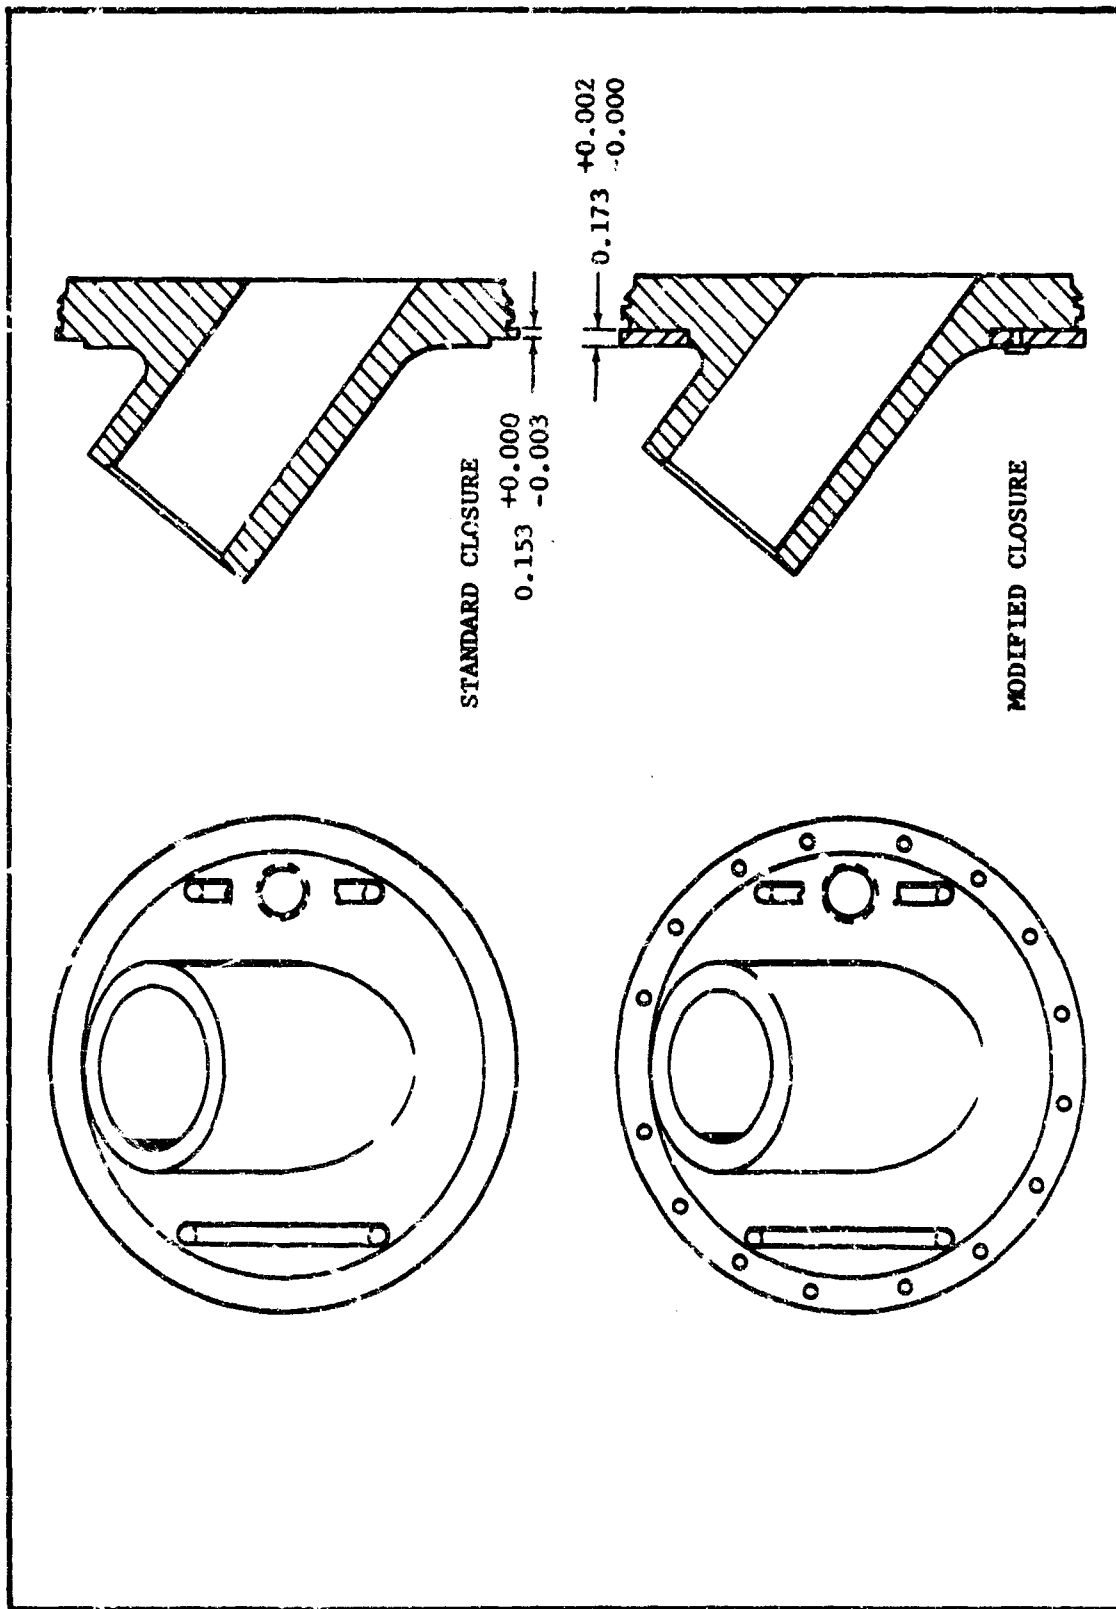
Figure 13. Hydrotest Closure Comparison

The original hydroproof nozzle port closures have a lip thickness dimension of 0.150 to 0.153 in., whereas, the corresponding dimension for the operational nozzle hardware is 0.175 to 0.180 in. Simulated hydroproof loading tests showed that a change in closure-lip thickness had a marked effect on the stresses in the snap ring groove area of a nozzle port flange. The purpose of these tests was, therefore, to evaluate and compare the stresses on a nozzle-port flange during actual hydroproofing with the standard hydroproof closures and with closures modified to correspond to the operational nozzle hardware dimensions. (See Figure 13.)
