## **AIRCRAFT GROUND-FLOTATION INVESTIGATION**

### **PART IV. DATA REPORT ON TEST SECTION 3**

**TECHNICAL REPORT AFFDL-TR-66-43, PART IV**

**APRIL 1966**

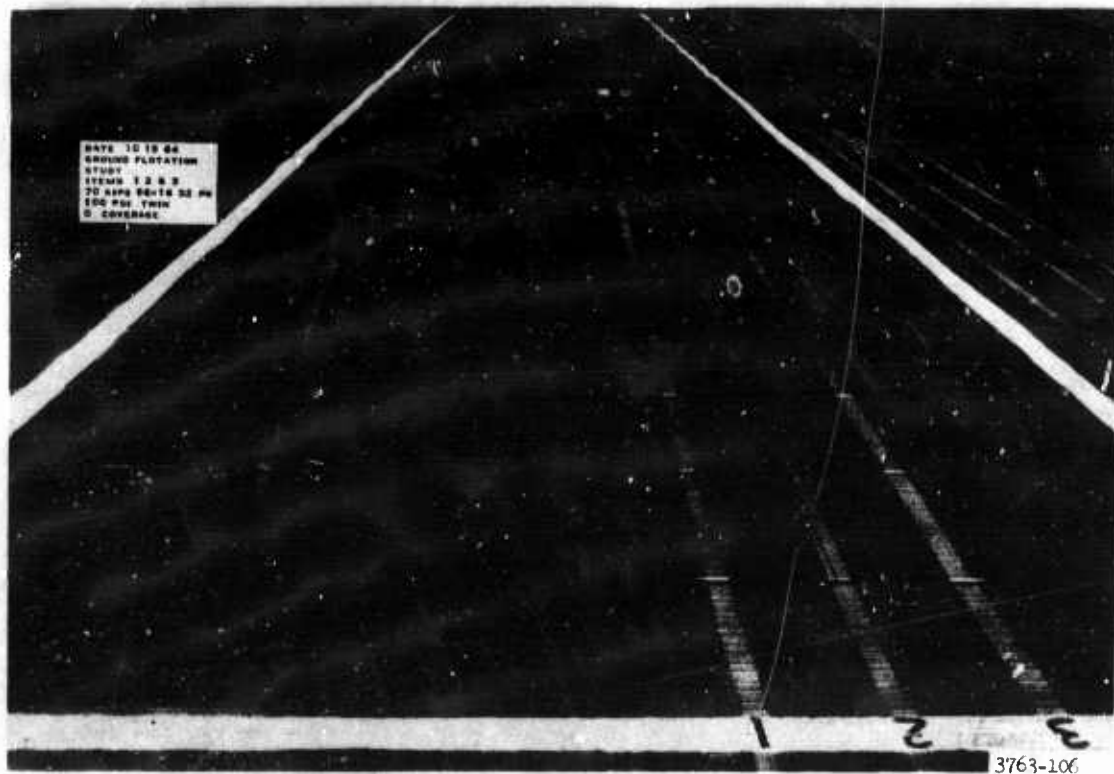
**Figure 3.** Lane 5, item 1, prior to traffic

Item 1. **Figure 3** shows item 1 (foreground) prior to traffic. Mat deterioration and subgrade deformation increased steadily with trafficking. The item was considered failed due to roughness at 28 coverages. A segment of the mat at the 30-coverage level after two post-failure coverages is shown in **Figure 4**. The rated CBR for the item was 2.0.

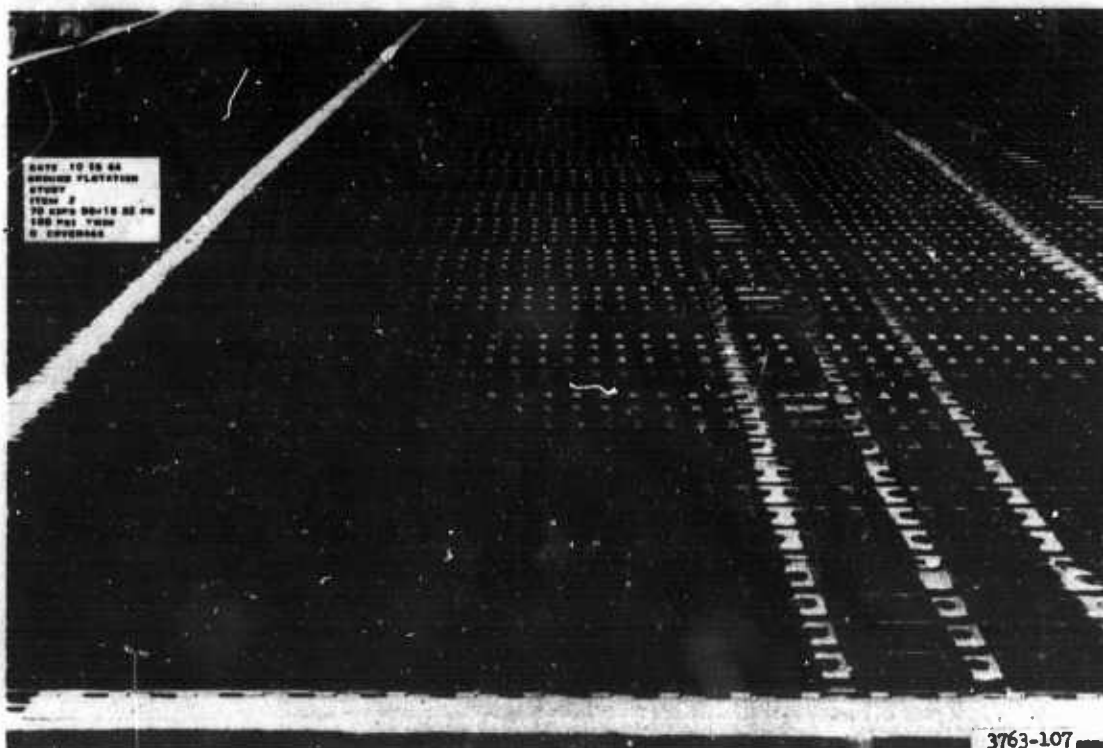
**Figure 5.** Lane 5, item 2, prior to traffic

Item 2. Item 2 prior to traffic is shown in **Figure 5**. The item was considered failed due to roughness at 28 coverages. Two postfailure coverages were applied. **Figure 6** shows the item at the 30-coverage level. As the item approached failure (28 coverages), the subgrade became less resistant to displacement and the resulting plastic deformation conformed to the impression made by the last pass of the tracking vehicle. The M8 steel landing mat was flexible enough to follow the contours of the deformed subgrade without breaking. The rated CBR for the item was 3.8.

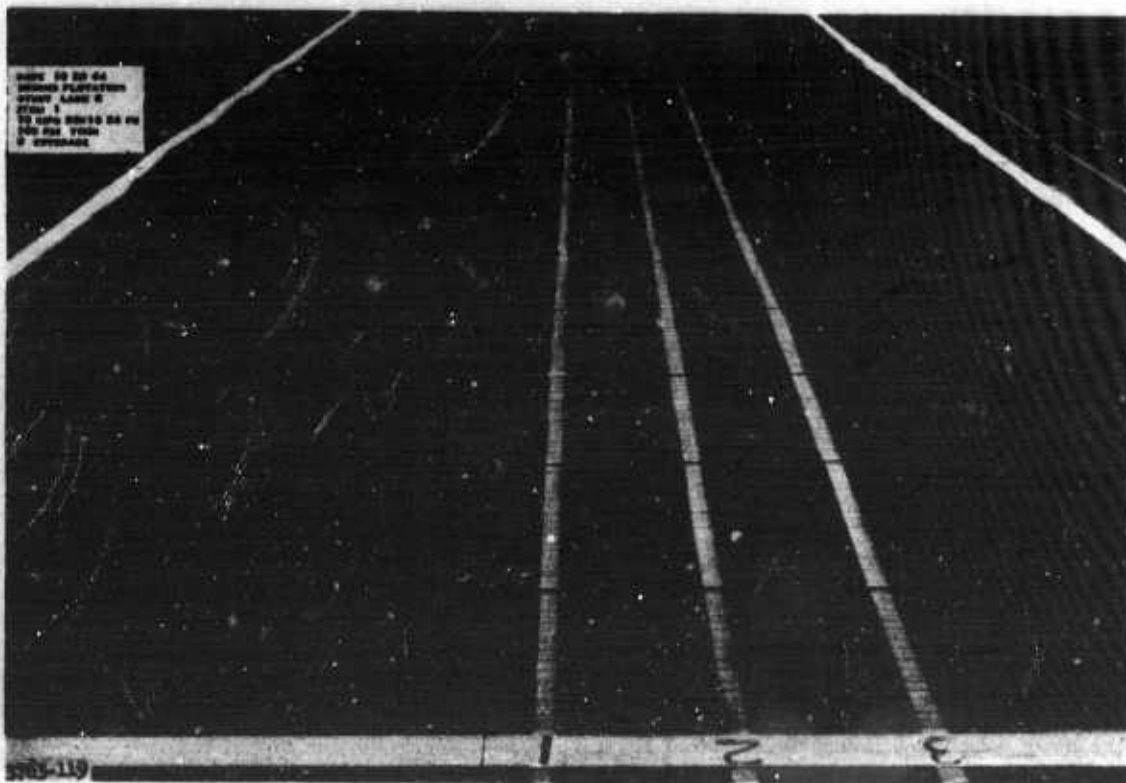
**Figure 9.** Lane 6, item 1, prior to traffic

Item 1. **Figure 9** shows item 1 prior to traffic. After the first 20 coverages, the rate of mat deterioration (breakage) increased. Displacement of the subgrade away from the center toward the outside of the traffic lane created a concave cross section. The item was considered failed due to roughness and mat deterioration at 130 traffic coverages. Traffic was continued to 156 coverages (**Figure 10**). The rated CBR was 2.0.

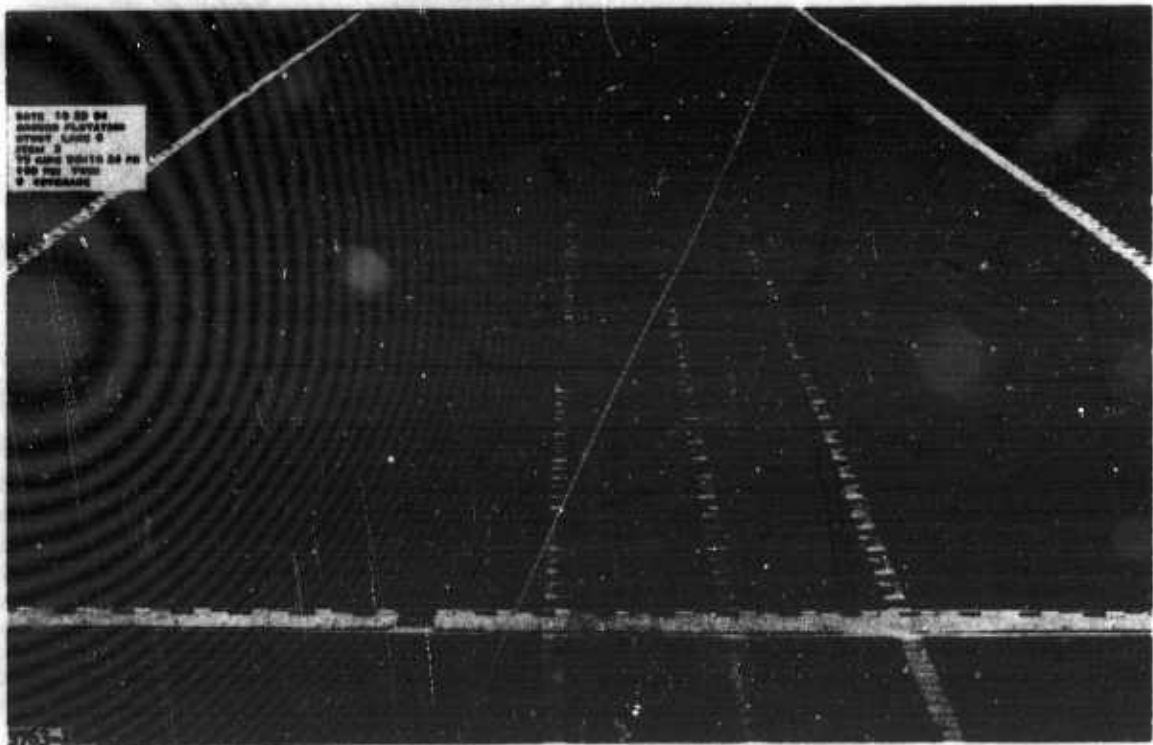
**Figure 11.** Lane 6, item 2, prior to traffic

Item 2. **Figure 11** shows item 2 prior to traffic. At 50 coverages no mat breaks were observed and differential deformations were within the allowable range for serviceable surfaces. The item was considered failed due to roughness at 76 coverages (**Figure 12**). The rated CBR was 3.6.

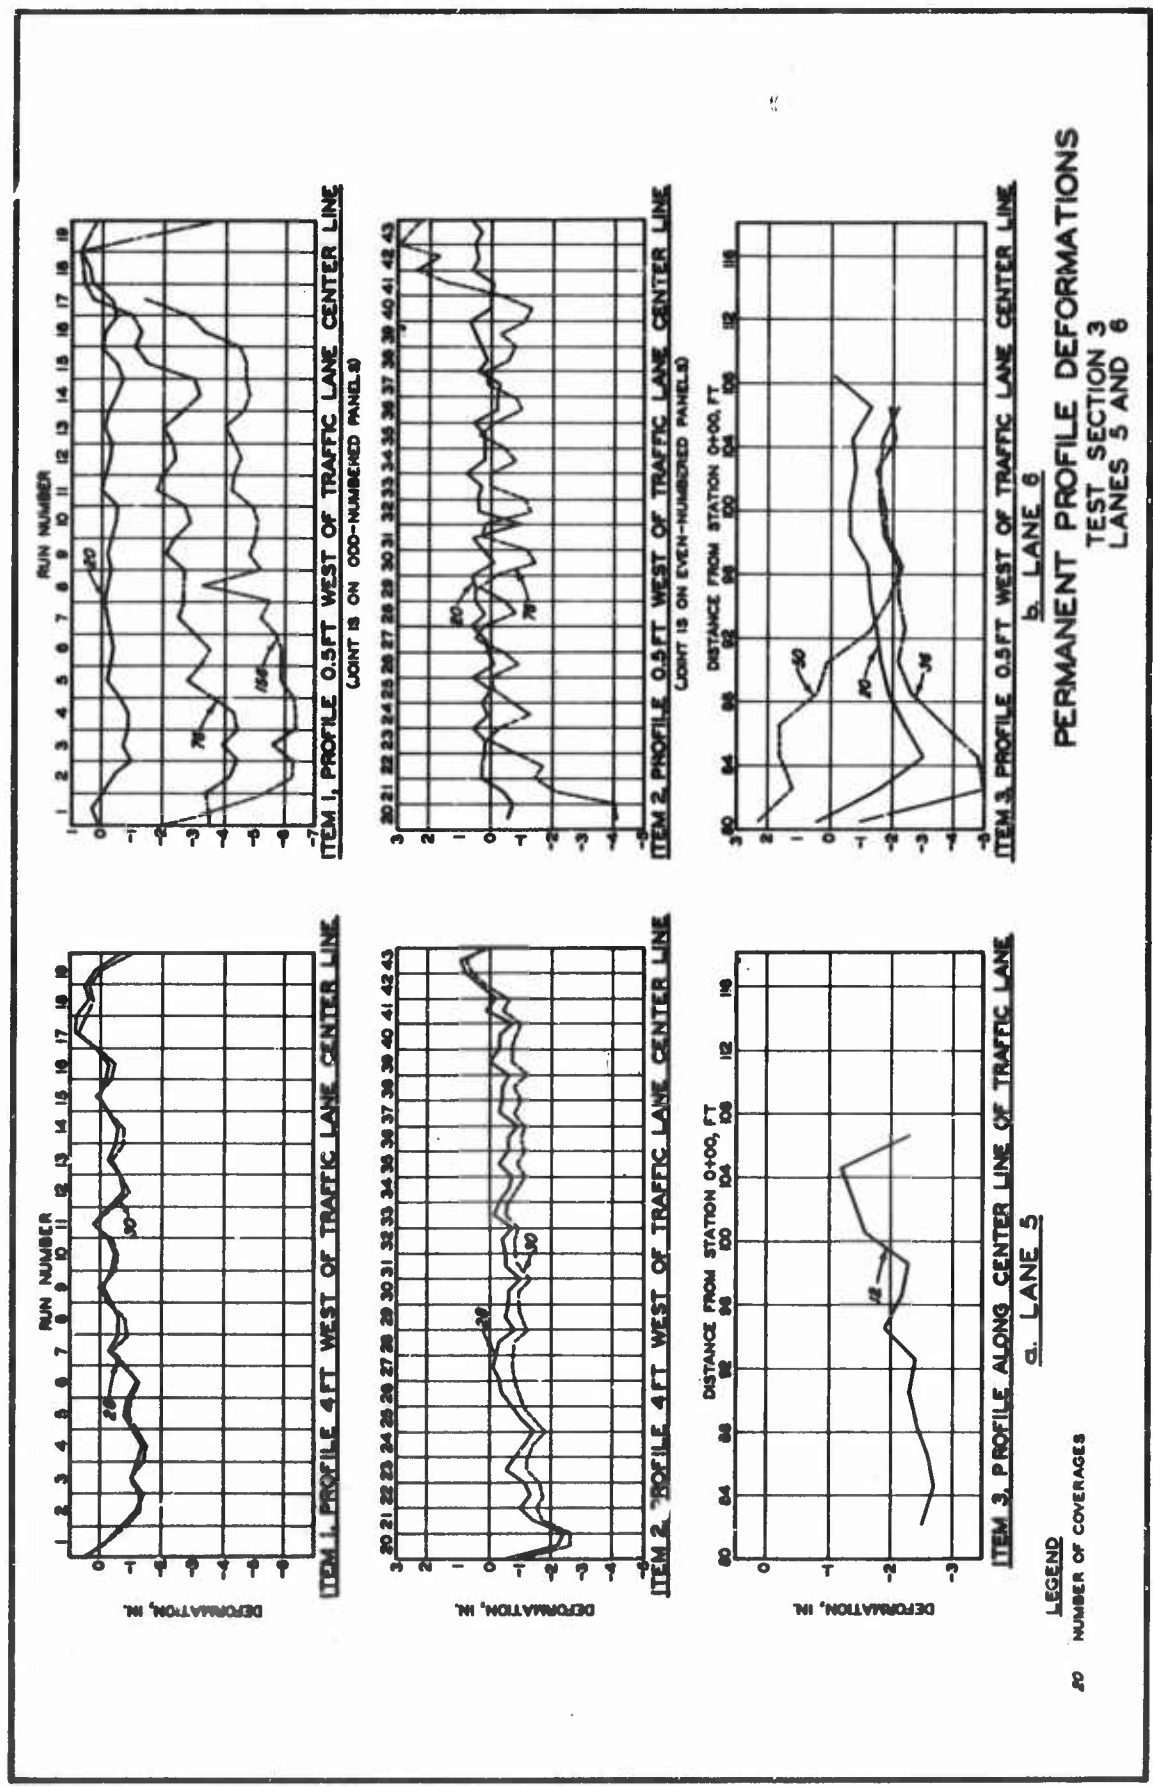
Figure 22  
25

- b. Deformation. Average cross-section deformations at 28 and 30 coverages are shown in **Figure 21**. Considerable change in cross section occurred between the two coverage levels, particularly at the mat joint line. Profile deformation along a joint line 4 ft off of the lane center line is shown in **Fig 22**. Maximum dishing of about 0.50 in. was measured at failure.

- a. Roughness. At 12 coverages the item had 4-in.-deep ruts. With four postfailure coverages the item deteriorated badly with ruts in excess of 12 in. in depth. Table 1 gives differential deformations as measured at failure.
- b. Deformation. The center-line profile in **Fig 22** shows the general longitudinal subsidence of the traffic lane. The average cross-sectional deformation in **Fig 21** illustrates the extreme rutted condition of the item.
- c. Deflection. Total soil deflections under static load of the test vehicle are plotted in **Fig 23** for 0 and 12 coverages. The elastic component of deflection (table 1) averaged 0.65 in. prior to traffic and 0.7 in. at failure.
- d. Rolling resistance. Drawbar pull values for 0 and 12 coverages are presented in table 1. Peak and rolling drawbar values increased significantly with traffic while initial values were practically unchanged.

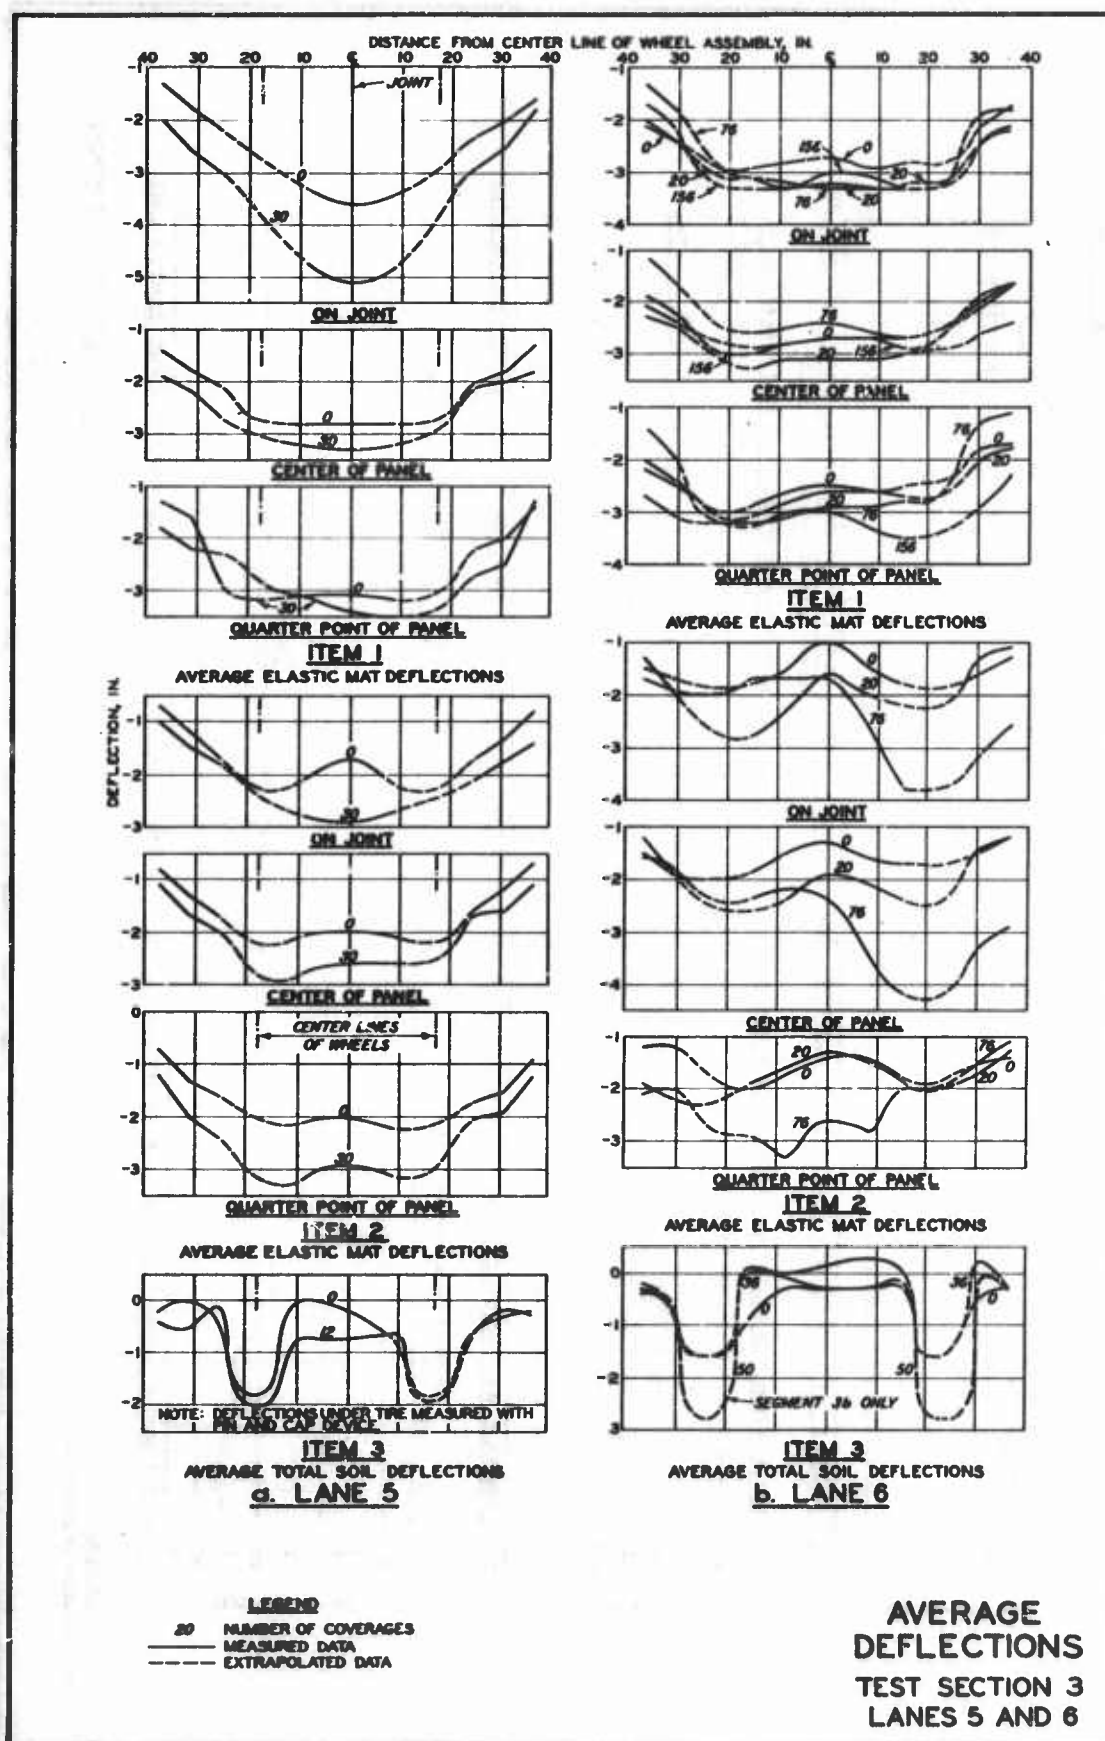
Figure 23

- c. Deflection. **Fig 23** reflects substantial increases in deflection between the 0- and 30-coverage levels at each of the three locations at which measurements were made in item 1. With the mat joint at the center of the twin-wheel assembly, the resulting surface configuration resembles that typical of single-wheel loads. A similar but flatter pattern is seen in the plot showing deflections with the midpoint of the panel at the center line of the assembly. The plot with the quarter point of a panel at the center line of the assembly assumes a shape that reflects the twin-wheel loading. Elastic subgrade deflection was 2.1 in. as measured by the pin and cap device at 30 coverages.

- c. Deflections. Elastic mat deflections under the static load of the test vehicle were measured at 0 and 30 coverages. The average deflection plots in **Fig 23** show a configuration reflecting the twin-wheel loading. Table 1 shows elastic subgrade deflection as measured at 0 and 30 coverages.
