REPORT NO. RS-TR-66-5

**METALLURGICAL EXAMINATION OF BULLPUP "A"  
PROPULSION UNIT S/N 4800 AFTER THREE YEARS OF STORAGE**

April 1966

**Materials Engineering and Development Branch  
Structures and Mechanics Laboratory  
Research and Development Directorate  
U. S. Army Missile Command  
Redstone Arsenal, Alabama 35809**

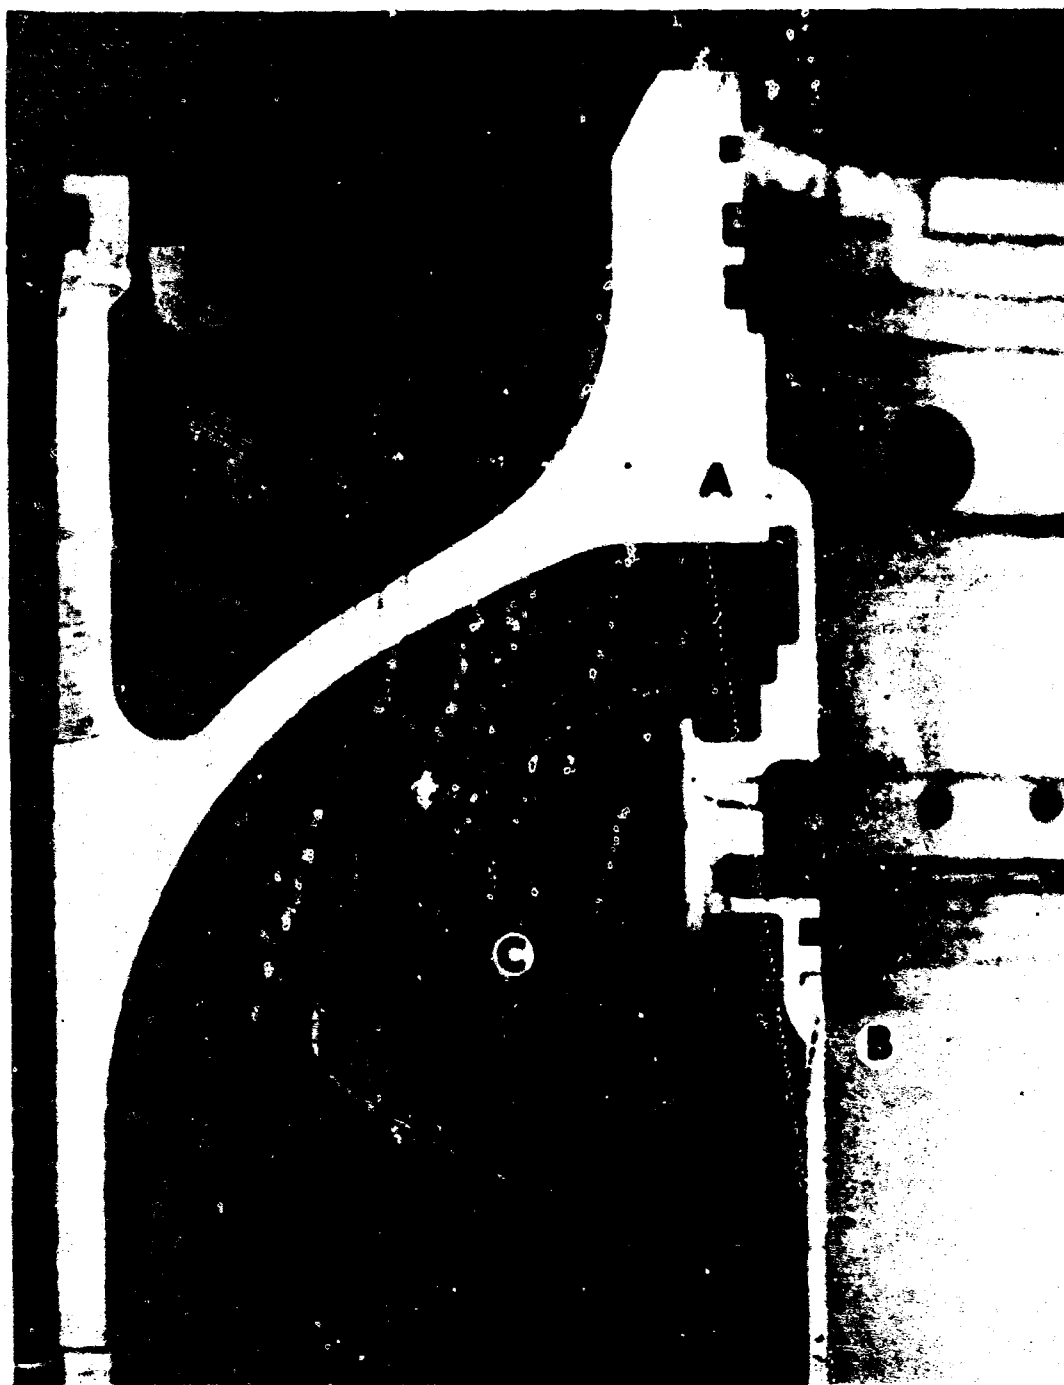
Figure 15. Forward End of Oxidizer Tank, Sectioned, Close-Up View

- A. Burst Band to Forward Dome Weld
- B. Burst Band to SPGG Tube Weld
- C. Solid Propellant Gas Diffuser and Deflector Assembly

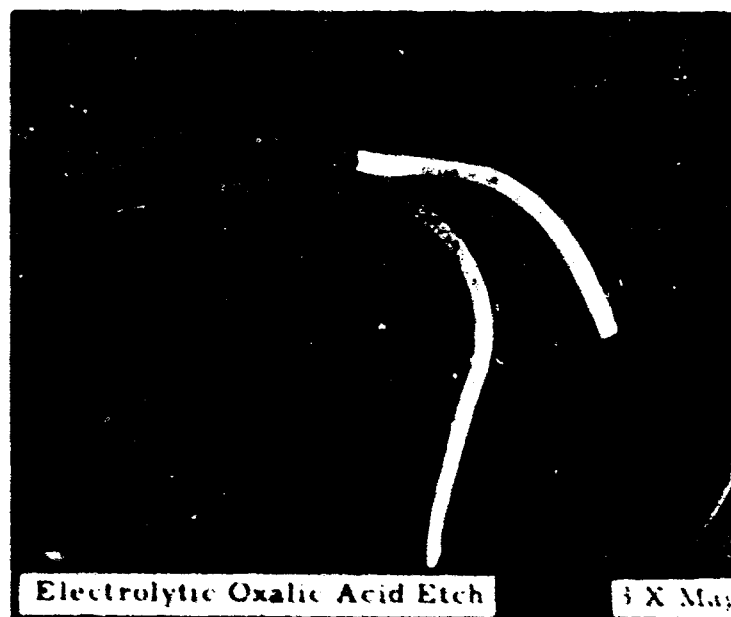
Figure 21. Stainless Steel Solid Propellant Gas Diffuser and Deflector, in Two Pieces

Examination of the interior surfaces of the oxidizer tank revealed, in addition to the amber colored deposit, a slight etch condition over all surfaces. This etch was slightly more apparent at the weld heat affected zone (HAZ). The surface of the stainless steel SPGG diffuser and deflector was etched fairly heavily under the green flaky deposit.

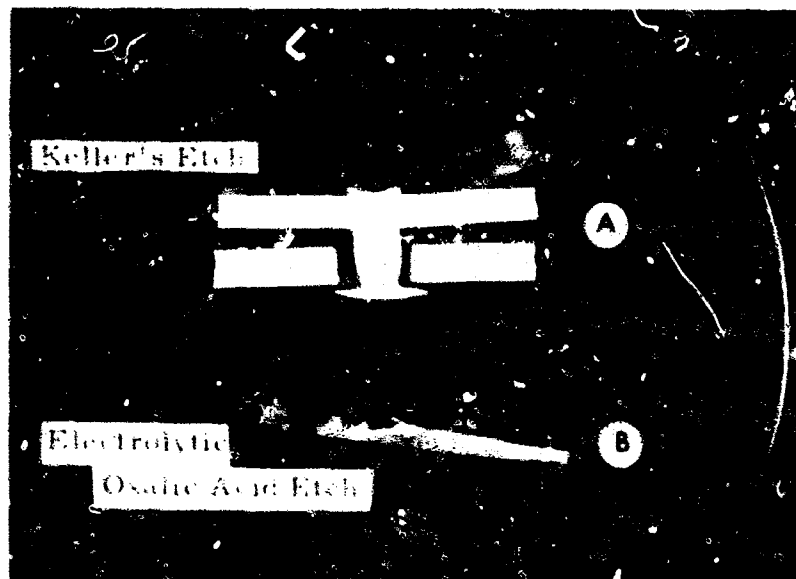
Figure 49. Oxidizer Director and Screen Assembly

- A. Aluminum Retainer, Director, and Rivet;  
Stainless Steel Screen
- B. Stainless Steel Retainer and Screen

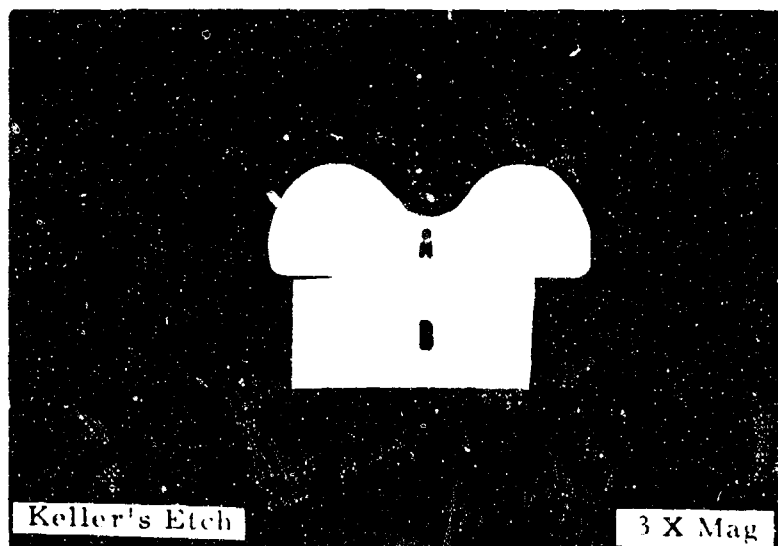
Figure 54. Aluminum Retainer Ring, Oxidizer  
Director and Screen Assembly

- A. Transverse Section
- B. Longitudinal Section

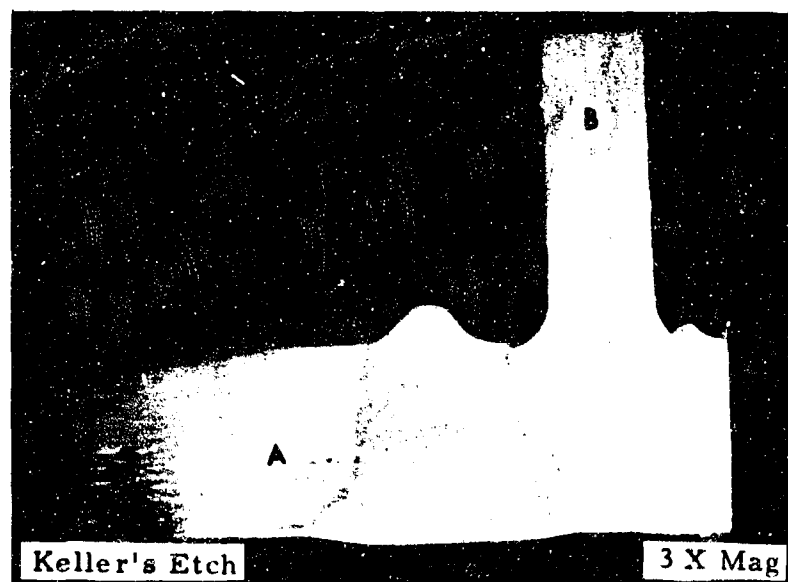
**Figure 56. Center Bulkhead to Tank Weld**

A. Oxidizer Tank Wall  
B. Bulkhead
