WOOD  
STRUCTURE  
PERFORMANCE  
IN AN  
EARTHQUAKE  
IN ANCHORAGE, ALASKA

# WOOD STRUCTURE PERFORMANCE IN AN EARTHQUAKE<sup>1</sup>

IN ANCHORAGE, ALASKA MARCH 27, 1964

FOREST PRODUCTS LABORATORY<sup>2</sup> FOREST SERVICE

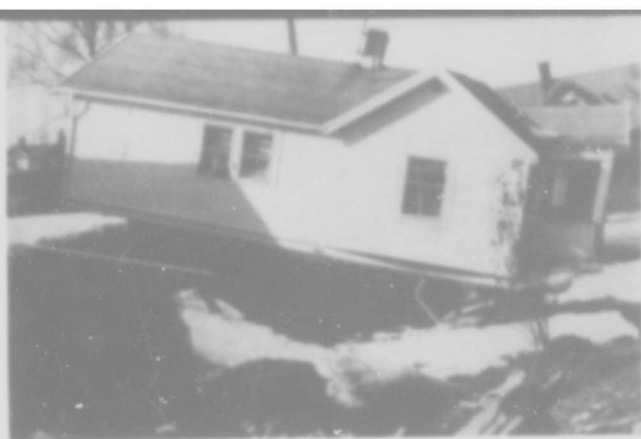
ZM 126 423

Figure 7.--Although the porch is somewhat awry, this small wood frame house was rigid enough to span the hole caused by earth subsidence.

in hurricane areas or diagonal wood or plywood sheathing nailed to both floor and wall framing would probably have prevented this type of failure. The wood floor and wall systems were usually sufficiently strong to support the weight of the house even though most of the foundations had failed (fig. 7).

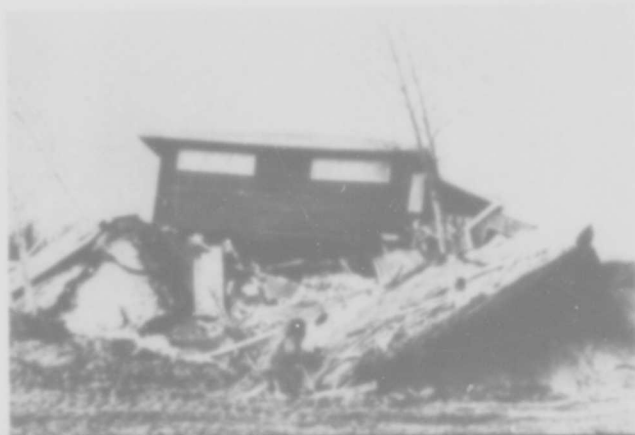
Figure 10.--Although this wood house had been exposed to earth slides as well as shocks from the earthquake, only moderate damage to the structural frame was apparent.

Wood frame walls that were properly constructed resulted in an amazingly rigid unit with the capacity to resist shock and impact forces (figs. 10 and 11). Such construction involved braced frame wall, floor, and roof systems properly fastened together. Well-nailed sheathing and siding provided additional rigidity. The exterior walls are of the most important components of the structure, and the choice and use of materials, construction details, and fastening methods generally determine their performance (fig. 12). A conventional stud wall with diagonal sheathing, horizontal wood sheathing with let-in braces, or plywood sheathing provided the strength and rigidity necessary to resist the shocks of the earthquake as well as damage by earth slides.

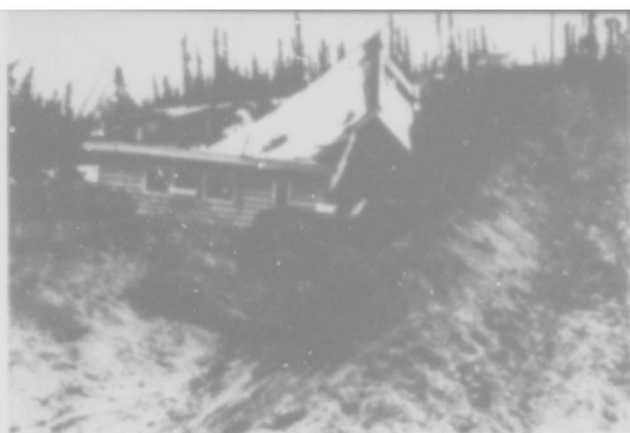
ZM 126 428

Figure 11.--Although tipped and dropped many feet, this wood frame house still retained its identity.

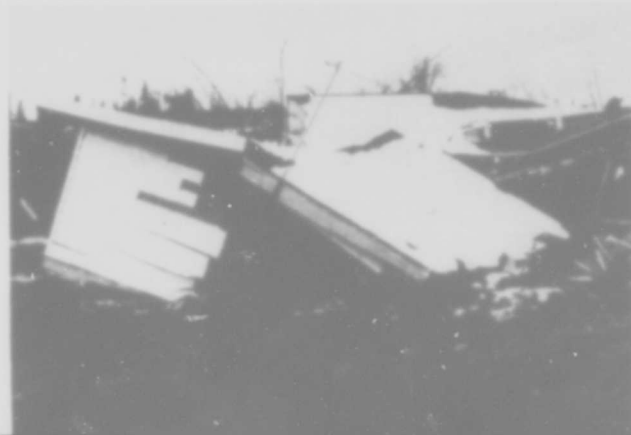
Figure 14.--The impact of the sudden earth subsidence was sufficient to cause shearing of the fiberboard sheathing.

sheathing in 25/32-inch thickness, when used properly, seemed to perform satisfactorily except where high stresses had caused shear failures between studs (fig. 14). However, not all fiberboard sheathing was applied properly with good nailing. Often 4- by 8-foot sheets were placed horizontally without edge nailing between studs. Some 2- by 8-foot fiberboard sheathing was also noted. Generally, failures of this type of sheathing consisted of nailhead pullthrough or shearing out at the nails due, in part, to inadequate nailing. These walls were usually racked beyond repair.

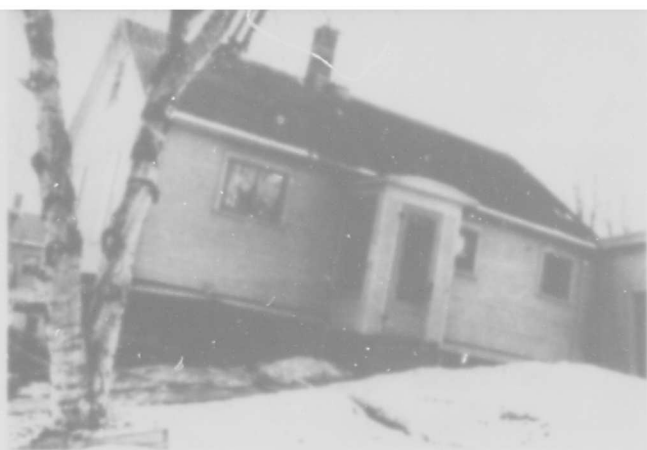
ZM 126 454

Figure 15.--Wood sheathing and siding over a wood framework, together with good nailing, provided strength and rigidity in this house.

The use of horizontal wood sheathing, generally with let-in bracing, was quite common, especially in the older houses. This combination with wood siding of some type had provided more than sufficient rigidity and strength as indicated by houses which spanned holes or were supported only at the center (fig. 15). Interior wall covering of plaster or dry wall likely provided additional racking resistance.

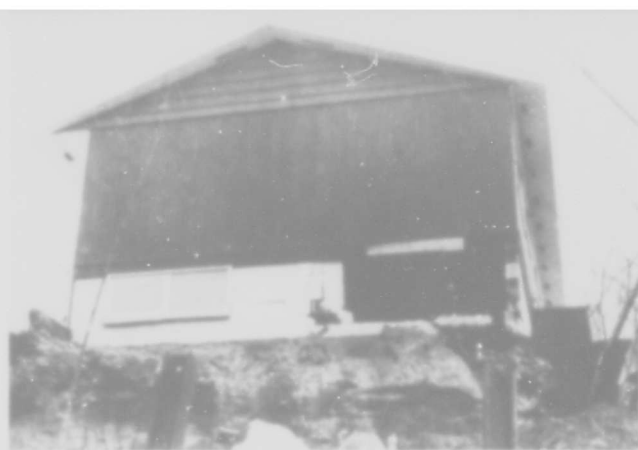
ZM 126 455

Figure 17.--Partial collapse of the basement wall had little effect on the rigidity of this plywood-sided house.

wall. Wood-sided walls performed well, as did panelized walls finished with plywood or paper-overlaid plywood (figs. 16 and 17). A number of houses, both old and new, with wood sheathing and a stucco (over wire lath) finish also appeared resistant to the forces of the earthquake and earth drops (fig. 18). Such finishes were also used on several wood-frame apartments with little or no evident damage. The use of a single covering material such as drop siding without benefit of sheathing did not supply sufficient strength (fig. 19). In

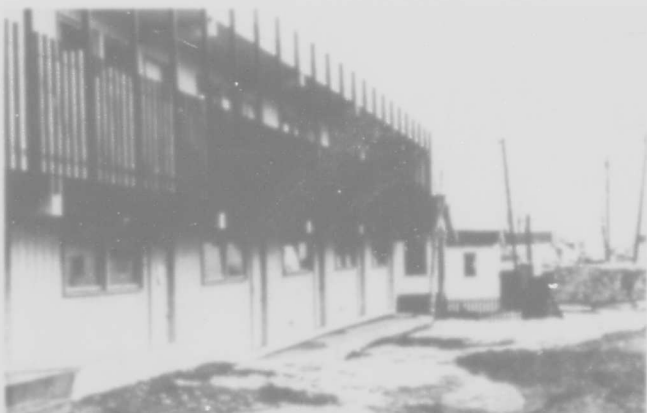
Figure 16.--Although this wood frame apartment building had dropped almost 6 feet, the plywood-faced panels helped to minimize damage. ZM 126 455

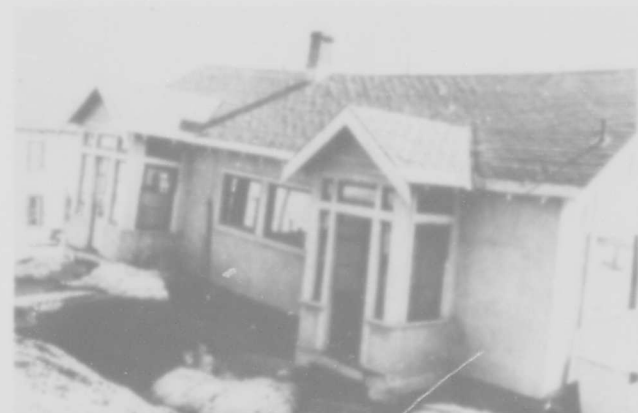
Figure 18.--Although the earth dropped under this house, the wood sheathing and stucco exterior provided a good shear wall. ZM 126 456

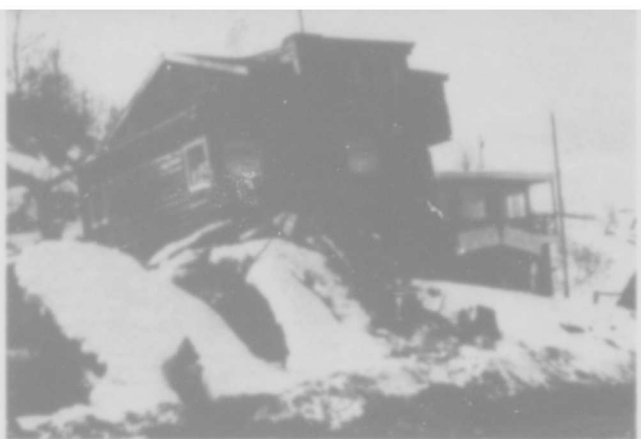
ZM 126 444

Figure 25.--Although the earth beneath it had rolled and slid, the log house remained relatively undamaged.

Several log houses, new and old, were located in the earth drop areas. Beyond some minor damage, these structures appeared in excellent condition (figs. 24 and 25).

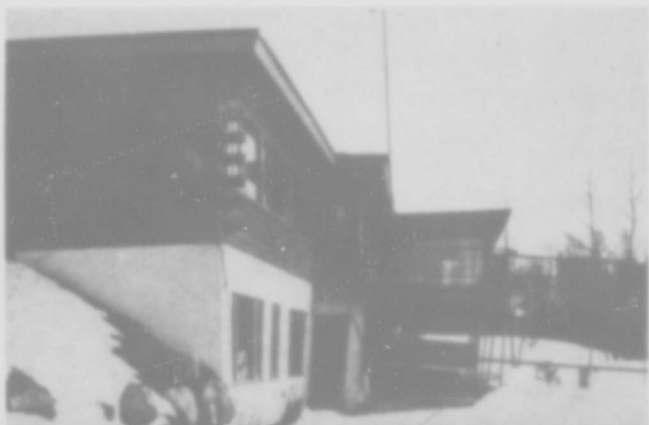
ZM 126 446

Generally, in most wood frame construction, the roofs resisted damages by the earthquake very well even though subjected to severe earth drops (figs. 26 and 27). Most of the roofs on dwellings were of conventional construction with ceiling joists, rafters, and normal rafter ties. No wood trusses were noted. Several houses with low-pitch roofs were constructed with a ridge beam and wood decking or with ridge and intermediate purlin beams. In general, this type of roof construction had good resistance to damage. One

Figure 26.--Even though this wood frame house had dropped into an earth slide area, the roof remained rigid and essentially undamaged.

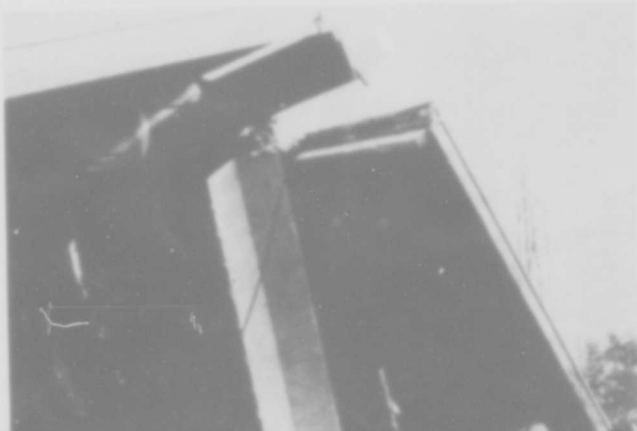
house constructed in this manner was located in the Turnagain area where severe earth subsidence and movement had occurred. However, the ridge beam, made up of three nail-laminated 2- by 12-inch members, failed by nail withdrawal and subsequent opening and failure at the ridge line (fig. 28). This type of beam should normally be a glue-laminated or solid beam or members should be securely bolted together.

Figure 28.--Nail-laminated ridge beam separated, causing roof failure of this attached garage.

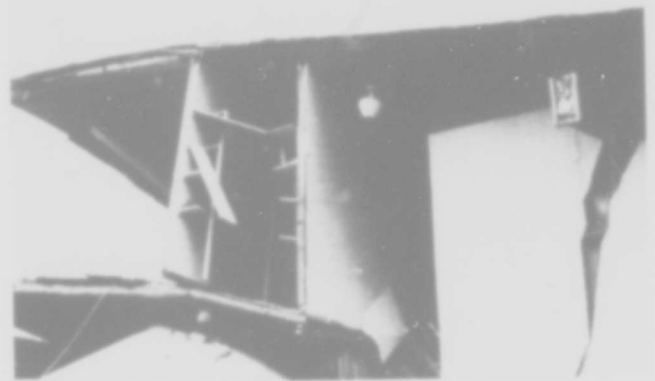
ZM 126 336

Several office buildings, though not essentially wood frame structures, contained glue-laminated wood beam and wood deck roof construction. The beams and decking of these buildings, which had dropped into holes caused by earth failures, were in reasonably good condition. Because of failure of masonry or post and panel side walls, the alignment was slightly awry, but there was little evident damage to these wood components. Such roof and floor construction was used in a large hardware store in the downtown area (fig. 29). Failure of the earth had dropped the building 10 to 15 feet. While the decking and floor were tilted

Figure 29.--The wood deck roof and floor and the wood partitions retained enough rigidity and strength to allow removal of stock in this hardware store even after it had fallen 10 feet or more into an earth subsidence area.
