VUF-1010
FINAL REPORT

VELA UNIFORM PROJECT **SHOAL**

STRUCTURAL SURVEY OF PRIVATE MINING PROPERTIES

U.S. BUREAU OF MINES

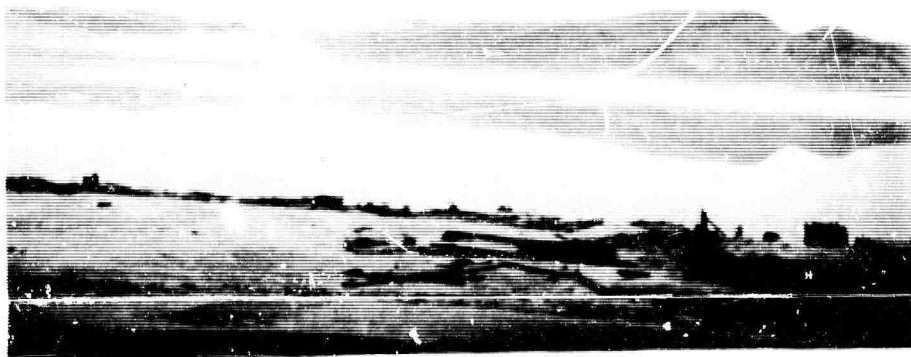
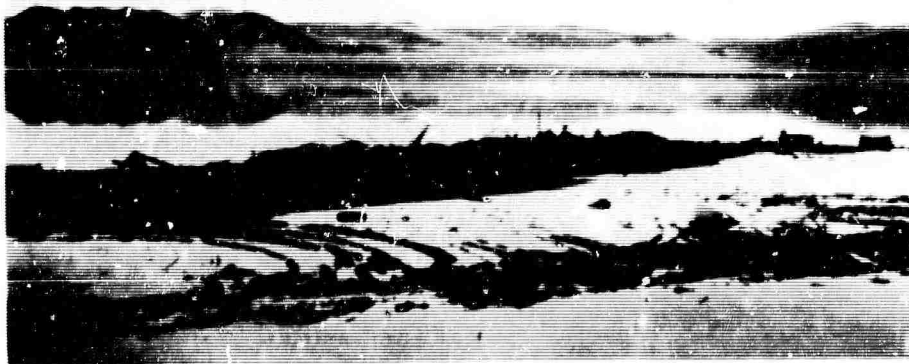
Photo 1-2-2. Freshtot. September 30, 1963.

Photo No. 1-2-2. Northeast across the salt pond and toward the north end of the Sand Springs Range.

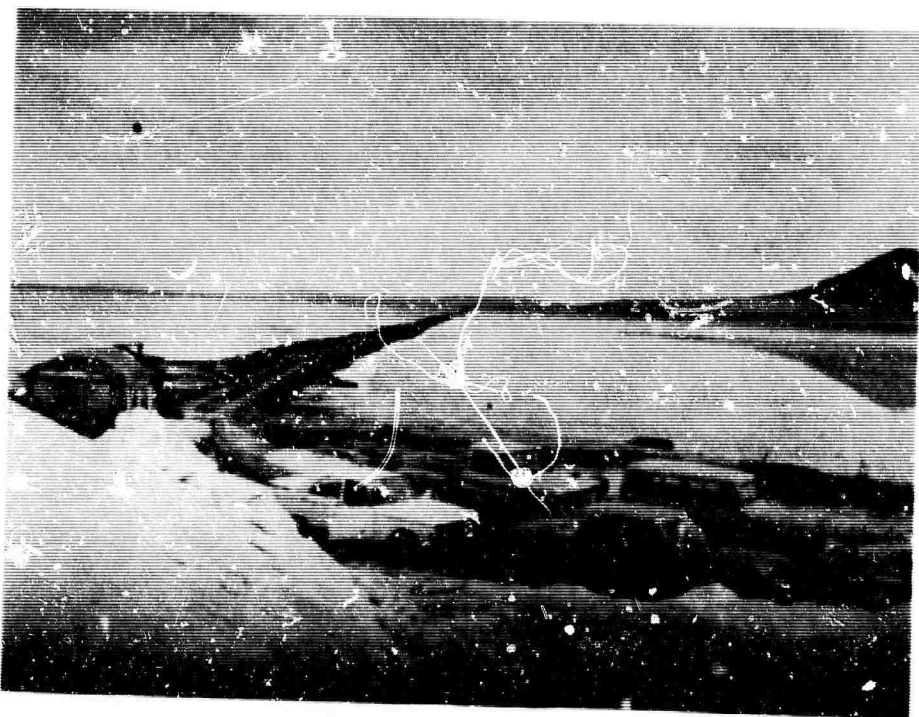
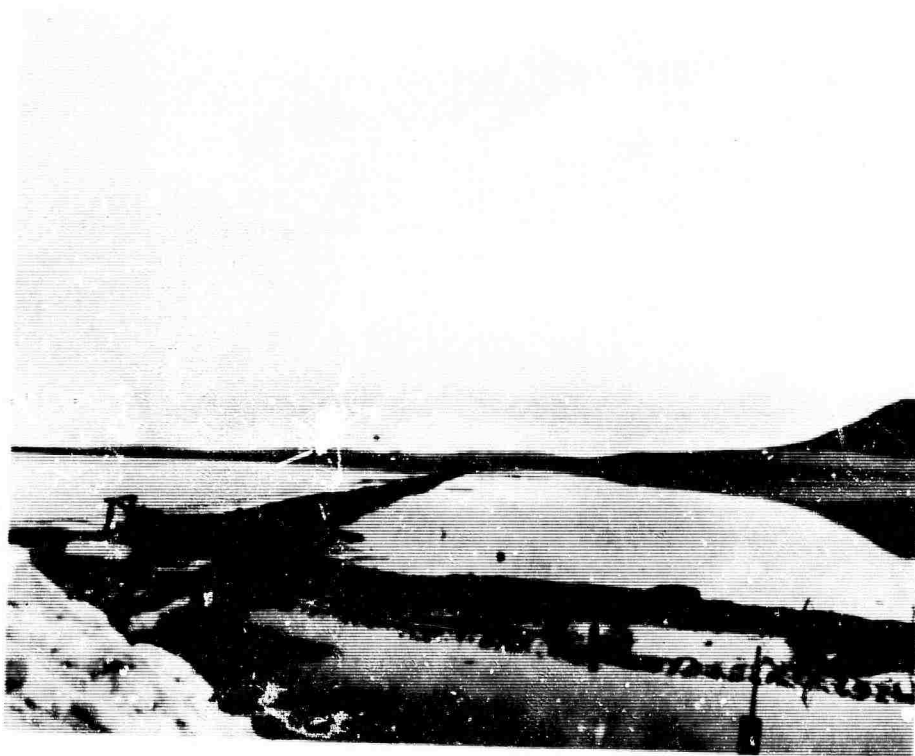
Photo 1-3-3. Preshot. September 30, 1963.

Photo No. 1-3-3. Northwest along the access road and northern portion of the salt pond.

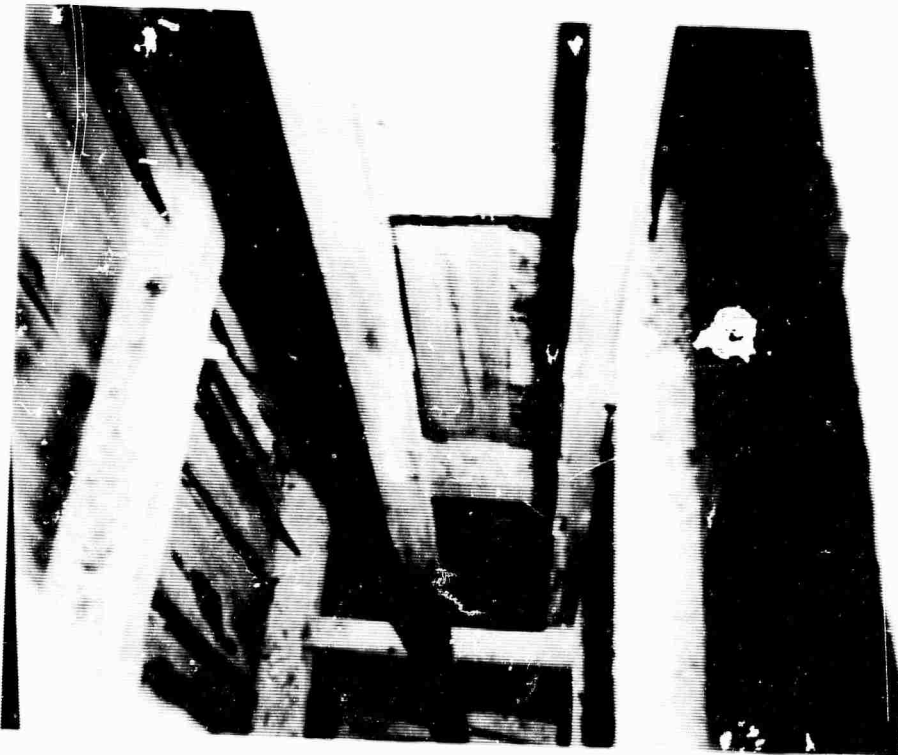
Photo 2-1-4. Preshot, September 30, 1963.

Photo No. 2-1-4. North two-compartment vertical shaft. Some lagging gone, no partition with manway. Timbered dimensions are 6 x 4 feet. This shaft is reportedly 225 feet deep, but is blocked with debris and water at an estimated 50 feet.

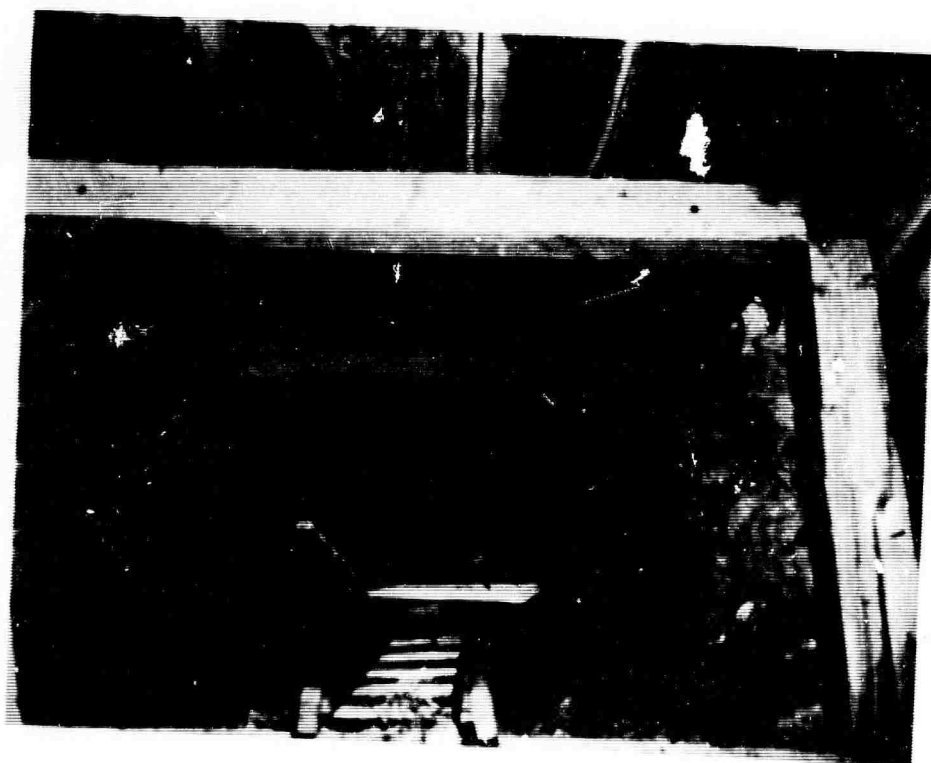
Photo 2-2-5. Preshot. September 30, 1963.

Photo No. 2-2-5. Northeast one-compartment shaft inclined at 65 degrees for about 20 feet, then inclined at an estimated 45 degrees. Some sets and lagging caved, with debris in shaft. Timbered dimensions are 8 x 6 feet. Shaft sunk in 1953 and is only about 30 feet deep.

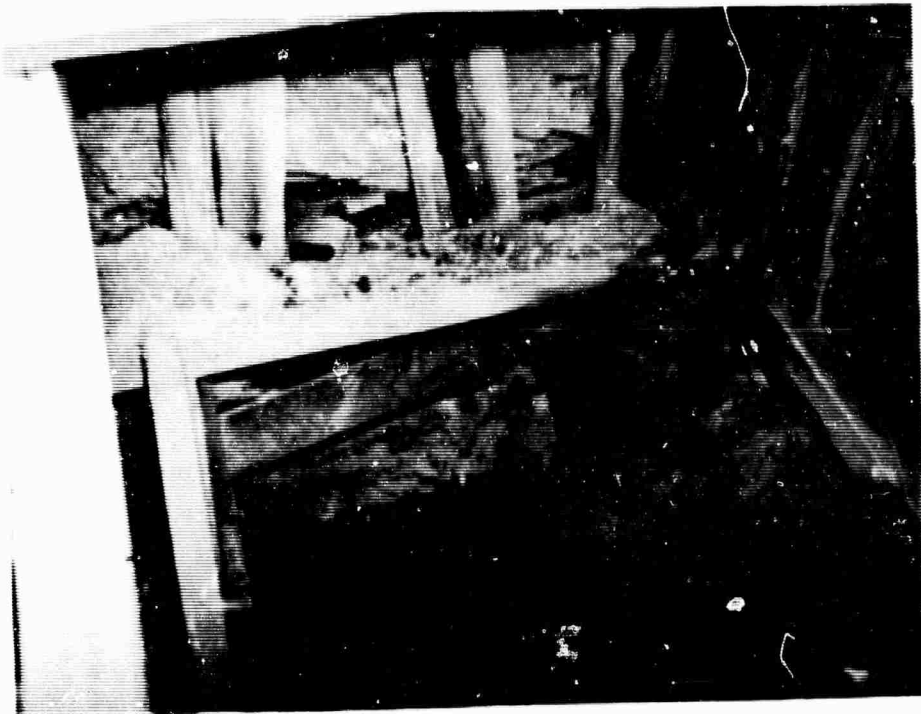
Photo 2-3-6. Preshot. September 30, 1963.

Photo No. 2-3-6. Southeast one-compartment shaft, about 200 feet long, inclined at 60 degrees, but flattens at depth. Shaft collar and lagging caved, with no sets below collar sets. Generally in weakened and caved condition near surface. Combination bucket guide and ladder in place. Timbered dimensions are 8 x 6 feet.

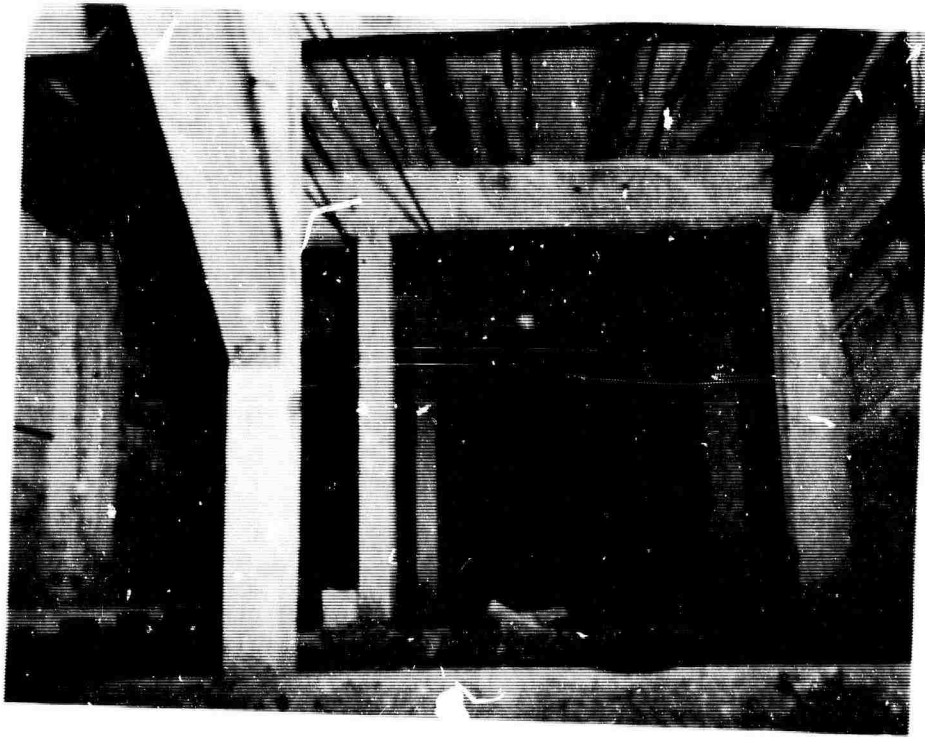
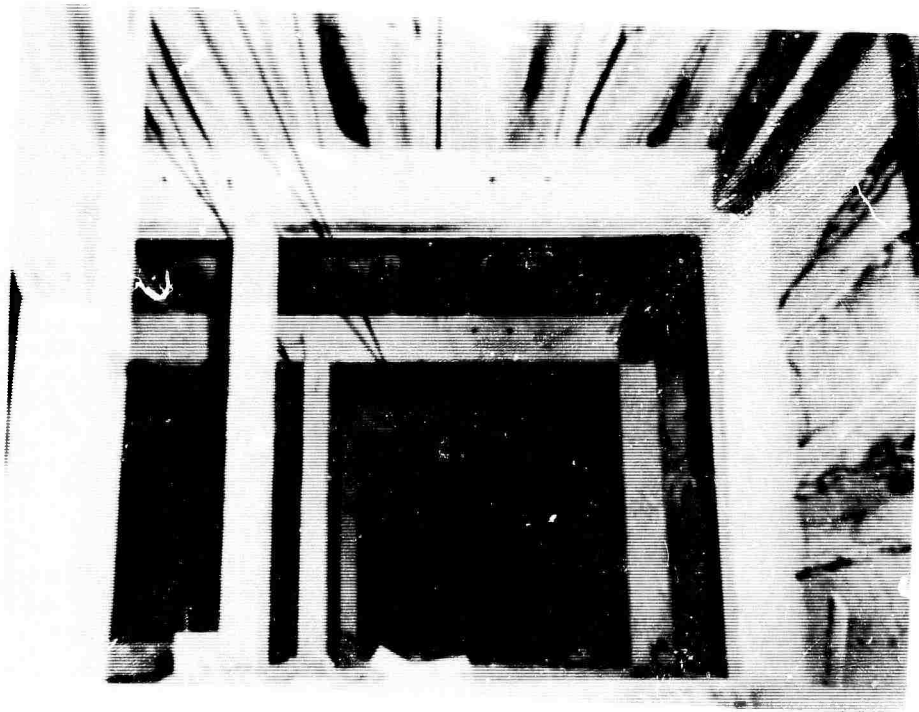
Photo 2-4-7. Preshot. September 30, 1963.

Photo No. 2-4-7. Southwest two-compartment shaft inclined at 60 degrees. Sets, lagging, and ladder in place. No partition with manway, nor cage guides. Timbered dimensions are 9 x 6 feet. Reportedly about 200 feet long.

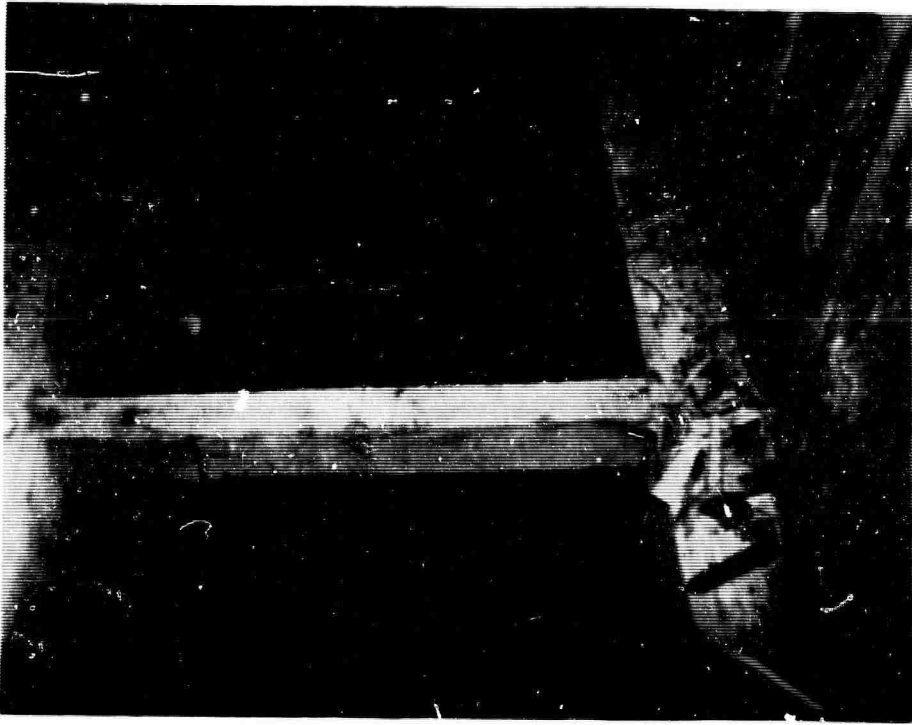
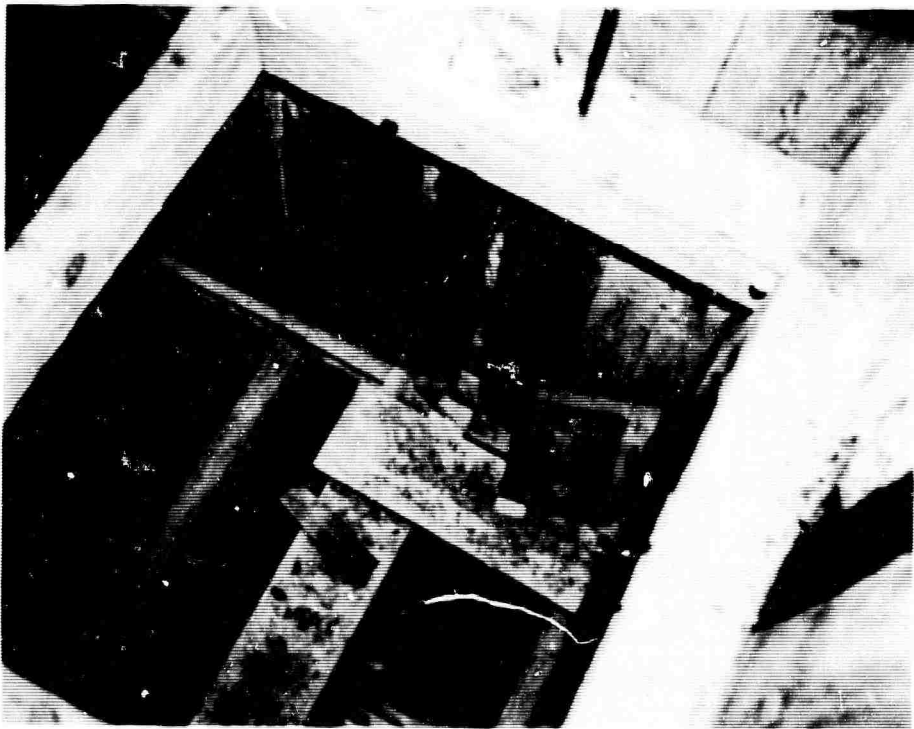
Photo 2-5-8. Preshot. September 30, 1963.

Photo No. 2-5-8. Northwest two-compartment vertical shaft, reportedly 250 feet deep. Lagging, sets, and ladders with landings every two sets in place. No partition with manway, nor cage guides on manway side. Timbered dimensions are 10 x 6 feet.

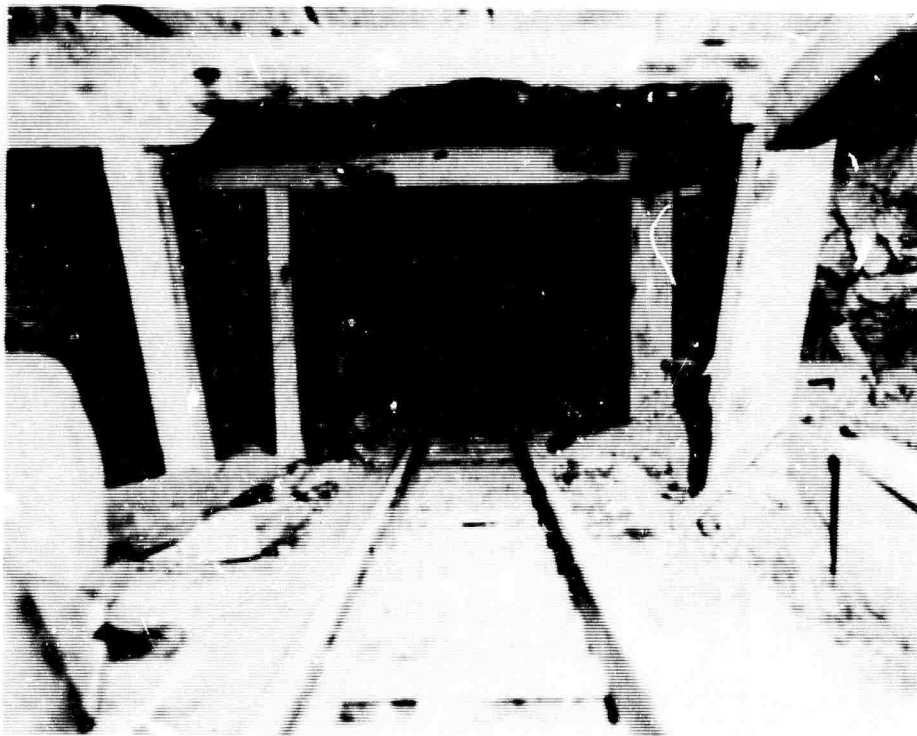
Photo 3-1-9. Preshot. September 30, 1963.

Photo No. 3-1-9. Two-compartment haulage shaft inclined at 45 degrees to intersection with main vertical shaft at about 60 feet. Sets and combination ladder and skip guides in place. No lagging or partition with manway. Shaft is in caved condition near surface. Timbered dimensions are 8 x 4 feet. The main shaft reportedly is about 500 feet deep.

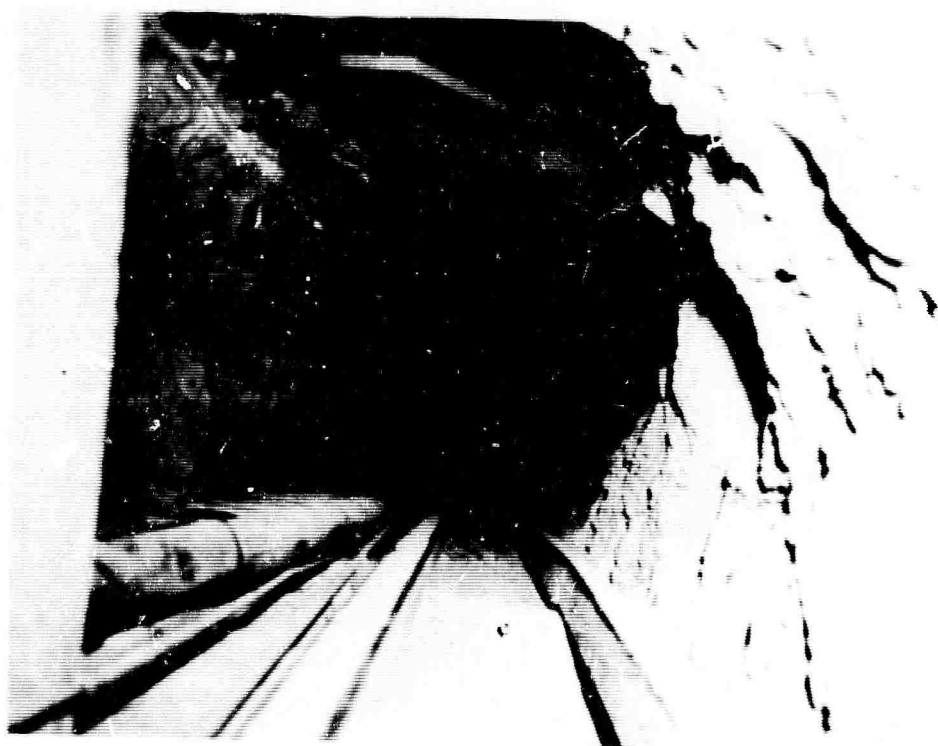
Photo 4-1-11. Preshot. September 30, 1963.

Photo No. 4-1-11. View at 100-foot level of main shaft looking down to 150-foot level. Shaft inclined at about 35 degrees to lower level.

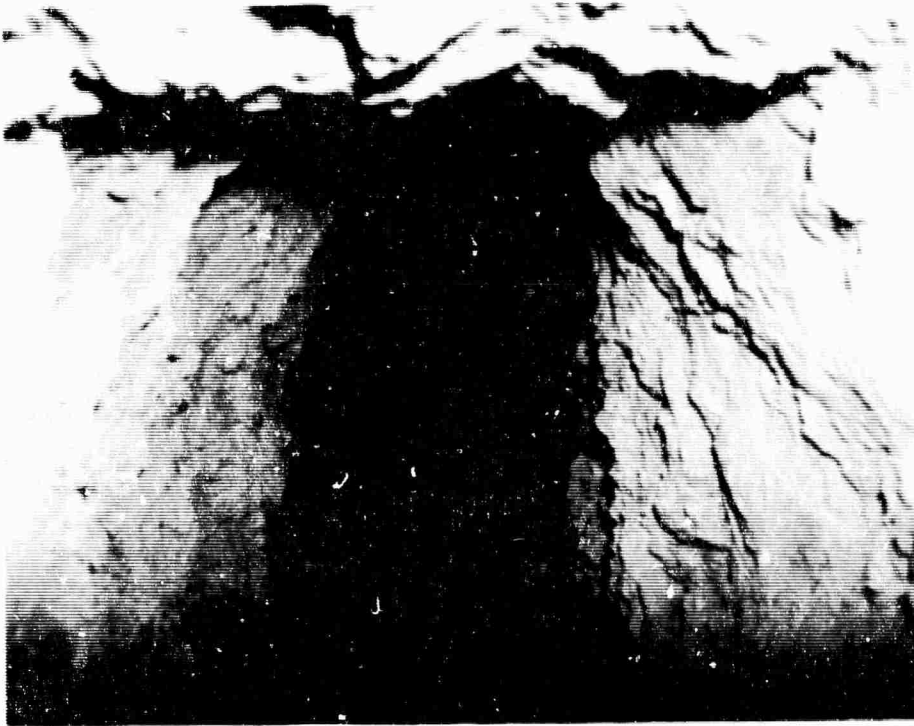
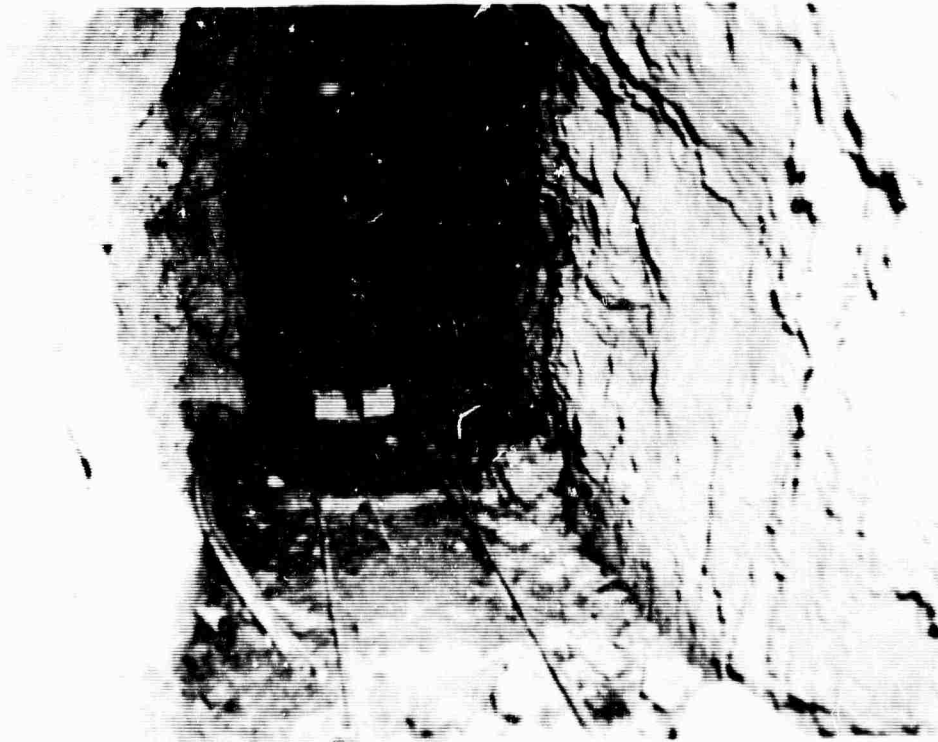
Photo 4-2-12. Preshot. September 30, 1963.

Photo No. 4-2-12. View looking back along 150-foot level development drift toward shaft station. Miscellaneous equipment scattered along drift.

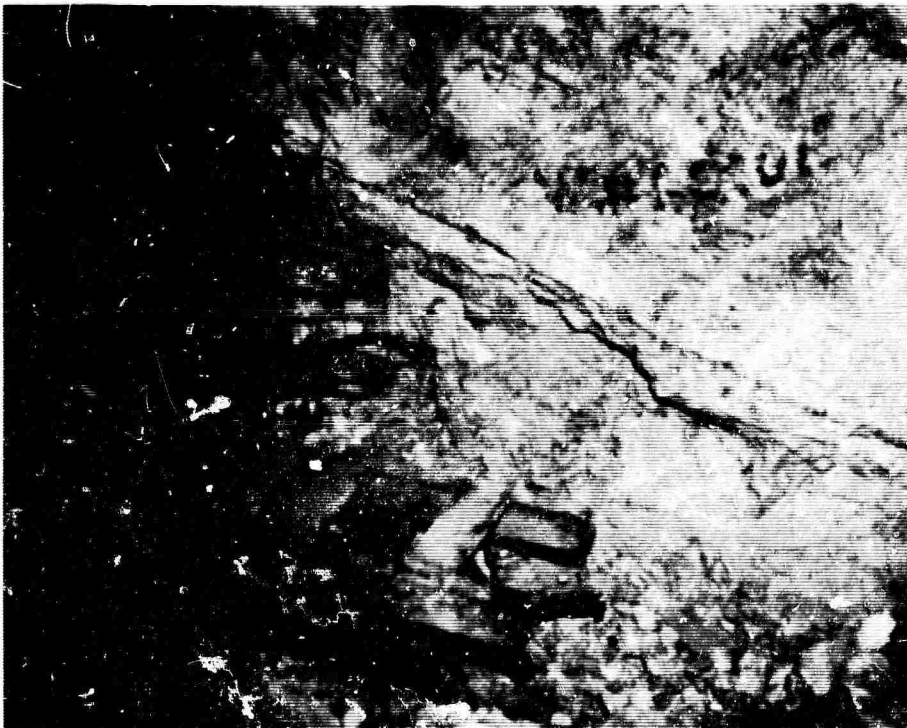
Photo 4-4-14. Preshot. September 30, 1963.

Photo No. 4-4-14. Rock walls at the intersection between development drift and cross-cut on 150-foot level.

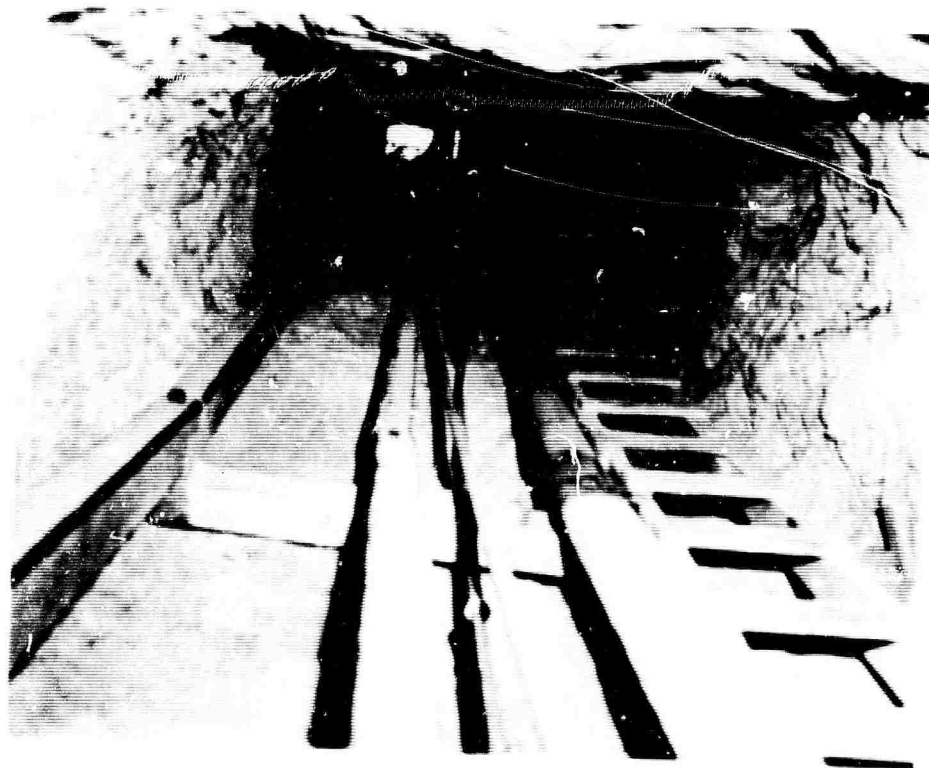
Photo 4-5-15. Preshot. September 30, 1963.

Photo No. 4-5-15. At the 100-foot level shaft station looking upward. The inclination of the upper shaft is 55 degrees to the 100-foot level and 35 degrees to the 150-foot level. No constructed shaft structure but occasional 6 x 6-inch timber stulls are used for support. Rock dimensions are irregular about 8 x 5 feet. Ladderway, bucket guides, ventilation pipes and air line in place.

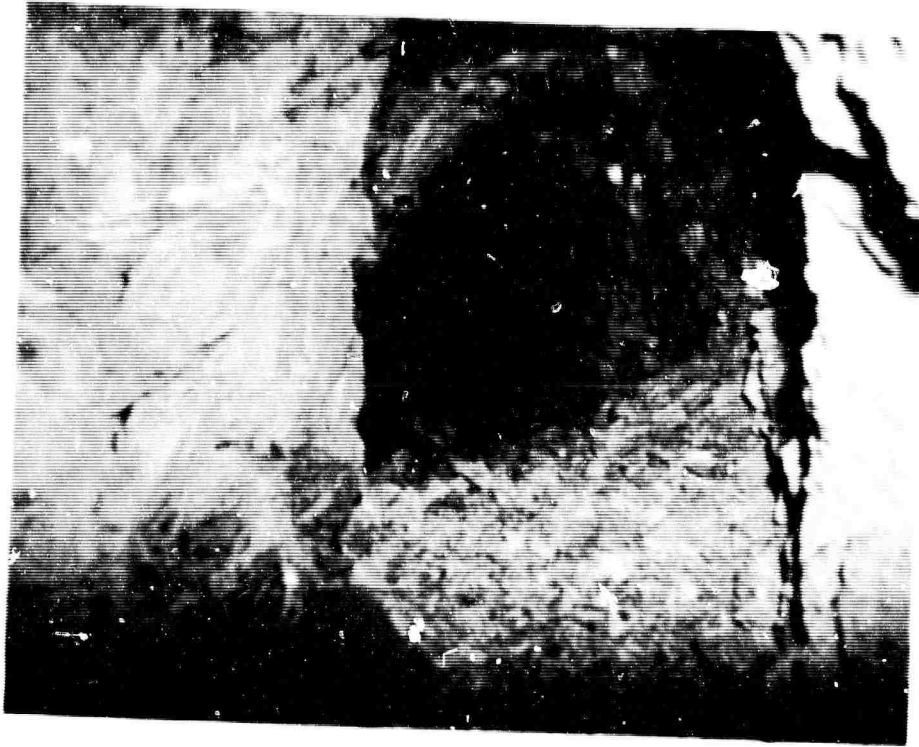
Photo 4-7-17. Preshot. September 30, 1963.

Photo No. 4-7-17. Minor rock falls along main drift crossing contact with shear zone on the 100-foot level. The drift dimensions are about 6 x 4 feet and the bearing is about north-south. All development drifts are unsupported.

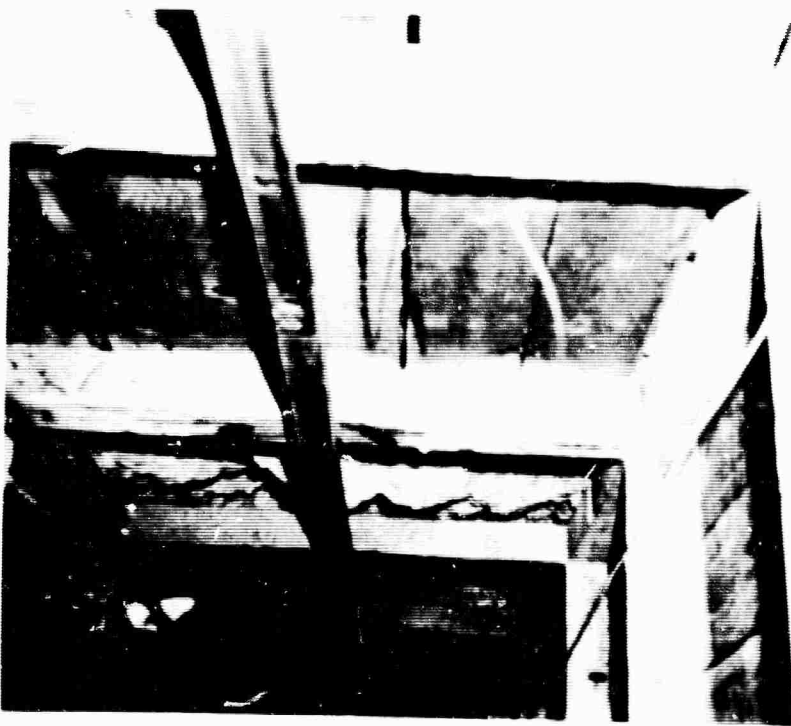
Photo 5-1-18. Preshot, September 30, 1963.

Photo No. 5-1-18. Main vertical shaft. Timbered dimensions are 7 x 5 feet. Reported depth is about 600 feet. Lagging, sets, and cage guides in place. Some sets in good rock have no lagging. One compartment timber construction without manway.

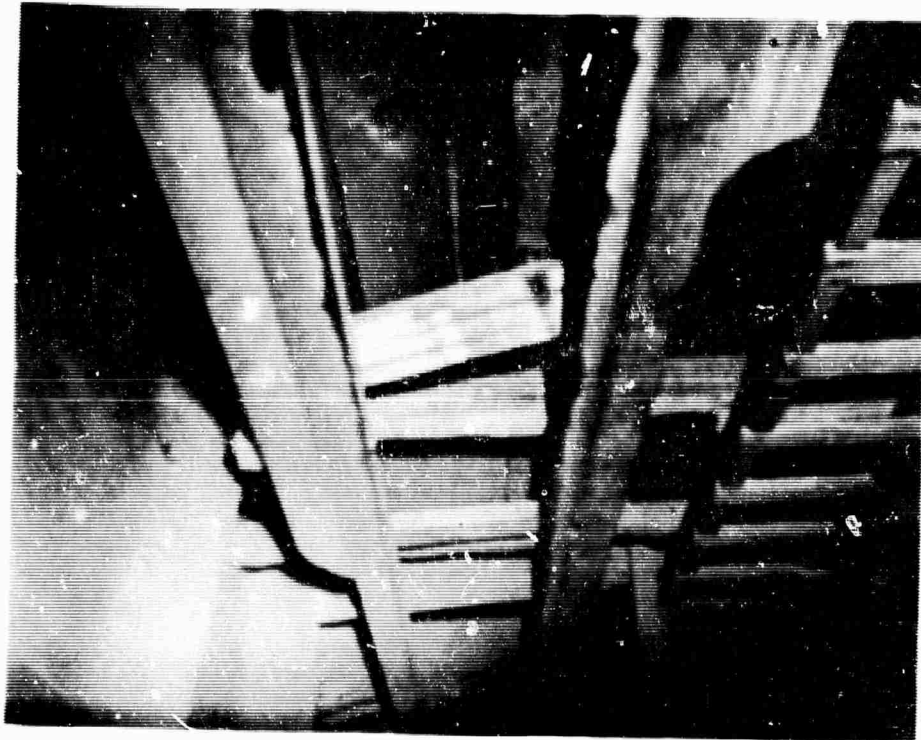
Photo 7-1-23. Preshot. October 1, 1963.

Photo No. 7-1-23. Prospect shaft inclined at about 80 degrees. Timbered dimensions are 8 x 4 feet, and the shaft is estimated to be about 75 feet deep. Lagging, sets, bucket guides, and ladder in place. Manway not partitioned from cage compartment.

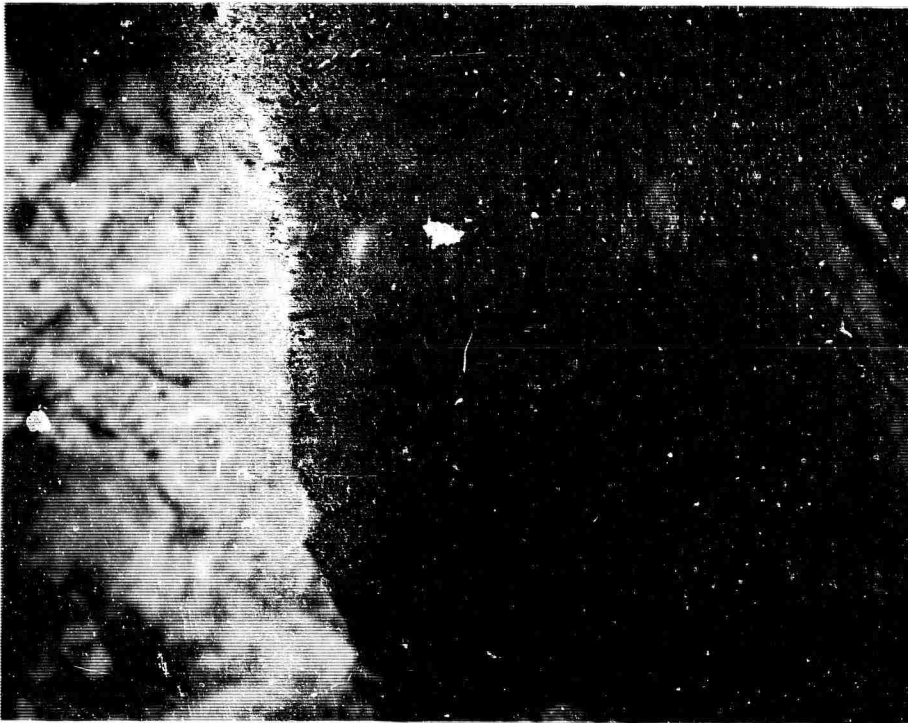
Photo 7-2-24. Preshot. October 1, 1963.

Photo No. 7-2-24. Prospect shaft inclined at estimated 30 degrees for about 25 feet and then continued at 60 degrees. Rock dimensions are about 5 x 5 feet. Shaft is entirely unsupported. Combination ladder and bucket guides in place.

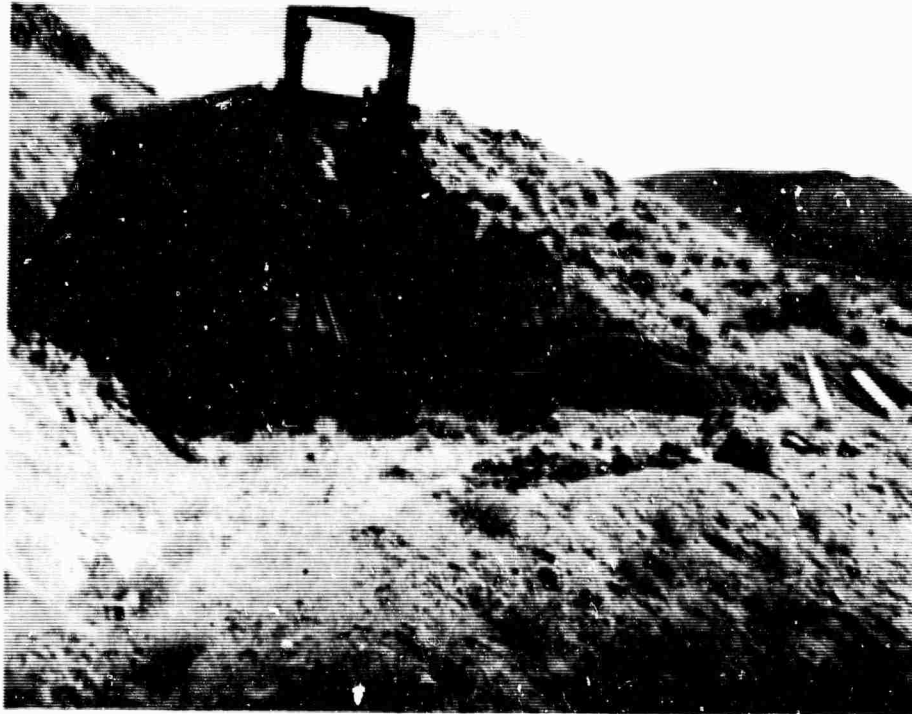
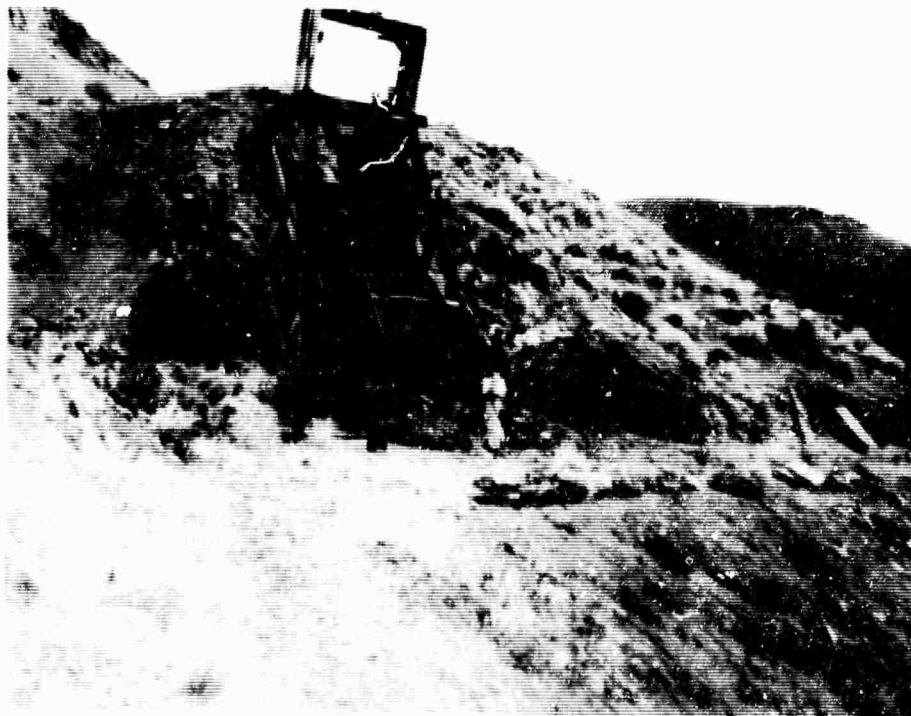
Photo 8-1-25. Preshot. October 1, 1963.

Photo No. 8-1-25. Surface area around Red Ant No. 2 headframe and shaft. Steep rock slopes and open cut shown on north side, toward surface zero, with rock slopes undercut and near vertical.

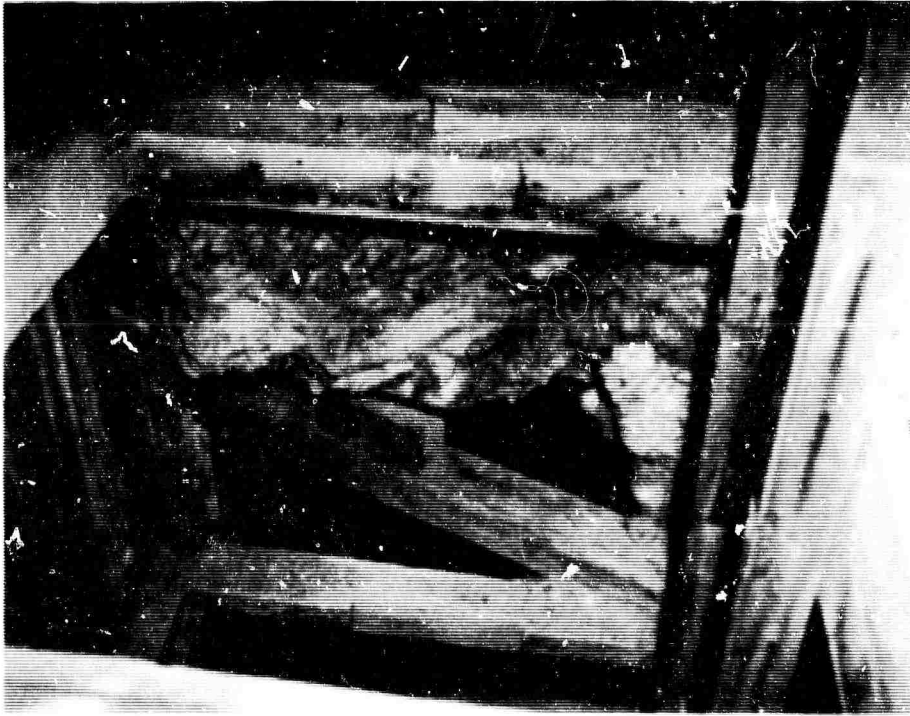
Photo 8-2-26. Preshot. October 1, 1963.

Photo No. 8-2-26. Vertical one-compartment shaft of Red Ant No. 2 at first level about 15 feet below collar. Timber sets and lagging in place to first level. Partially timber supported to Red Ant No. 2 adit level at about 40 feet in depth. Ladder and bucket guides in place.

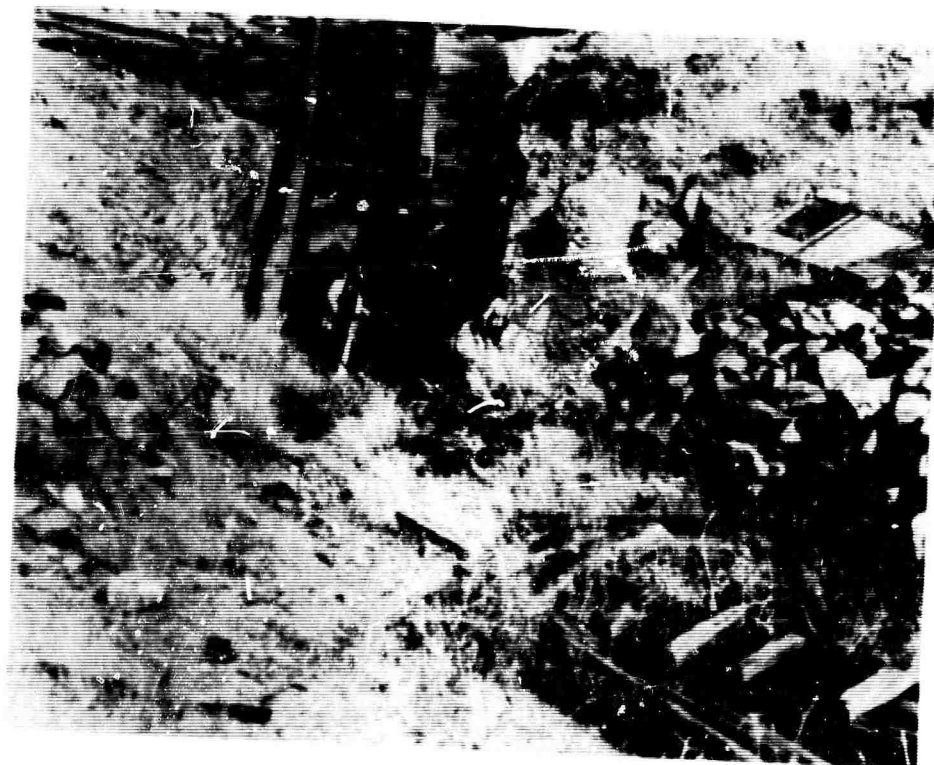
Photo 8-5-29. Preshot. October 1, 1963.

Photo No. 8-5-29. Portal of Red Ant No. 2 adit on hillside below shaft. Four portal sets of 4 x 4-inch timber with timber cribbing for mine dump.

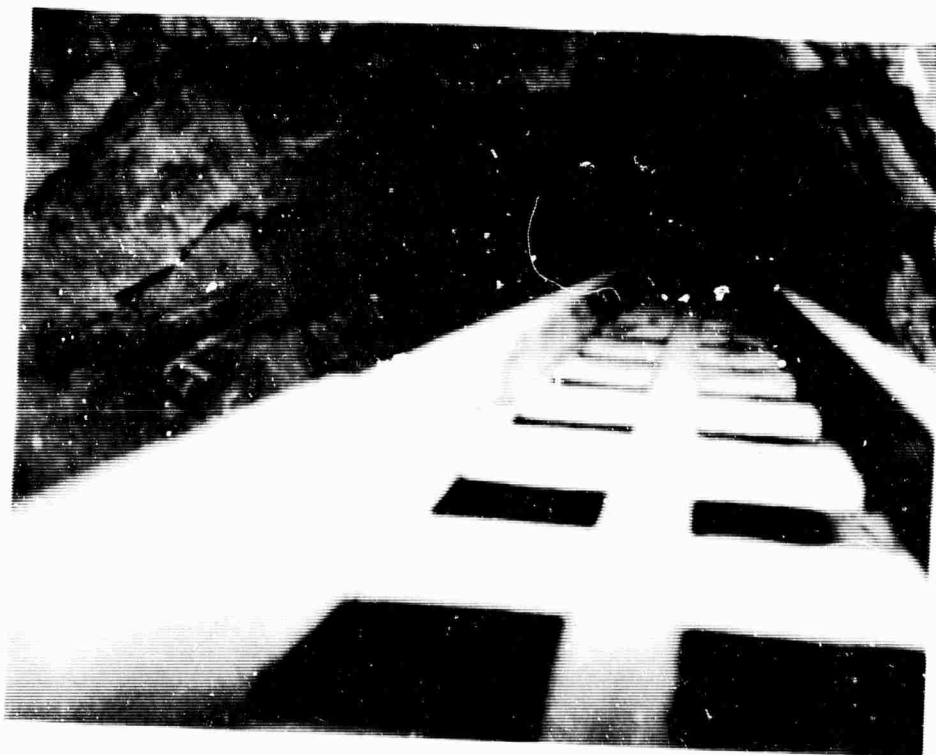
Photo 8-7-31. Preshot. October 1, 1963.

Photo No. 8-7-31. East End Mine exploratory shaft inclined at estimated 45 degrees. Rock dimensions are irregular, about 4 x 4 feet. The shaft is about 40 feet in depth. Except for one timber collar set, the shaft is unsupported. Combination bucket guides and ladder in place.

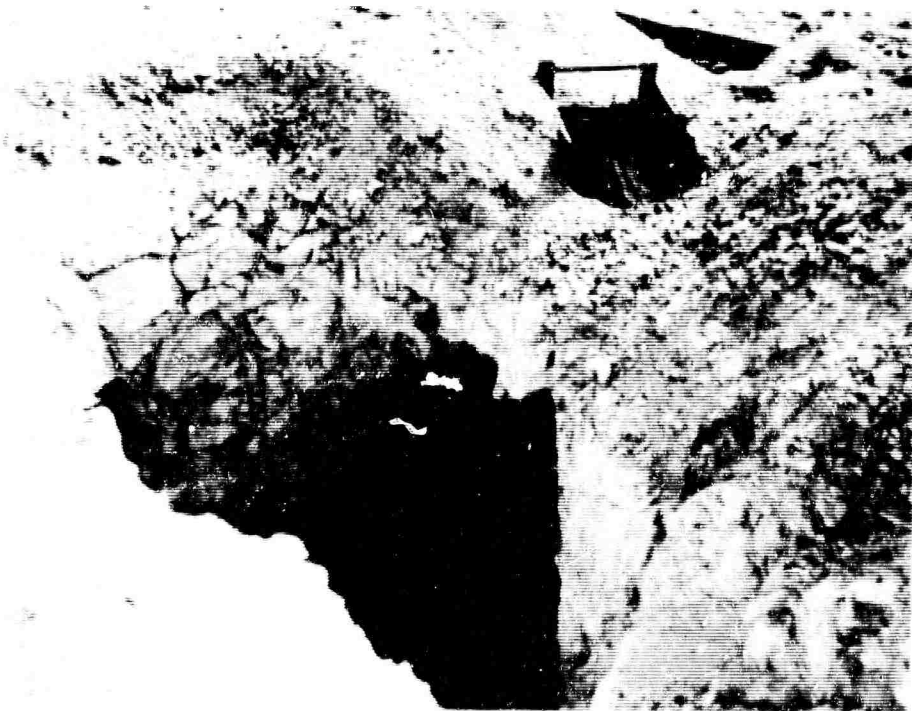
Photo 10-1-36. Preshot. October 1, 1963.

Photo No. 10-1-36. Open stope mined to surface. Irregular width about 6 to 8 feet, and less than 100 feet in depth. Randomly placed timber stulls are used for support. The rock is heavily fractured.

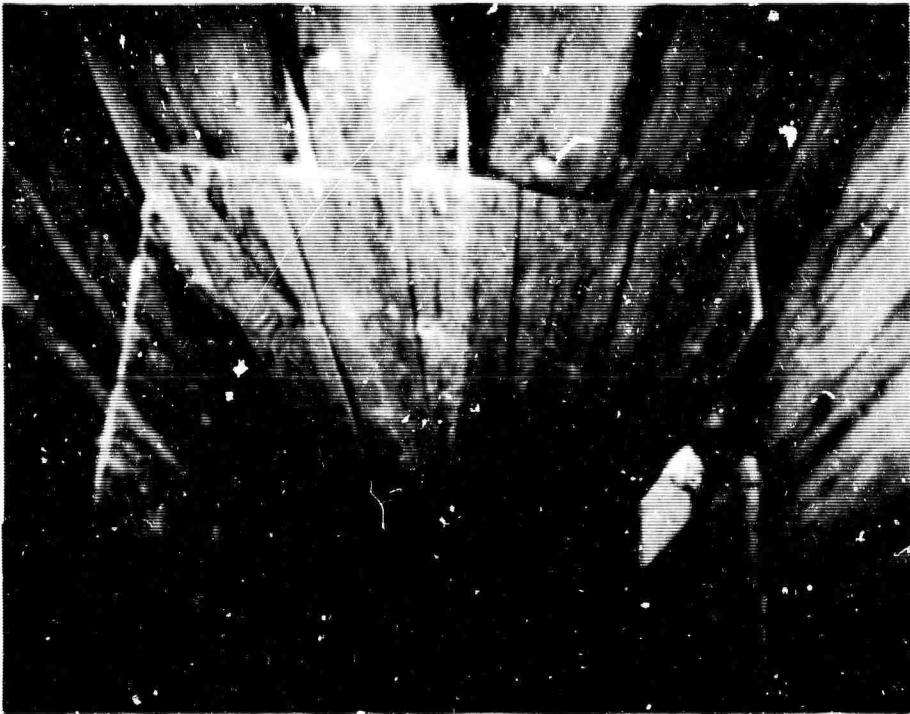
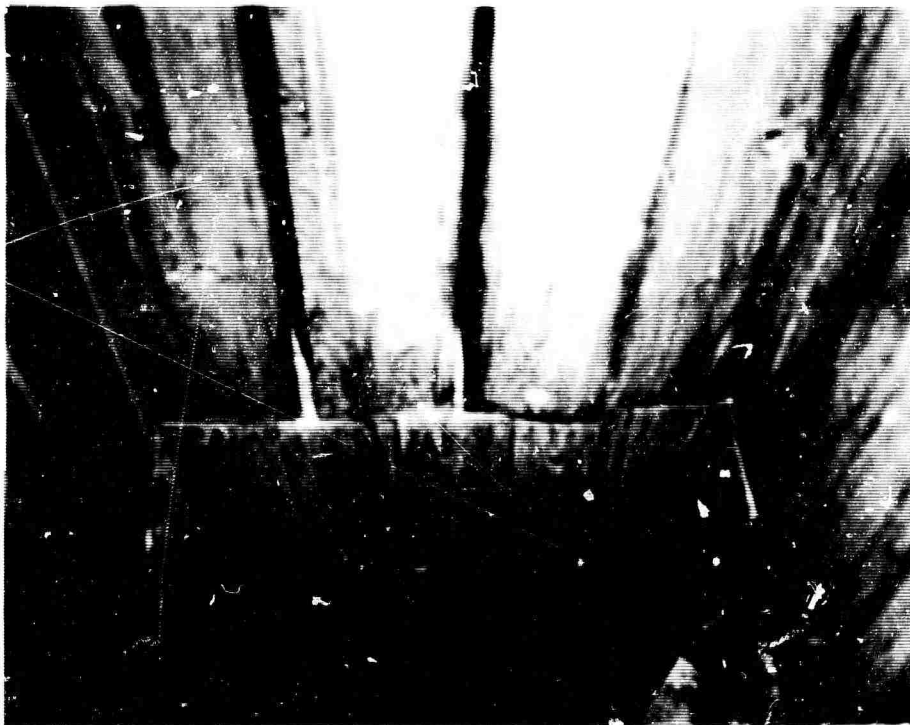
Photo 10-3-38. Preshot. October 1, 1963.

Photo No. 10-3-38. Hoisting compartment of east vertical shaft. Timbered dimensions are about 6 x 5 feet. Sets and lagging in place but some lagging gone. No cage guides.

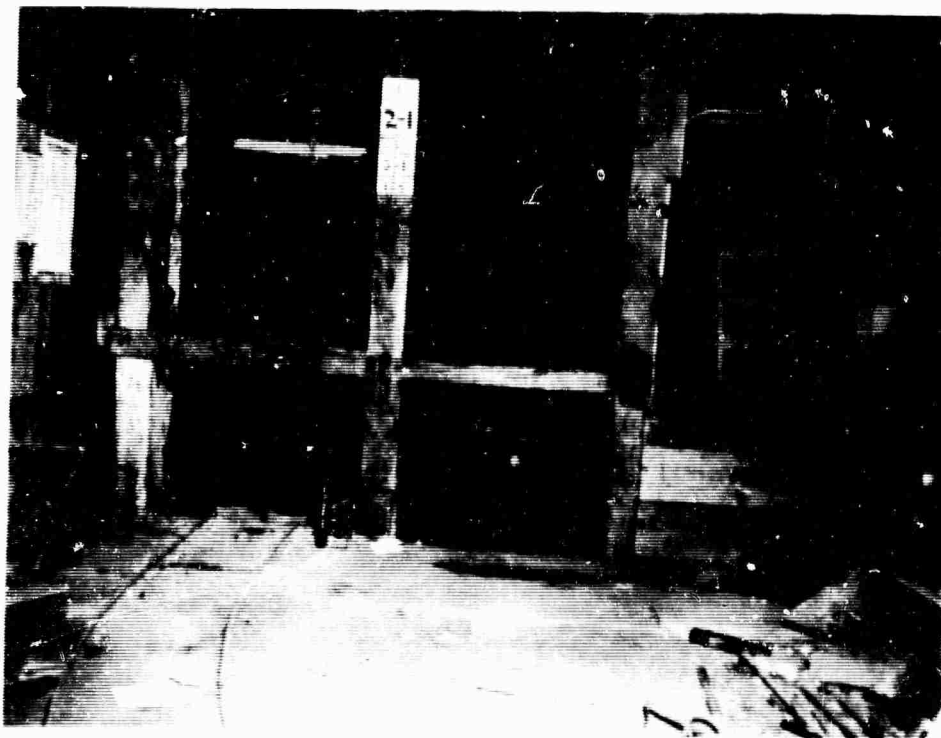
Photo 11-1-44. Preshot. October 2, 1963.

Photo No. 11-1-44. Shaft station on 100-foot level, elevation 5007 feet. Timbered dimensions are 13 x 6 feet, cage compartment is 5 x 5 feet, the other compartment cannot be used because of squeezing ground. The manway is usable.

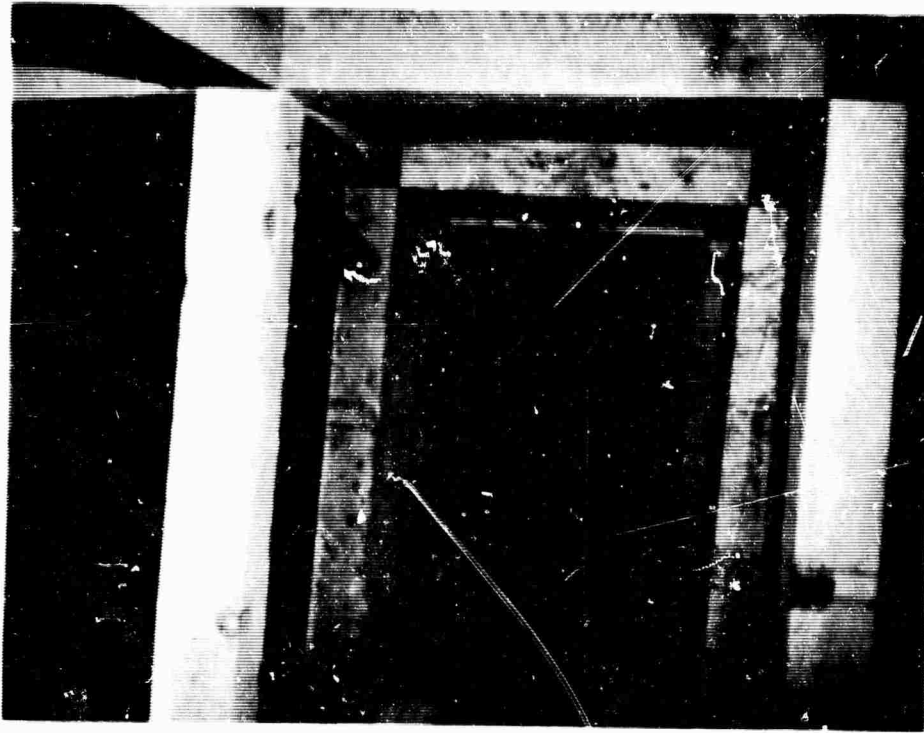
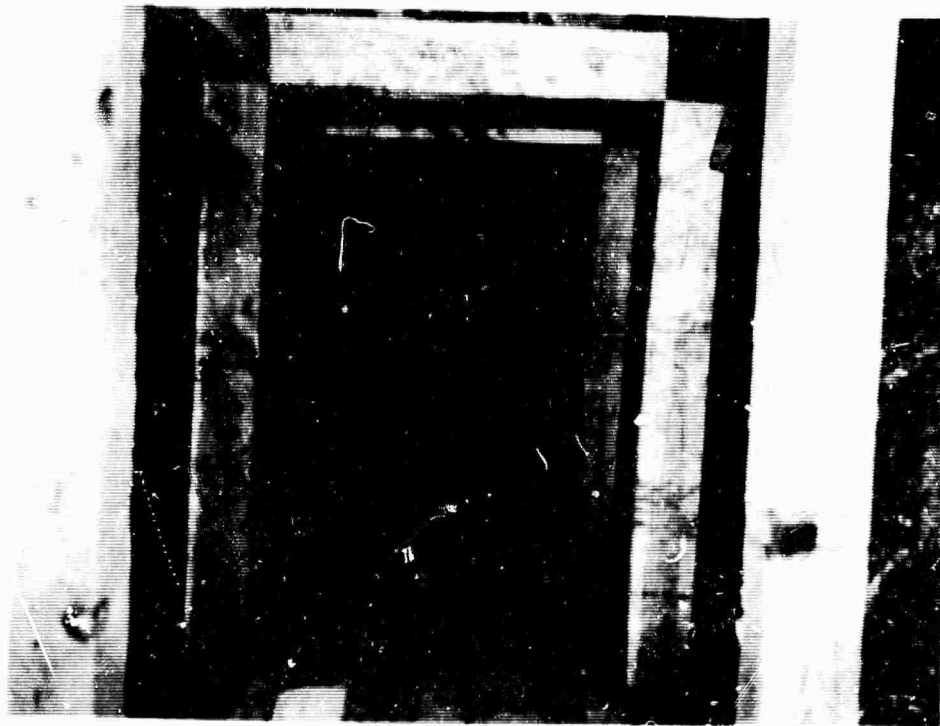
Photo 11-2-45. Preshot. October 2, 1963.

Photo No. 11-2-45. Lengthwise view of 250 stope two sets below the 100-foot level. This stope is square set on irregular 5 x 5-foot centers with 8 x 8-inch timbers. Some areas are supported by timber cribbing. Estimated stope dimensions are 100 feet in length and 25 to 75 feet in width. In vertical dimension the 250 stope extends for several levels. Some timber posts and caps in square sets have been crushed and squeezed by ground movement. The bearing of the stope is about north-south.
