VUF-1010
FINAL REPORT

VELA UNIFORM PROJECT **SHOAL**

STRUCTURAL SURVEY OF PRIVATE MINING PROPERTIES

U.S. BUREAU OF MINES

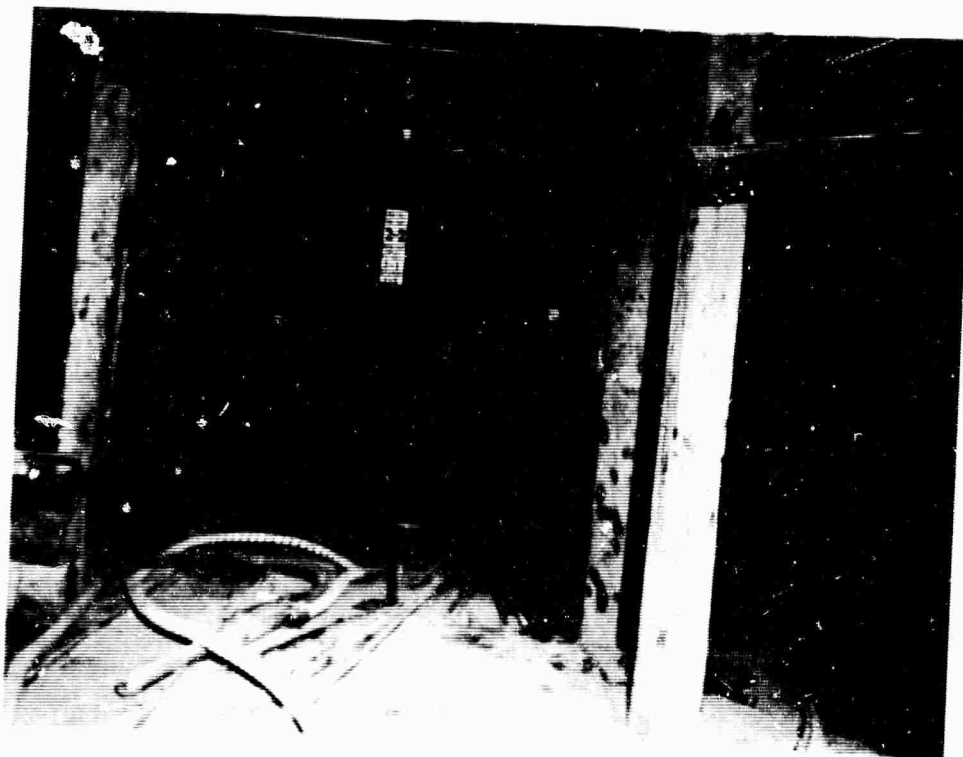
Photo 11-4-47. Preshot. October 2, 1963.

Photo No. 11-4-47. Shaft station on 200-foot level, elevation 4902 feet. See notes on Photo No. 11-1-44.

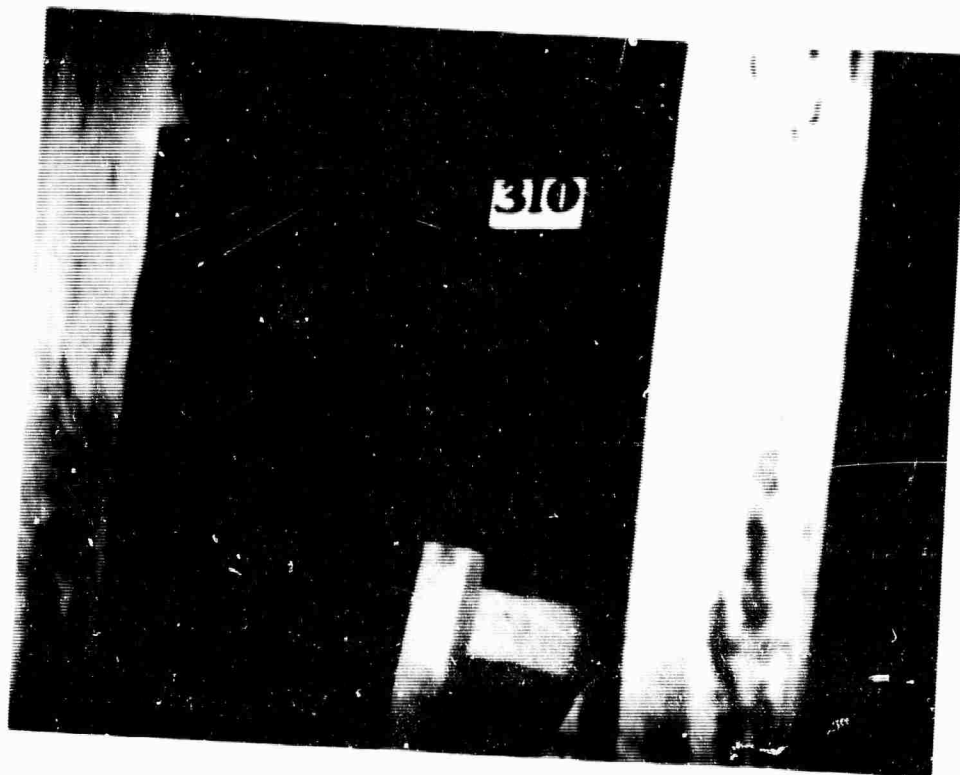
Photo 11-6-49. Preshot. October 2, 1963.

Photo No. 11-6-49. Widthwise view of 310 stope on 200-foot level. This stope is supported by square sets on irregular 5 x 5-foot centers with round 10-inch and rough 8 x 8-inch timbers. Some portions of the stope are supported by timber cribbing. The stope is about 50 feet long, up to 25 feet wide, and it extends from the 300 to the 100-foot level.

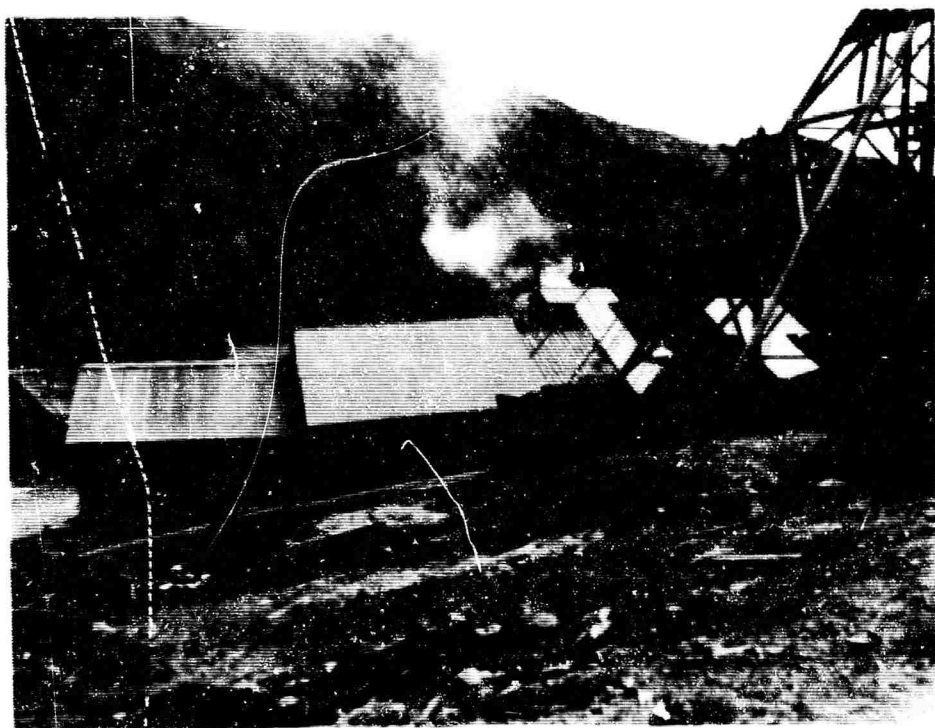
Photo 11-15-58. Postshot. October 28, 1963.

Photo No. 11-15-58. Subsidence by undermining from the 250 stope has caused a four degree northward tilt to hoist house. The concrete foundation for the hoisting equipment has a large crosswise crack immediately behind the main drum. The hoist consists of a cylindrical double drum electric powered system mounted on a steel frame.

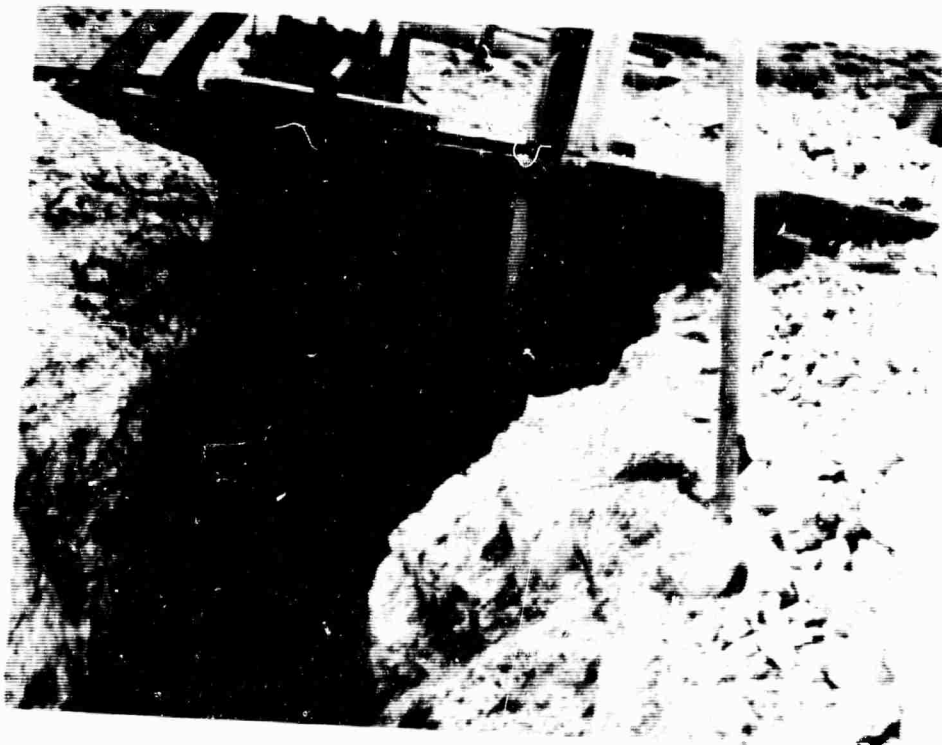
Photo 12-1-59. Preshot. October 7, 1963.

Photo No. 12-1-59. Vertical prospect shaft about 25 feet in depth with stope mined to surface around shaft. Timber prospect headframe with steel hand winch in place on surface. The shaft consists of four timber legs with a ladder in place. The stope contains two timber stulls.

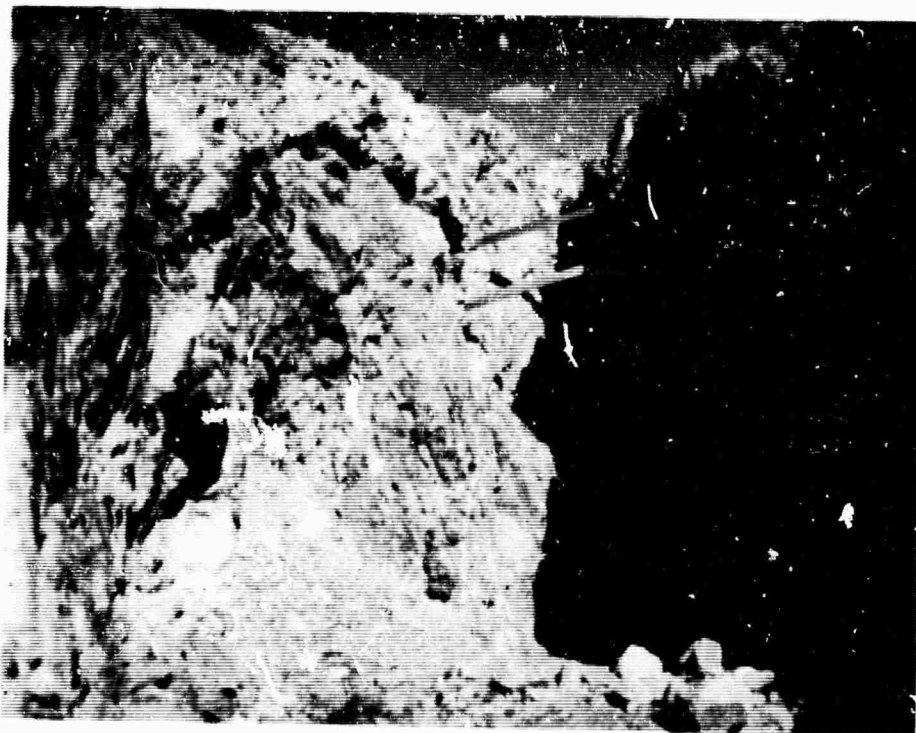
Photo 13-2-61. Preshot. October 2, 1963.

Photo No. 13-2-61. Open cut about 100 feet long, up to 15 feet deep, and of irregular width up to 6 feet. Two 6 x 6-inch timber stulls are used for support.

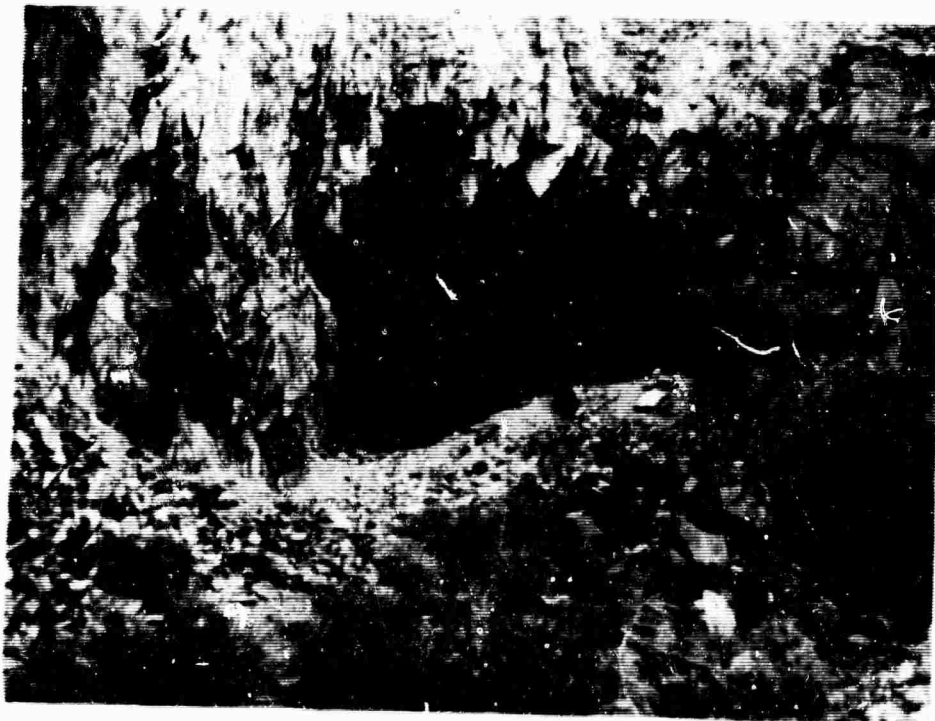
Photo 13-4-63. Preshot. October 2, 1963.

Photo No. 13-4-63. Entrance to west adit. Rock dimensions are about 7 feet wide, 6 feet high, and several hundred feet long. The rock is fractured and weakened above the adit portal. Some rock falls have previously occurred at the portal and along the adit. No support was used for this adit.

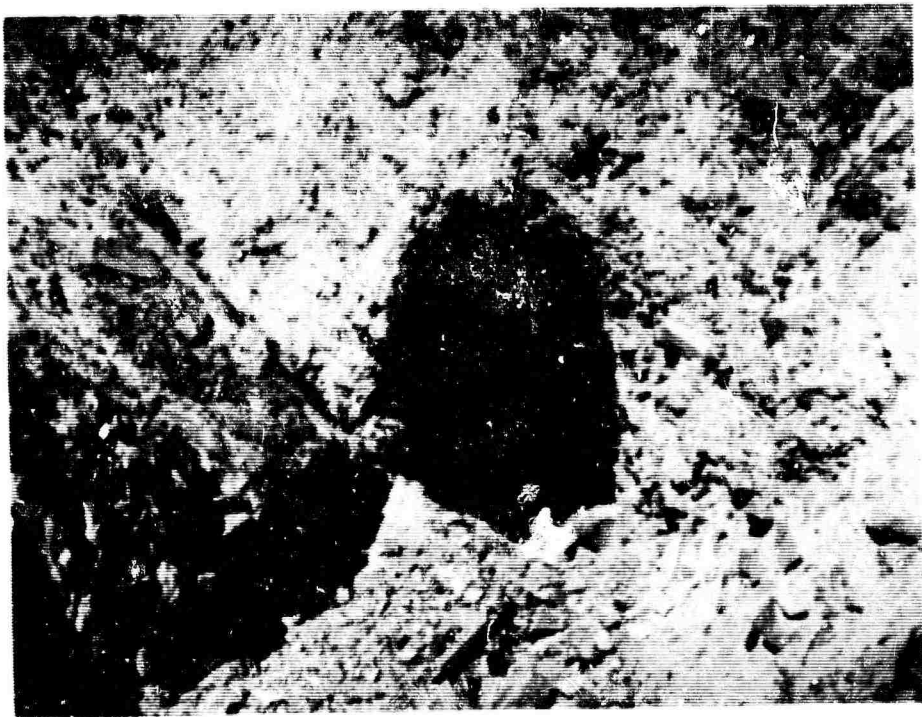
Photo 13-5-64. Preshot. October 2, 1963.

Photo No. 13-5-64. Entrance to east adit. Rock dimensions are about 6 x 3 feet and several hundred feet in length. Some rock falls have previously occurred at the portal and along the adit. No support was used for this adit. The portal has been driven in semi-consolidated alluvium.

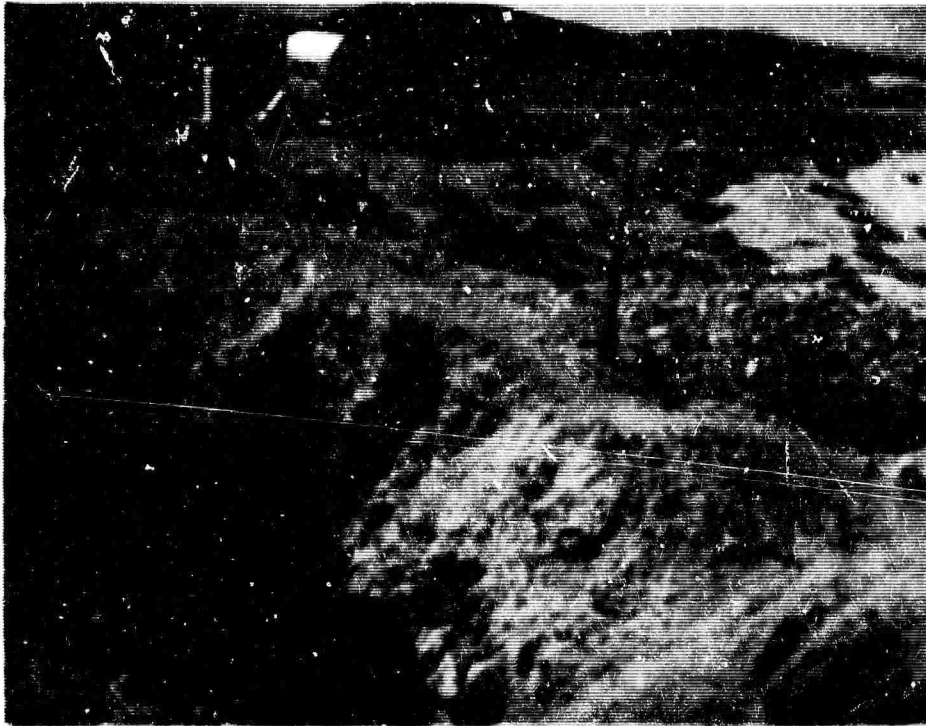
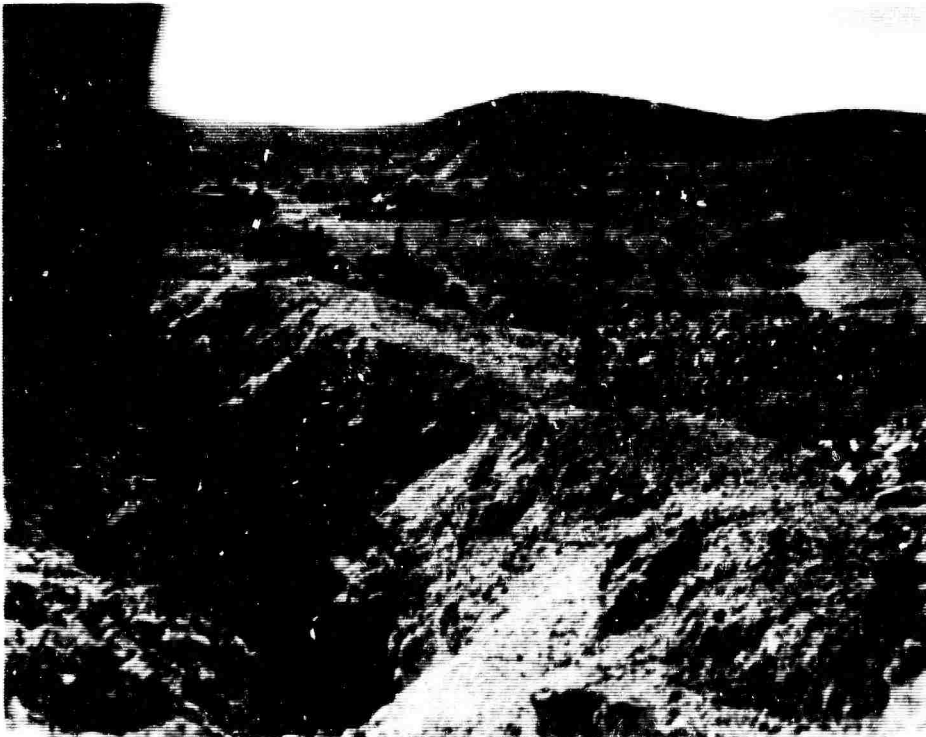
Photo 14-1-66. Preshot. October 3, 1963.

Photo No. 14-1-66. Nearly vertical open stope mined to the surface immediately to the south of the main shaft. Irregular width 3 to 8 feet, and 100 feet or more in length and depth. The trailer in the center background lies near the edge of the open stope. The trailer burned down from unknown causes on October 19, 1963.

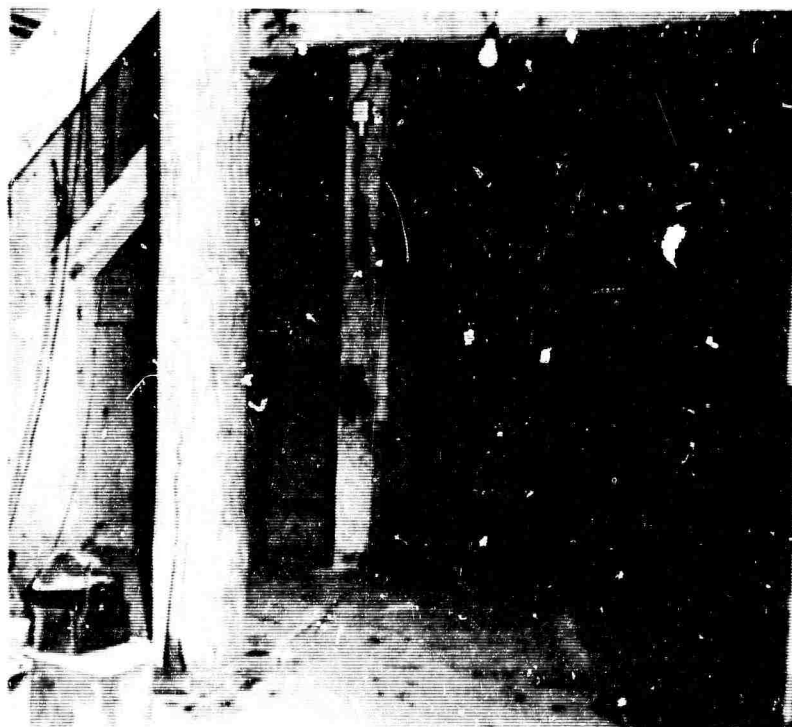
Photo 15-1-70. Preshot. October 10, 1963.

Photo No. 15-1-70. Shaft station on 350-foot level. The timbered dimensions of the shaft are 16 x 6 feet. The shaft is three-compartment, all timbered, with only one compartment in use for shaft rehabilitation work.

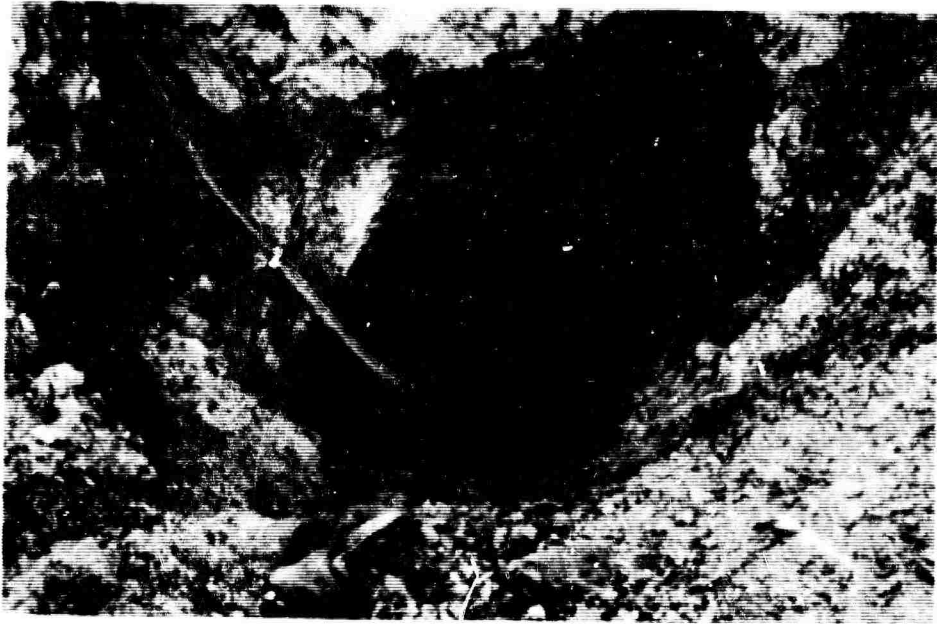
Photo 16-2-76. Preshot. October 22, 1963.

Photo No. 16-2-76. Caved portal of south adit. The adit bearing is about east-west. No support was used for this adit which is about 6 feet high and 3 feet wide.

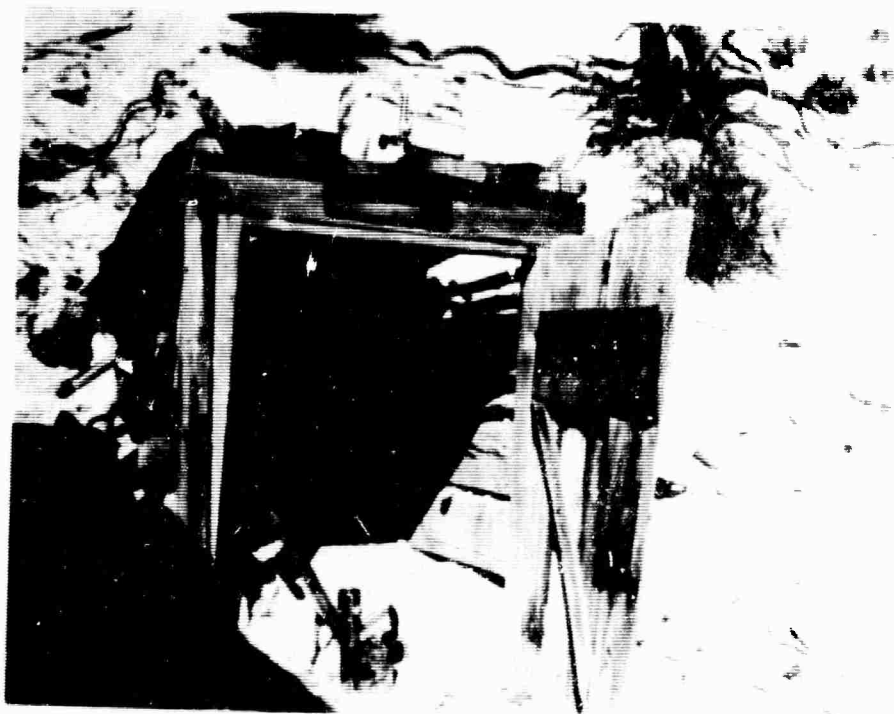
Photo 16-3-77. Preshot. October 22, 1963.

Photo No. 16-3-77. Portal of central adit. The adit bearing is about east-west and the length is about 400 feet. Five 6 x 6-inch timber sets on irregular 6 x 4-foot spacing with timber sprags for lagging are at the portal, otherwise the adit is unsupported. The adit dimensions are about 6 feet in height and 4 feet in width.

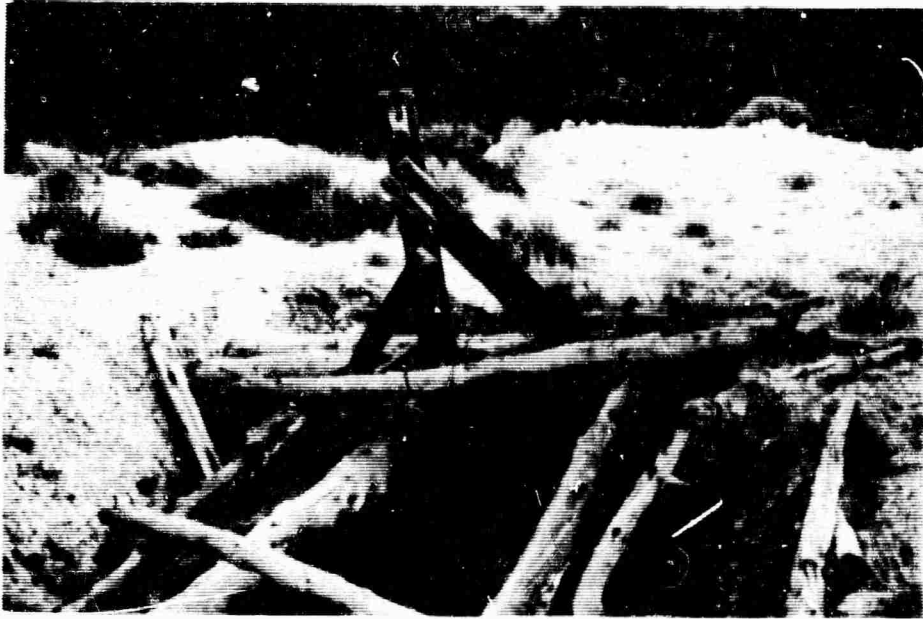
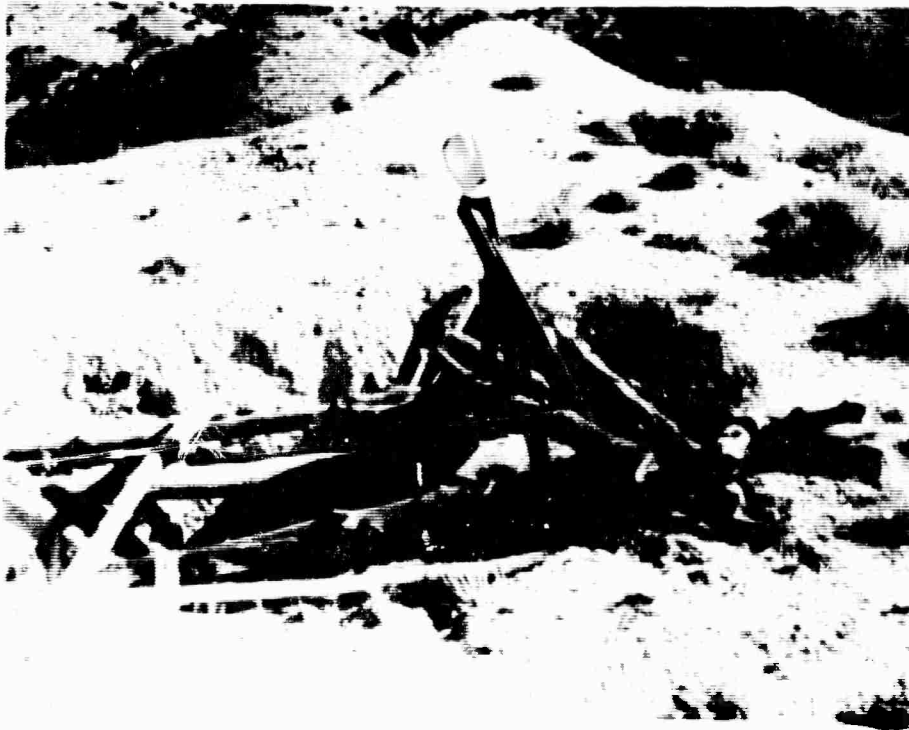
Photo 16-4-78. Preshot. October 22, 1963.

Photo No. 16-4-78. Surface view of main vertical shaft looking to southeast. Some uncut timber sprags are laid across the collar. No support was used in this shaft. The rock dimensions are about 5 x 5 feet. The shaft is caved and sealed with debris about 30 feet below the surface.

No damage resulting from the Shoal event was observed to the inspected portions of this property.
