# VELA UNIFORM PROJECT **SHOAL**

**PRESHOT AND POSTSHOT STRUCTURE SURVEY**  
Holmes & Narver, Inc.

December 1963

# **PRESHOT AND POSTSHOT STRUCTURE SURVEY**

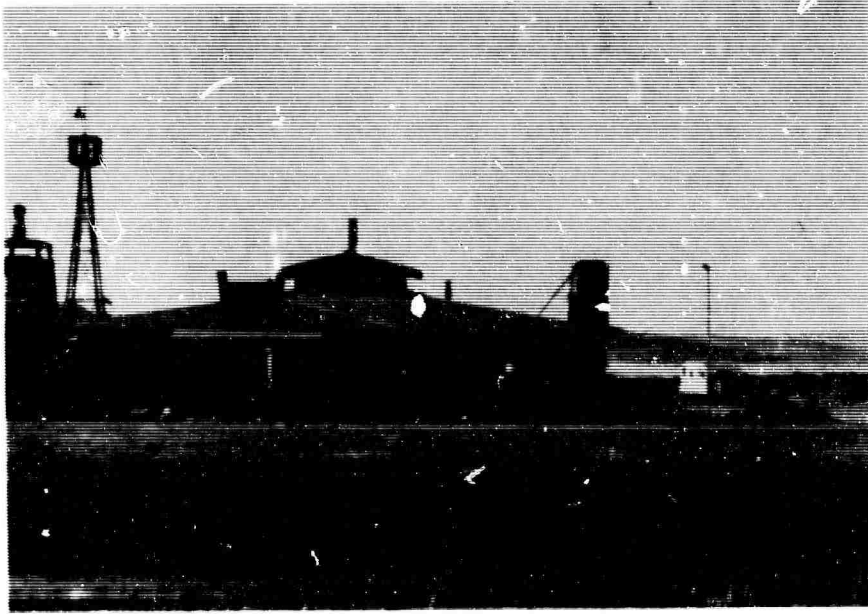
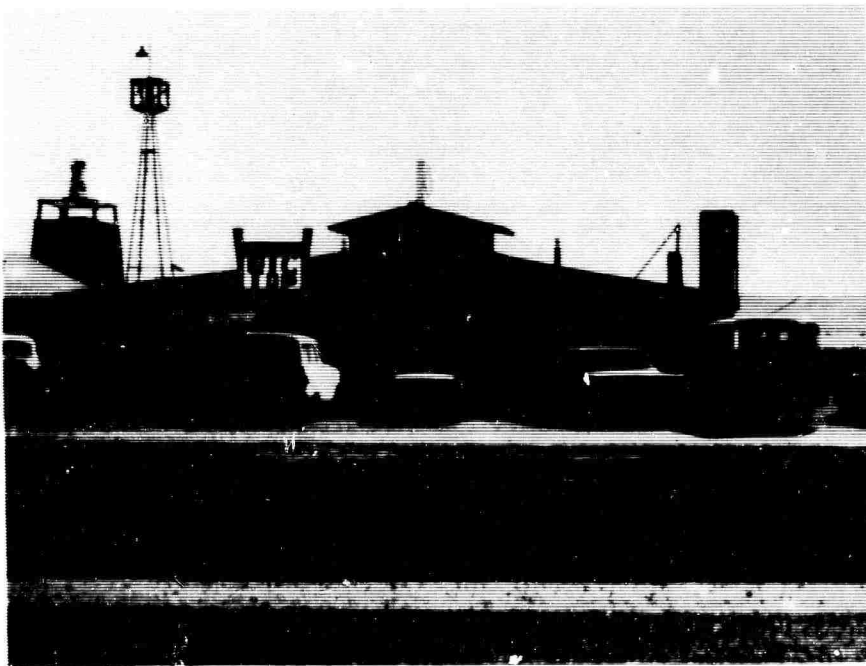
Photo No. 2-1 - Preshot - September 23, 1963

- 2-1 Restaurant and Bar (See photo 2-1) This is a 40 x 50-foot wood frame structure with a concrete masonry fireplace and chimney at the west end of the structure. This structure was built about 1955. No damage was noted as a result of the postshot survey.

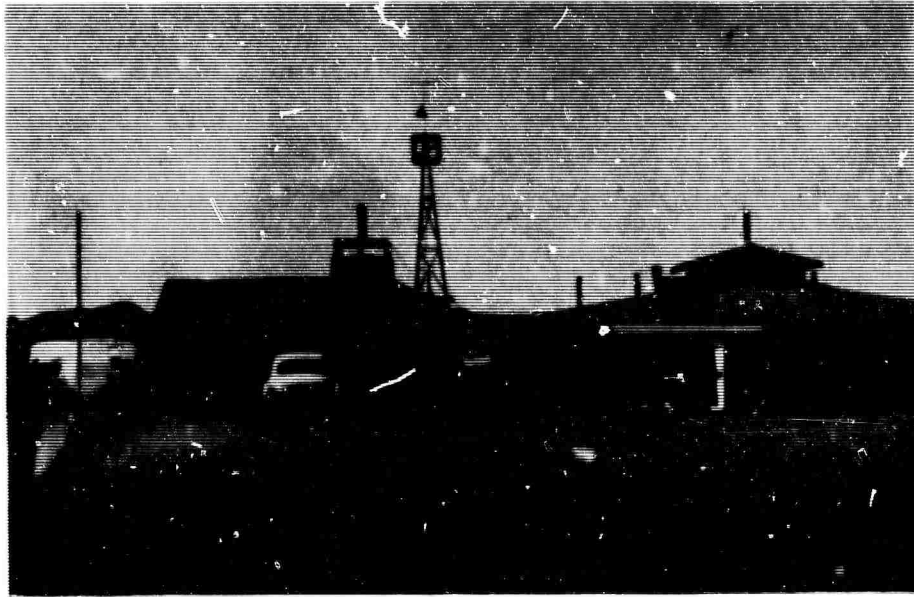
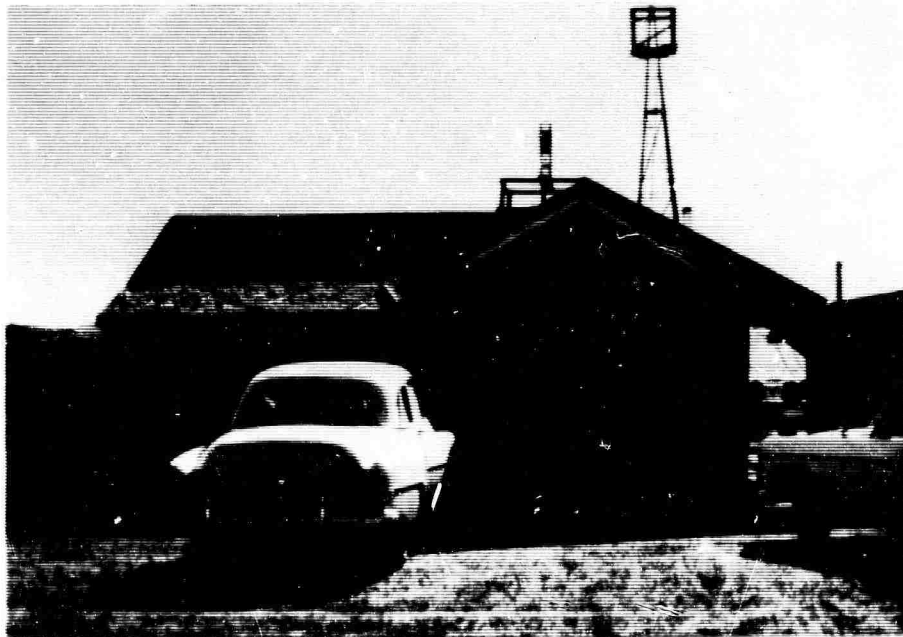
Photo No. 2-2 - Preshot - September 23, 1963

- 2-2 Residence (See photo 2-2) This is a 30 x 30-foot three bedroom, wood frame structure that was built about 1956. No damage was noted as a result of the postshot survey.

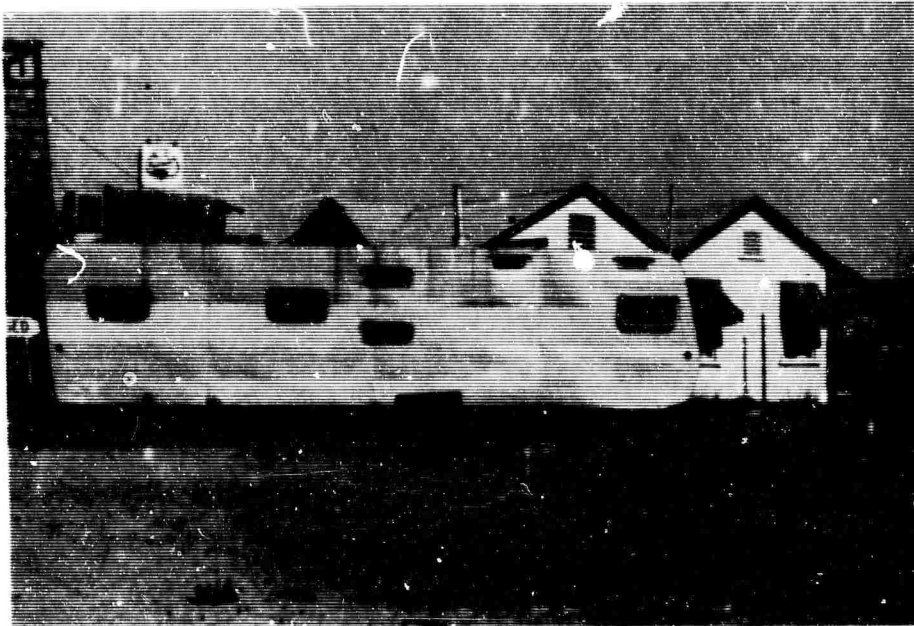
Photo No. 2-3 - Preshot - September 23, 1963

- 2-3 Trailer (See photo 2-3) This is a 30-foot long x 8-foot wide aluminum-covered trailer. No damage was noted as a result of the postshot survey.
- 2-4 Road Crew Trailer (See photo 2-4) This temporary road crew trailer was on the property when it was visited on September 23, 1963, but had been removed when the property was visited on October 26, 1963.

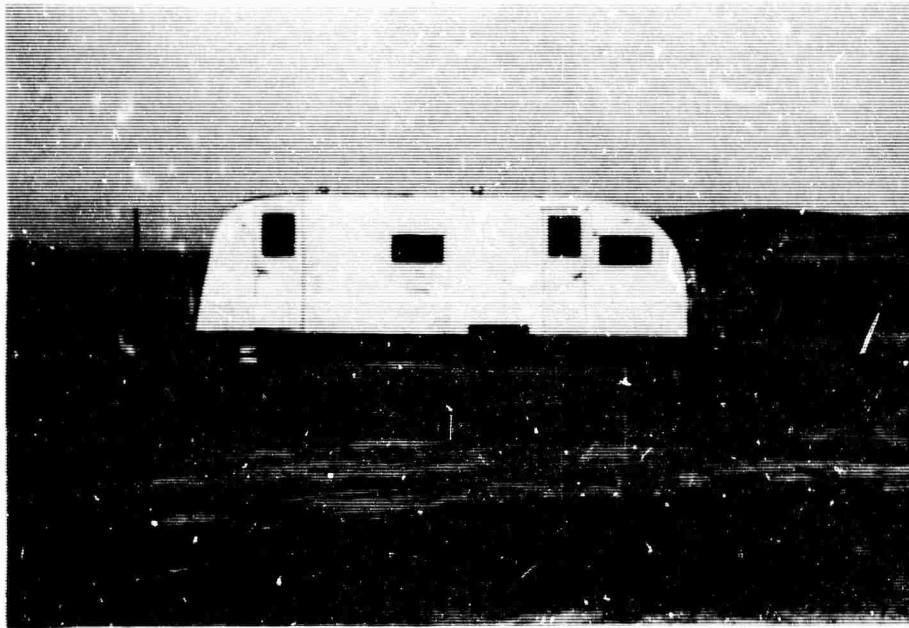
Photo No. 2-4 - Preshot - September 23, 1963

A trailer identified by Serial No. 2-4 had been removed from the location and was not present at shot time; therefore, no postshot photograph was taken. Another trailer which is identified by Serial No. 22-5 was burned down during the weekend of October 19, 1963, according to the owners. A detailed report of these changes is included in Appendix A. No other physical changes were observed.

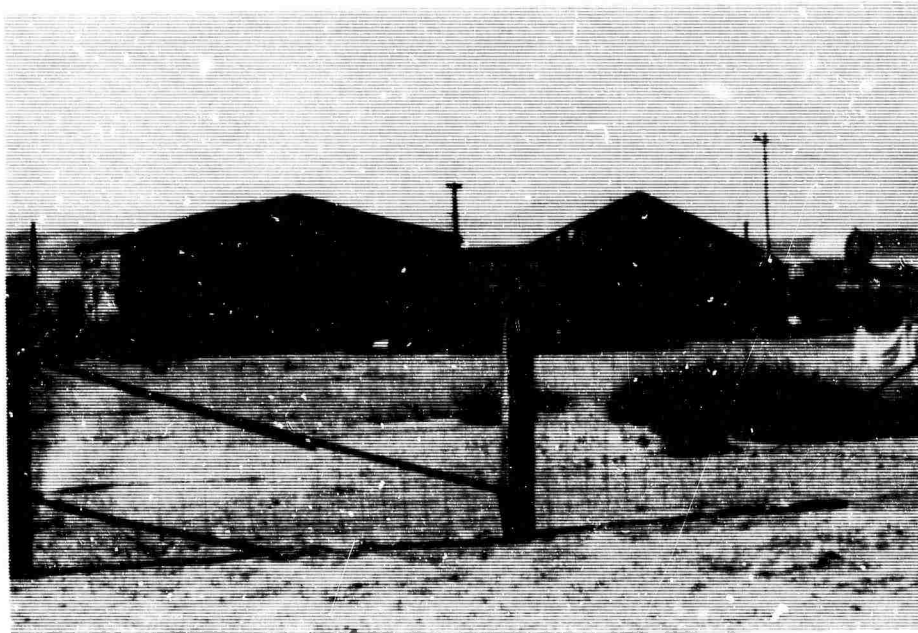
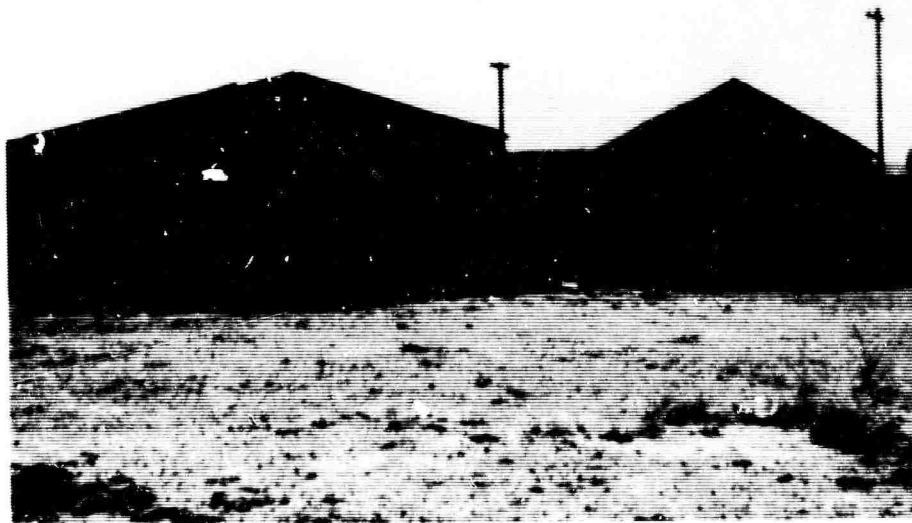
Photo No. 2-5 - Preshot - September 23, 1963

- 2-5 Power, Pump and Storage Building (See photo 2-5) The westerly structure, on the left in the photos, was built about 1945. It is unpainted, but is otherwise in fair condition except for some

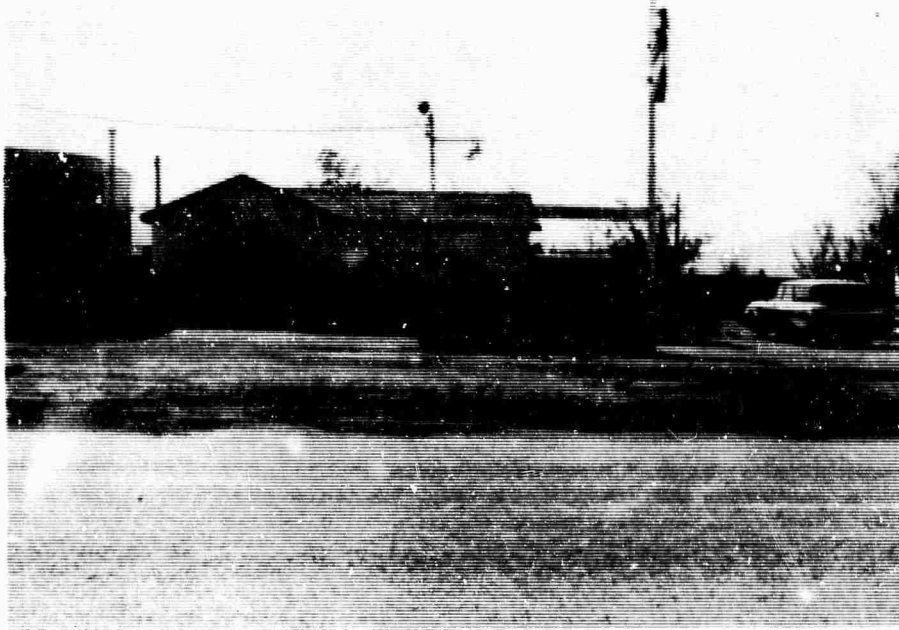
Photo No. 3-2 (1) - Preshot - September 23, 1963

- 3-2 Garage (See photos 3-2(1) and 3-2(2)) 24 x 30-foot concrete block structure built about 1953. There are three gasoline pumps. There is a wood tower or platform structure supporting the T.V. antenna. This structure is roughly built of planks and boards. See photo 3-2(2). No damage was noted as a result of the postshot survey.

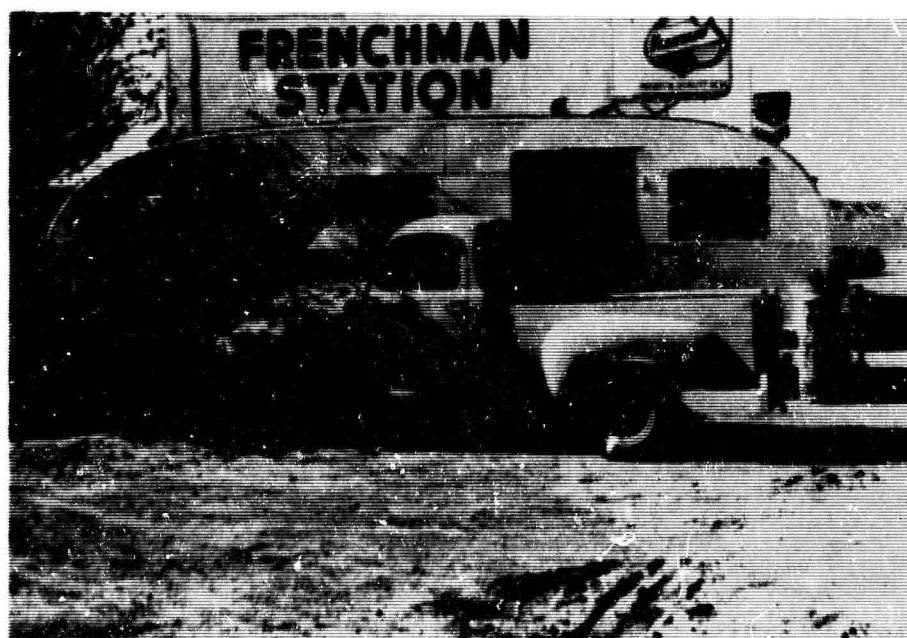
Photo No. 3-4 (1) - Preshot - September 23, 1963

- 3-4 Trailer (See photos 3-4(1) and 3-4(2)) This is a 25-foot long metal covered trailer. No damage was noted as a result of the postshot survey.

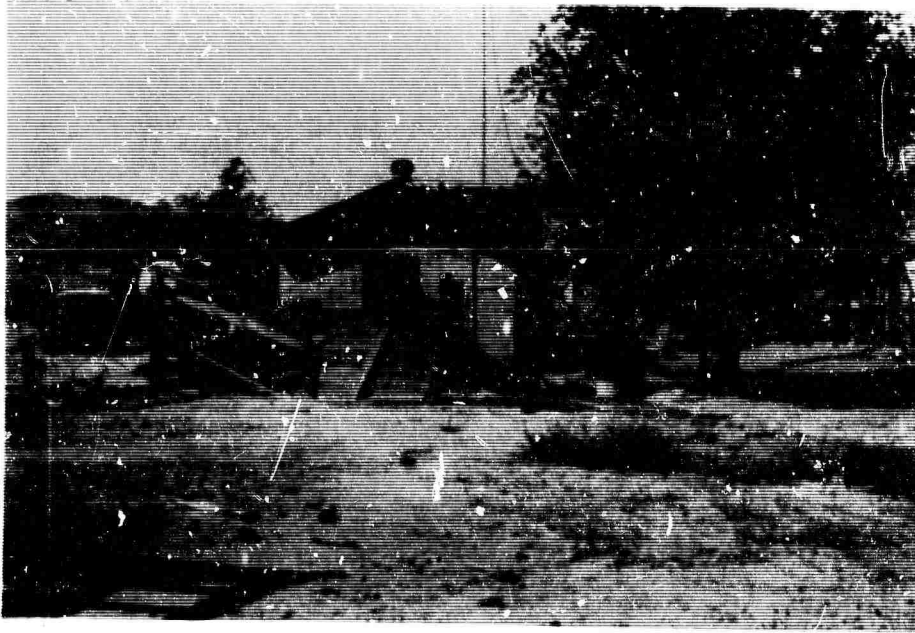
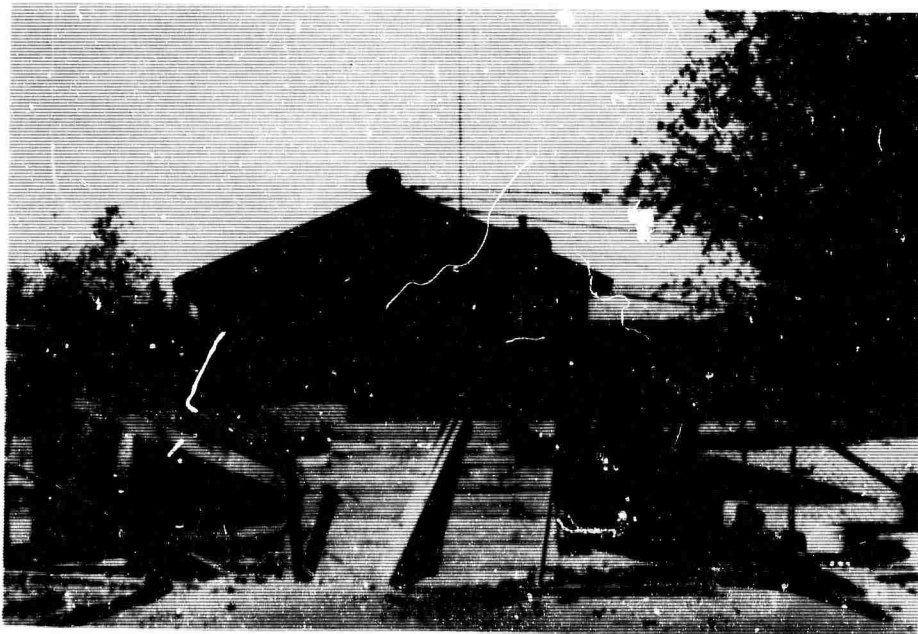
Photo No. 3-5 (1) - Preshot - September 23, 1963

- 3-5 Pump house (See photos 3-5(1) through 3-5(4)) This is a 15 x 20-foot concrete masonry pump house built about 1953. AZ 254° clockwise from magnetic north. No damage was noted as a result of the postshot survey.

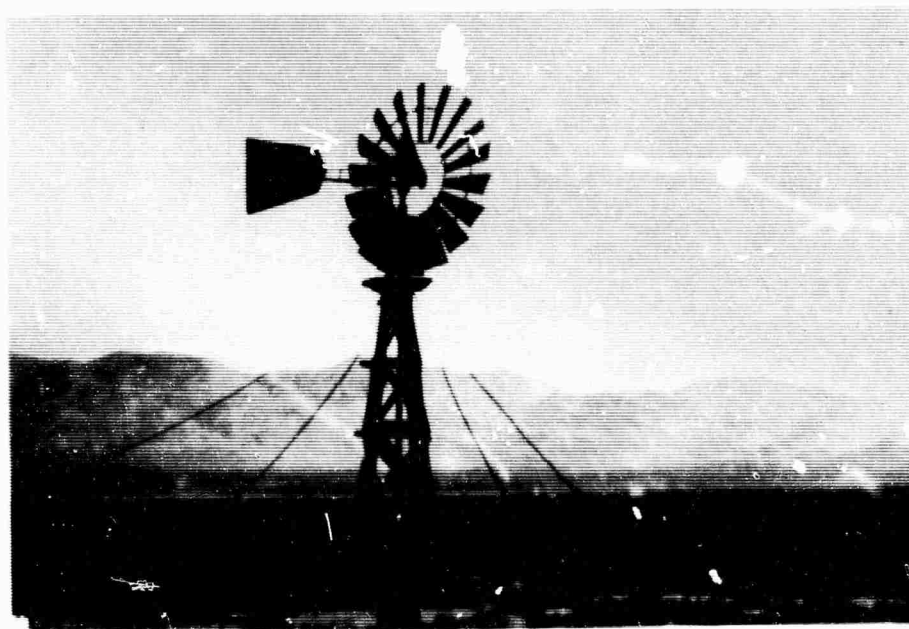
Photo No. 4-1 (1) - Preshot - September 23, 1963

- 4-1 Windmill Structure (See photos 4-1(1) and 4-1(2)) Windmill - braced and guyed wooden structure. Age uncertain, about 10 years. AZ 65° clockwise from magnetic north. No damage was noted as a result of the postshot survey.

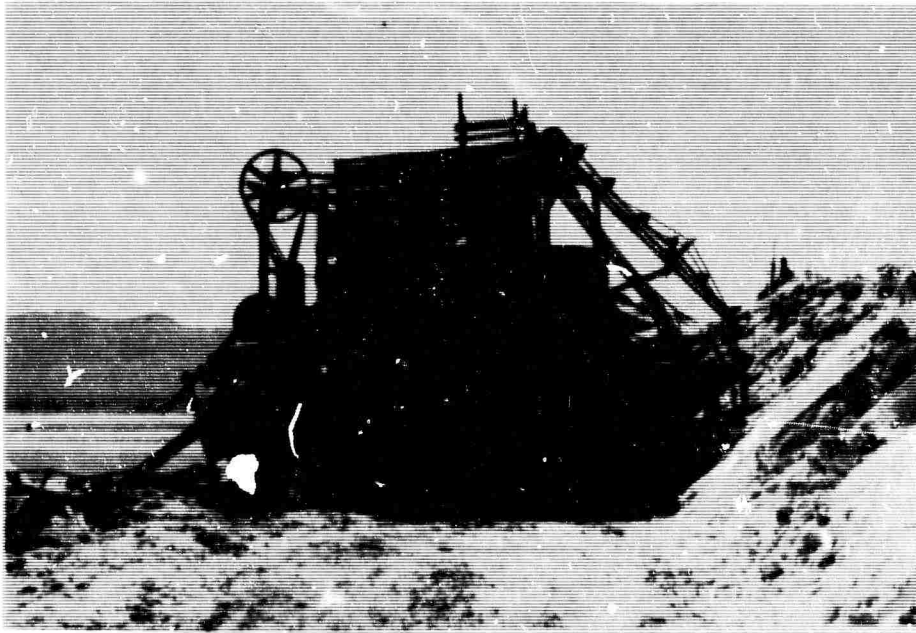
Photo No. 5-1 (1) - Preshot - September 24, 1963

- 5-1 Loading Bins and Ramp (See photos 5-1(1) and 5-1(2)) Consists of loading bins and ramp of wood construction. No damage was noted as a result of the postshot survey.

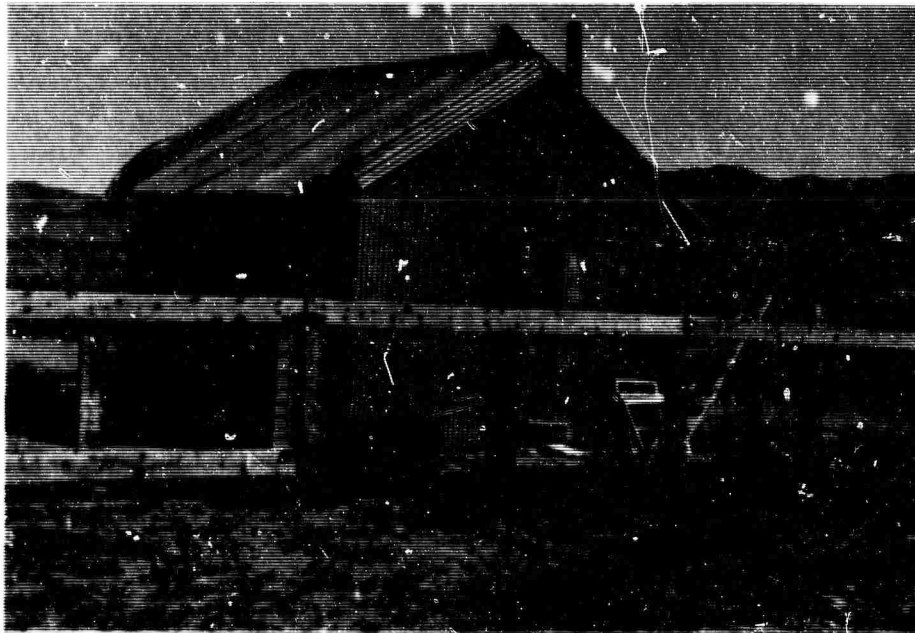
Photo No. 6-1 - Preshot - September 24, 1963

- 6-1 Shack (See photo 6-1) This structure is a 16 x 16-foot wood frame, corrugated sheet metal-covered shack. Roofing and siding are damaged and all windows have been removed. No damage was noted as a result of the postshot survey.
- 6-2 Shack (See photo 6-2) This shack is a 16 x 16-foot wood structure. It is unpainted and the boards of the siding are warped and badly weathered. No damage was noted as a result of the postshot survey.

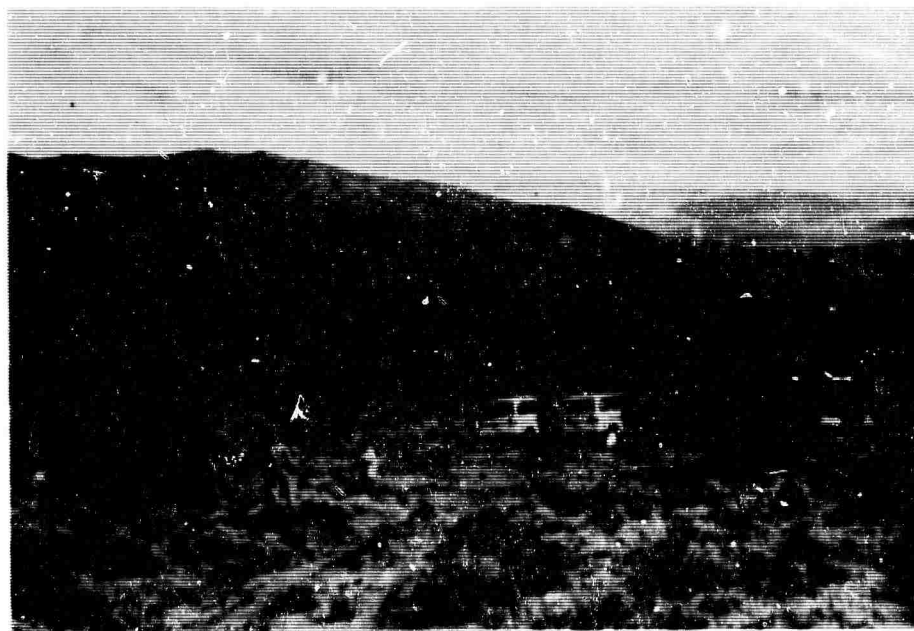
Photo No. 7-1 - Preshot - September 24, 1963

- 7-1 Shack, Trailer and Outhouse (See photo 7-1) This 8 x 12-foot wood frame shack is covered with green mineral surfaced asphalt roll roofing. Also a 2-wheel small trailer and outhouse. No damage was noted as a result of the postshot survey.

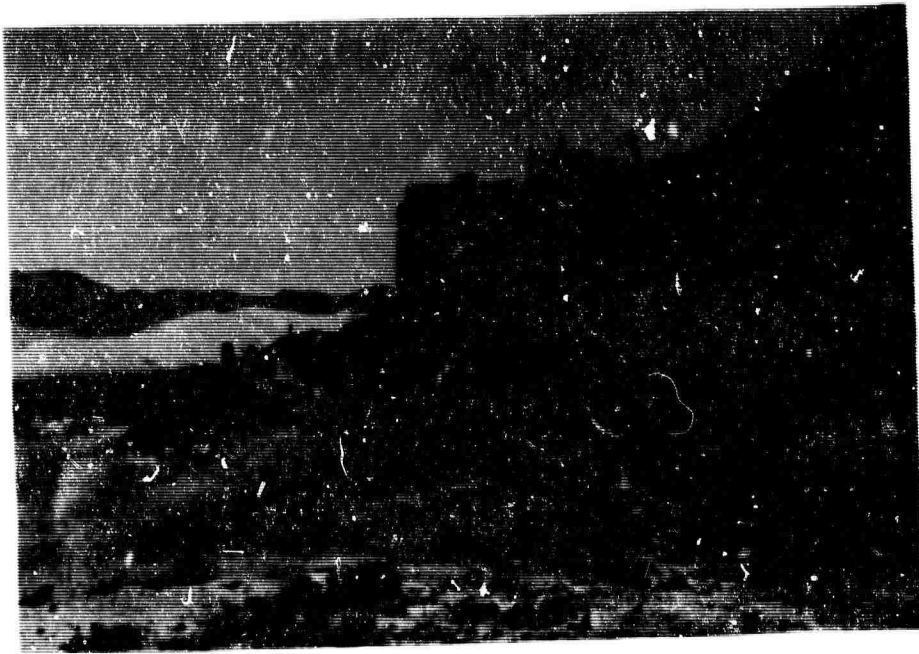
Photo No. 8-1 - Preshot - September 25, 1963

- 8-1 Storage Bin and Foundations (See photo 8-1) Abandoned wood storage bin and concrete foundations. No damage was noted as a result of the postshot survey.

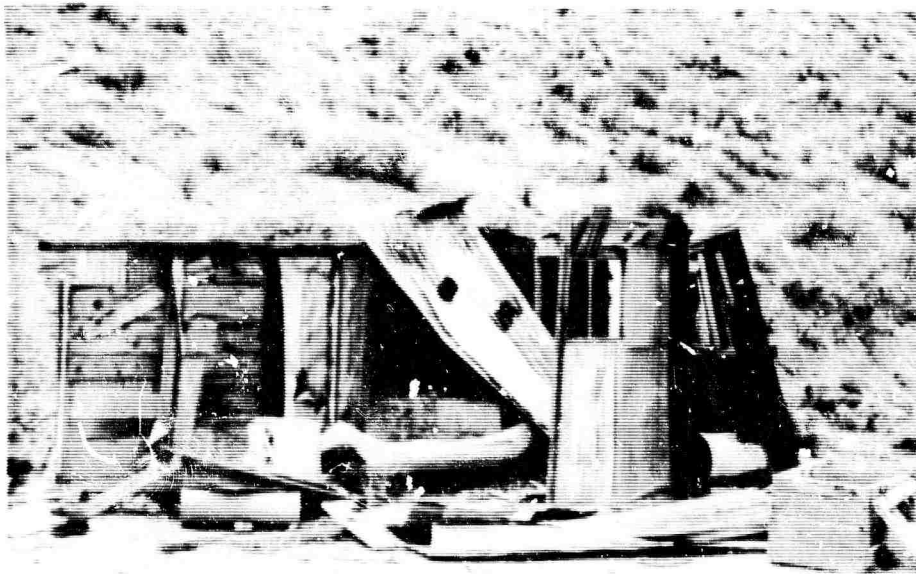
Photo No. 10-2 - Preshot - September 30, 1963

- 10-2 Cabin (See photo 10-2) Abandoned wrecked cabin. Roof is completely missing and most of the walls have collapsed. No damage was noted as a result of the postshot survey.
- 10-3 Shack (See photo 10-3) This 16 x 20-foot shack is abandoned. Wood frame and wood and roofing felt covered, generally in dilapidated condition. Roof covering is entirely gone. Windows are missing, boards are warped and the roof structure sags. No damage was noted as a result of the postshot survey.

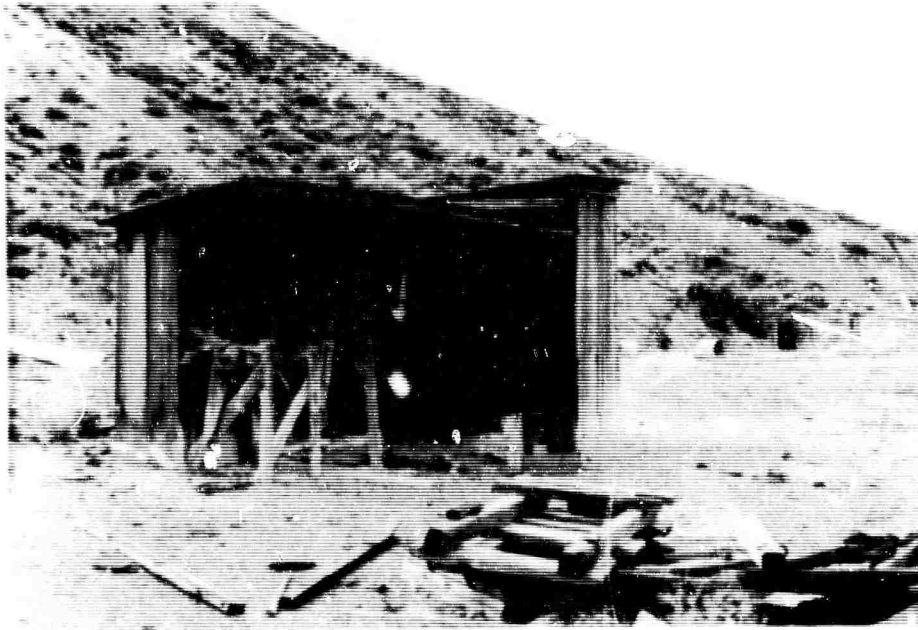
Photo No. 11-1 - Preshot - September 30, 1963

- 11-1 Shack (See photo 11-1) This 10 x 20-foot abandoned shack is a dilapidated wood structure. Boards are warped and weatherbeaten. One side of shack is completely missing. No damage was noted as a result of the postshot survey.
- 11-2 Foundations (See photo 11-2) Concrete mill foundations - abandoned. Mill superstructure completely missing. No damage was noted as a result of the postshot survey.

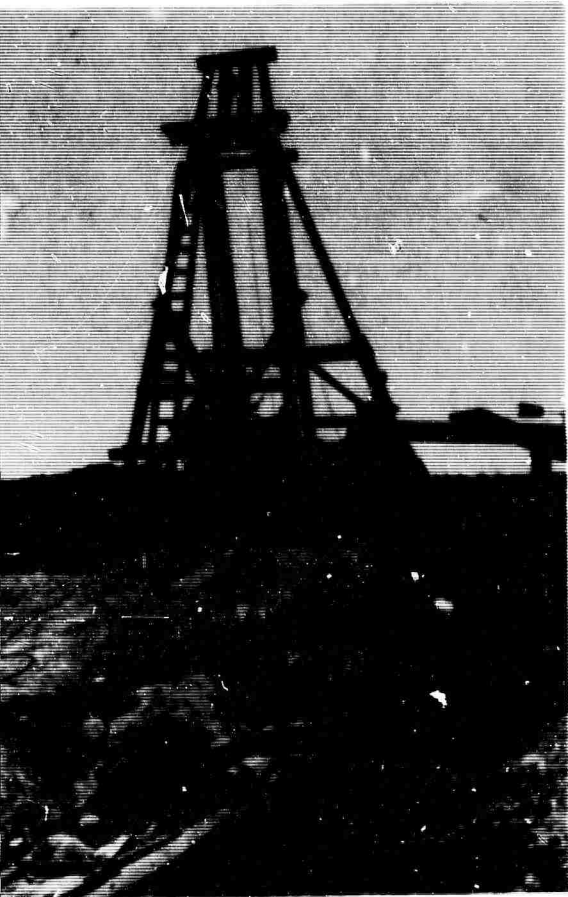
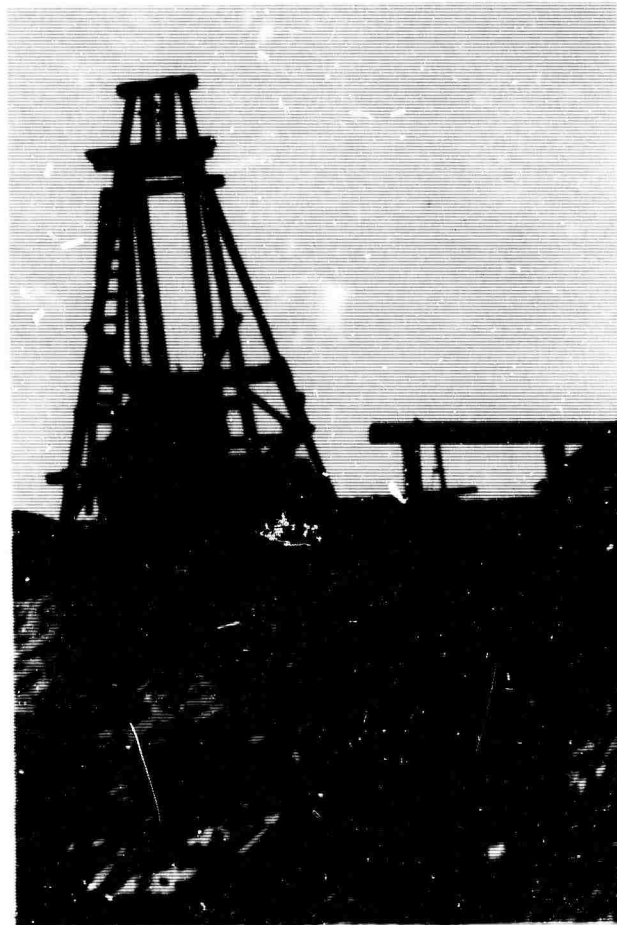
Photo No. 12-2

- 12-2 Headframe (See photo 12-2) Headframe structure of wood in good usable condition. No damage was noted as a result of the postshot survey.
- 12-3 Hoist house (See photo 12-3) This hoist house is 15 x 20-foot wood frame and partly wood and partly corrugated metal covered. No windows exist, and structure is unpainted. No damage was noted as a result of the postshot survey.
- 12-4 Shed (See photo 12-4) This is a 8 x 8-foot shed of wood frame and corrugated metal covering. Has no windows and is in a battered but usable condition. No damage was noted as a result of the postshot survey.

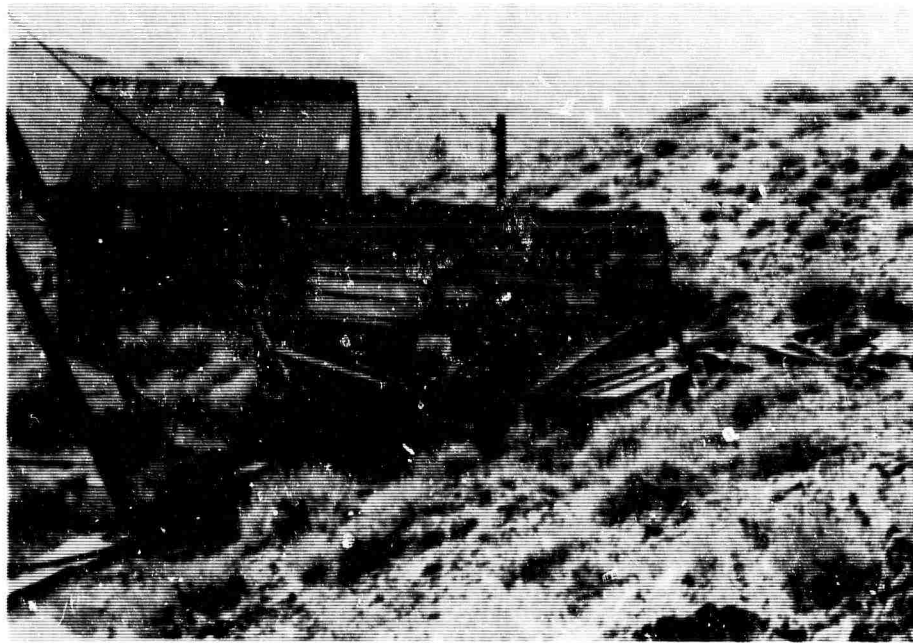
Photo No. 13-1 - Preshot - September 30, 1963

- 13-1 Shed (See photo 13-1) Corrugated metal-covered wood frame. All doors and windows are missing. Corrugated metal roof is ripped and punctured. Hoist house is a wood structure. Roof covering is missing. Roof structure is partly caved and side walls are leaning and broken. No damage was noted as a result of the postshot survey.

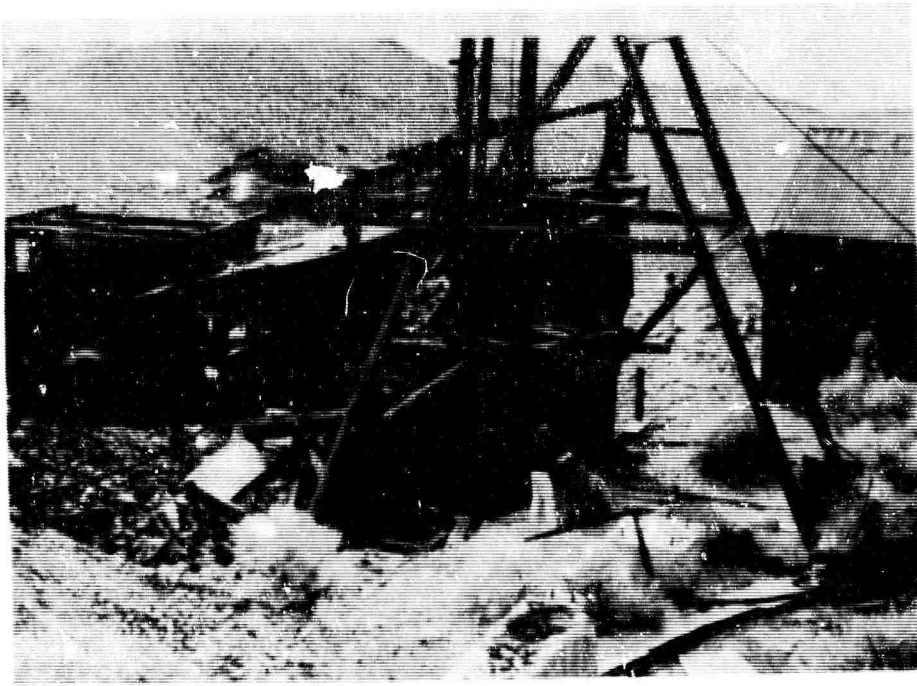
Photo No. 13-2 - Preshot - September 30, 1963

- 13-2 Headframe (See photo 13-2) This is a wood structure with some members broken. No damage was noted as a result of the postshot survey.
- 13-3 Mill Building (See photo 13-3) This is a 50 x 200-foot mill building of wood. Corrugated metal roof is almost entirely missing. Doors and windows are missing. Generally dilapidated structure. No damage was noted as a result of the postshot survey.

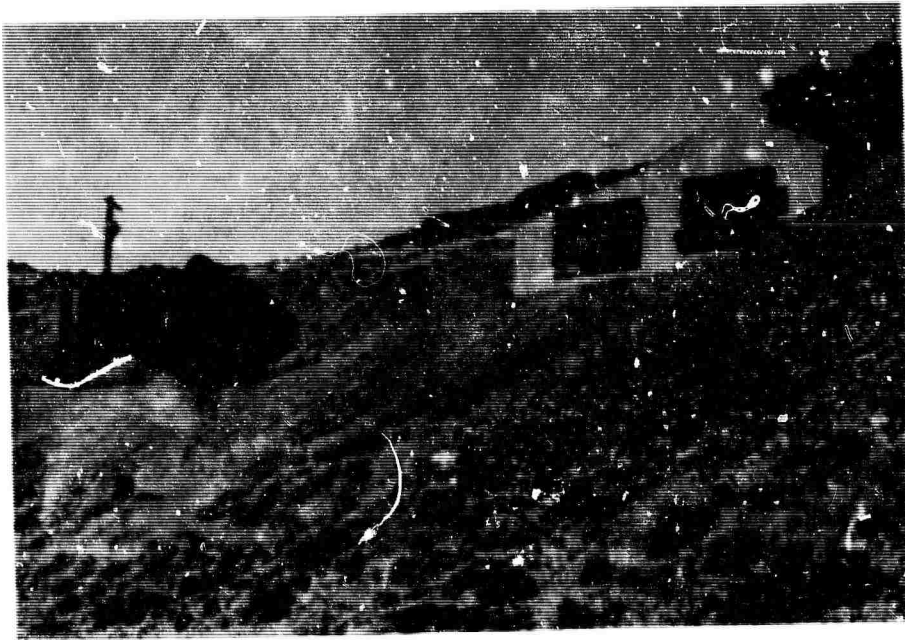
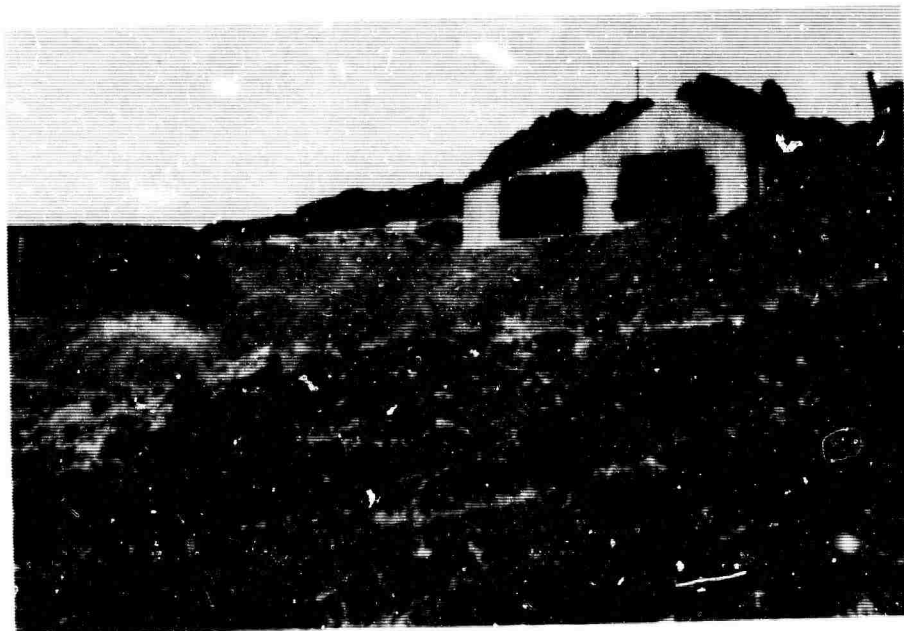
Photo No. 13-4 - Preshot - September 30, 1963

- 13-4 Shed (See photo 13-4) This is a 20 x 30-foot building of wood frame and corrugated metal siding. Windows are boarded over but glass is generally broken. No damage was noted as a result of the postshot survey.

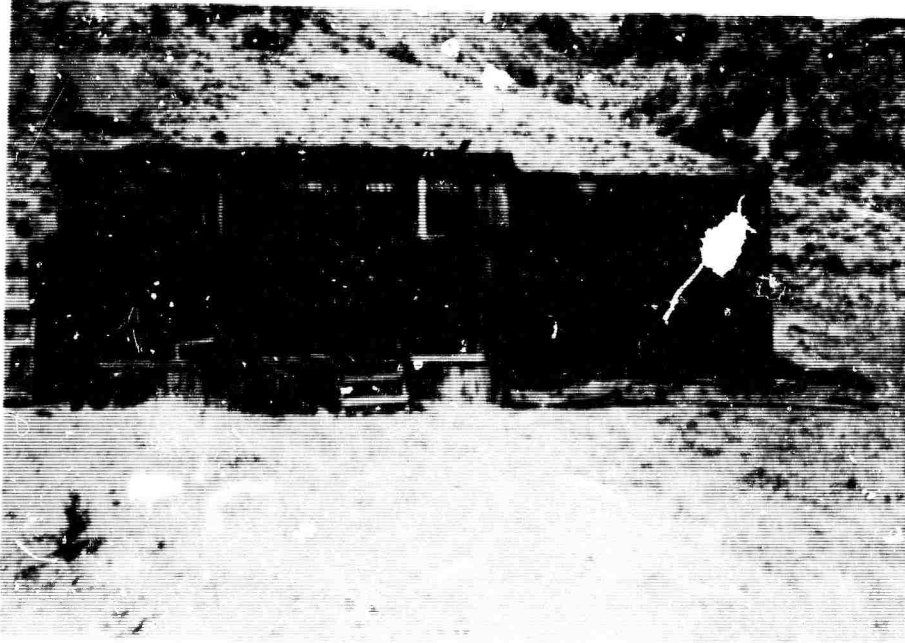
Photo No. 13-6 - Preshot - September 30, 1963

- 13-6 Shack (See photo 13-6) This is a 10 x 25-foot shack of wood frame and siding. Generally in dilapidated condition. Doors, windows are missing. Shack is unpainted weather-beaten and boards are warped. Corrugated roof is partly missing. No damage was noted as a result of the postshot survey.

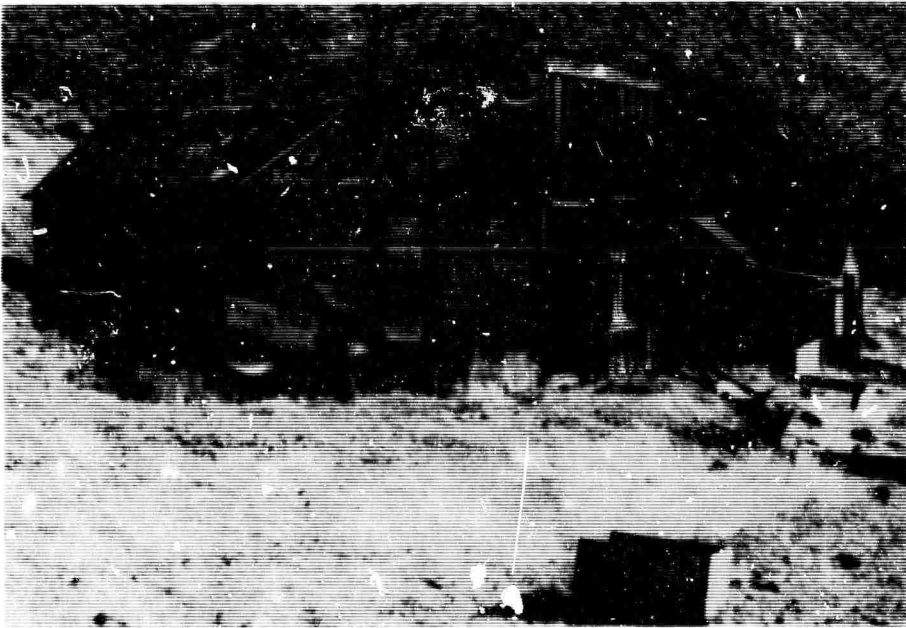
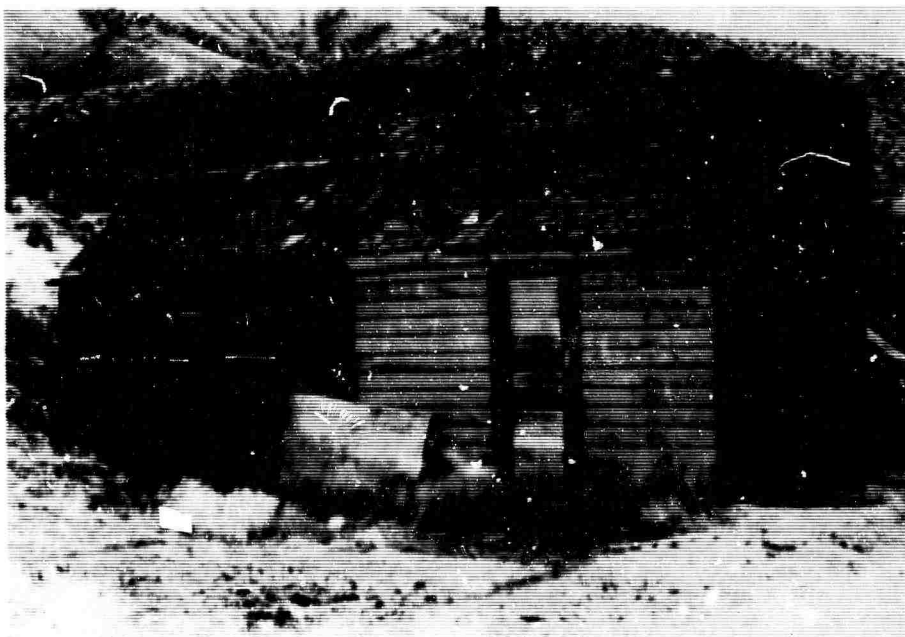
Photo No. 13-7 - Preshot - September 30, 1963

- 13-7 Store Building (See photo 13-7) This 12 x 24-foot store building is wood frame and siding with wood shingle roof. Doors and windows are missing. Several holes exist in the roof. Siding is weather-beaten and curled. No damage was noted as a result of the postshot survey.

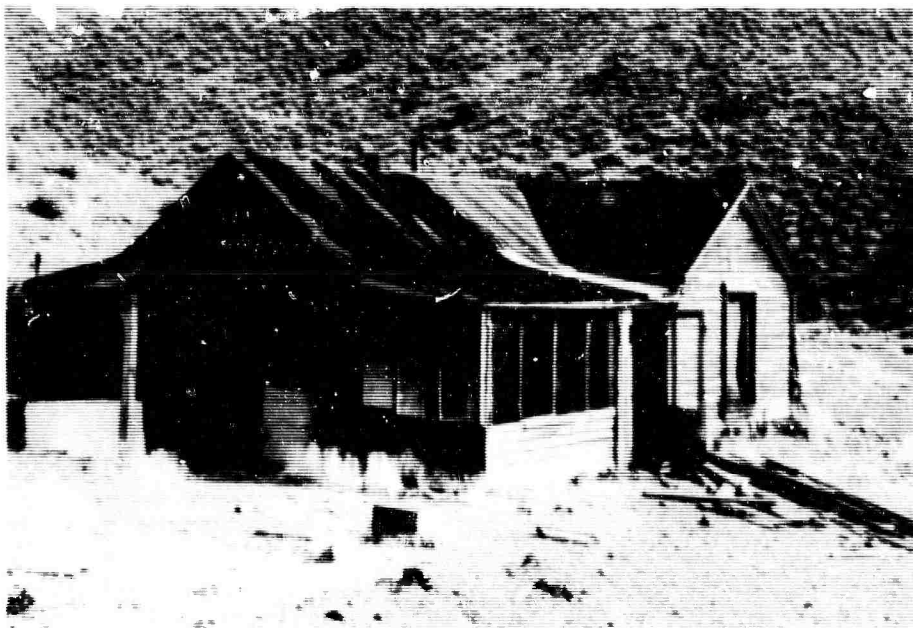
Photo No. 13-8 - Preshot - September 30, 1963

- 13-8 House (See photo 13-8) This 20 x 30-foot house is wood frame and siding. Doors and windows are missing. Generally dilapidated. No damage was noted as a result of the postshot survey.

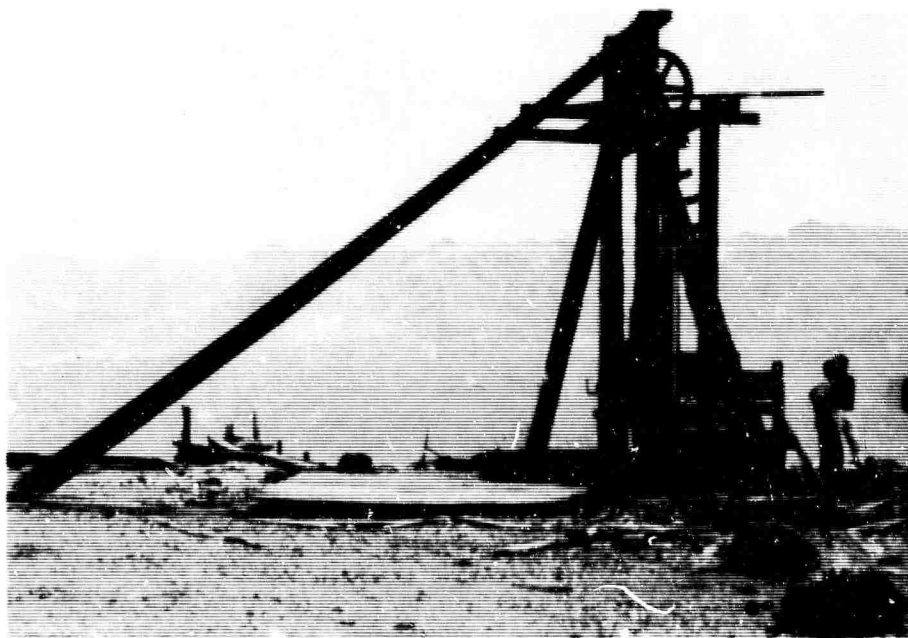
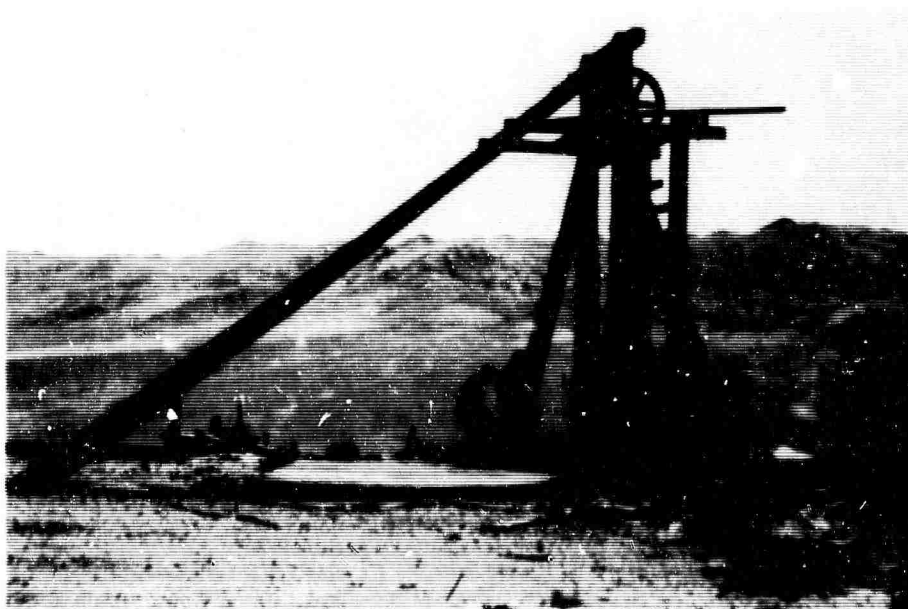
Photo No. 14-1 - Preshot - September 30, 1963

- 14-1 Headframe (See photo 14-1) Wooden headframe structure of round wood poles weathered. No damage was noted as a result of the postshot survey.
- 14-2 Cabin (See photo 14-2) This is a 16 x 16-foot abandoned cabin. Wood frame and siding, wood shingle roof partly missing. No damage was noted as a result of the postshot survey.
- 14-3 Cabin (See photo 14-2) This is a 16 x 16-foot abandoned cabin. Wood frame and siding, wood shingle roof partly missing. No damage was noted as a result of the postshot survey.

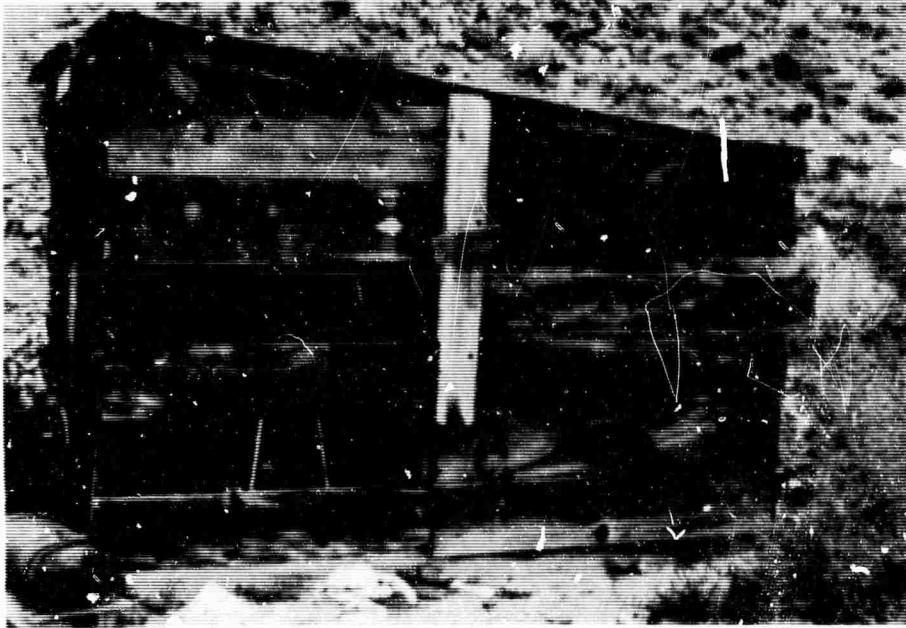
Photo No. 15-1 - Preshot - September 30, 1963

- 15-1 Shack (See photo 15-1) This shack of wood frame and board siding with corrugated-metal roof is 12 x 12 feet. Siding is weather-beaten and warped. Some of the boards are missing. No damage was noted as a result of the postshot survey.
- 15-2 Shack (See photo 15-2) This is an 8 x 15-foot wood frame shack covered with roll roofing on roof and sides. Door and window missing. No damage was noted as a result of the postshot survey.
- 15-3 Headframe (See photo 15-3) Headframe structure of wood somewhat weathered. No damage was noted as a result of the postshot survey.

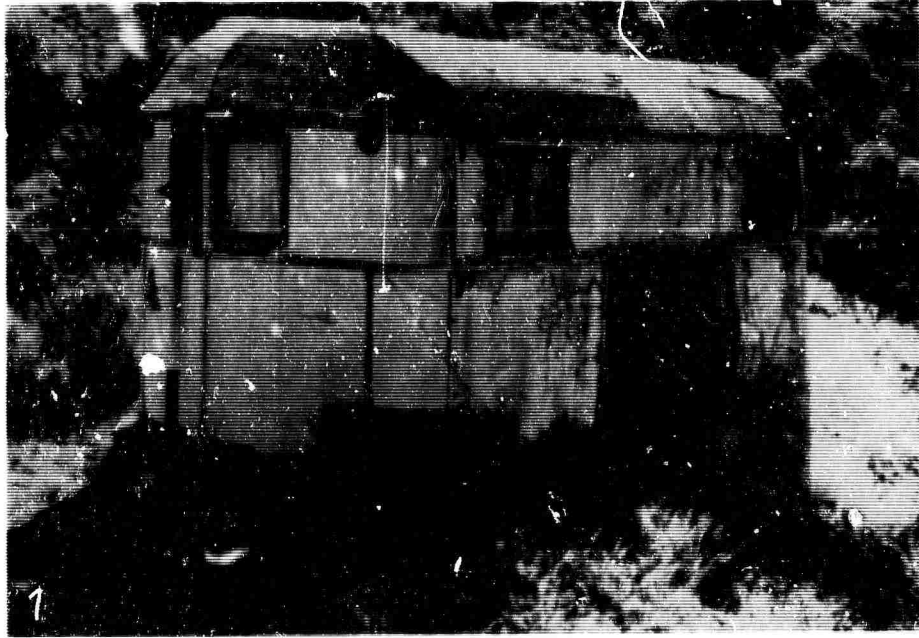
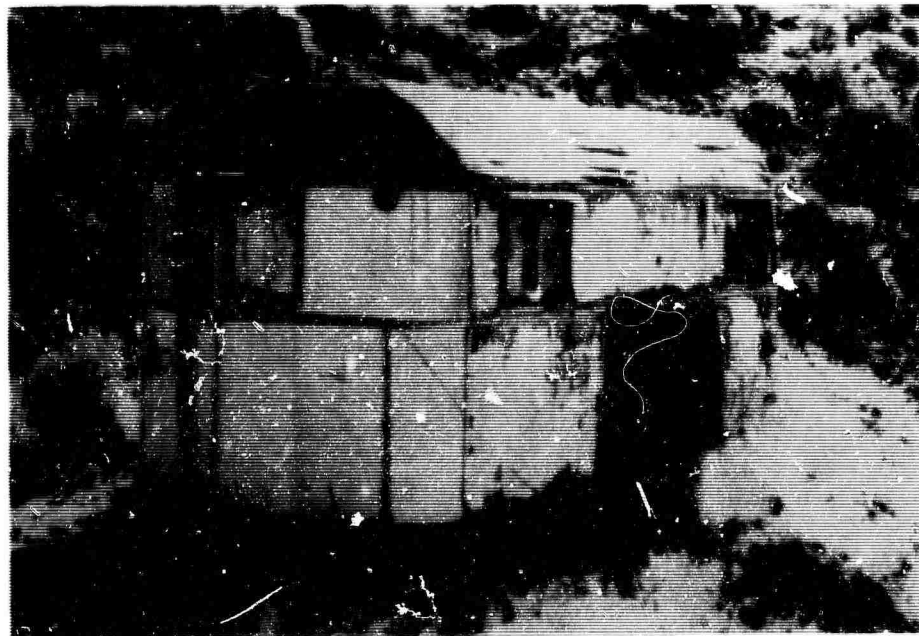
Photo No. 17-1 - Preshot - October 1, 1963

17-1 Trailer (See photo 17-1) Abandoned 16-foot trailer, dilapidated and unoccupied. No damage was noted as a result of the postshot survey.

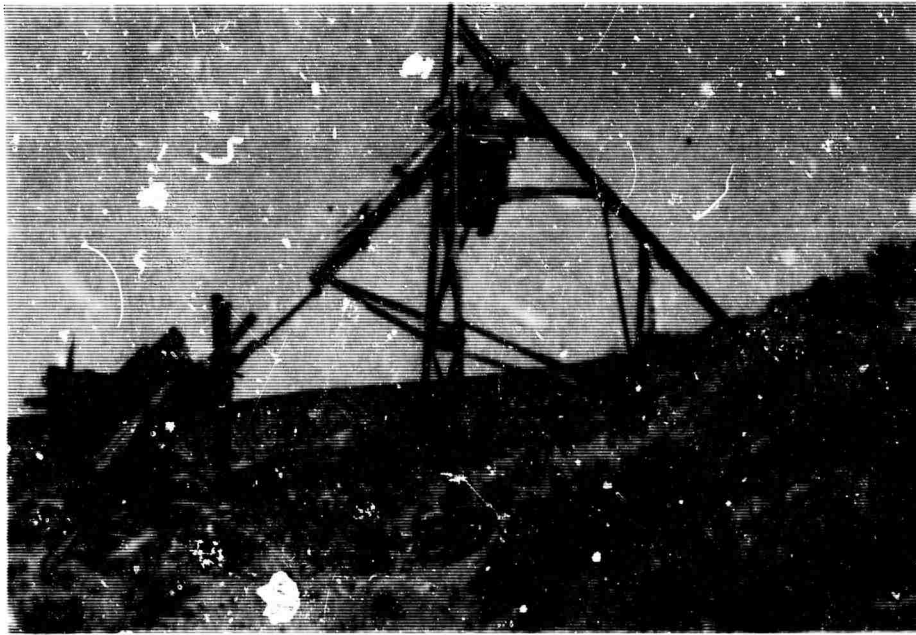
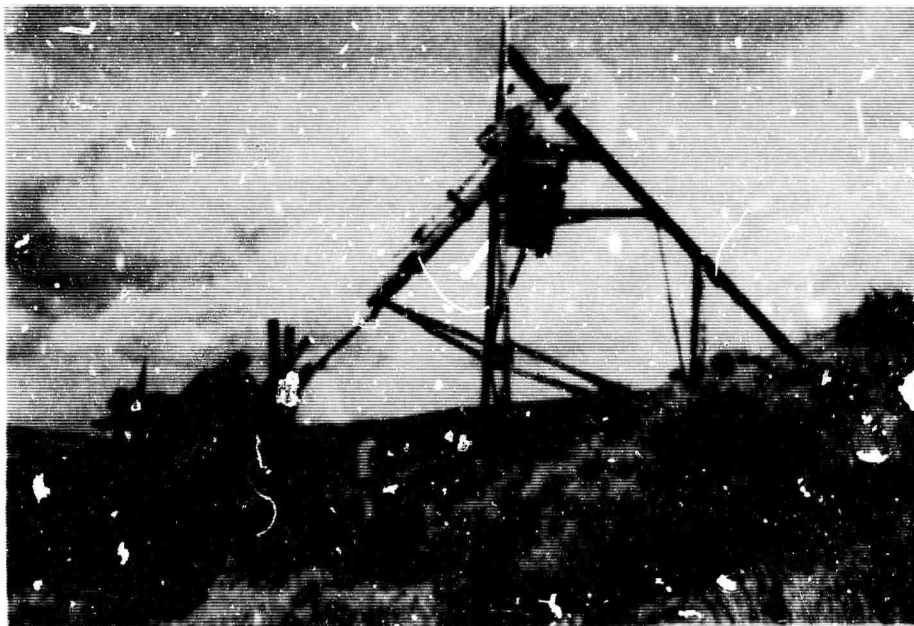
Photo No. 18-1 - Preshot - October 1, 1963

18-1 Headframe (See photo 18-1) This wood headframe structure is the only structure at this site. Structure is weathered. No damage was noted as a result of the postshot survey.
