# VELA UNIFORM PROJECT **SHOAL**

**PRESHOT AND POSTSHOT STRUCTURE SURVEY**  
Holmes & Narver, Inc.

December 1963

# **PRESHOT AND POSTSHOT STRUCTURE SURVEY**

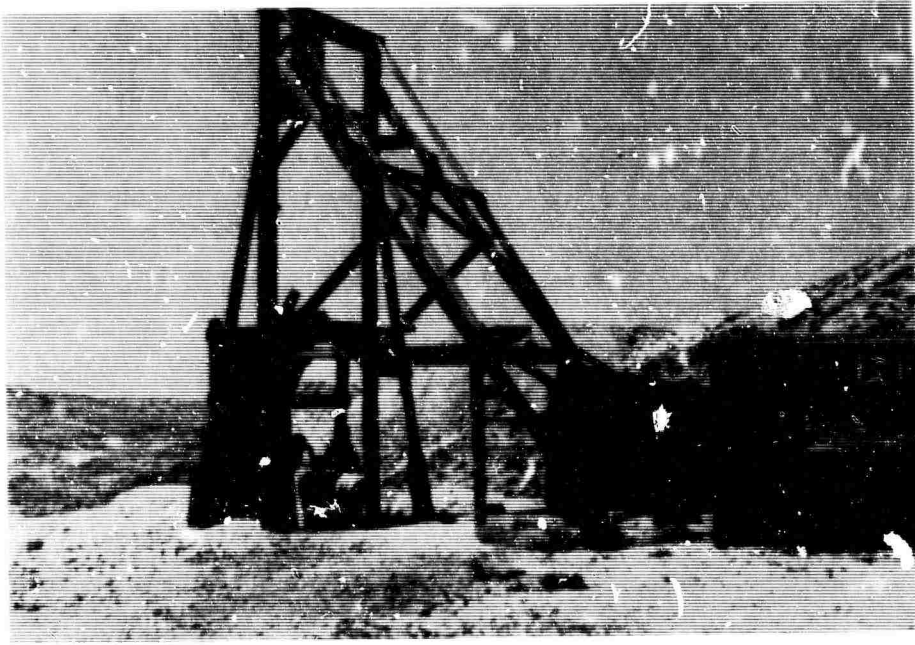
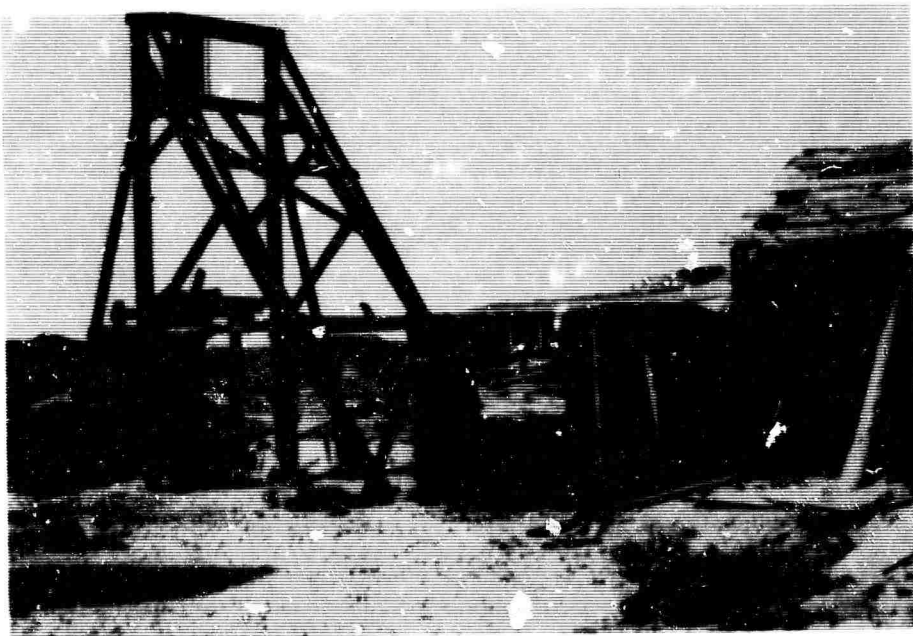
Photo No. 19-1 - Preshot - October 1, 1963

19-1 Headframe (See photo 19-1) Wooden headframe weather-beaten. 20 x 20-foot hoist house of wood frame and siding in dilapidated condition. Doors and windows missing. Shed also 20 x 20 feet, in dilapidated condition. Metal-covered wood frame with doors and windows missing. No damage was noted as a result of the postshot survey.

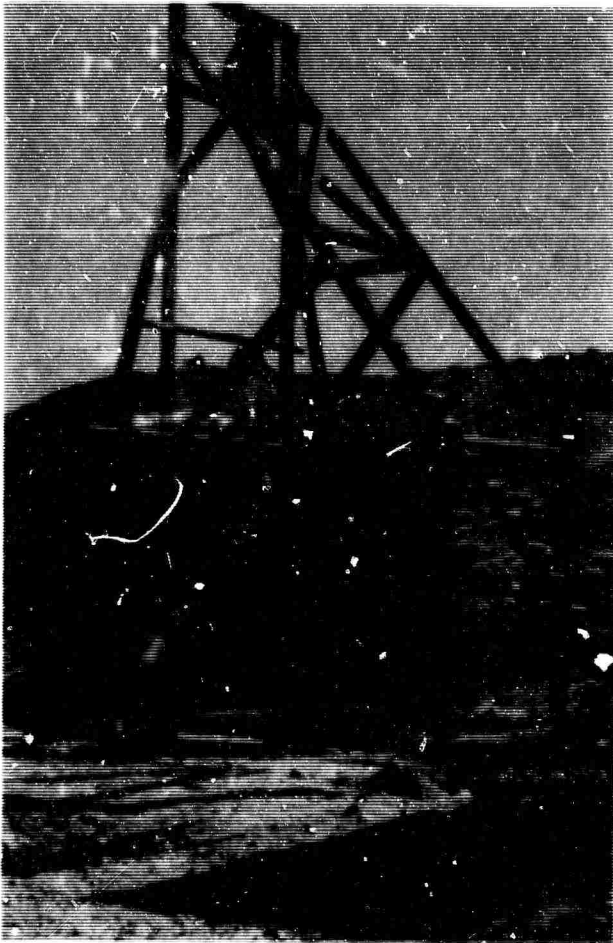
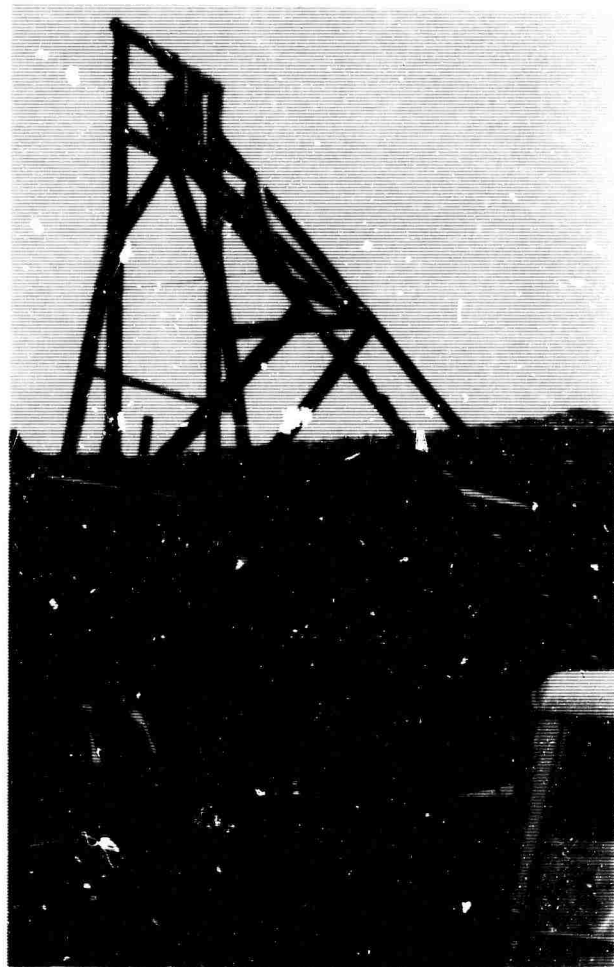
Photo No. 20-1

20-1 Headframe (See photo 20-1) This lower level wood headframe is weathered but otherwise in fair condition. No damage was noted as a result of the postshot survey.

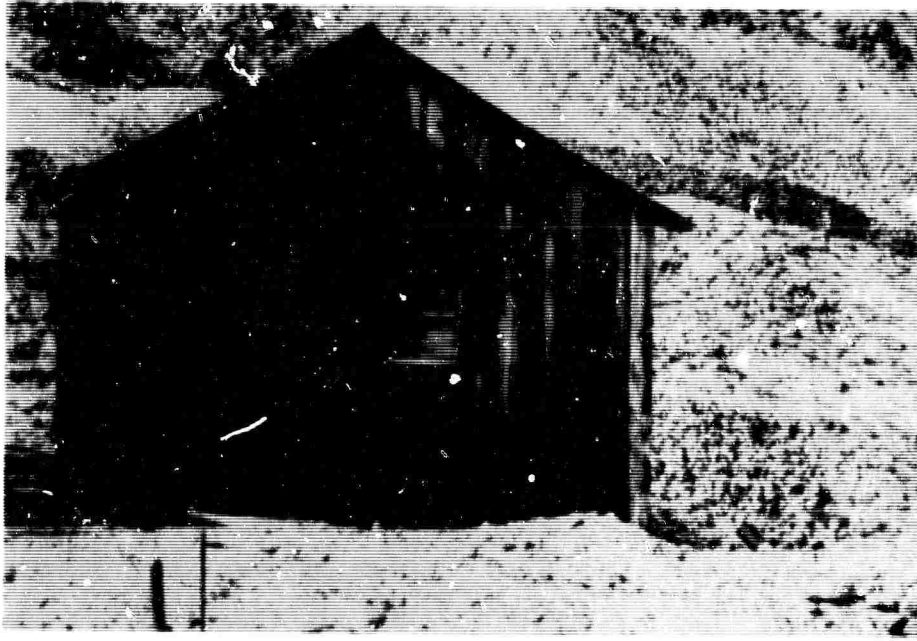
Photo No. 20-3 - Preshot - October 1, 1963

- 20-3 Shack (See photo 20-3) Lower level 16 x 16-foot shack of wood frame and siding and corrugated metal roof. Siding weather-beaten and warped. Door panels broken and windows missing. No damage was noted as a result of the postshot survey.

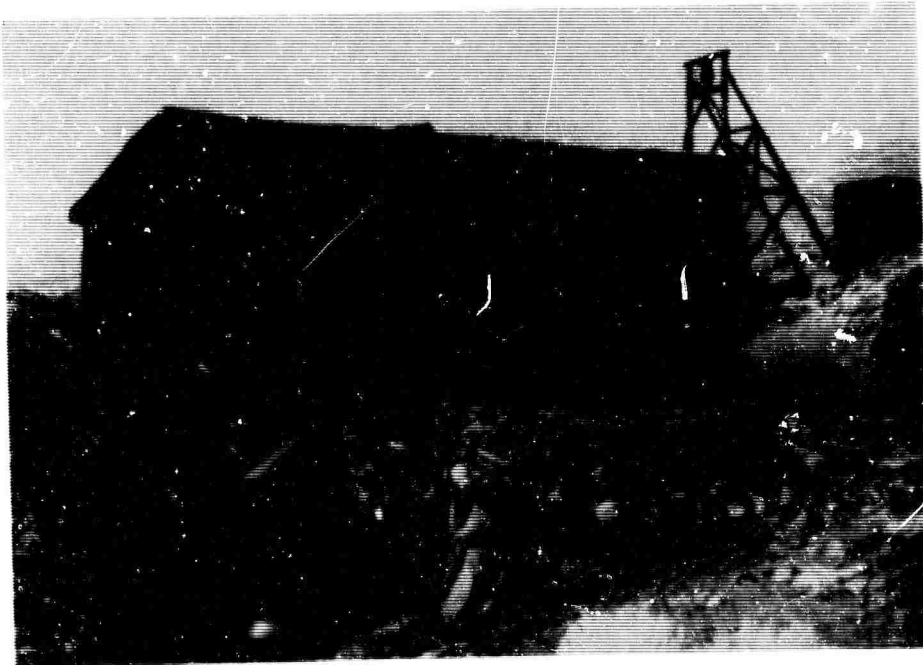
Photo No. 20-4 - Preshot - October 1, 1963

- 20-4 Shed (See photo 20-4) Upper level 15 x 30-foot shed of wood frame and siding and corrugated metal roof. Roof beaten and partly missing. Siding weathered, warped, and partly missing. All doors and windows missing. No damage was noted as a result of the postshot survey.

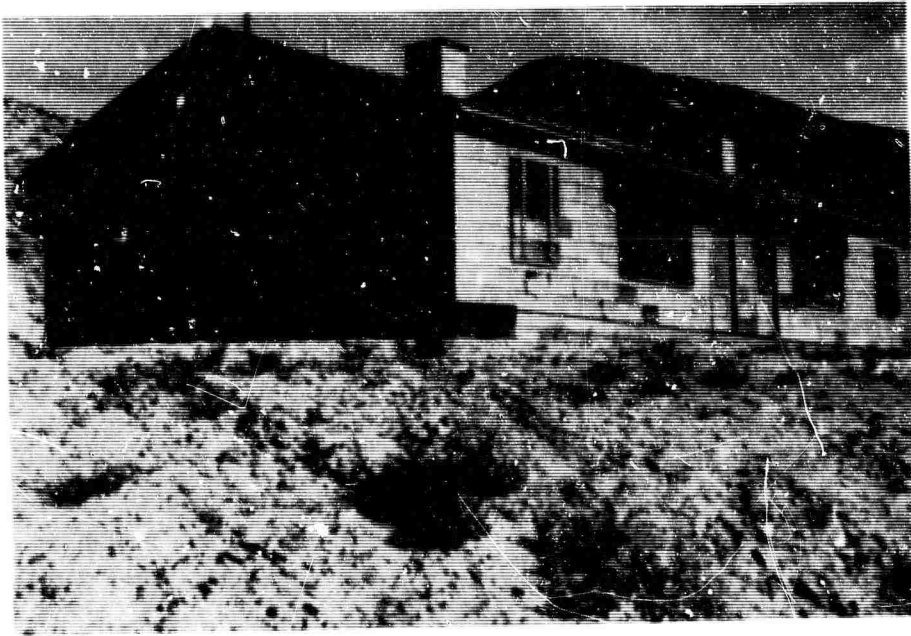
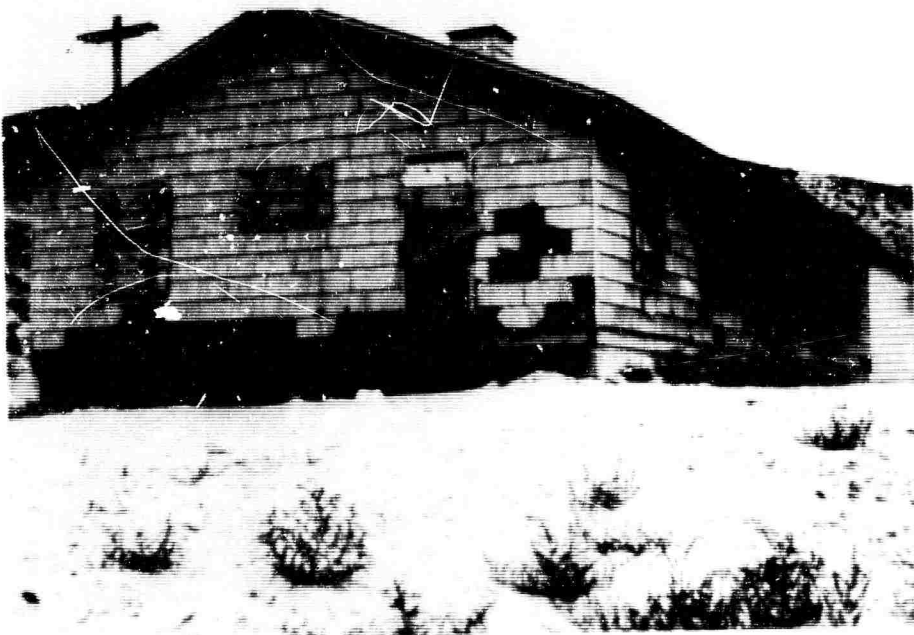
Photo No. 21-1 - Preshot - October 8, 1963

- 21-1 Residence (See photo 21-1) This structure is wood frame, asbestos shingle covered. Size is about 27 x 55 feet. AZ 295° clockwise from magnetic north. This has been recently moved to this site and is now in the process of being renewed inside and out. No damage was noted as a result of the postshot survey.
- 21-2 Residence (See photo 21-2) This is a wood frame, aluminum siding covered structure. Size is 27 x 55 feet. AZ 295° clockwise from magnetic north. This structure has been recently

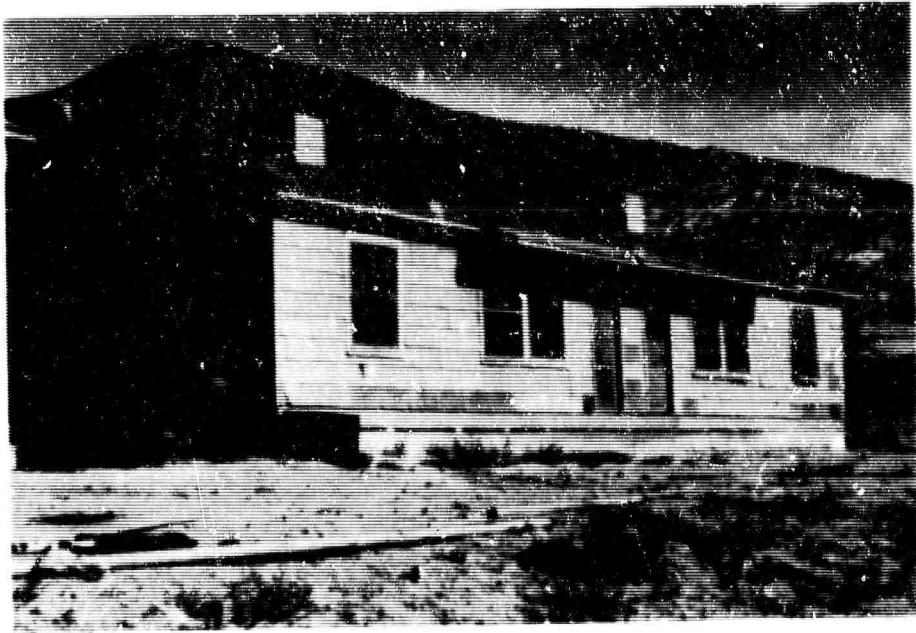
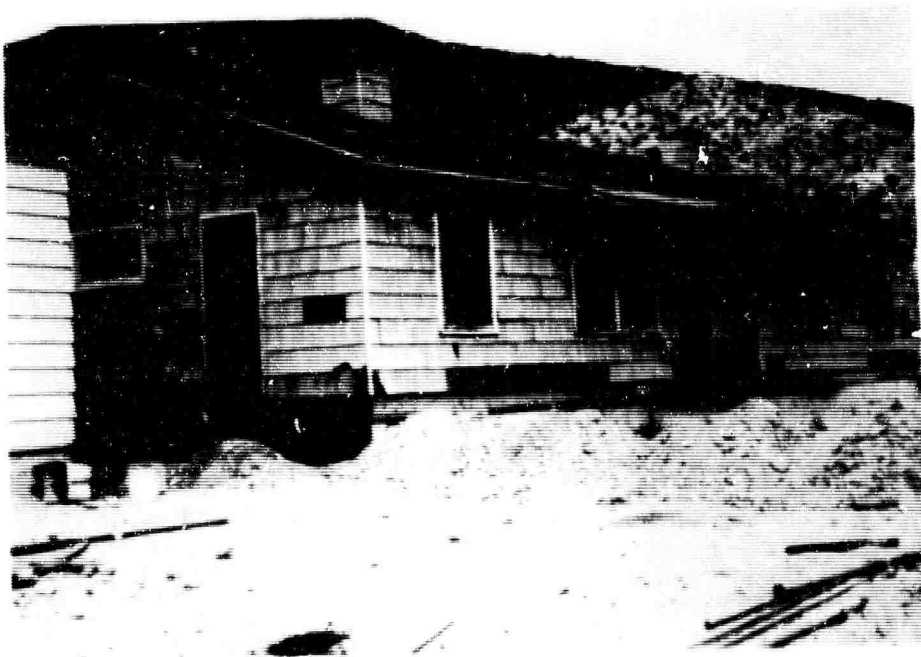
Photo No. 21-3 - Preshot - October 8, 1963

- 21-3 Residence (See photo 21-3) This structure is wood frame, asbestos shingle covered. Size is 27 x 55 feet. AZ 295° clockwise from magnetic north. This structure has been recently moved to this site, and is in the process of being renewed inside and out. No damage was noted as a result of the postshot survey.

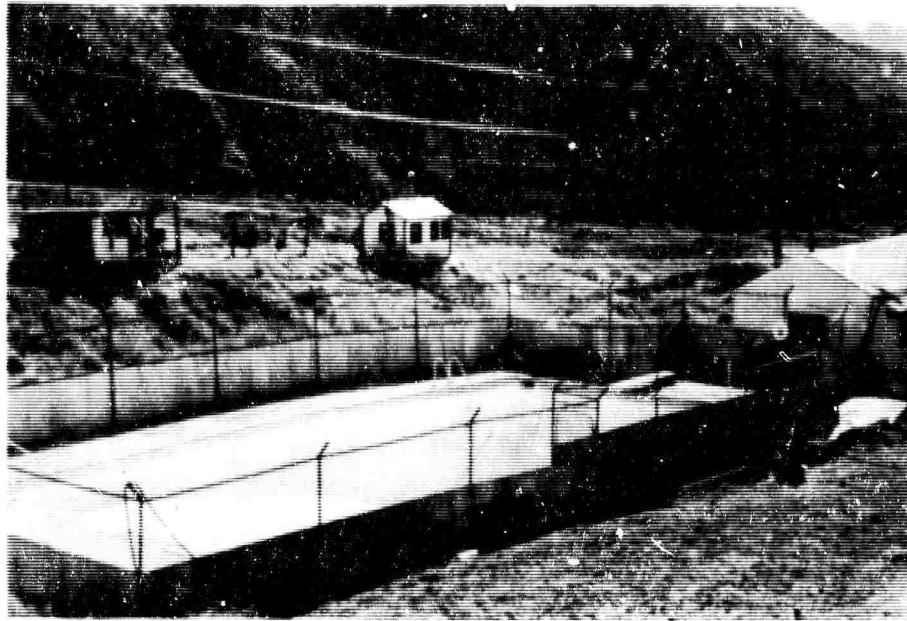
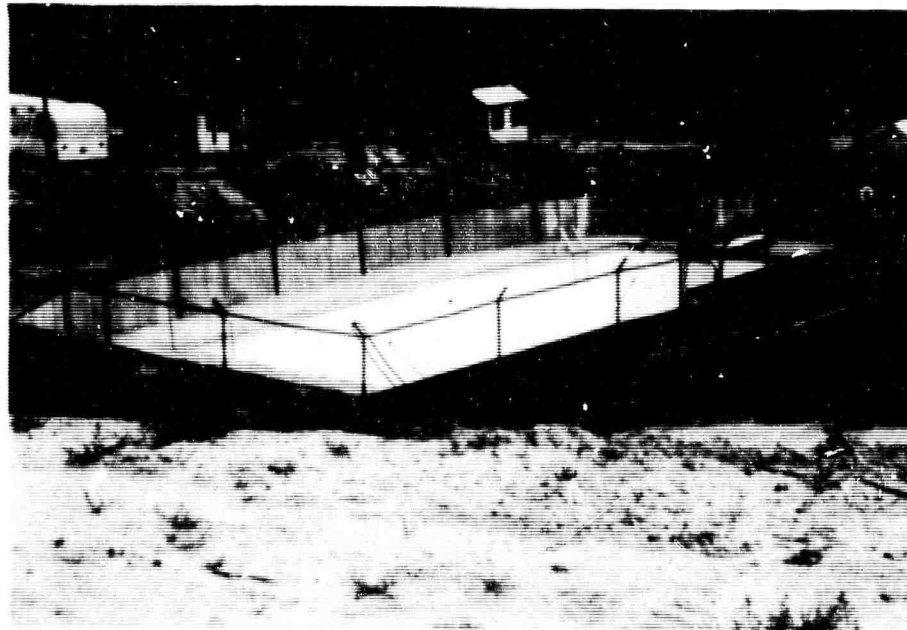
Photo No. 21-4 - Preshot - October 2, 1963

- 21-4 Swimming Pool (See photo 21-4) This structure is a concrete swimming pool with a chain link fence around it AZ 130° clockwise from magnetic north. Size 20 x 50 feet. No damage was noted as a result of the postshot survey.

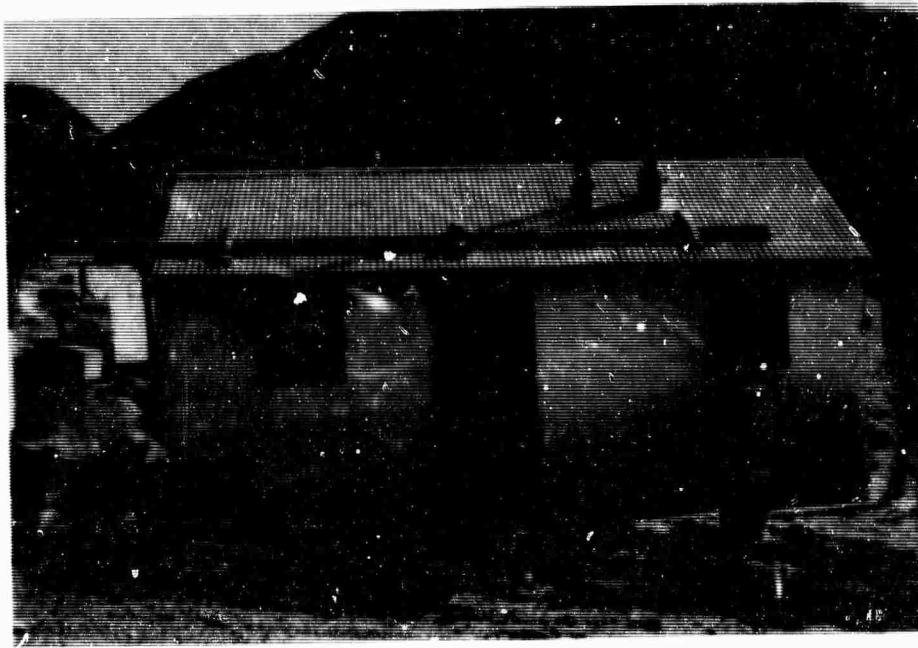
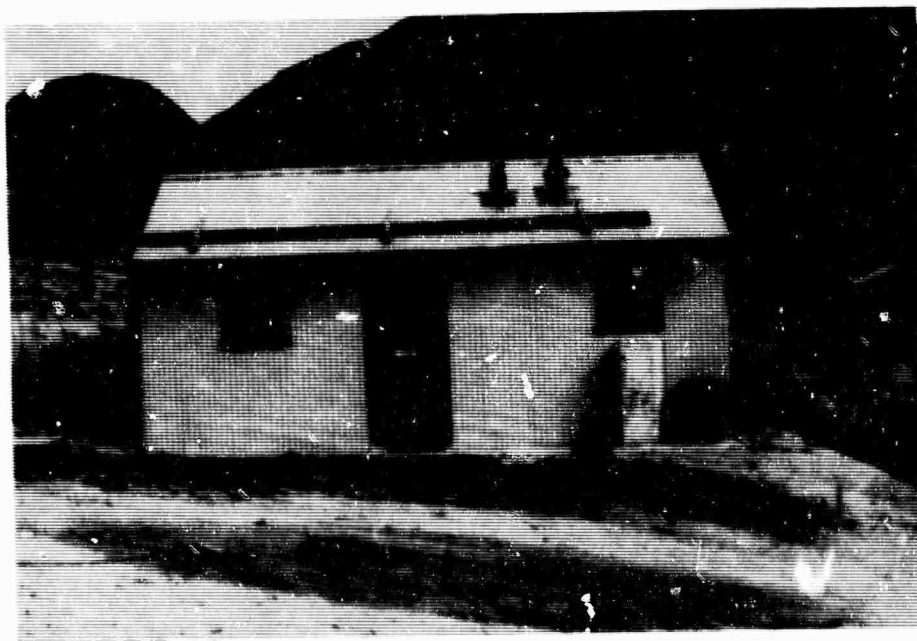
Photo No. 21-5 Preshot - October 2, 1963

- 21-5 Bath House (See photo 21-5) This structure is a wood frame and corrugated-metal-covered bath house. Size about 12 x 22 feet. AZ 40° clockwise from magnetic north. No damage was noted as a result of the postshot survey.

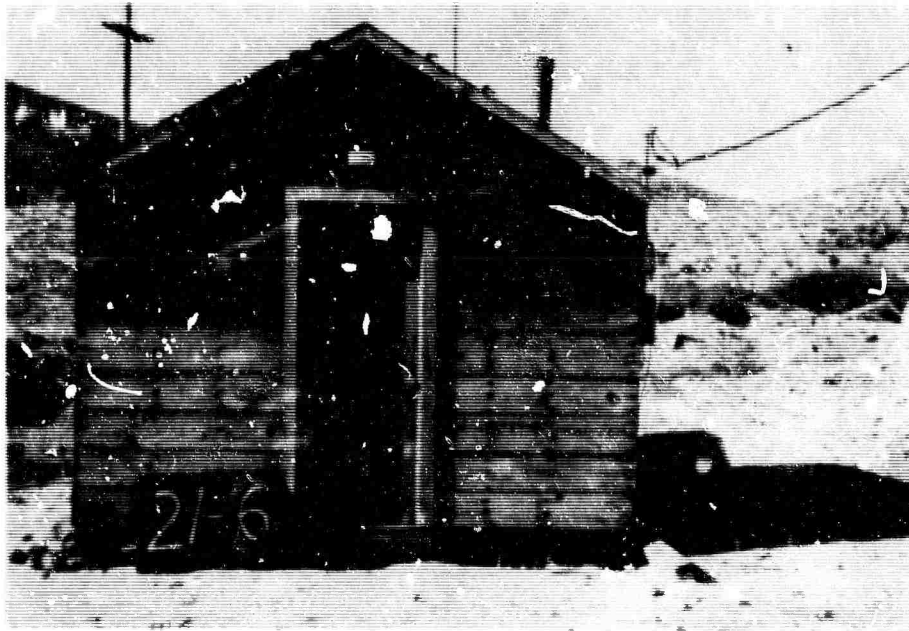
Photo No. 21-6 - Postshot - October 28, 1963

- 21-6 Shack (See photo 21-6) This is a wood frame, wood-covered shack, about 10 x 12 feet. AZ 225° clockwise from magnetic north. The structure is unpainted and weathered and the glass in the door is broken. No damage was noted as a result of the postshot survey.

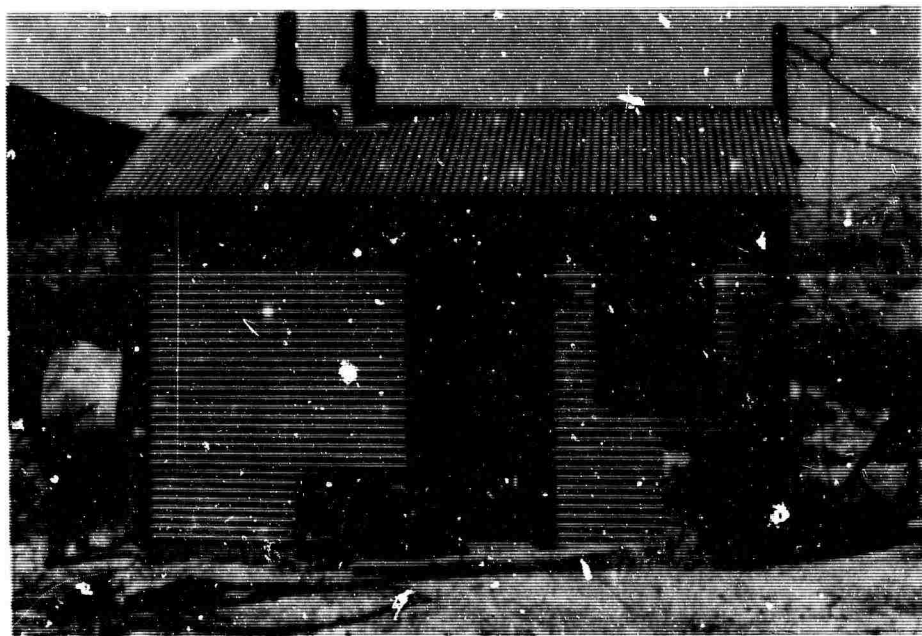
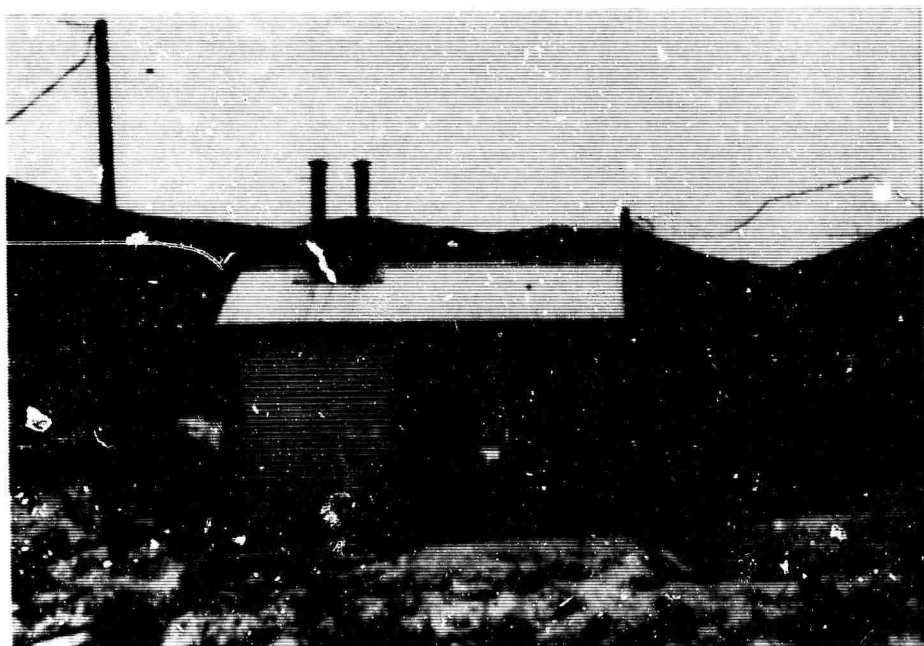
Photo No. 21-7 - Preshot - October 2, 1963

- 21-7 Bath House (See photo 21-7) This structure is a 9 x 15-foot wood frame and corrugated-metal-covered bath house for women. AZ 225° clockwise from magnetic north. No damage was noted as a result of the postshot survey.

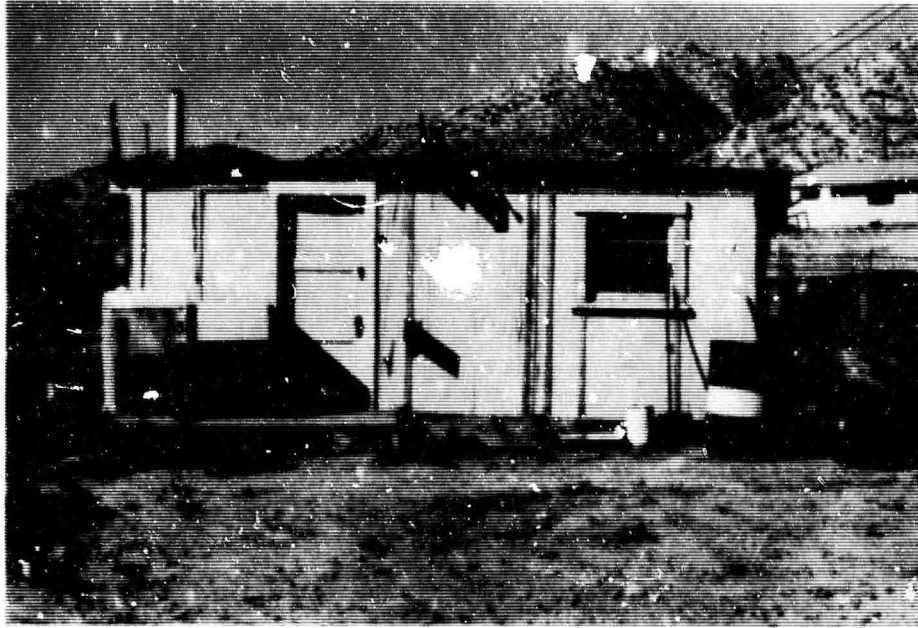
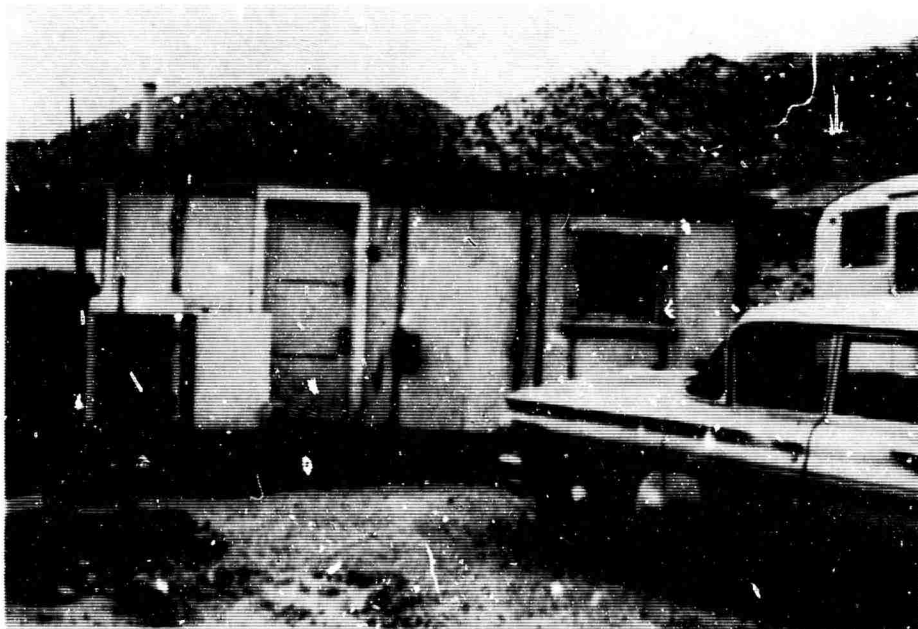
Photo No. 21-8 - Preshot - October 2, 1963

- 21-8 Shack (See photo 21-8) This is an 8 x 15-foot wood shack. AZ 250° clockwise from magnetic north. Flywood siding is weathered and checked. No damage was noted as a result of the postshot survey.

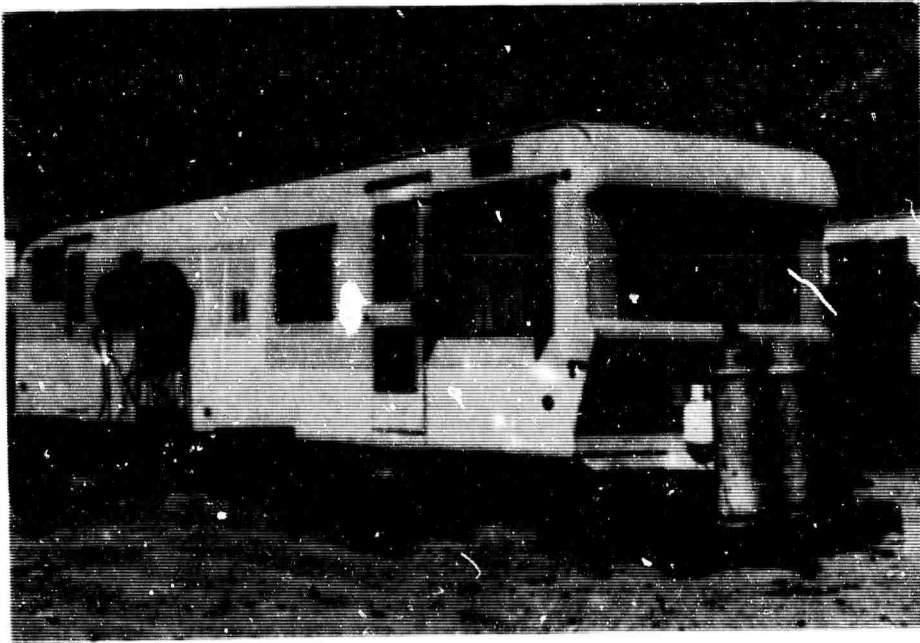
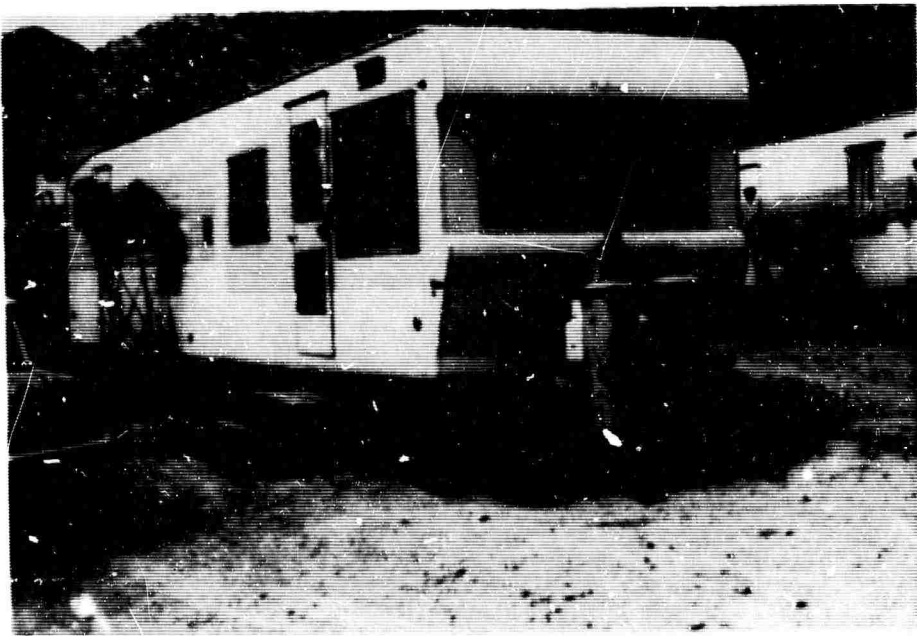
Photo No. 21-9 - Preshot - October 2, 1963

- 21-9 Trailer (See photo 21-9) This is a 36-foot long by 8-foot wide metal covered trailer. AZ 227° clockwise from magnetic north. No damage was noted as a result of the postshot survey.

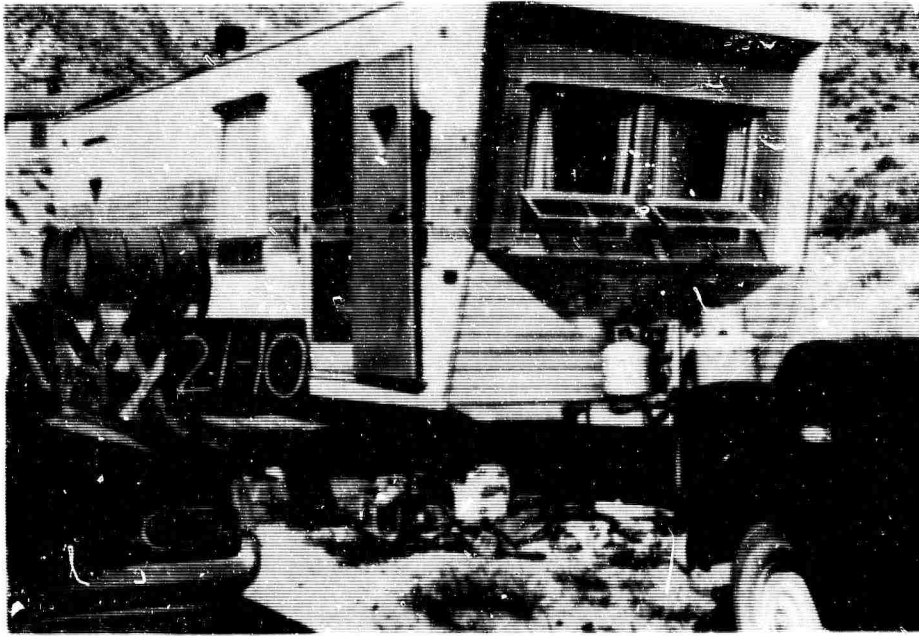
Photo No. 21-10 - Preshot - October 2, 1963

- 21-10 Trailer (See photo 21-10) This is a 24-foot long by 8-foot wide metal-covered trailer. AZ 227° clockwise from magnetic north. No damage was noted as a result of the postshot survey.

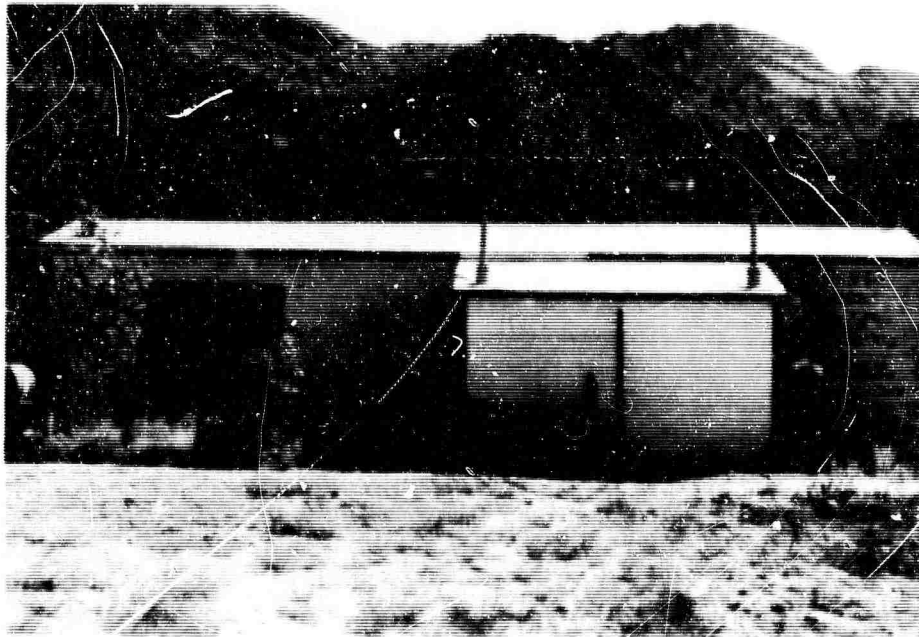
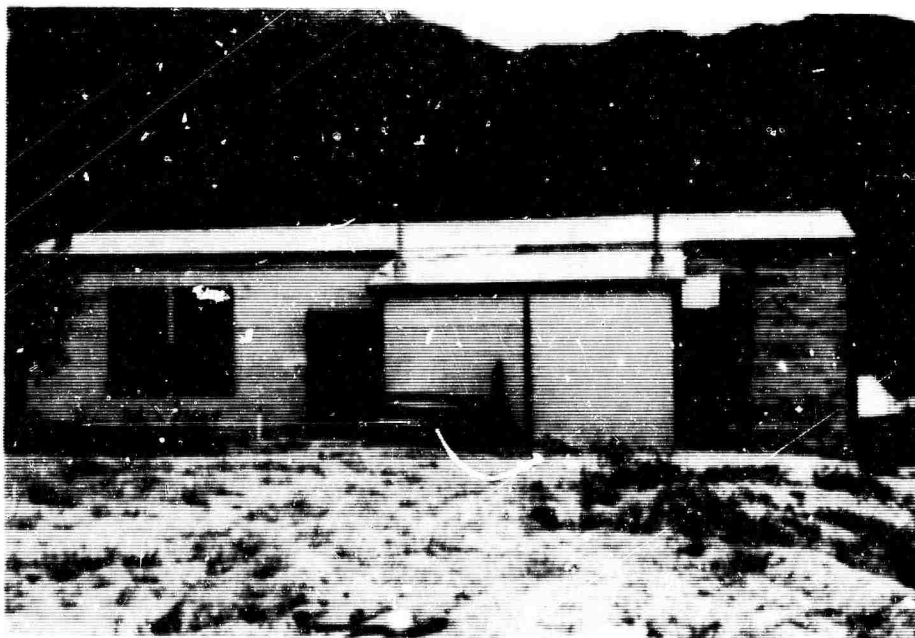
Photo No. 21-12 - Postshot - October 28, 1963

- 21-12 Residence (See photo 21-12) This structure is a 27 x 42-foot residence of wood frame with part wood siding and the rest covered with corrugated metal. AZ 80<sup>0</sup> clockwise from magnetic north. No damage was noted as a result of the post-shot survey.

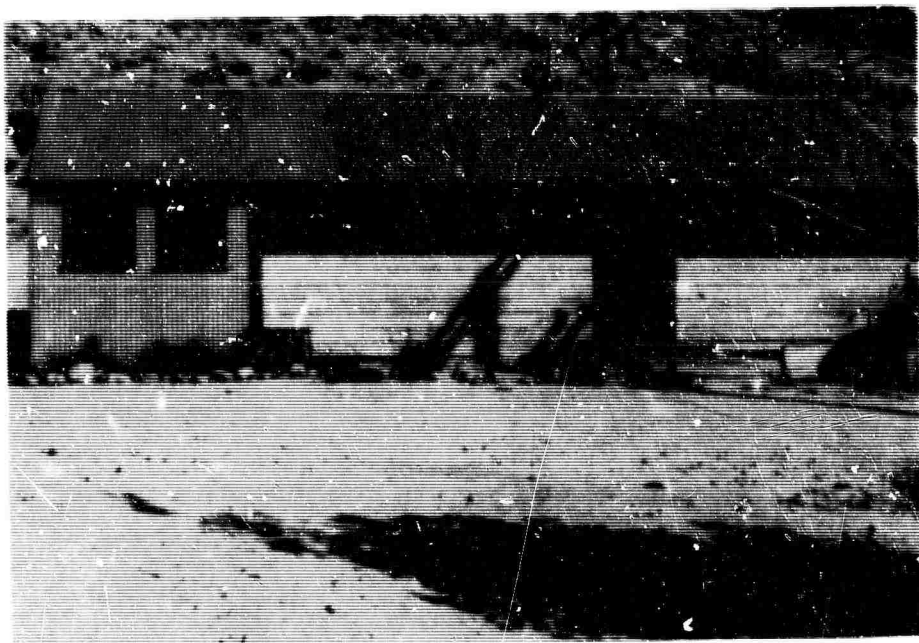
Photo No. 21-13 - Postshot - October 28, 1963

- 21-13 School House and Residence (See photo 21-13) This structure is a combined school house and residence of wood frame with part wood siding and the rest covered with corrugated metal. Roof is corrugated metal. It is 27 x 36 feet. AZ is 0<sup>0</sup> from magnetic north. No damage was noted as a result of the post-shot survey.

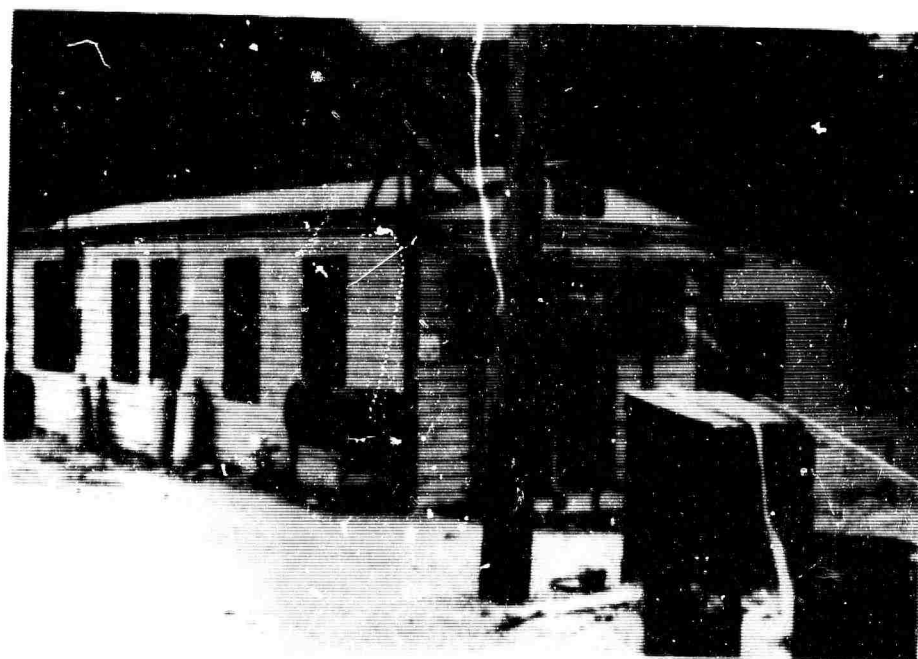
Photo No. 21-14 - Postshot - October 28, 1963

- 21-14 Residence (See photo 21-14) A residential wood frame structure covered partly with wood siding and partly with corrugated metal. Dimensions are 36 x 42 feet. Roof is corrugated metal. AZ is 70<sup>0</sup> clockwise from magnetic north. No damage was noted as a result of the postshot survey.

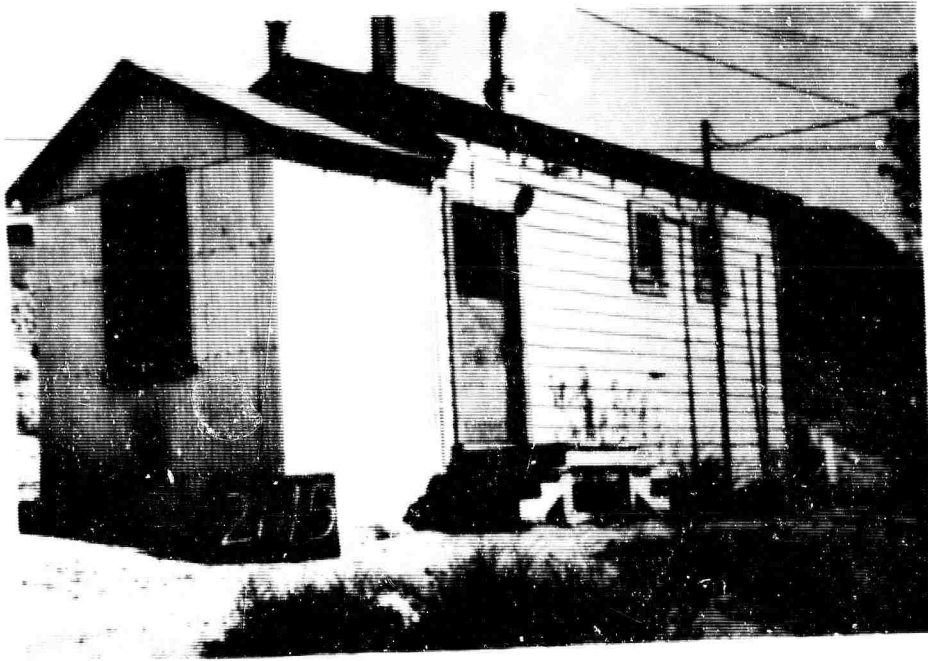
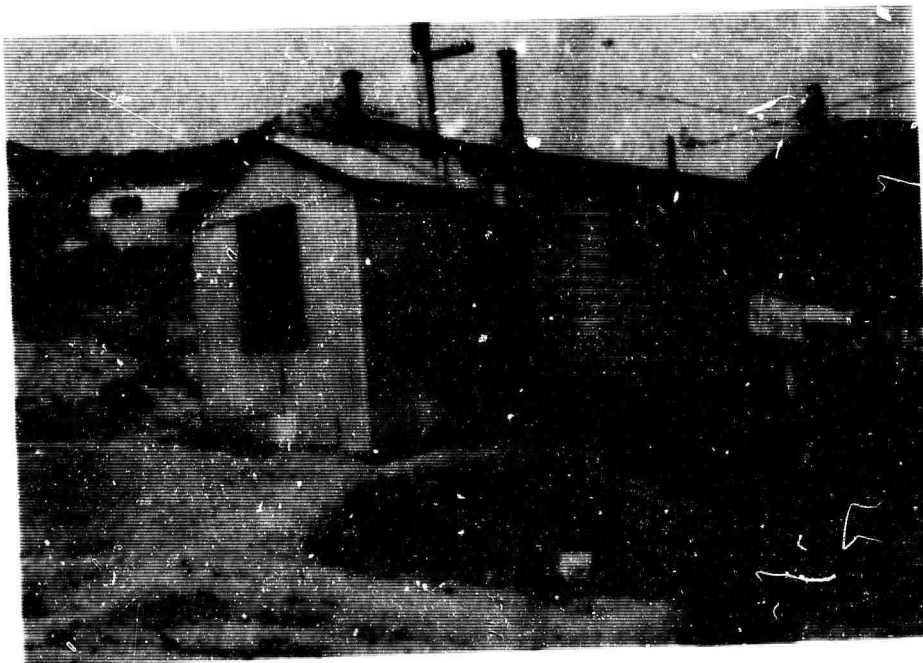
Photo No. 21-15 - Postshot - October 28, 1963

- 21-15 Bath House (See photo 21-15) Bath house structure, 9 x 24 feet, of wood frame and wood siding with some corrugated metal covering. AZ 330<sup>0</sup> clockwise from magnetic north. No damage was noted as a result of the postshot survey.

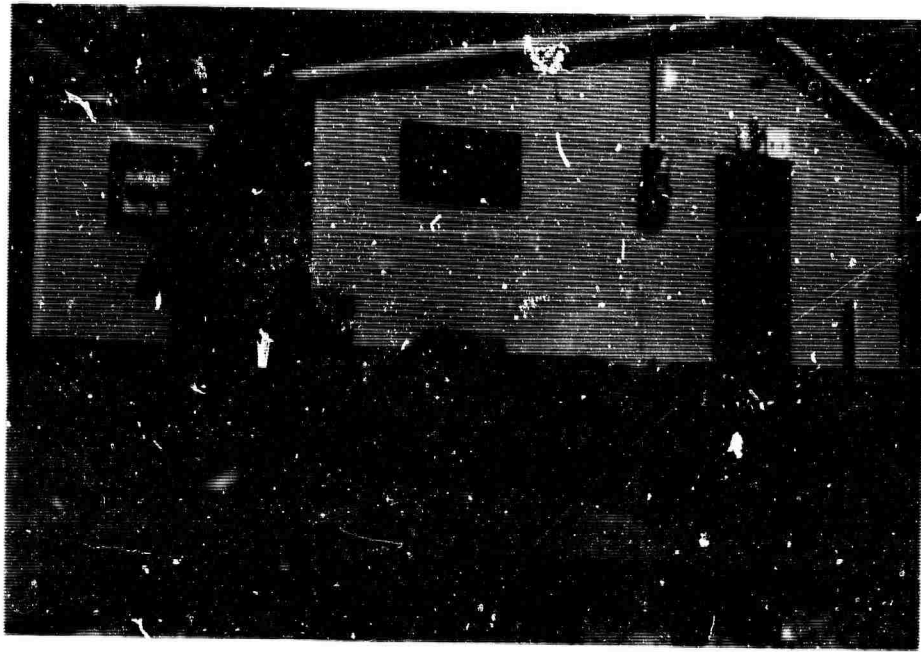
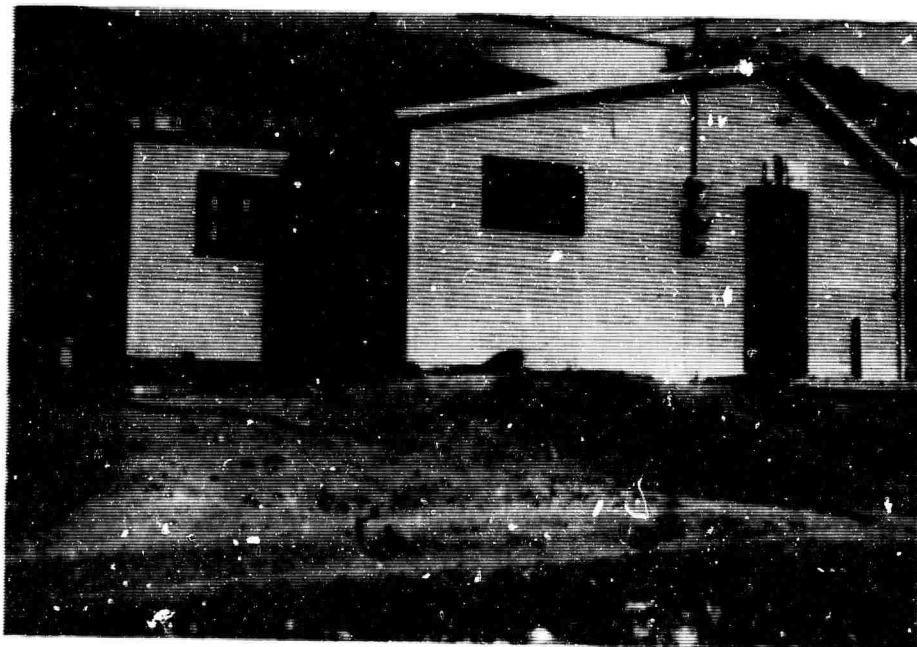
Photo No. 21-16 - Postshot - November 4, 1963

- 21-16 Residence (See photo 21-16) This is a residential structure approximately 27 feet square, of wood frame and corrugated metal siding. AZ 330<sup>0</sup> clockwise from magnetic north. No damage was noted as a result of the postshot survey.

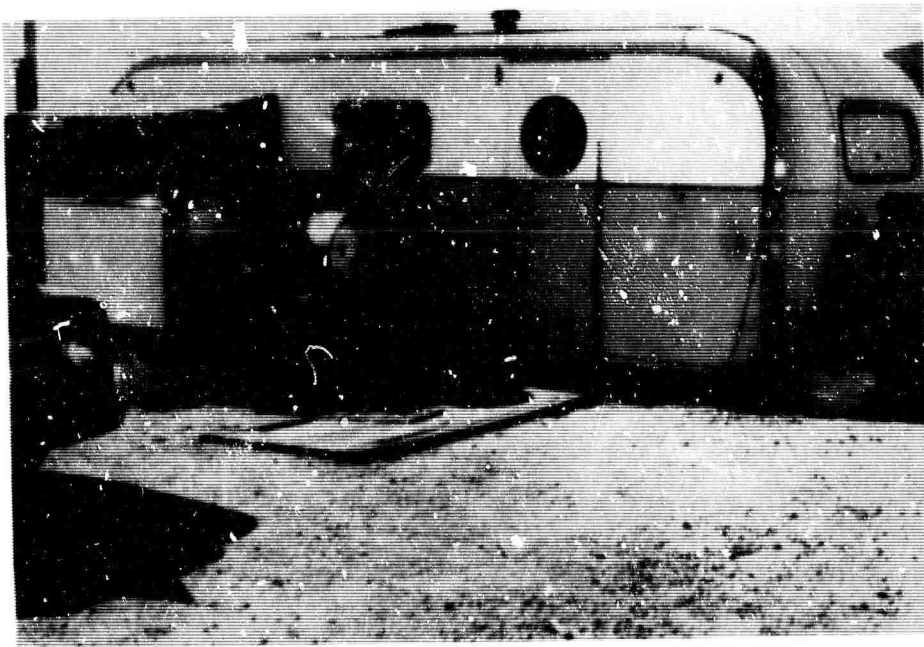
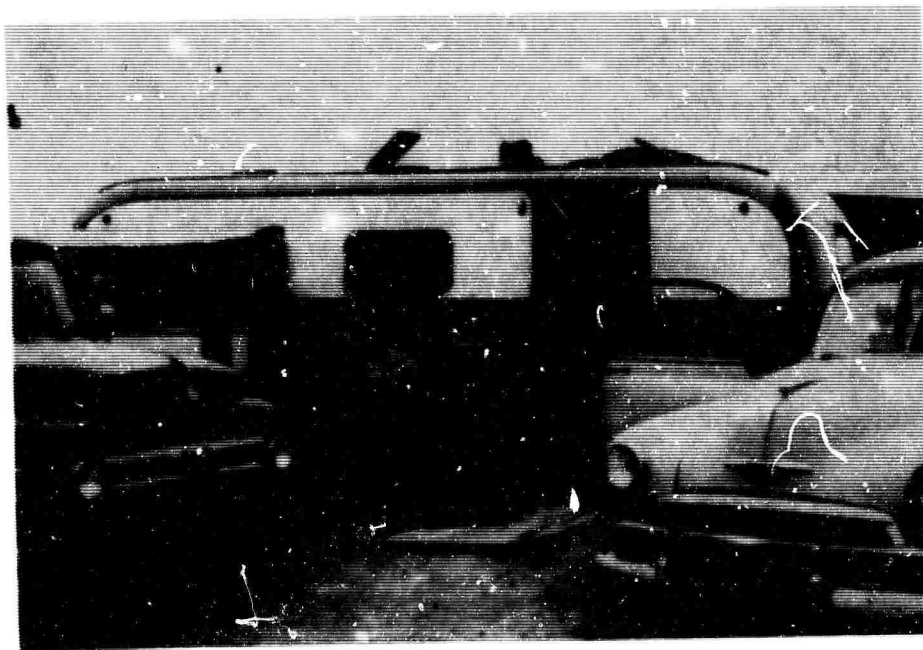
Photo No. 21-17 - Postshot - October 28, 1963

- 21-17 Trailer (See photo 21-17) This is an 18-foot long by 8-foot wide metal-covered trailer. AZ 115<sup>0</sup> clockwise from magnetic north. No damage was noted as a result of the postshot survey.

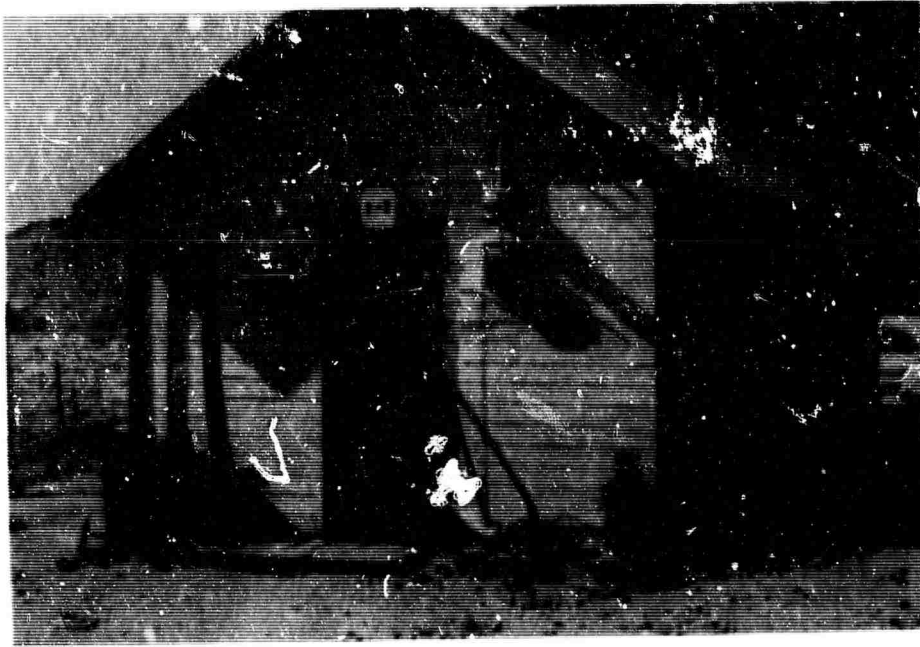
Photo No. 21-19 - Postshot - October 28, 1963

- 21-19 Residence (See photo 21-19) This is a 12 x 24-foot residence of wood frame and wood siding. AZ 220° clockwise from magnetic north. No damage was noted as a result of the postshot survey.

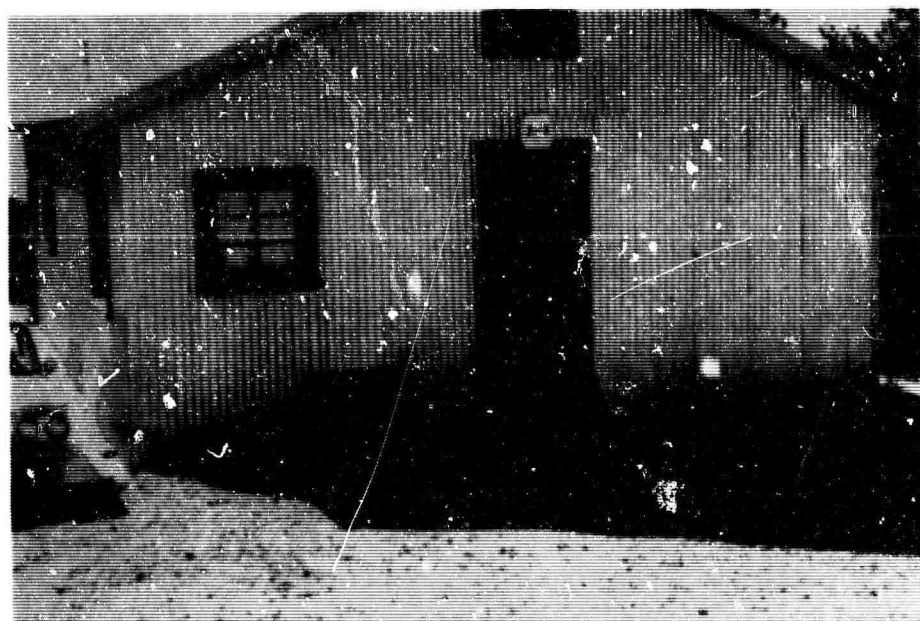
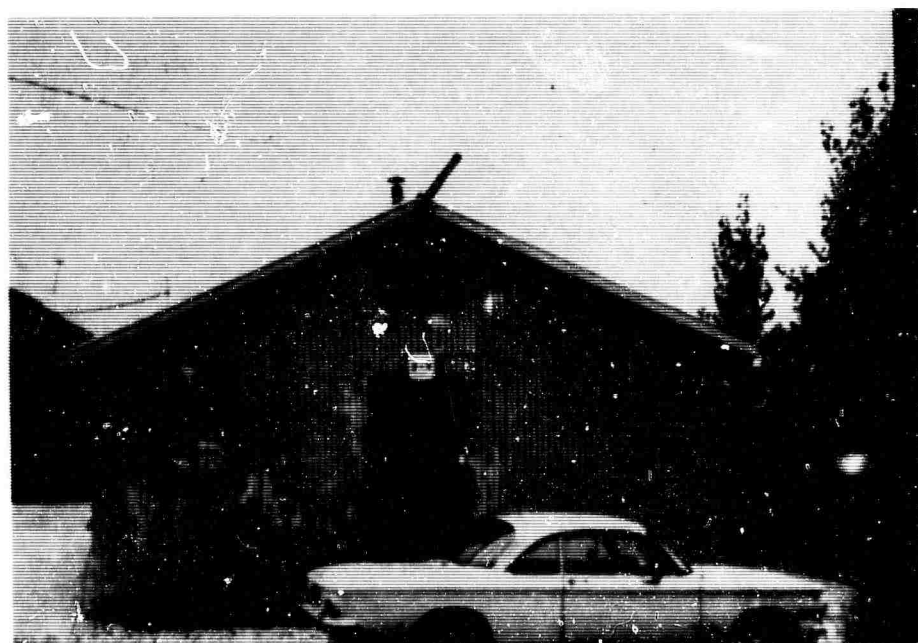
Photo No. 21-20 - Postshot - October 28, 1963

- 21-20 Residence (See photo 21-20) This is an 18 x 36-foot residential structure of wood frame and corrugated metal siding. AZ 140° clockwise from magnetic north. No damage was noted as a result of the postshot survey.
