# VELA UNIFORM PROJECT **SHOAL**

**PRESHOT AND POSTSHOT STRUCTURE SURVEY**  
Holmes & Narver, Inc.

December 1963

# **PRESHOT AND POSTSHOT STRUCTURE SURVEY**

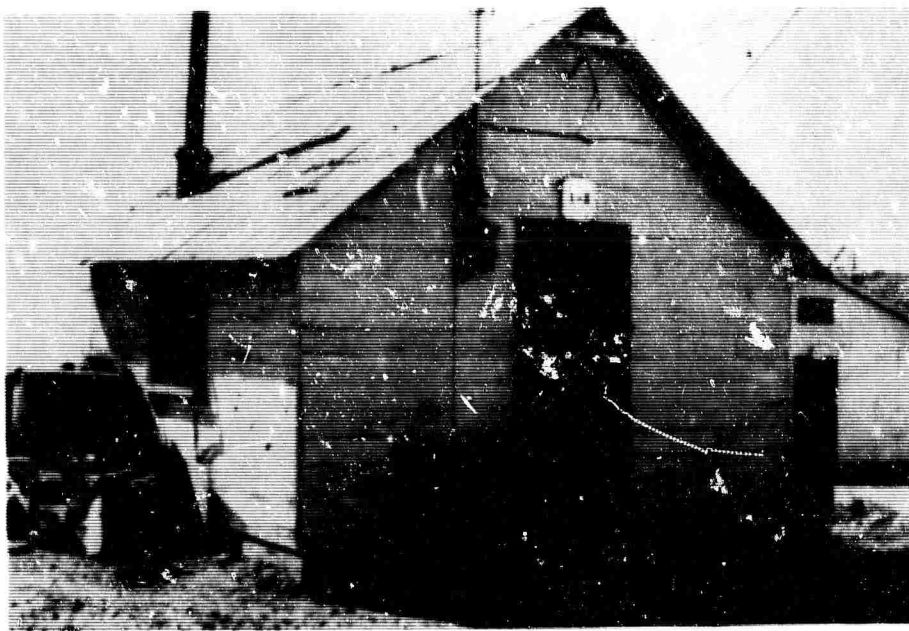
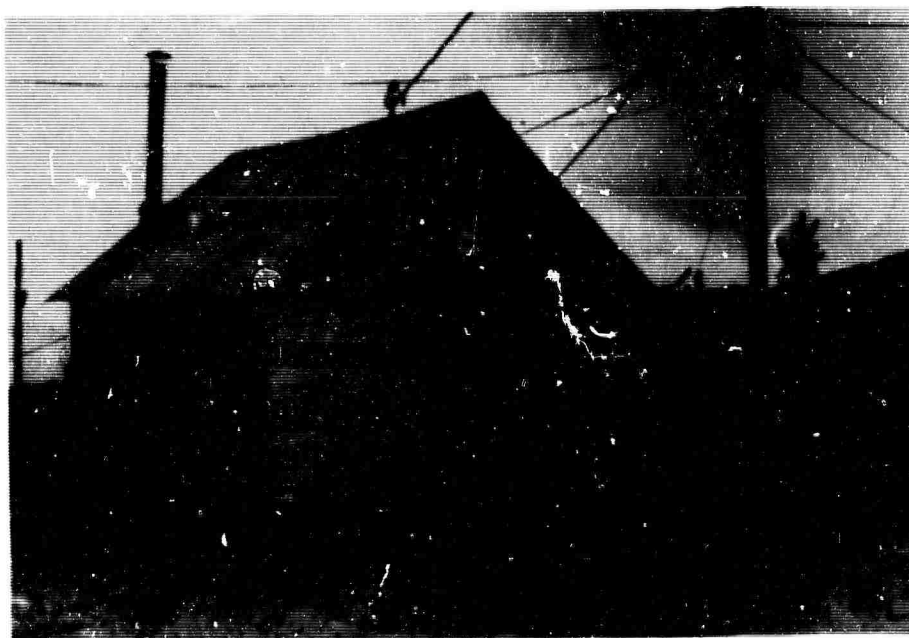
Photo No. 21-21 - Postshot - October 18, 1963

- 21-21 Residence (See photo 21-21) This is a 12 x 12-foot residence of wood frame and siding. AZ 135° clockwise from magnetic north. No damage was noted as a result of the postshot survey.

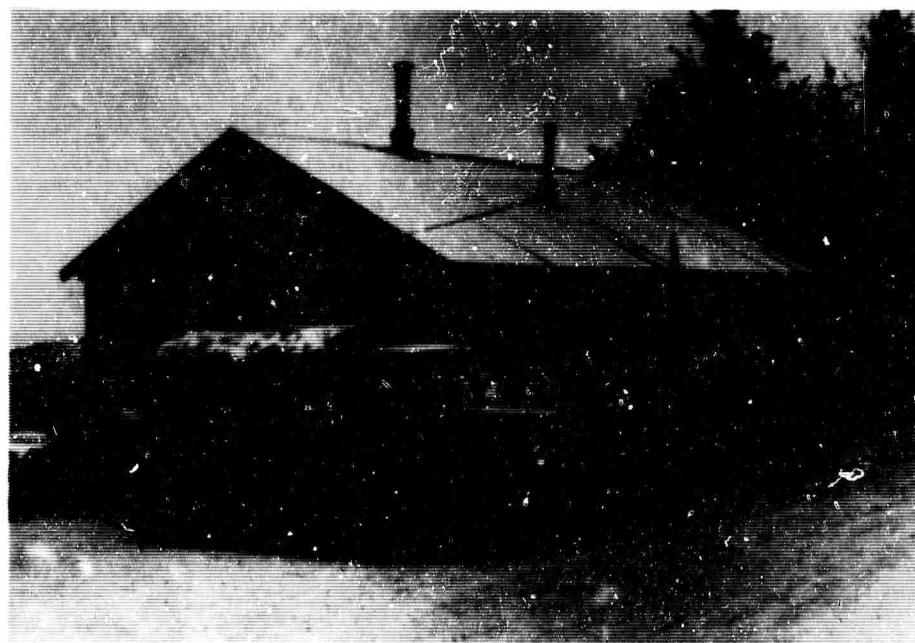
Photo No. 21-22 - Postshot - October 28, 1963

- 21-22 Residence (See photo 21-22) This is an 18 x 27-foot residential structure of wood frame and corrugated metal siding. AZ 220° clockwise from magnetic north. No damage was noted as a result of the postshot survey.

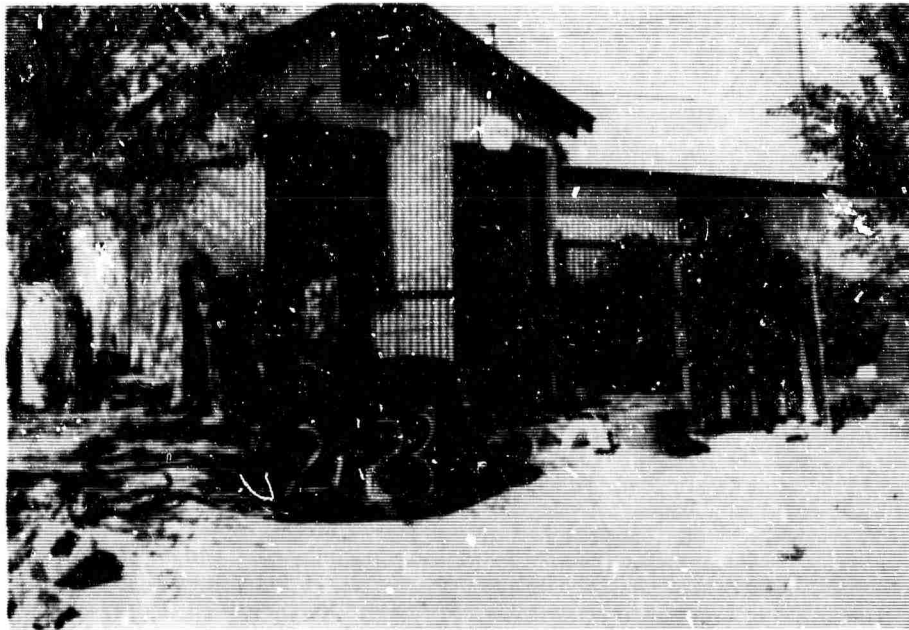
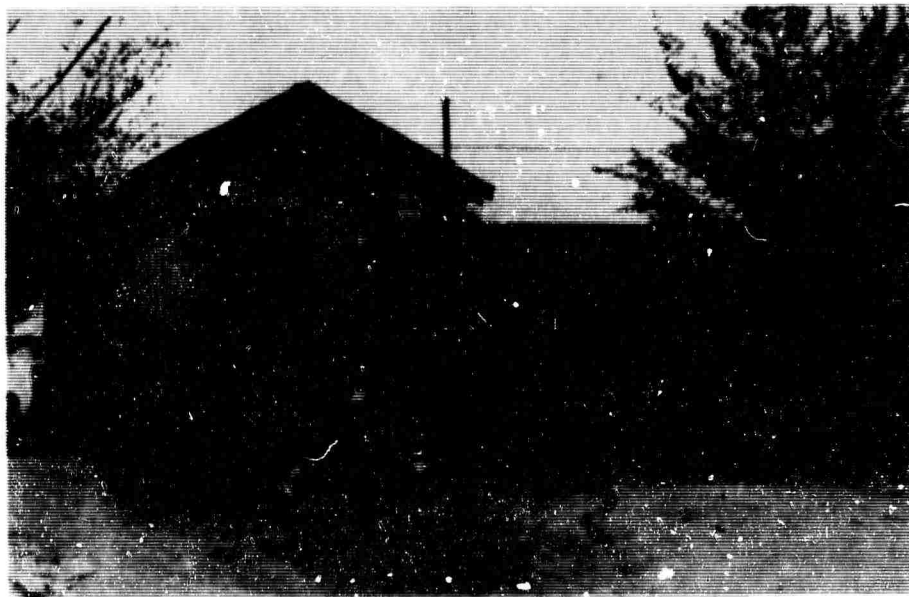
Photo No. 21-23 - Postshot - October 28, 1963

- 21-23 Residence (See photo 21-23) This is a 24 x 24-foot residential structure of wood frame and corrugated metal siding. AZ 220° clockwise from magnetic north. No damage was noted as a result of the postshot survey.

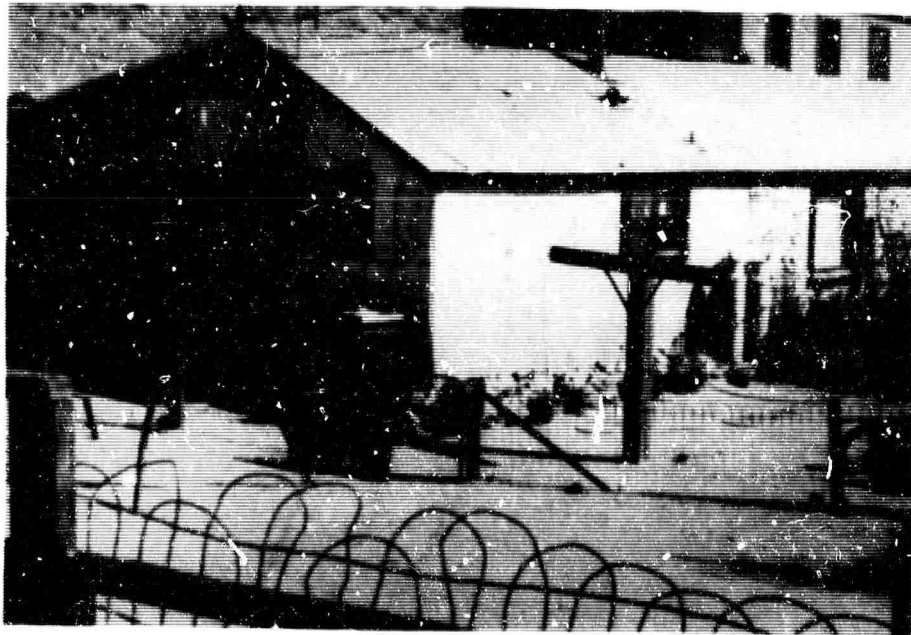
Photo No. 21-24 - Postshot - October 28, 1963

- 21-24 Residence (See photo 21-24) This is a 27 x 30-foot residential structure of wood frame and corrugated metal siding. AZ 70° clockwise from magnetic north. No damage was noted as a result of the postshot survey.

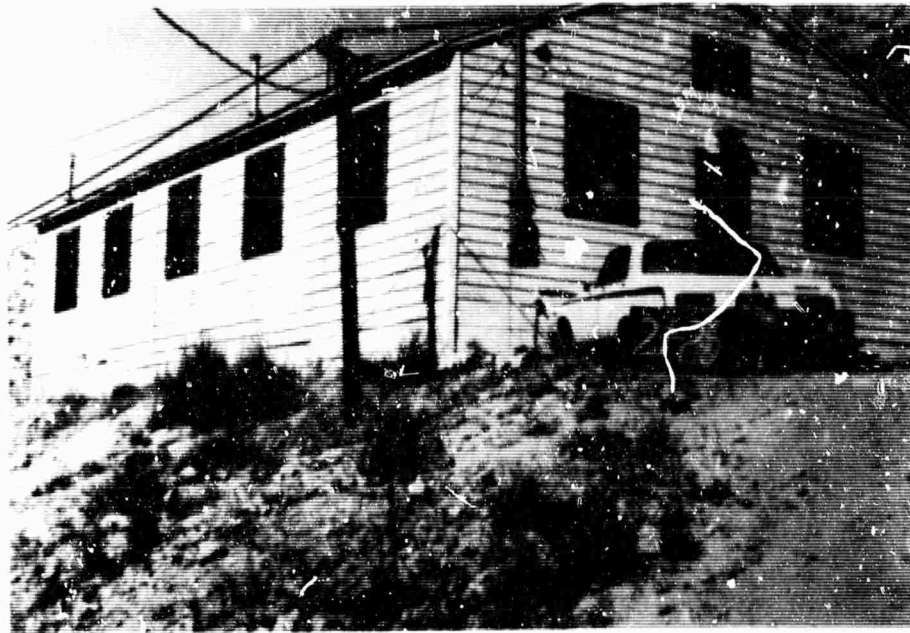
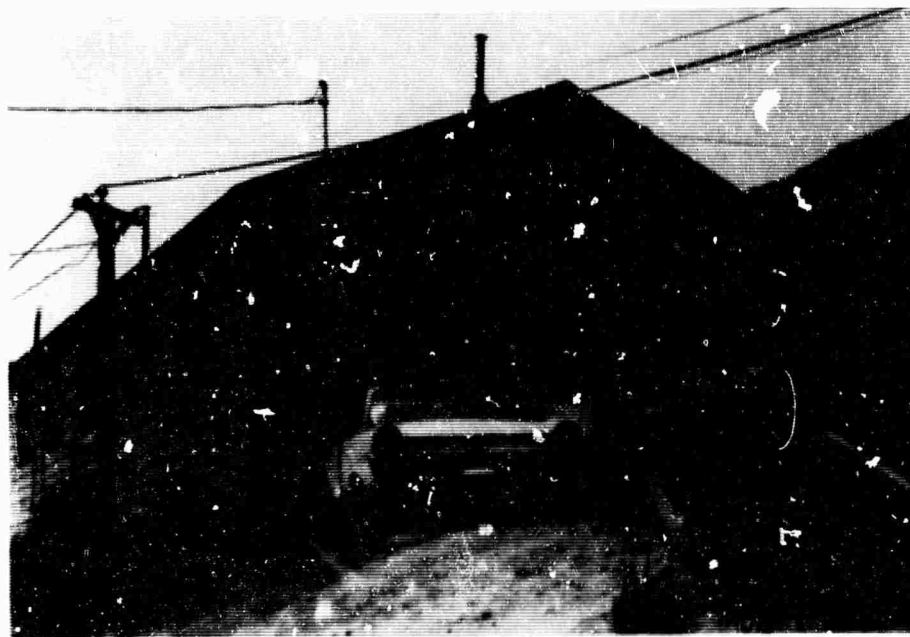
Photo No. 21-25 - Postshot - October 28, 1963

- 21-25 Bunkhouse (See photo 21-25) This is a 24 x 45-foot bunkhouse of wood frame and wood siding. AZ 250° clockwise from magnetic north. No damage was noted as a result of the postshot survey.

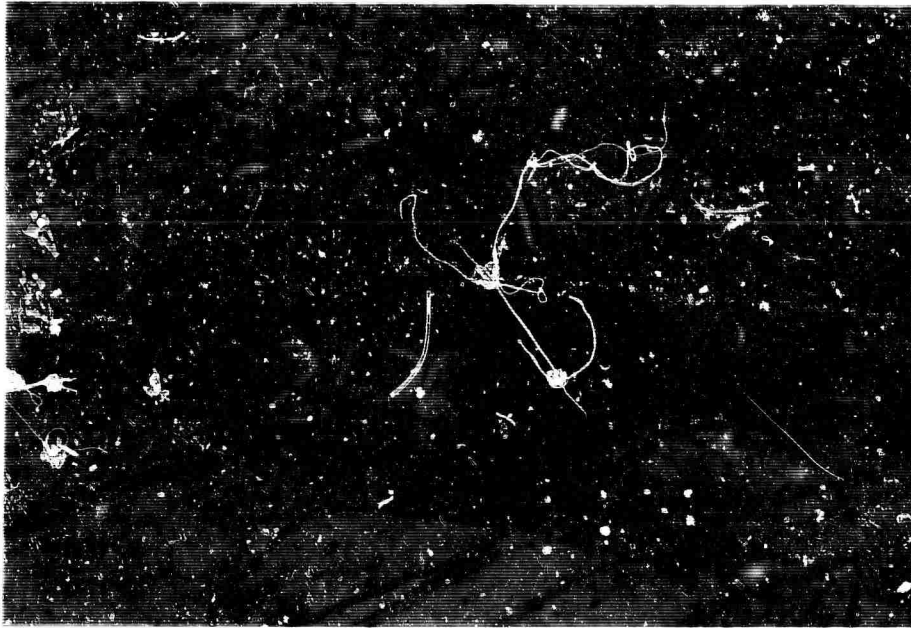
Photo No. 21-26 - Postshot - October 28, 1963

- 21-26 Tanks (See photo 21-26) Two steel stove oil tanks 4 feet in diameter by 12 feet long. AZ 250° clockwise from magnetic north. No damage was noted as a result of the postshot survey.

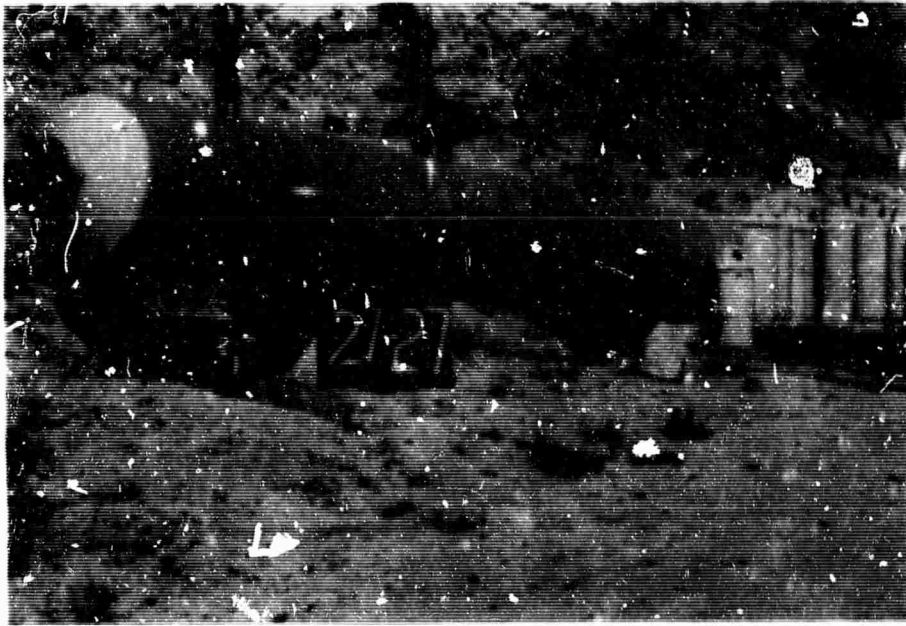
Photo No. 21-27 - Postshot - October 28, 1963

- 21-27 Tank (See photo 21-27) Steel propane tank, 4 feet in diameter by 45 feet long. AZ 250° clockwise from magnetic north. No damage was noted as a result of the postshot survey.

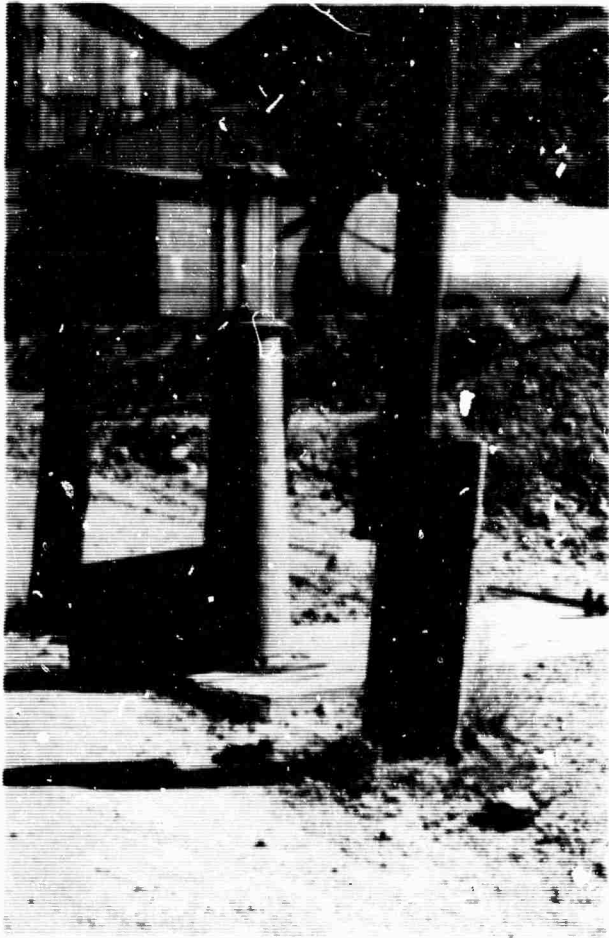
Photo No. 21-28

- 21-28 Pump (See photo 21-28) Manual type gasoline pump. AZ 90° from magnetic north. No damage was noted as a result of the postshot survey.
- 21-29 Shed (See photo 21-29) Photo shows a 12 x 12-foot burned-out shed. AZ 345° clockwise from magnetic north. It was assumed that this structure would be removed before the shot date; however, it was still in place after the shot. No damage was noted as a result of the postshot survey.

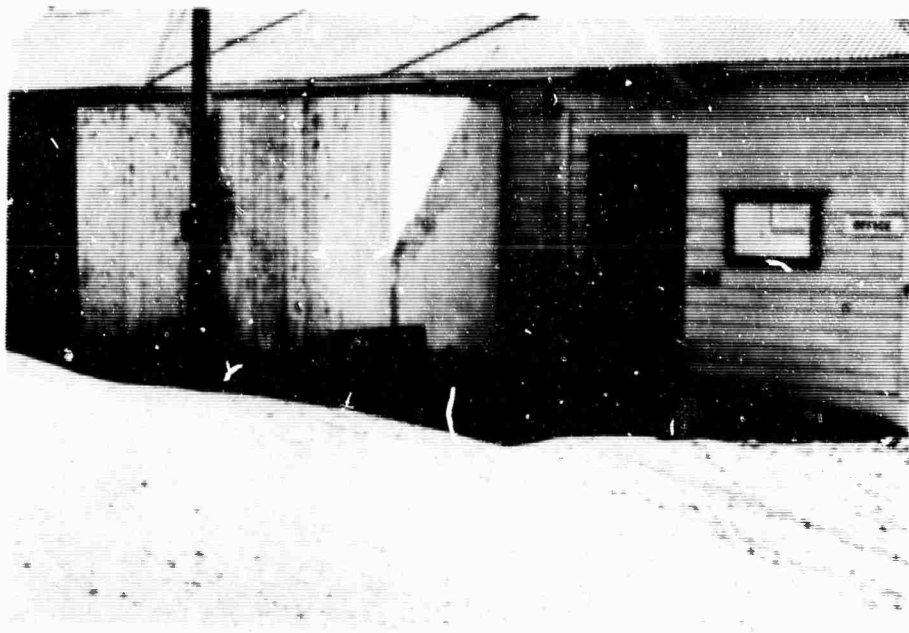
Photo No. 21-30 - Preshot - October 2, 1963

- 21-30 Office (See photo 21-30) This is a 20 x 40-foot office building of wood frame and wood siding. AZ 80° clockwise from magnetic north. No damage was noted as a result of the postshot survey.

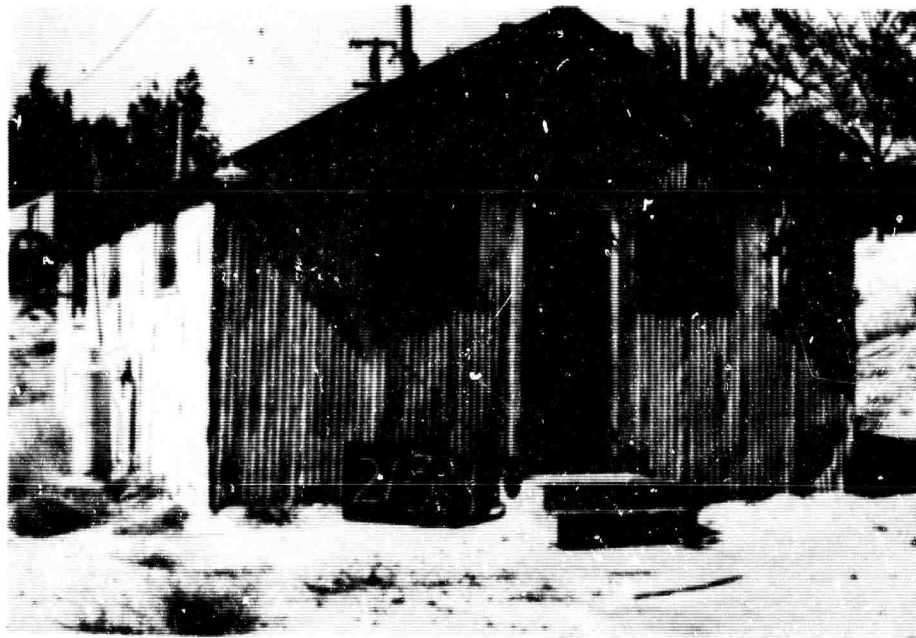
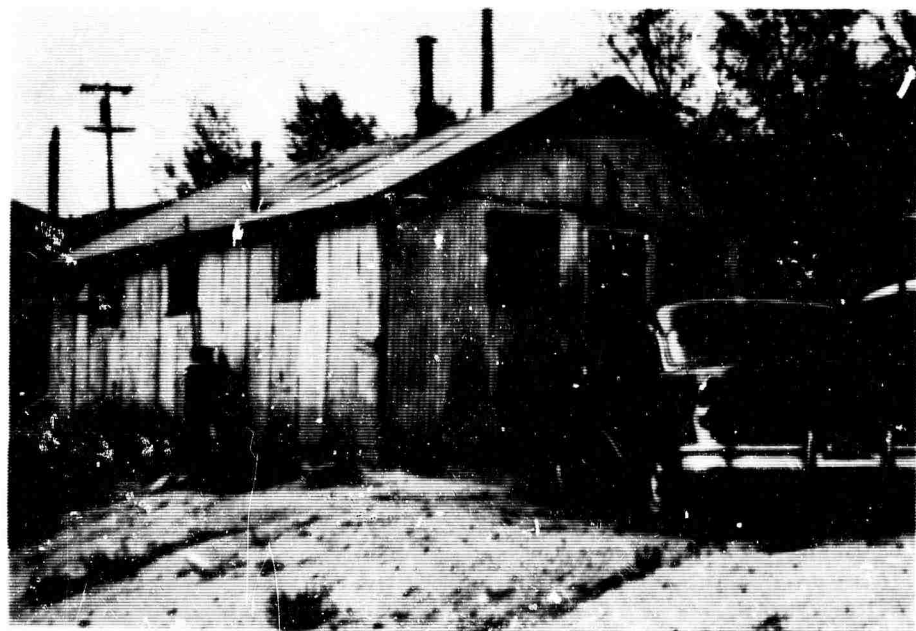
Photo No. 21-32 - Preshot - October 2, 1963

- 21-32 Residence (See photo 21-32) This structure is a residence of wood frame and corrugated metal siding. Size is 18 x 27 feet. AZ 225° clockwise from magnetic north. No damage was noted as a result of the postshot survey.

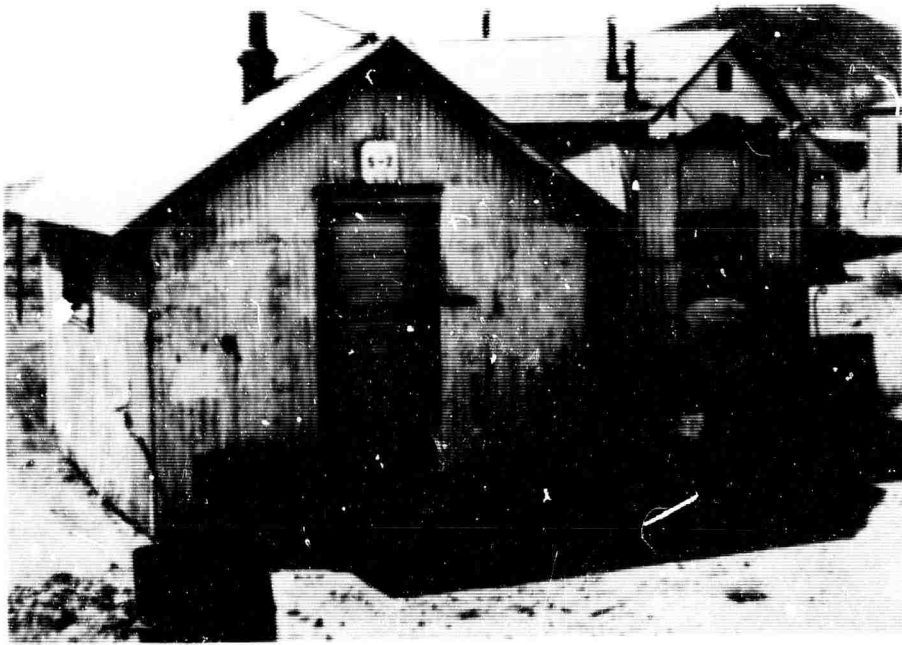
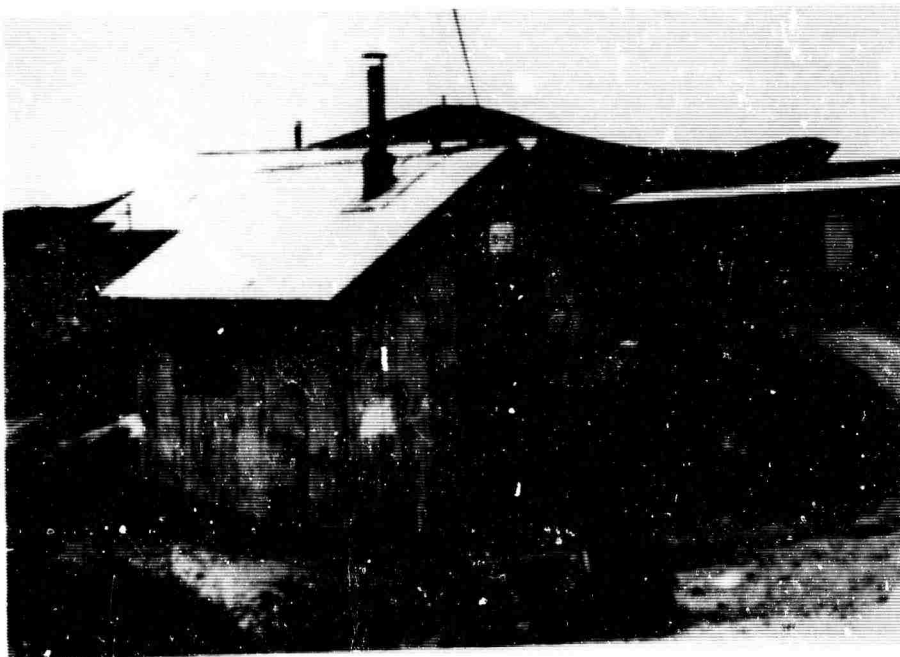
Photo No. 21-33 - Preshot - October 2, 1963

- 21-33 Store Room (See photo 21-33) This is a 12 x 15-foot wood frame with corrugated metal siding store room structure. AZ 150° clockwise from magnetic north. No damage was noted as a result of the postshot survey.

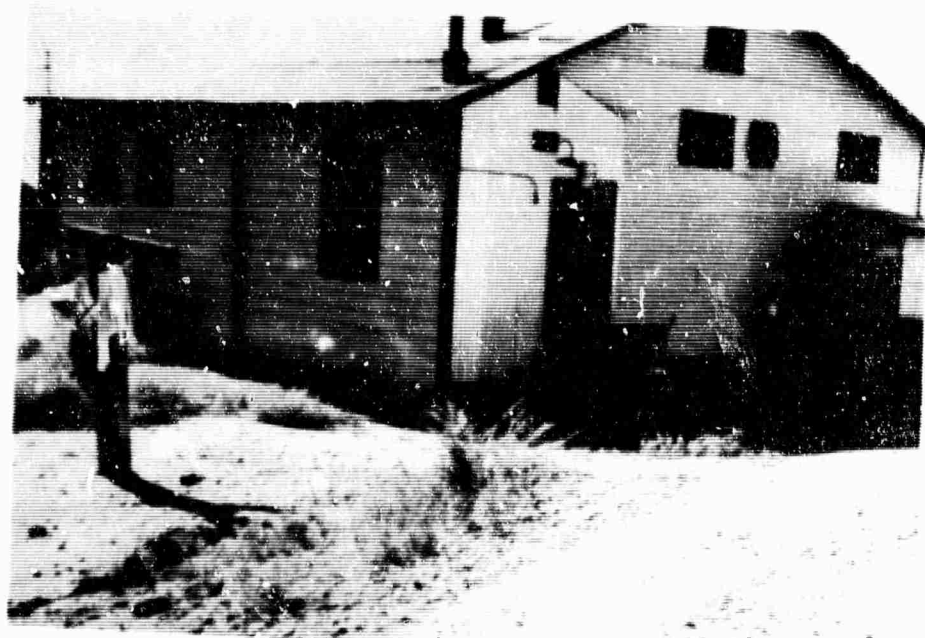
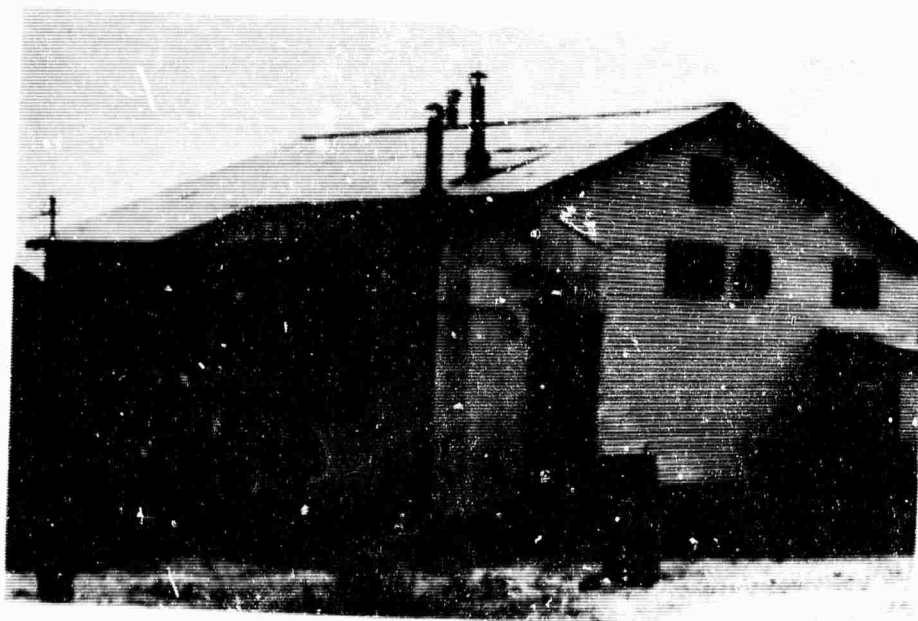
Photo No. 21-34 - Preshot - October 2, 1963

- 21-34 Change Room (See photo 21-34) Change room structure, 30 x 30 feet, of wood frame and corrugated metal siding. AZ 130° clockwise from magnetic north. No damage was noted as a result of the postshot survey.

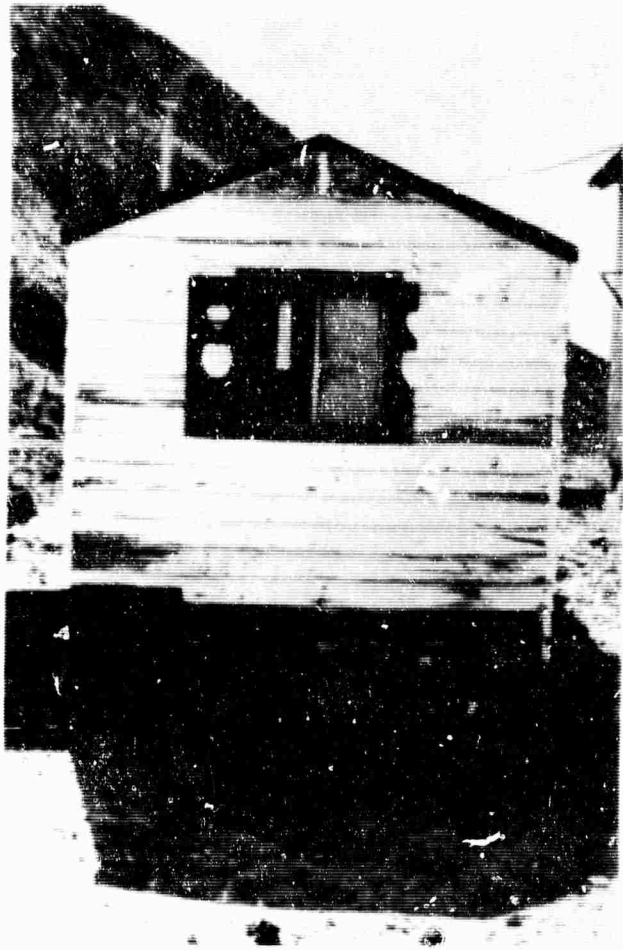
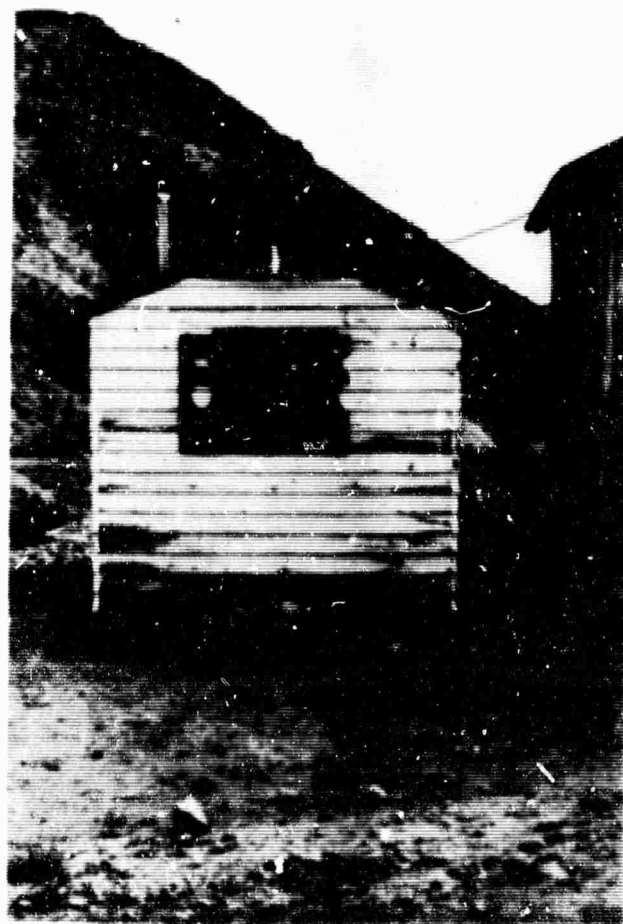
Photo No. 21-35

- 21-35 Bunkhouse (See photo 21-35) This is a wood frame and siding 6 x 15-foot bunkhouse. AZ 145° clockwise from magnetic north. No damage was noted as a result of the postshot survey.

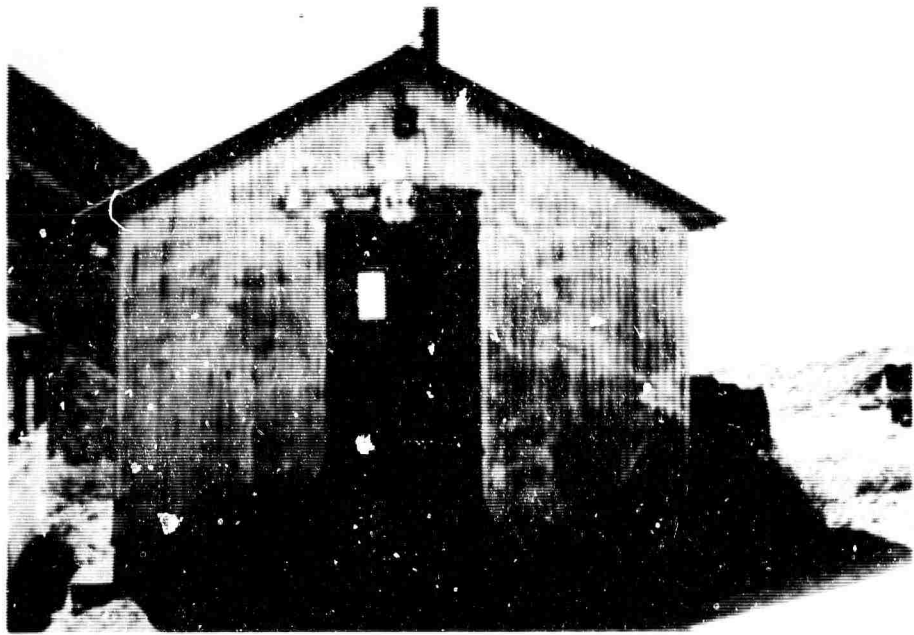
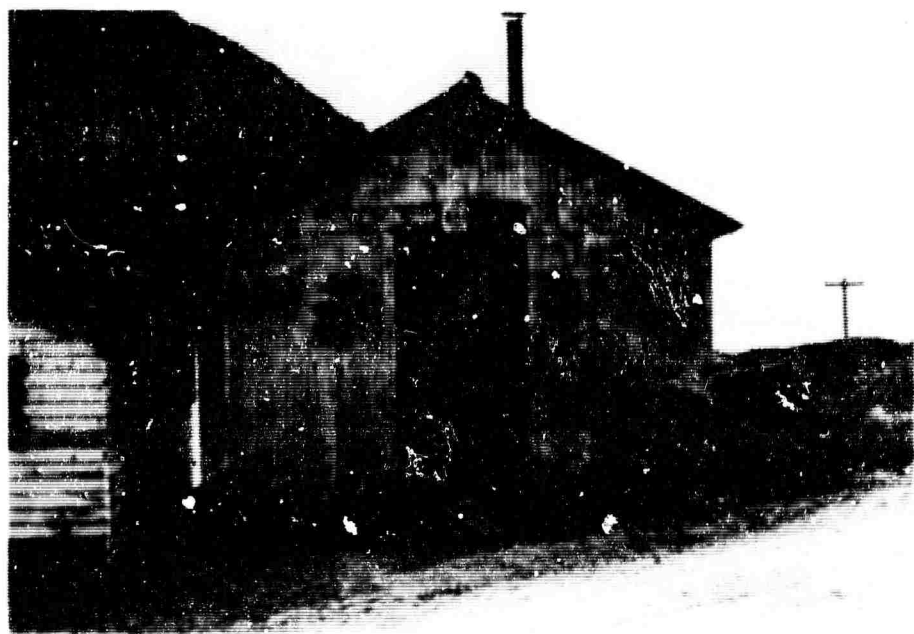
Photo No. 21-36 - Preshot - October 2, 1963

- 21-36 Bunkhouse (See photo 21-36) This is a wood frame and corrugated metal siding 12 x 14-foot burkhouse. AZ 145° clockwise from magnetic north. No damage was noted as a result of the postshot survey.

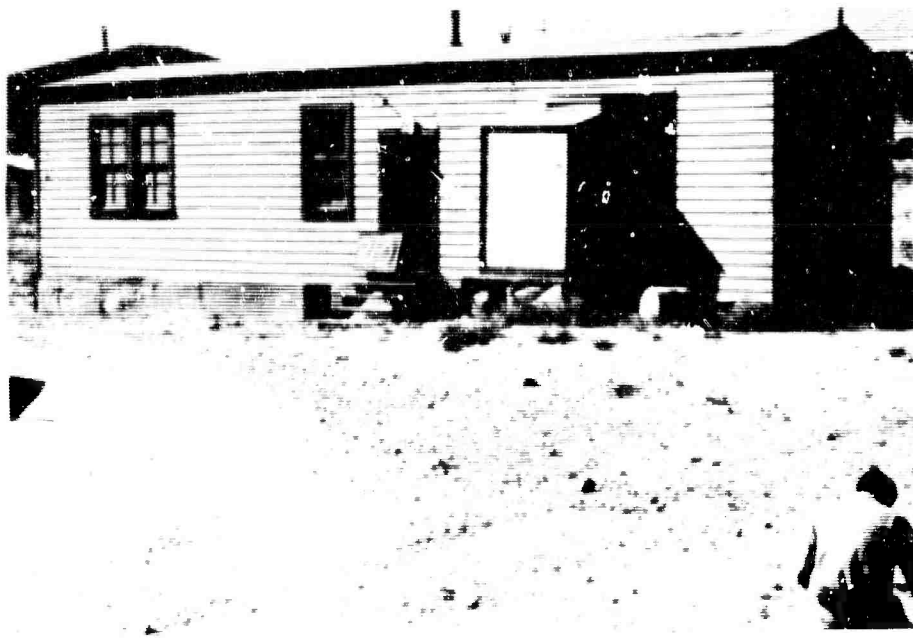
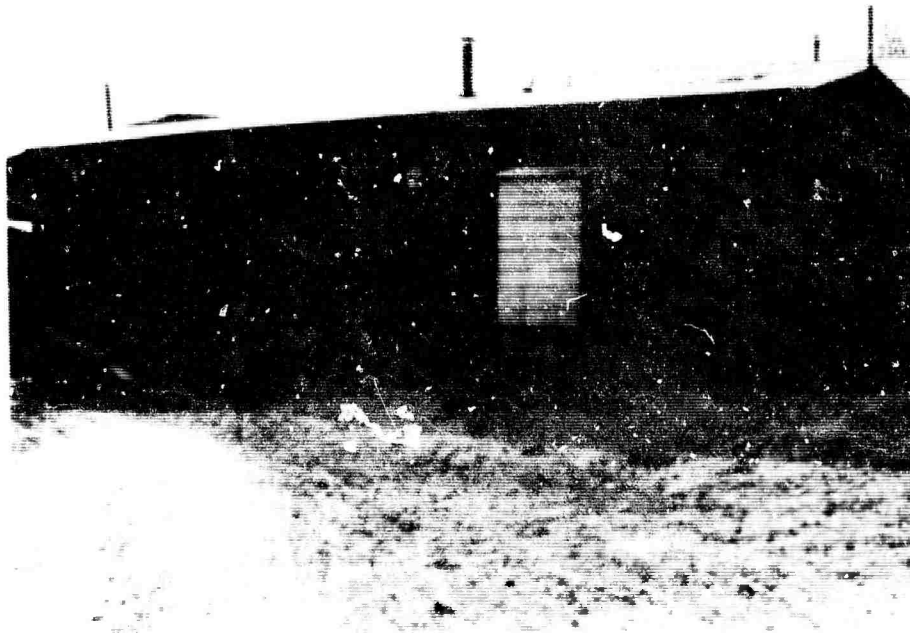
Photo No. 21-37 - Preshot - October 2, 1963

- 21-37 Club House (See photo 21-37) This is a 12 x 42-foot wood frame and wood siding club house building. AZ 245° clockwise from magnetic north. No damage was noted as a result of the postshot survey.

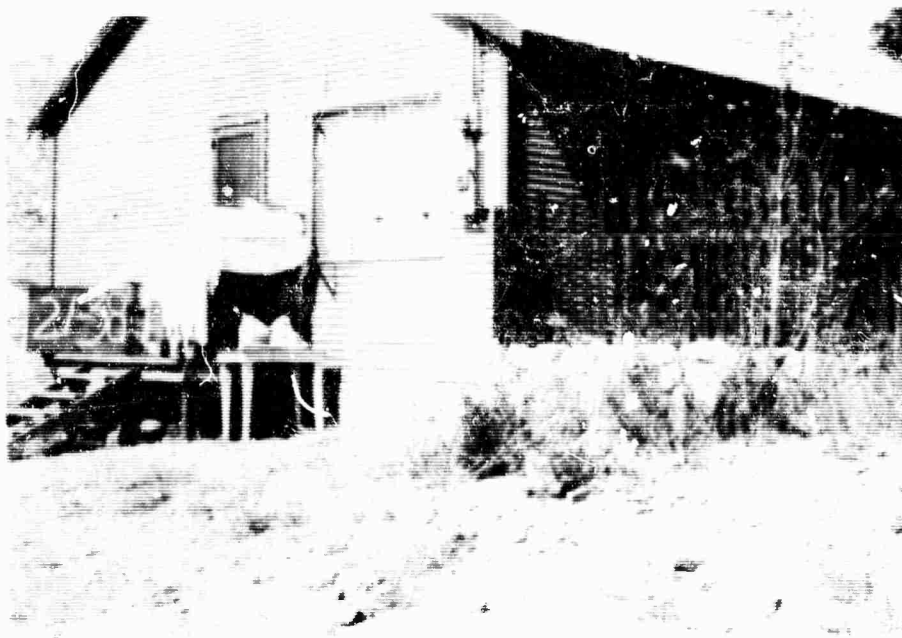
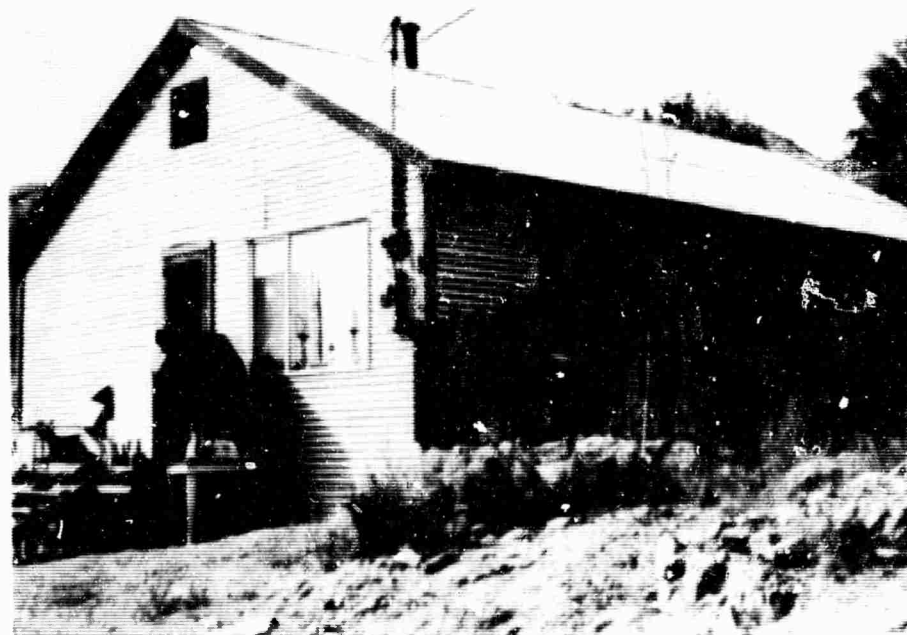
Photo No. 21-38 - Preshot - October 2, 1963

- 21-38 Residence (See photo 21-38) This is a 21 x 30-foot residence of wood frame with corrugated metal siding. AZ 330° clockwise from magnetic north. No damage was noted as a result of the postshot survey.

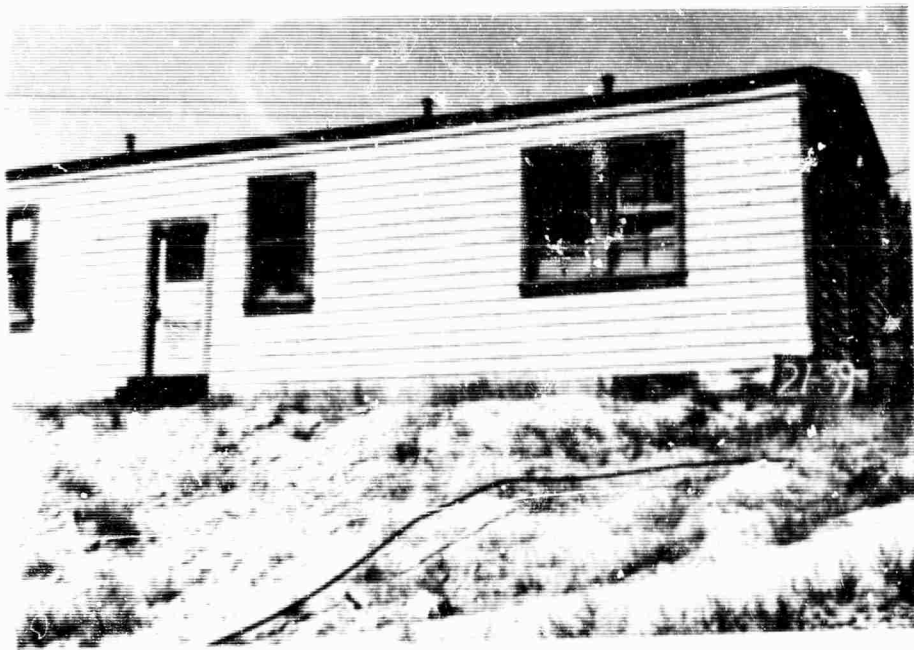
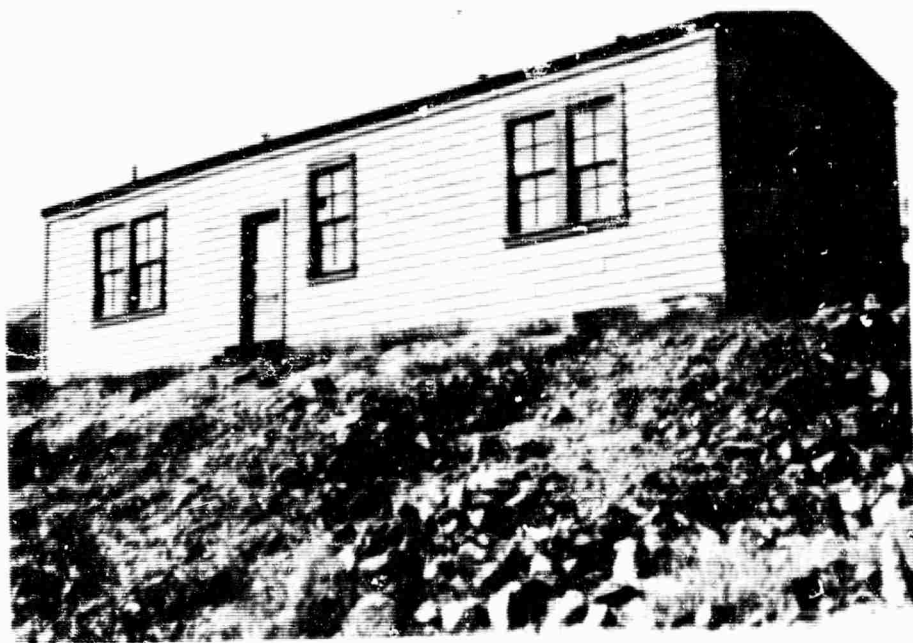
Photo No. 21-39 - Preshot - October 2, 1963

- 21-39 Storehouse (See photo 21-39) This is a 21 x 42-foot wood frame and wood siding storehouse. AZ 230° clockwise from magnetic north. No damage was noted as a result of the postshot survey.

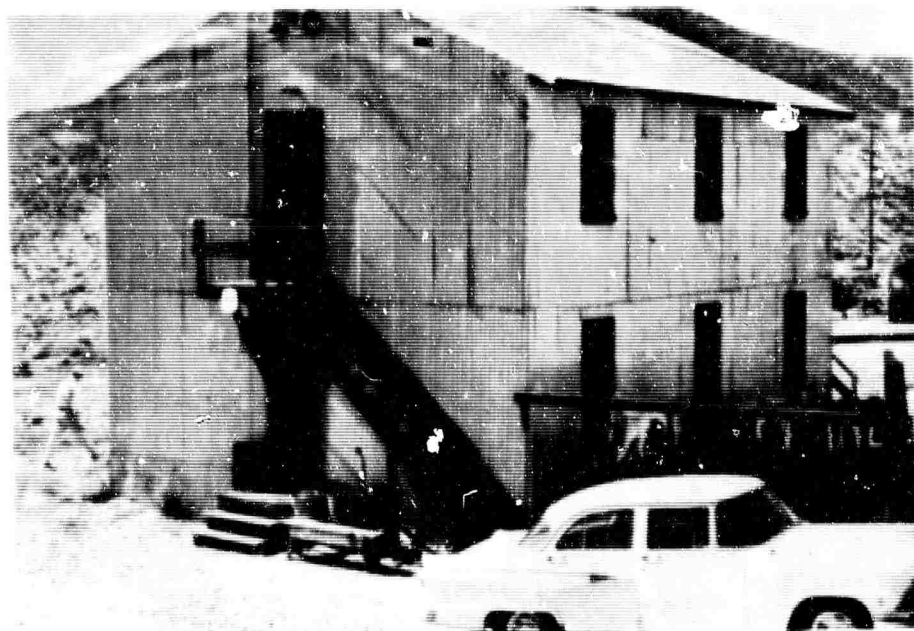
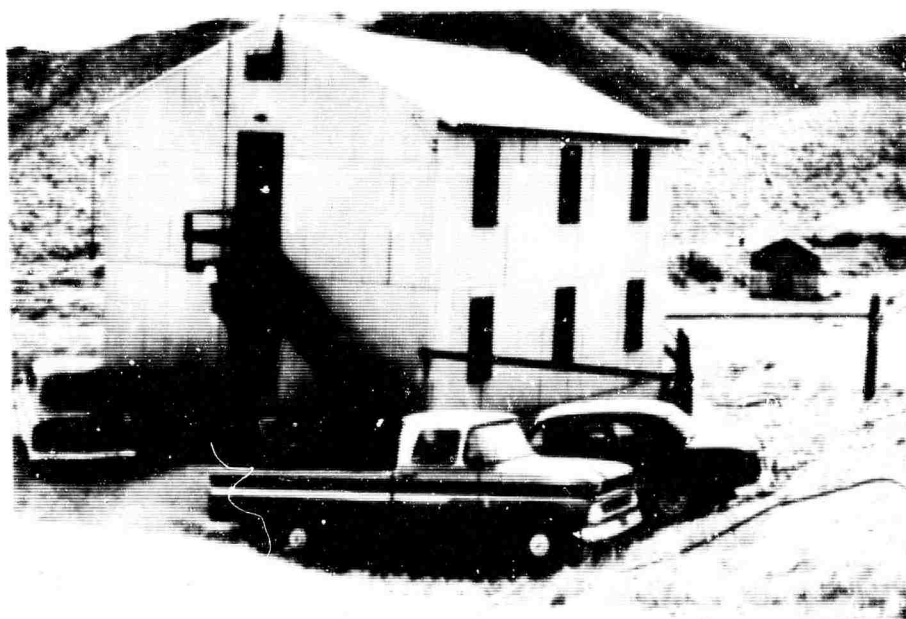
Photo No. 21-40 - Preshot - October 2, 1963

- 21-40 Bunkhouse (See photo 21-40) This is a 27 x 30-foot bunkhouse of wood frame with corrugated metal siding. This is a two story structure. AZ 230° clockwise from magnetic north. No damage was noted as a result of the postshot survey.

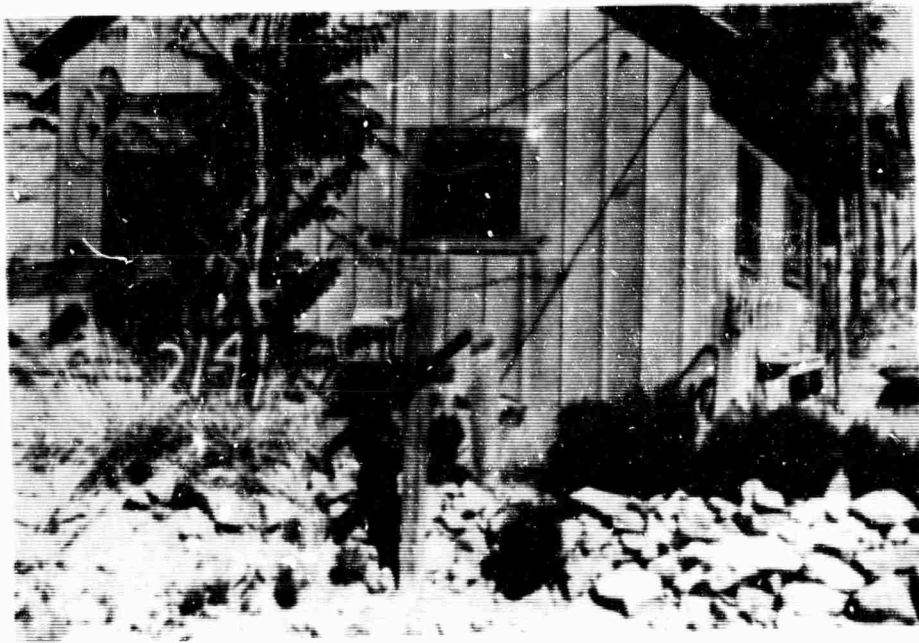
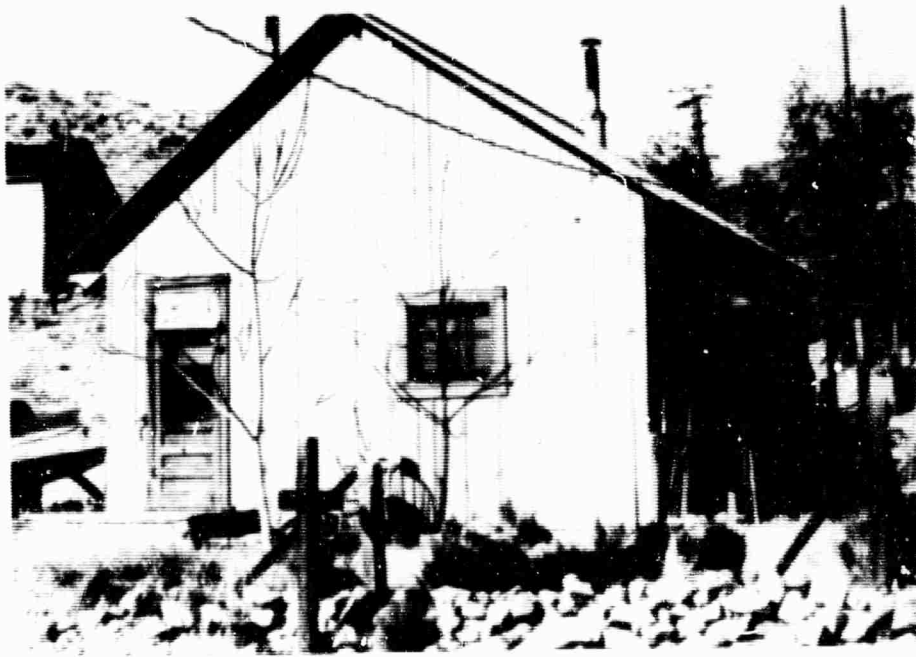
Photo No. 21-41 - Preshot - October 2, 1963

- 21-41 Residence (See photo 21-41) This is a 15 x 18-foot wood frame and corrugated metal siding residential structure. AZ 355° clockwise from magnetic north. No damage was noted as a result of the postshot survey.

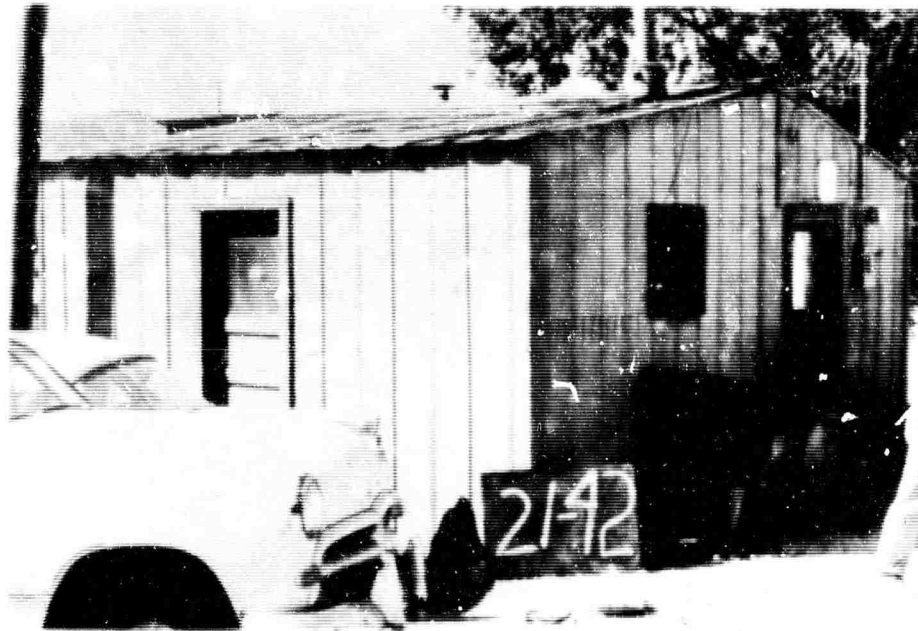
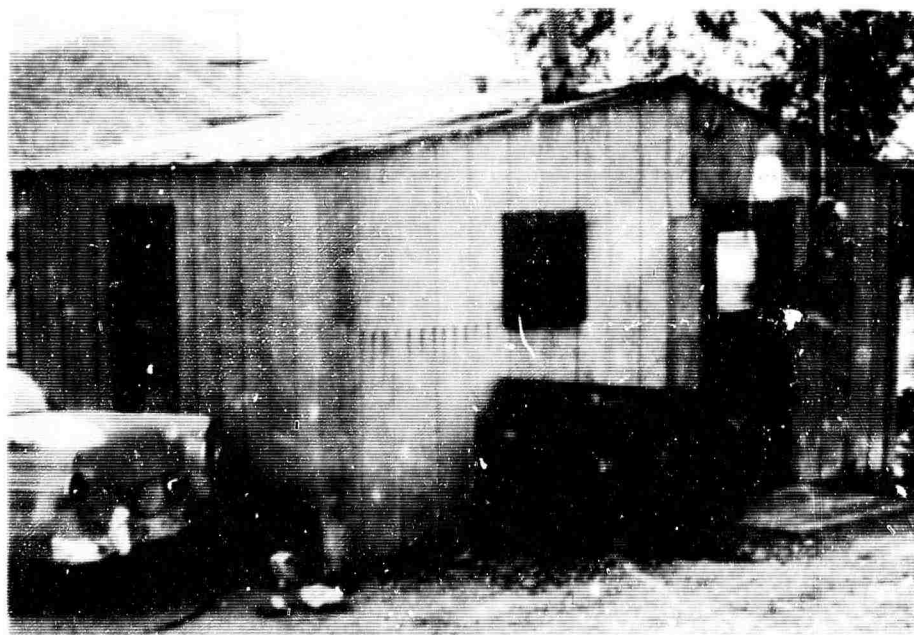
Photo No. 21-42 - Preshot - October 2, 1963

- 21-42 Residence (See photo 21-42) This is a 15 x 15-foot residence of wood frame and corrugated metal siding. AZ 175° clockwise from magnetic north. No damage was noted as a result of the postshot survey.

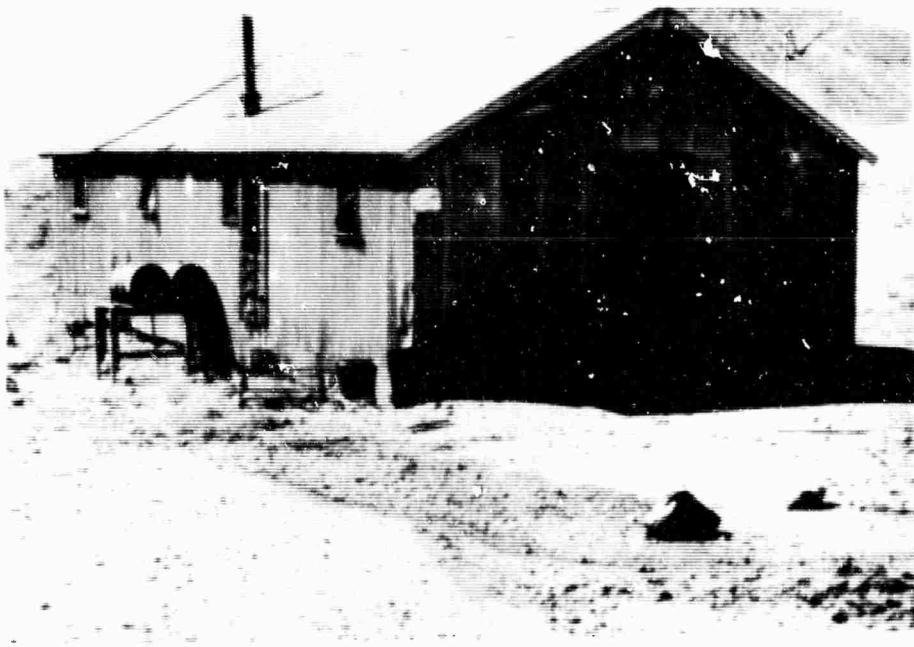
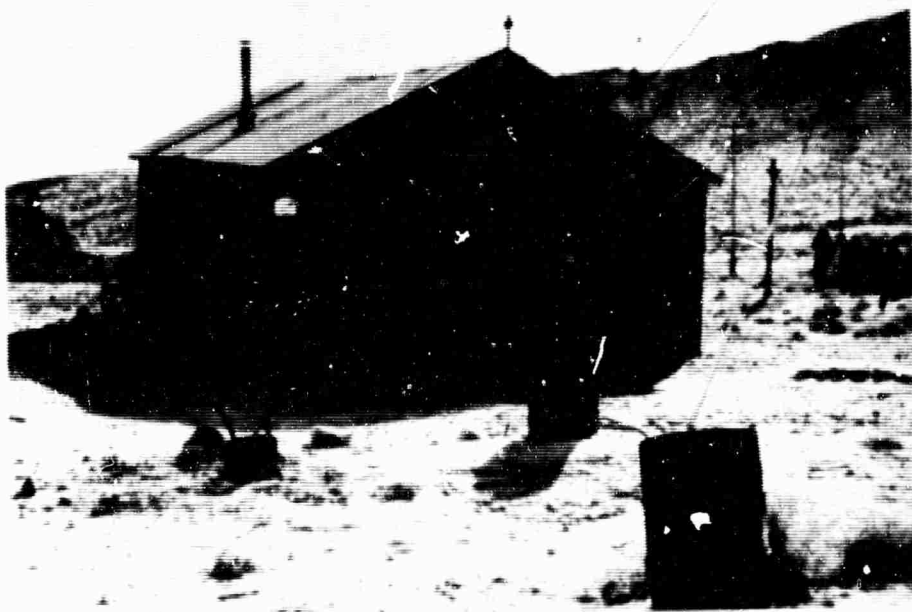
Photo No. 21-43 - Preshot - October 2, 1963

- 21-43 Residence (See photo 21-43) This is an 18 x 45-foot residence of wood frame and corrugated metal siding. AZ 175° clockwise from magnetic north. No damage was noted as a result of the postshot survey.
