# VELA UNIFORM PROJECT **SHOAL**

**PRESHOT AND POSTSHOT STRUCTURE SURVEY**  
Holmes & Narver, Inc.

December 1963

# **PRESHOT AND POSTSHOT STRUCTURE SURVEY**

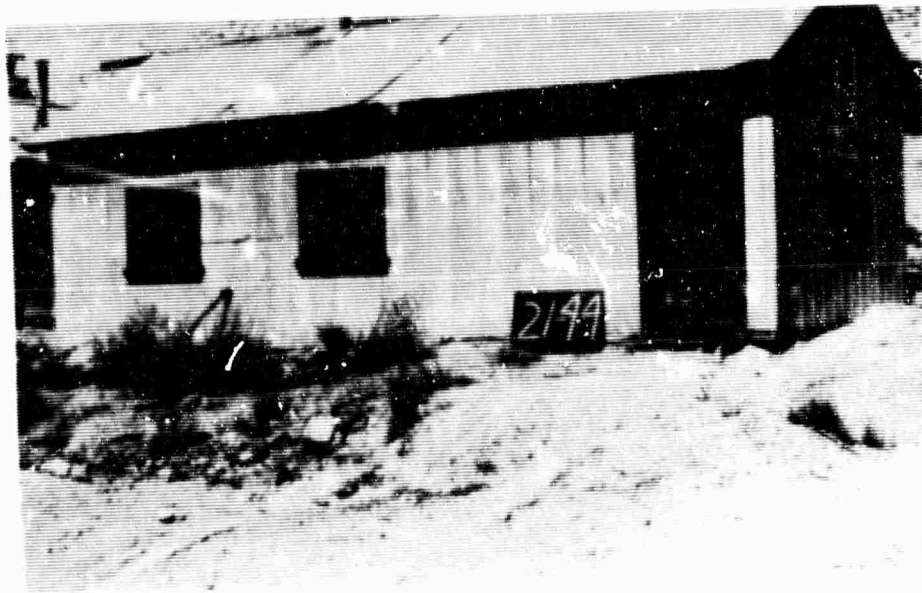
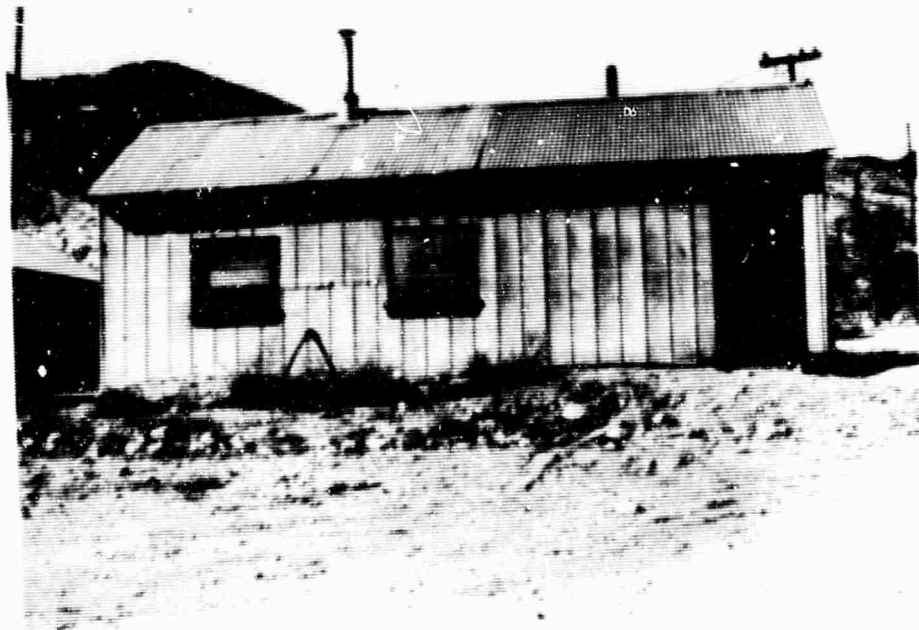
Photo No. 21-44 - Preshot - October 2, 1963

- 21-44 Storehouse (See photo 21-44) This is a 14 x 27-foot wood frame and corrugated metal storehouse. AZ 345° clockwise from magnetic north. No damage was noted as a result of the postshot survey.

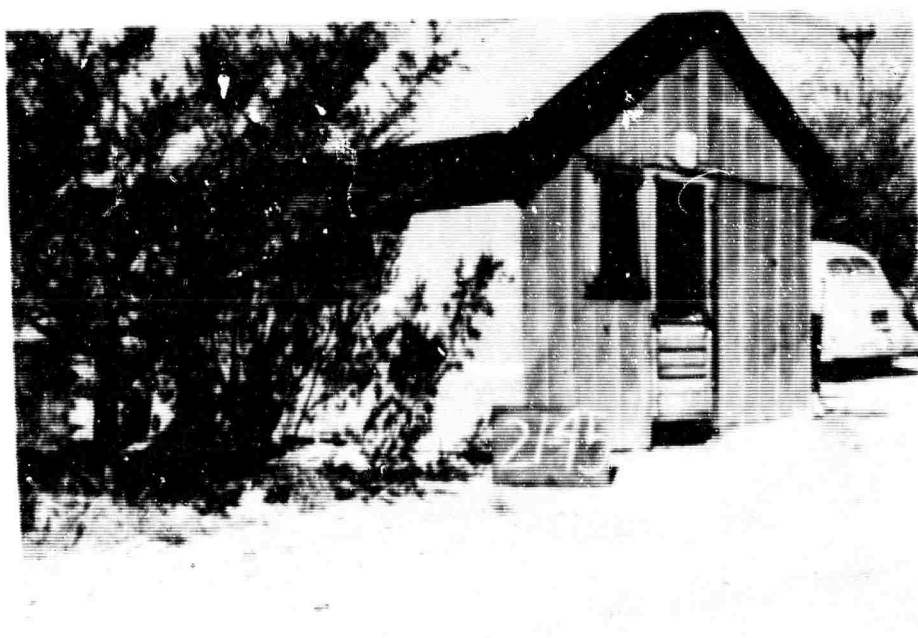
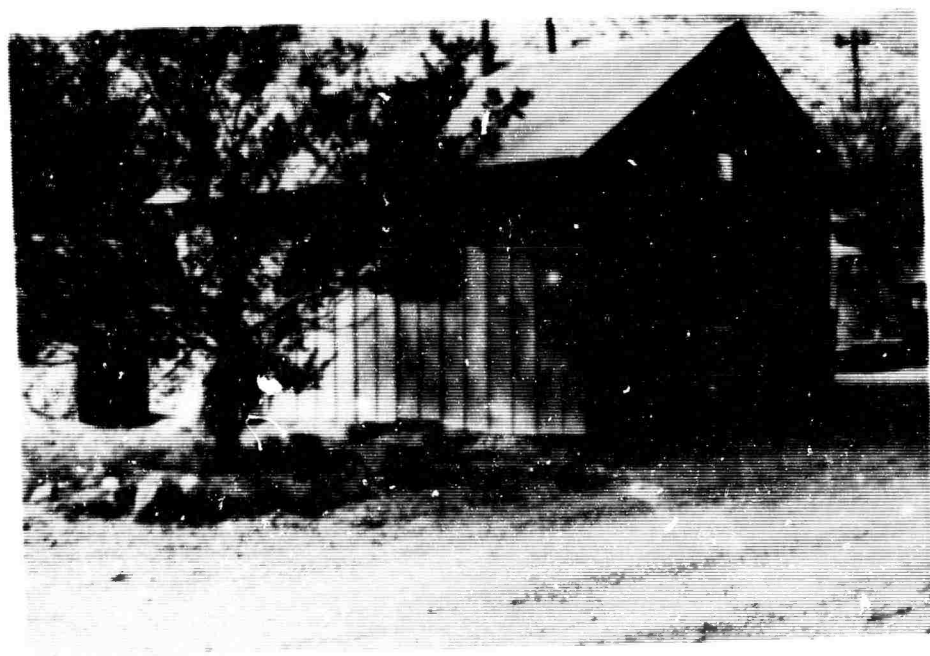
Photo No. 21-45 - Preshot - October 2, 1963

- 21-45 Residence (See photo 21-45) This is a 12 x 15-foot residence of wood frame and corrugated metal siding. AZ 250° clockwise from magnetic north. No damage was noted as a result of the postshot survey.

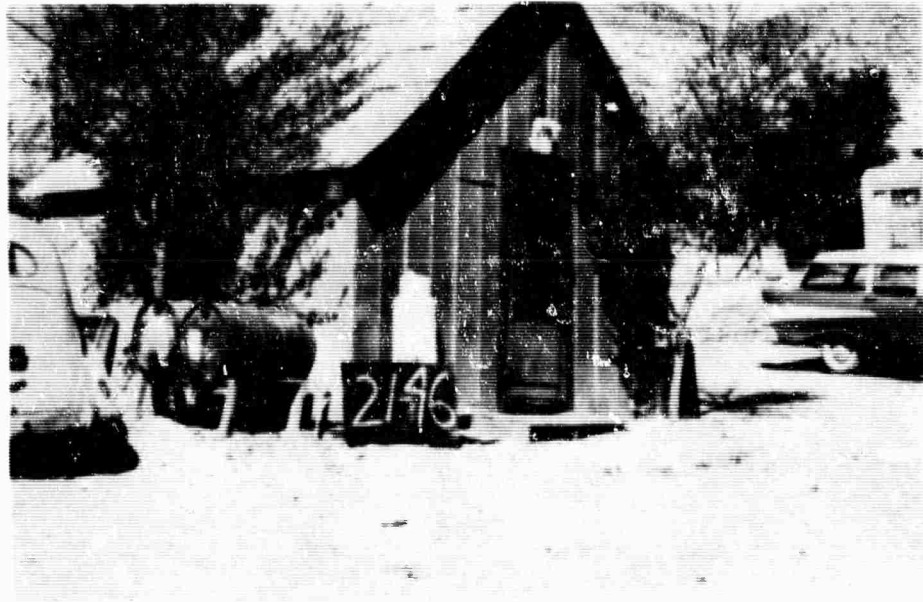
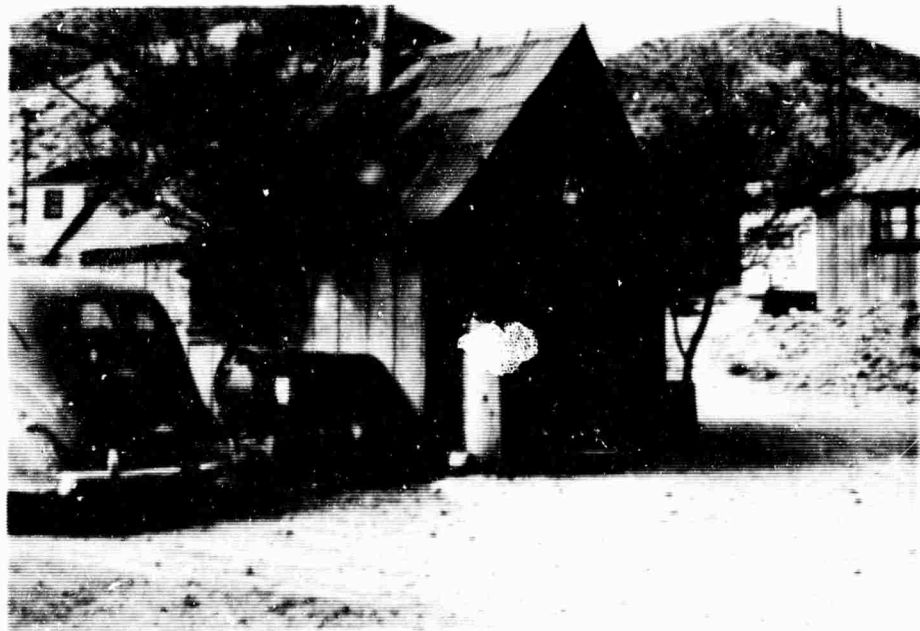
Photo No. 21-46 - Preshot - October 2, 1963

- 21-46 Residence (See photo 21-46) This is a 12 x 15-foot residence of wood frame and metal siding. AZ 250° clockwise from magnetic north. No damage was noted as a result of the postshot survey.

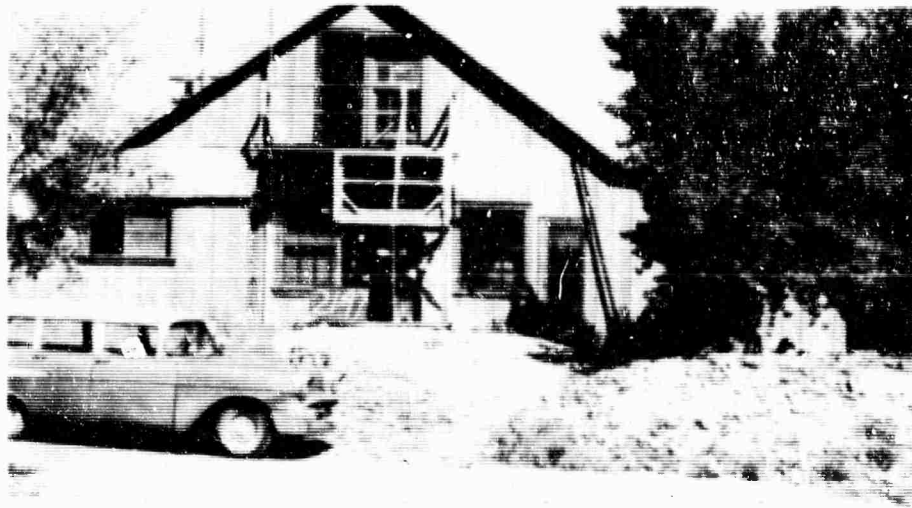
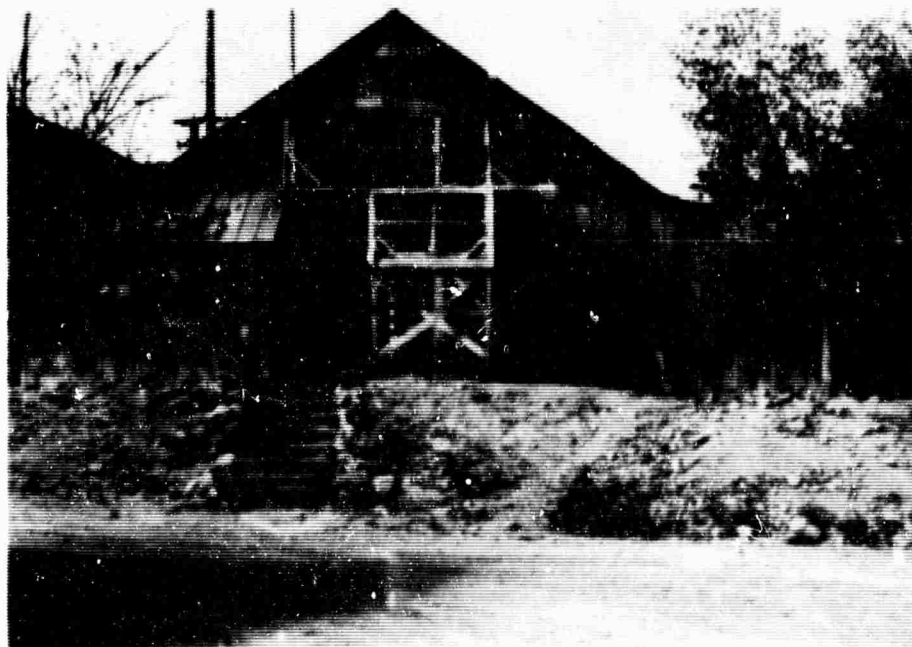
Photo No. 21-47 - Preshot - October 2, 1963

- 21-47 Residence, Cook House and Commissary (See photo 21-47) This is a 39 x 48-foot residence, cook shack, and commissary structure of wood frame and metal siding. AZ 340° clockwise from magnetic north. No damage was noted as a result of the postshot survey.

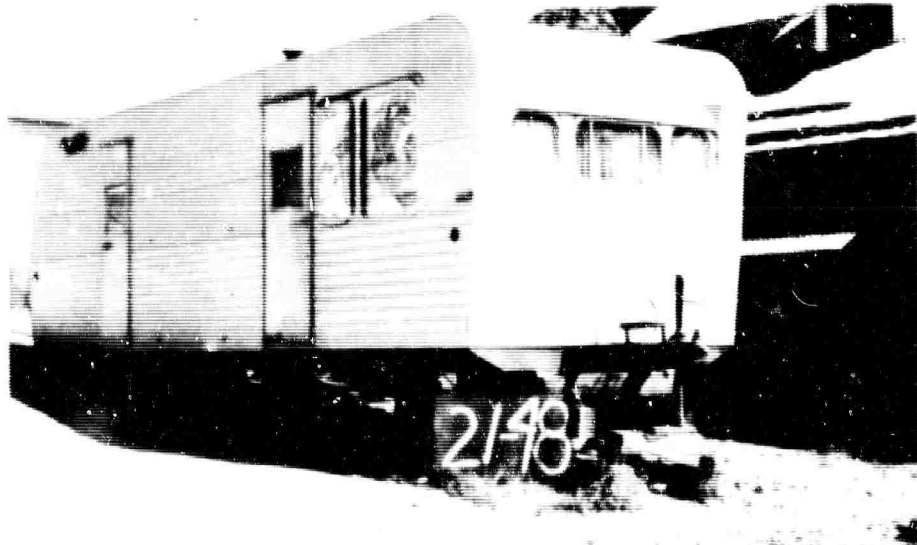
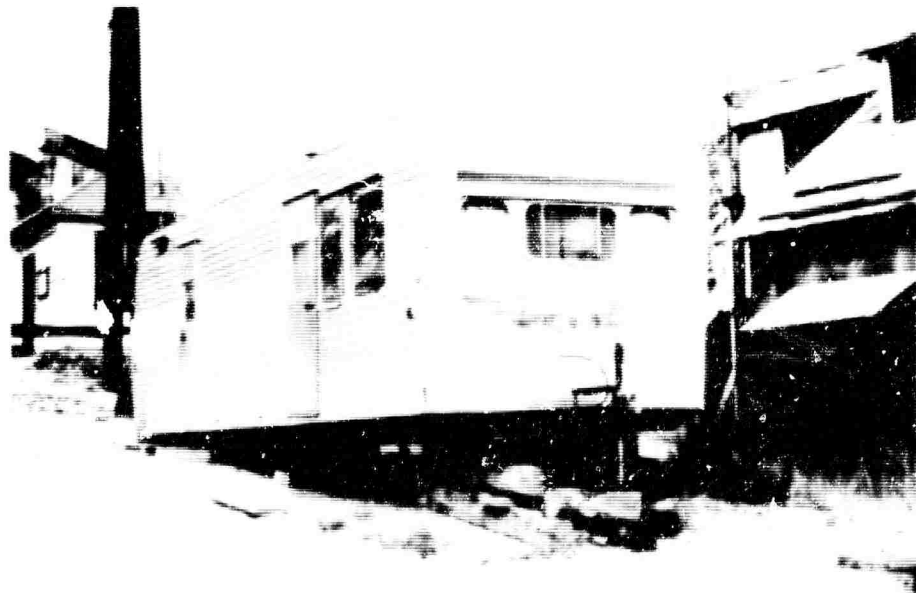
Photo No. 21-48 - Preshot - October 2, 1963

- 21-48 Trailer (See photo 21-48) This is a 25 x 8-foot metal covered trailer. AZ 85° clockwise from magnetic north. No damage was noted as a result of the postshot survey.

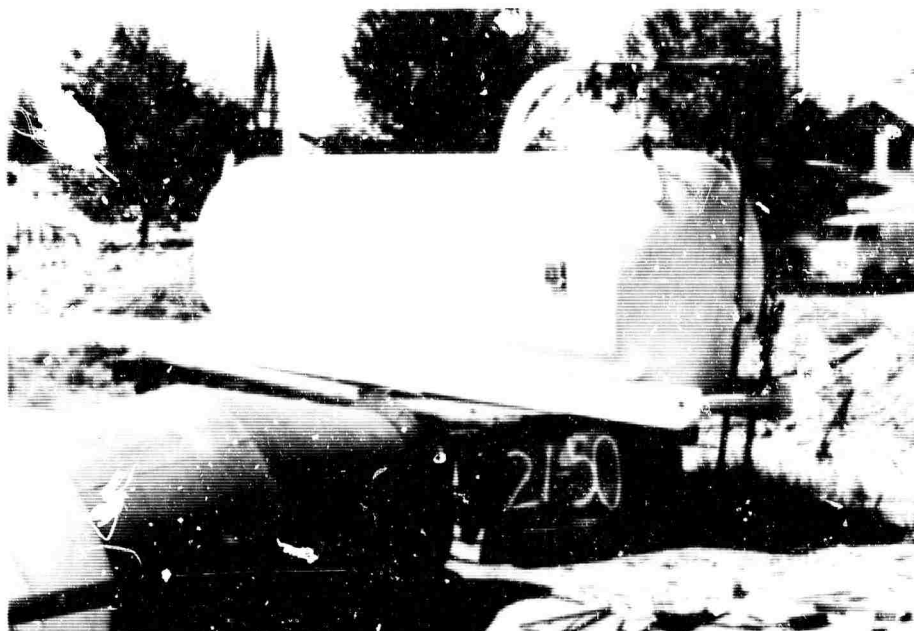
Photo No. 21-50 - Preshot - October 2, 1963

- 21-50 Tank (See photo 21-50) The 5 x 22-foot hydrochloric acid tank of steel on 8-foot wood cribbing was built during 1963. AZ 250° clockwise from magnetic north. No damage was noted as a result of the postshot survey.

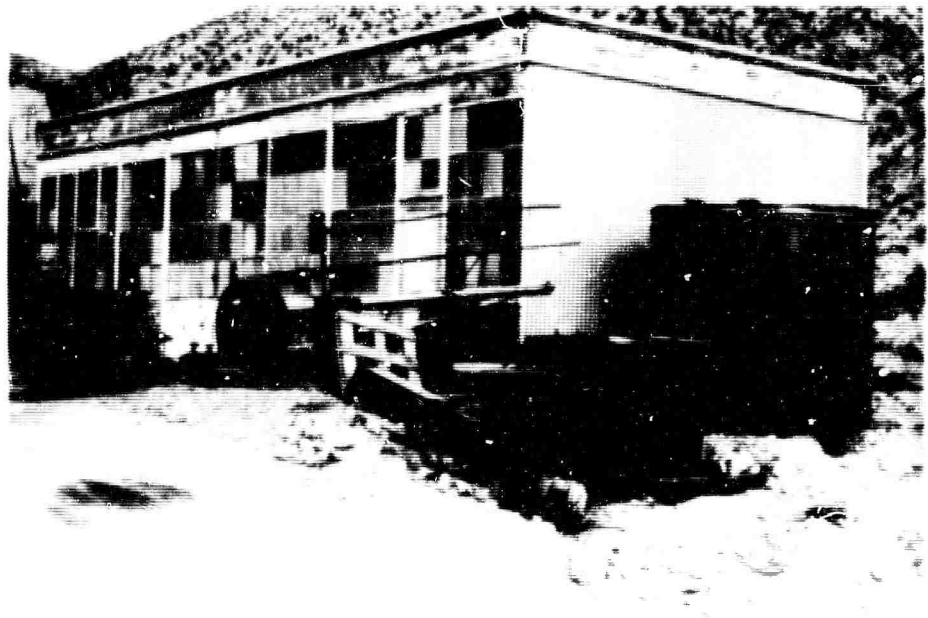
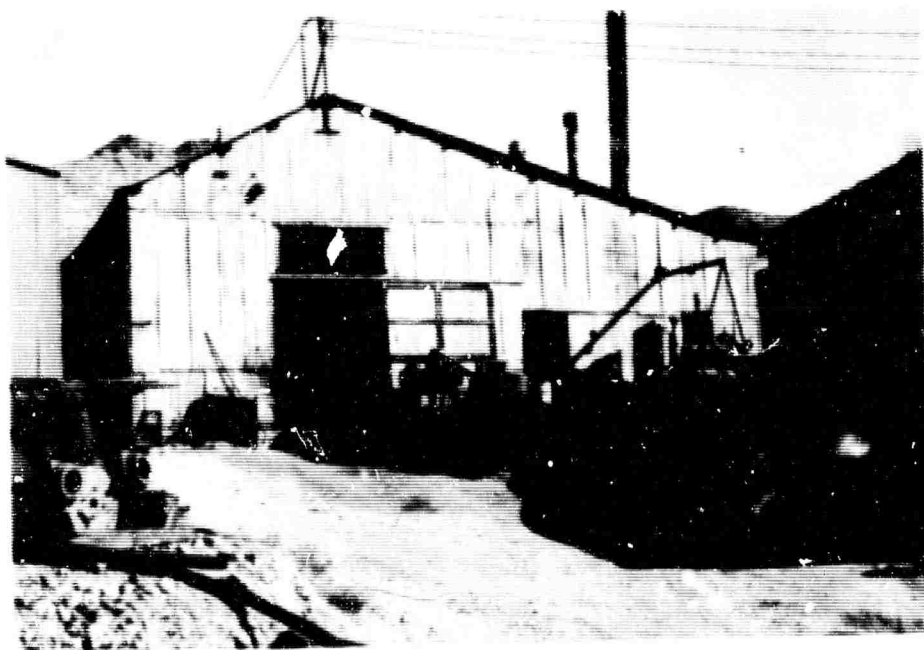
Photo No. 21-56 - Postshot - October 28, 1963

- 21-57 Power House (See photo 21-57) This standby power house is 45 x 60 feet, steel and wood frame with metal siding. AZ 350° clockwise from magnetic north. No damage was noted as a result of the postshot survey.

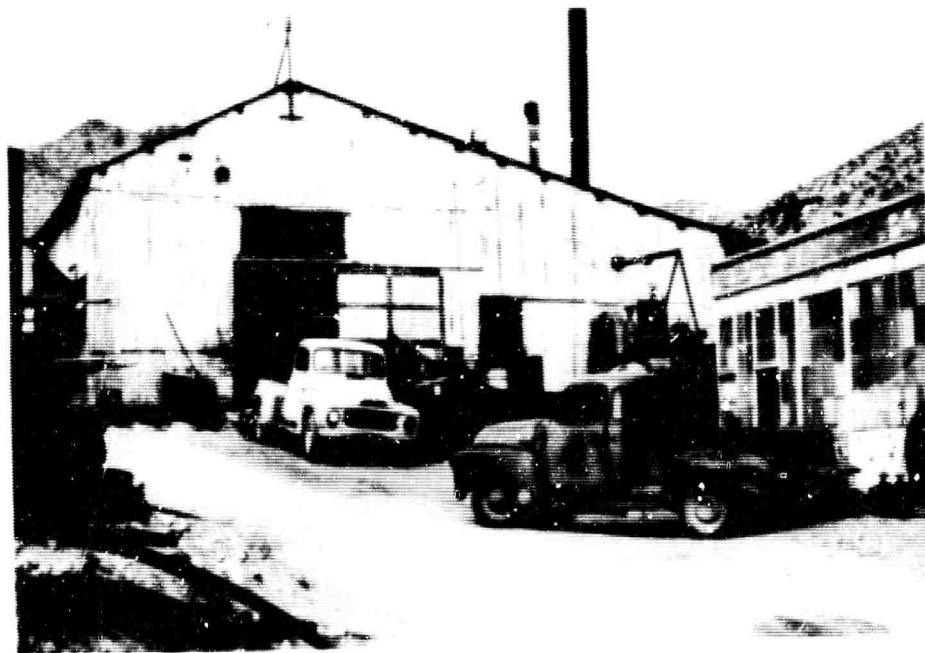
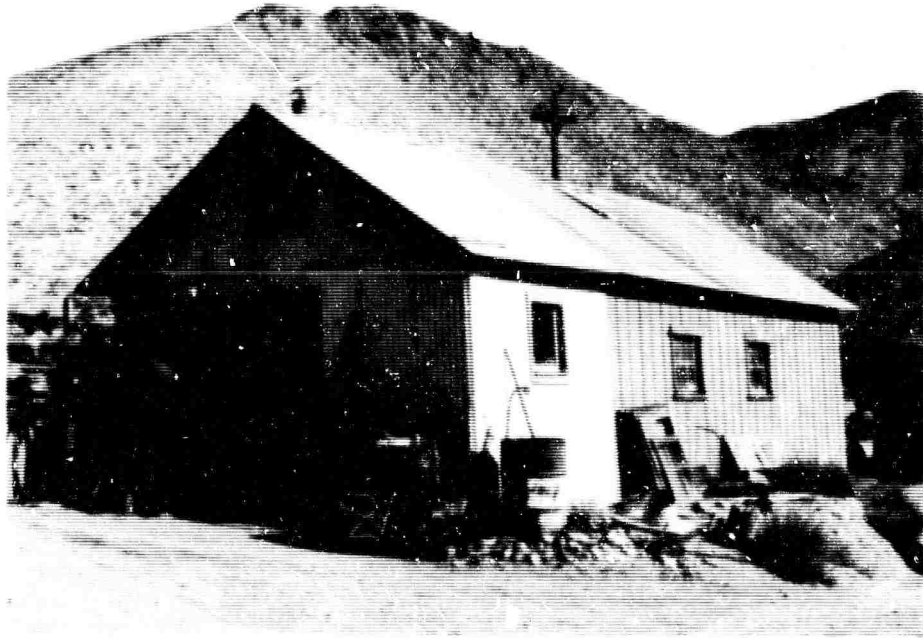
Photo No. 21-57 - Postshot - October 28, 1963

- 21-58 Carpentry Shop (See photo 21-58) Building is a 14 x 36-foot wood frame and metal-siding structure used as carpentry shed. AZ 30° clockwise from magnetic north. No damage was noted as a result of the postshot survey.

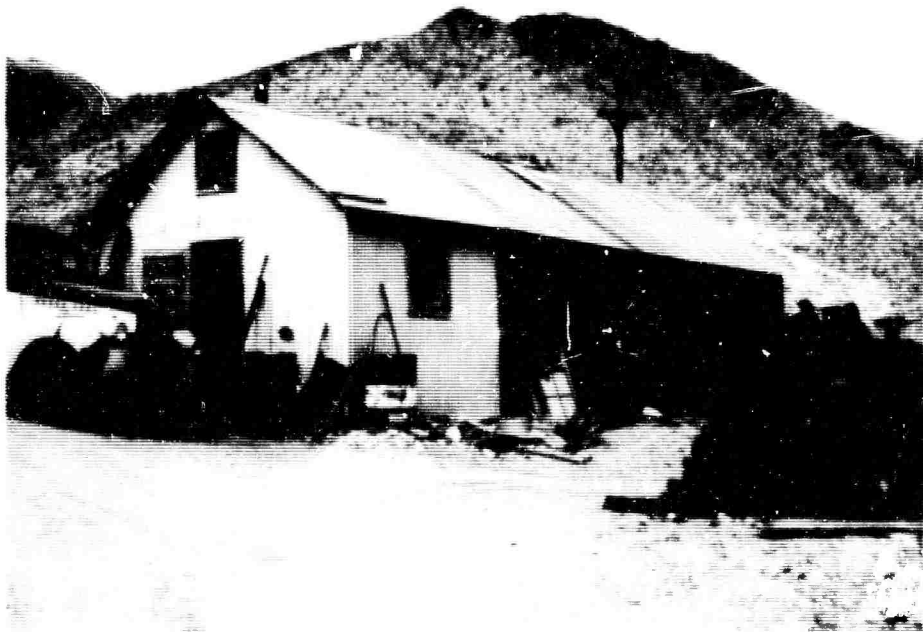
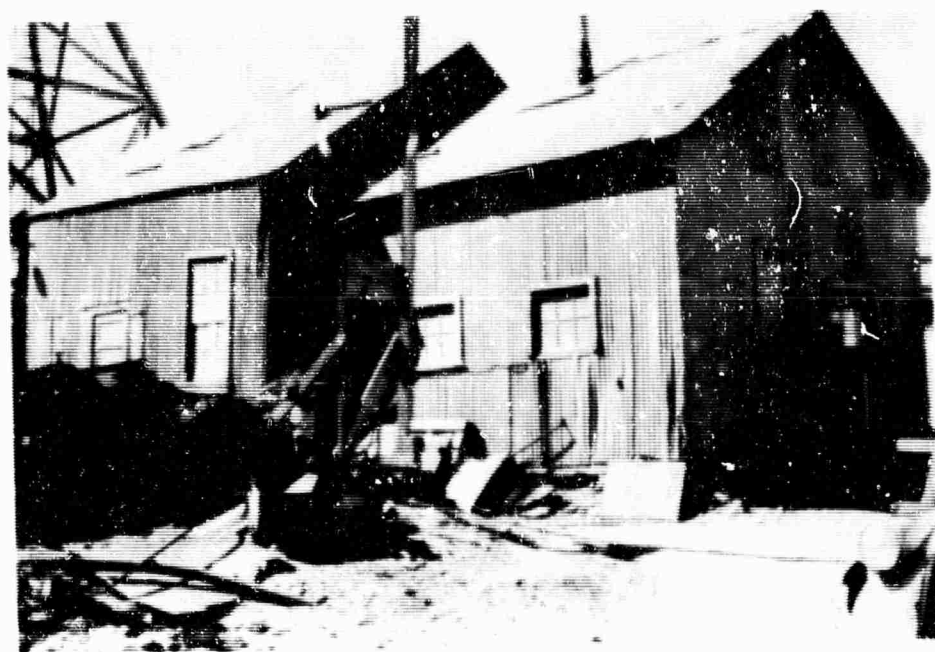
Photo No. 21-58 - Postshot - October 28, 1963

- 21-59 Hoist House (See photo 21-59) This hoist house is a 20 x 36-foot wood frame and corrugated metal-siding structure. AZ 210° clockwise from magnetic north. No damage was noted as a result of the postshot survey.

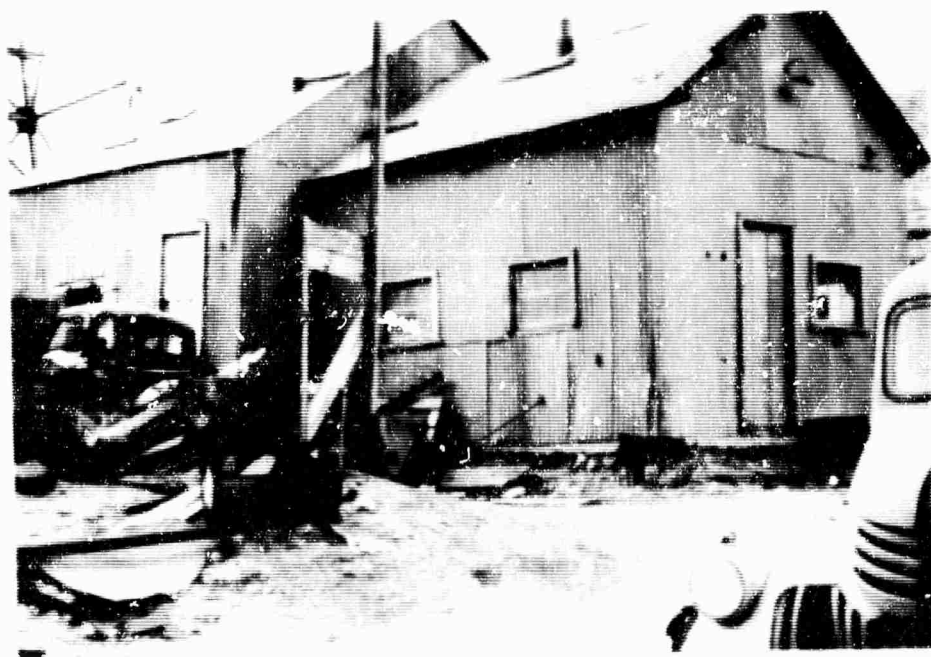
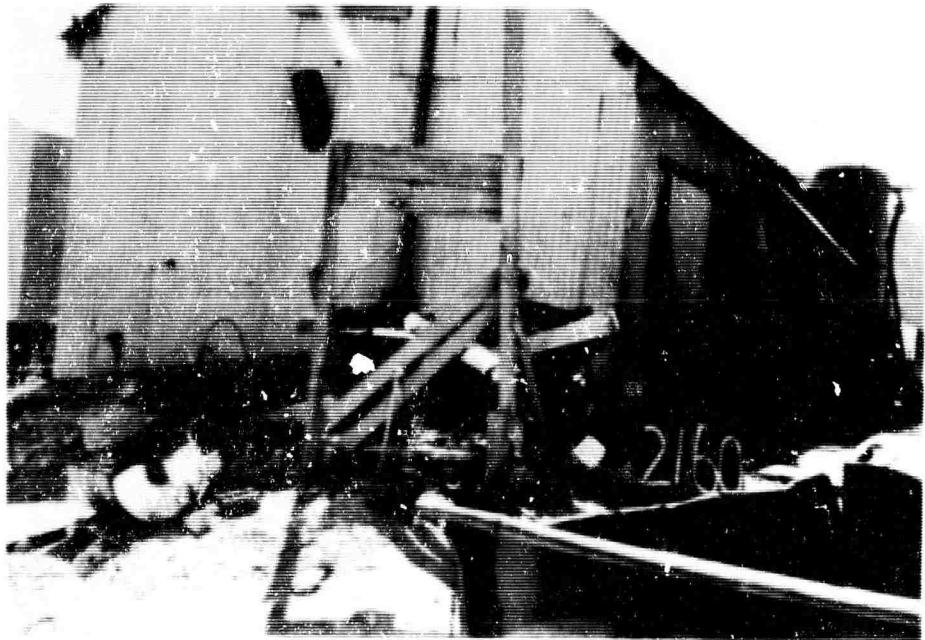
Photo No. 21-59 - Postshot - October 28, 1963

- 21-60 Blacksmith Shop (See photo 21-60) Building is a 14 x 48-foot blacksmith shop of wood frame and corrugated metal siding. AZ 195° clockwise from magnetic north. No damage was noted as a result of the postshot survey.

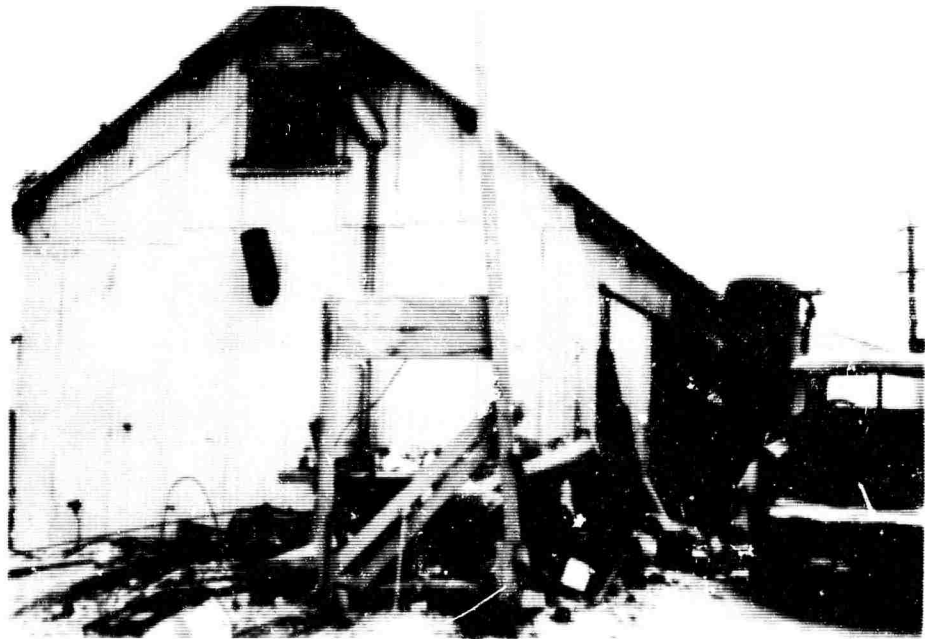
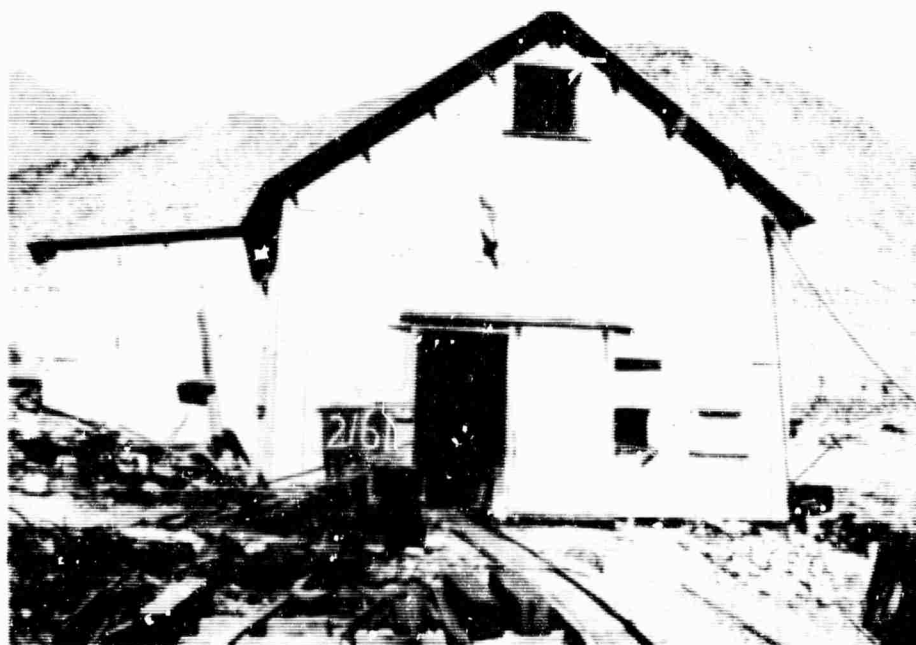
Photo No. 21-60 - Postshot - October 28, 1963

- 21-61 Timber Shed (See photo 21-61) This timber shed is a 22 x 48-foot wood frame and metal siding structure. AZ 350° clockwise from magnetic north. No damage was noted as a result of the postshot survey.

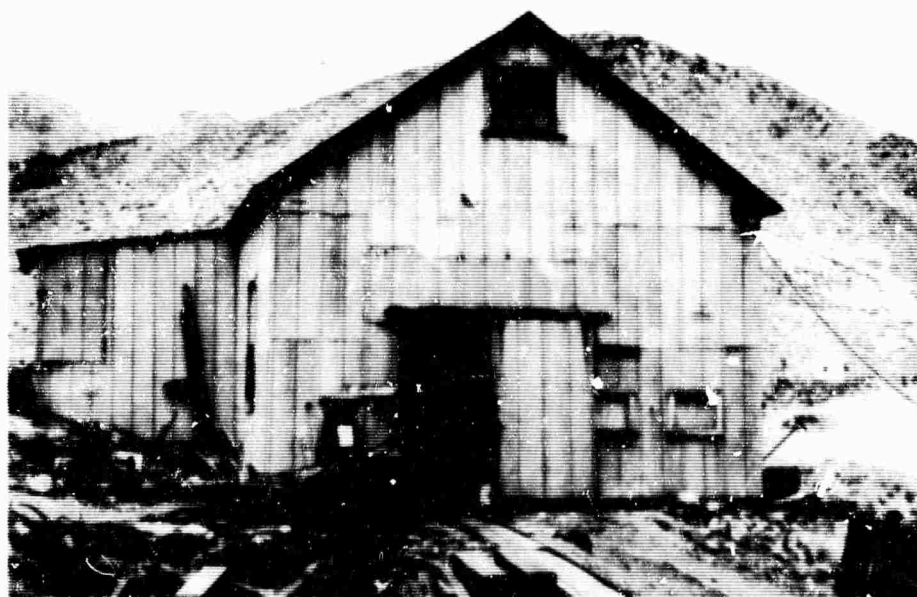
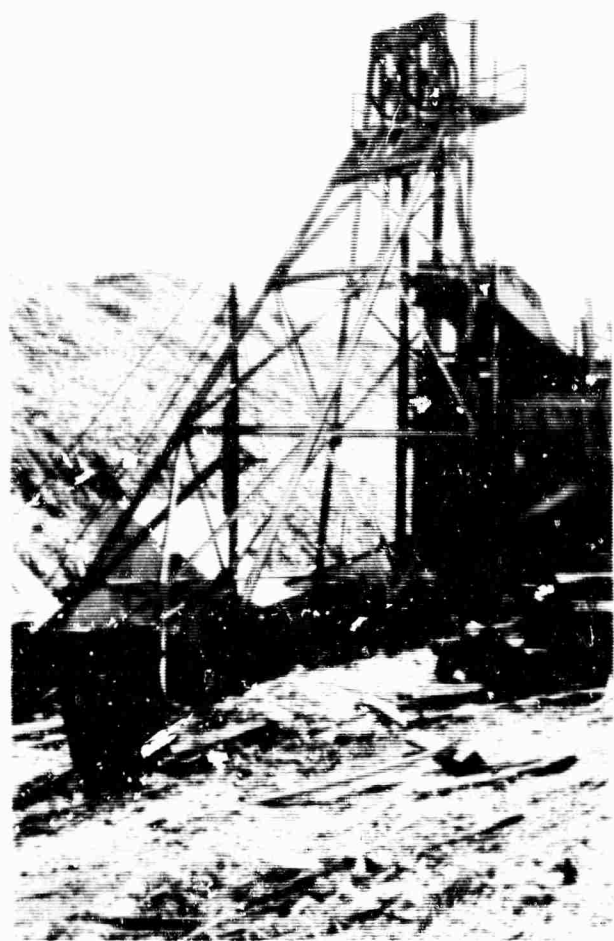
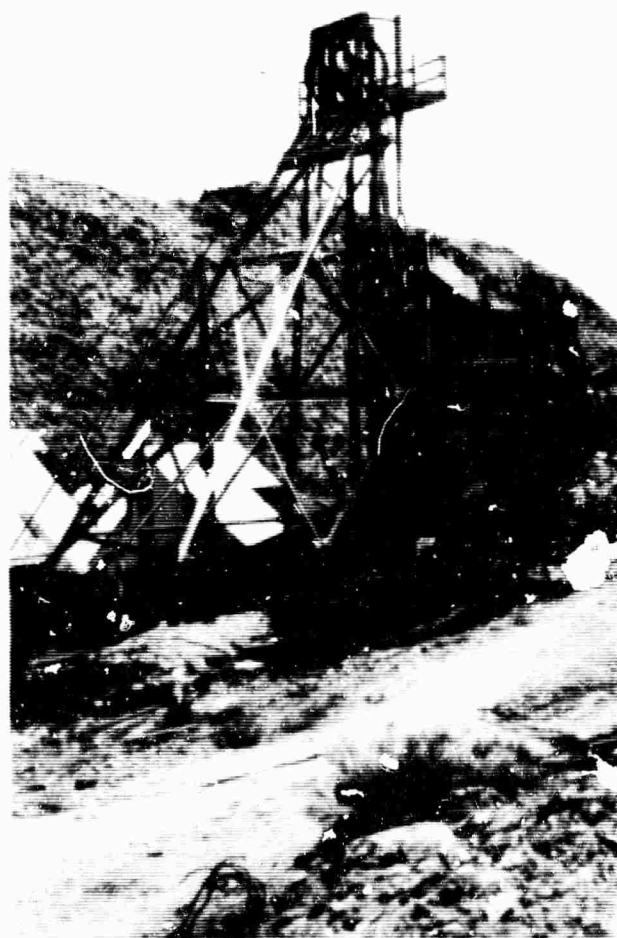
Photo No. 21-62

- 21-62 Headframe (See photo 21-62) Steel headframe structure with an approximately 30 x 30-foot base. AZ 195° clockwise from magnetic north. No damage was noted as a result of the postshot survey.

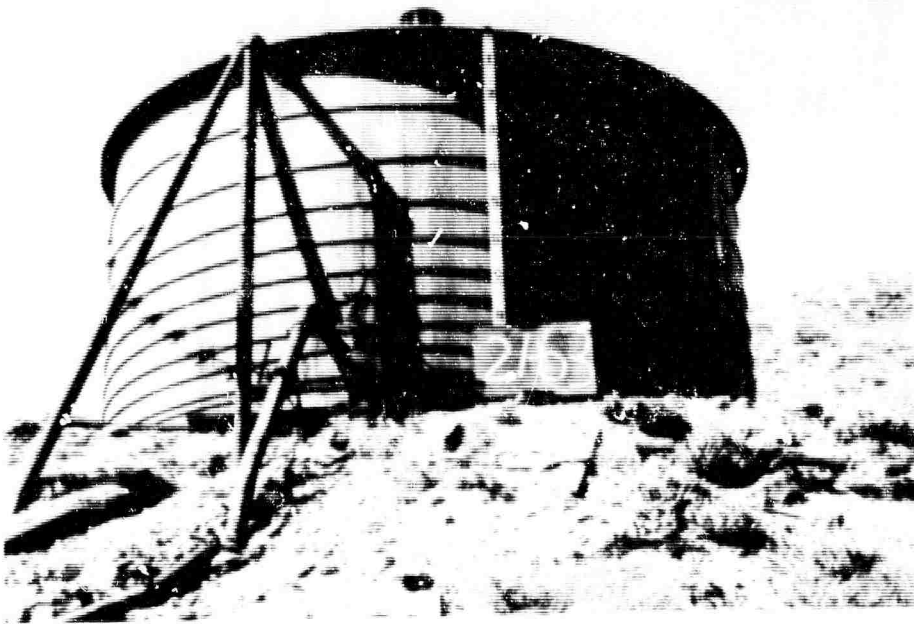
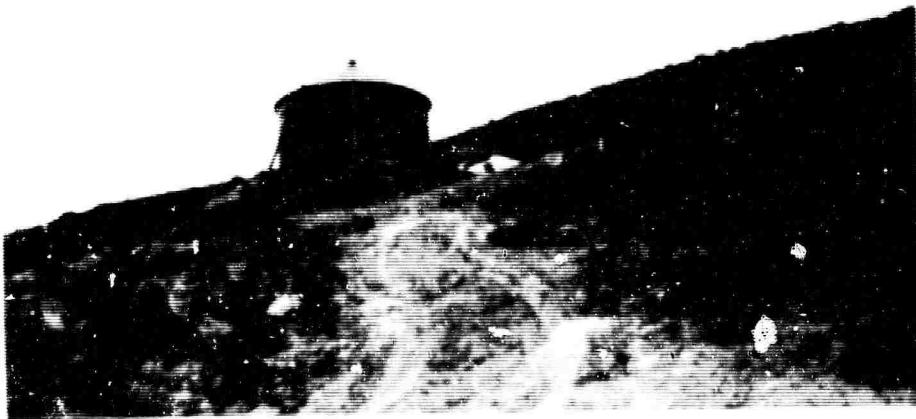
Photo No. 21-63 - Preshot - October 2, 1963

- 21-63 Water Tank (See photo 21-63) Wood stave water tank, 22 feet in diameter and 12 feet high. Built June 1963. AZ 280° clockwise from magnetic north. No damage was noted as a result of the postshot survey.

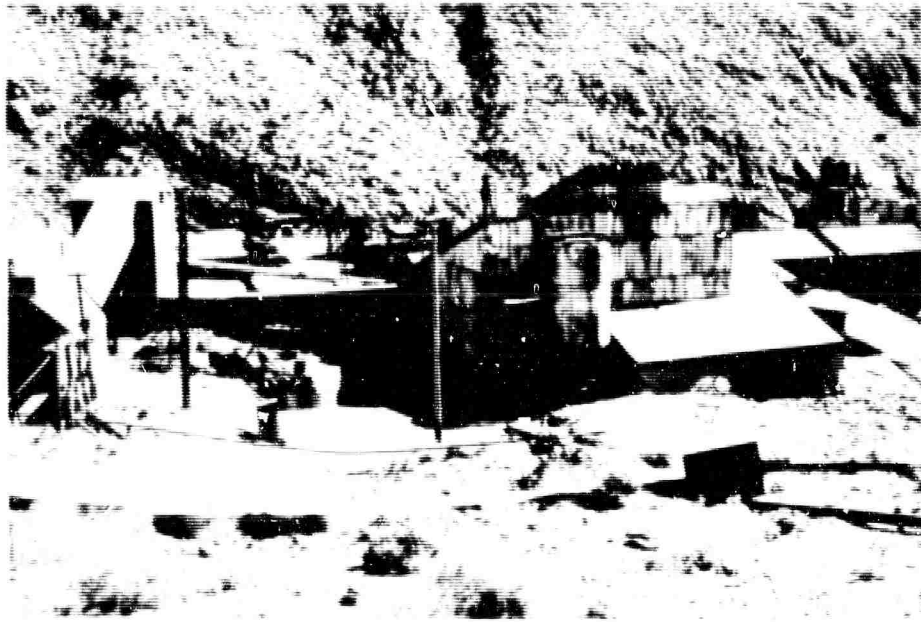
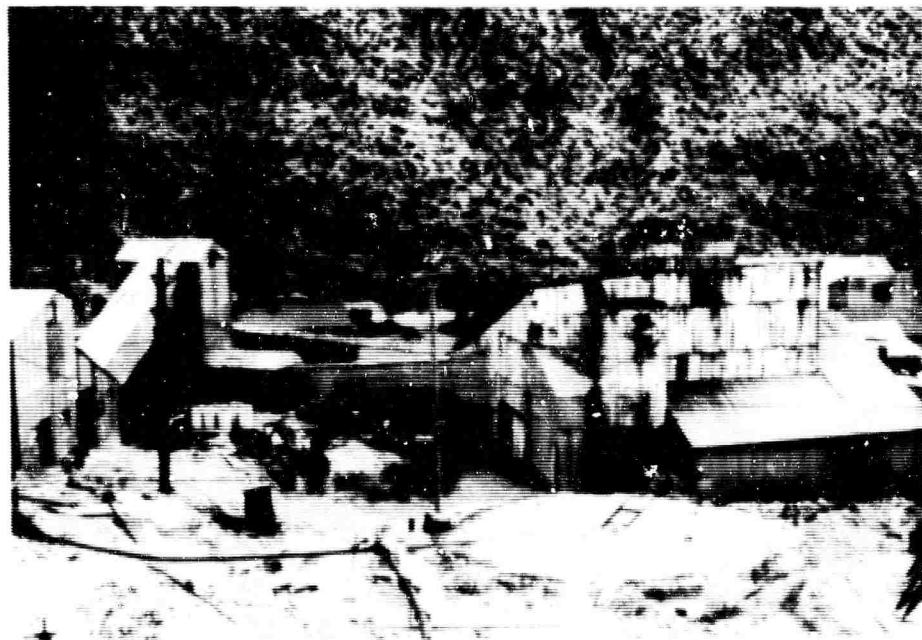
Photo No. 21-64 - Preshot - October 2, 1963

- 21-64 Mill (See photo 21-64) Unused mill structure with crushing plant of metal frame and covering. Also covered pipeline in 1 x 2-foot metal and wood box. AZ 115° clockwise from magnetic north. No damage was noted as a result of the postshot survey.

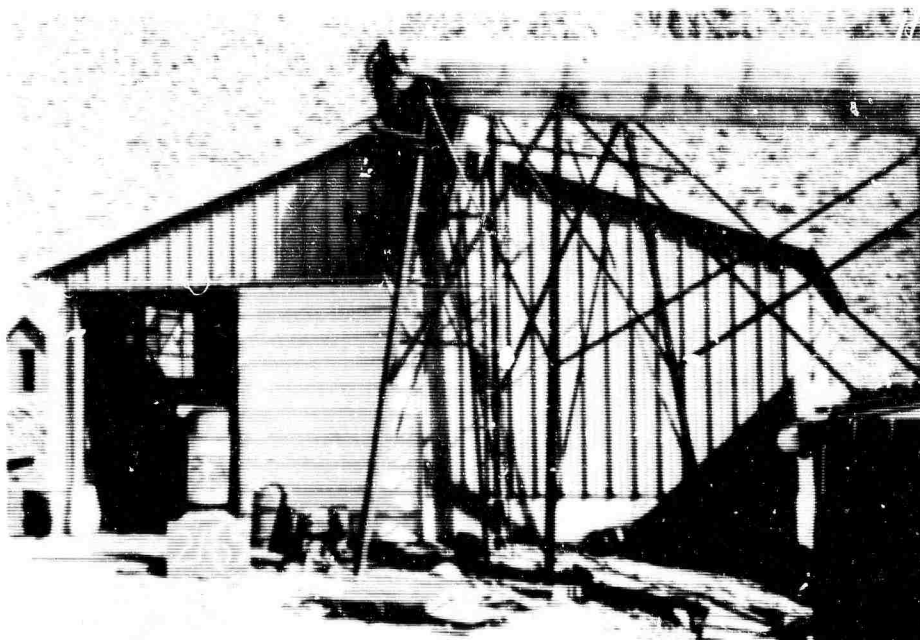
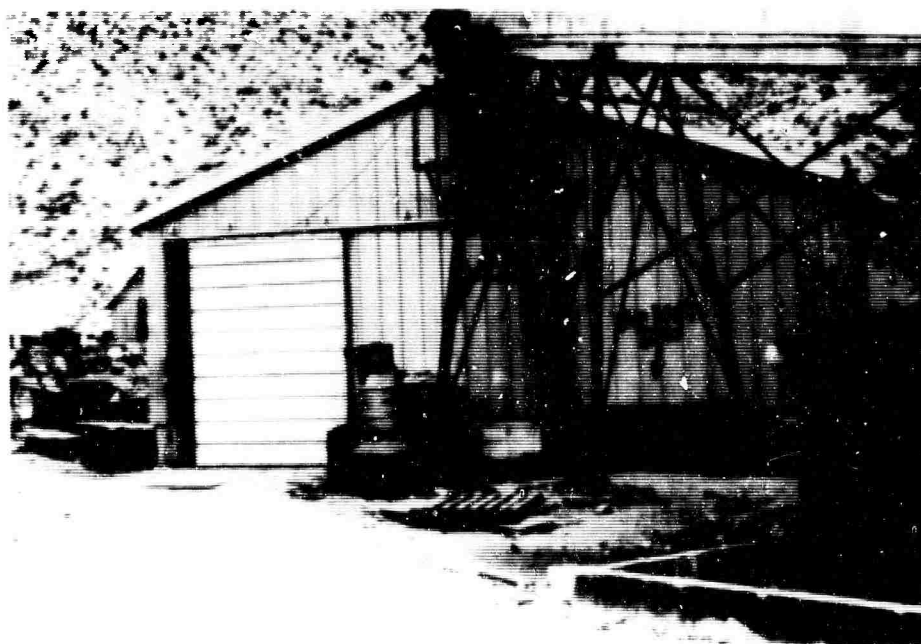
Photo No. 21-65 - Preshot - October 2, 1963

- 21-65 Bagging House (See photo 21-65) This structure is a 36 x 42-foot rigid frame, metal-covered bagging house. AZ 75° clockwise from magnetic north. No damage was noted as a result of the postshot survey.

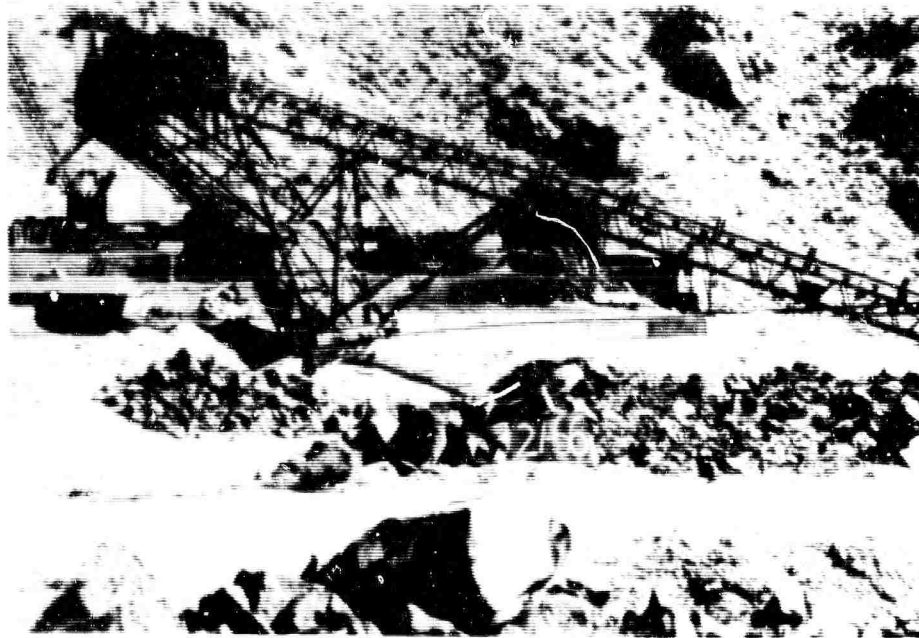
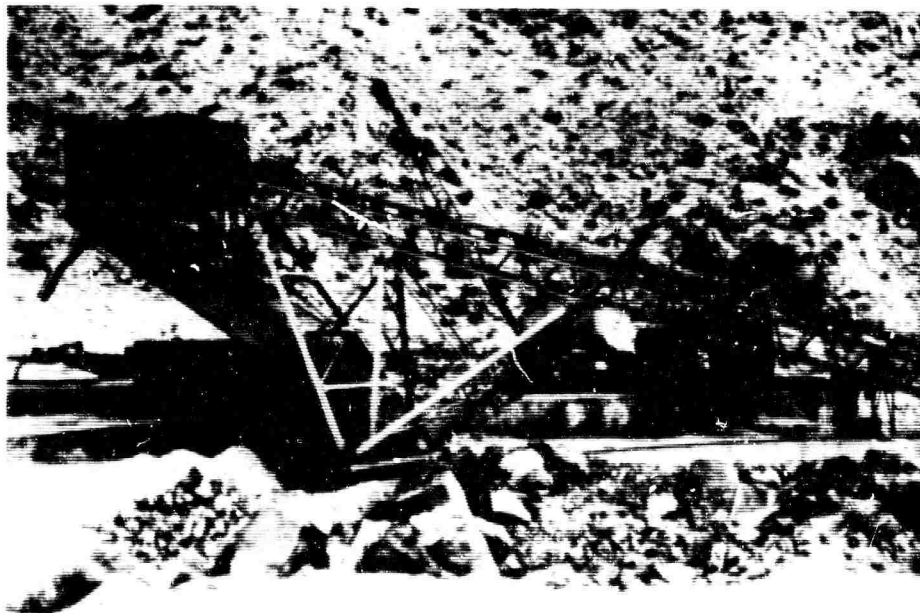
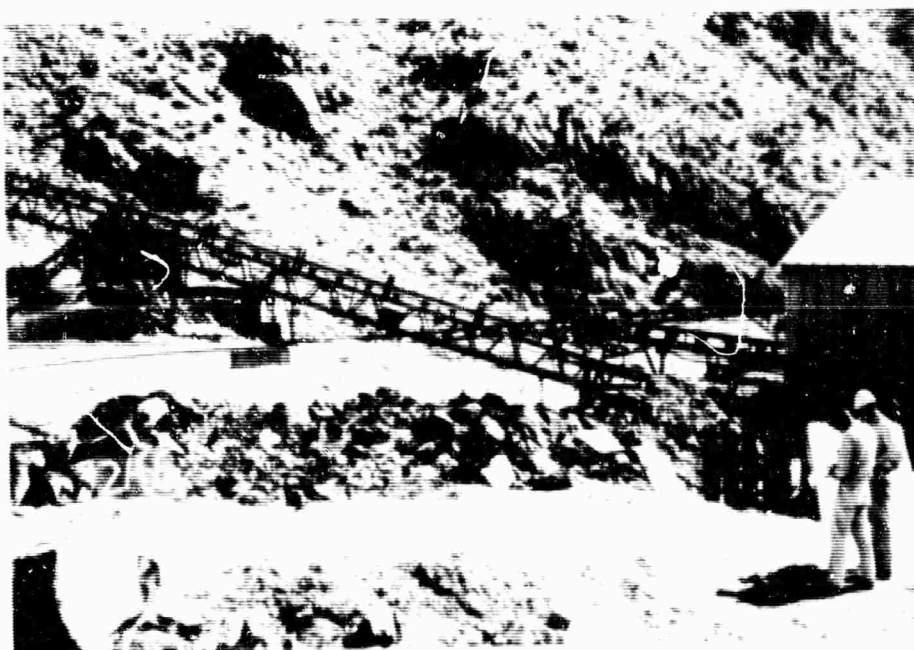
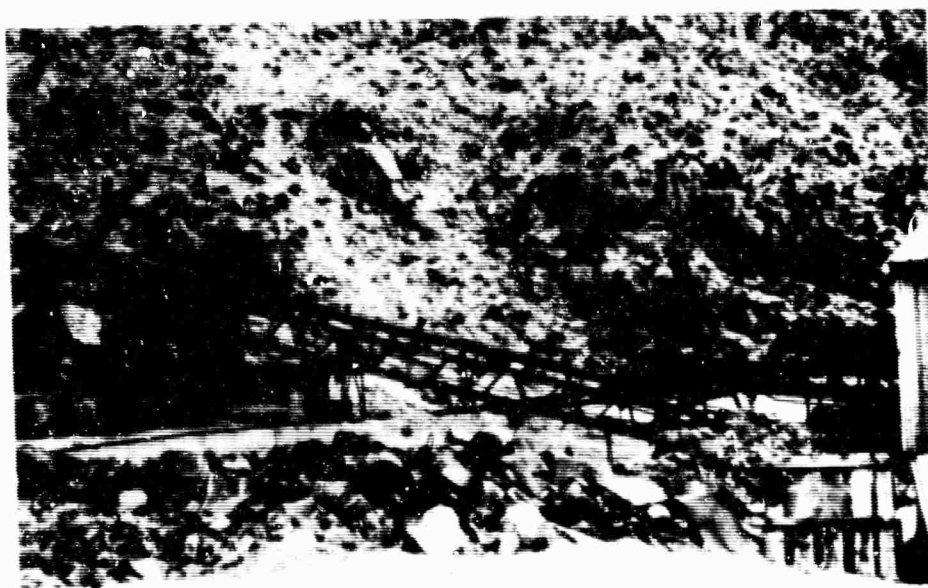
- 21-66 Conveyor (See photos 21-66(1) and 21-66(2)) Kiln site area is 26 x 135 feet, with 85-foot long swinging conveyor. Conveyor support is trussed steel structure. Kiln site is reinforced concrete and brick. AZ 85° clockwise from magnetic north. No damage was noted as a result of the postshot survey.

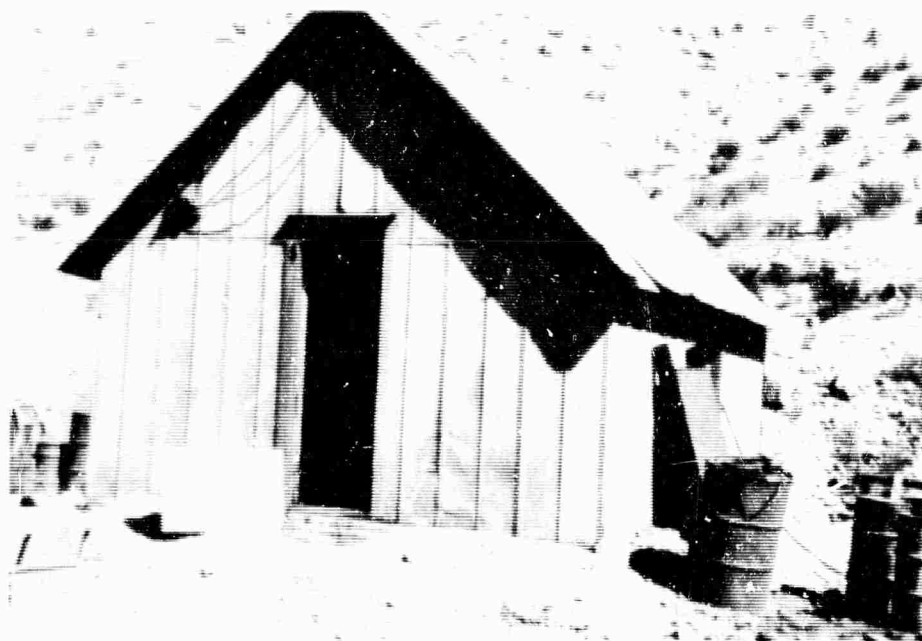
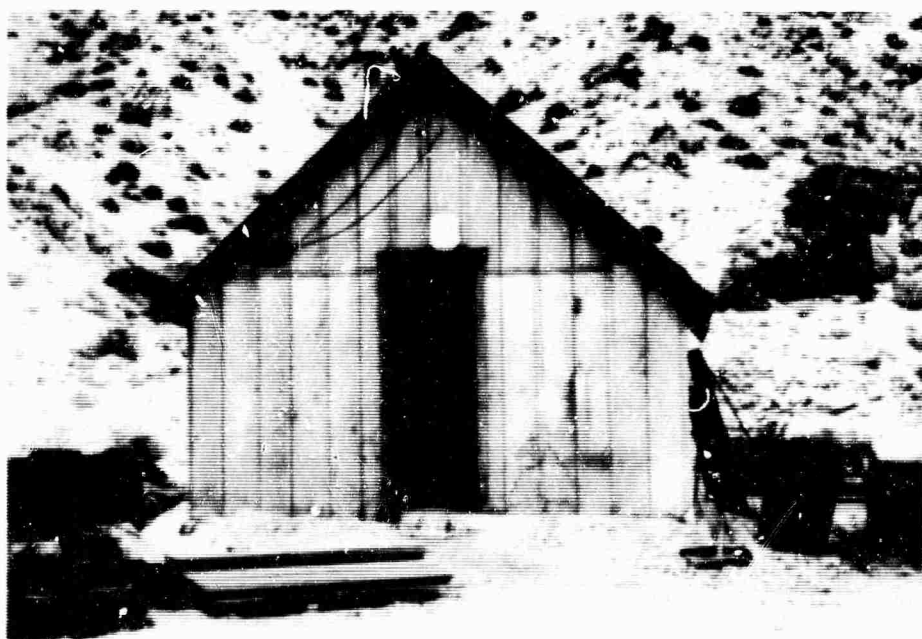
Photo No. 21-67 - Preshot - October 2, 1963

- 21-67 Work Shed (See photo 21-67) This is a 15 x 15-foot work shed of wood frame with metal siding. AZ 70° clockwise from magnetic north. No damage was noted as a result of the postshot survey.

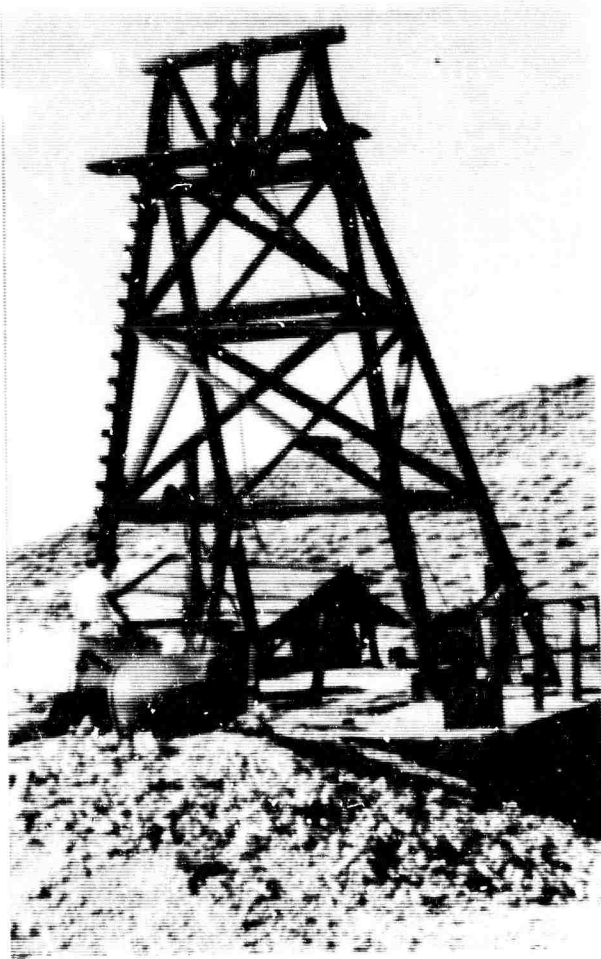
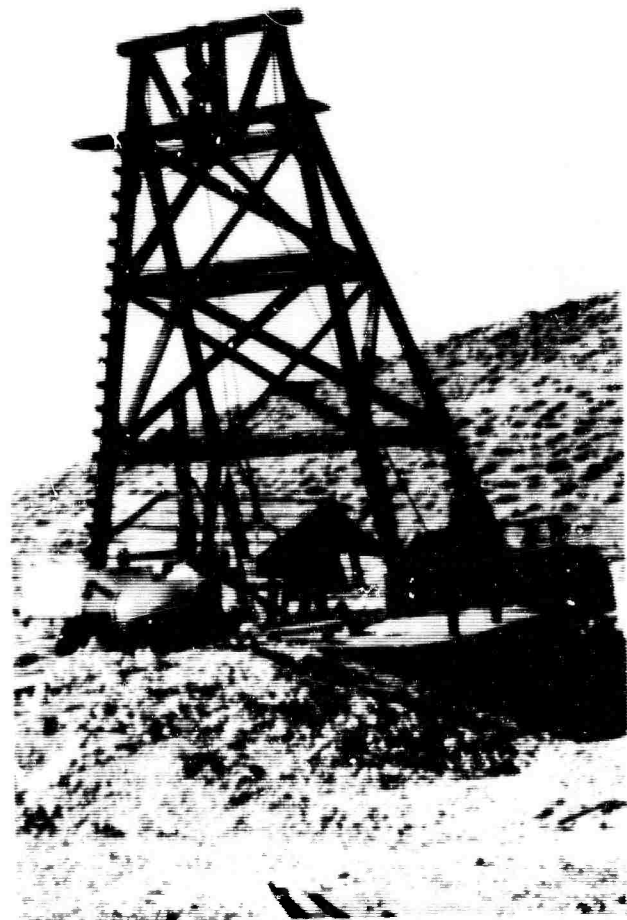
Photo No. 22-1

- 22-1 Headframe (See photo 22-1) Wooden headframe structure. Platform is warped and split. No damage was noted as a result of the postshot survey.
- 22-2 Shed (See photo 22-2) This wooden shed is 12 x 12 feet. Roof is caved in. Outer boards are weathered and warped and some missing. Doors and windows are missing. No damage was noted as a result of the postshot survey.
- 22-3 Shed (See photo 22-3) This shed is a 10 x 50-foot dilapidated wood structure. Walls are leaning and roof has sagged. Roofing, doors, windows and siding, in part, are missing. No damage was noted as a result of the postshot survey.
