# VELA UNIFORM PROJECT **SHOAL**

**PRESHOT AND POSTSHOT STRUCTURE SURVEY**  
Holmes & Narver, Inc.

December 1963

# **PRESHOT AND POSTSHOT STRUCTURE SURVEY**

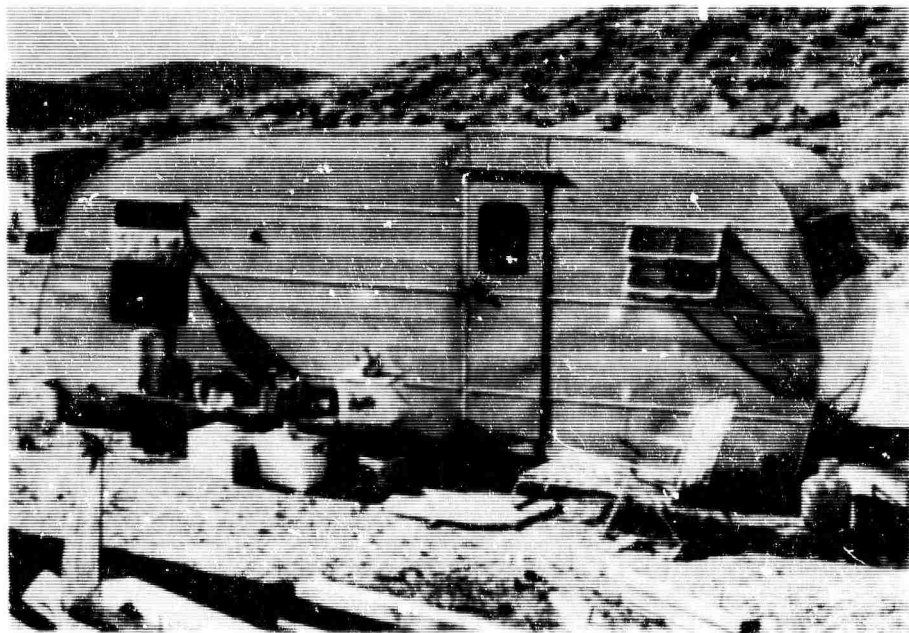
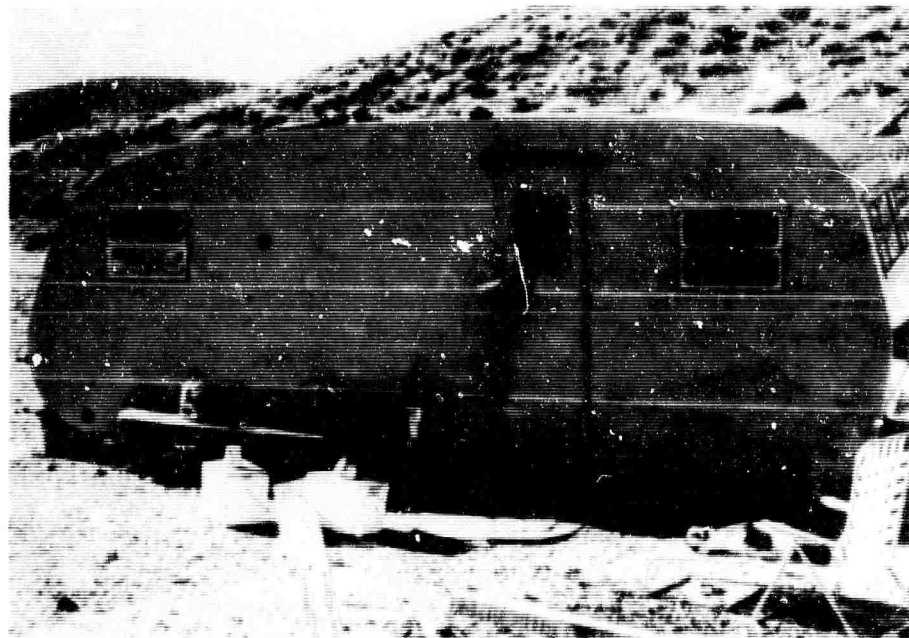
Photo No. 22-4 - Preshot - October 3, 1963

- 22-4 Trailer (See photo 22-4) This is a 20-foot metal covered trailer. No damage was noted as a result of the postshot survey.
- 22-5 Trailer (See photo 22-5) This 8 x 22-foot metal covered trailer was in good condition at the time of the preshot visit, October 3, 1963, but was entirely destroyed by fire prior to the postshot visit on October 31, 1963. According to the lessees, Jim and Tony Trease, destruction of the trailer occurred during the weekend of October 19, and was not in any way associated with the Shoal Event.

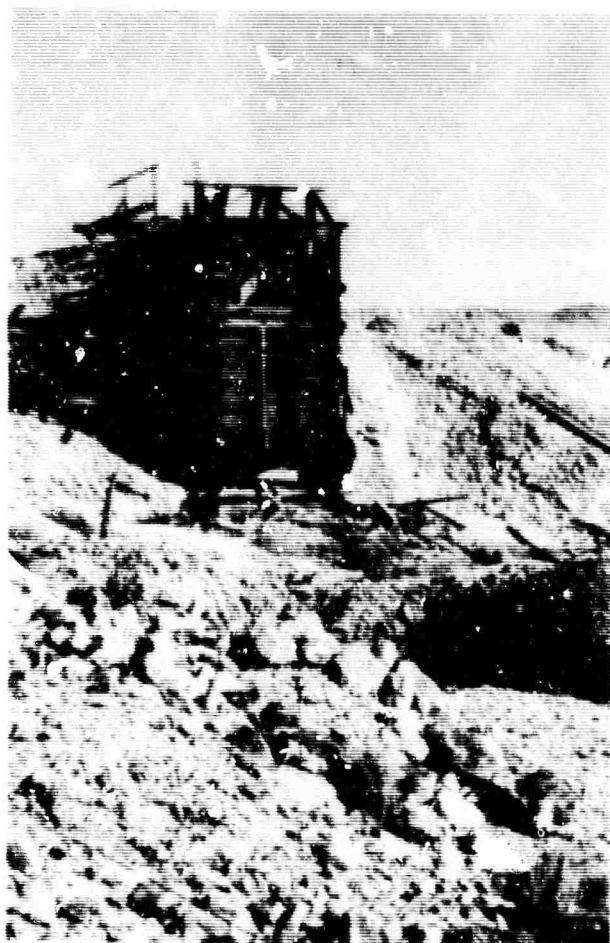
Photo No. 22-6

- 22-6 Bin (See photo 22-6) Wood, loading structure. No damage was noted as a result of the postshot survey.
- 22-7 Outhouse (See photo 22-7) This 4 x 4-foot wooden outhouse is weathered but intact. No damage was noted as a result of the postshot survey.

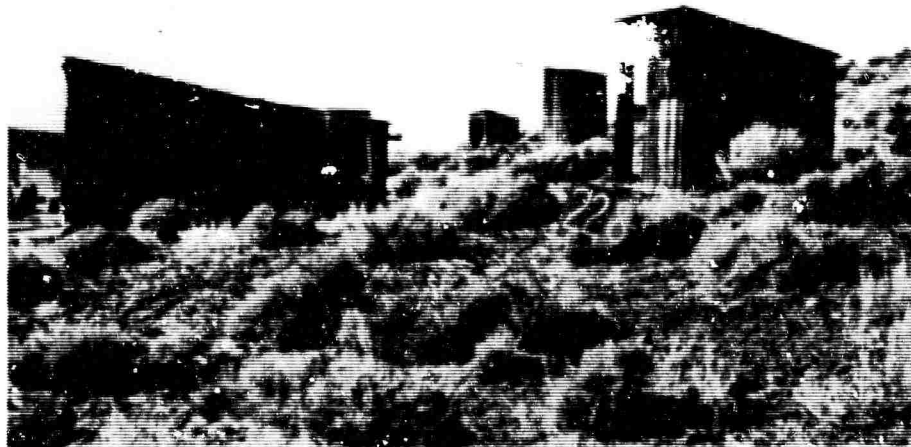
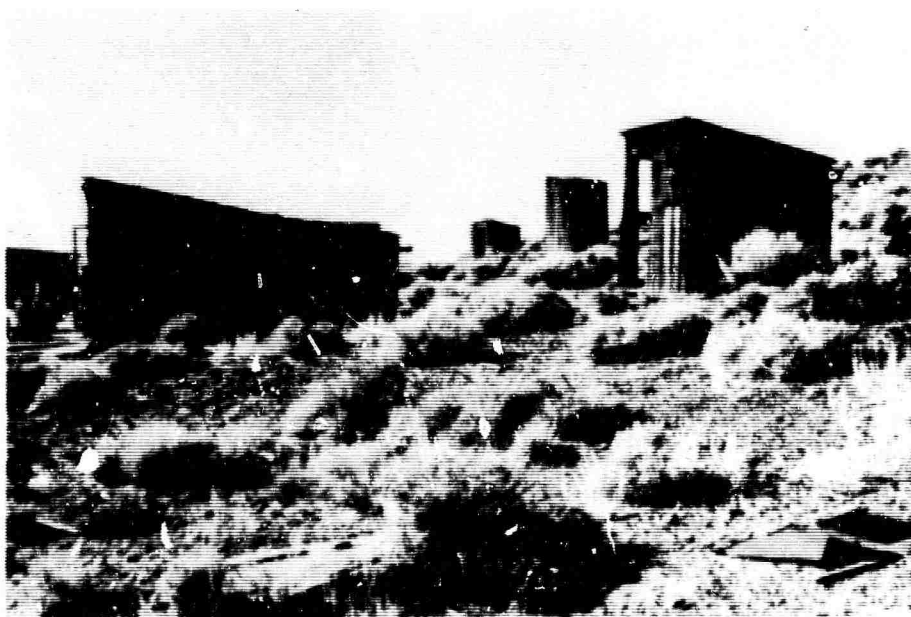
Photo No. 22-8 - Preshot - October 3, 1963

- 22-8 Shed (See photo 22-8) This 6 x 10-foot unoccupied wooden shed is in poor condition. Weathered and warped. Doors and windows missing. No damage was noted as a result of the postshot survey.

- 22-9 House (See photo 22-8) This 20 x 50-foot wood structure is partly occupied. In poor condition, with some doors and windows missing. No damage was noted as a result of the postshot survey.

- 22-10 Outhouse (See photo 22-8) This 3 x 5-foot outhouse is usable but weathered and warped. No damage was noted as a result of the postshot survey.
- 22-11 Outhouse (See photo 22-8) This 3 x 5-foot outhouse is leaning, weathered, and warped. Door missing. No damage was noted as a result of the postshot survey.

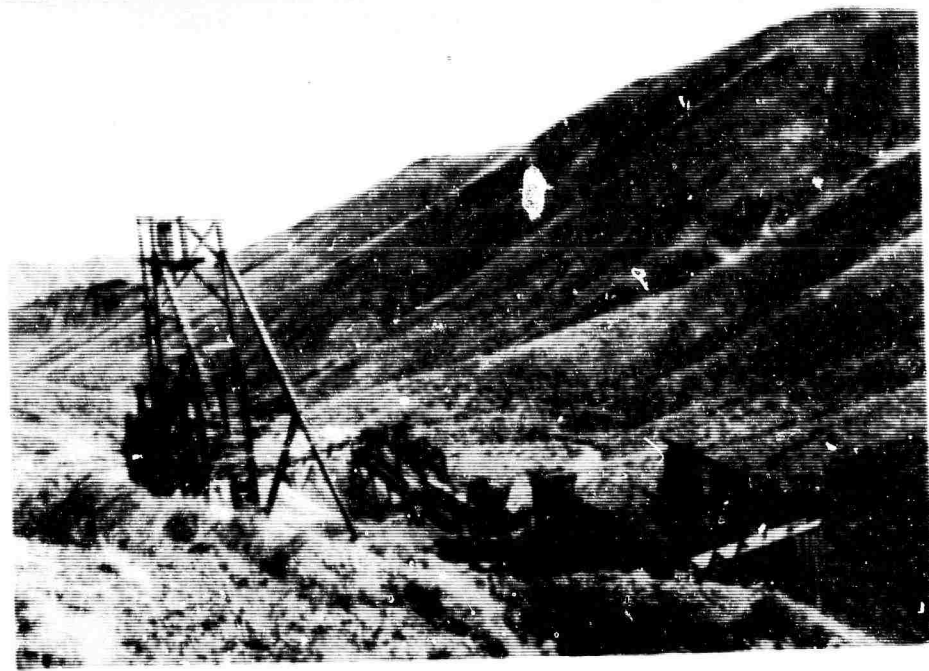
Photo No. 23-1 - Preshot - October 2, 1963

- 23-1 Headframe (See photo 23-1) Wood headframe, tramway, and ore bin. Weather-beaten and abandoned. Hoist house structure with roof missing. Siding warped and missing, and doors and windows missing. No damage was noted as a result of the postshot survey.
- 23-2 Shack (See photo 23-2) This 20 x 20-foot shack is wood frame and siding with corrugated metal roof. Siding weathered and warped. Doors and windows missing. No damage was noted as a result of the postshot survey.
- 23-3 House (See photo 23-3) This 20 x 36-foot house is wood frame and siding with corrugated metal roof. Siding weathered and warped. Doors and windows missing. No damage was noted as a result of the postshot survey.
- 23-4 Headframe and Ore Bins (See photo 23-4) Headframe, tramway, and ore bins all of wood construction, all weathered. No damage was noted as a result of the postshot survey.

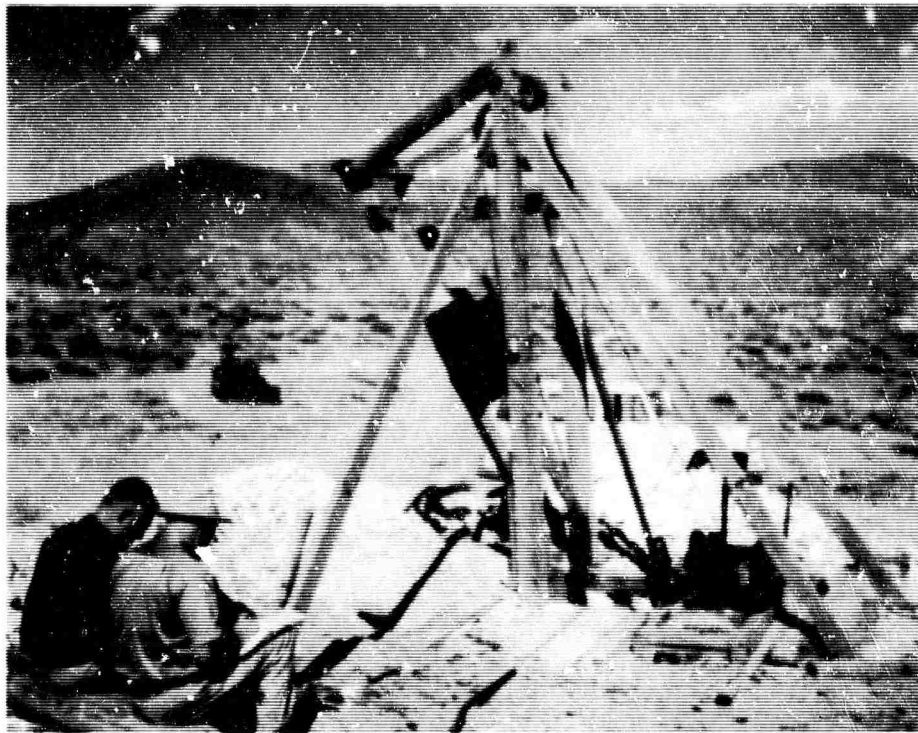
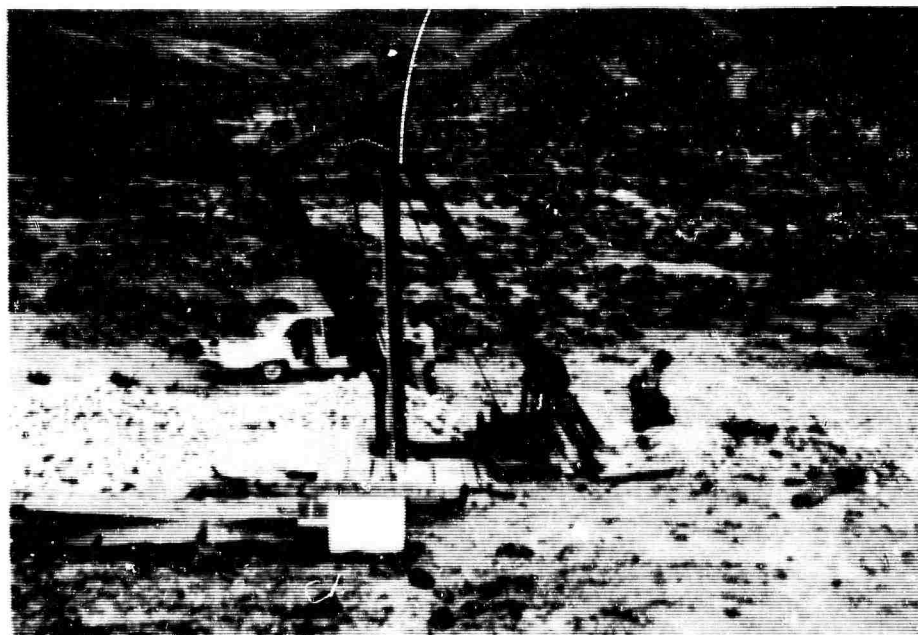
Photo No. 24-1 - Preshot - October 2, 1963

- 24-1 Headframe (See photo 24-1) Wood prospect headframe is the only structure on this site. No damage was noted as a result of the postshot survey.

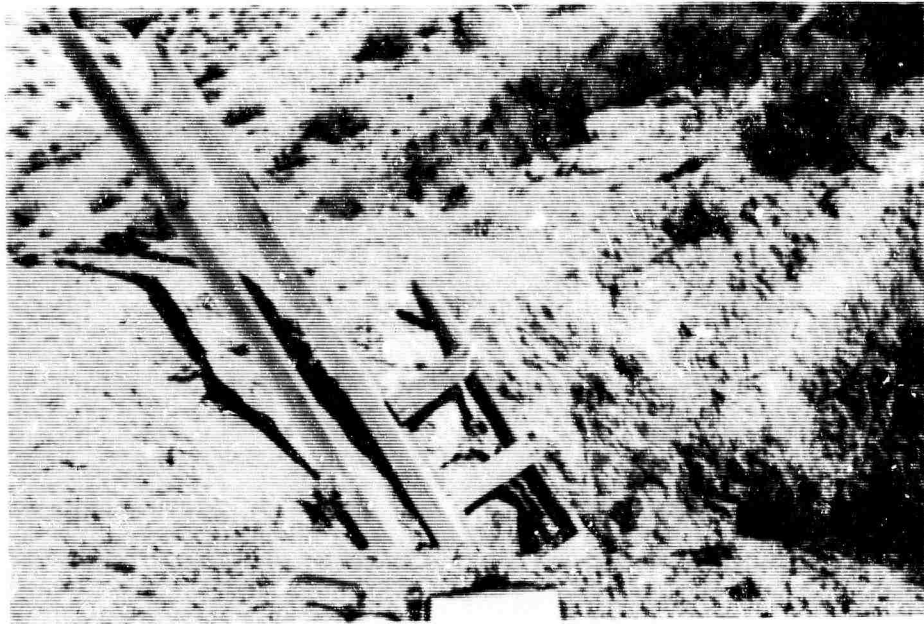
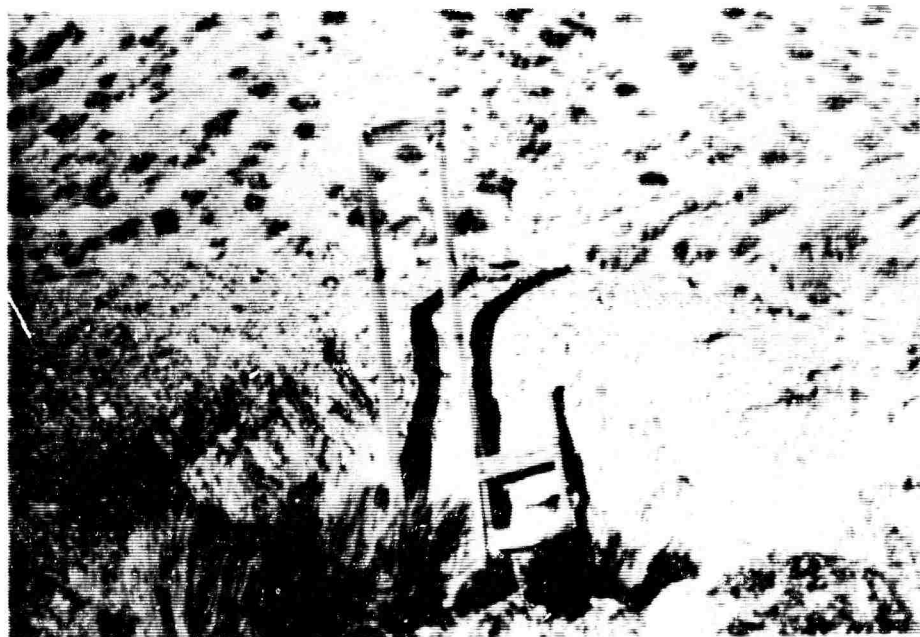
Photo No. 25-1 - Preshot - October 1, 1963

- 25-1 Ladder (See photo 25-1) No structures except ladder at this location. No damage was noted as a result of the postshot survey.

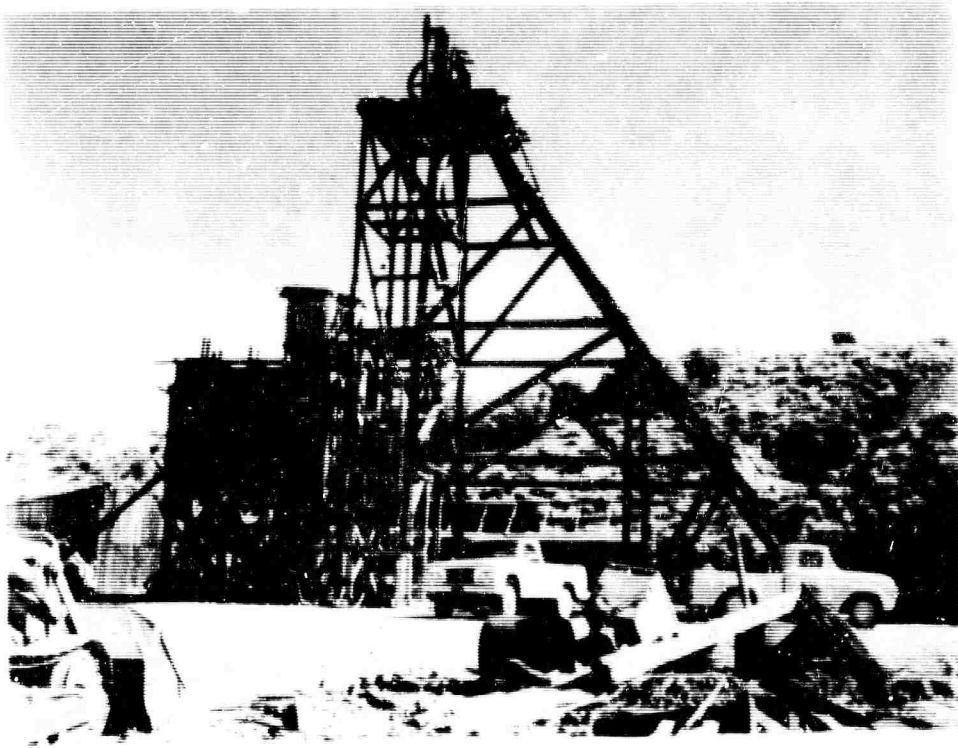
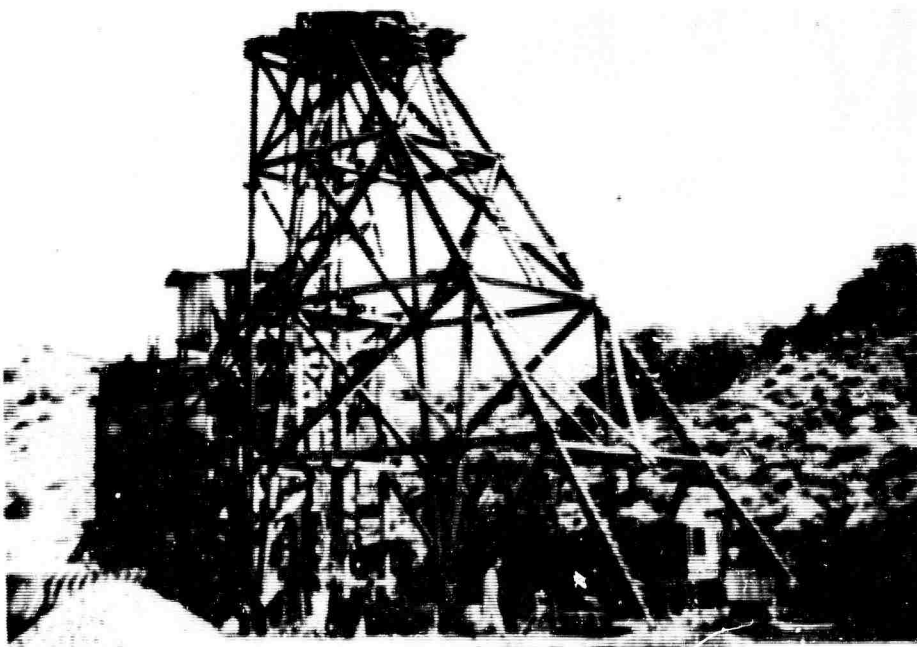
Photo No. 26-1 - Preshot - October 10, 1963

- 26-1 Headframe (See photo 26-1) Wood headframe structure. No damage was noted as a result of the postshot survey.
- 26-2 Shaft Collar (See photo 26-2) Wood shaft collar and base of headframe. No damage was noted as a result of the postshot survey.
- 26-3 Hoist House and Generator Building (See photo 26-3) Hoist house and generator buildings of wood frame and corrugated metal roofing and siding. Structures have some siding missing. No damage was noted as a result of the postshot survey.
- 26-4 Camp Buildings (See photo 26-4) Abandoned, dilapidated camp structures of wood construction. Doors and windows generally are missing. No damage was noted as a result of the postshot survey.

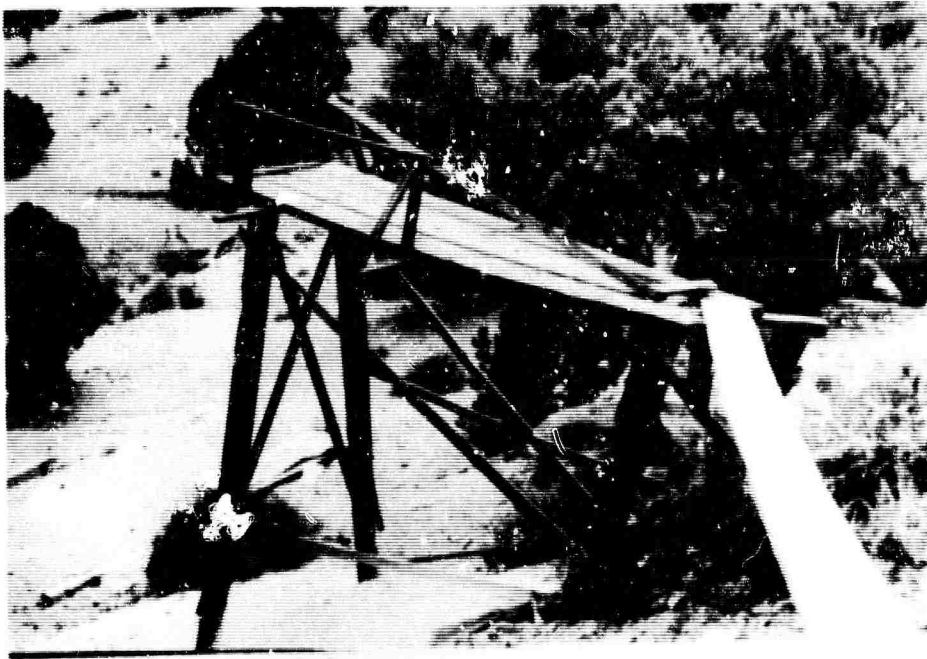
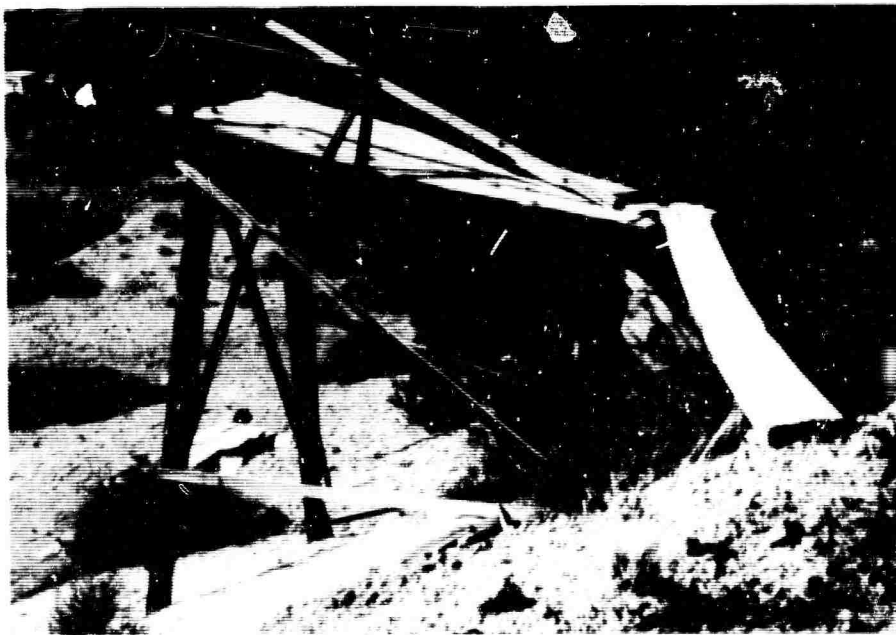
Photo No. 27-1 - Preshot - October 22, 1963

- 27-1 Trestle (See photo 27-1) Lower wooden trestle dilapidated. No damage was noted as a result of the postshot survey.
- 27-2 Trestle (See photo 27-2) Upper wooden trestle dilapidated. No damage was noted as a result of the postshot survey.
- 27-3 Blacksmith Shop (See photo 27-3) This is a 12 x 12-foot corrugated metal covered wood frame structure. No damage was noted as a result of the postshot survey.
