OPERATION PLUMBBOB

EVALUATION OF BURIED CORRUGATED-STEEL ARCH
STRUCTURES AND ASSOCIATED COMPONENTS

Issuance Date: February 22, 1961

OPERATION PLUMBBOB—PROJECT 3.3

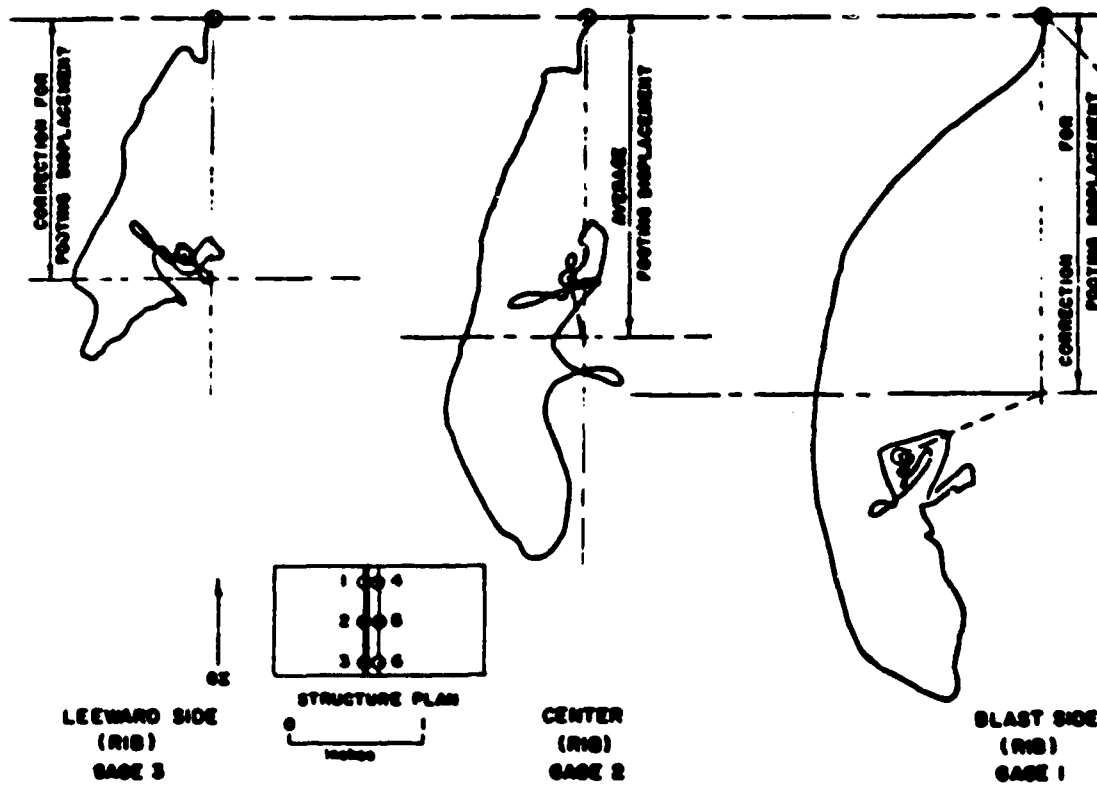
Figure 2.28 Deflection records at rib, Structure 3.3a.

The arch-deflection data given in Table 2.4 has been taken from scratch-gage records. Full-scale scratch-gage traces are given in Figures 2.28 through 2.32.

are shown in Figures 2.28 through 2.32. A horizontal and a vertical line are drawn through the initial point. Another horizontal line is drawn a distance below the initial scribe point equal to the correction for residual footing displacement. The heavy dashed line indicates approximately the residual deflection of the point on the arch due only to arch flexure, arch compression, and arch-joint slippage.
