THE GREAT ALASKA EARTHQUAKE

Volume II

Illustrations and Maps

TECHNICAL REPORT NO. AFWL-TR-65-92, Vol II

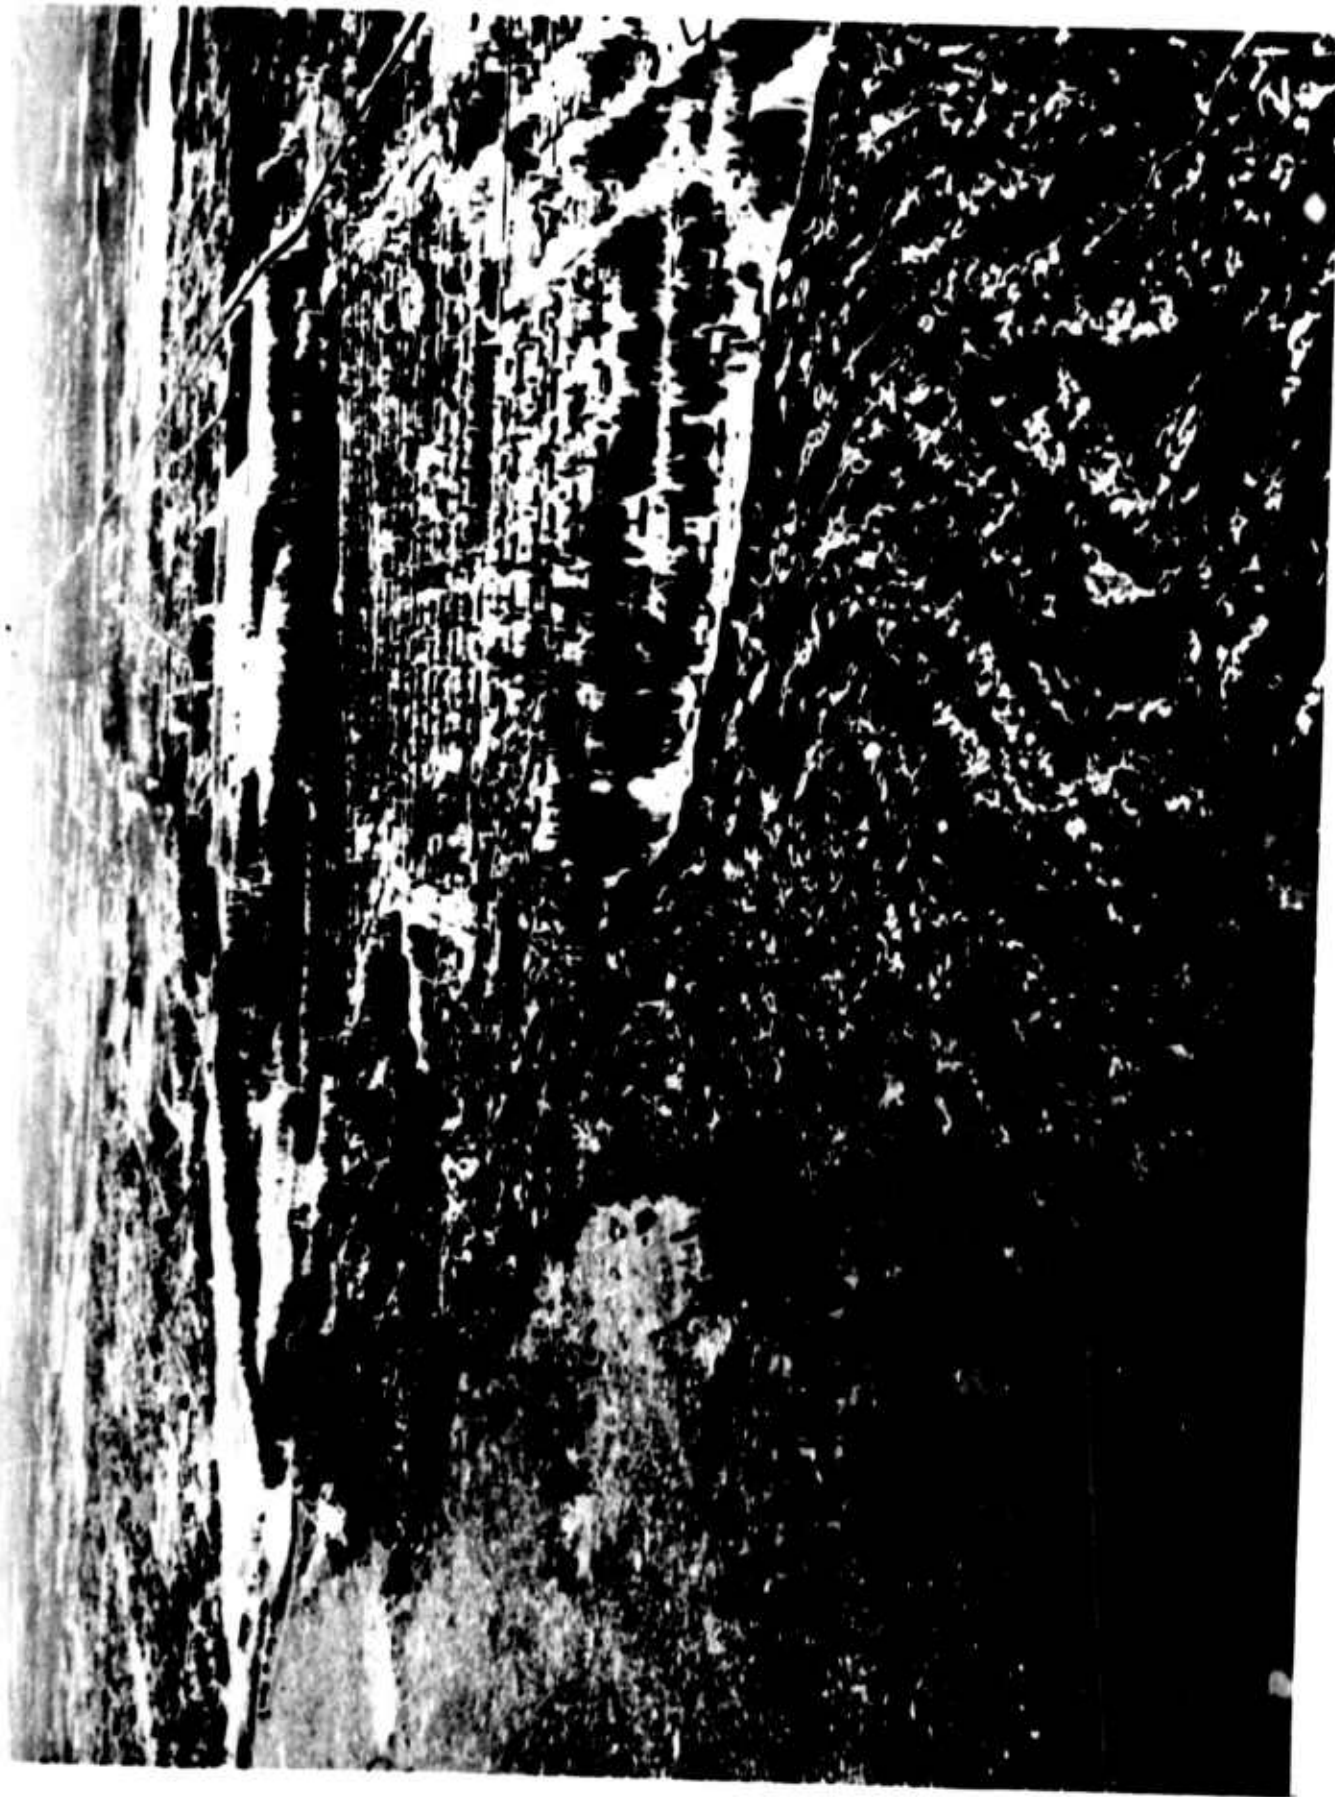
Figure 45. Turnagain Slide (Toe of the east end of the slide, eroded by tidal action)

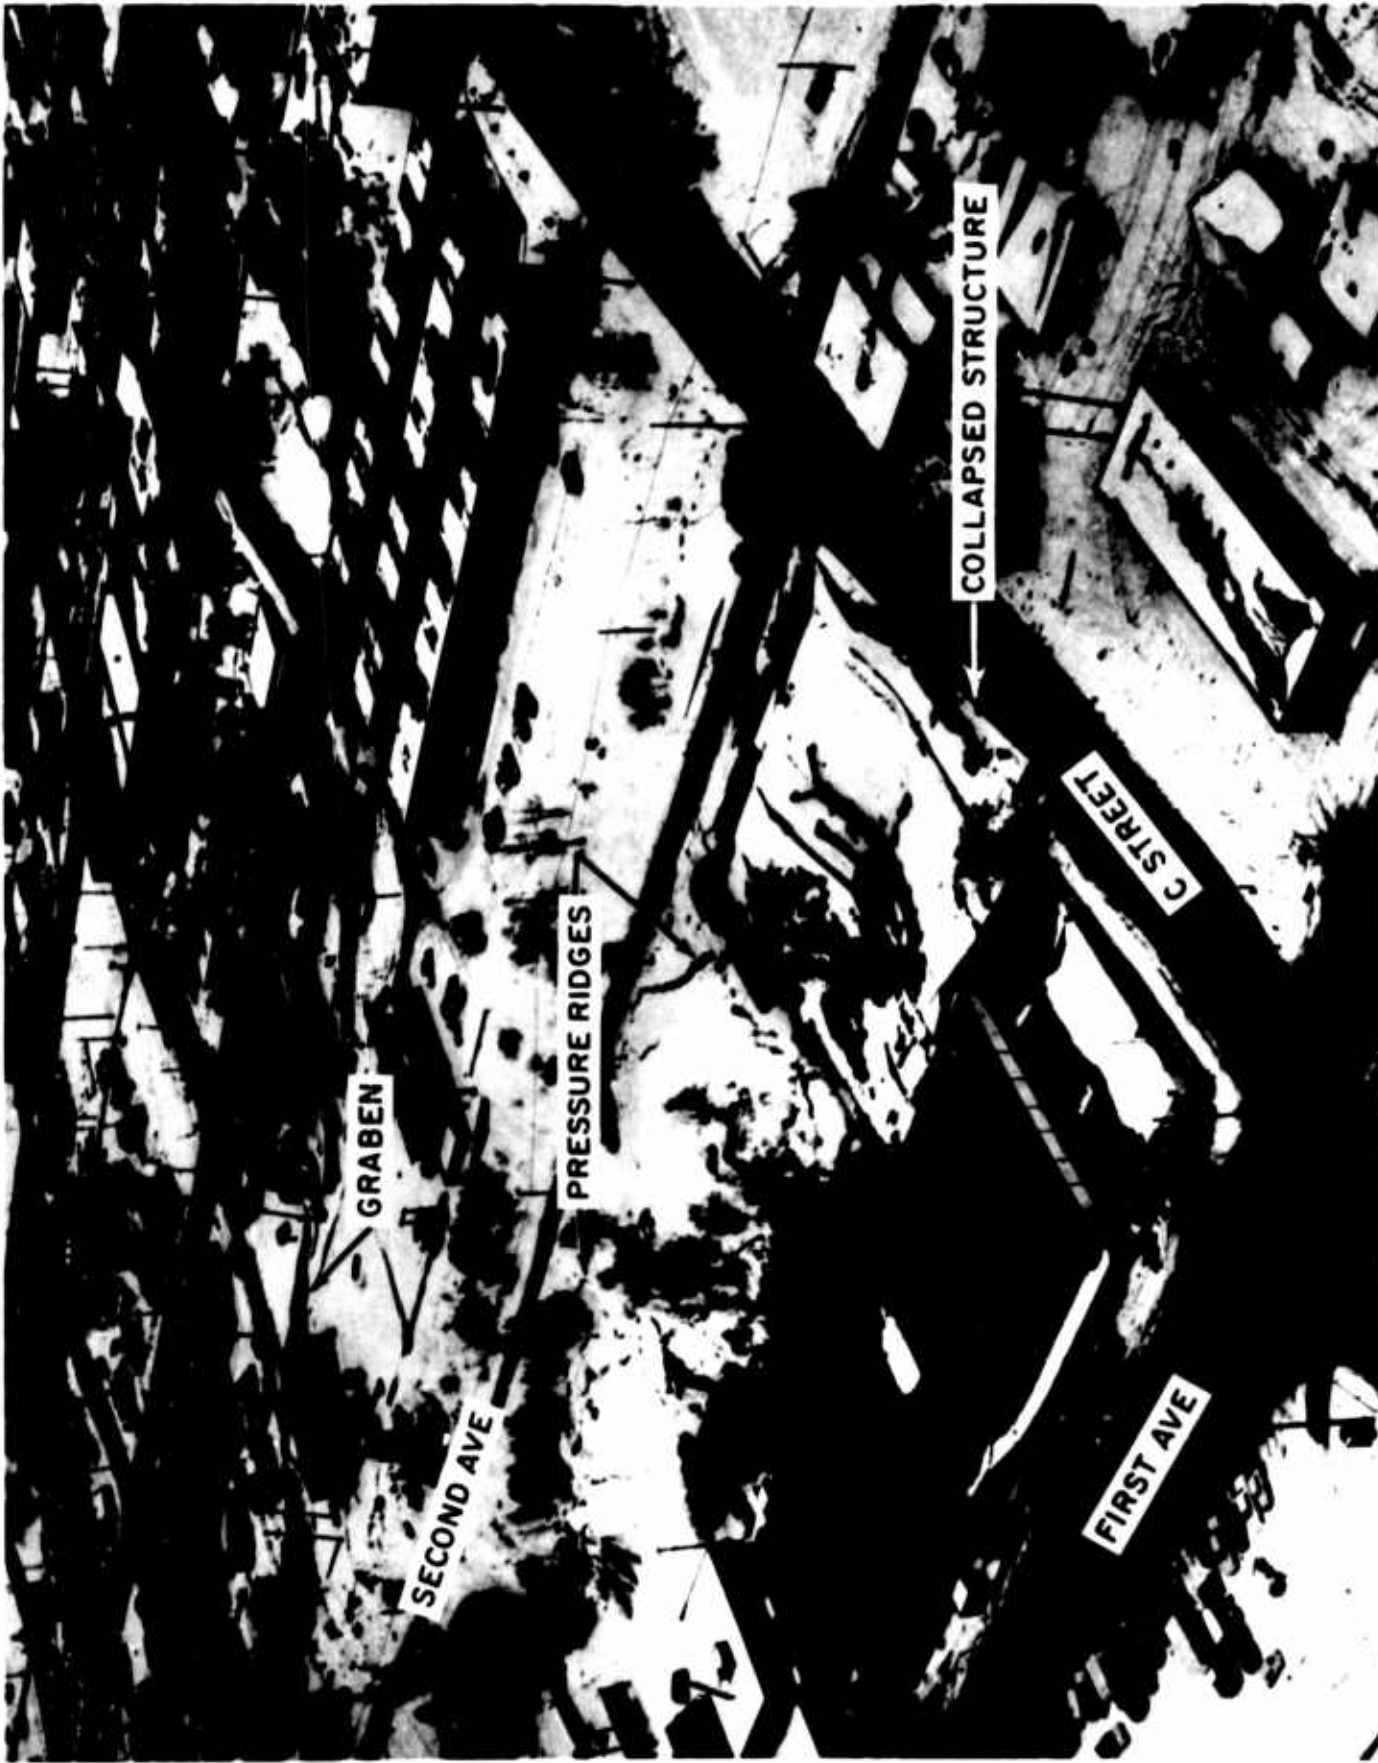
Figure 56. Fourth Avenue Slide
(Coca-Cola Bottling Company and Anchorage Cold Storage Company at First Avenue and C Street)

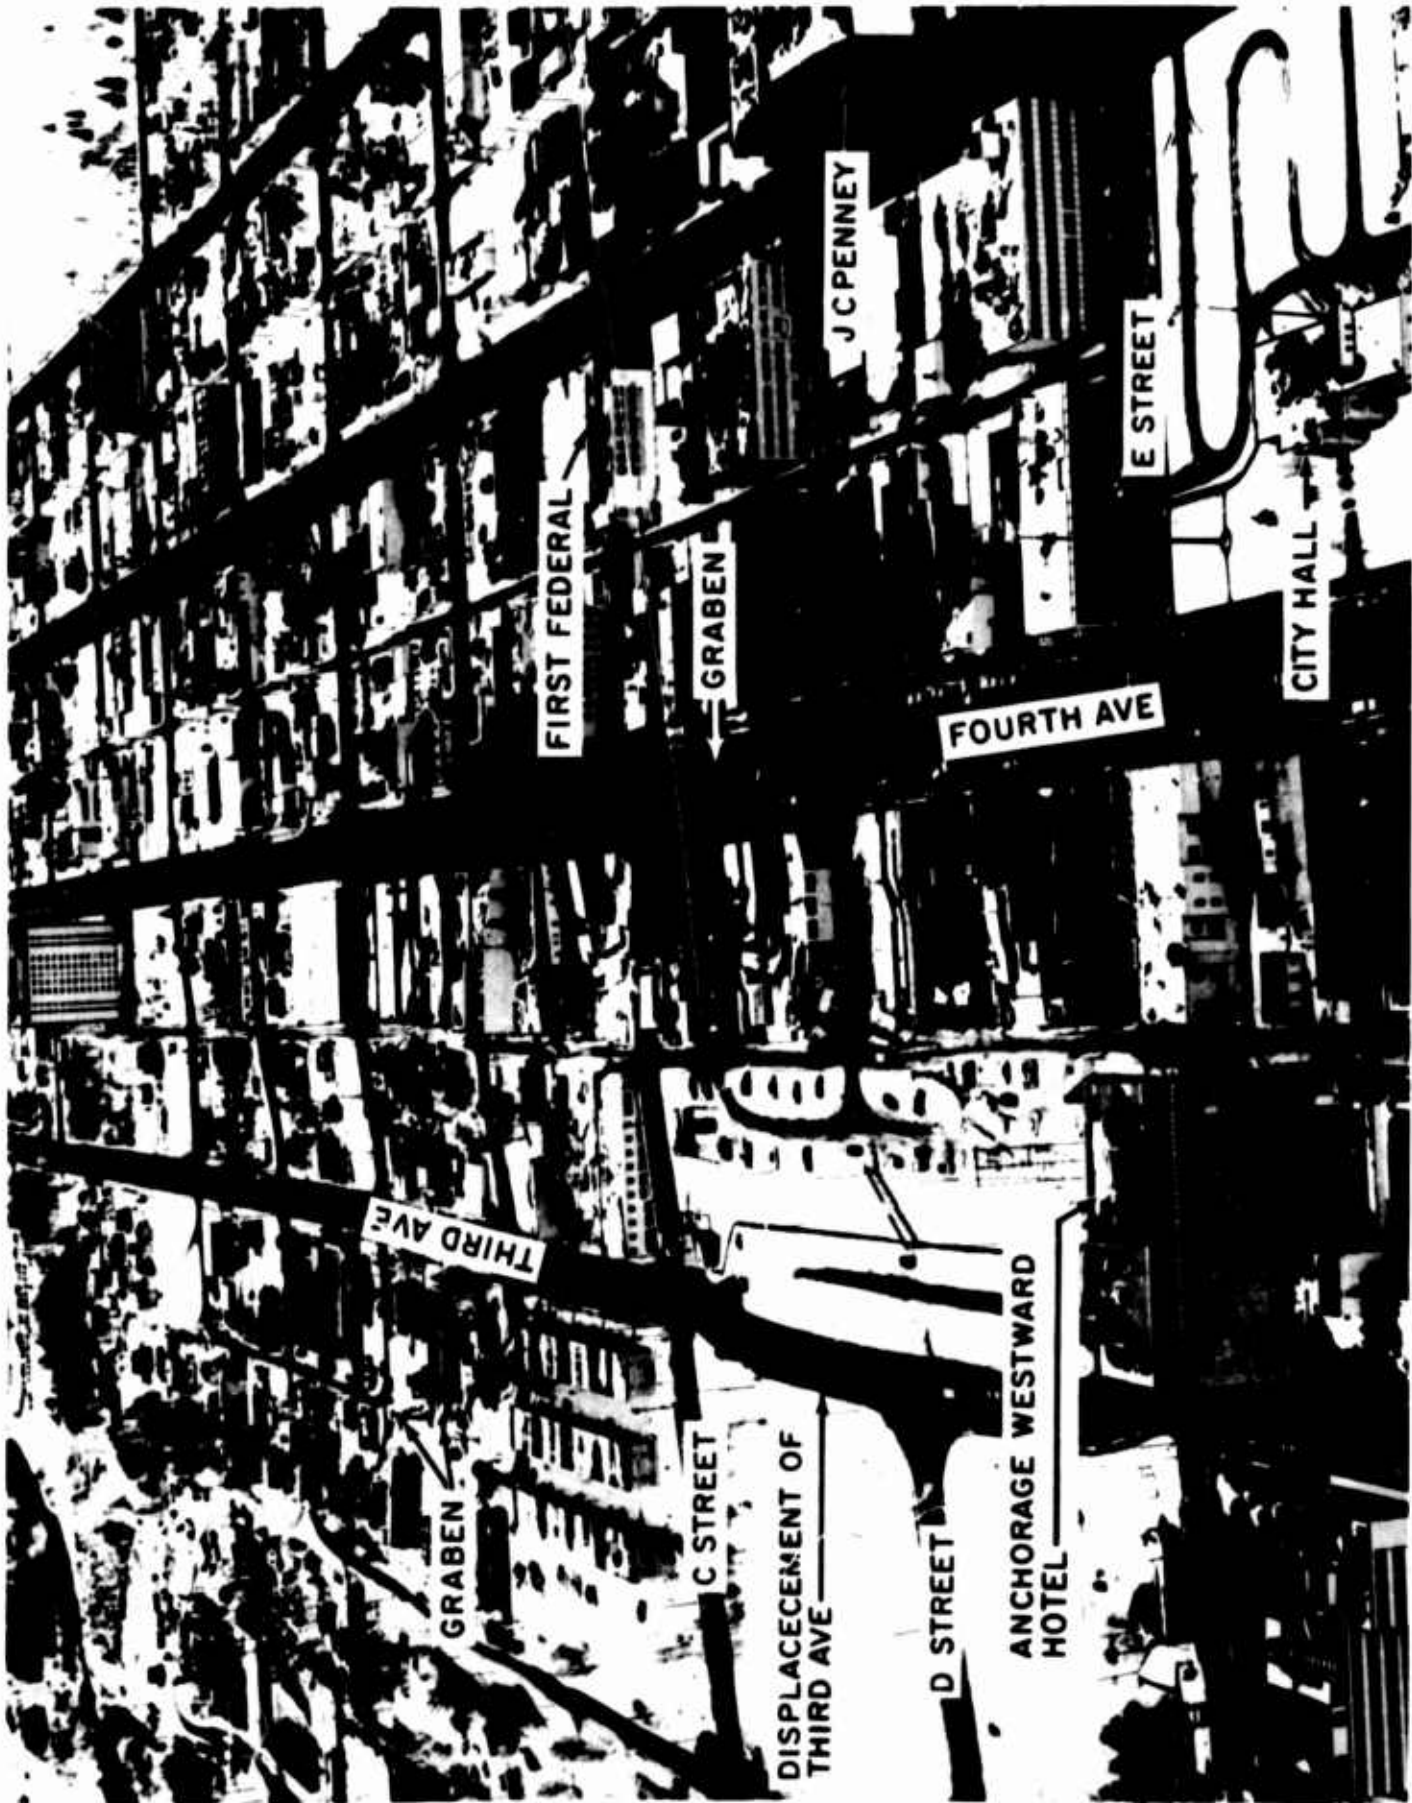
Figure 58. Fourth Avenue Slide
 (Aerial view of damage to commercial buildings on the north side of Fourth Avenue)

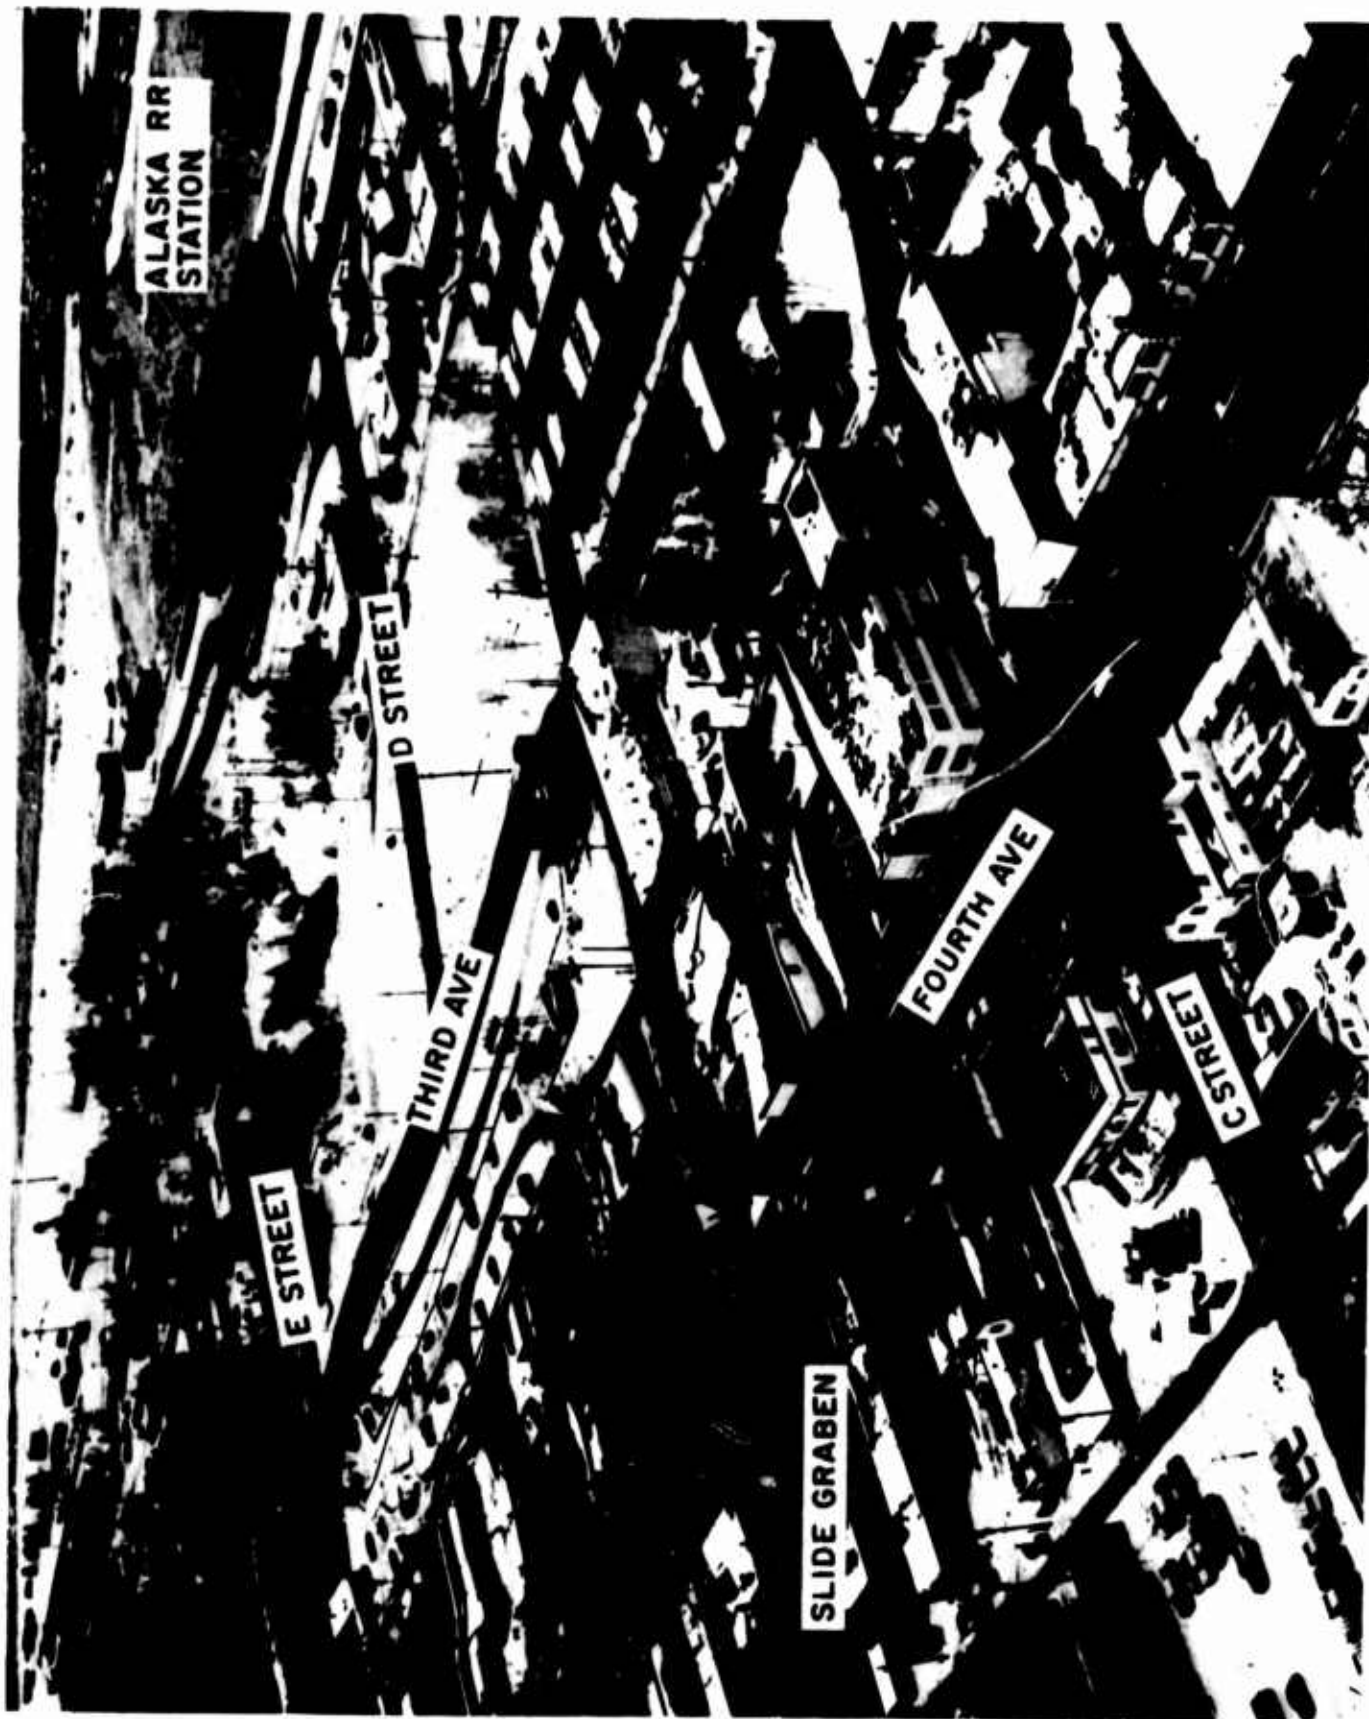
Figure 59. Fourth Avenue Slide
(Aerial View of damage to commercial buildings on the north side of Fourth Avenue)

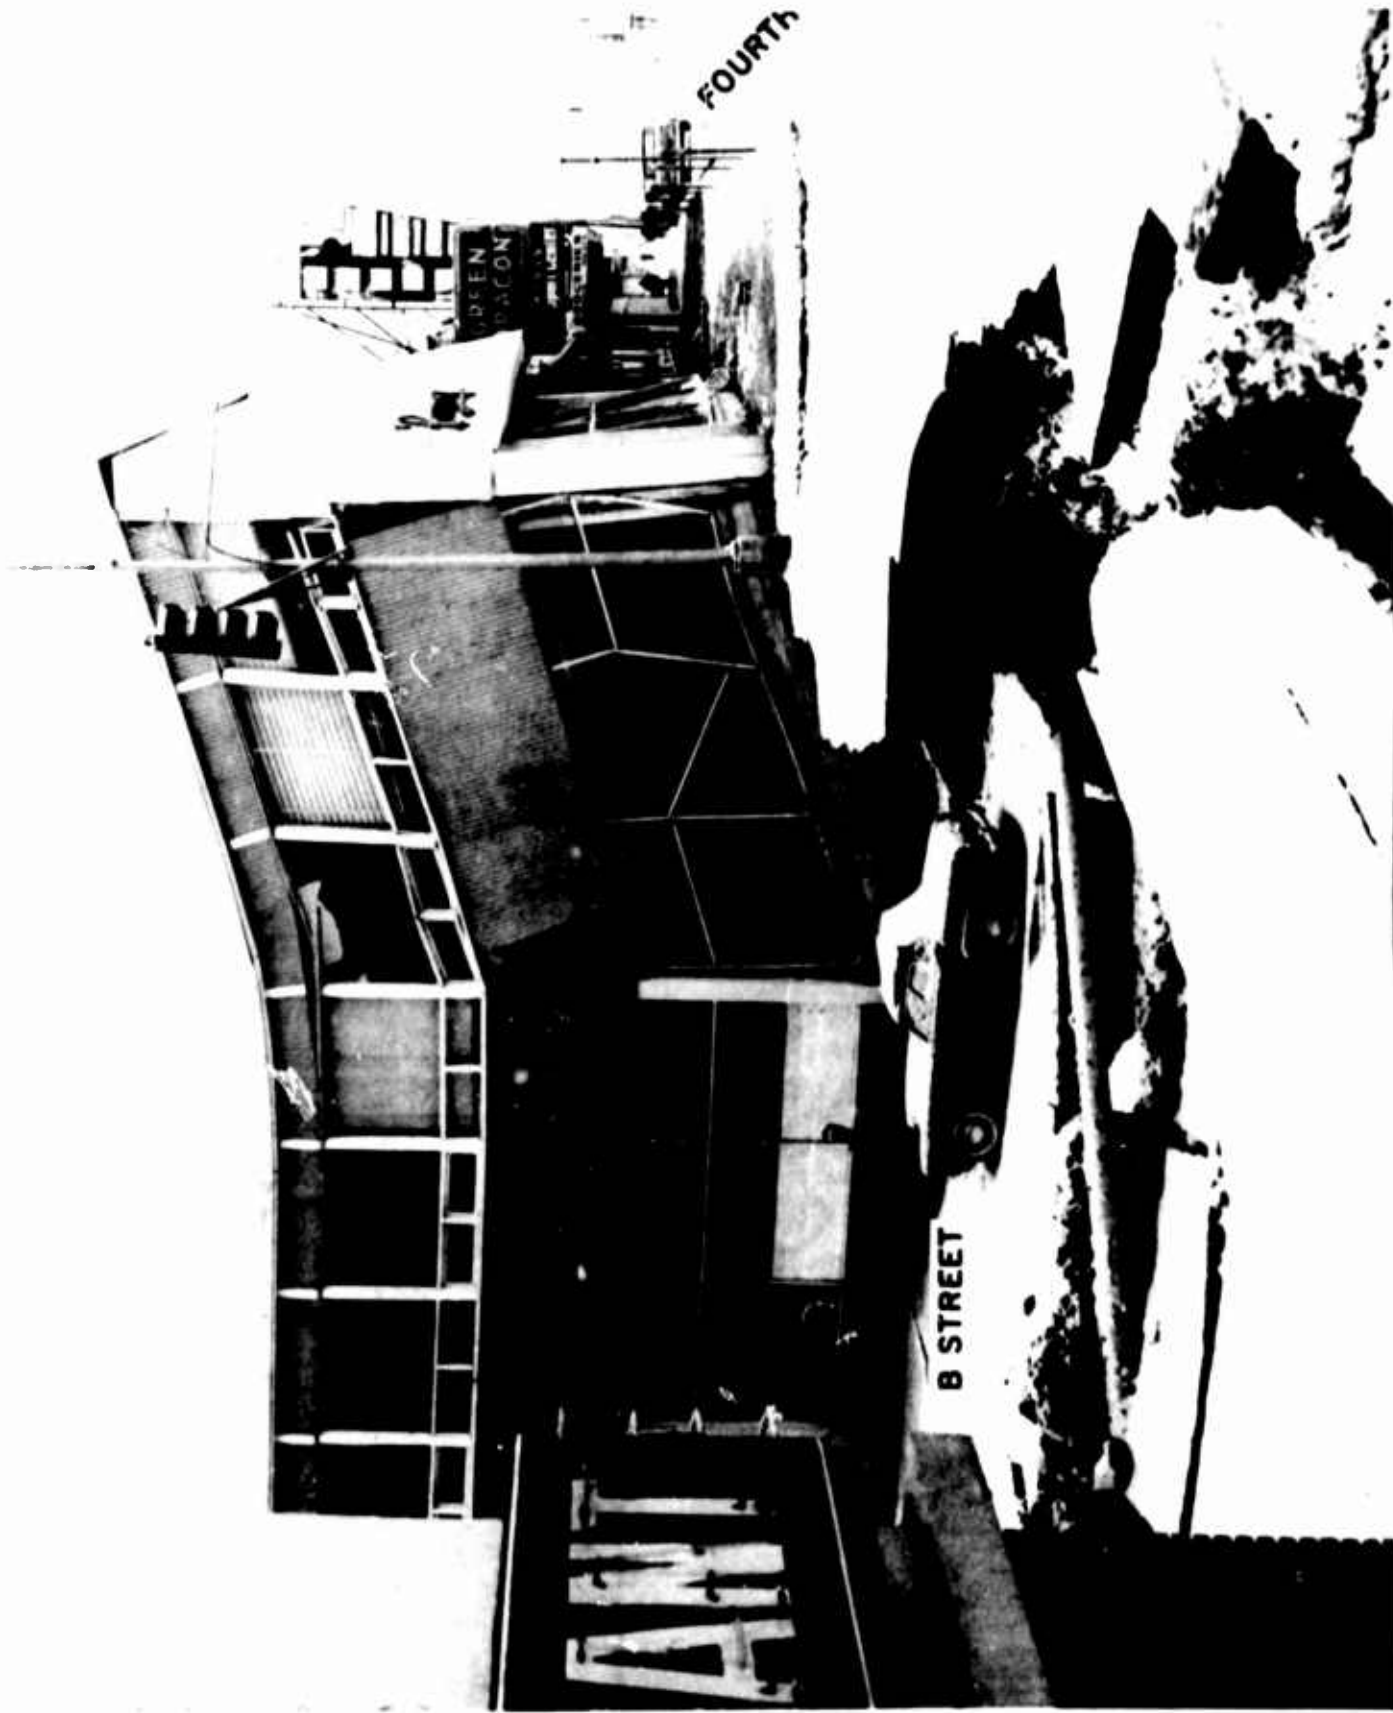
Figure 64. Fourth Avenue Slide (B Street and Fourth Avenue)

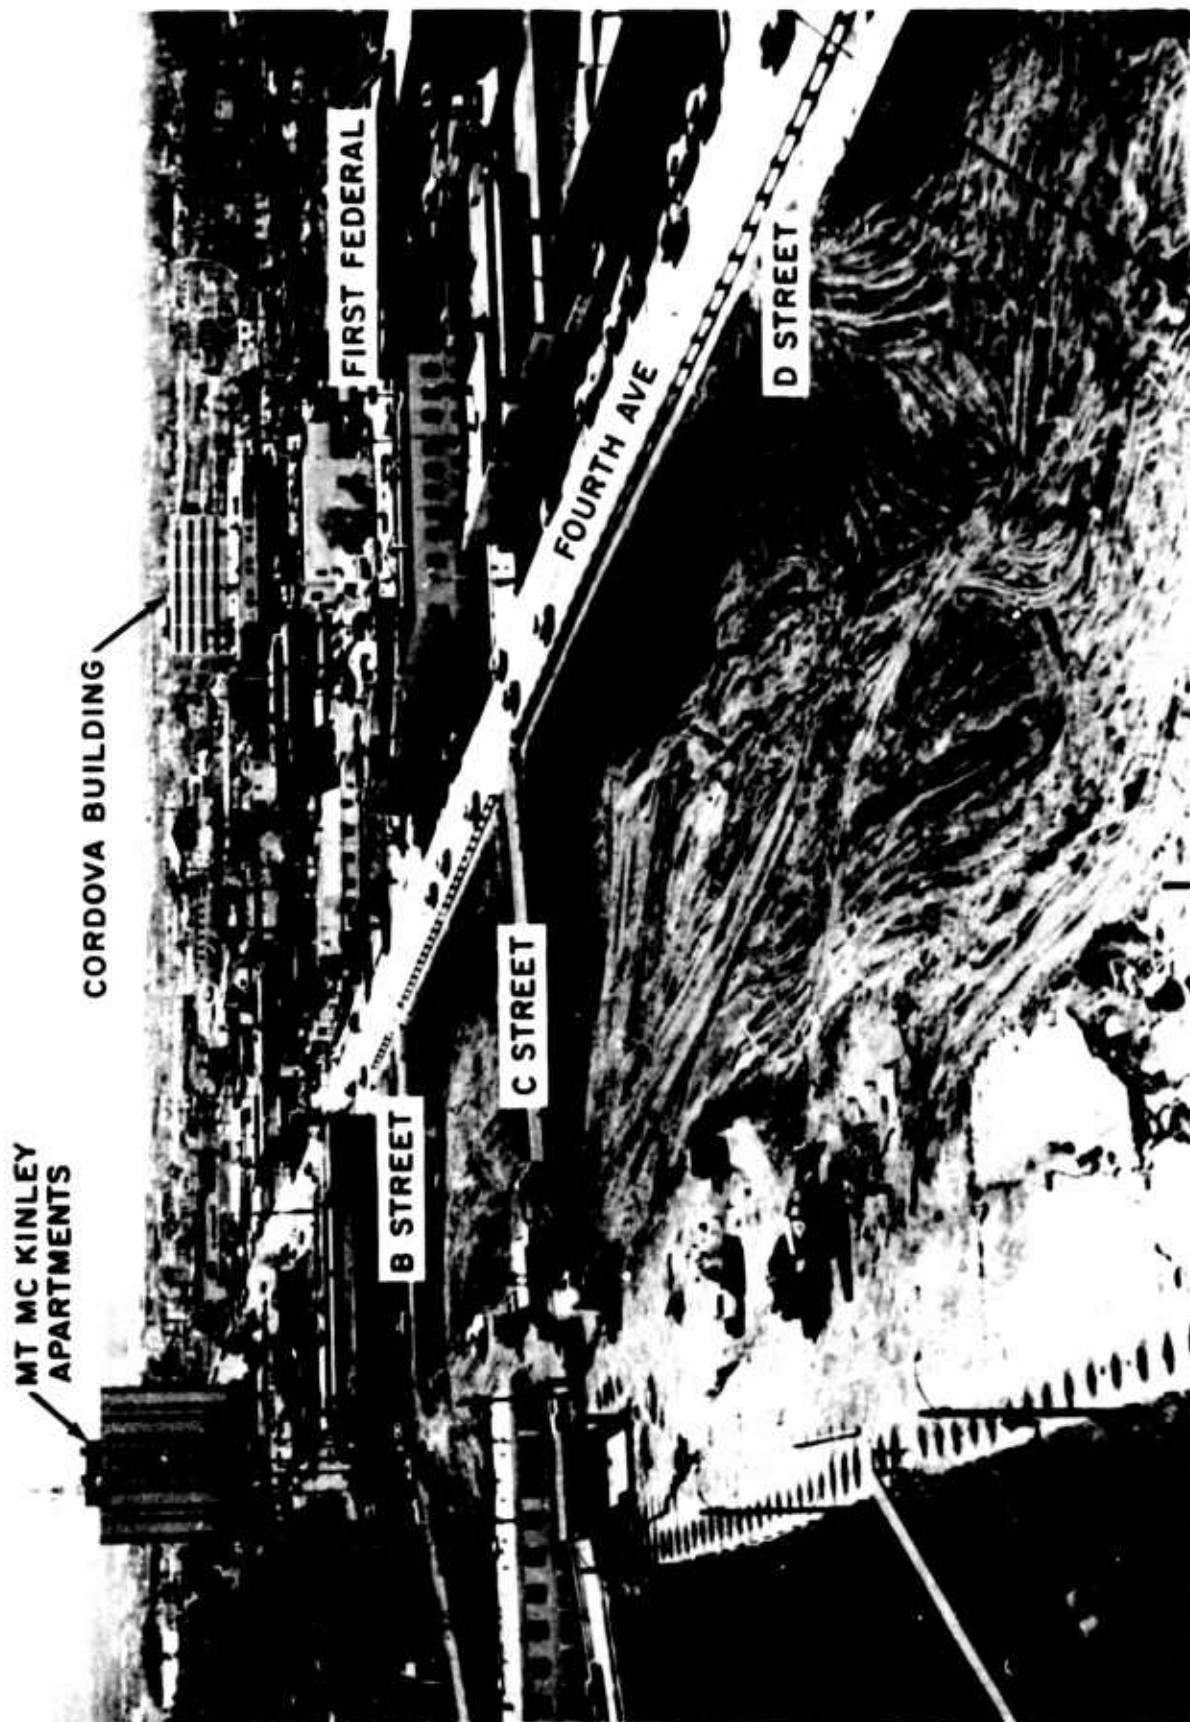
Figure 72. Fourth Avenue Slide (Fourth Avenue between B and D Streets after demolition)

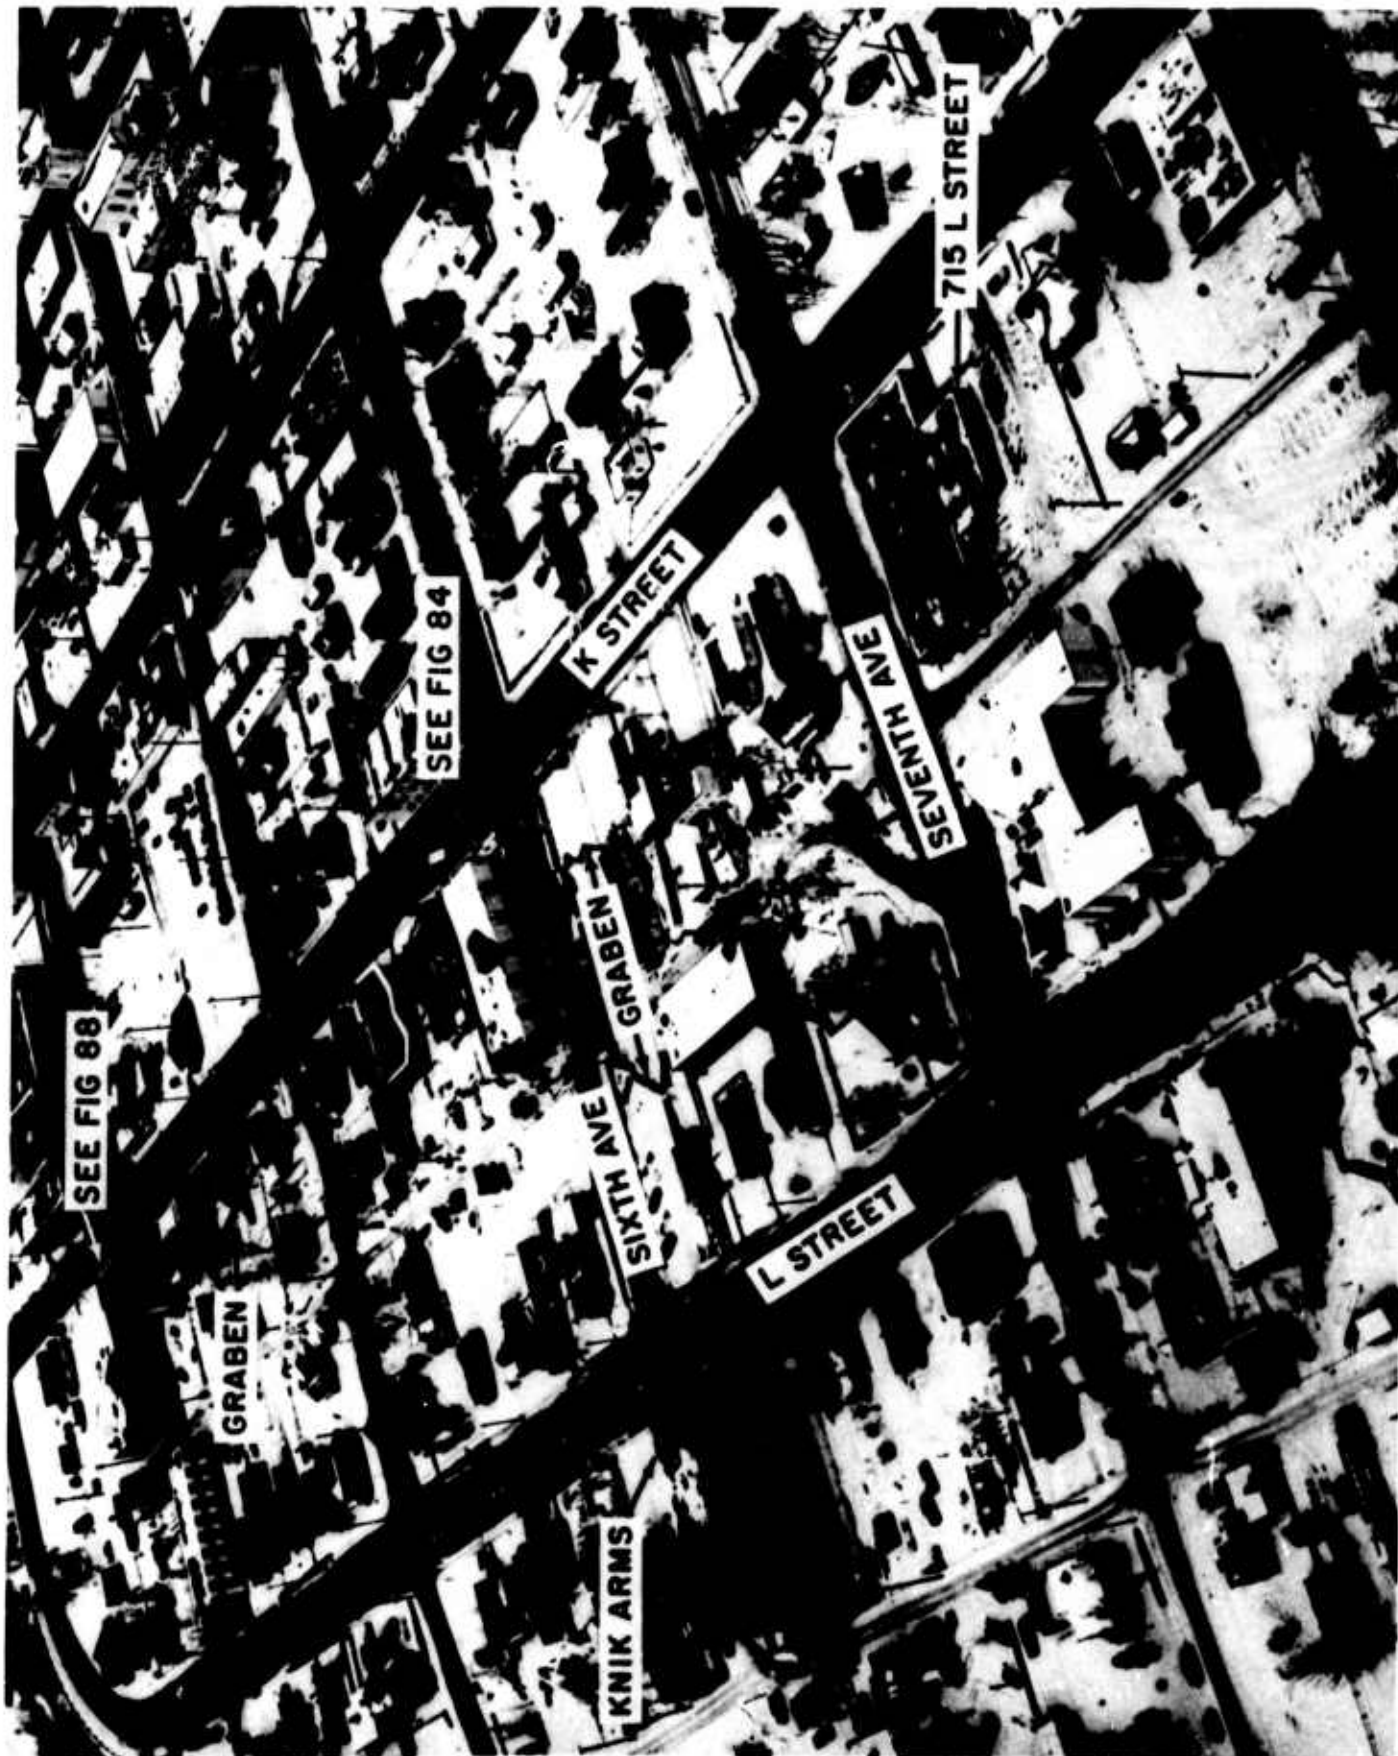
Figure 83. L Street Slide (Northern end of graben, paralleling K Street)

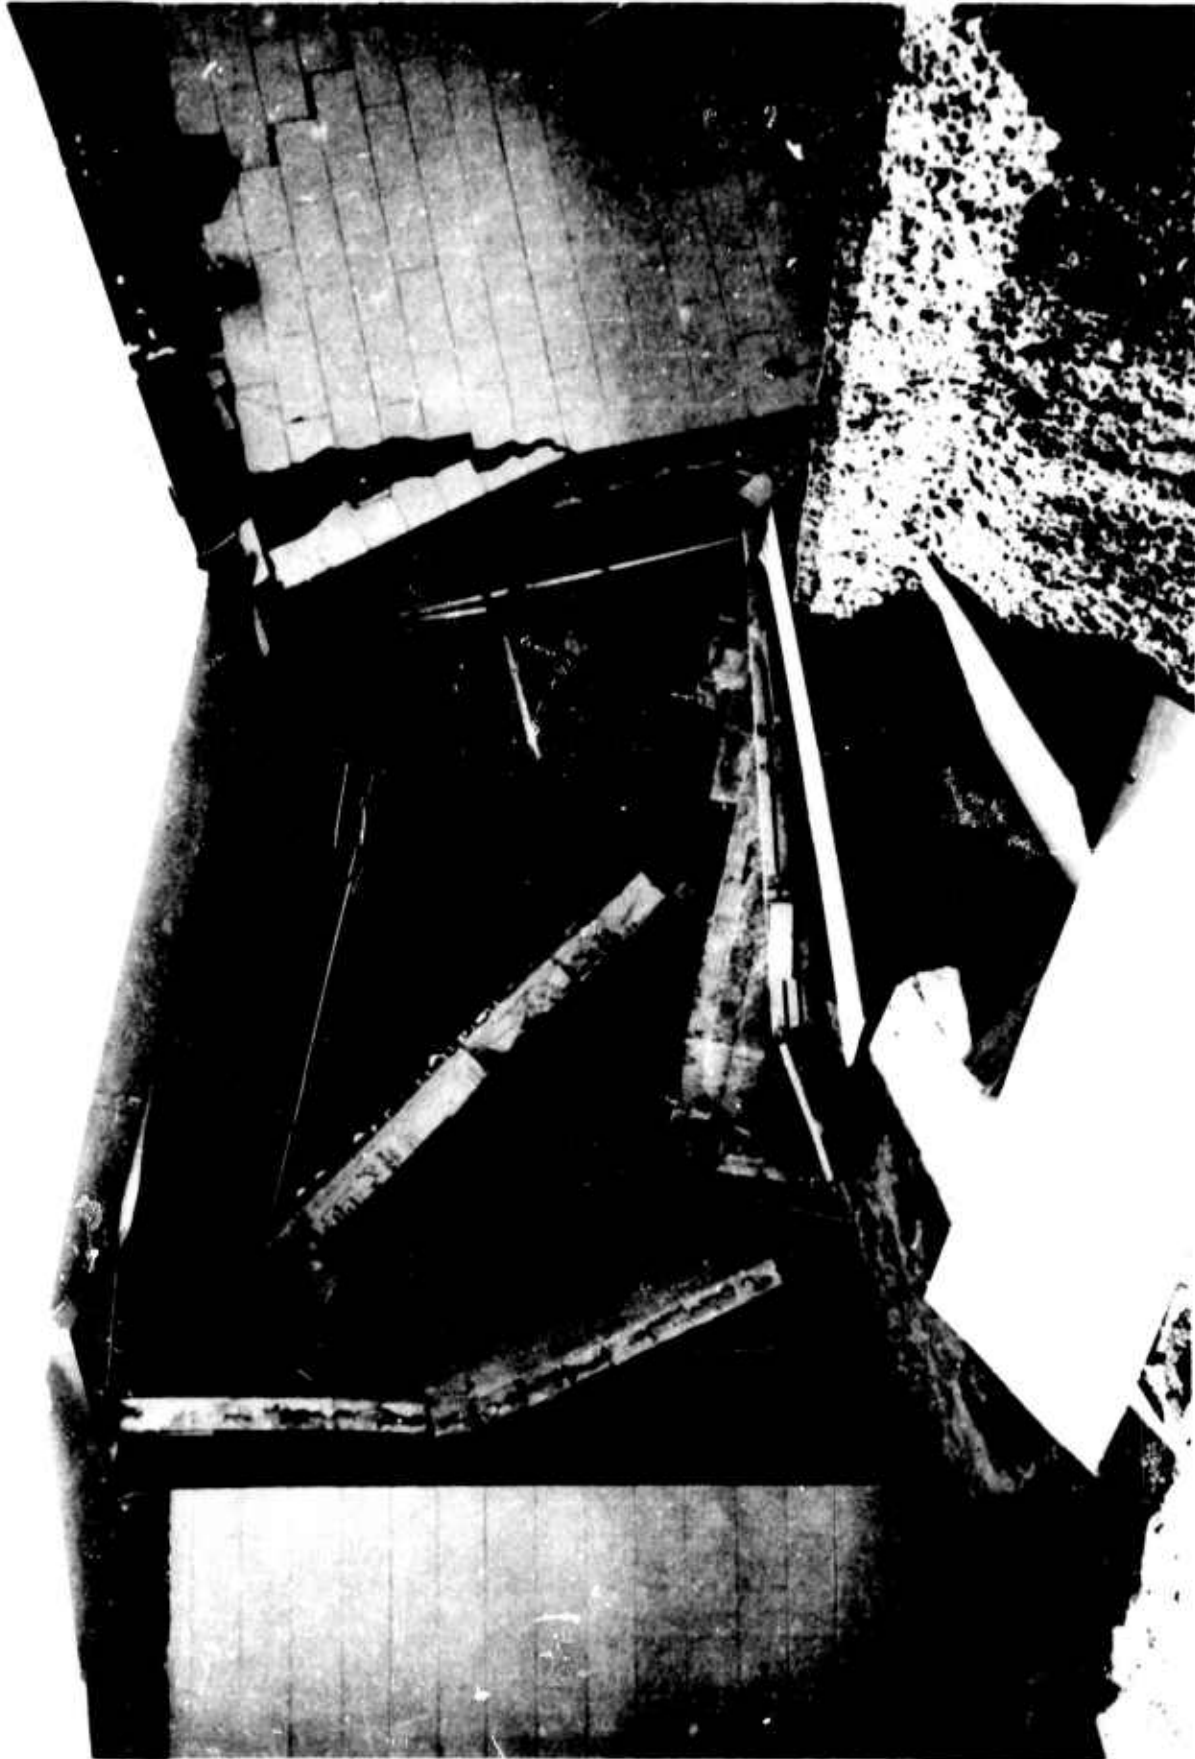
Figure 101. Government Hill Slide (Looking into the east-west corridor of the Government Hill school)

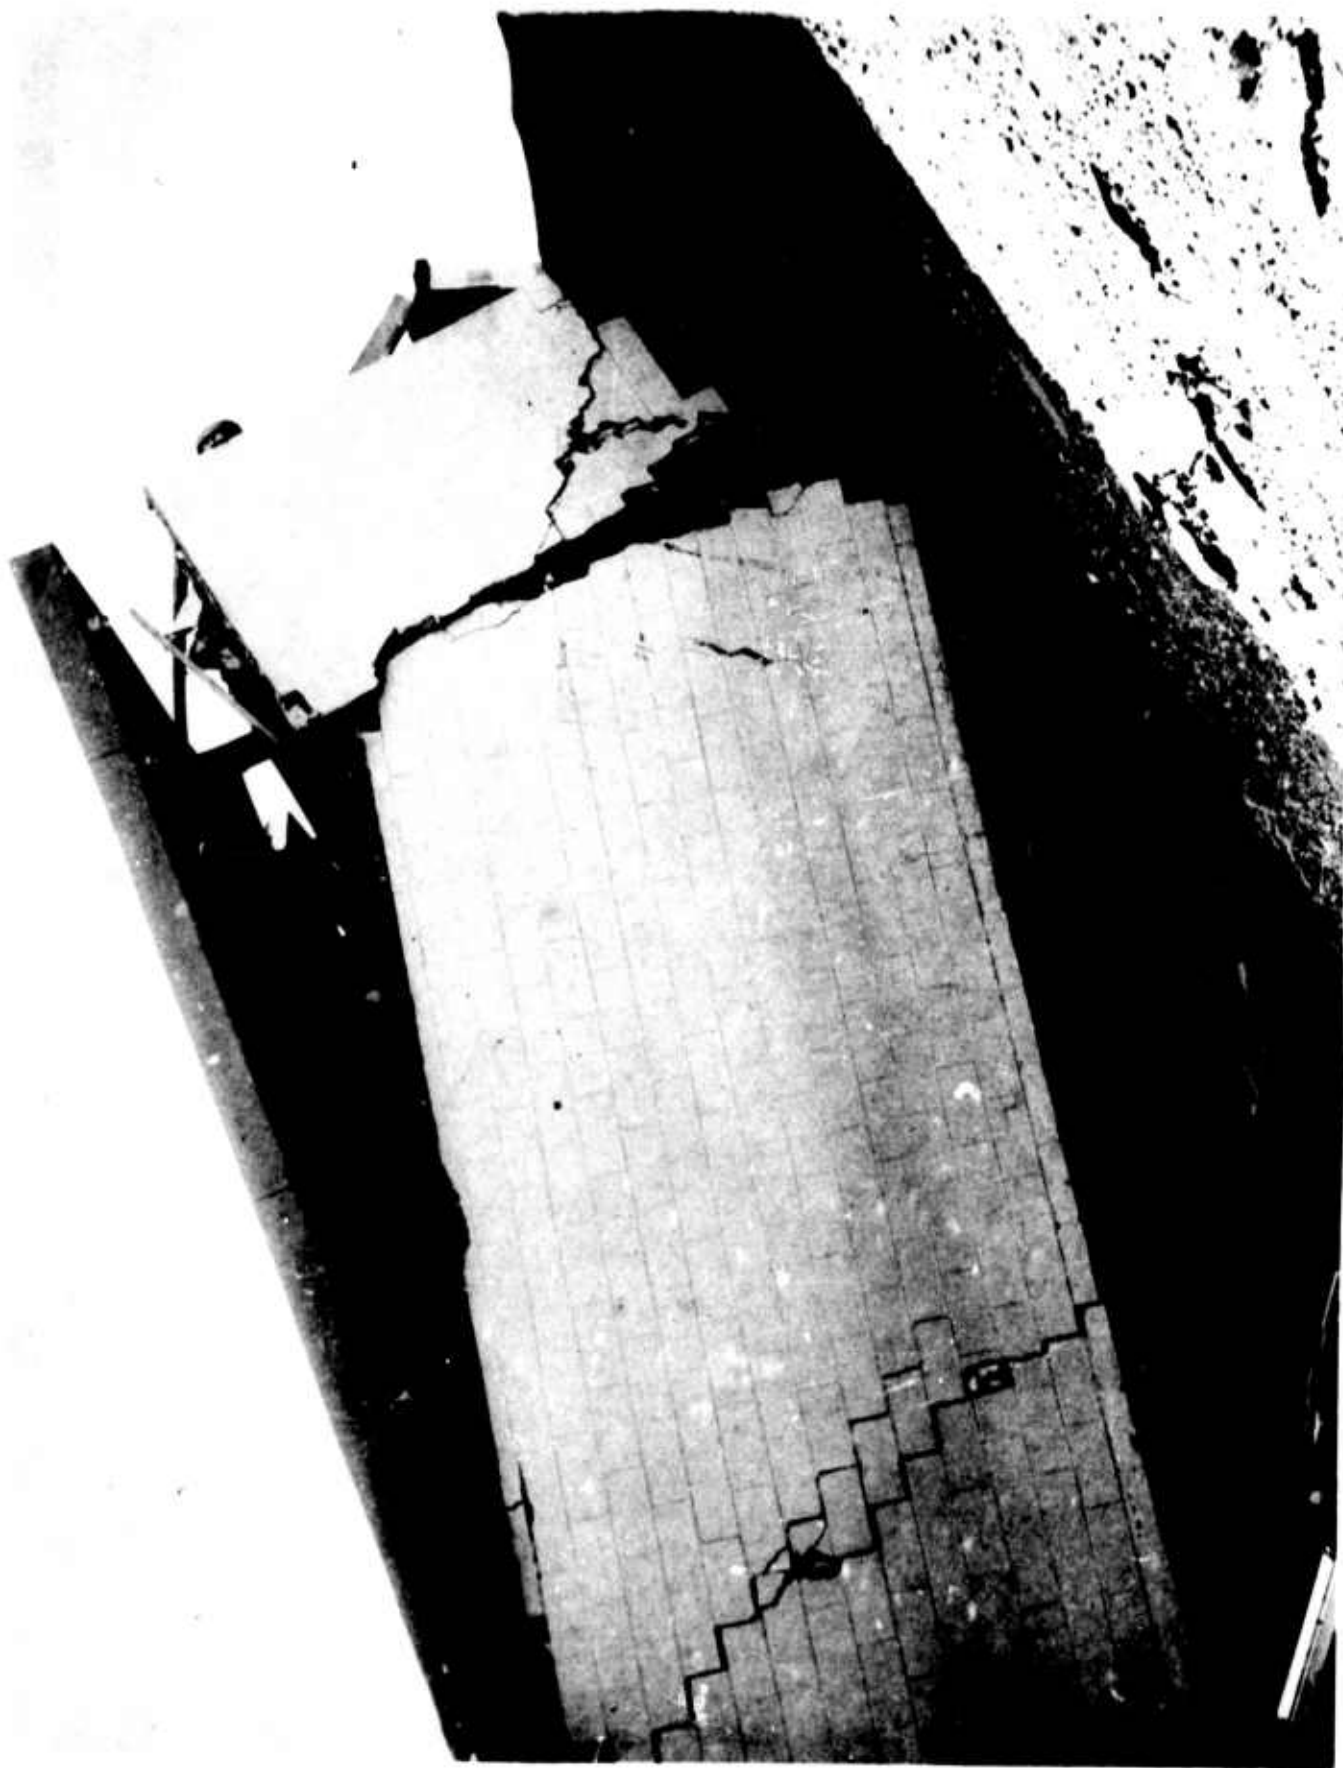
Figure 102. Government Hill Slide (Northeast corner of the east-west wing of the Government Hill School)
