THE GREAT ALASKA EARTHQUAKE

Volume II

Illustrations and Maps

TECHNICAL REPORT NO. AFWL-TR-65-92, Vol II

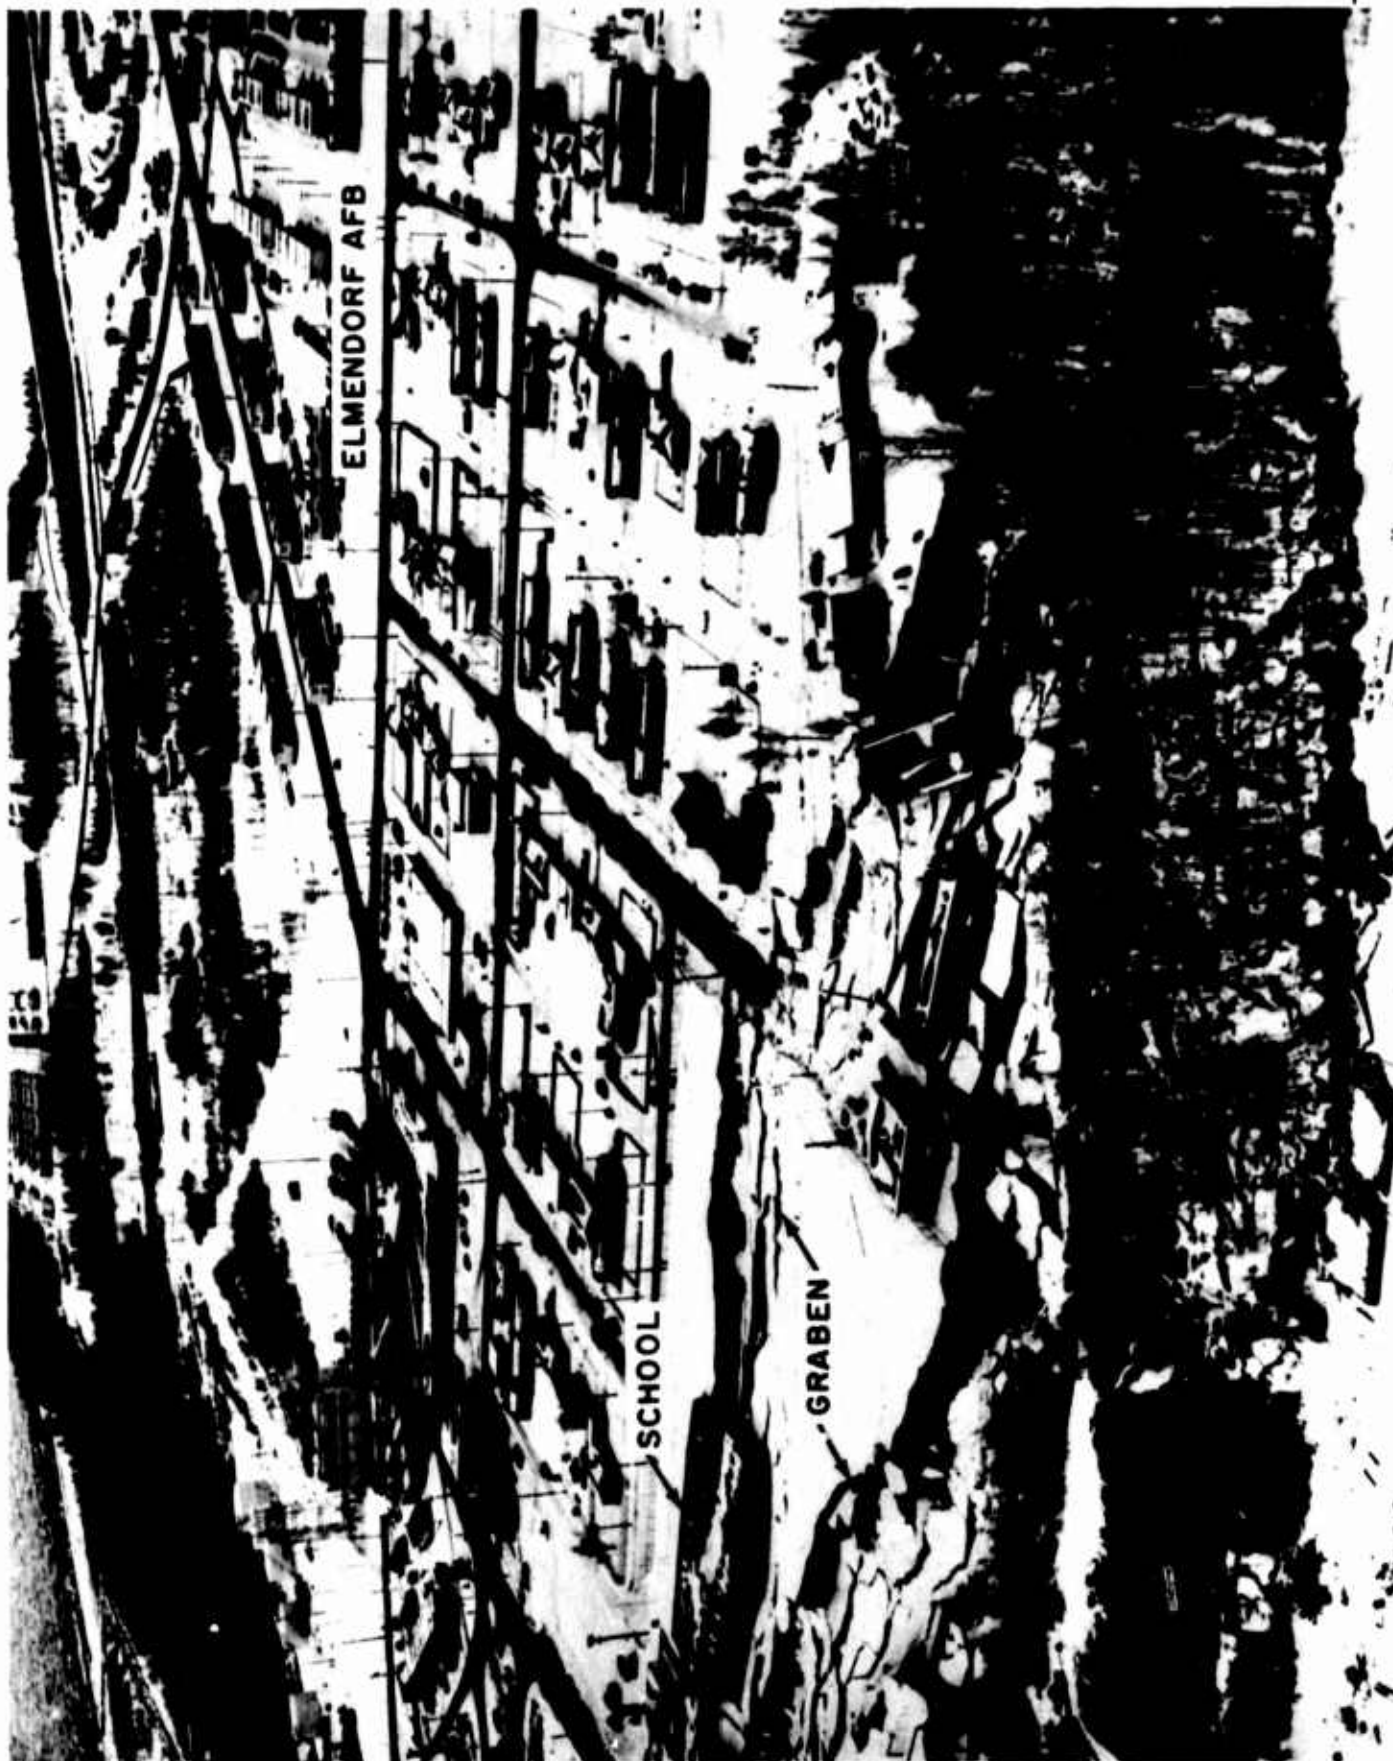
Figure 103. Government Hill Slide (Aerial view of the east end of the slide showing damage to residential buildings)

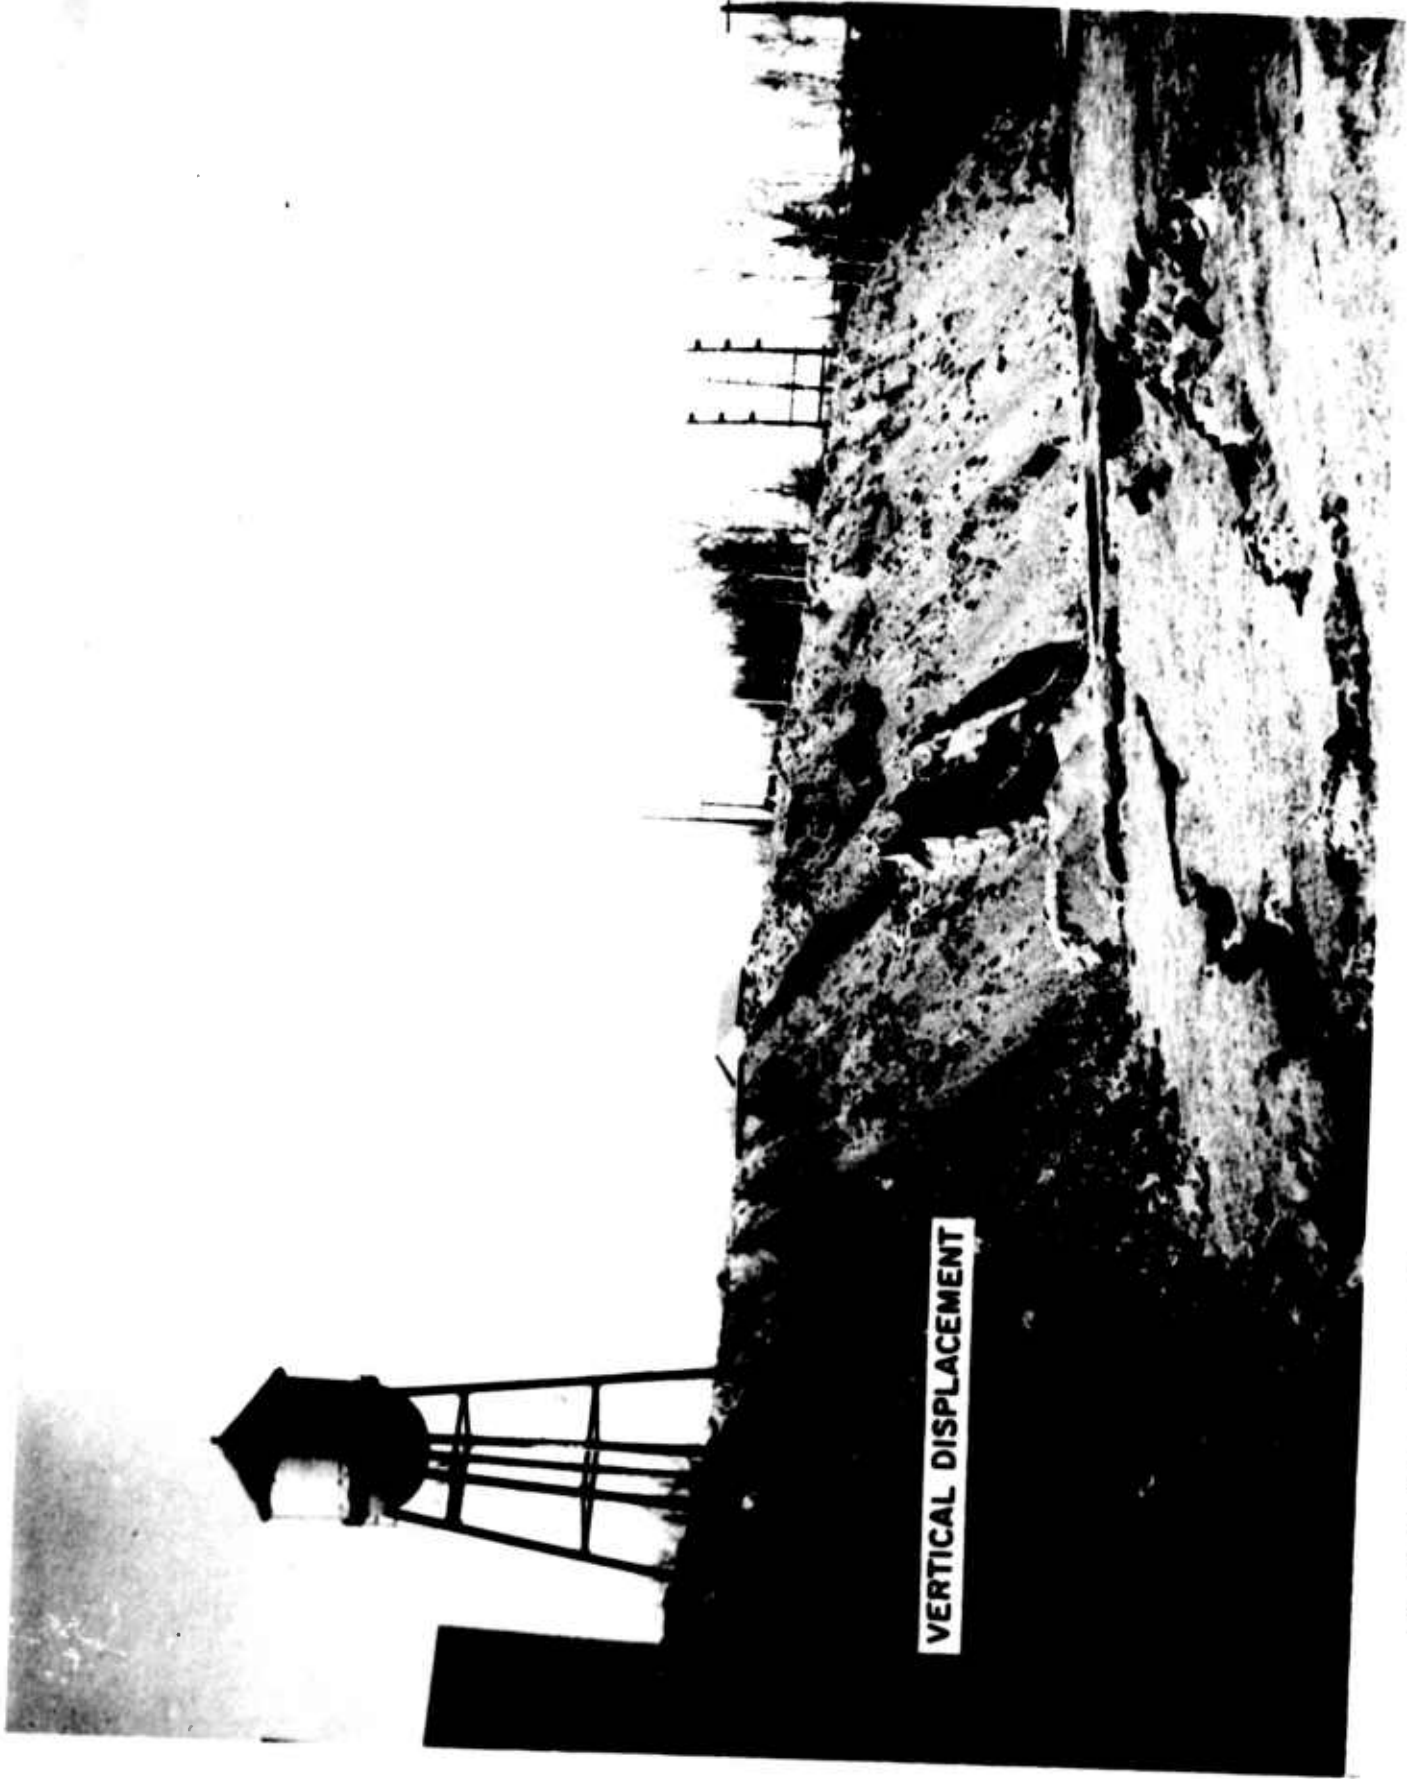
Figure 116. First Avenue Slide (Vertical displacement produced by the graben)

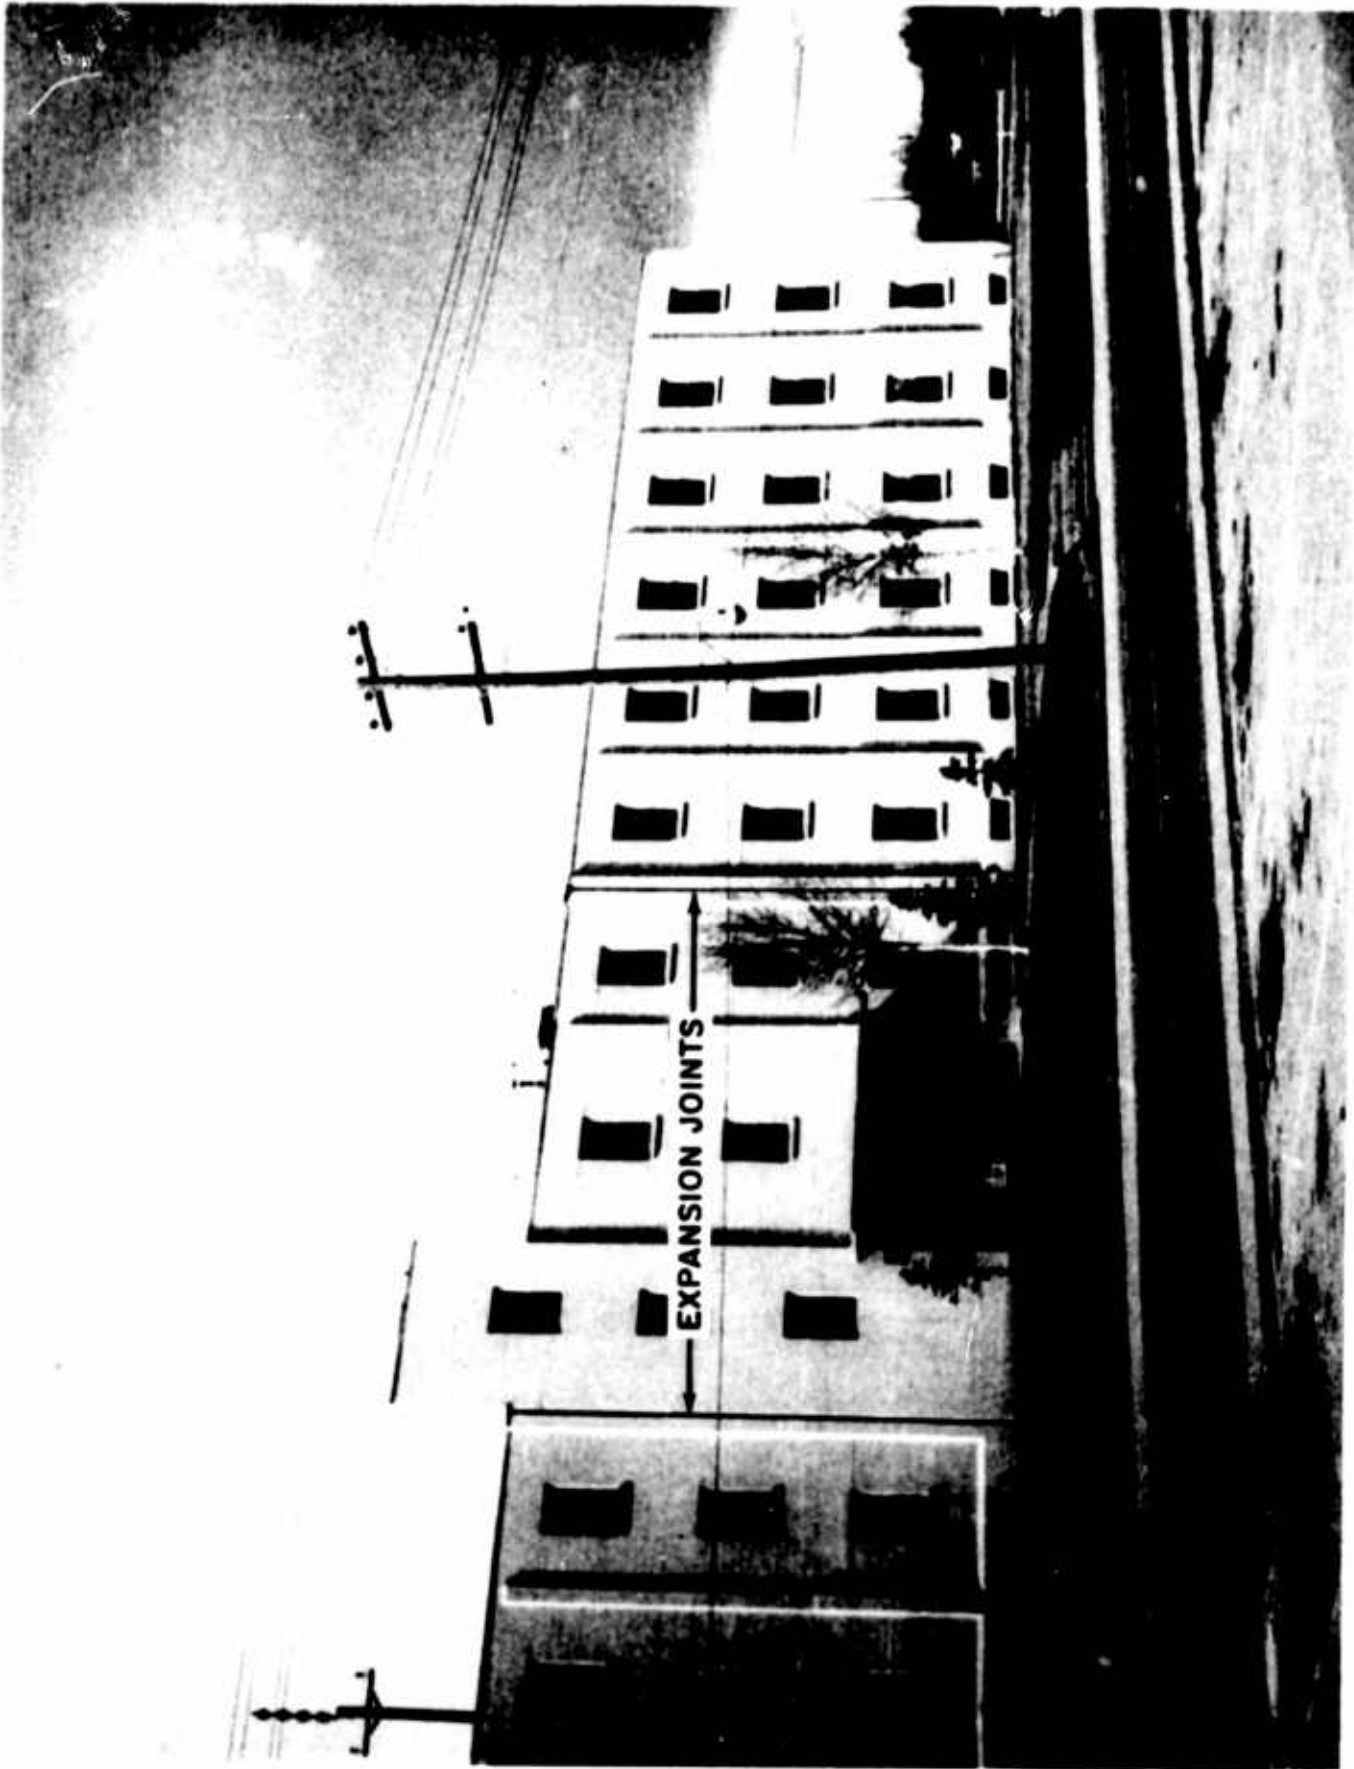
Figure 123. Elmendorf AFB 750-Man Barracks (East end of Building 31-270 showing expansion joints)

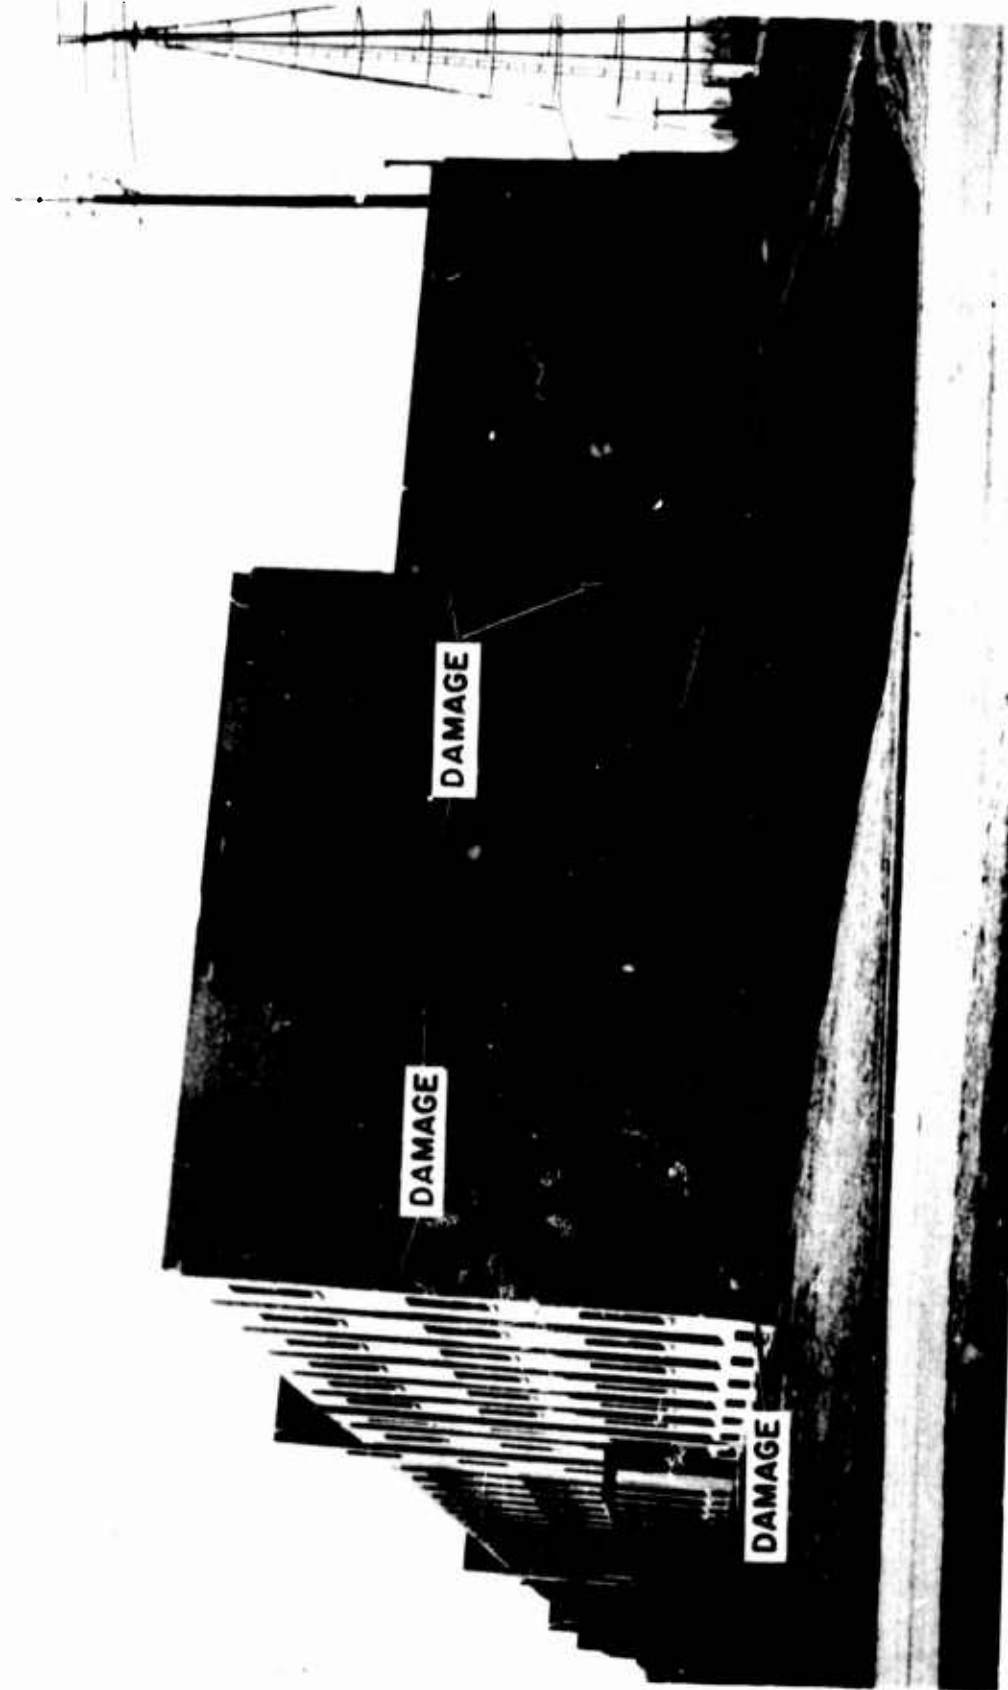
Figure 124. Elmendorf AFB 750-Man Barracks (East side of Building 31-270 showing projecting wing and cracks in structural frame)

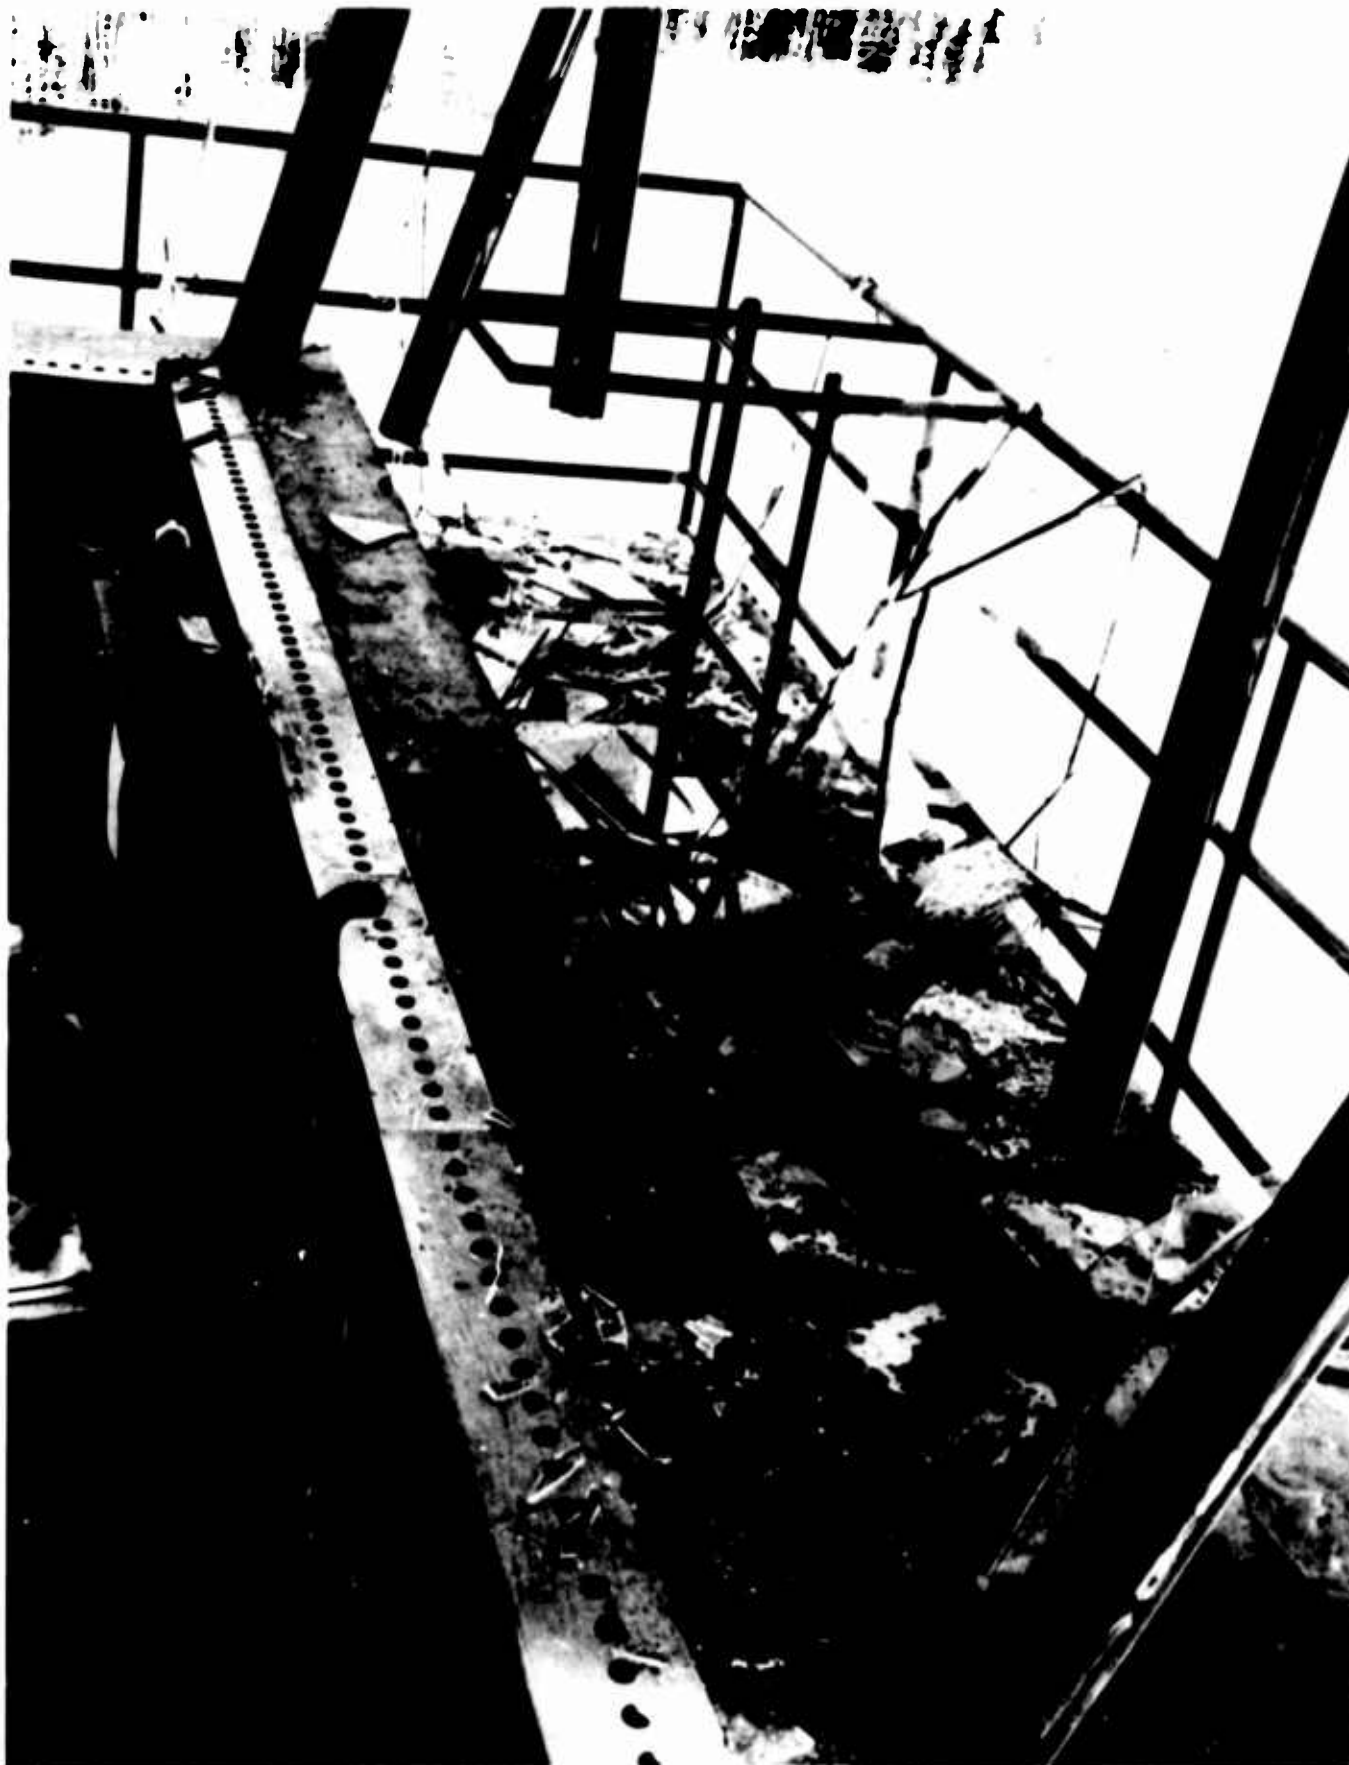
Figure 133. Elmendorf AFB Aircraft Control Tower
(Severely damaged observation cupola)

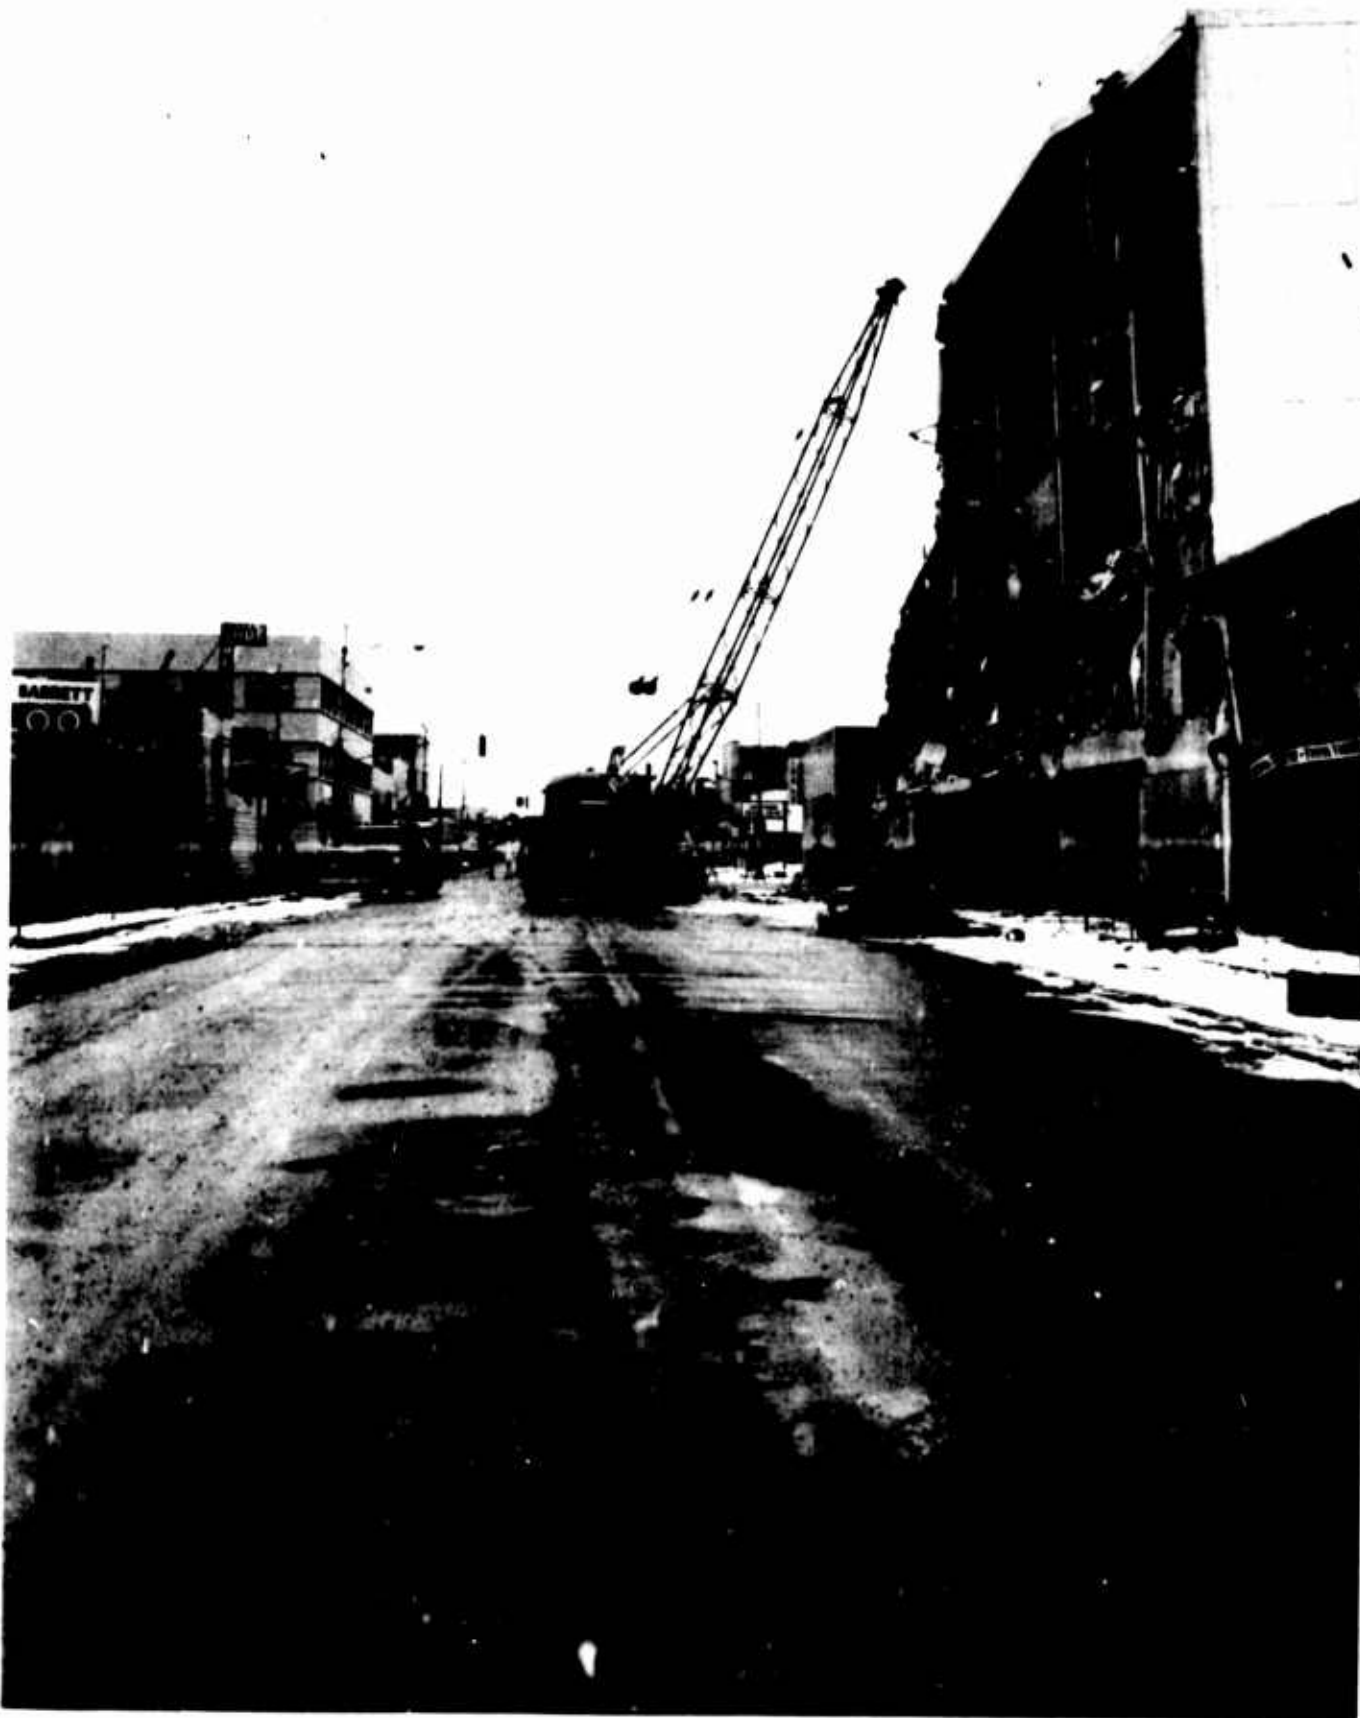
Figure 140. J. C. Penney Building (Damage to the northwest corner of the structure. Notice numerous floorslab failures.)

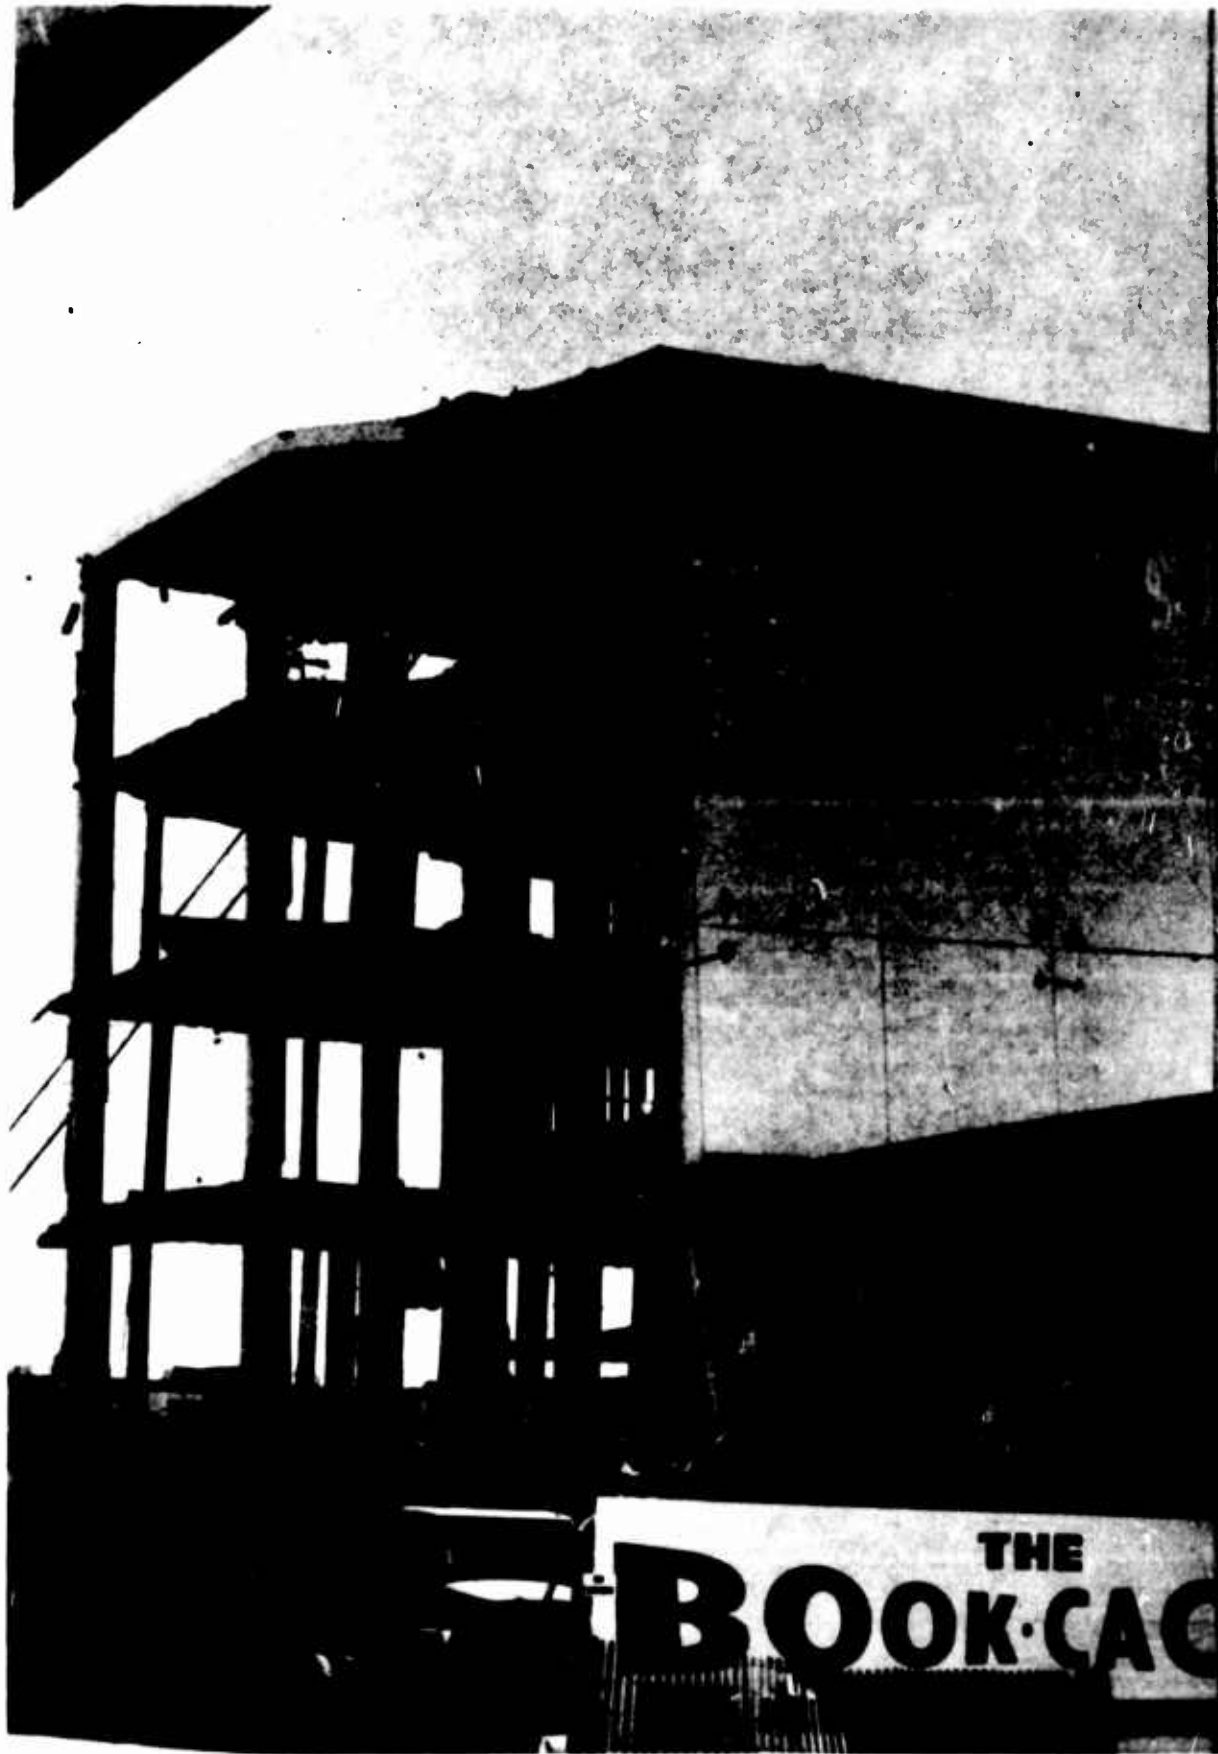
Figure 143. J. C. Penney Building (Floor slab failures along the north side of the structure)

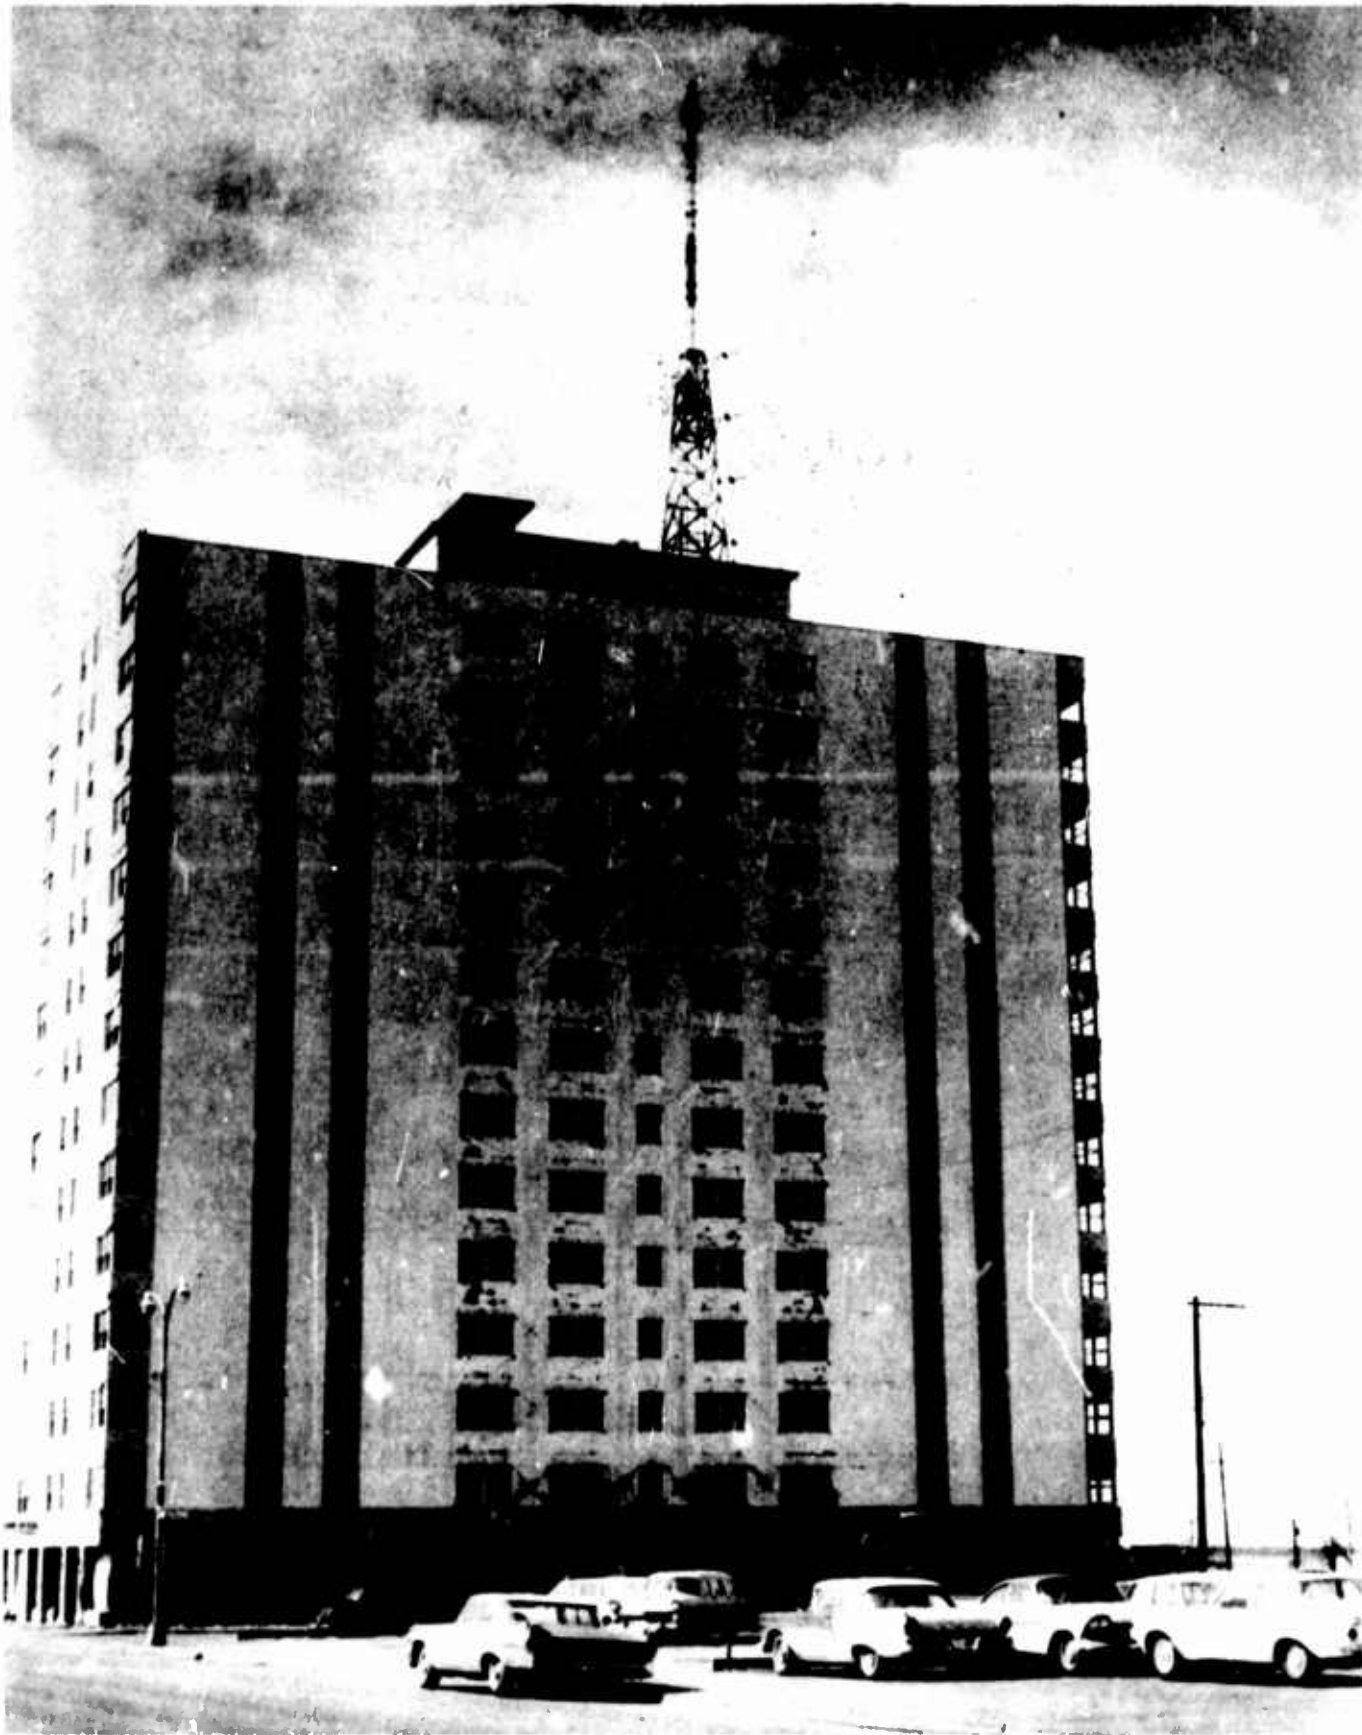
Figure 144. Mount McKinley Building (East side of the fourteen-story reinforced-concrete structure showing diagonal tension cracks in spandrel walls)

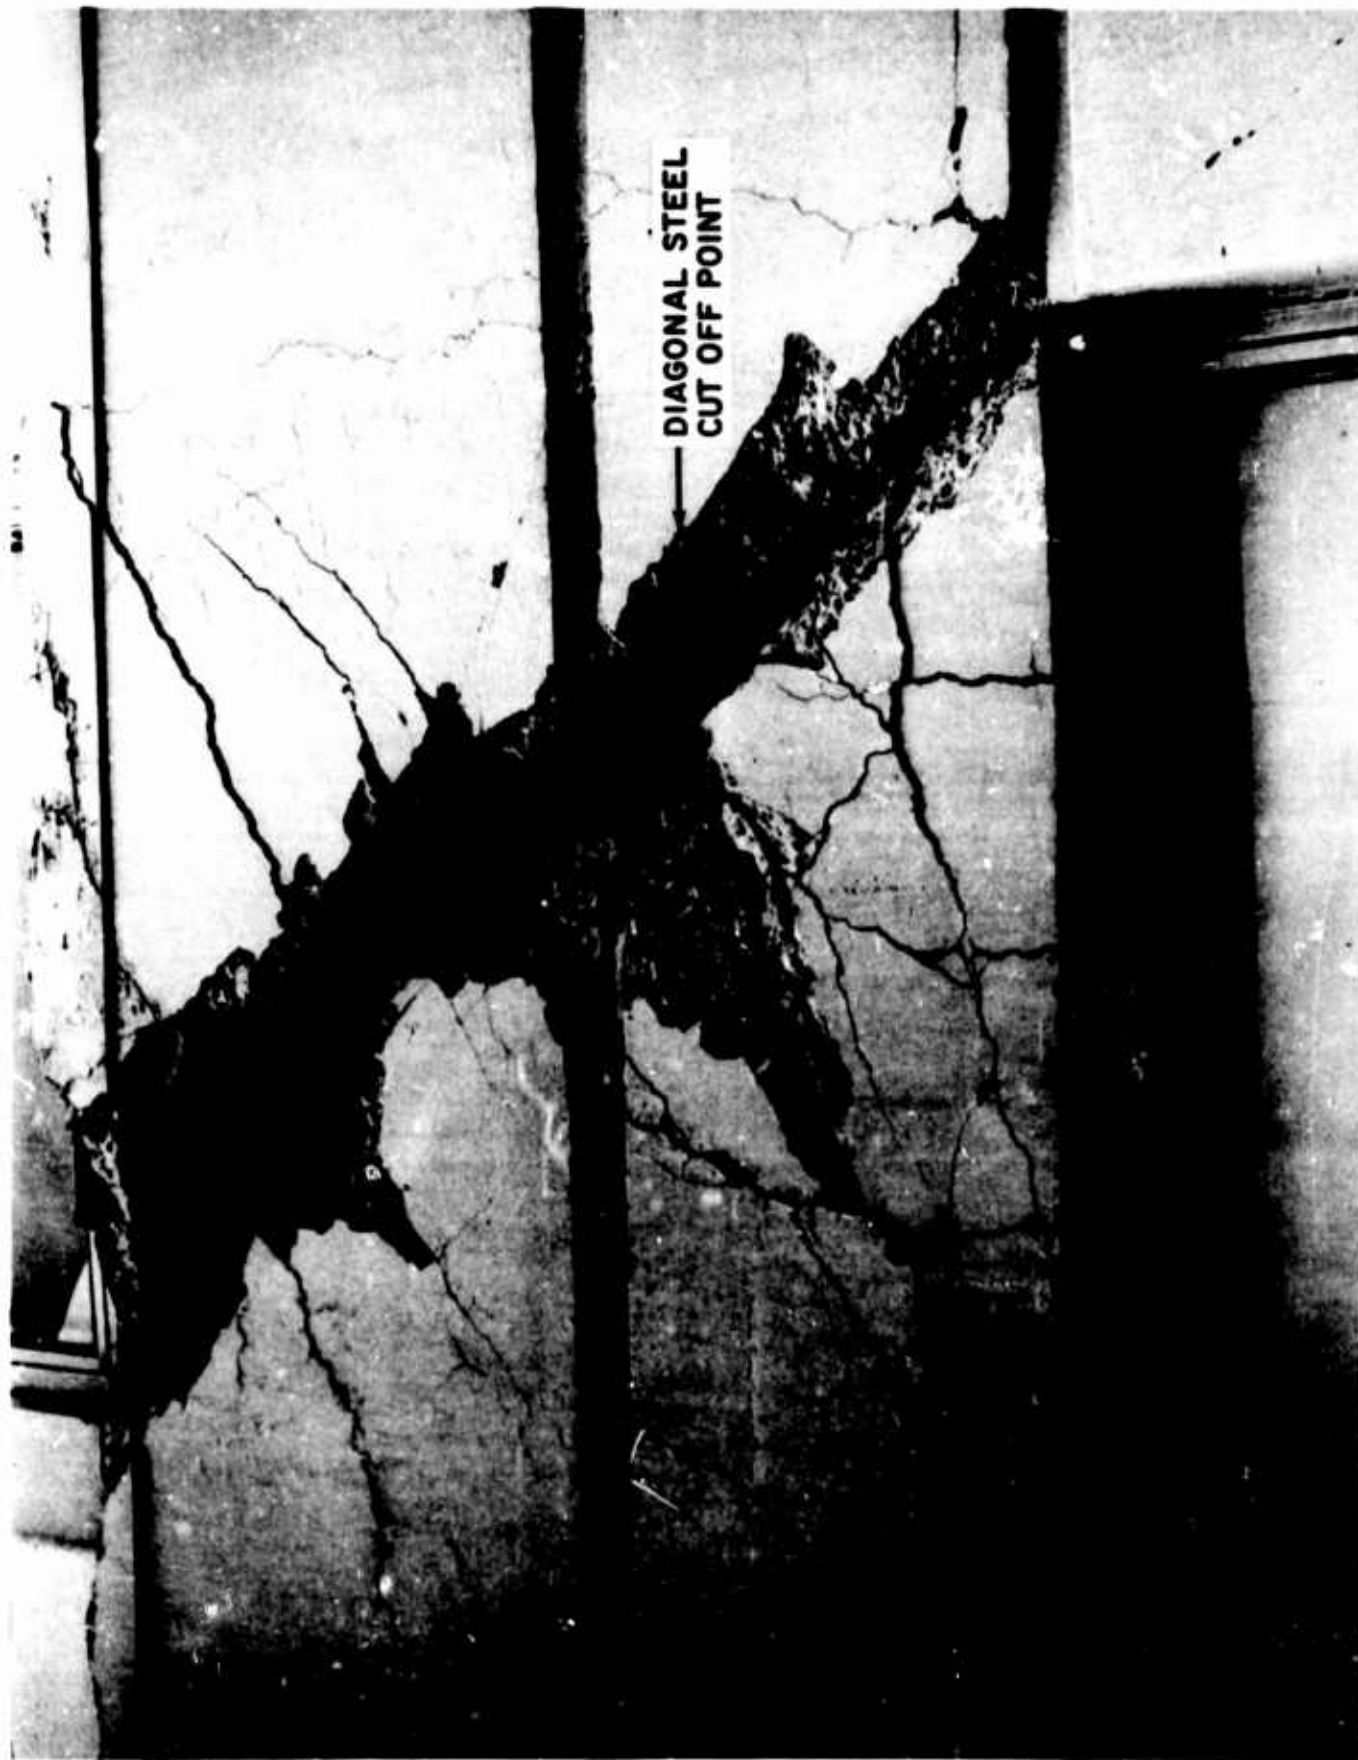
Figure 153. Mount McKinley Building (Diagonal tension failure in east wall at second-floor level)

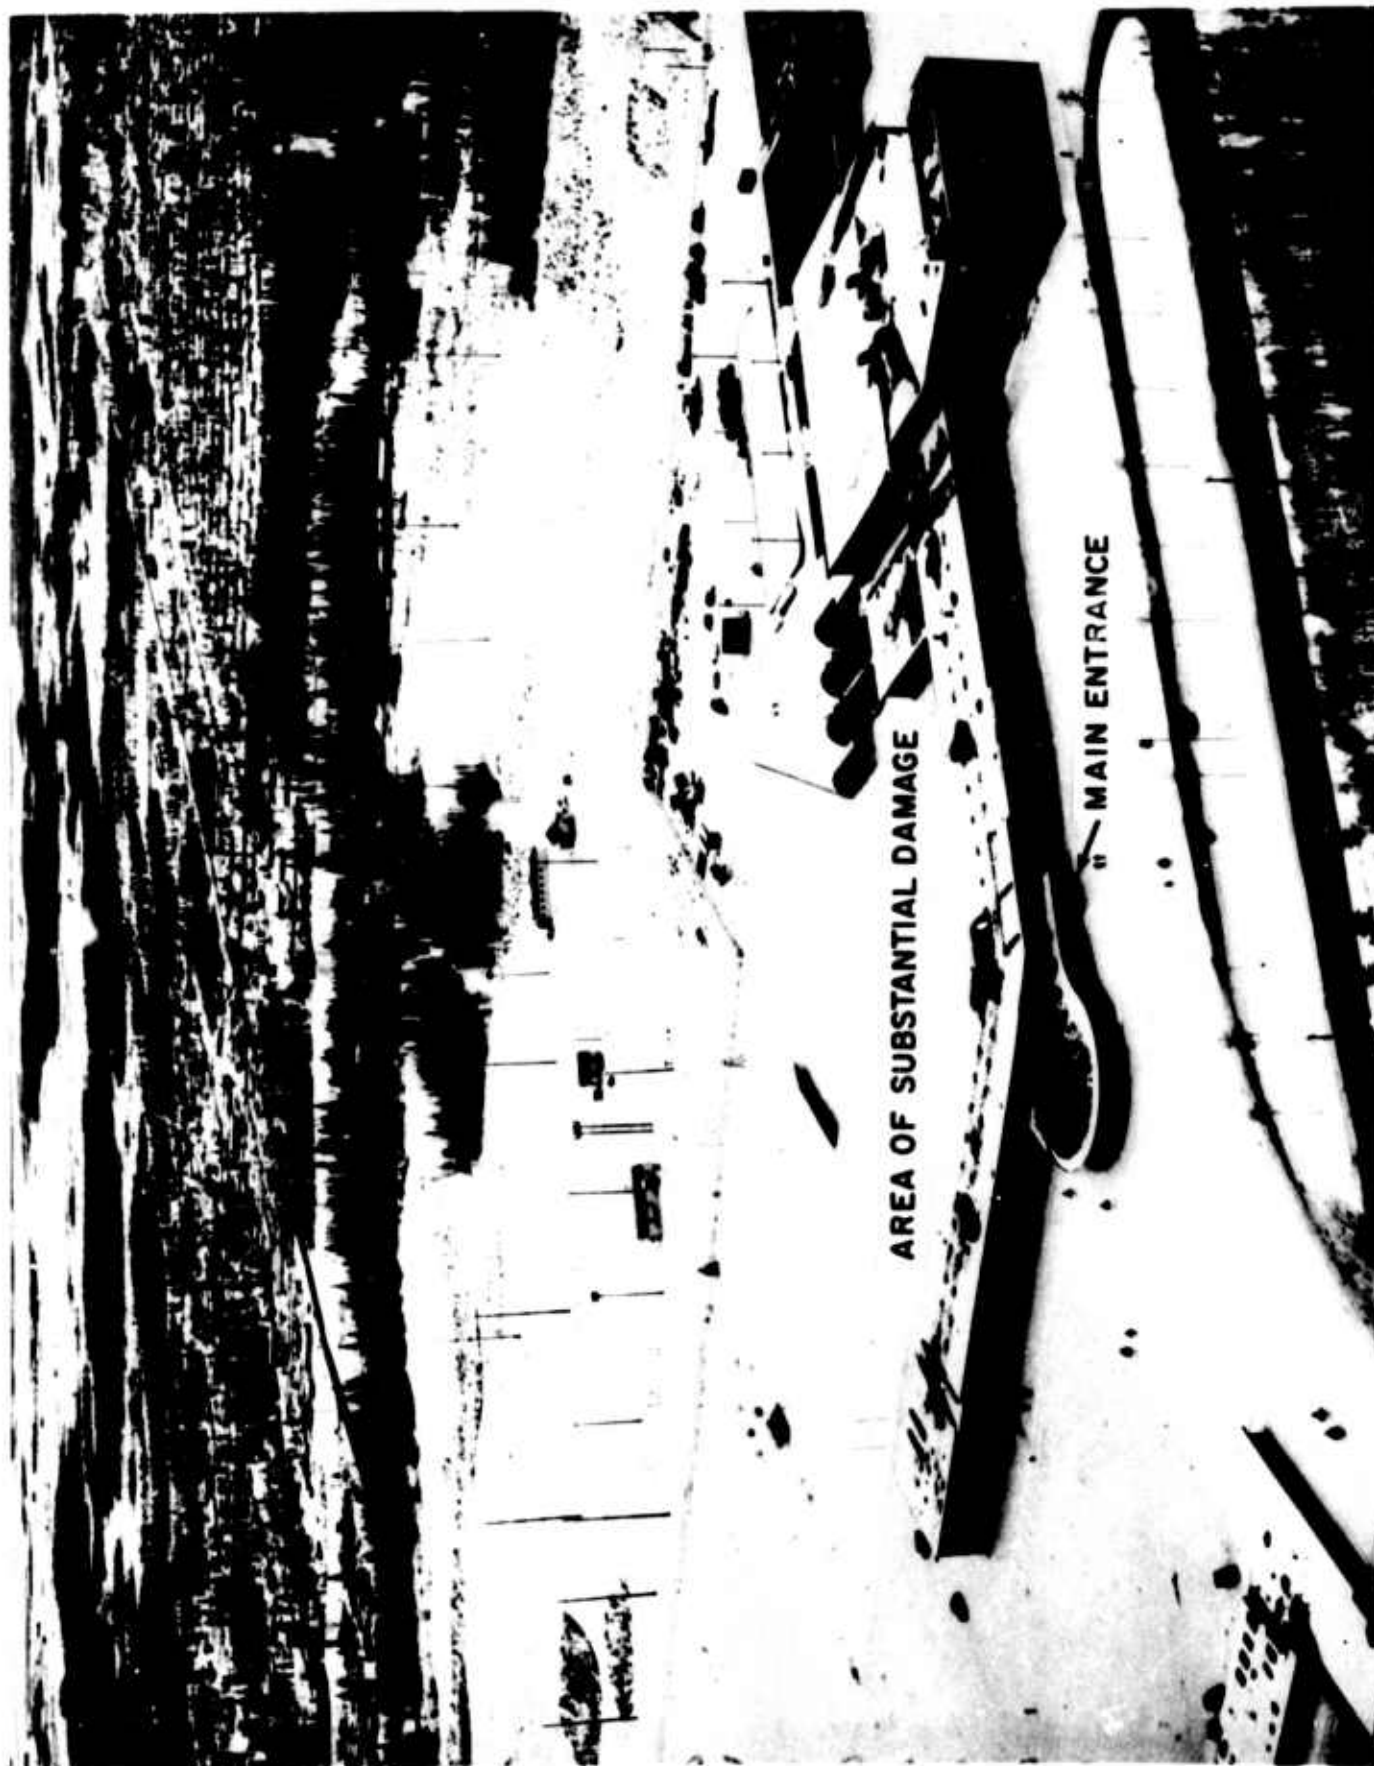
Figure 157. West Anchorage High School (Aerial view after the quake)
