THE GREAT ALASKA EARTHQUAKE

Volume II

Illustrations and Maps

TECHNICAL REPORT NO. AFWL-TR-65-92, Vol II

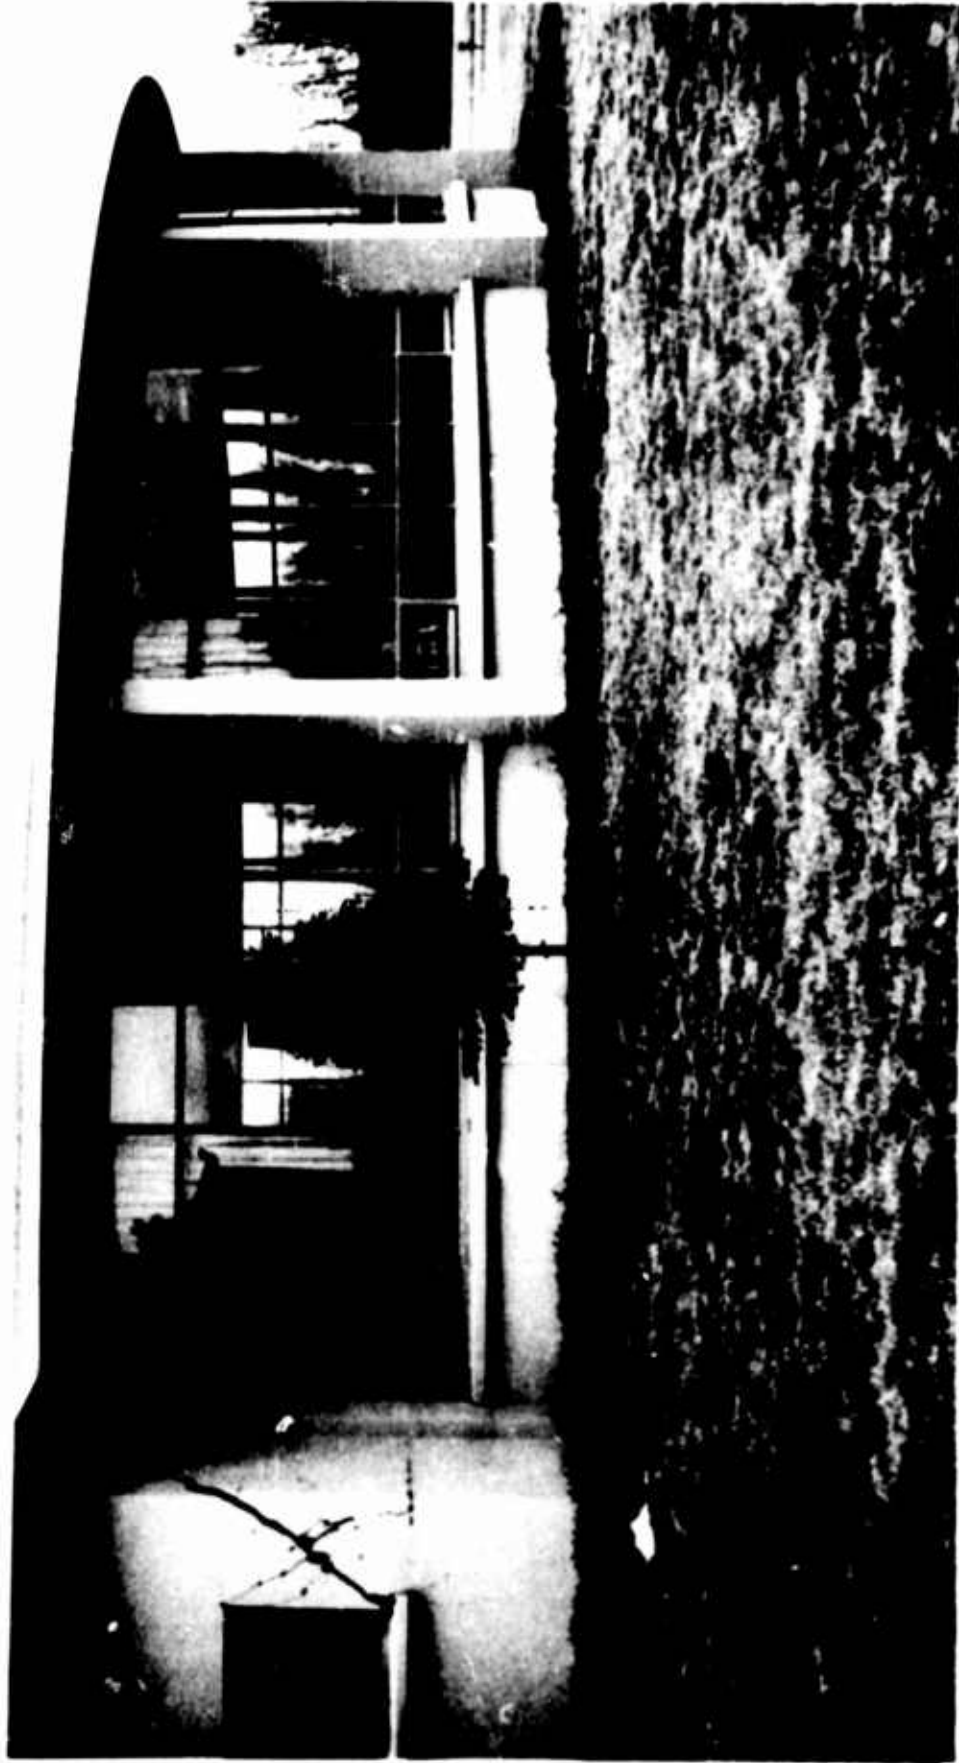
Figure 173. West Anchorage High School (The library received relatively minor damage.)

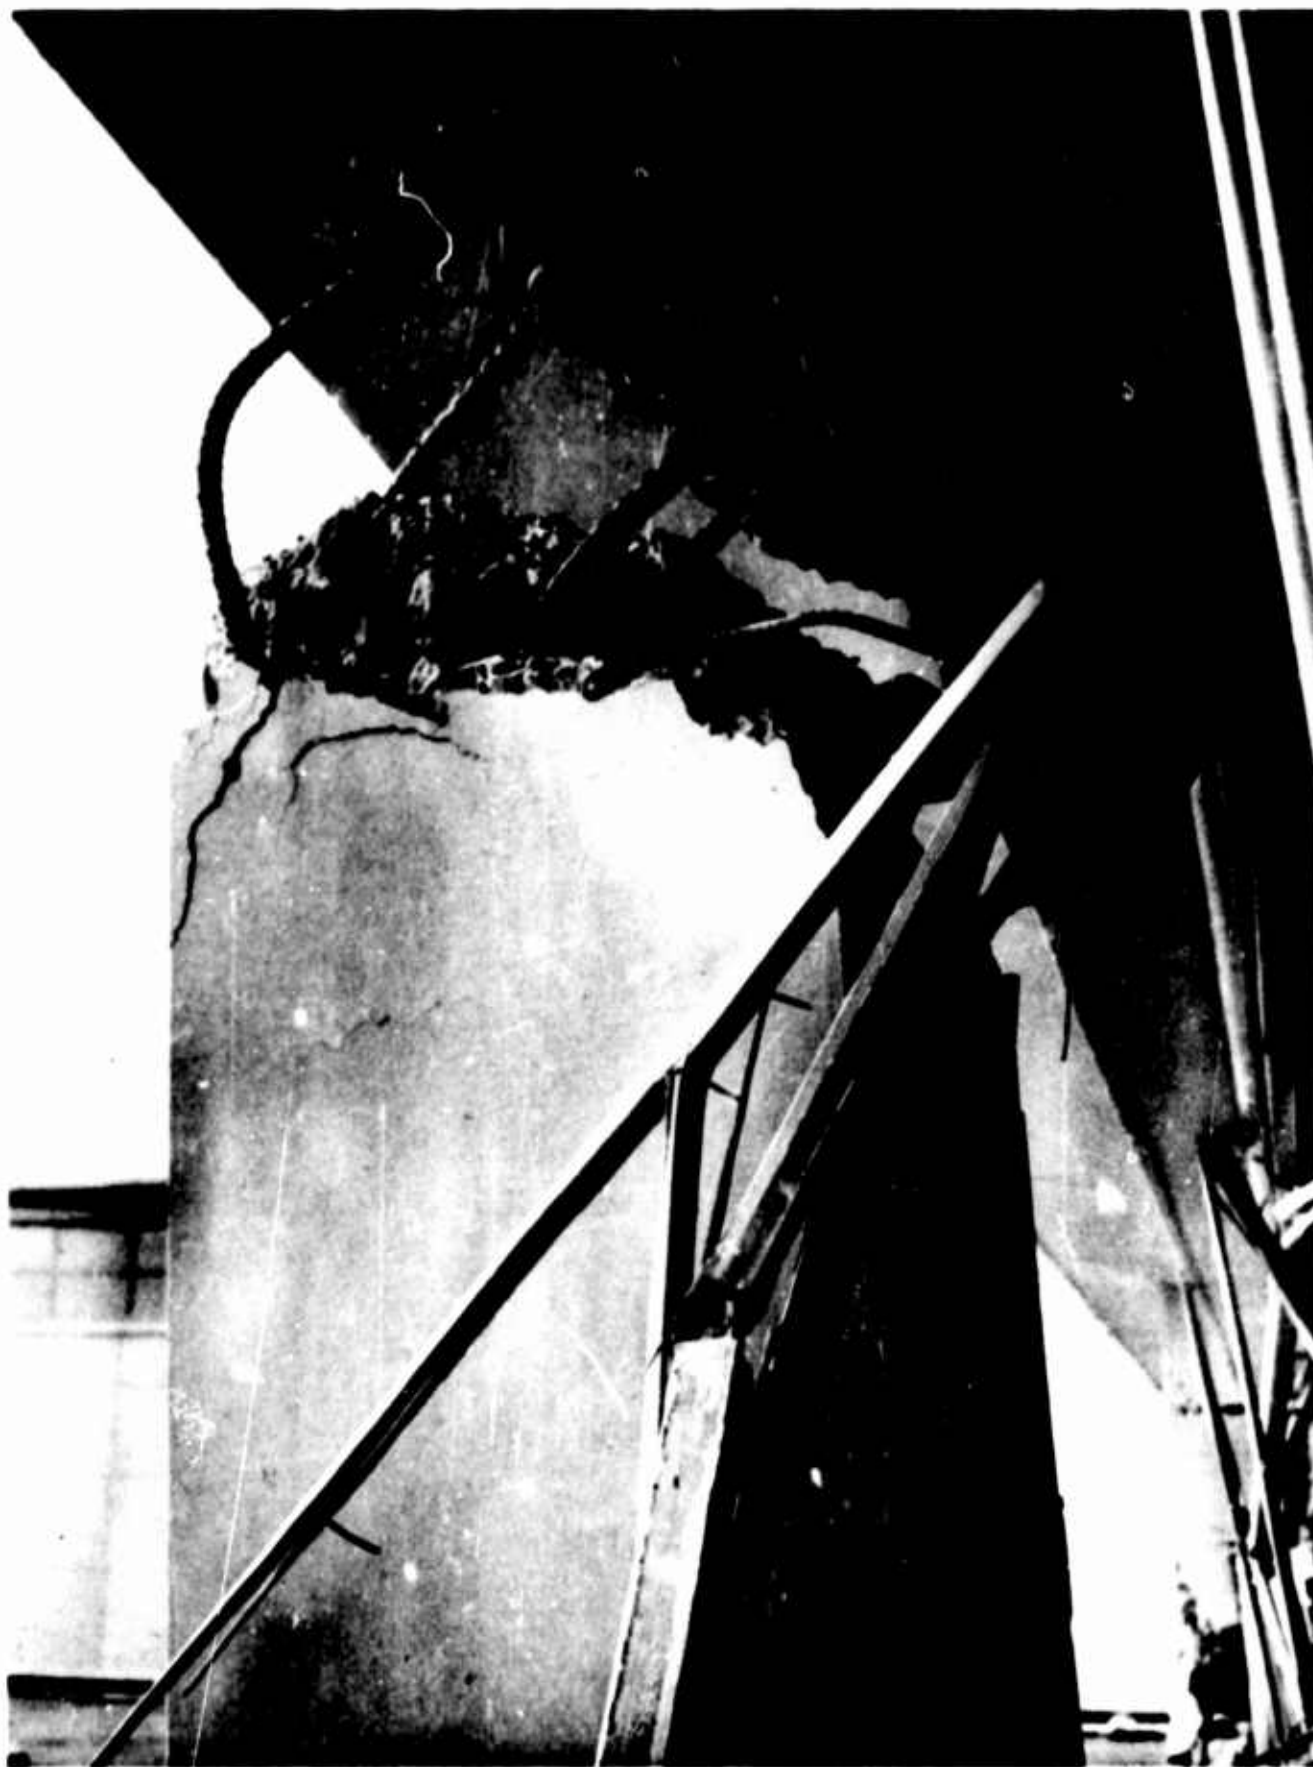
Figure 180. West Anchorage High School
(Complete fracture of a second-story column in south wall of wing B.
The reinforcing steel is bent but not broken.)

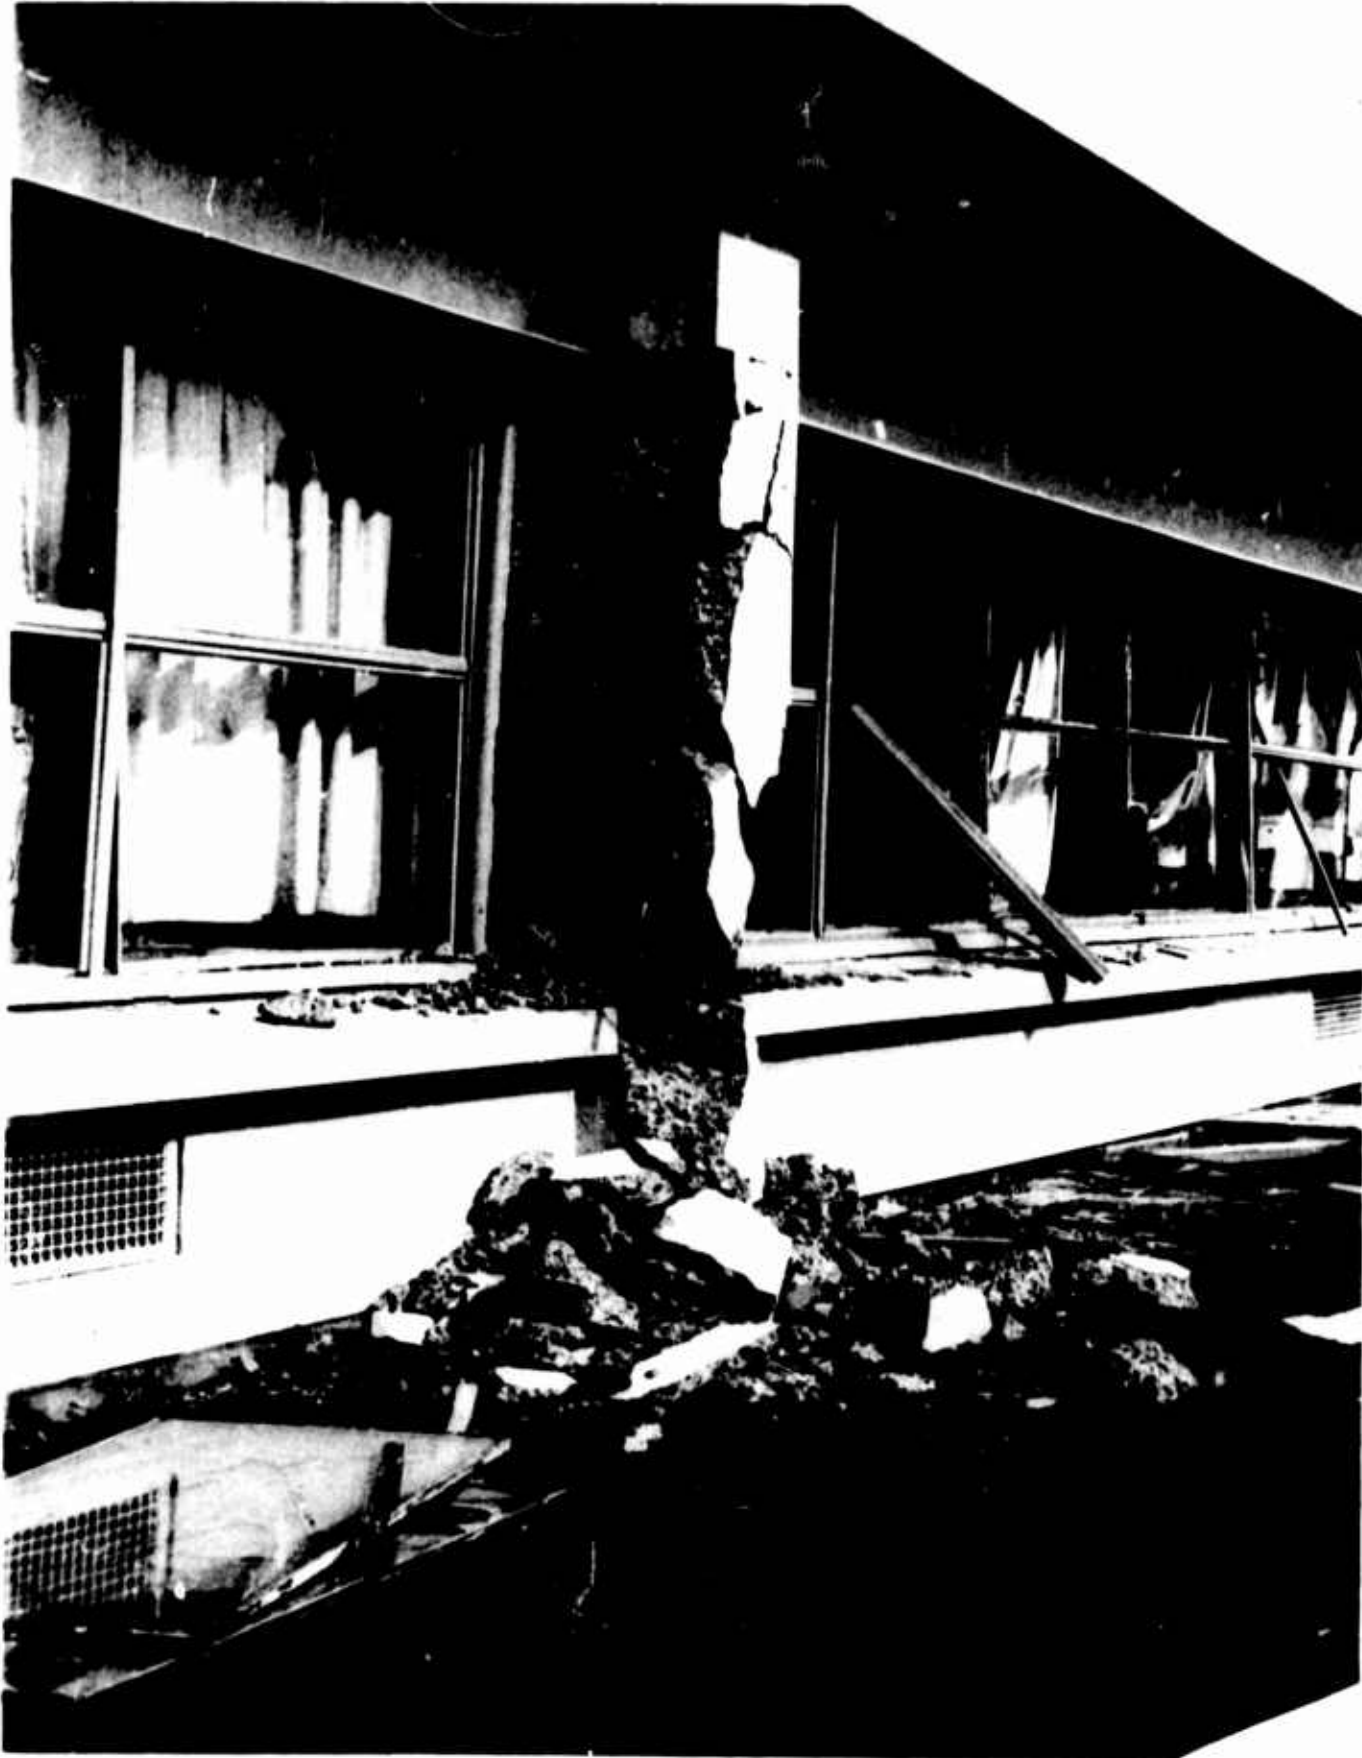
Figure 182. West Anchorage High School
(Damage to short second-story column in south wall of wing B
above the cafeteria was not prevented by light horizontal ties)

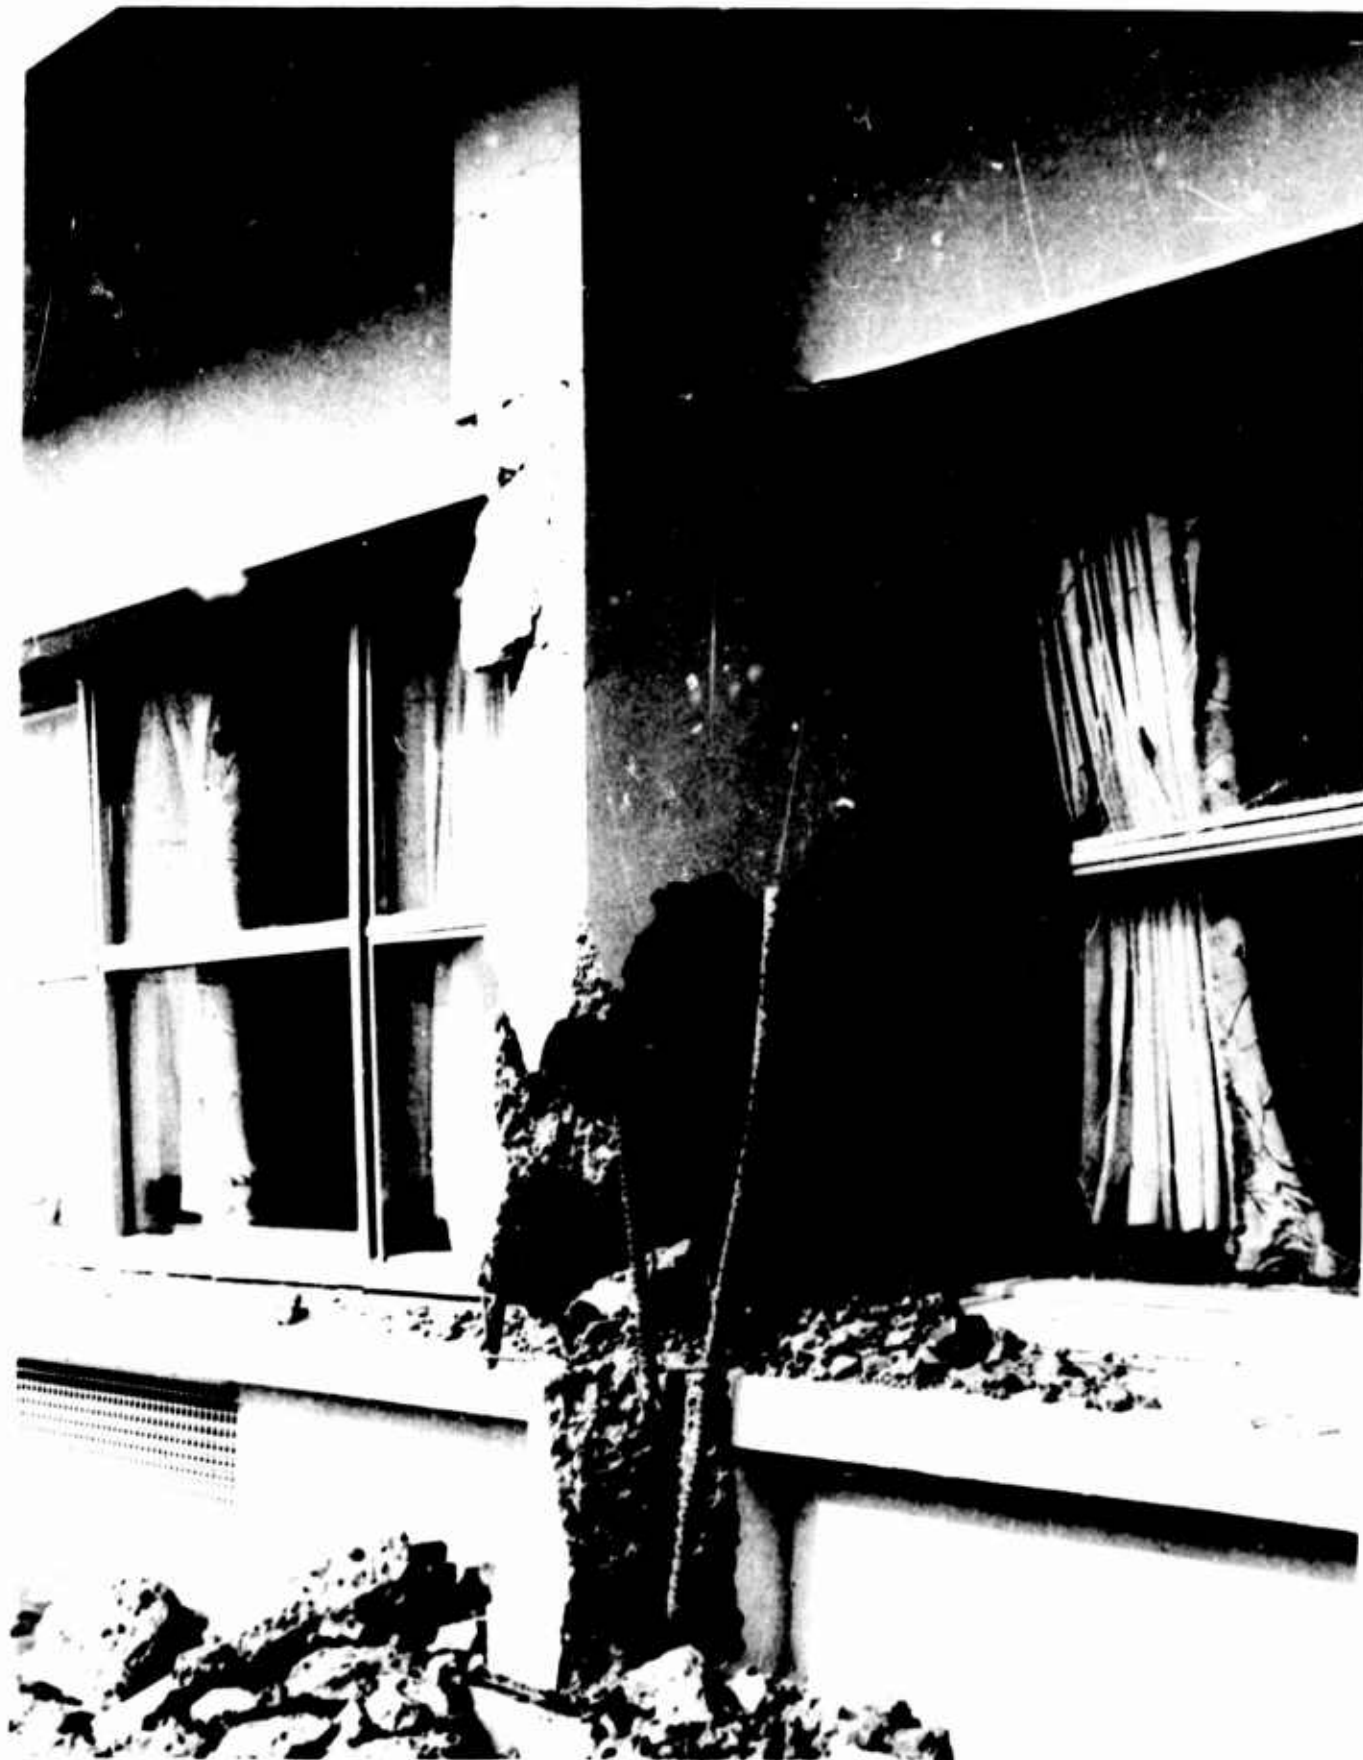
Figure 183. West Anchorage High School
(The other side of the column shown in figure 182)

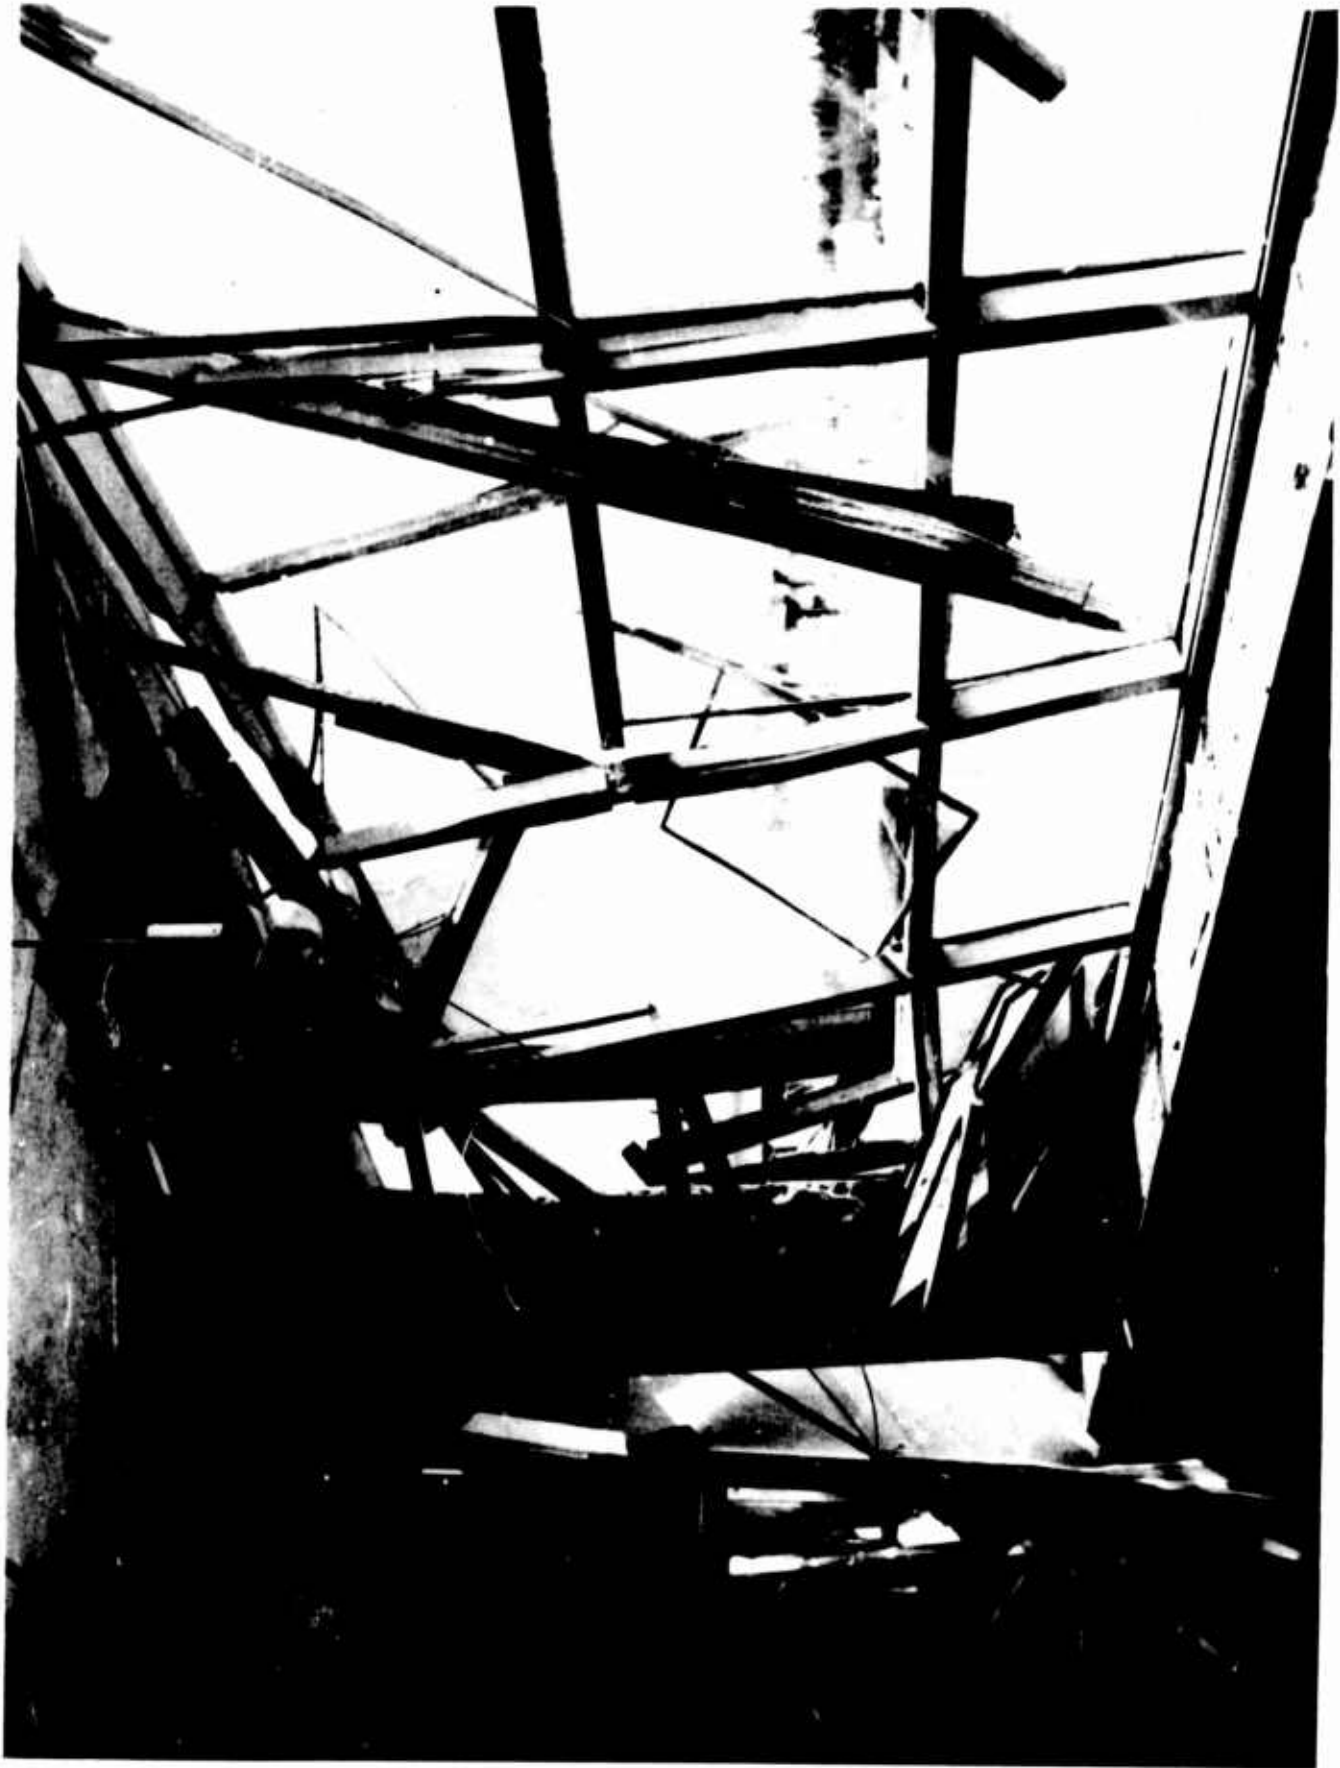
Figure 184. West Anchorage High School (Interior damage to second-floor classroom on south side of wing B)

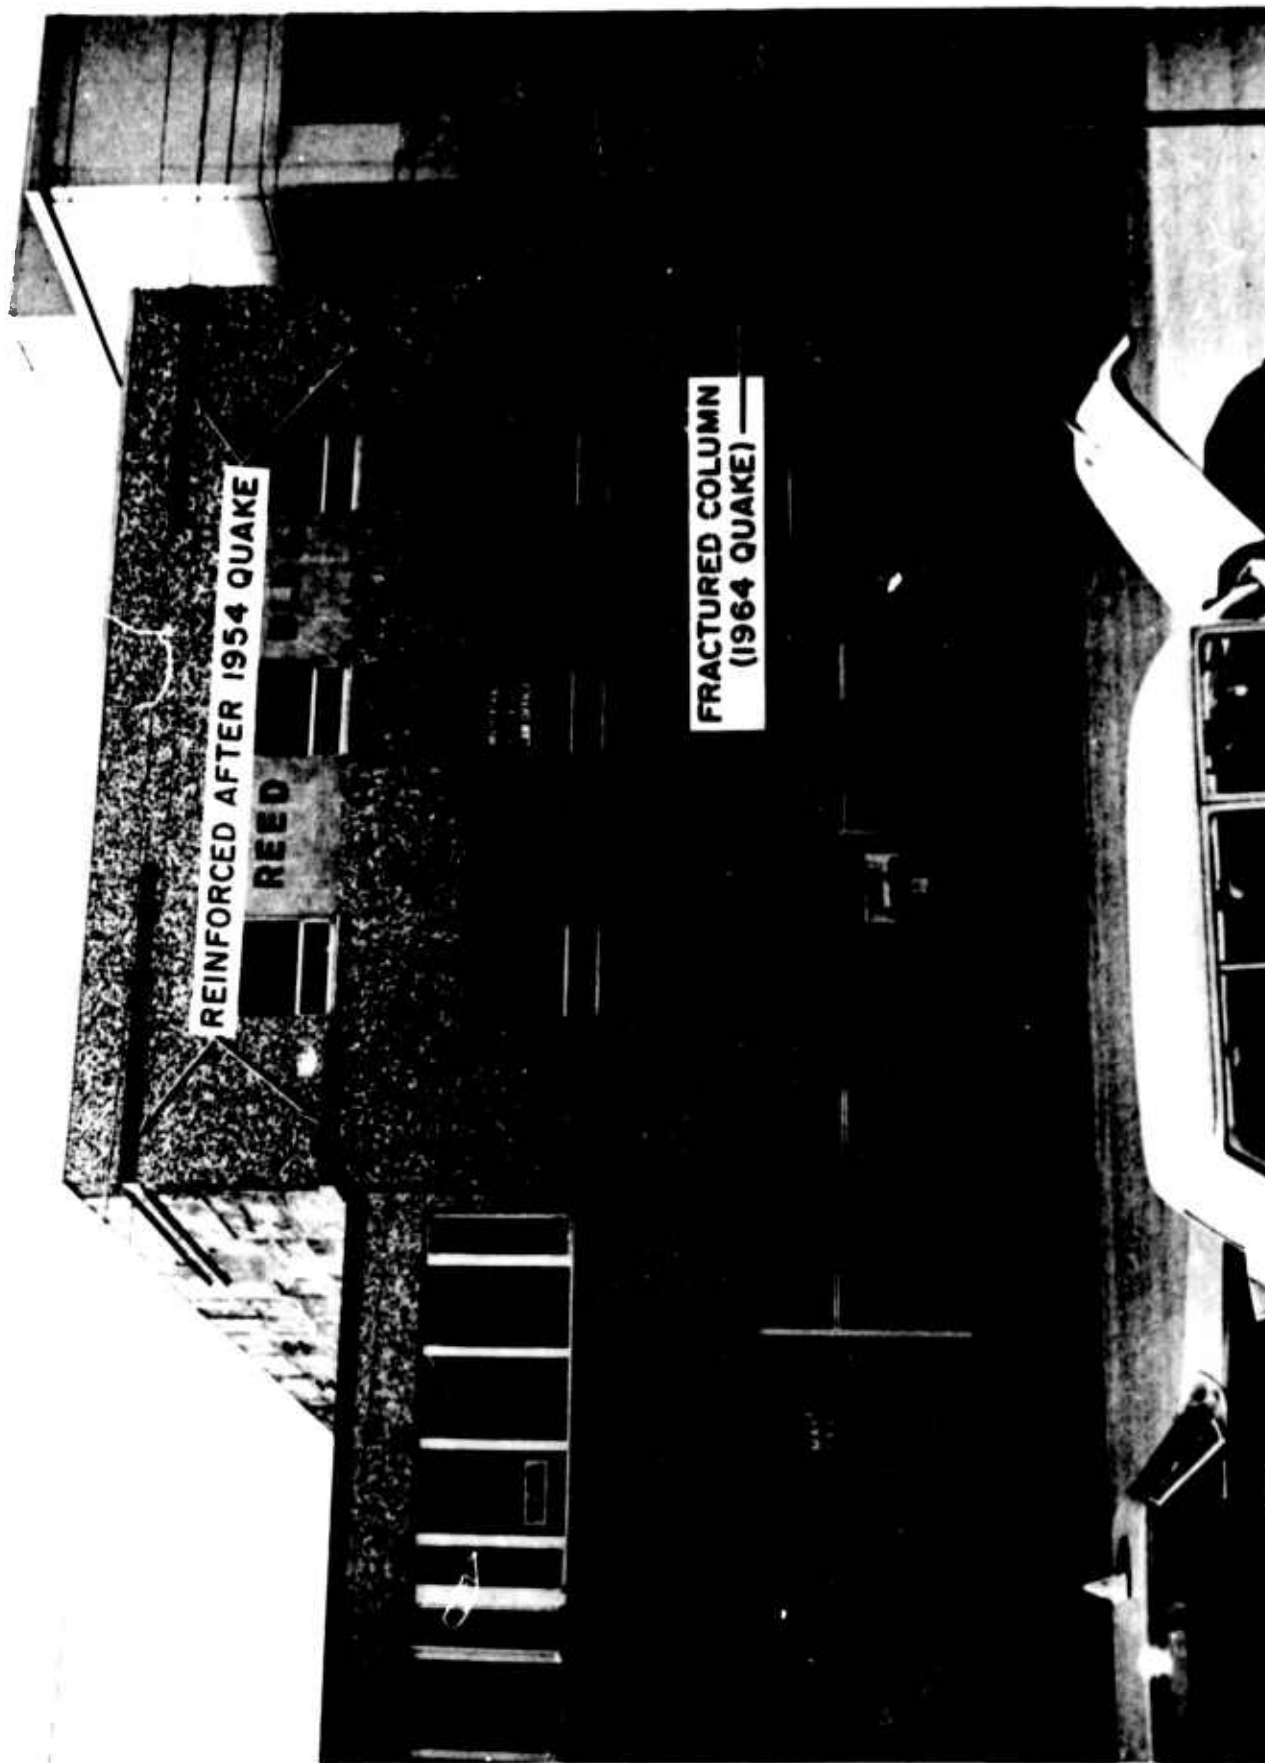
Figure 185. Reed Building (North side of the structure showing effects of previous earthquake damage as well as remedial measures taken to repair recent damage)

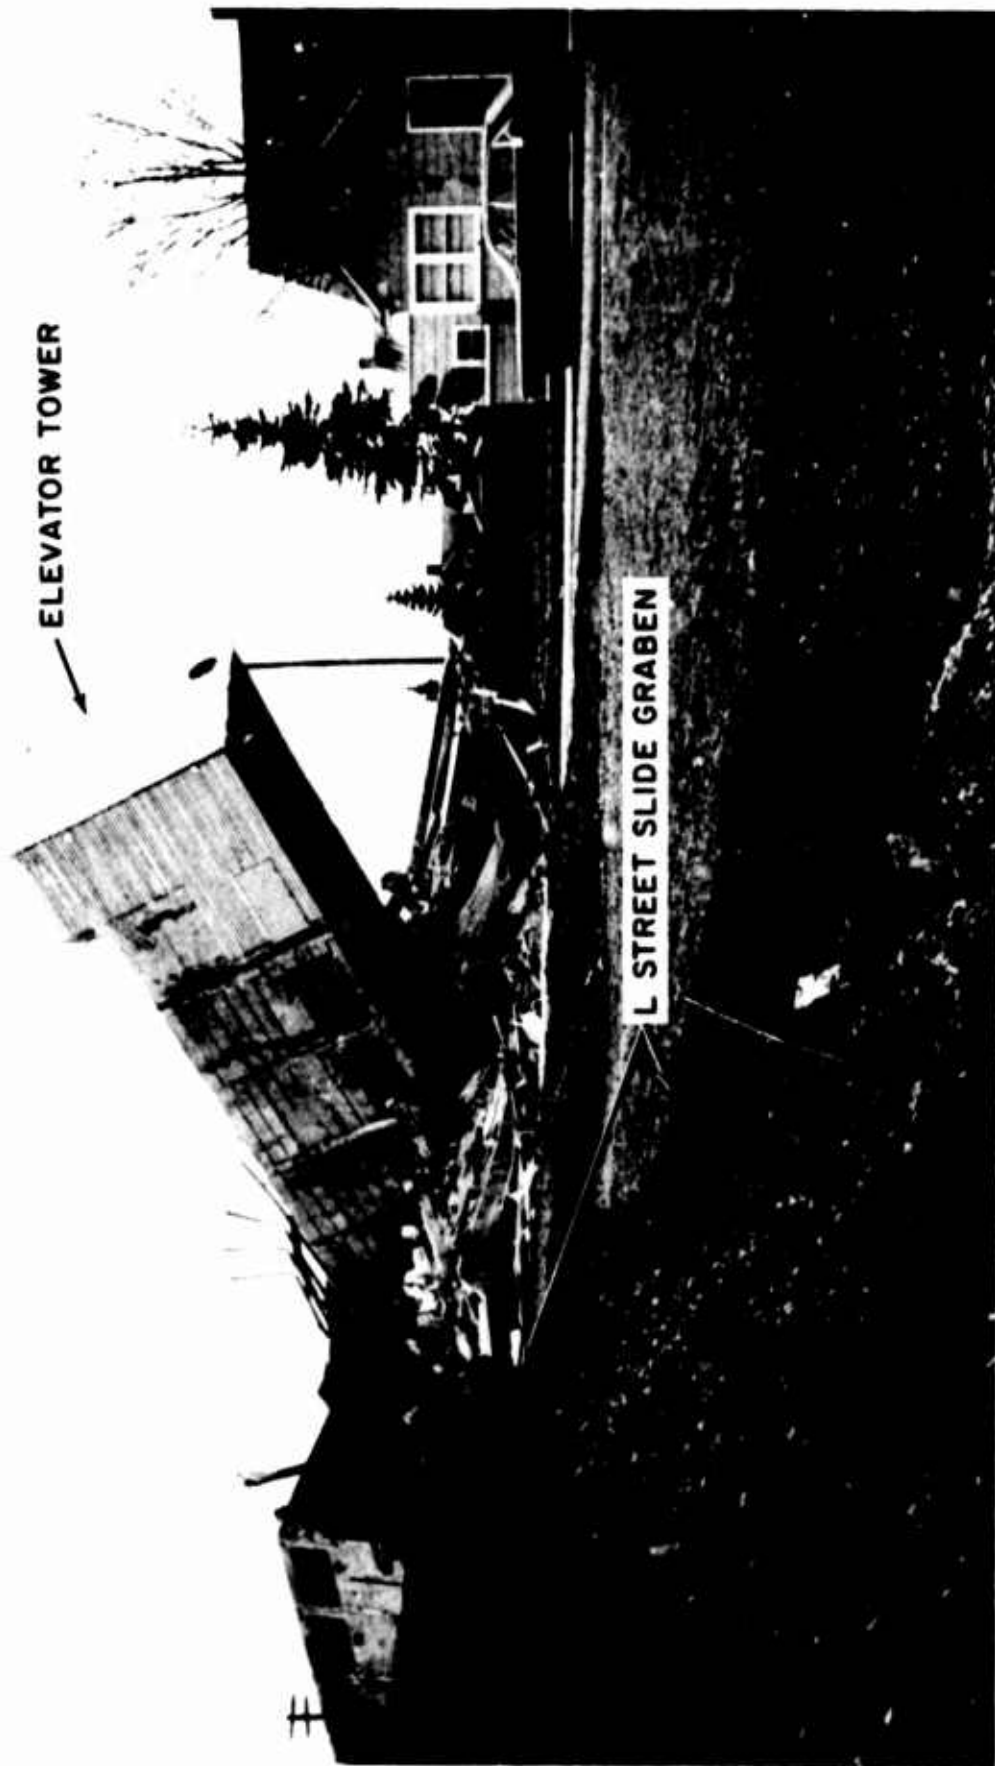
Figure 189. Four Seasons Apartments
(East side of the collapsed structure showing a portion of the L Street slide graben)

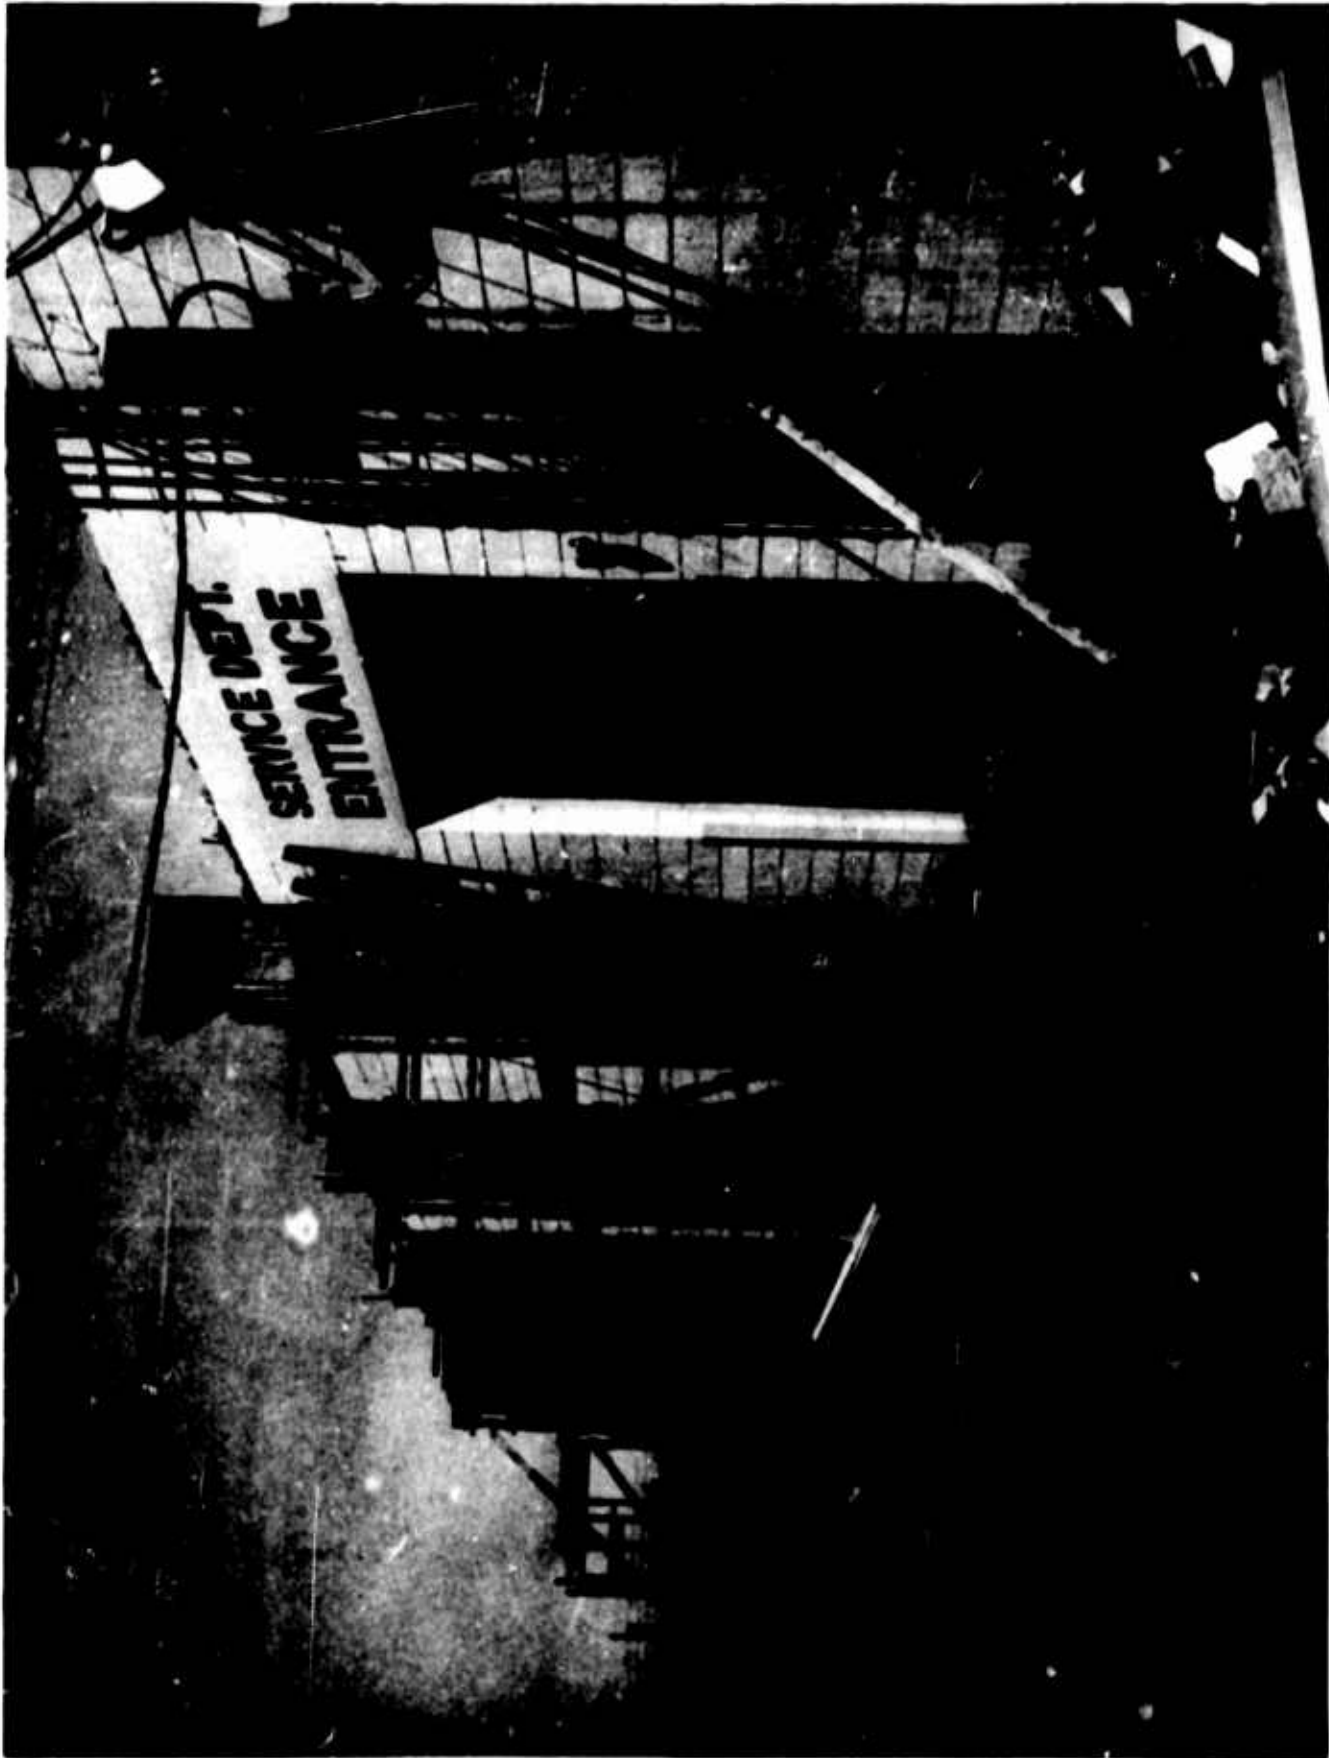
Figure 201. Fifth Avenue Chrysler Center (Remedial measures being taken to strengthen the standing portion of the structure)

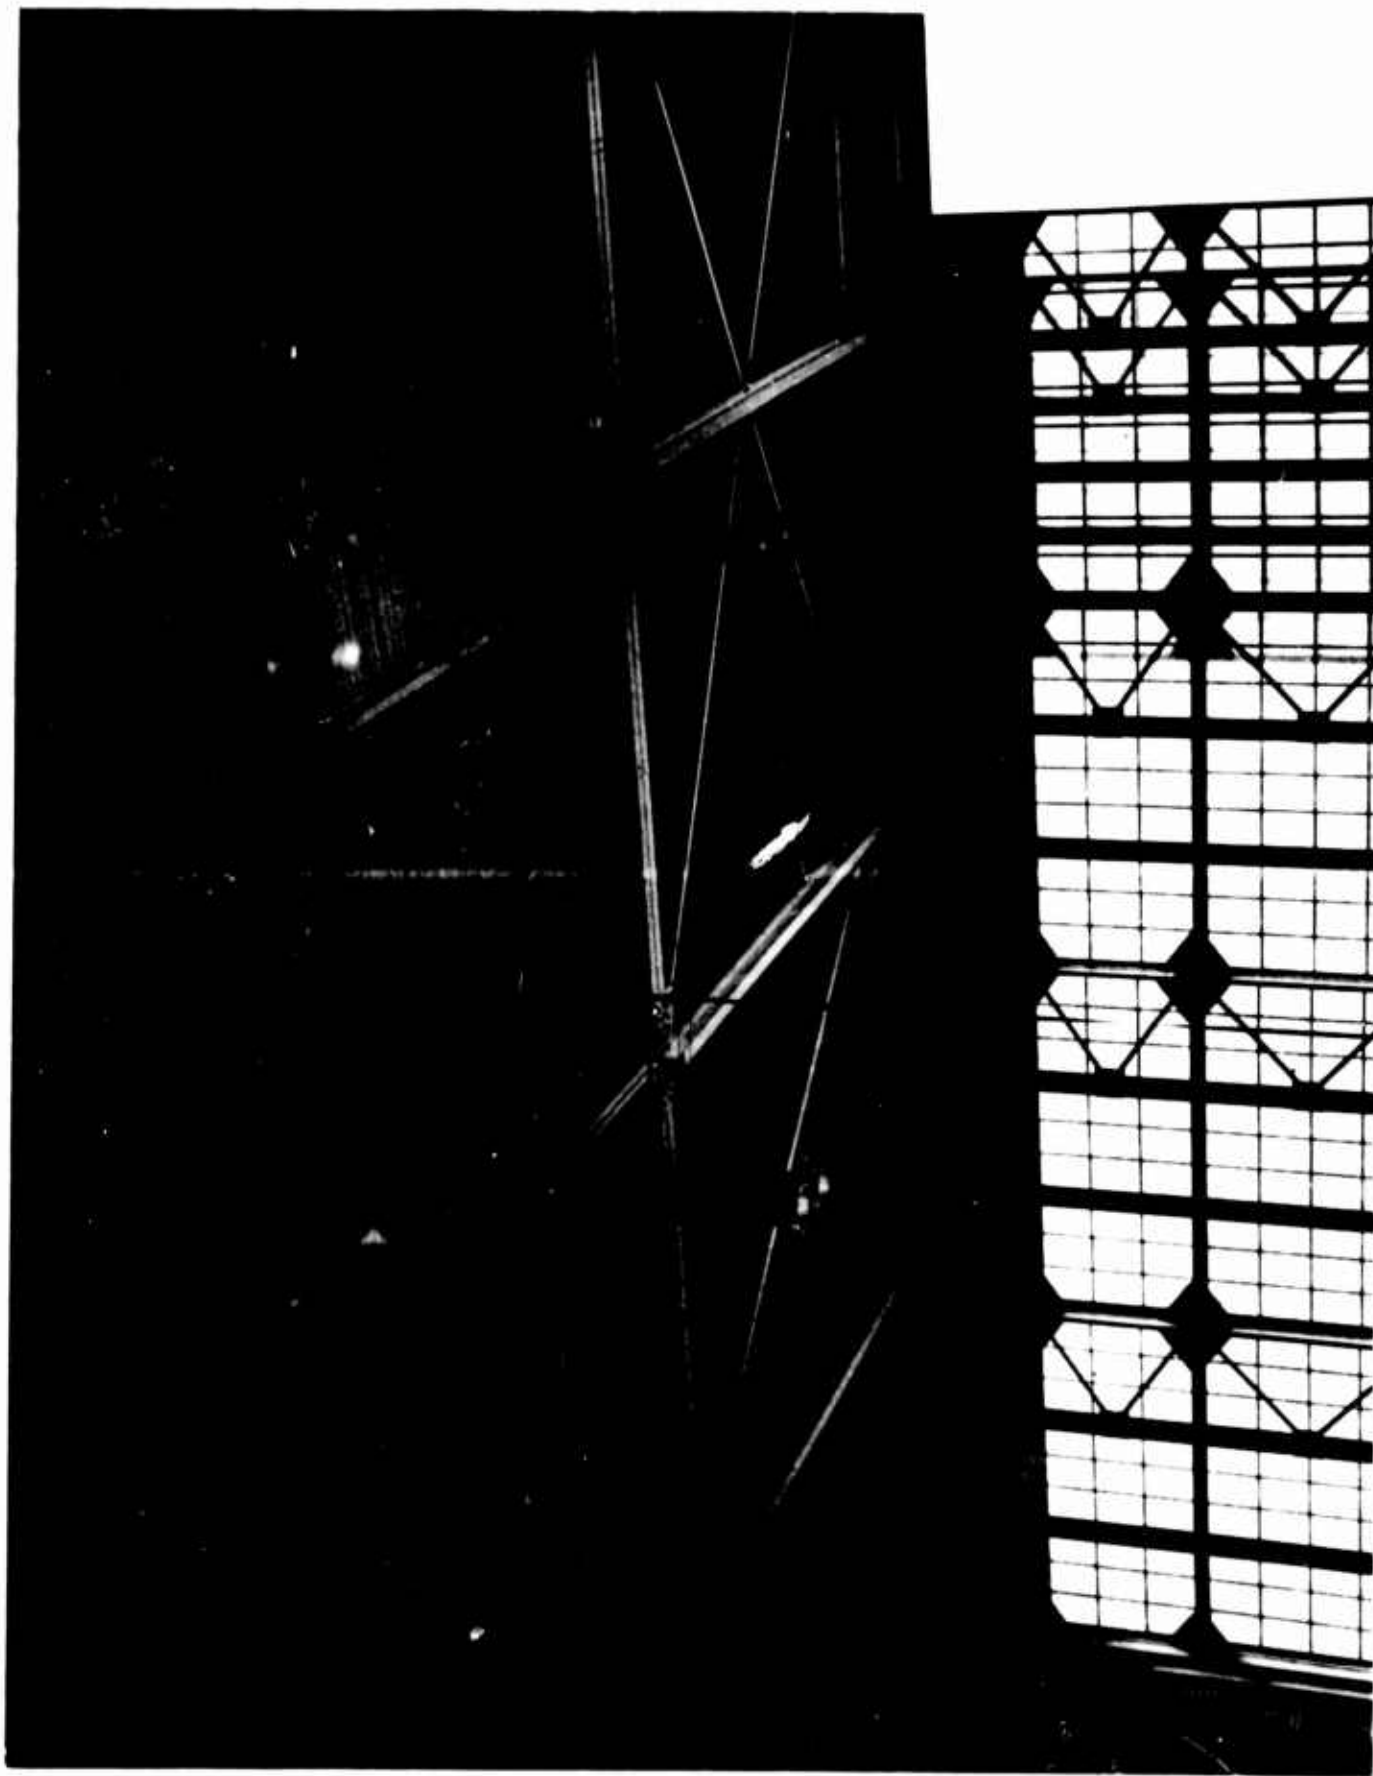
Figure 211. Elmendorf AFB Aircraft Maintenance Hangar (Roof framing in the hangar)

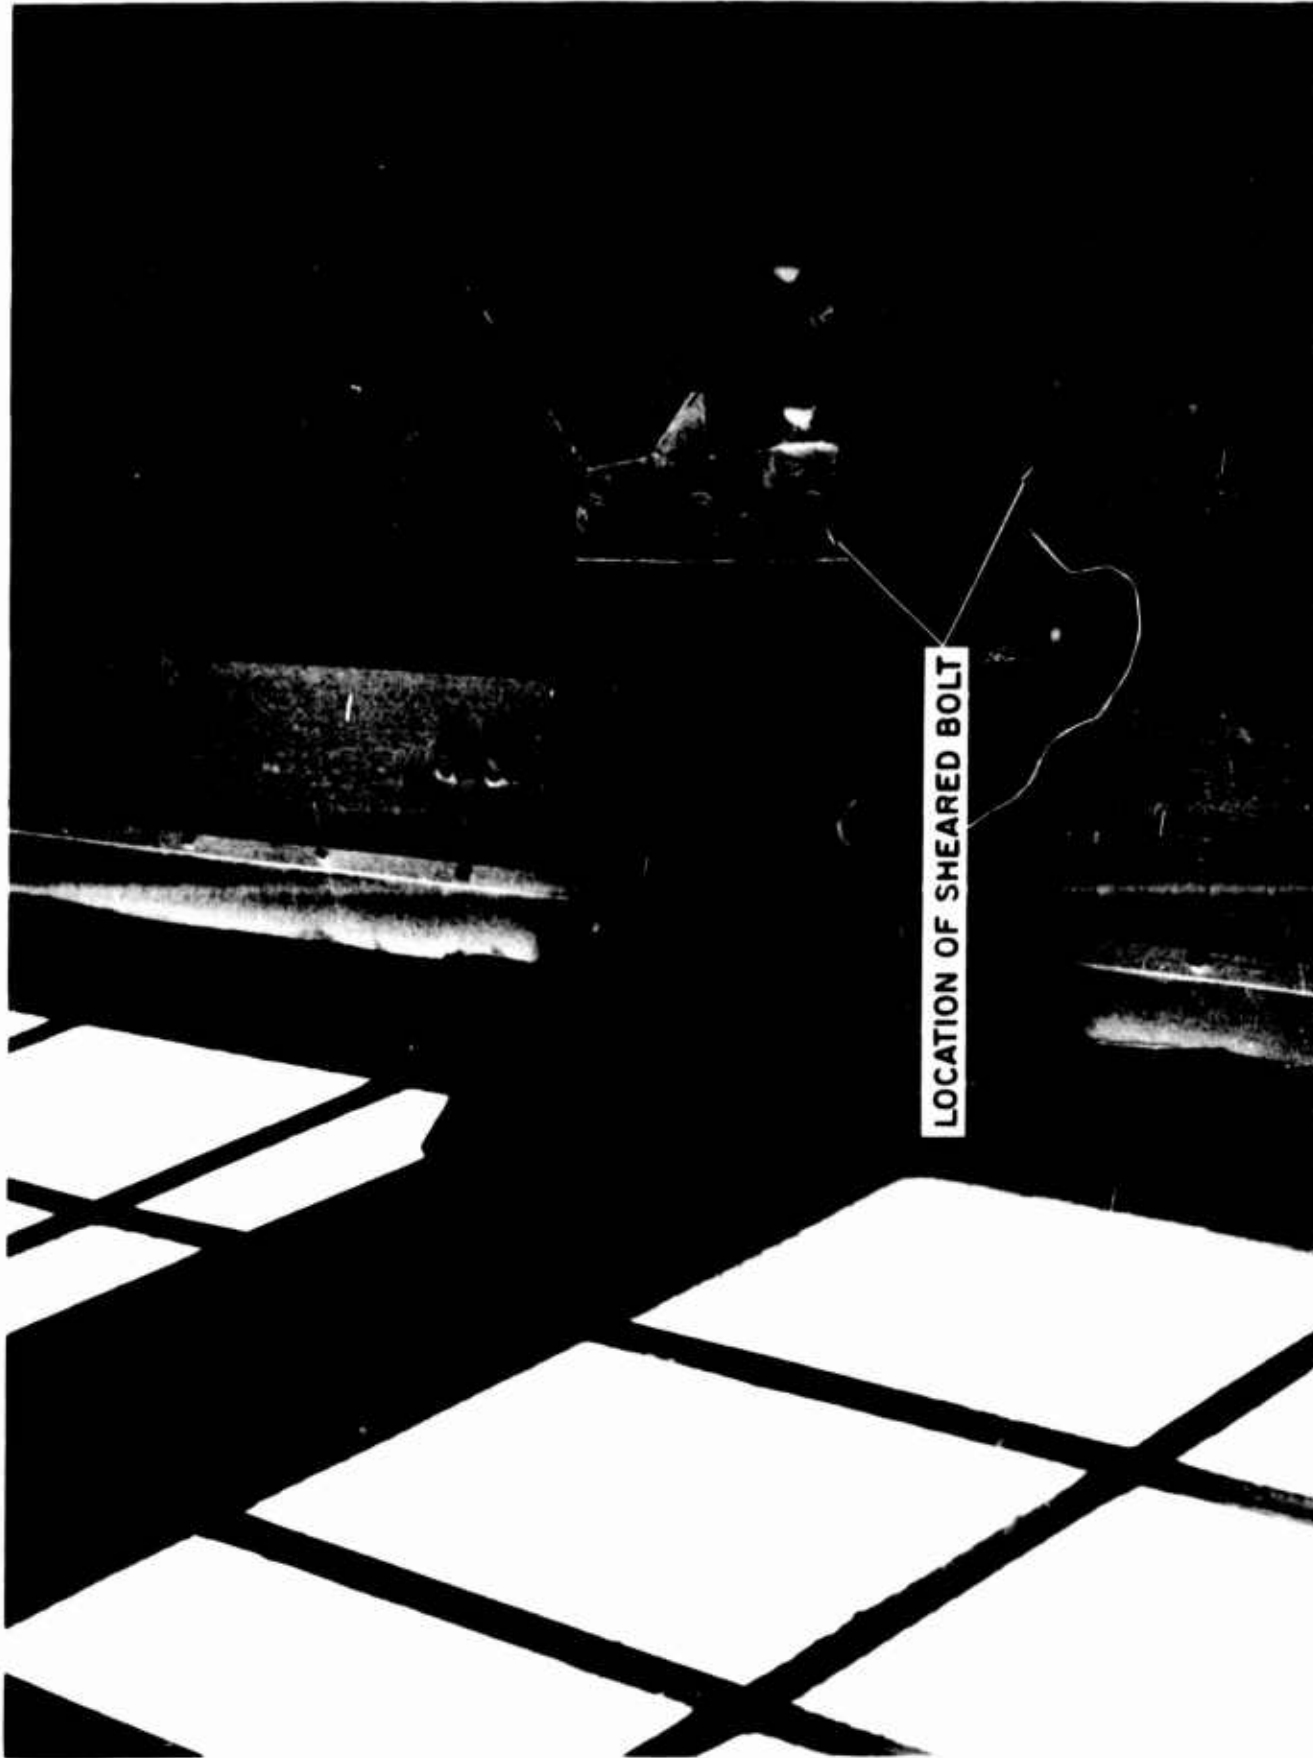
Figure 213. Elmendorf AFB Aircraft Maintenance Hangar
(Failed crossbracing connection. Note two of three bolts had been omitted)
