THE GREAT ALASKA EARTHQUAKE

Volume II

Illustrations and Maps

TECHNICAL REPORT NO. AFWL-TR-65-92, Vol II

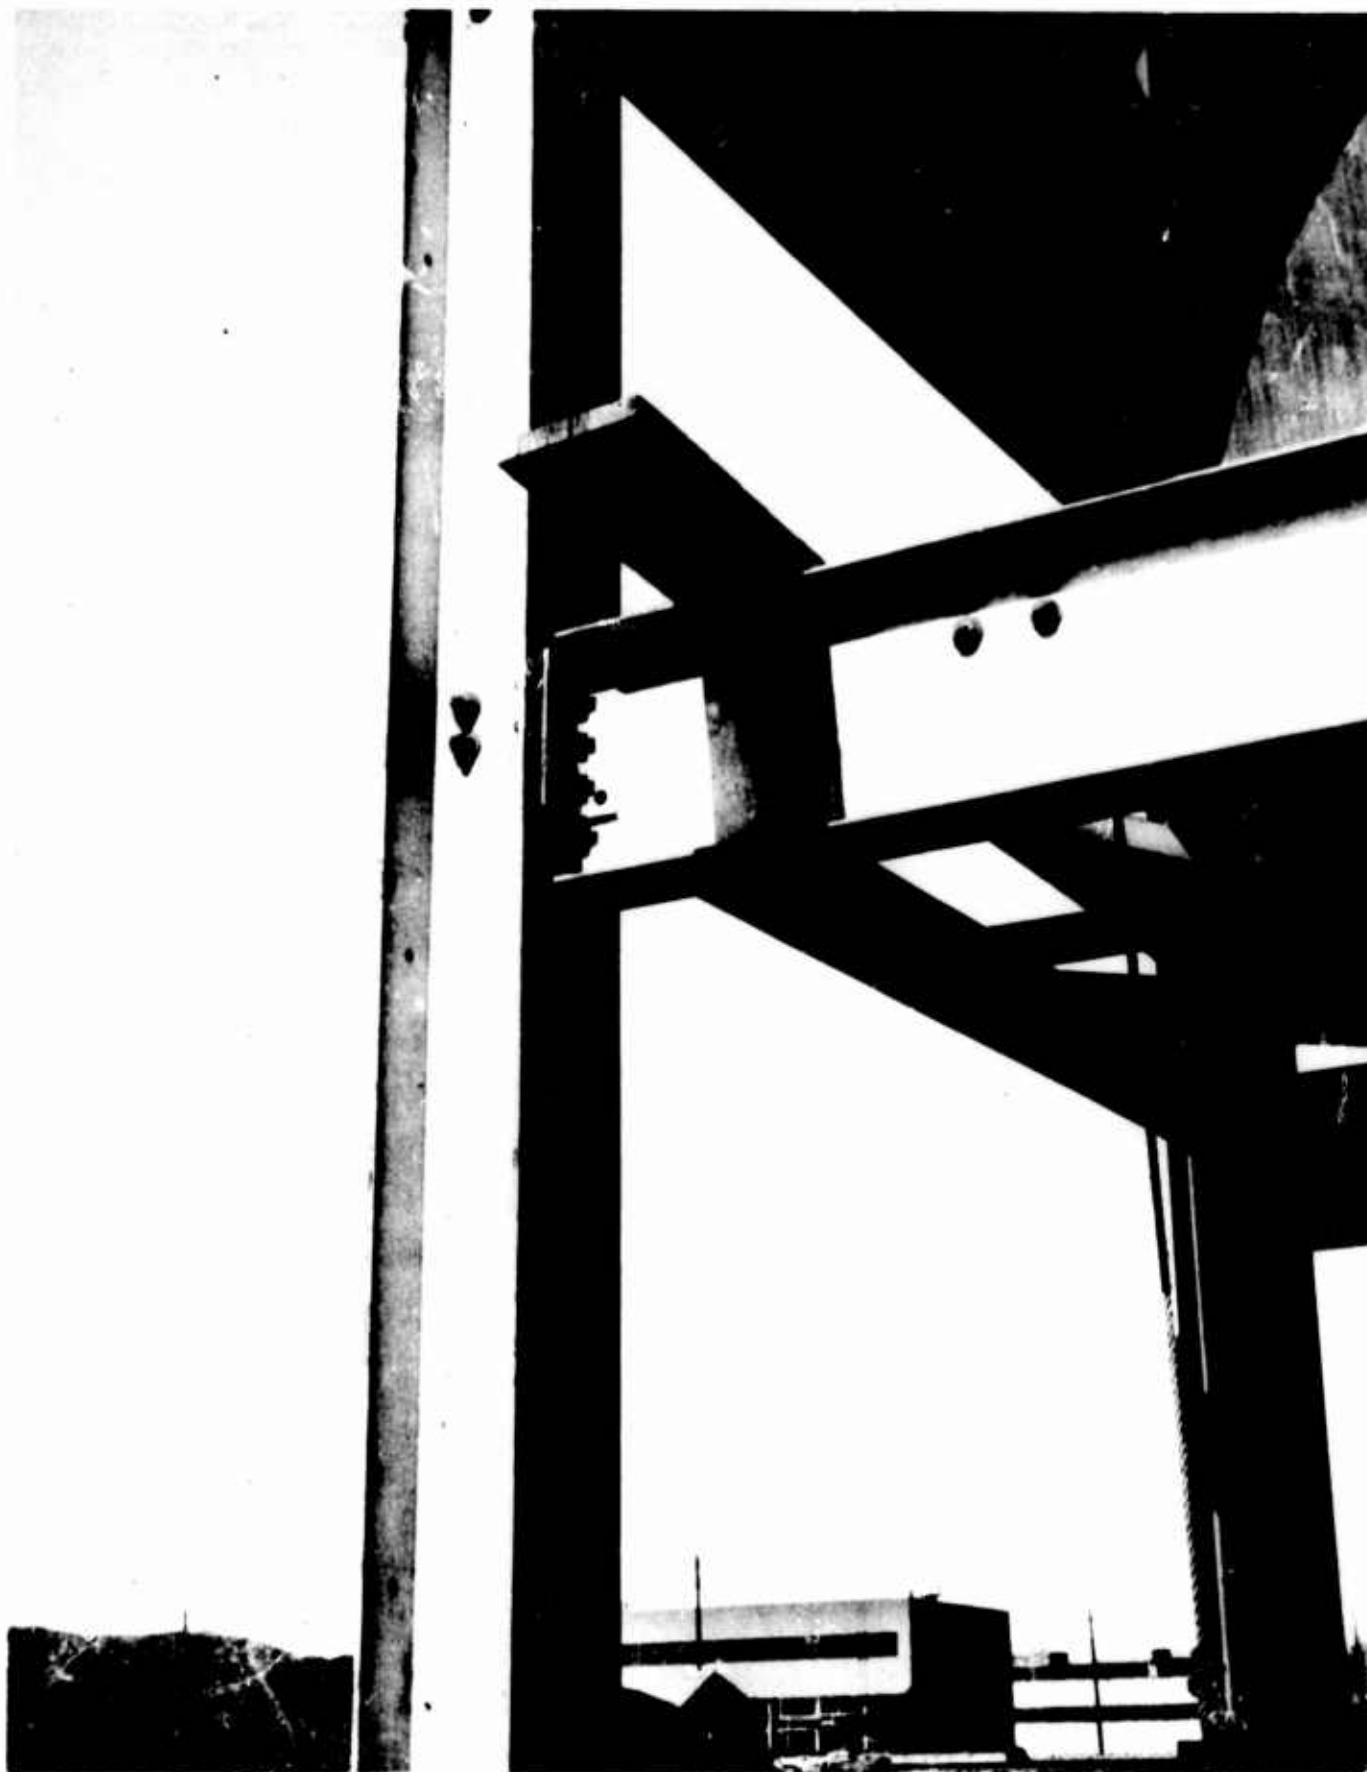
Figure 222. Alaska Brewery Company Structure (Typical undamaged bolted connection)

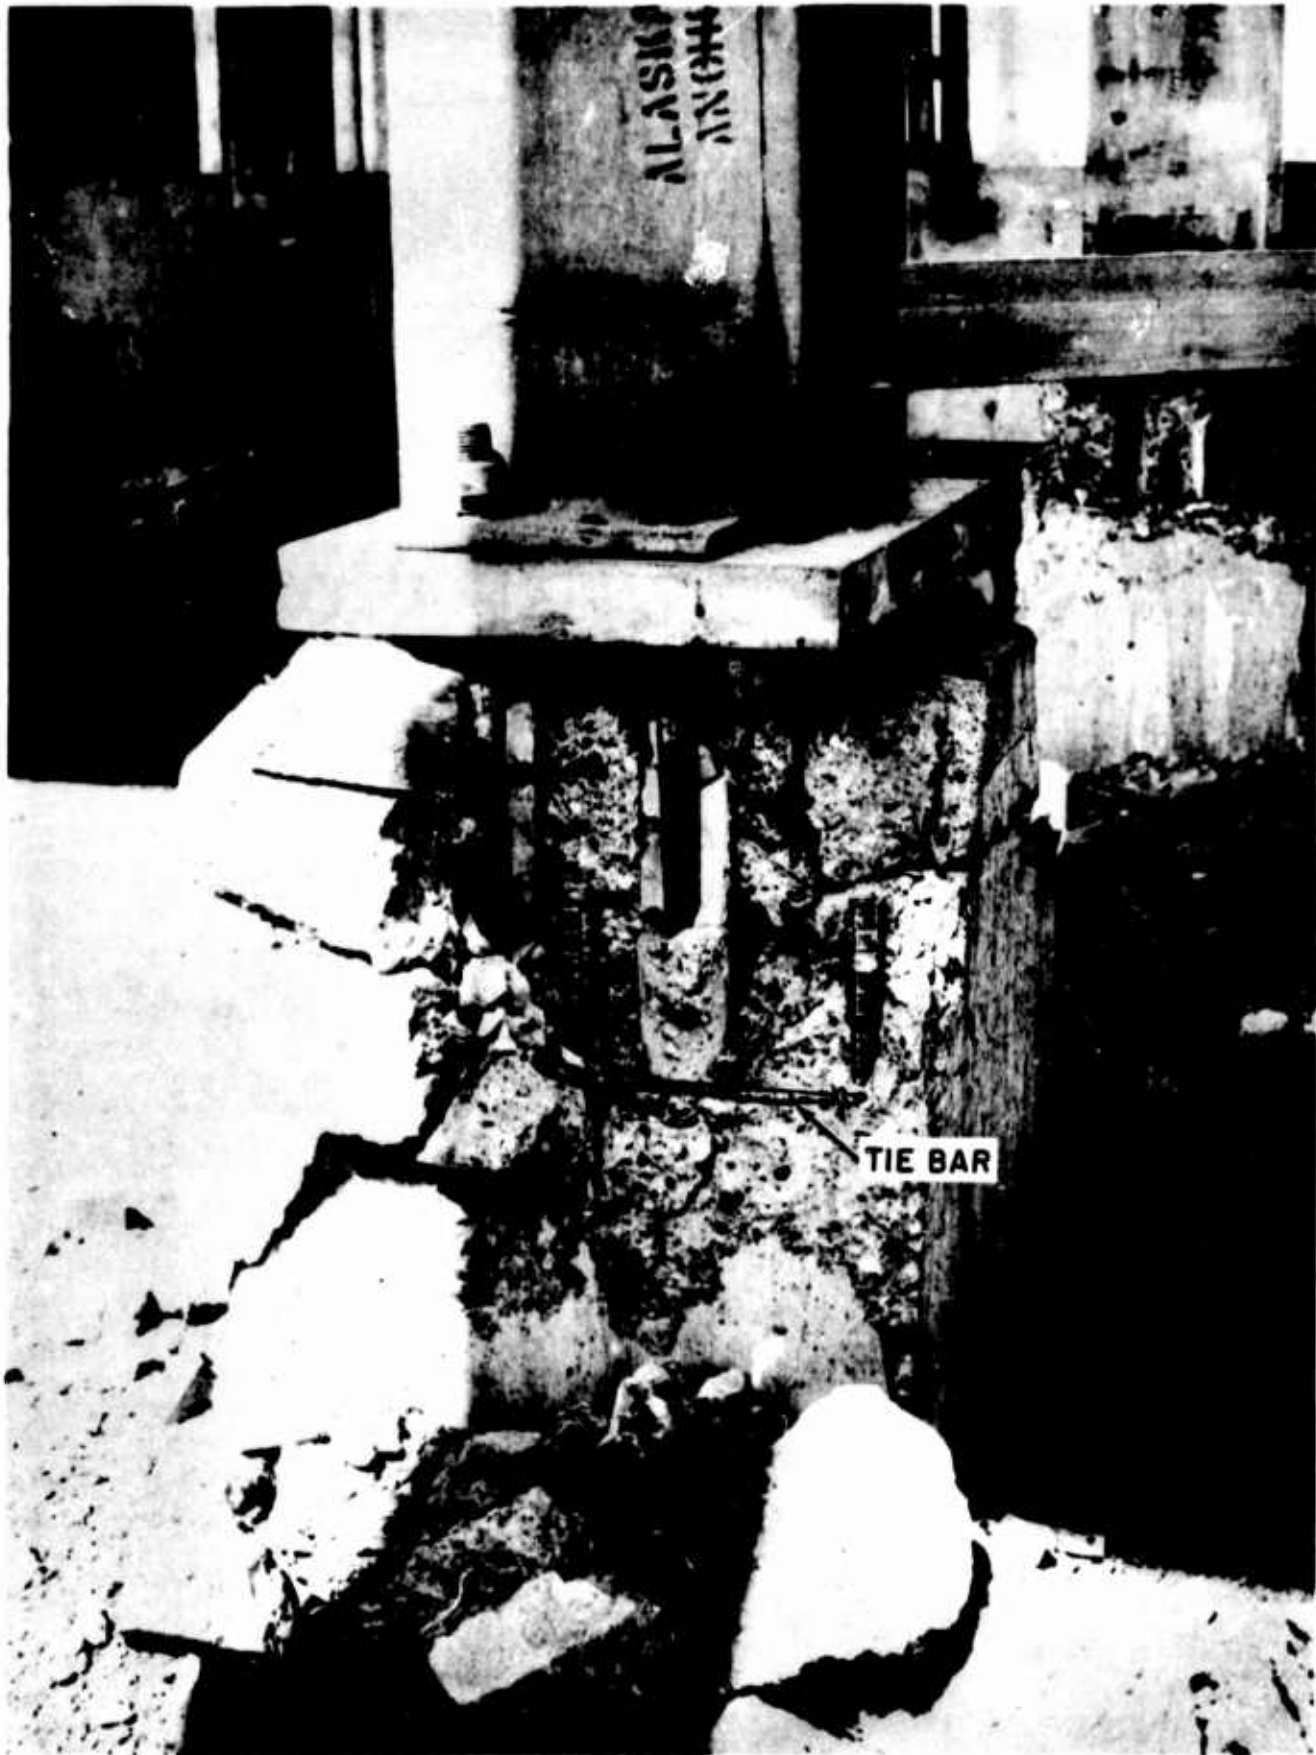
Figure 224. Alaska Brewery Company Structure
(Damage to an interior footing, mainly above first horizontal tie)

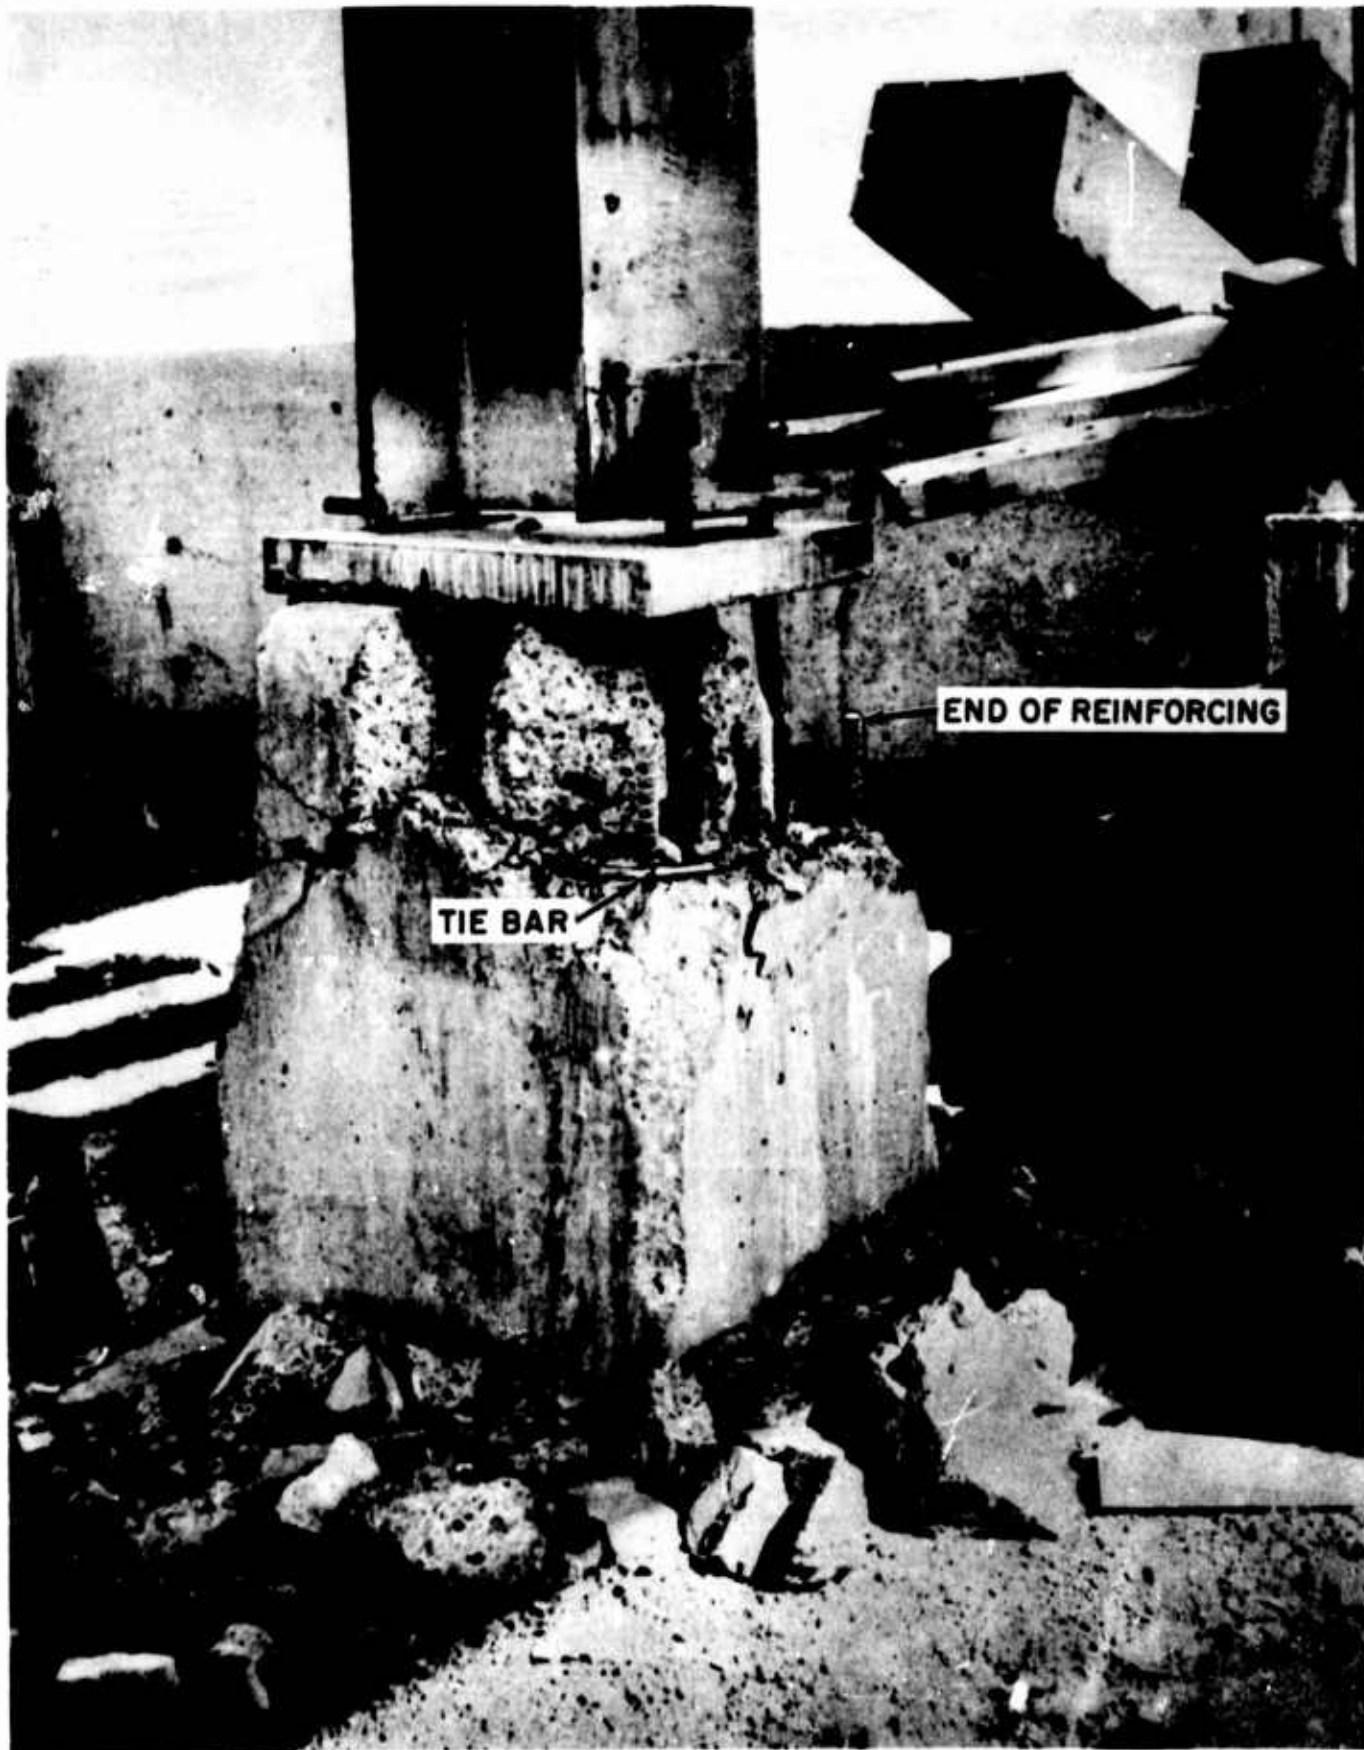
Figure 225. Alaska Brewery Company Structure
(Damage to an interior footing, mainly above first horizontal tie)

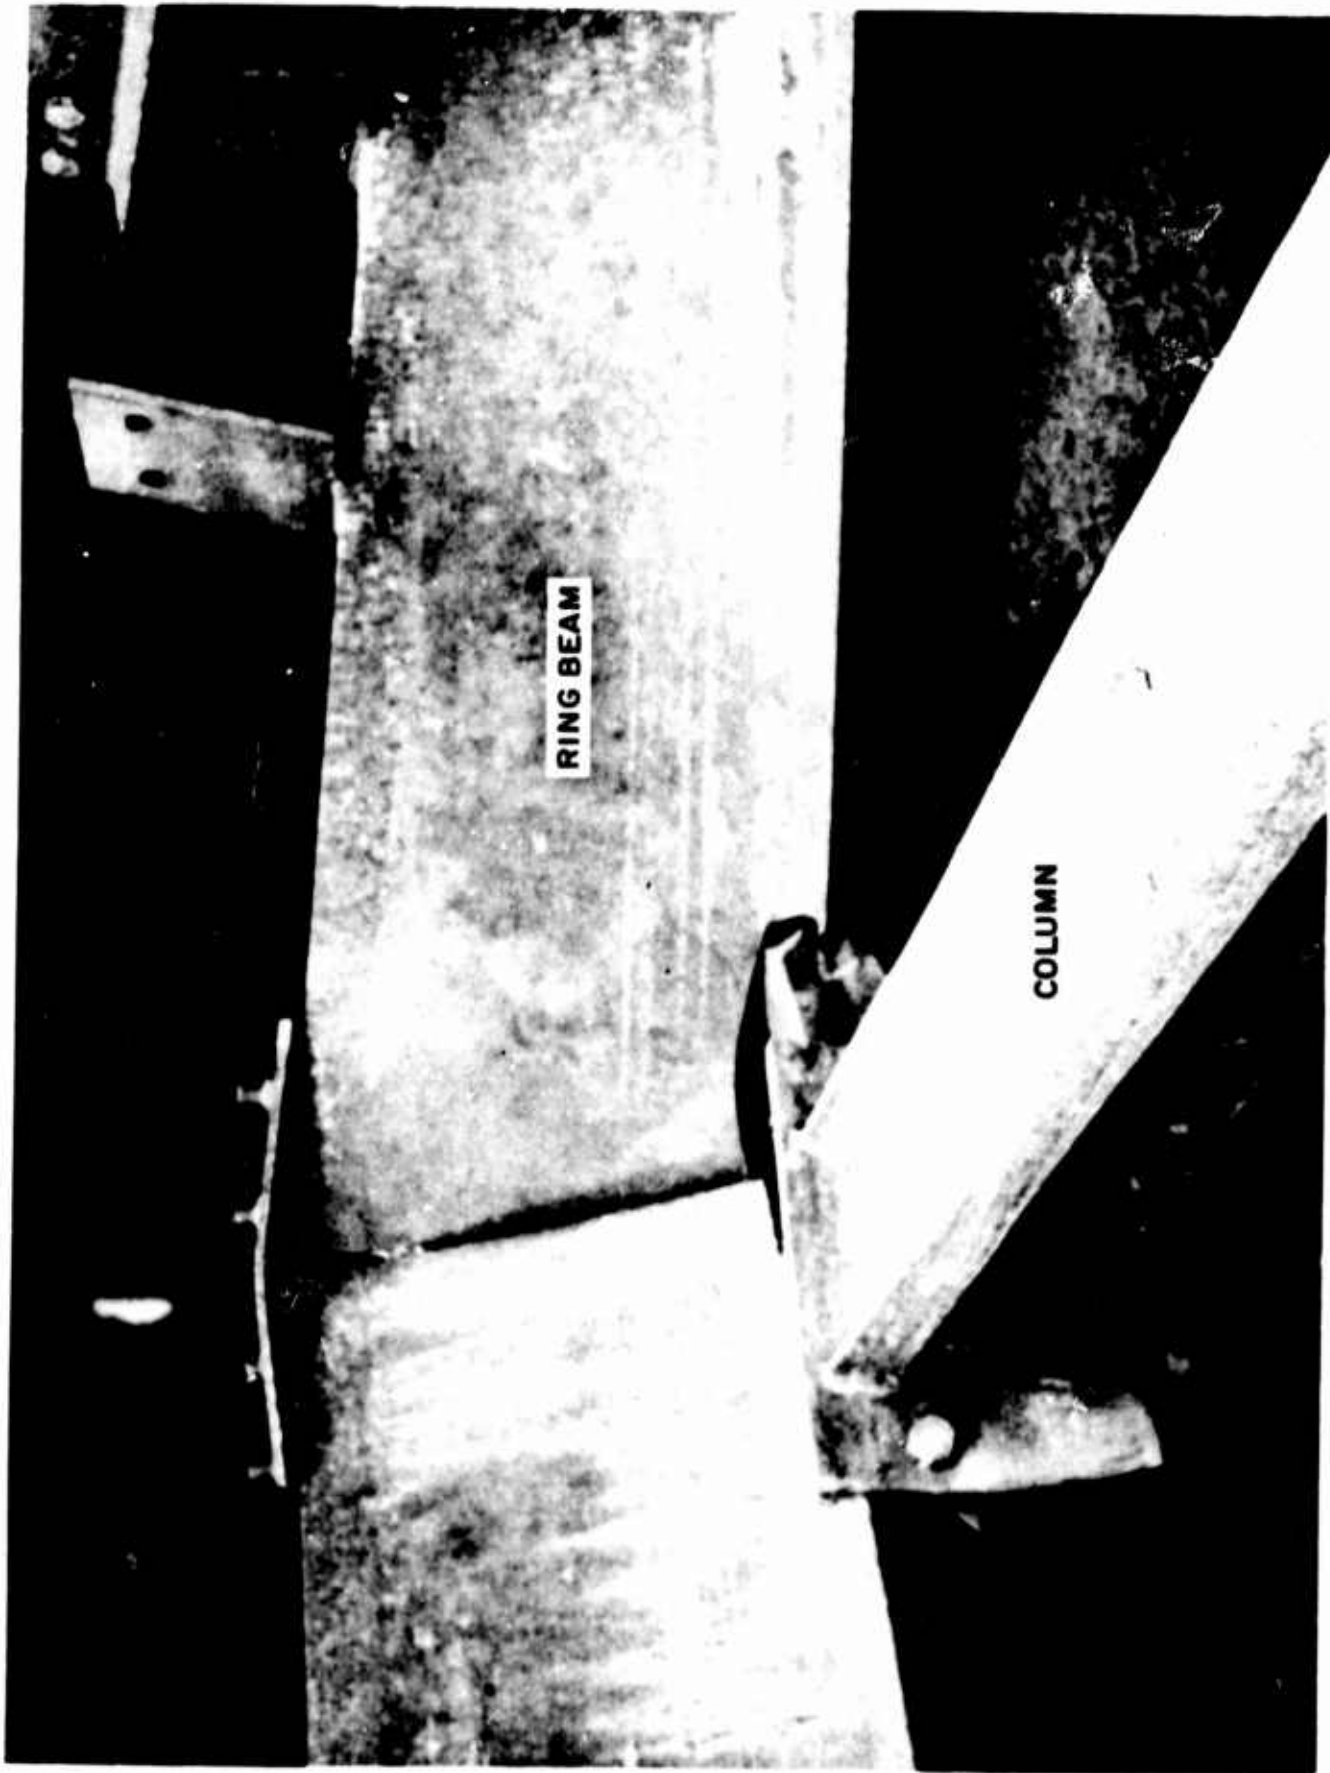
Figure 236. Shell Oil Company Waterfront Storage Tank
(Closeup of failed ring beam/column connection inside collapsed tank)

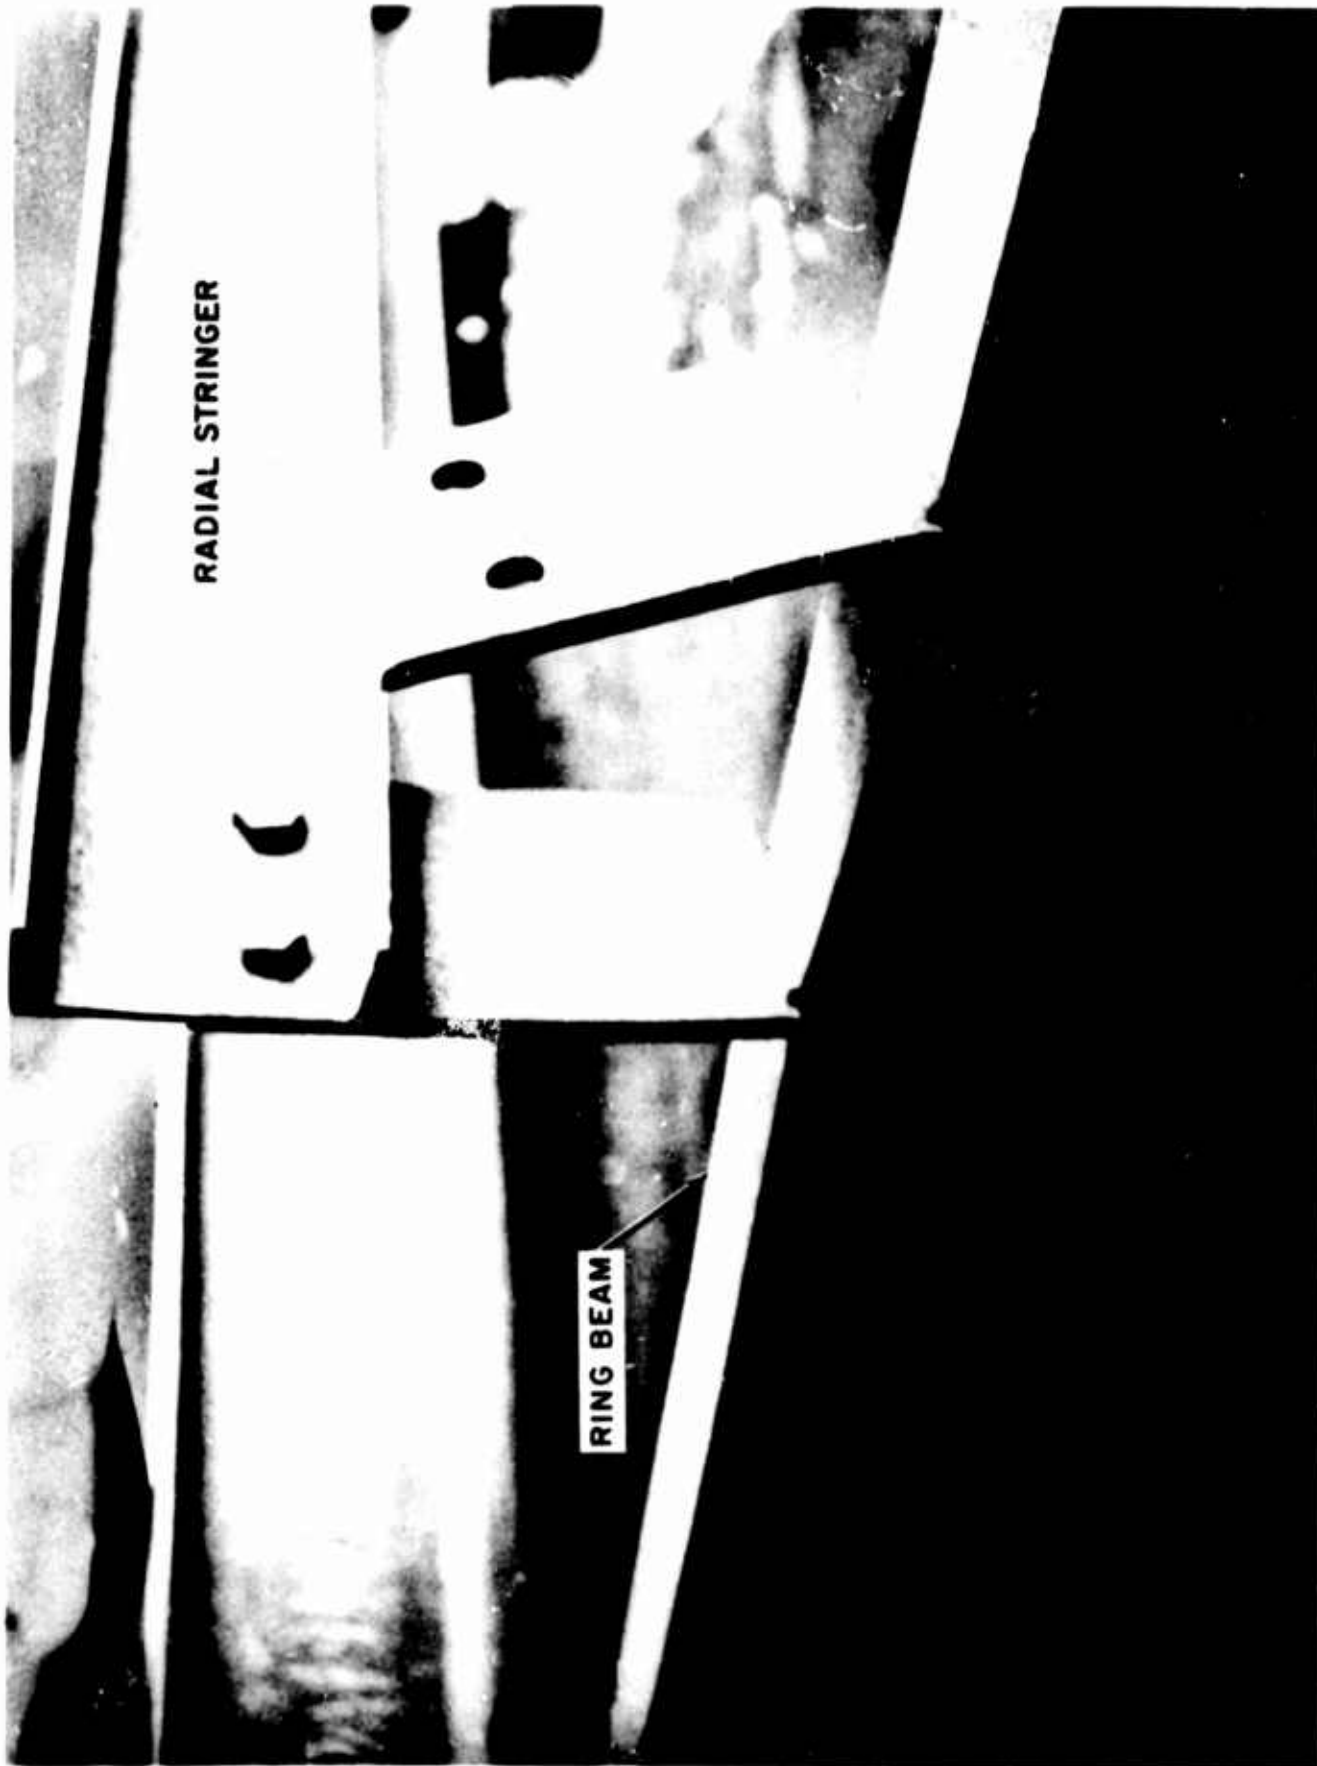
Figure 237. Shell Oil Company Waterfront Storage Tank
(Closeup of failed bolted connection between radial stringer and ring beam inside collapsed tank)

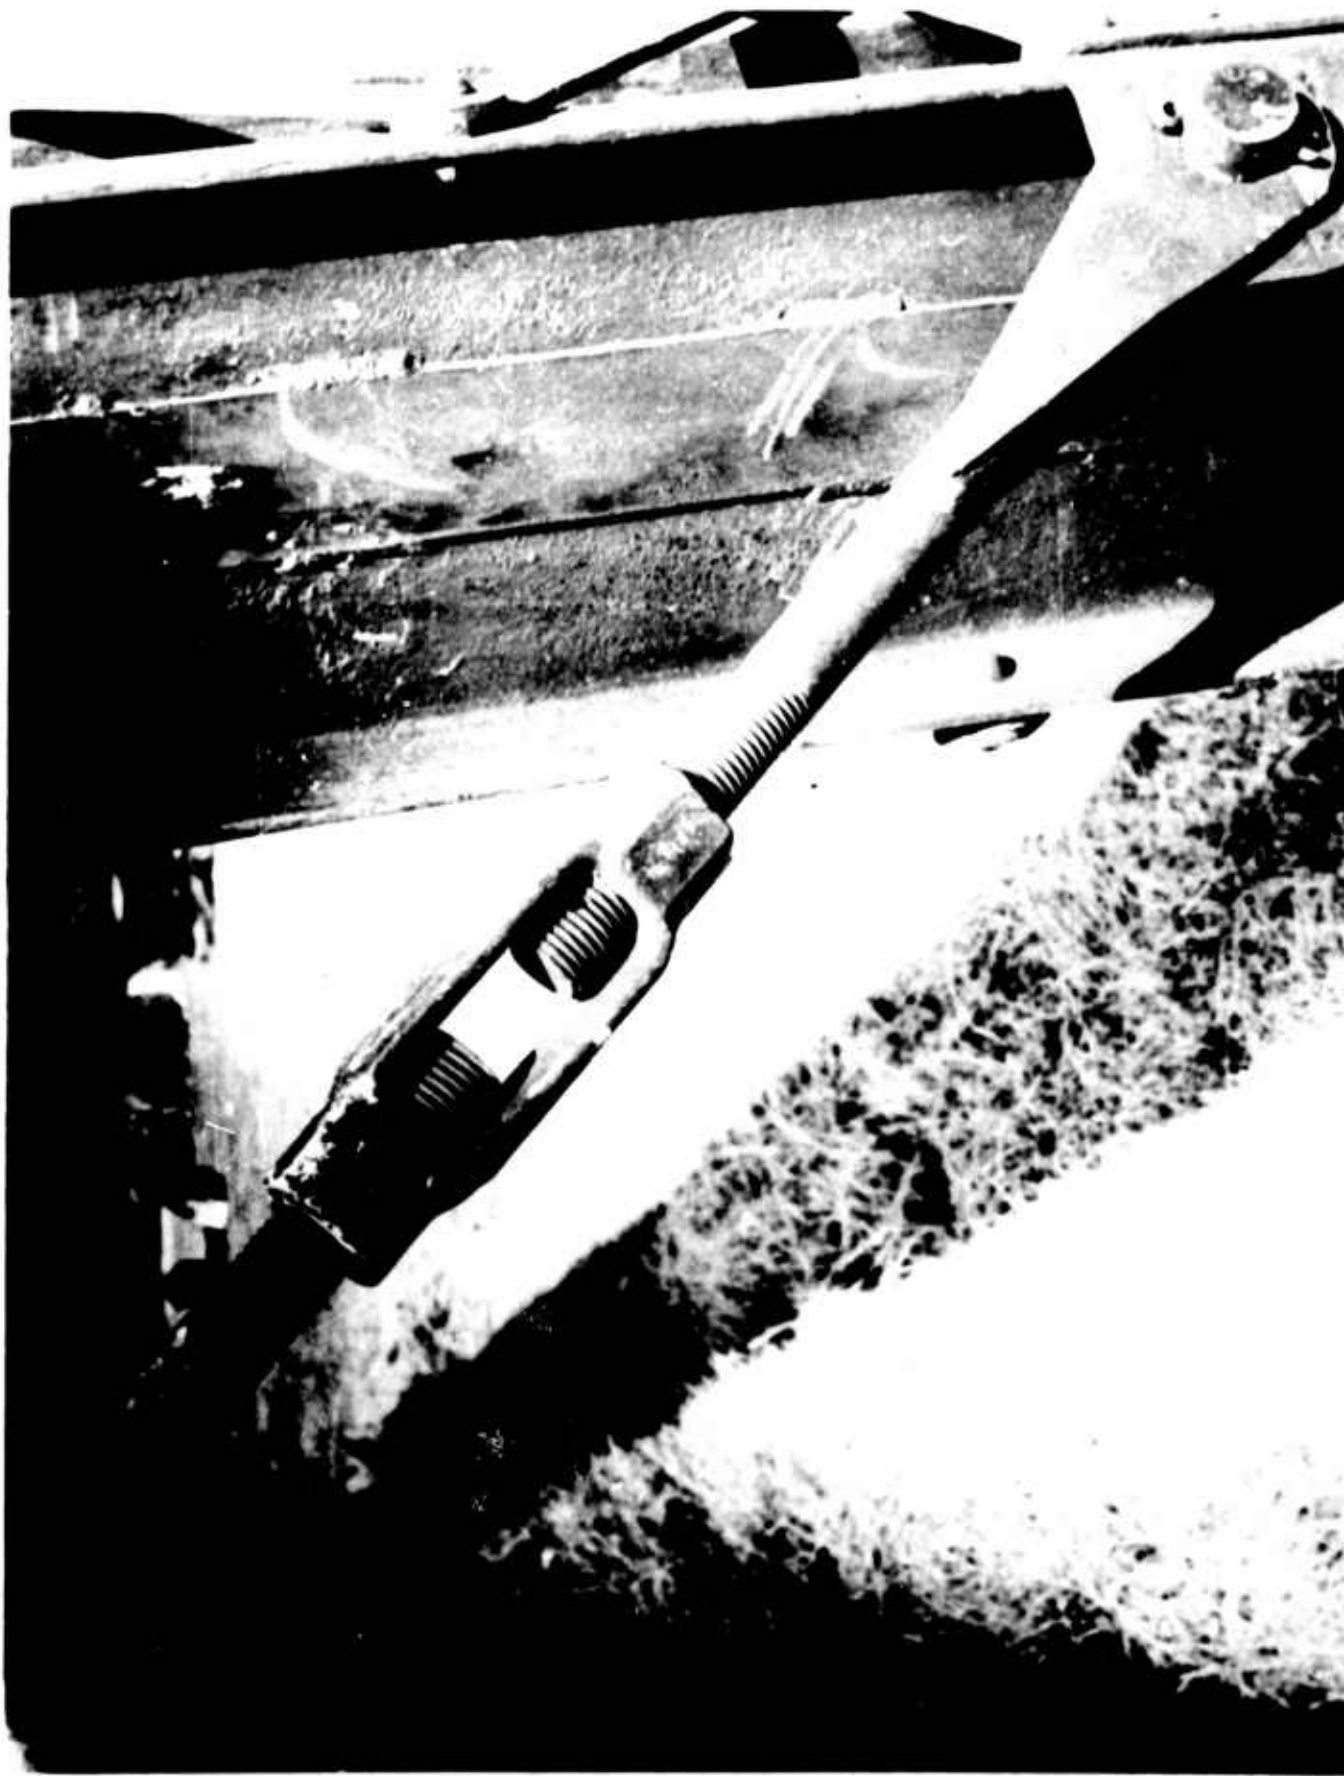
Figure 251. Alaska Native Hospital Water Tower
(Tie-rod turnbuckle at base of tower shows no sign of yielding)

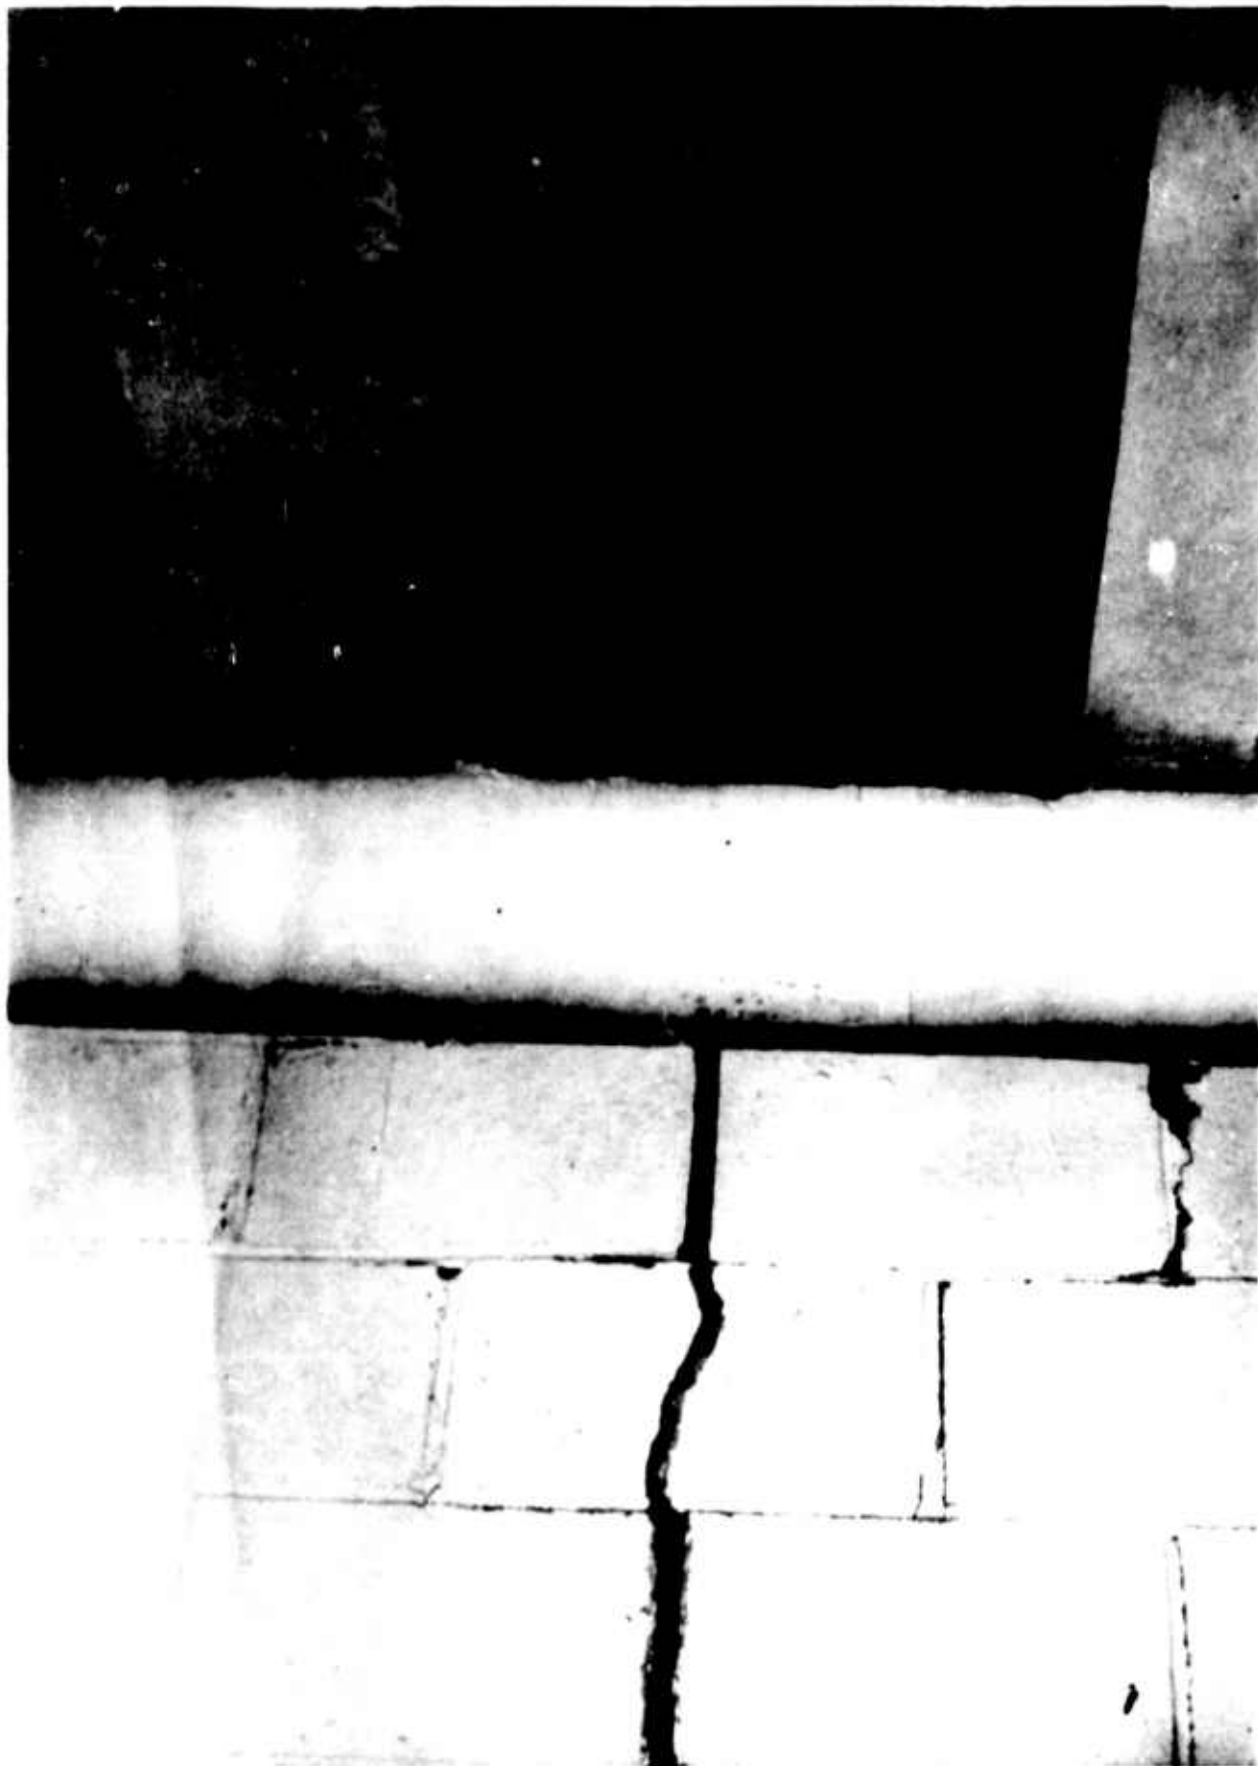
Figure 268. Elmendorf AFB Building 6-900
(Cracked masonry-block wall inside building)

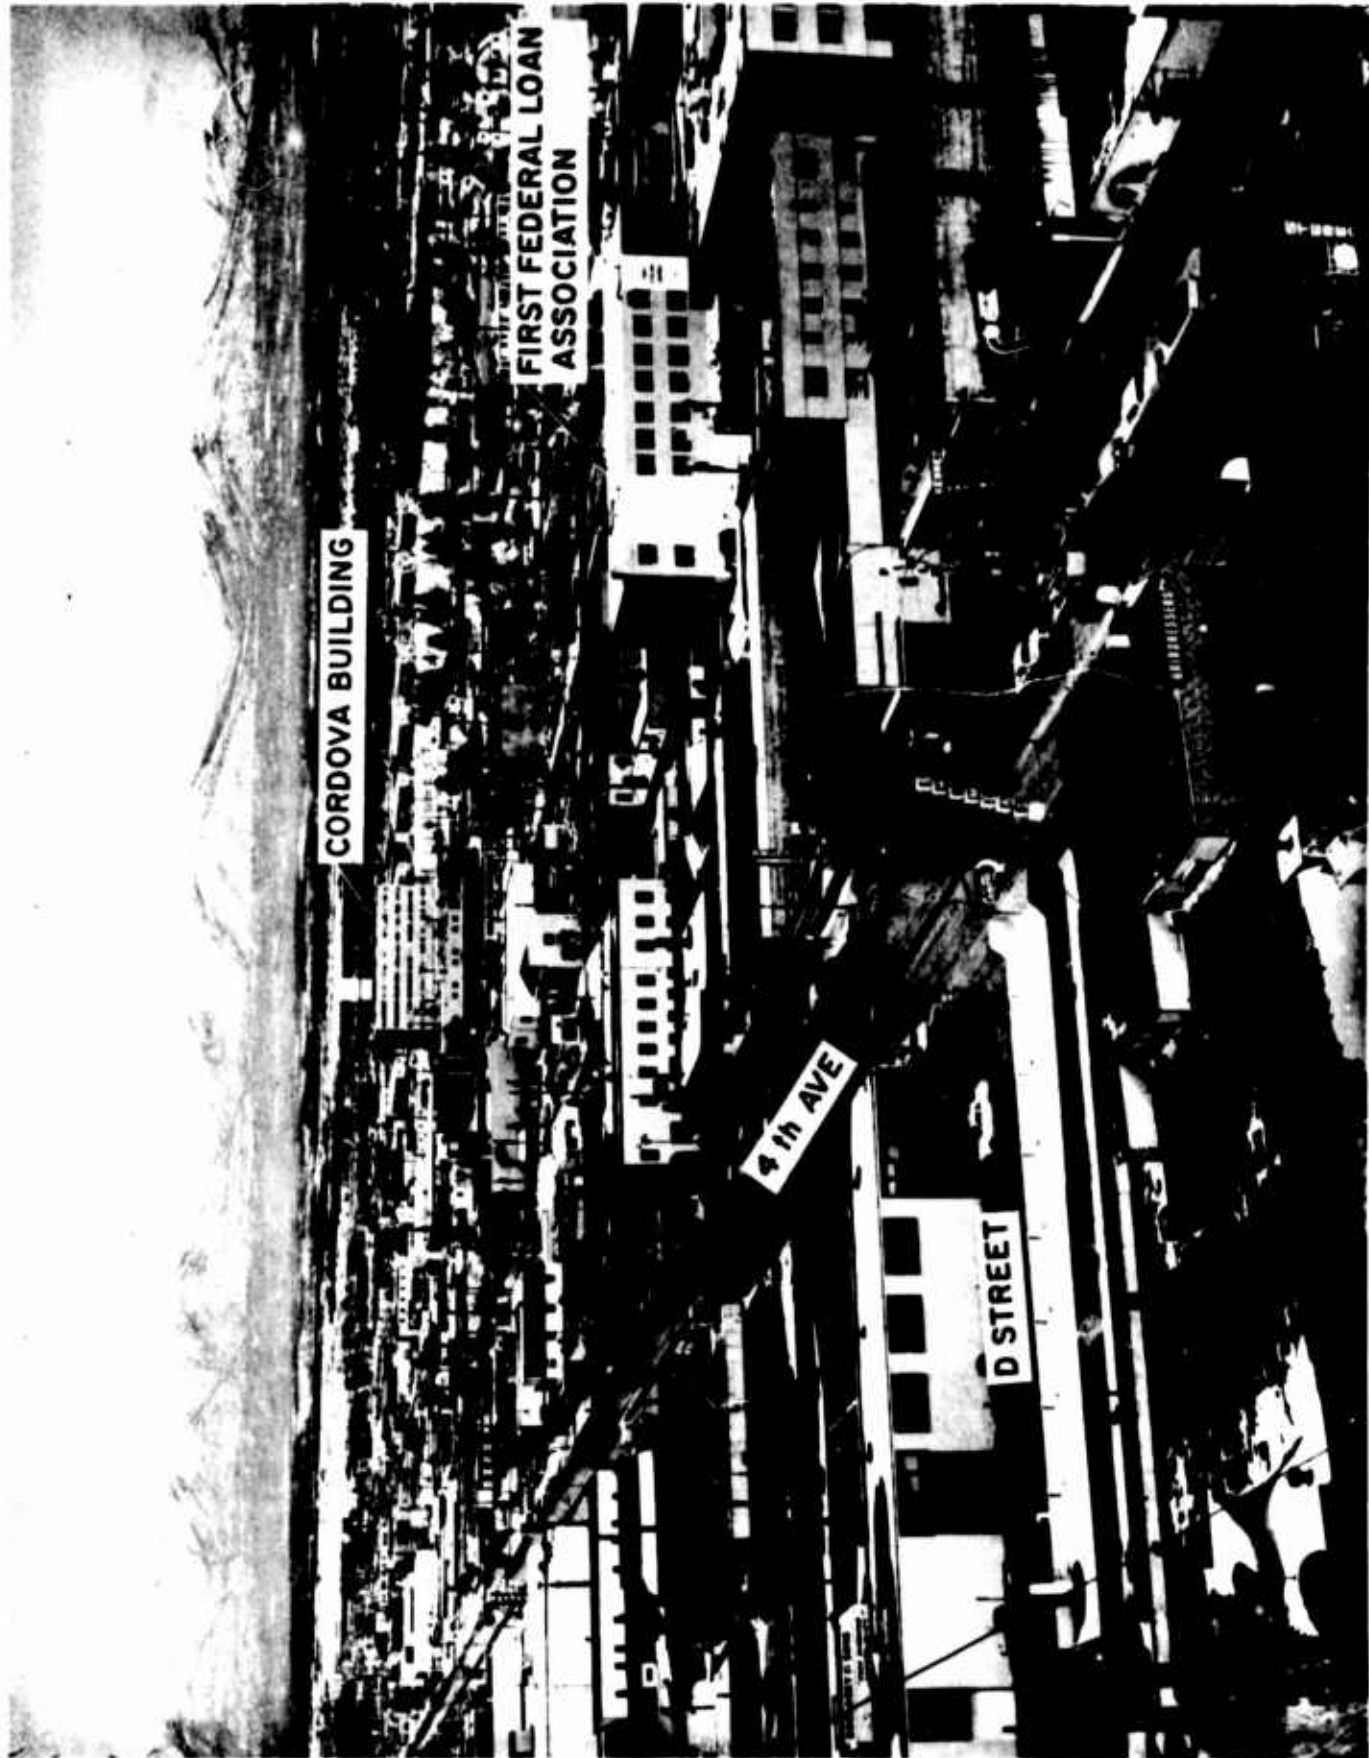
Figure 281. First Federal Savings and Loan Association Building (Downtown Anchorage before the earthquake. The First Federal Savings and Loan Association Building is in right center.)

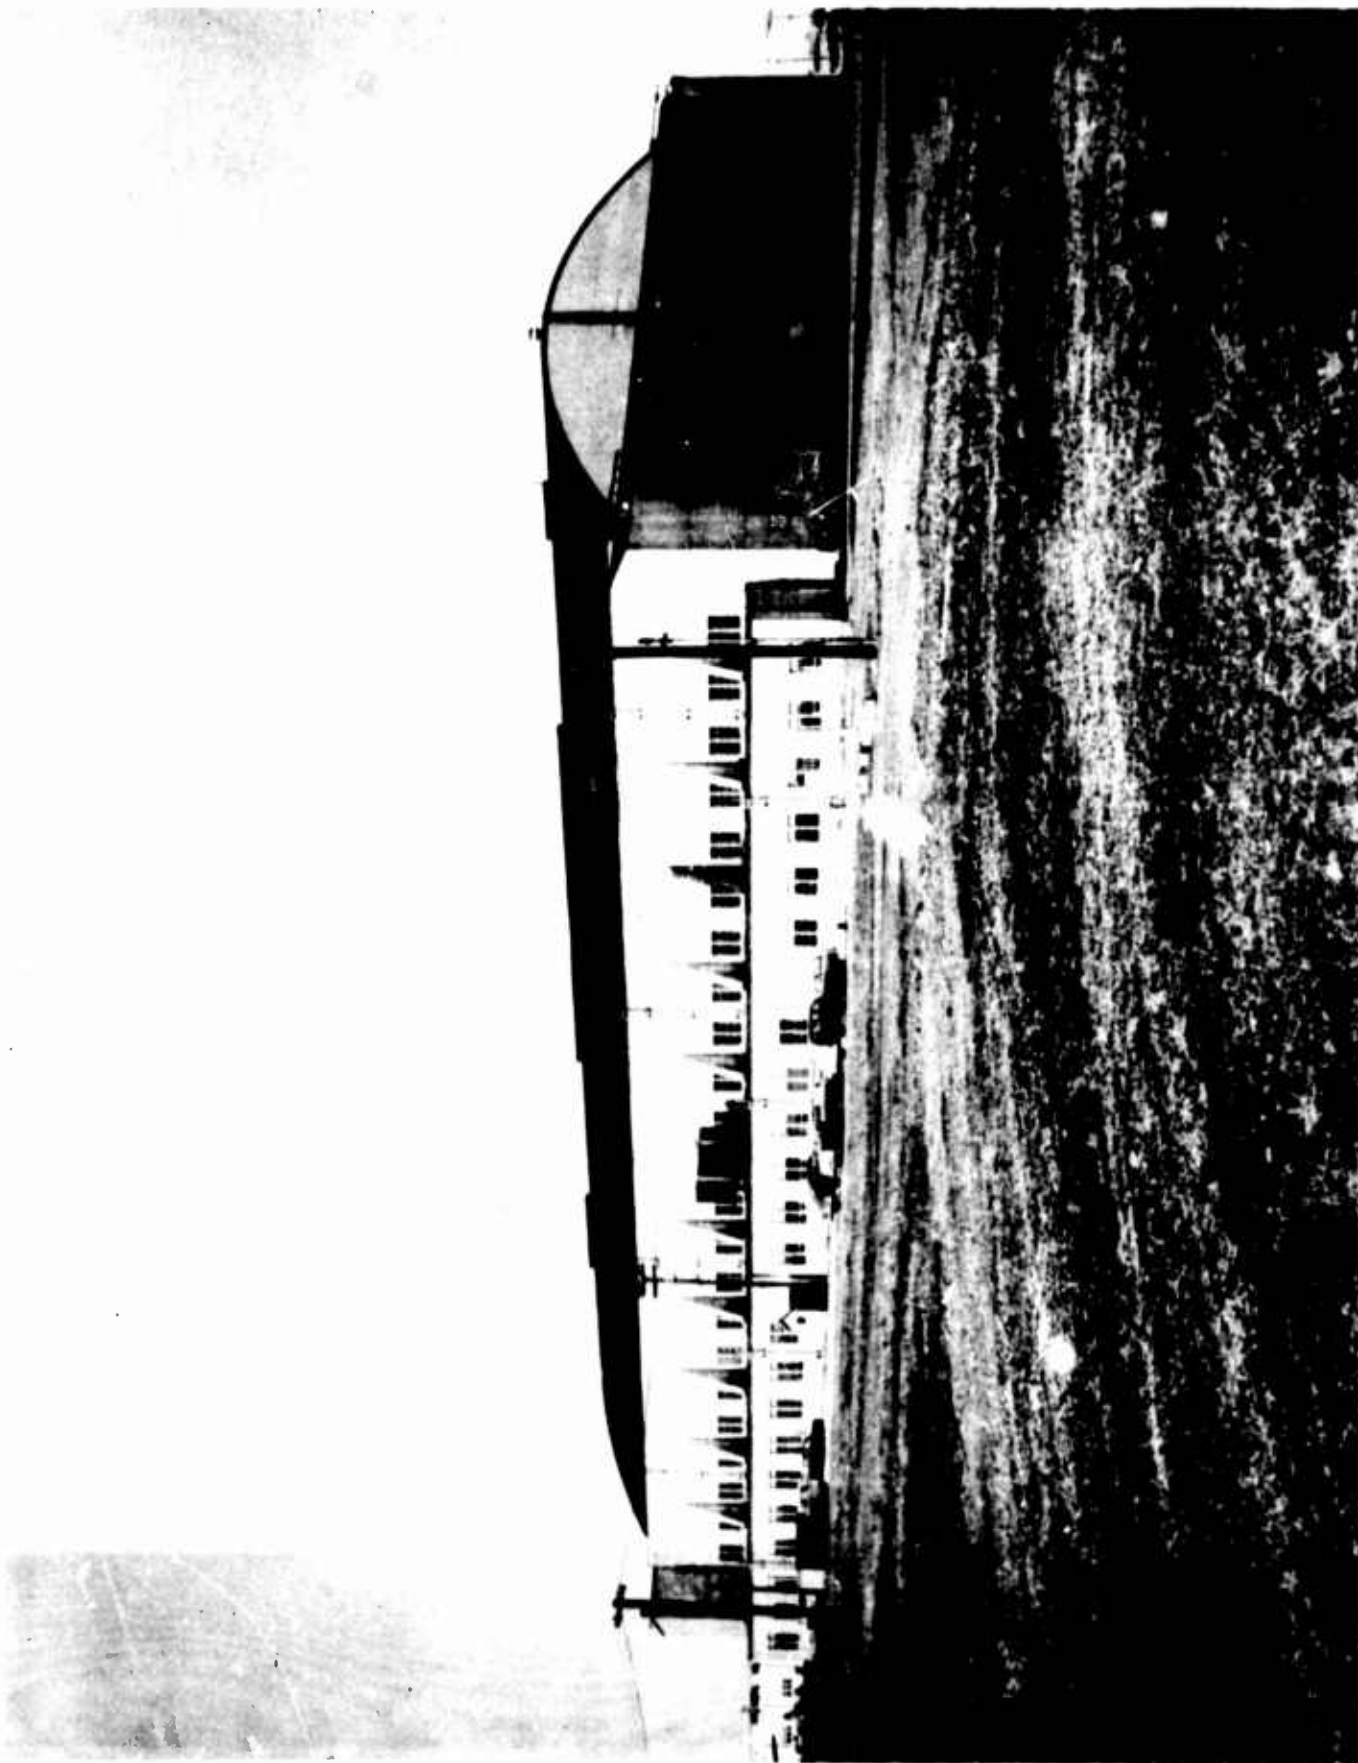
Figure 287. Elmendorf AFB Aircraft Maintenance Hangars
(South side of Building 32-060, one of two identical birchwood hangars)
