# A RESEARCH STUDY ON INTERNAL CORROSION OF HIGH PRESSURE BOILERS

## SECOND PROGRESS REPORT

**P. GOLDSTEIN**

Steam and Water Division  
Kreisinger Development Laboratory  
Combustion Engineering, Inc.  
Windsor, Connecticut

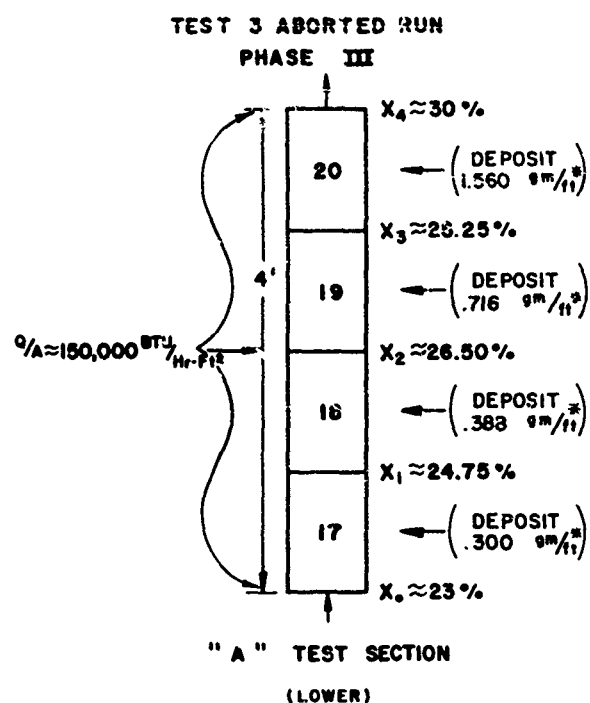
Fig. 5: Typical deposit distribution on a high-heat-flux "A" loop test section

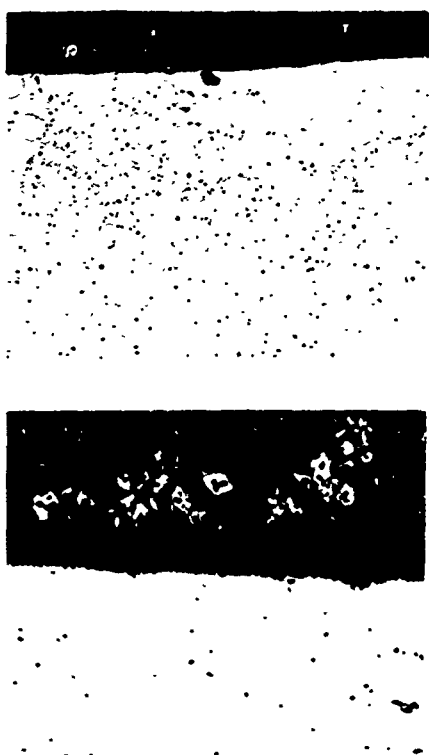
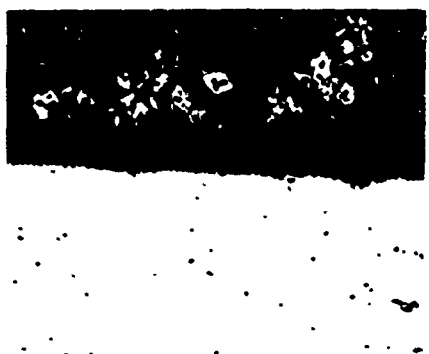
**Fig. VII-5:** Upper—100x photomicrograph of the deposit cross section from the dirty boiler volatile test  
Lower—400x photomicrograph as above
