CRASH INJURY EVALUATION

AO-1BF MOHAWK MOCKUP

AO-1BF U. S. ARMY "MOHAWK" MOCKUP EVALUATION
Bethpage, Long Island, New York
31 March 1960

REPORT OF CRASH INJURY EVALUATION
AvCIR-12-PV-117
August 1960

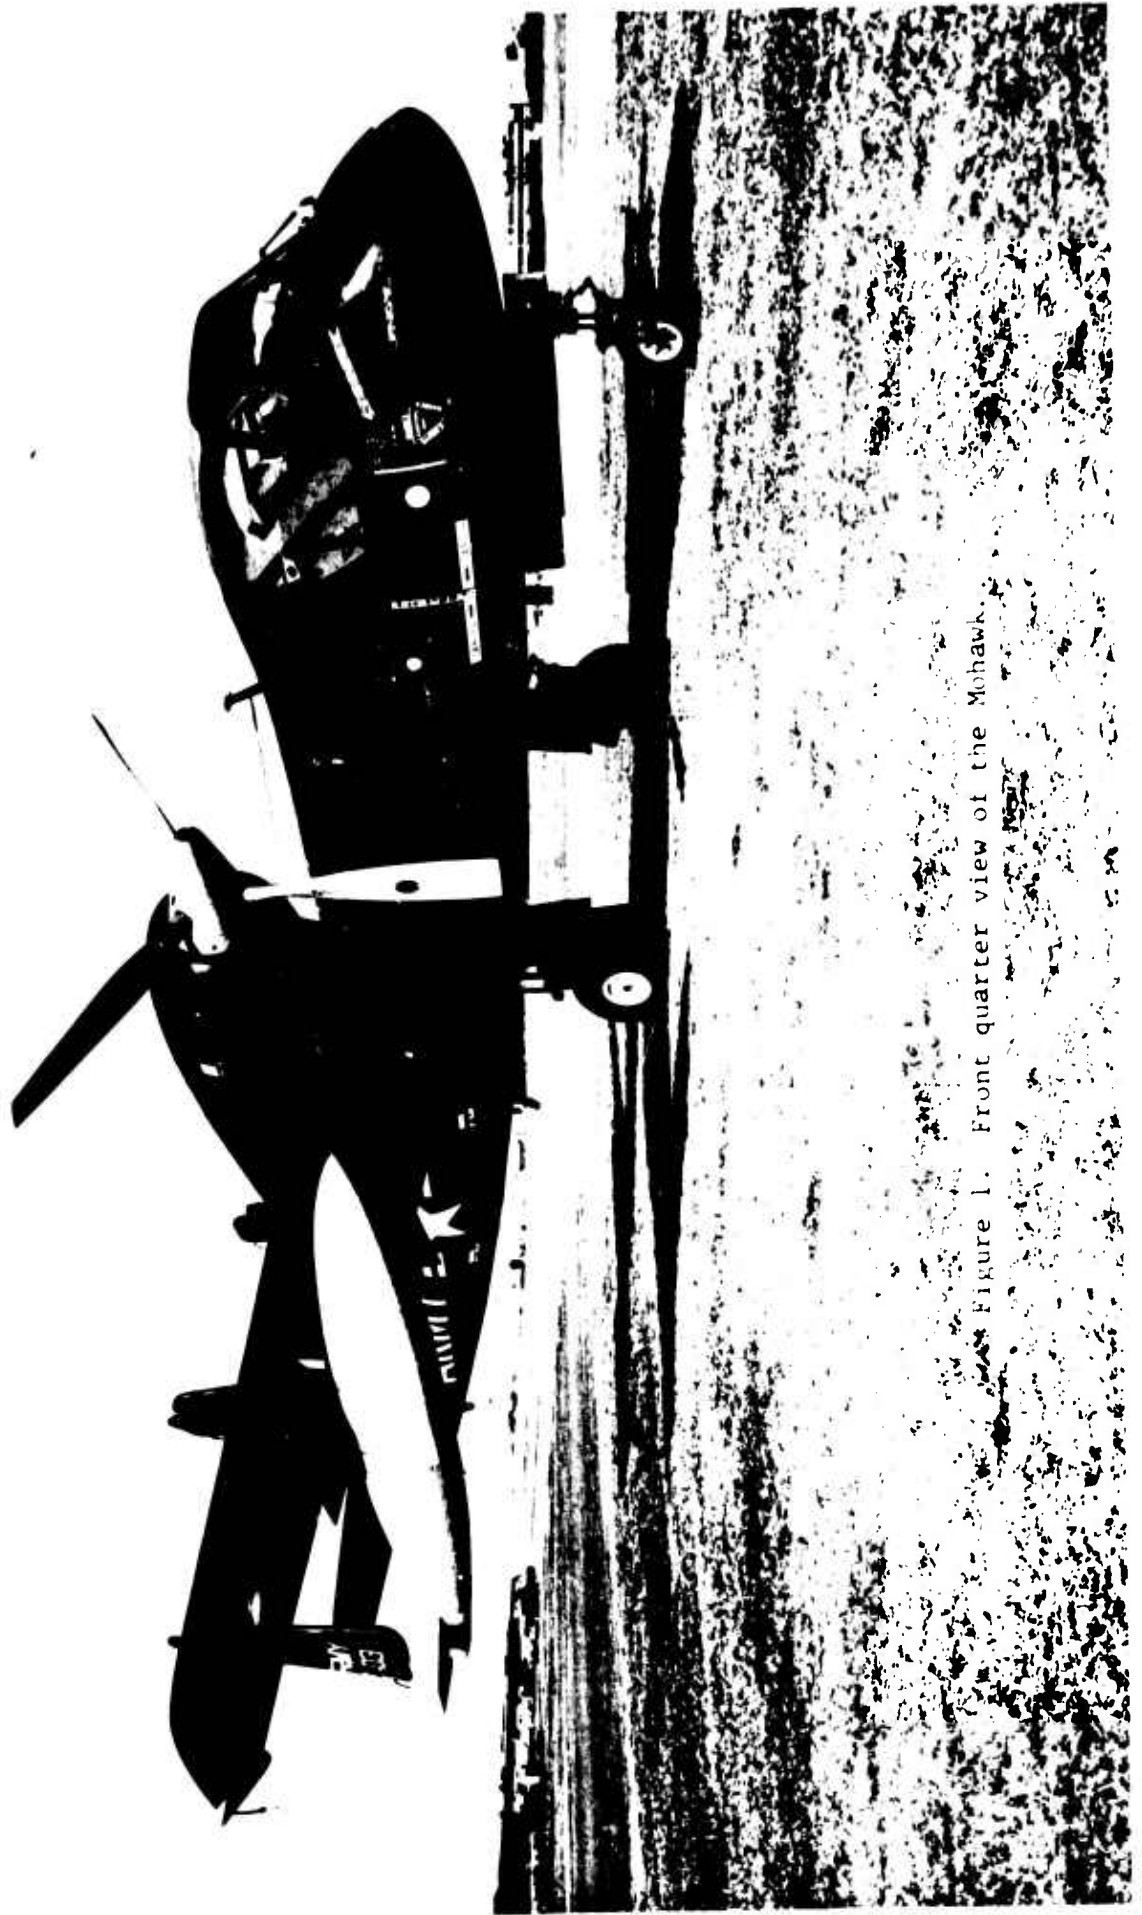
Figure 1. Front quarter view of the Mohawk.

The exterior markings (Figure 1 and 6) in regard to the exit release, ejection seat, and the propeller danger area are well placed and legible from a considerable distance. The rescue arrow, upper left in this photo and also in Figure 1, pointing out the exit release, is deemed adequate for rescue personnel.

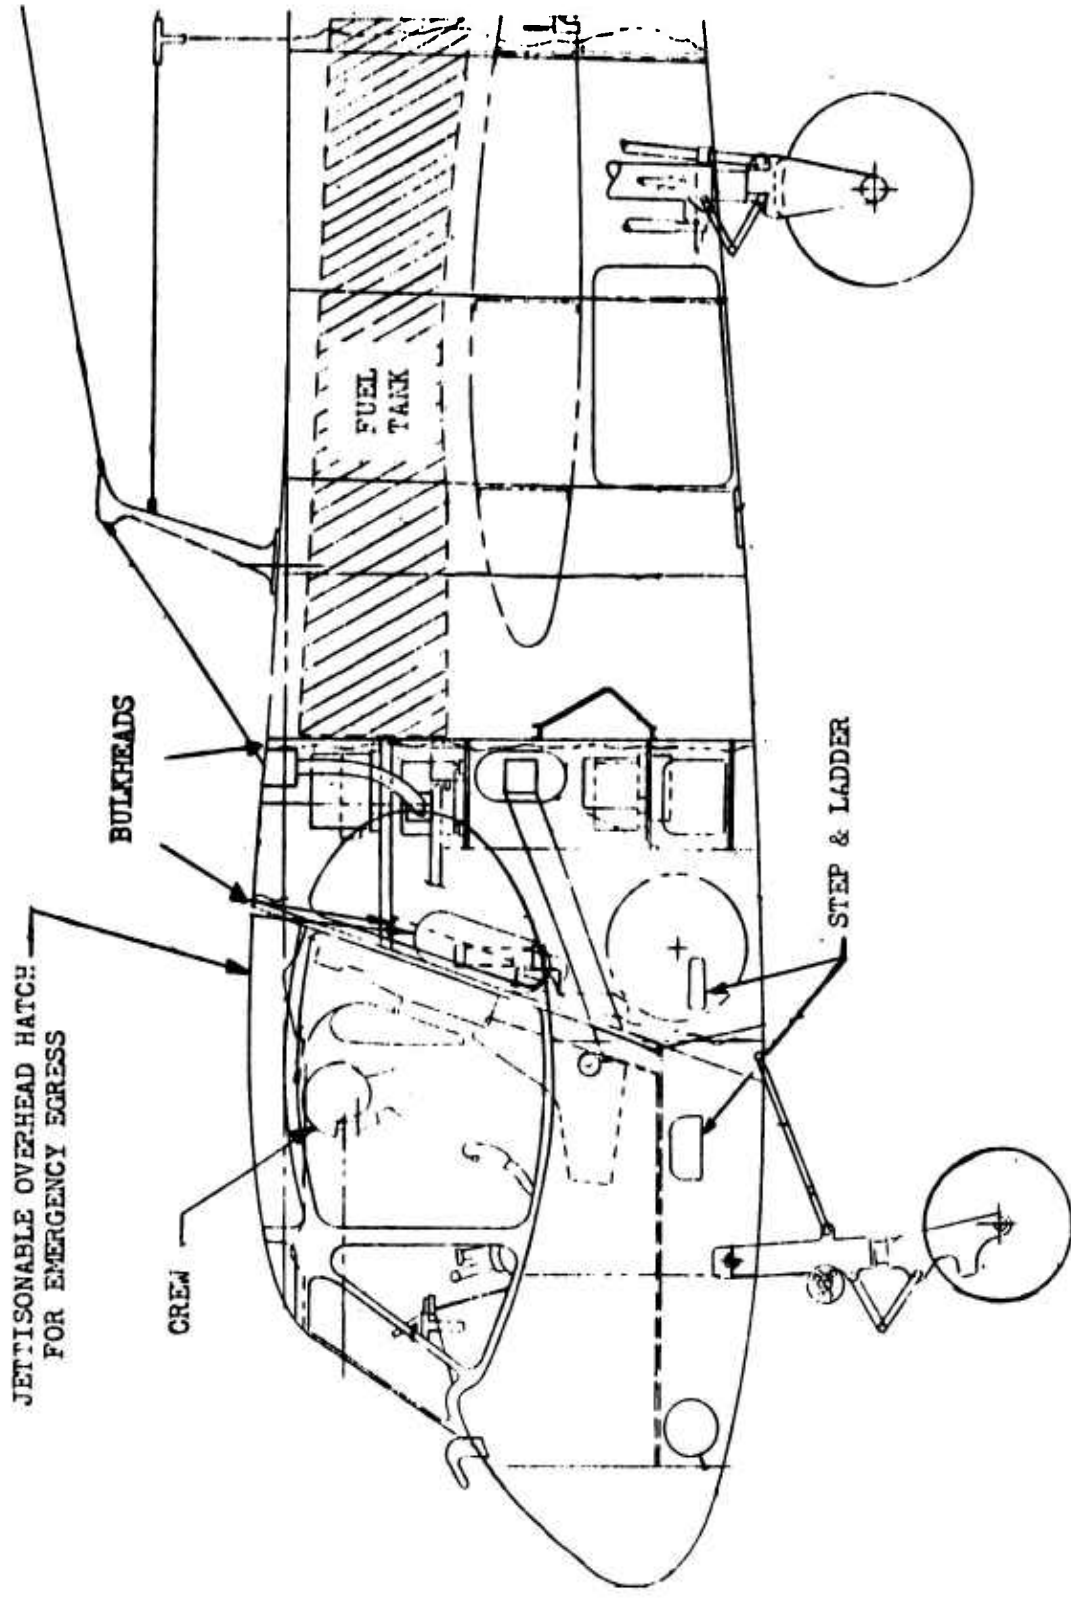
Figure 4. A reduced scale drawing of the forward portion of the Mohawk. Note the normal seated position of the pilot.

1. The cockpit is stressed for 40 G.
2. The self-sealing fuel tank, Figure 4, is located in the fuselage above the center section with two bulkheads separating the fuel tank area from the cockpit.
3. Further protection is afforded by the one-inch thick windshield and utilization of 1/2 -inch armor plate for the cockpit floor.
4. The relatively slow landing speed (55 knots) is also a desirable feature.
5. The Mohawk utilizes an in-flight fire extinguishing system in the engine nacelles, which is manually controlled by the pilot. Substantial post-crash fire protection could be provided with the incorporation of an impact actuated switch in this system. (See Post-Crash Factors in Appendix I.)

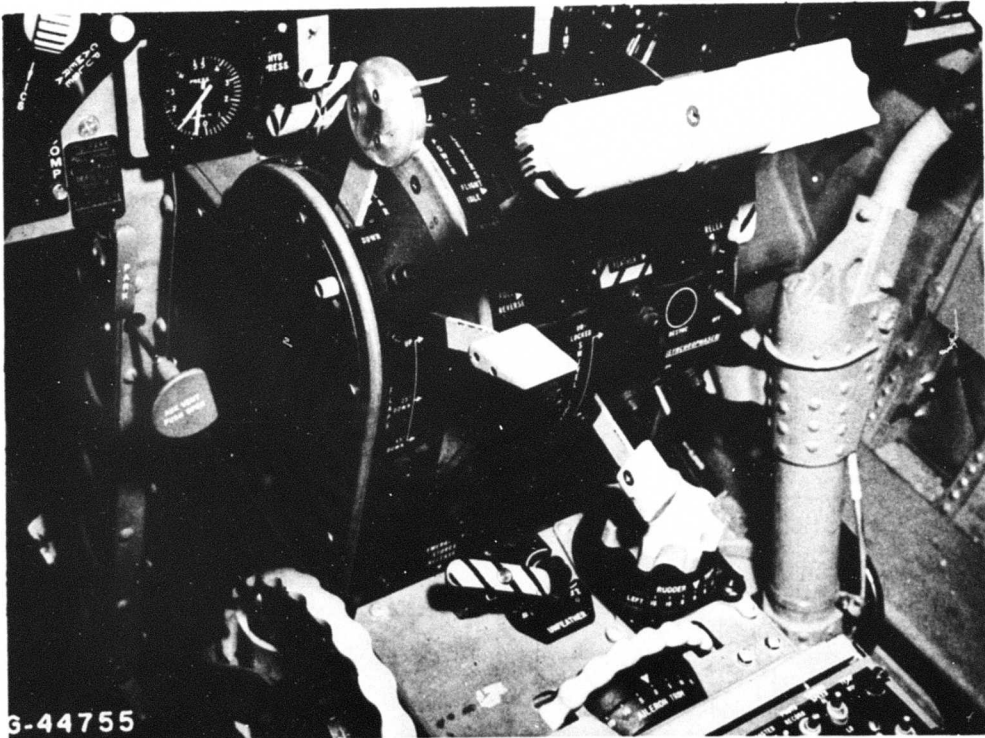
Figure 12. Close-up view of the engine control pedestal.

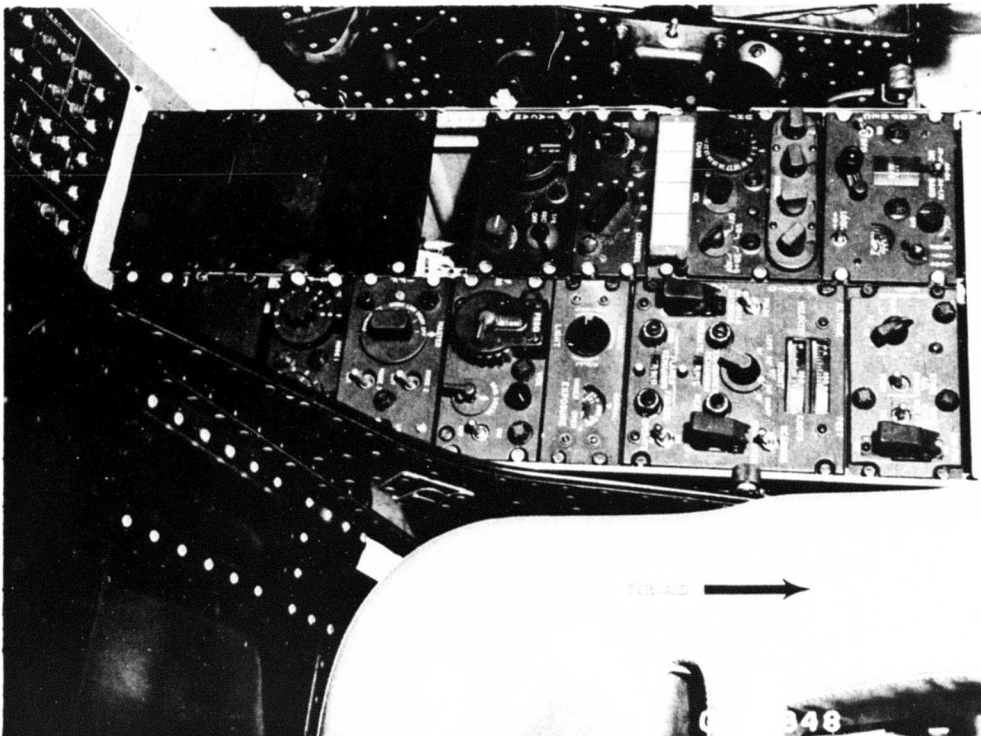
Figure 13. Radio console panel located between the occupants' seats.
