**USAAVLABS TECHNICAL REPORT 67-74**

**FEASIBILITY OF BURNING EMULSIFIED FUEL  
IN A 7LM100 ENGINE**

February 1968

**CONTRACT DAAJ02-67-C-0038  
FLIGHT PROPULSION DIVISION  
GENERAL ELECTRIC COMPANY  
CINCINNATI, OHIO**

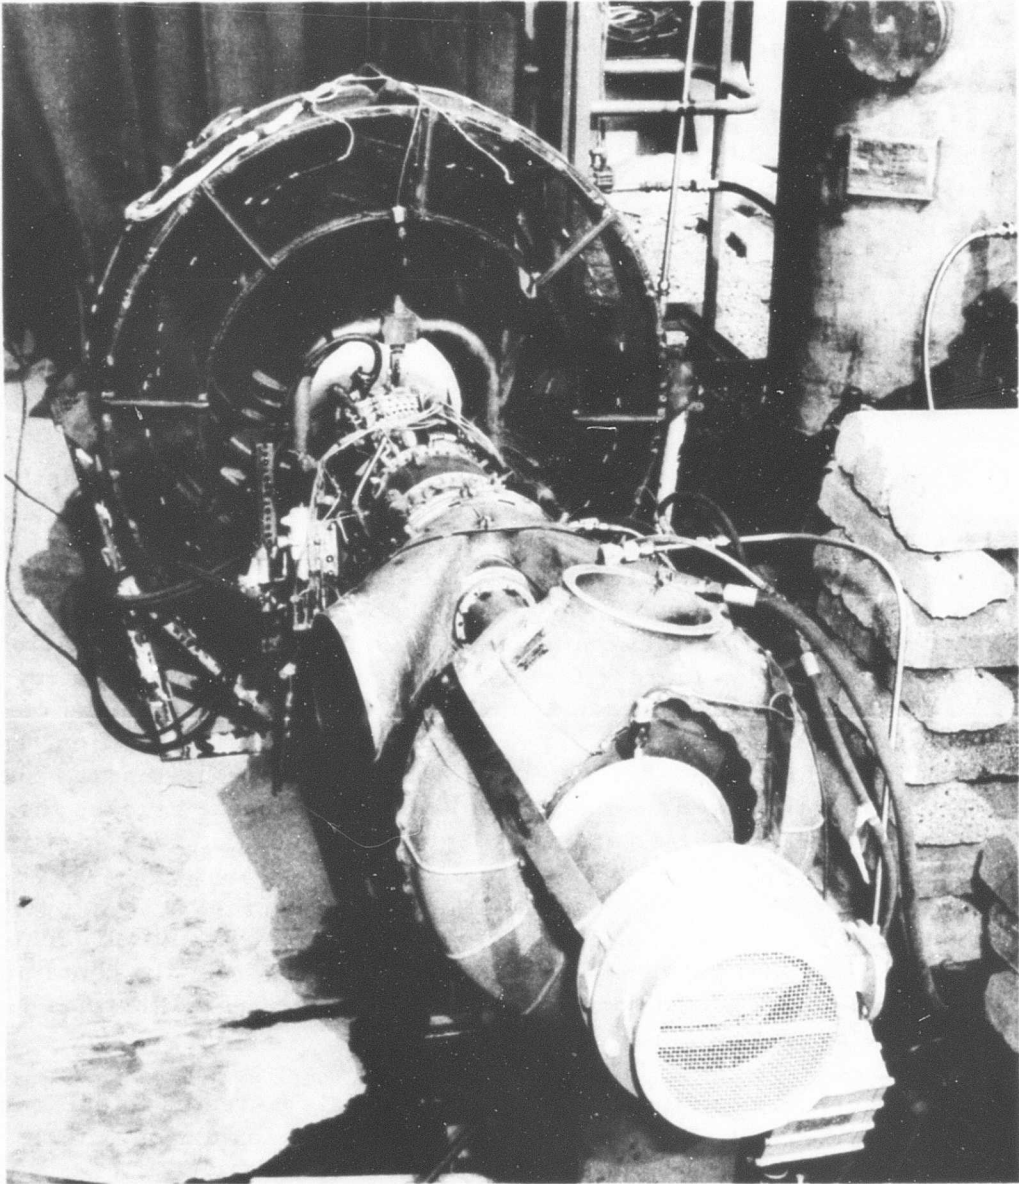
Figure 1. Test Stand.

The test stand used a dynamometer that consisted of the compressor portion of an aircraft turbosupercharger to absorb the engine output horsepower. A means of varying the load was provided by a damper valve in the supercharger inlet. Temperature rise across this unit was monitored as an indication of engine performance. Actual engine performance was based on  $N_g$ ,  $T_5$ , and CDP. Figure 1 shows this test stand.

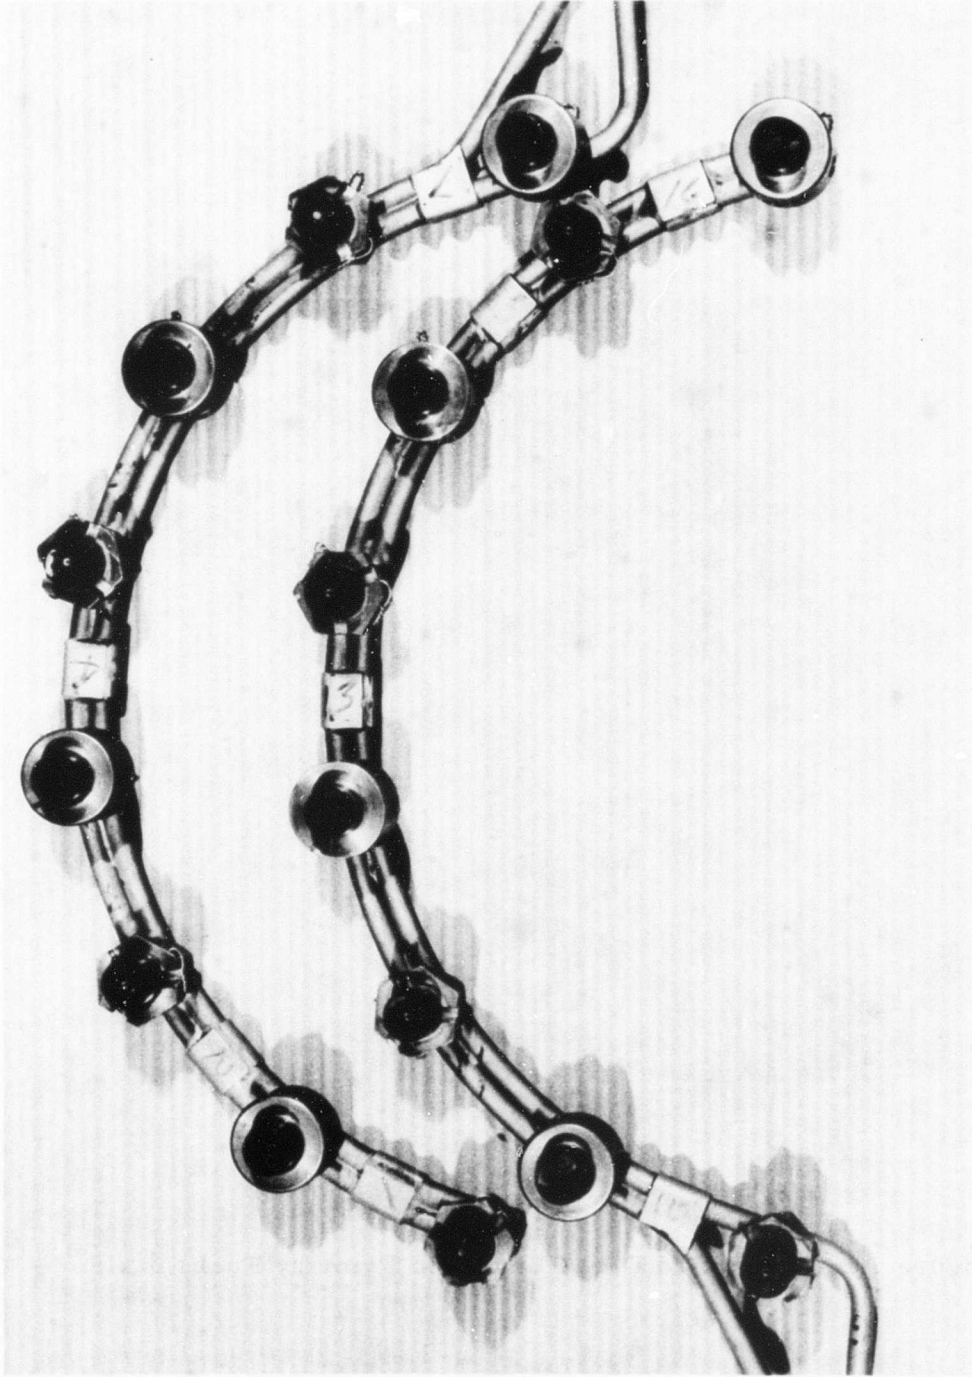
Figure 12. First Set of Fuel Nozzles.

It is suspected that a change in  $T_5$  profile occurred as a result of fuel nozzle clogging. No damage resulted from this suspected change, nor was there any sign of deterioration of hot-section parts. This assumption is based on variations of the  $T_5-T_6/N_g-T_5$  relationships and on a rise in fuel manifold pressure as a function of time.

2. An LM100 component combustor test is recommended to determine flame pattern and differences in combustor operation between straight JP-4 fuel and WSX-7165 emulsified fuel. Combustor operation should also be compared using new fuel nozzles versus nozzles that have operated from 4 to 6 hours and experienced the 35 to 40 percent restriction noted with the second set of nozzles used in this test.
