**USAAVLABS TECHNICAL REPORT 68-88**

**T63 REGENERATIVE ENGINE PROGRAM  
(EXTENDED ENDURANCE AND ENVIRONMENTAL TESTING)**

Edward J. Privoznik

December 1968

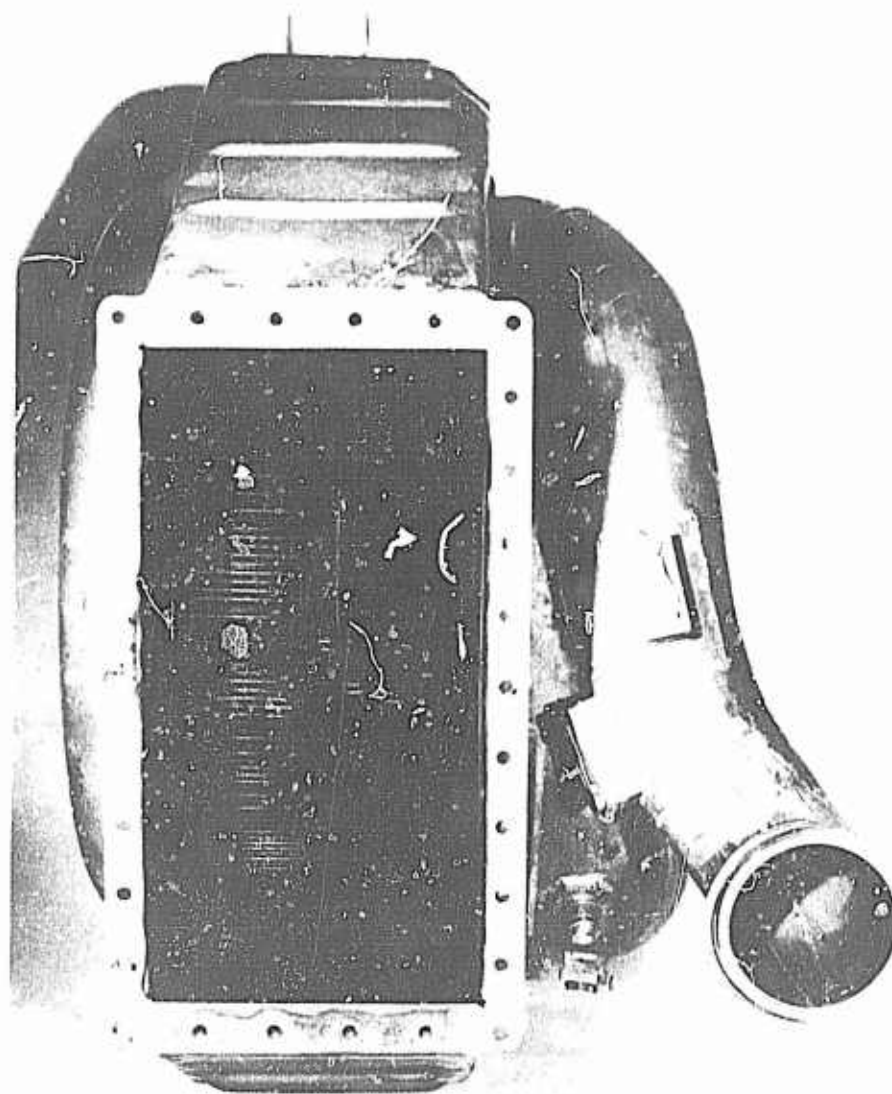
The regenerators were photographed prior to and after the 150-hour endurance test. At the completion of the test, there was a light deposit of carbon on the tubes but no evidence of buckling of any of the individual tubes in the core. In fact, the carbon deposit was heavier prior to starting the test than it was after the completion of the 150-hour endurance test. The last hour of flight testing consisted of low-power operation, which increases the accumulation of soft carbon. However, the post-endurance calibration was terminated with the maximum power operation. Thus, most of the carbon was burned off. Condition of the regenerator core is shown in Figures 4 and 5.

Figure 4. P/N 6858369 Regenerator Prior to 150-Hour Endurance Test.

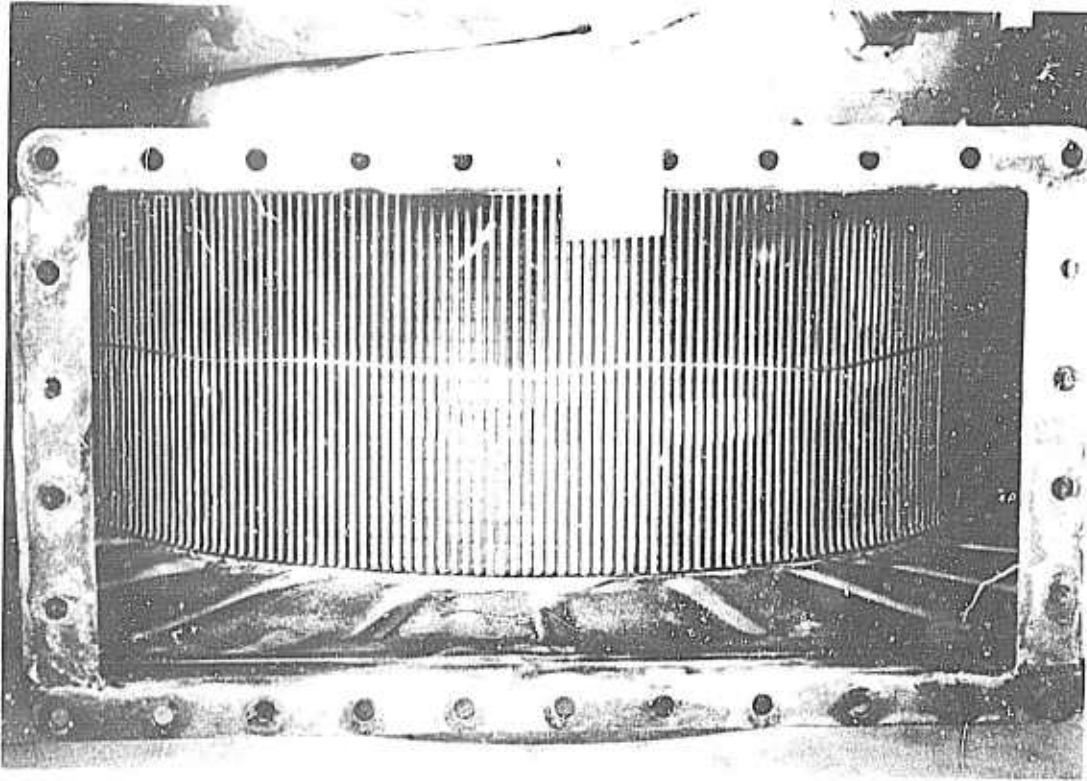
One of the potential problem areas in the regenerator is dust collection in the air inlet and outlet ducts. To determine the amount of dust collected in the regenerators, the regenerators were weighed before and after the dust ingestion test. The increase in weight was 0.04 pound on the left-hand regenerator and 0.07 pound on the right-hand regenerator. This increase in weight is not considered to be significant. Figures 15 and 16 show the left-hand regenerator after the dust ingestion test. There was some indication of a scale formation on the first row of tubes (gas inlet)

as shown in Figure 15. On the gas outlet side there was a film of dust collected, as shown in Figure 16. The tubes were wiped in the center to give some indication of the thickness of the film.

Figure 16. P/N 6858501 Regenerator (Left Side) After Dust Ingestion.

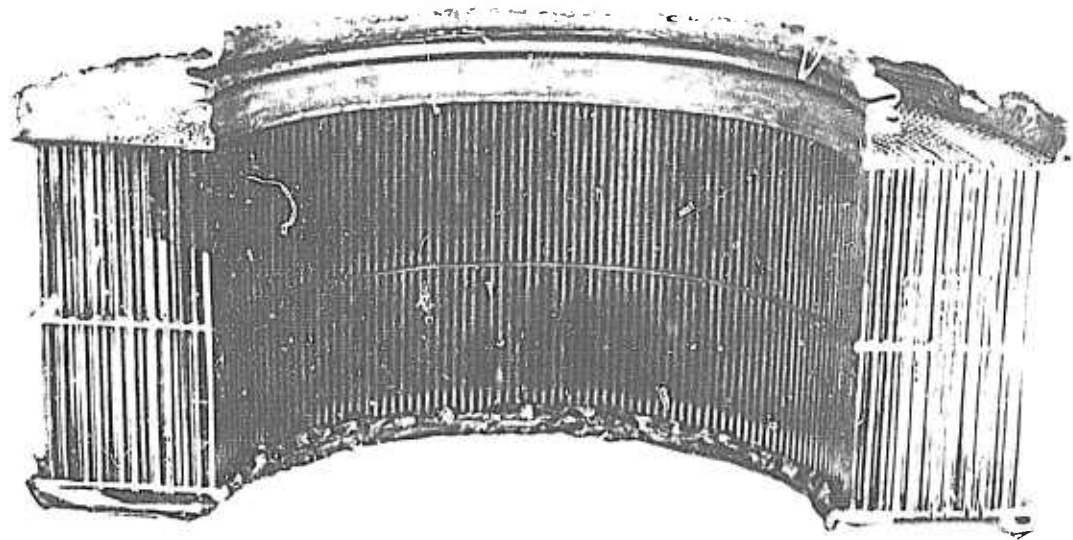
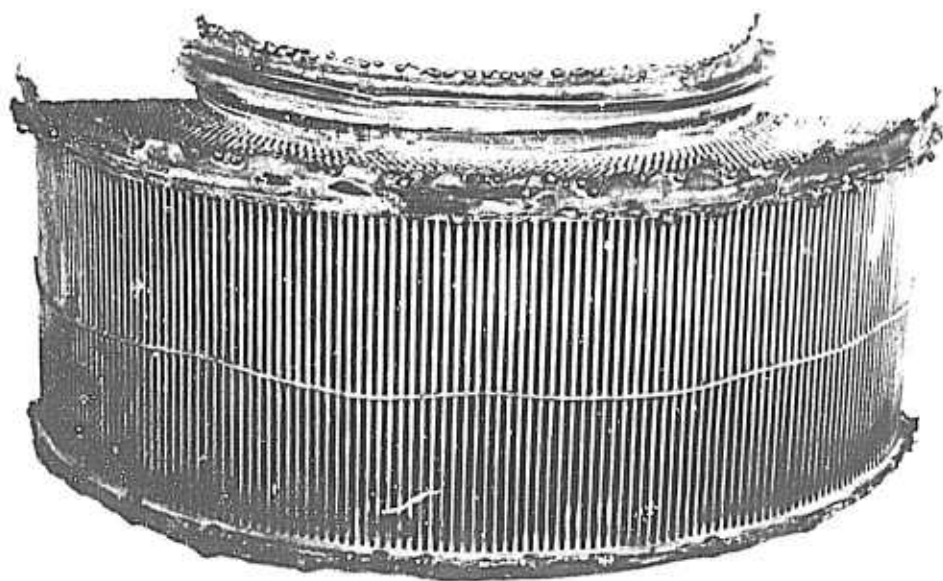
Figure 17 defines the regenerator configuration and can be used to locate the areas which were photographed during the metallurgical evaluation. Figures 18 and 19 show the first pass of the regenerator core. There is an indication of surface scale on the outside of the gas inlet tubes, as shown on Figure 18. Most of the dust that had collected on the outside of the gas outlet tubes during the test had been shaken off due to normal handling.

Gas Inlet - First Pass

Gas Outlet - First Pass

Figure 18. Gas Side of Regenerator Core - First Pass.

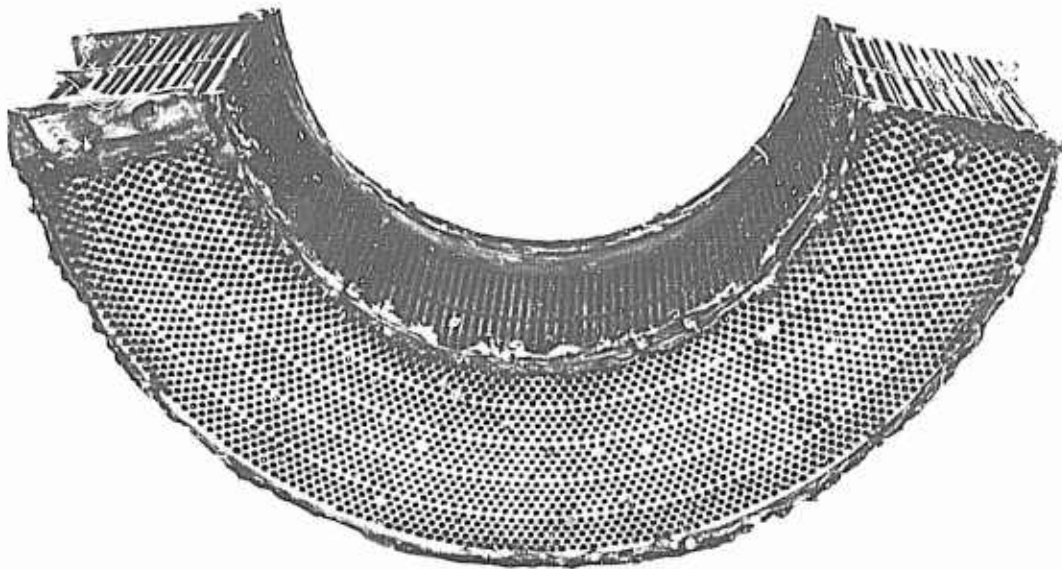
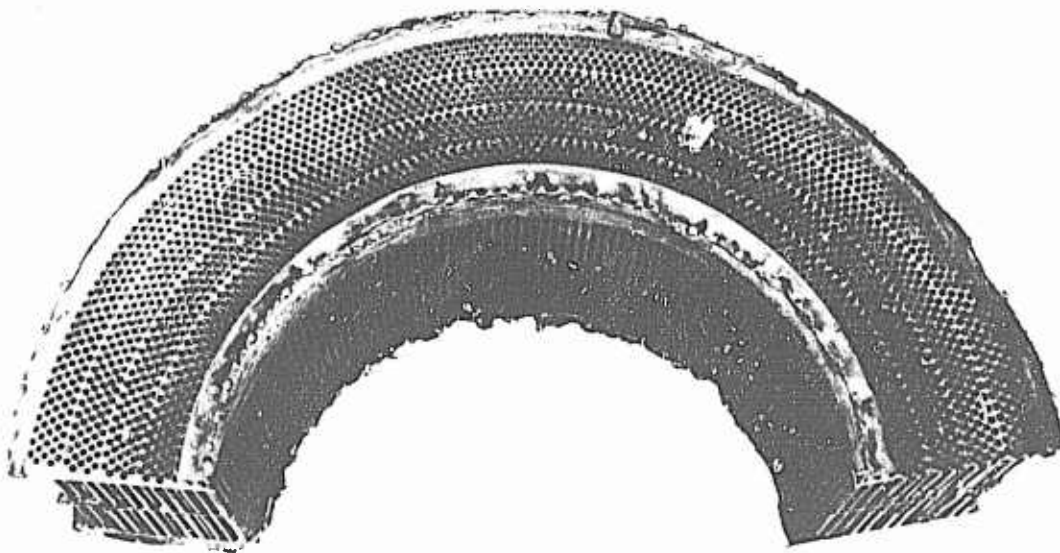
Air Inlet—First Pass

Air Outlet—First Pass

Figure 19. Air Side of Regenerator Core—First Pass.

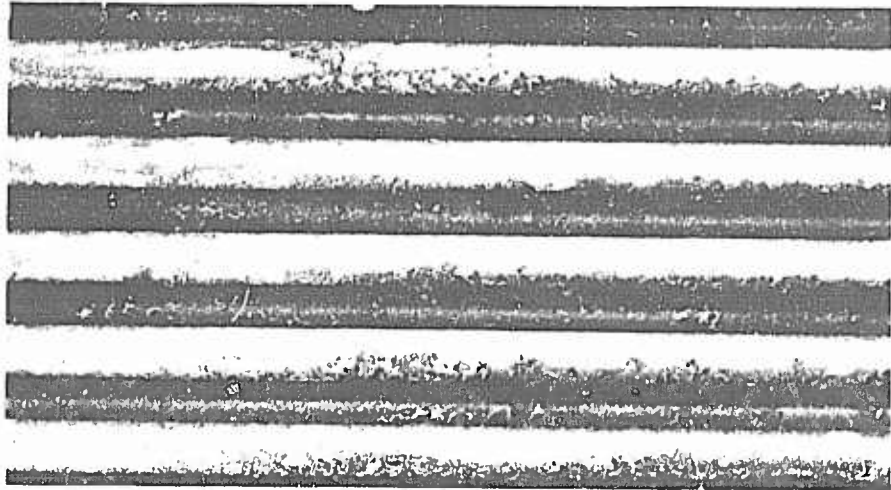
First Row of Tubes Before Cleaning

First Row

Seventh Row

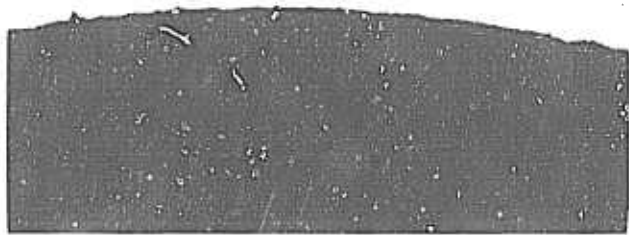
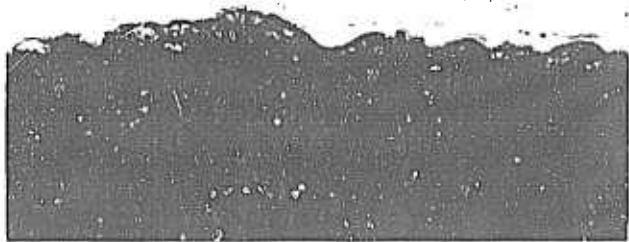
There was an indication of incipient oxidation on the surface of the braze and in the braze diffusion zone of isolated tubes in this area of the core as shown in Figure 24. The oxidation penetration was approximately 0.0005 inch. The oxidation is not considered to be serious and the photomicrographs are included primarily to document the oxidation. The tube metal temperatures in the first rows of the second pass of the core ranged from 800 to 1300°F. The steady-state metal temperatures were in the neighborhood of 800°F, with peak temperatures in the 1300°F range during transients.

Since the incipient oxidation was always associated with braze on the inside of the tubes, it is reasonable to believe that even this slight oxidation could be eliminated with the elimination of the braze.

Typical Cross Section of Tube  
(Second Pass—First Row)

Oxidation on ID of Tube with Braze  
(Second Pass—Second Row)

Figure 24. Cross Section of Gas Inlet Tubes—200X.
