**USAAVLABS TECHNICAL REPORT 68-82**

**DEVELOPMENT OF A  
CRASH-RESISTANT FLAMMABLE FLUIDS  
SYSTEM FOR THE UH-1A HELICOPTER**

**S. Harry Robertson**

January 1969

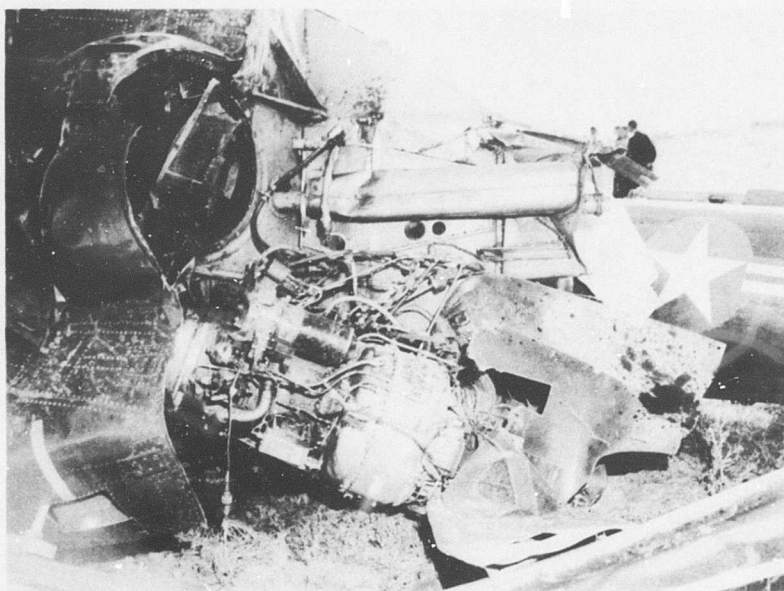
Figure 40. Postcrash Position of Engine.

The main rotor blades remained attached to the rotor head. The main transmission, as well as the engine, broke free of all mountings and displaced leftward, as shown in Figures 39, 40, and 41. Most of the cabin roof was torn free, and the fuselage broke, nearly separating, where the aft passenger compartment vertical bulkhead joins the floor; see Figure 42.

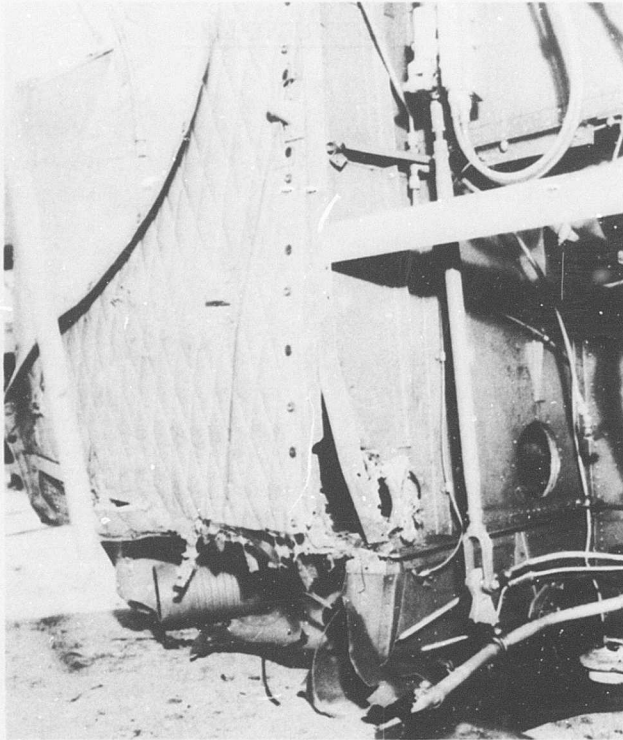
Figure 43. Deformed Structure and Exposed Fuel Cell.

The crash-resistant fuel tanks were not punctured, nor did they release their fuel load at any point. A bottom corner of the right cell was gouged when the supporting structure surrounding it failed and then displaced back and forth against the corner; see Figure 43. No other damage to the fuel cells was discovered. The tank system is shown re-assembled in Figure 44, a photograph taken after the cells were removed from the wreckage.

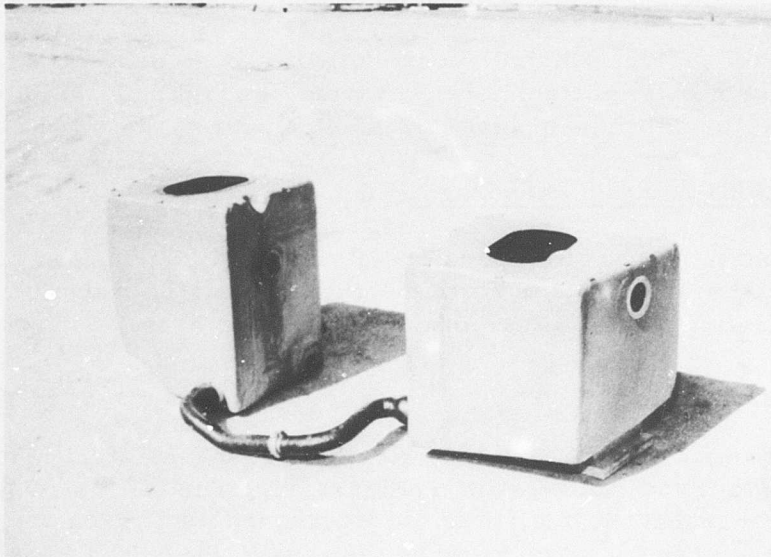
Figure 44. Tank System and Aft Crossover Assembly Reassembled After Test.

The aft crossover tube, made of flexible crash-resistant material, remained intact and can be seen in Figure 44. The aft tube was not displaced; consequently, the frangible interconnects at each end did not receive the necessary force to make them separate. The forward crossover tube, made of flexible hose, was intact and the valves were still attached to the tank.

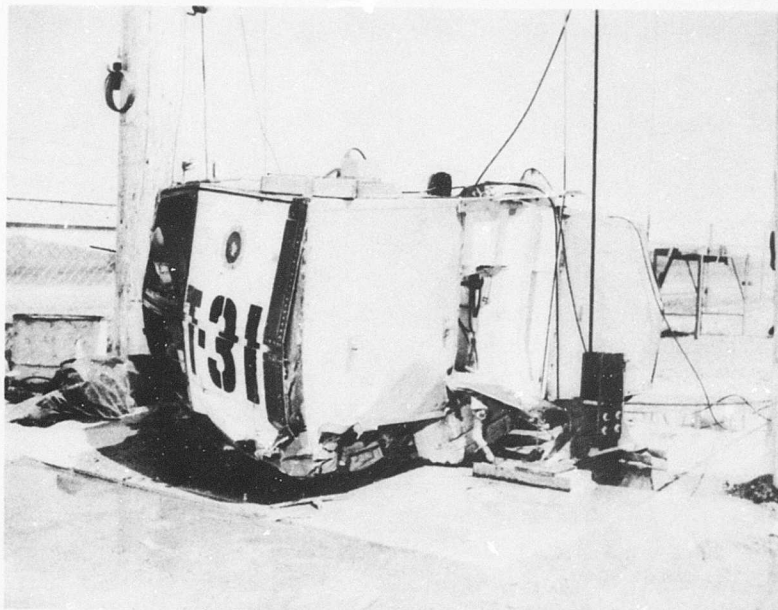
Figure 97. Posttest View of Section - Right and Front Sides.

The fuselage section impacted flatly onto the pad, completely enveloping the railroad ties positioned beneath. The posttest position of the section is shown in Figures 96 and 97. The condition of the bottom of the section can be seen in Figure 98. The vertical accelerations recorded atop

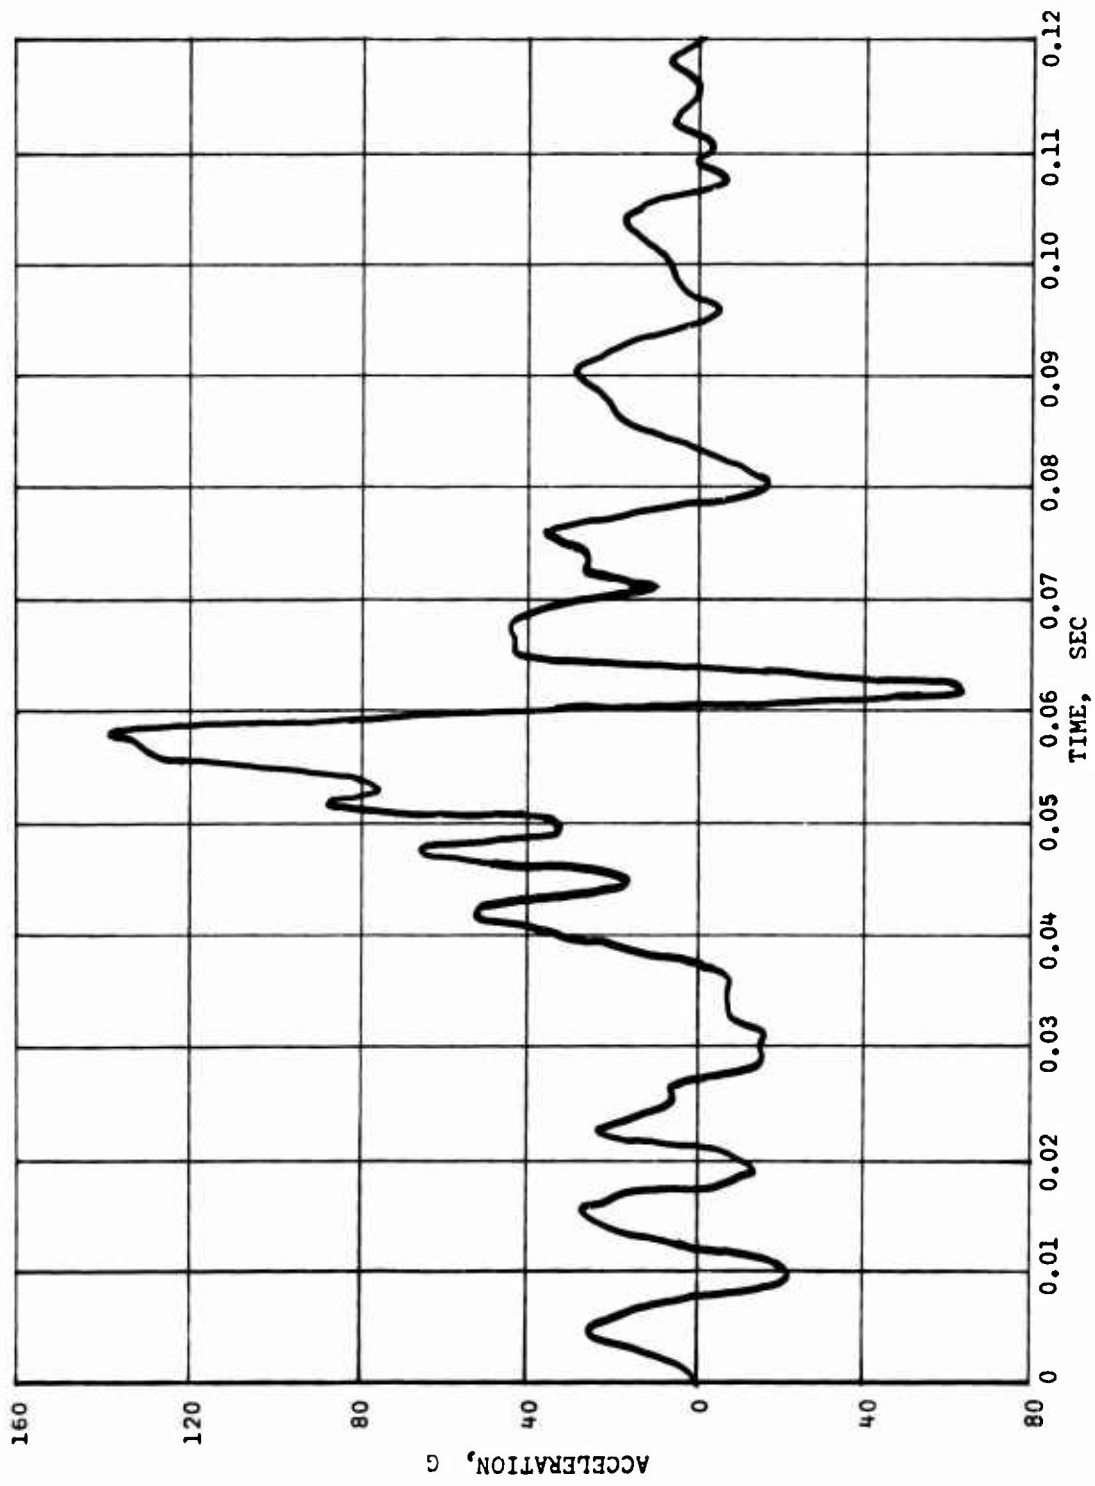
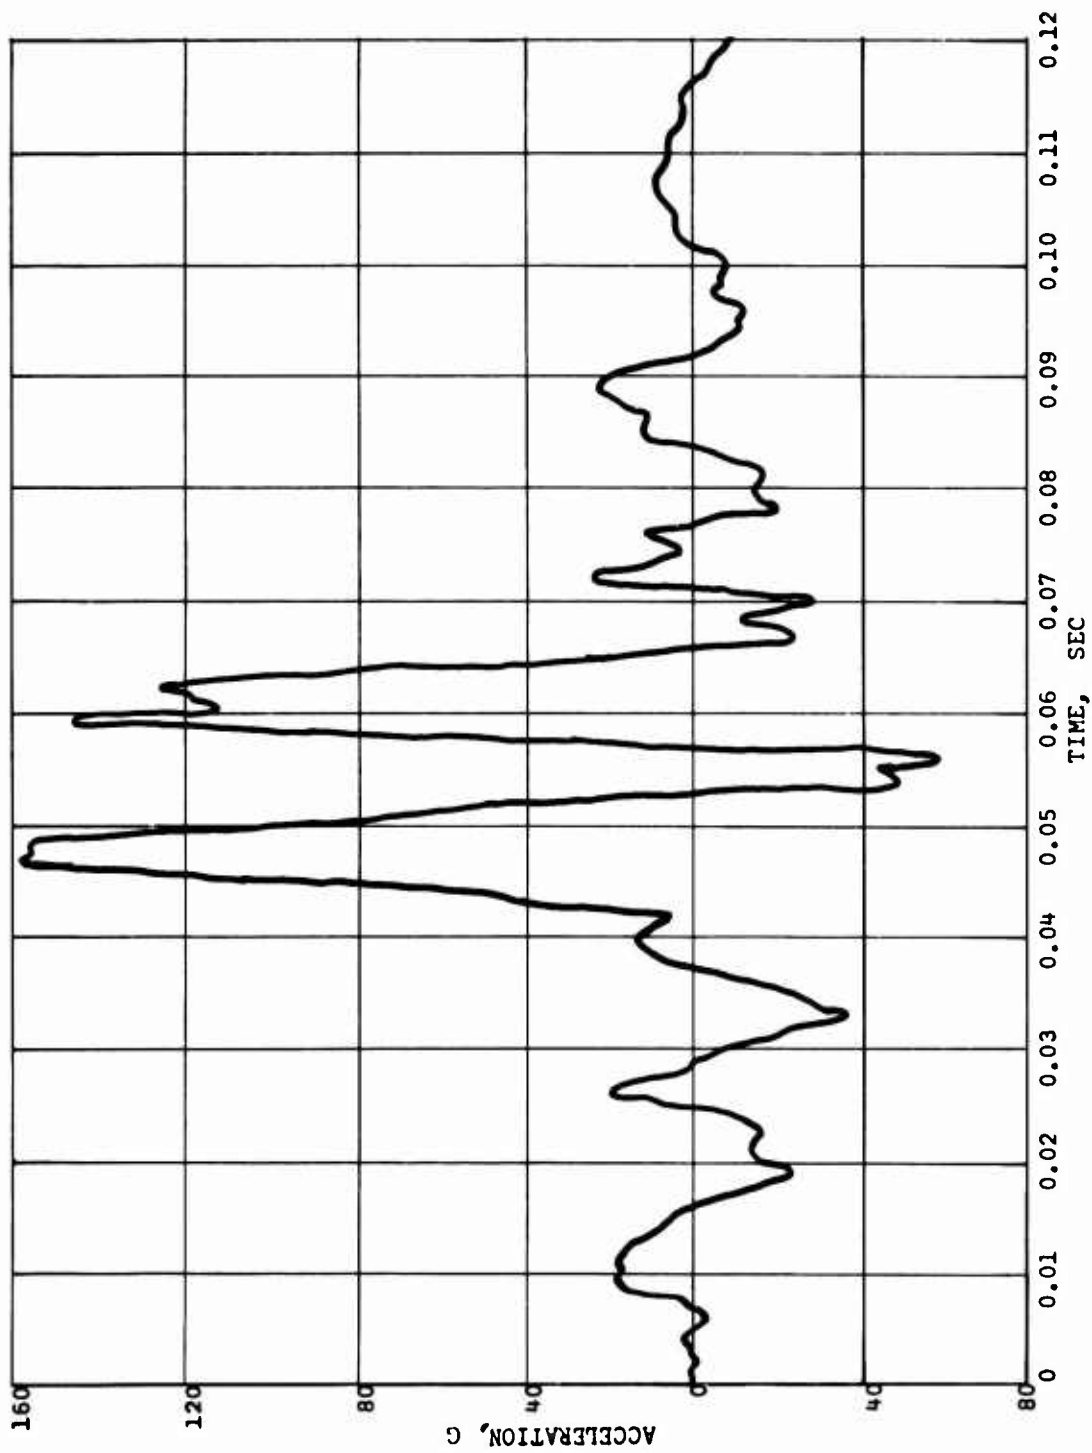
the fuel cell cavities had an average peak value of 145G; see Figures 99 and 100.

Figure 99. Acceleration - Time History Recorded on Top of Left Fuel Cell.

Figure 100. Acceleration - Time History Recorded on Top of Right Fuel Cell.

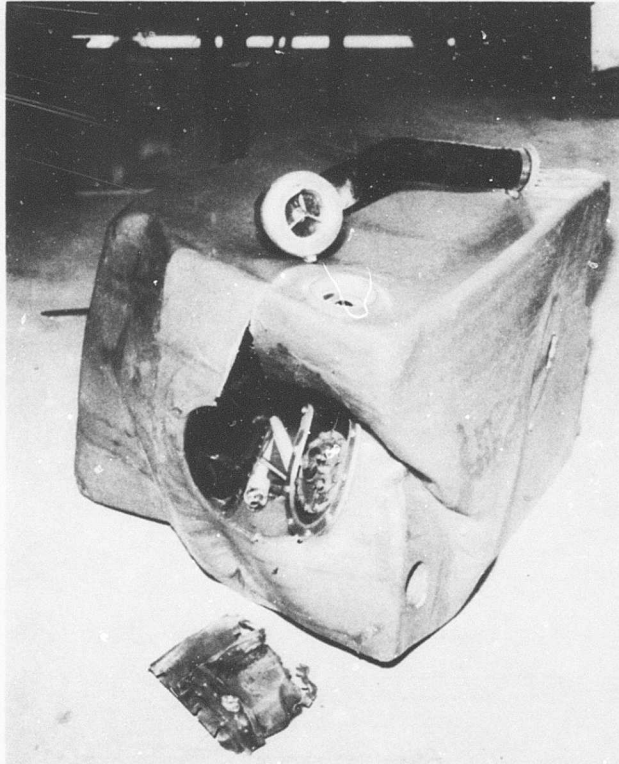
Figure 101. Posttest Bottom View of Left Fuel Cell.

The tie beneath the left fuel cell impacted the boost pump, driving it and the mounting diaphragm upward. A rip in the cell material commenced at the pump opening and ran rearward to the aft bottom edge of the cell. A rip and a large opening were created (Figure 101) as the attaching hardware in the pump mounting diaphragm pulled through the cell material (Figure 102). An interior cell view, showing that the tie penetrated the cell and that the electrical power leads to the pump were not damaged in their protected position inside the flexible hose, is shown in Figure 103. The quantity indicator collapsed (Figure 104) as the bottom of the cell moved upward.

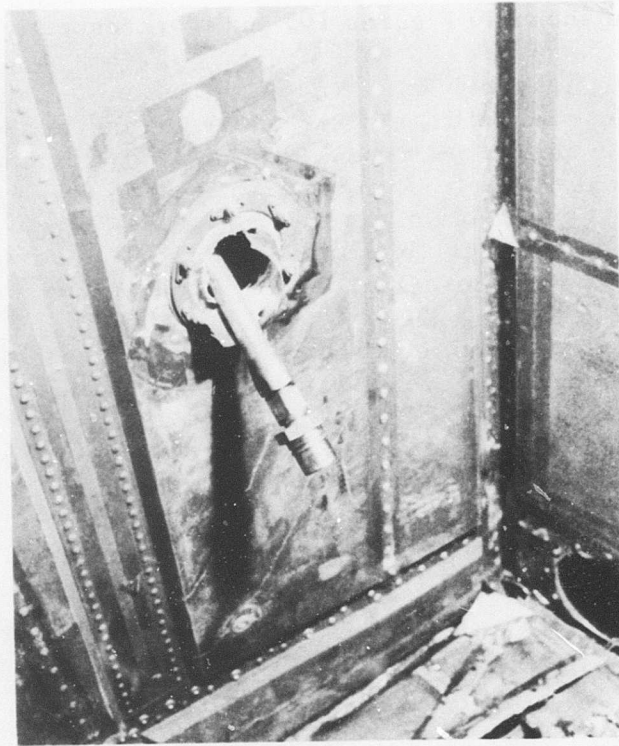
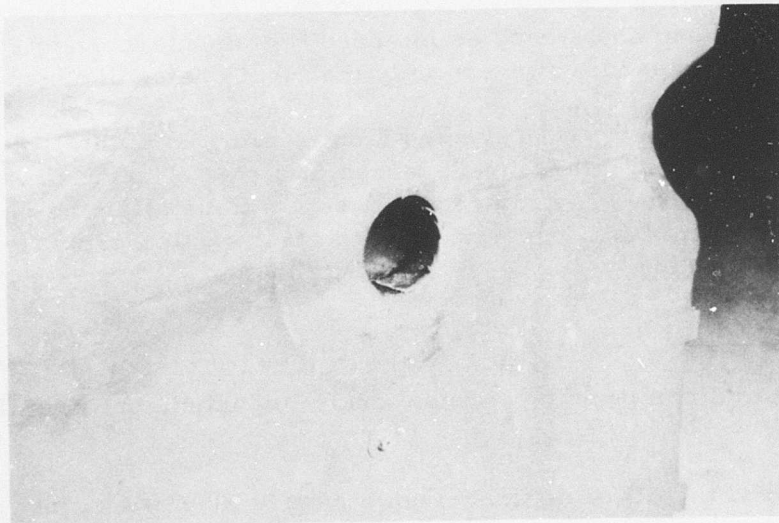
The self-sealing quick disconnect connecting the engine fuel line to the left cell did not separate, since there was adequate length to the line to preclude its being placed in tension. The frangible connector between the cell and cavity wall did separate as designed. The broken cavity wall attachment and the part of the connector that remained and displaced with

the fuel cell are shown in Figures 105 and 106, respectively.

Figure 105. Posttest View of Frangible Tank Wall Stabilizer at the Tank-to-Engine Fuel Line Airframe Opening.

Figure 106. Remains of the Frangible Tank Wall Stabilizer Surrounding the Tank-to-Engine Tank Outlet.

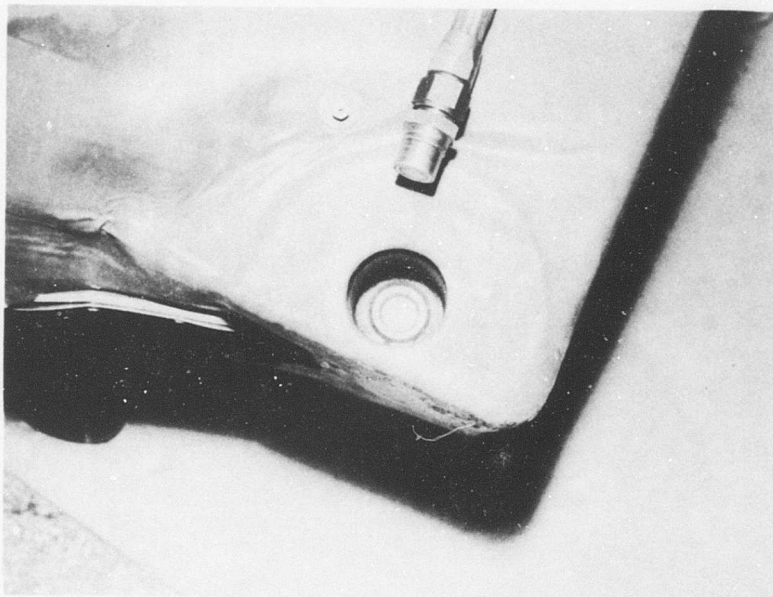
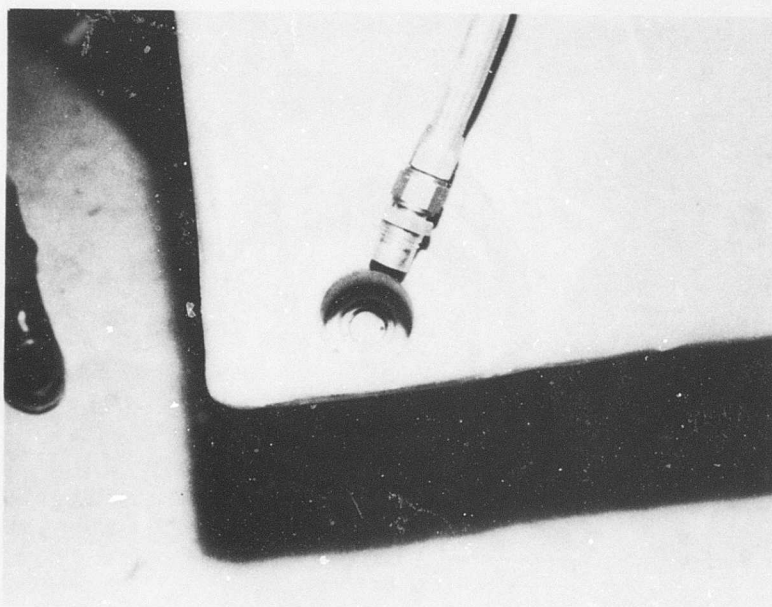
The forward crossover assembly was impacted near the self-sealing quick-disconnect connection to the left cell. The left disconnect separated from the cell and closed. The crossover disconnect connection to the right cell remained attached. There was no leakage from the assembly. All of the water in the left cell exited through the boost pump opening. Both self-sealing quick disconnects were still capable of functioning after the cells were removed from the fuselage section, as shown in Figures 107 and 108. The posttest condition of both crossover assemblies is shown in Figure 109.

Figure 107. Posttest Position of Breakaway Valve in Forward Crossover Attachment to Left Cell.

Figure 108. Posttest Position of Breakaway Valve in Forward Crossover Attachment to Right Cell.

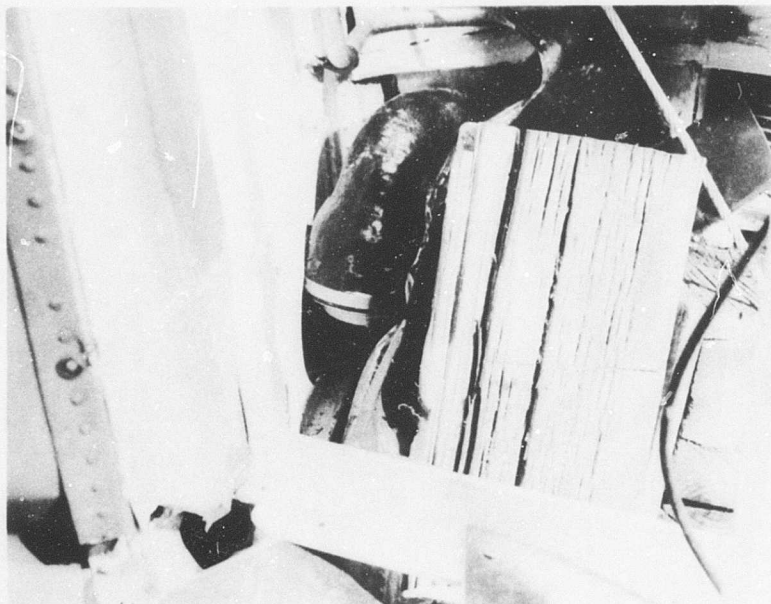
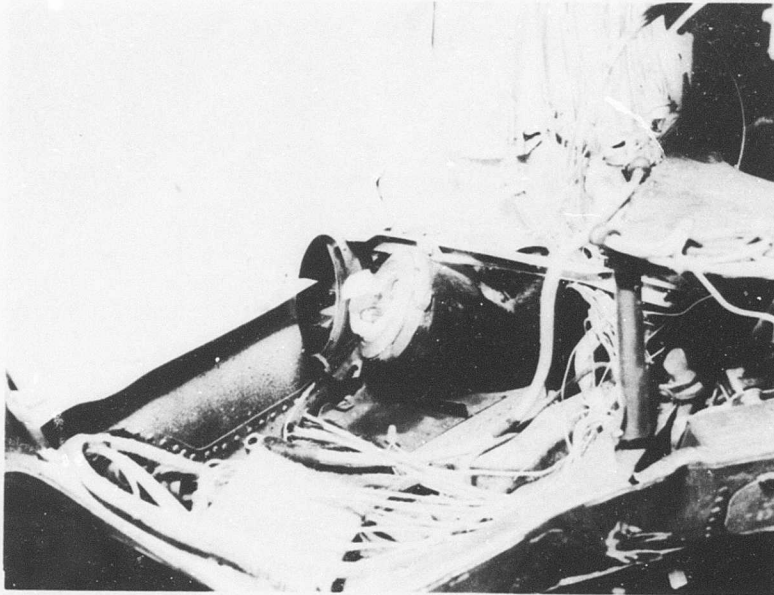
The aft crossover tube separated from each fuel cell at the self-sealing breakaway interconnect. The disconnects from the right and left cells are seen in Figures 110 and 111. The interconnect halves that remained in the cells closed and sealed as intended. Both interconnects in the crossover tube closed; however, only the right one sealed completely.

Figure 110. Aft Crossover Assembly Separation From the Right Cell.

Figure 111. Aft Crossover Assembly Separation  
From the Left Cell.

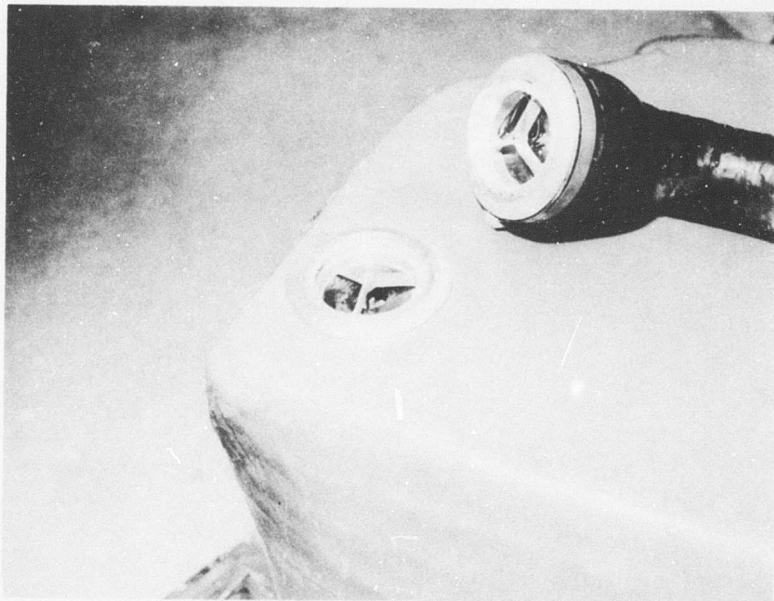
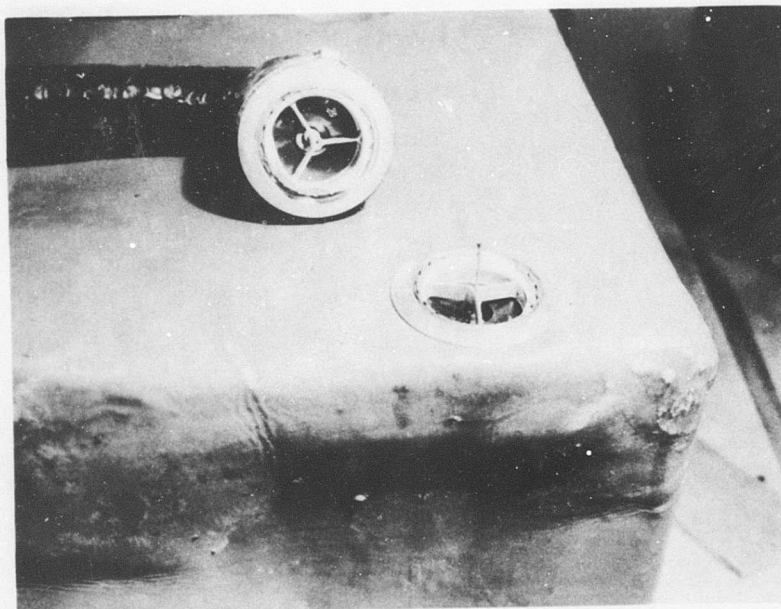
The left interconnect was prevented from sealing completely by a displaced O-ring. The interconnect leaked at a rate of approximately 1/2 pint per minute. The interconnect separations after the cells and the crossover had been removed from the test section are posed in Figures 112 and 113.

Figure 112. Breakaway Interconnect Separation -  
Right Side.

Figure 113. Breakaway Interconnect Separation - Left Side.

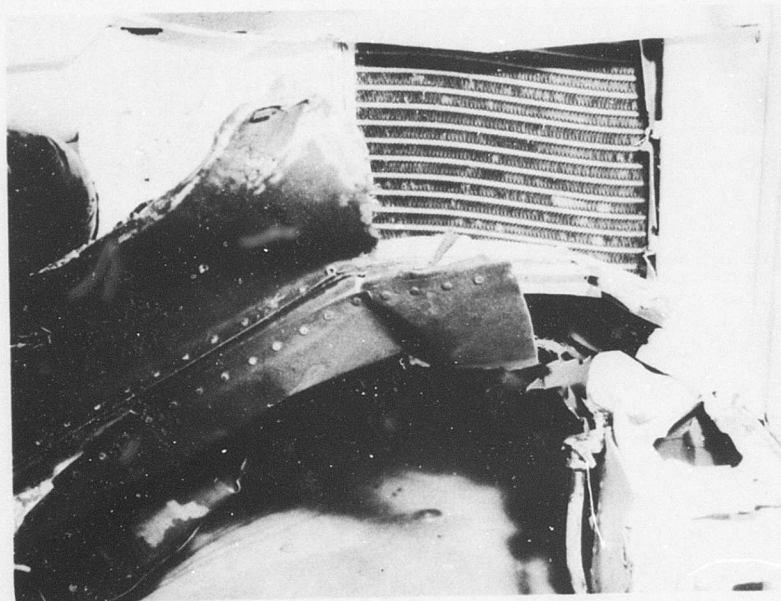
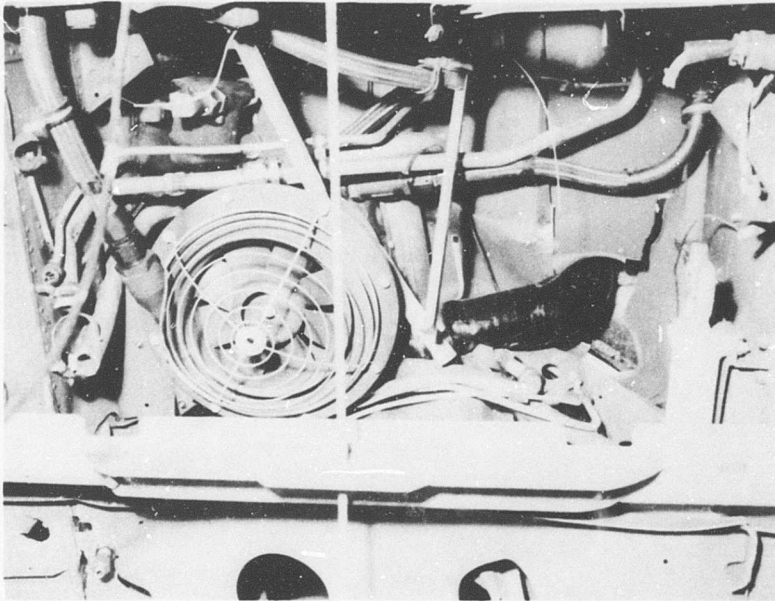
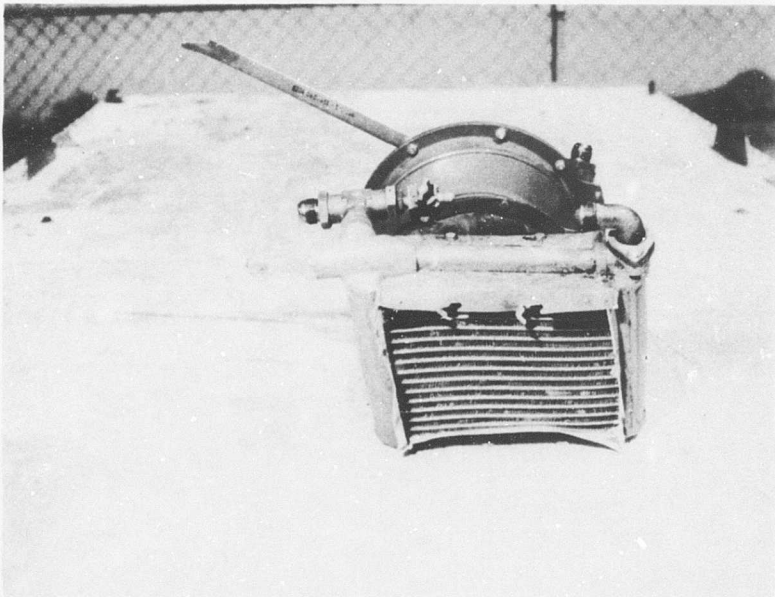
The oil system components were severely impacted, but no failures resulted.

The bottom of the oil cooler received a severe blow. A front view of the cooler is shown in Figure 114. The cooler can barely be seen behind the fan, as shown in Figure 115, a rear view. Deformation caused by impact with the railroad tie on the bottom of the unit is shown in Figure 116.

Figure 114. Posttest Front View of Oil Cooler.

Figure 115. Posttest Rear View of Oil Cooler.

Figure 116. Oil Cooler After Removal From Test Section.
