MISCELLANEOUS PAPER S-69-27

LANDING MAT OVERLAY ON DETERIORATED PAVEMENT

BARE BASE SUPPORT

U. S. Army Engineer Waterways Experiment Station
CORPS OF ENGINEERS
Vicksburg, Mississippi

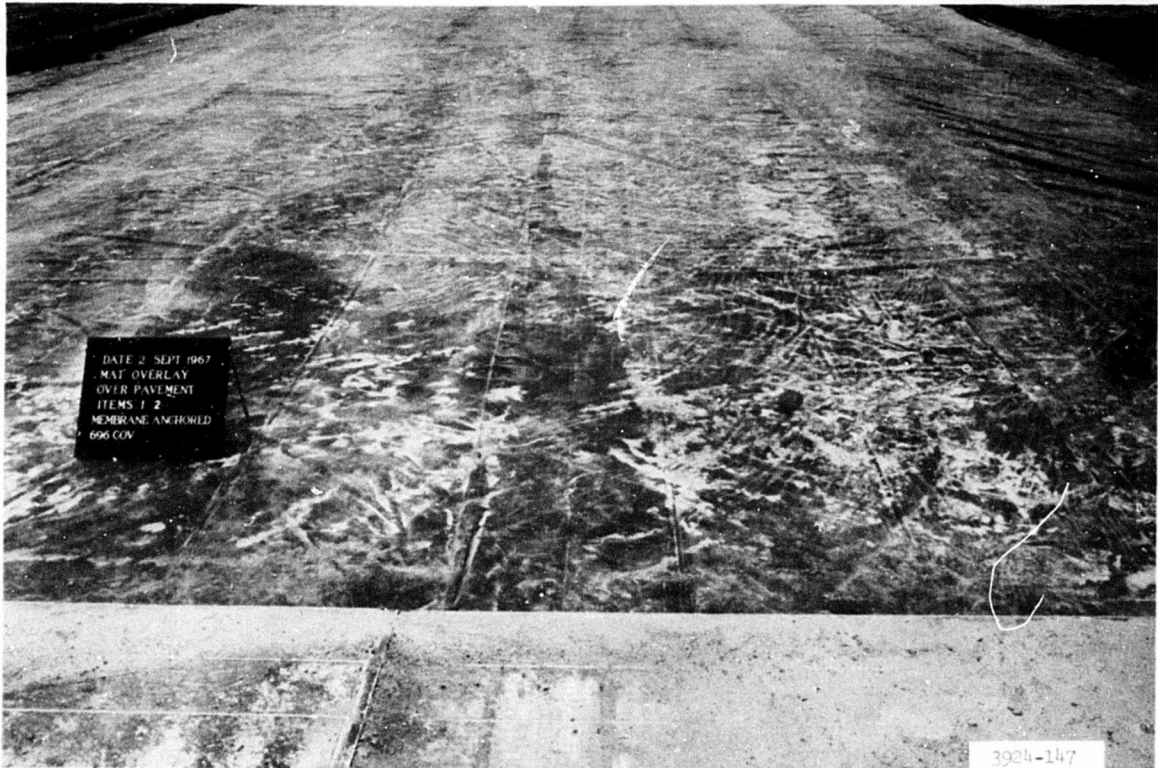
Photograph 47. T16 membrane on items 1 and 2 after secondary construction II

42. Work was begun on 31 August. The sand in items 1 and 2 had been allowed to air-dry for several days and was leveled by hand raking. Anchor trenches, as described in paragraph 41, were cut by hand and the T16 membrane was replaced on items 1 and 2. The south and west edges of the membrane were placed in the trench and secured to the bottom with anchor pins. The clay gravel in the first 15 ft of item 3 was stabilized with portland cement and compacted using the methods described in paragraph 37. A piece of WX18 membrane was placed on this area with one edge of the membrane in the lateral anchor trench between items 2 and 3. Both trenches were then backfilled, and the soil was well compacted. A view of the T16 membrane on items 1 and 2 at this time is shown in photograph 47. A view of the WX18 membrane is shown in photograph 48.

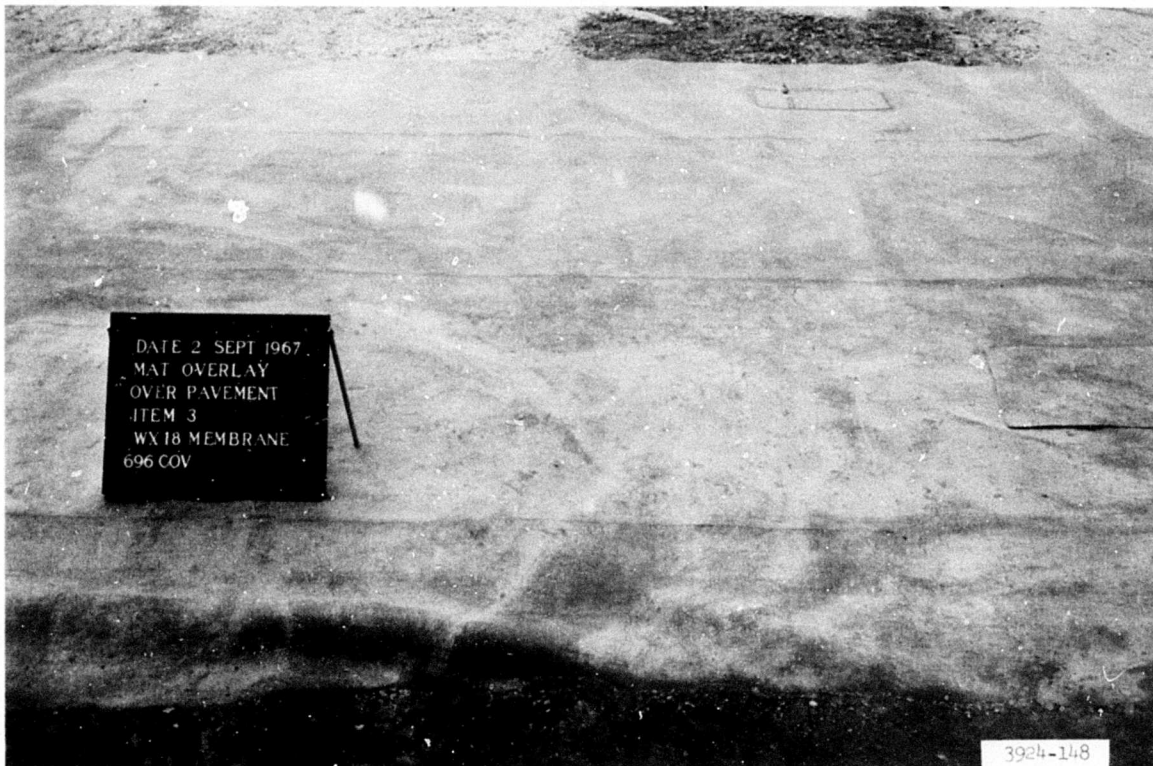
Photograph 48. WX18 membrane on item 3 after secondary construction II

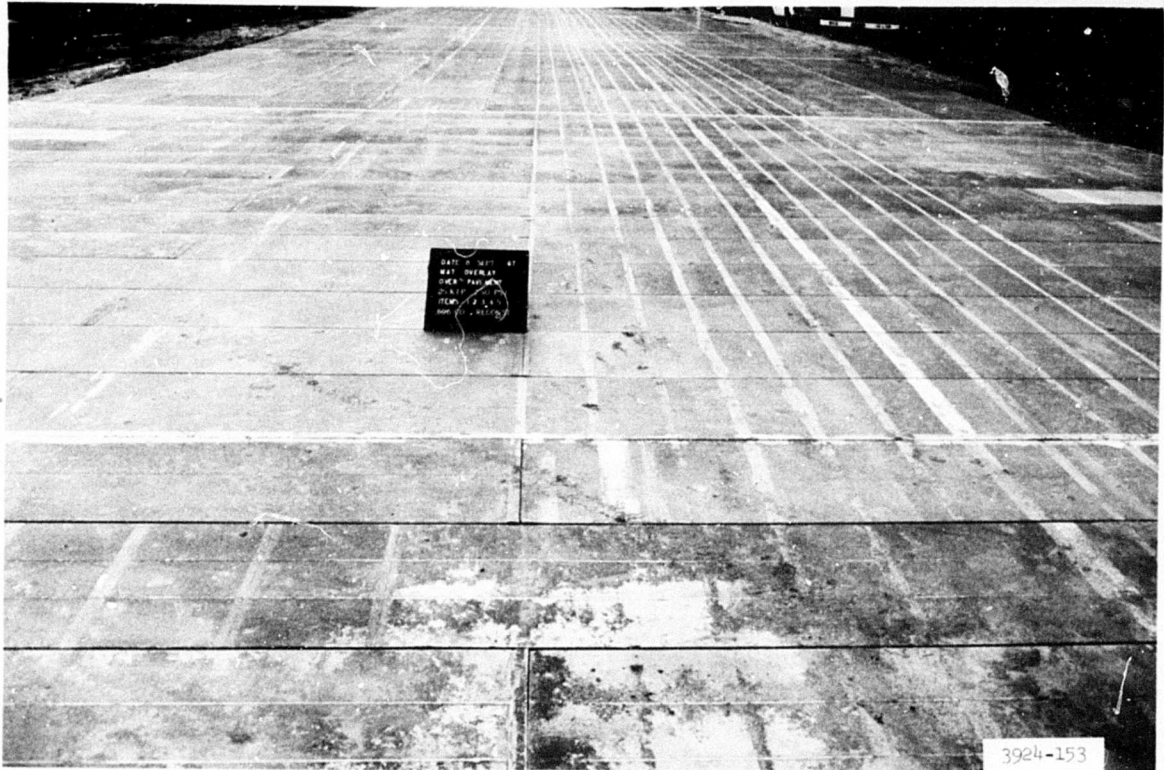
Photograph 50. General view of test section after completion of secondary construction II

43. Repairs were then made in item 5. The wet soil was removed from the area in which leakage had occurred and was replaced with dry lean clay. The replacement soil was well compacted and leveled with hand tools. As described in paragraph 41, a membrane-anchor trench was cut laterally at the transition between items 4 and 5 (see photograph 49). The free edge of the membrane was placed in the trench and secured with anchor pins, the trench was backfilled, and the soil was well compacted. All mat was then replaced on the test section, and again each mat panel was laid in its original position. A view of the test section after replacement of the mat is shown in photograph 50.
