EXPERIMENTAL STEEL PILE GROINS, PALM BEACH,  
FLORIDA

Corps of Engineers  
Washington, D. C.

BEACH EROSION BOARD  
OFFICE OF THE CHIEF OF ENGINEERS

TECHNICAL MEMORANDUM NO. 10

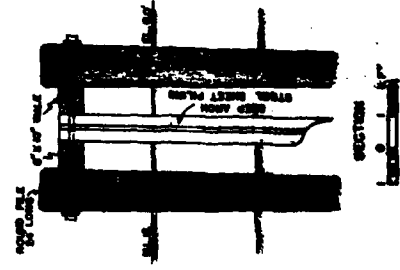
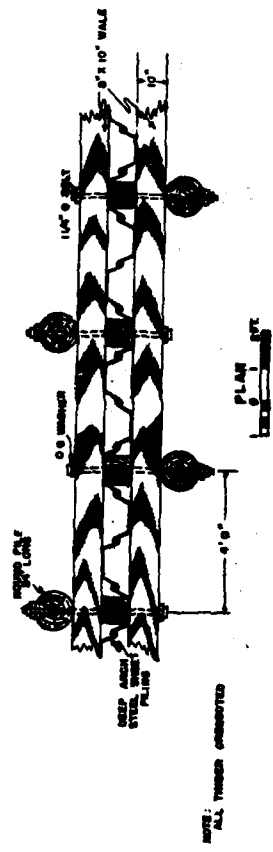
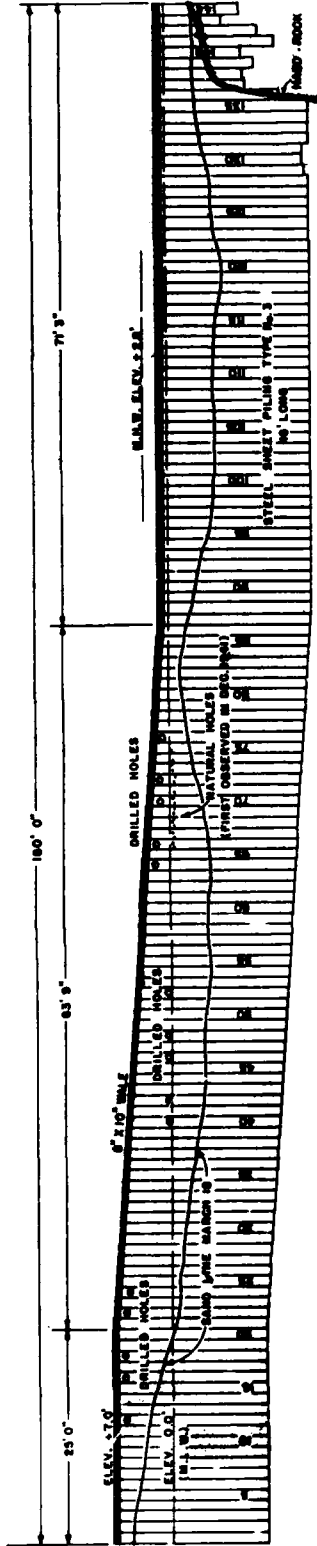
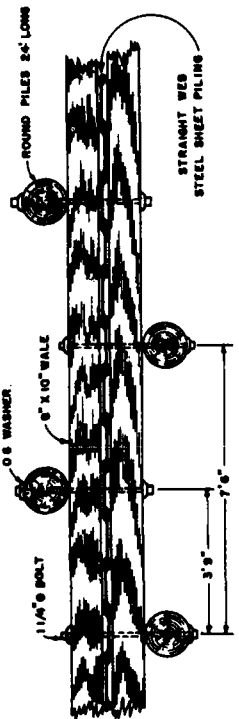
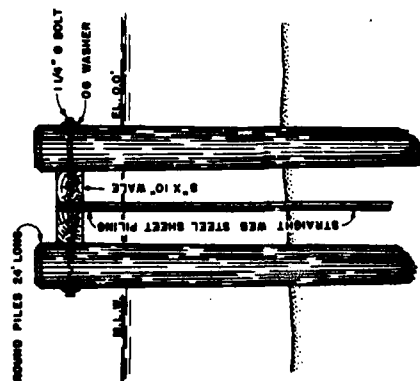
EXPERIMENTAL GROUND ISON  
 FIG. 5

May 1941. For the first time, holes are observed at the sand line in the piles between 90 and 110 feet from the bulkhead. See Figure 5.

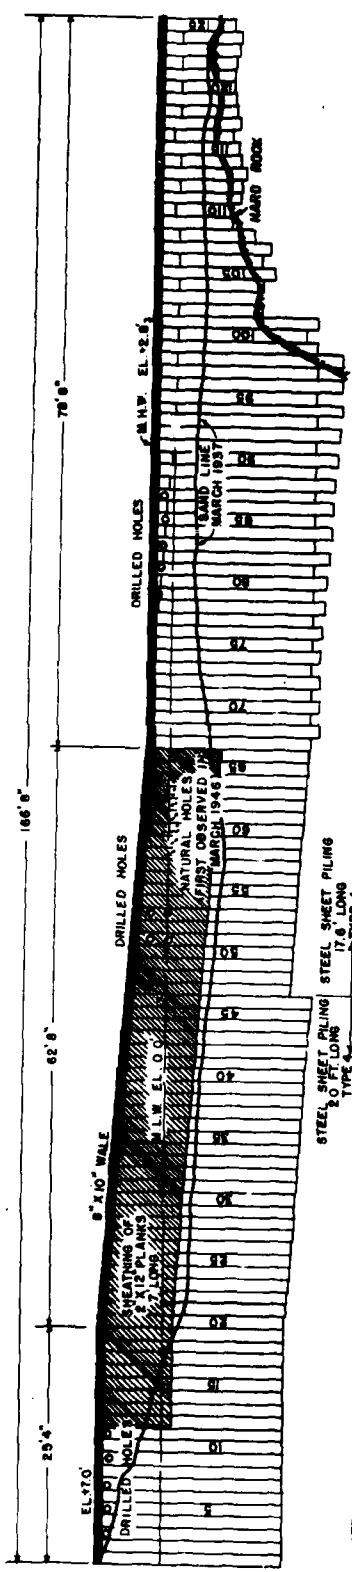
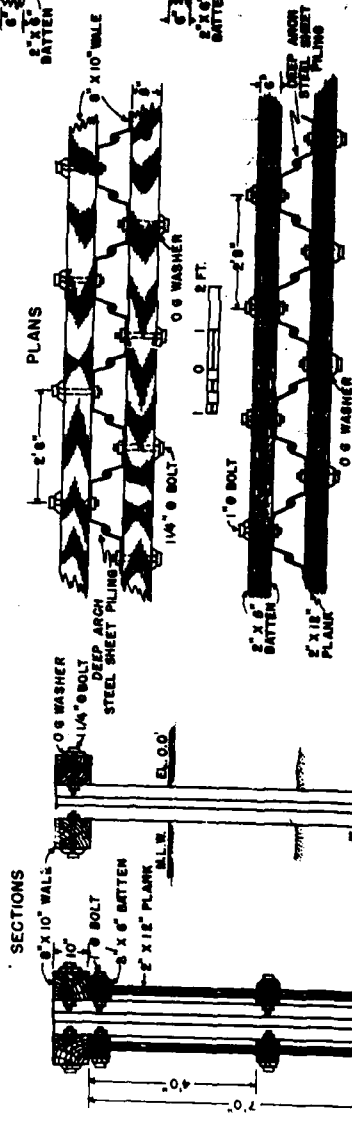
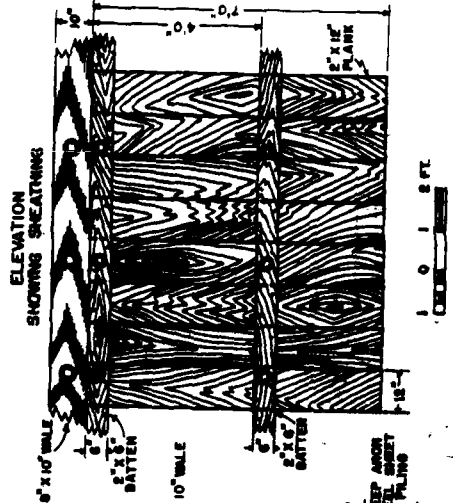
EXPERIMENTAL GROIN 131 N  
 FIG. 6

December 1941. For the first time holes are observed in the piles at the sand line in the interval between 81 and 92 feet from the bulkhead. See Figure 6. The outer 74 feet of wales are gone.

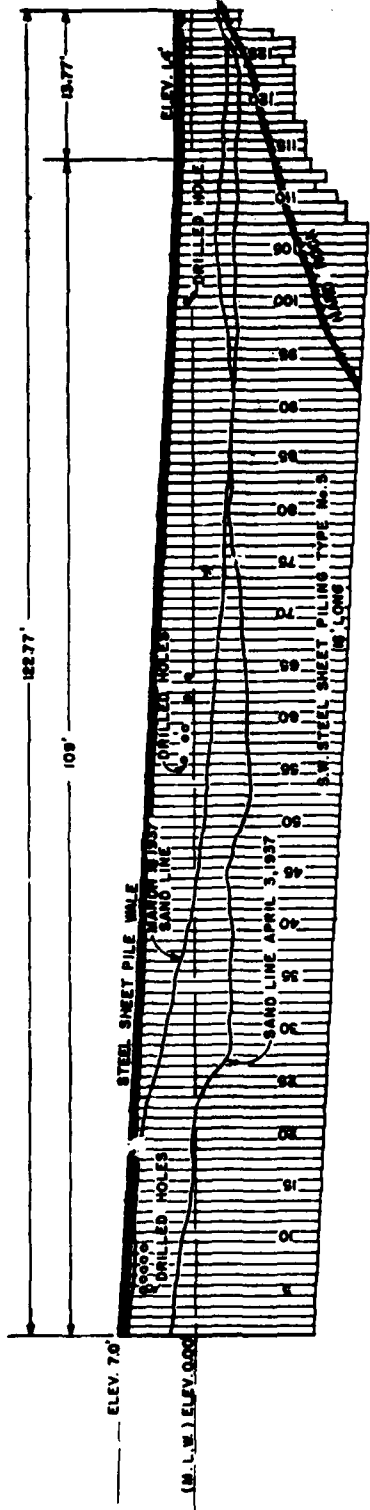
EXPERIMENTAL GROIN 121 N  
 FIG. 7

March 1946. The timber sheathing is gone beyond 65 feet from the bulkhead. Holes appear in the piling in the interval between 77 and 83 feet from the bulkhead. See Figure 7.

16. Wood Sheathing. The creosoted wood sheathing protecting Groin 121-N is shown on Figure 7. Three planks removed from the north side of the groin in order to measure the web thickness in August 1940 were not replaced. The sheathing did not afford complete protection to the piles because beach material was introduced into the space between the sheathing and the piles from the top of the groin by breaking waves. The smaller material, such as sand and shell, promptly washed out; but the stones and larger detritus remained to be agitated by water jetted through the spaces between the individual planks in the sheathing by wave action, thereby subjecting both the steel and the timber to wear from this source. The condition of the sheathing in August 1940 is shown on the upper photograph of Figure 12. The wood sheathing apparently protected the steel piling effectively over the first 5 years, after which it deteriorated rather rapidly. As shown by the lower photograph of Figure 12, by June 1946 the sheathing had become completely ineffective and all that remained were knife-edged stalagmite-shaped pieces of wood which projected above the sand line.

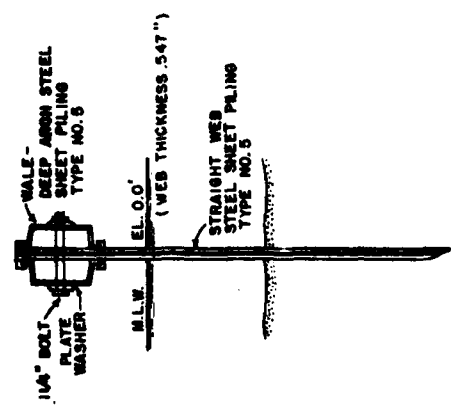
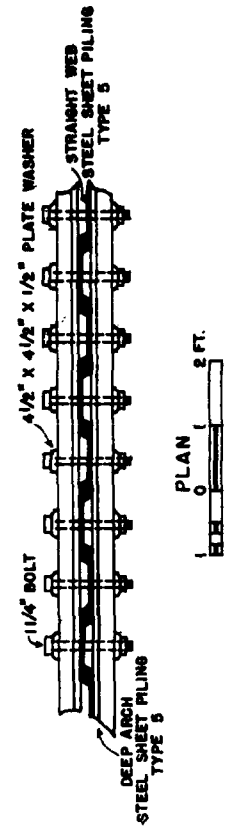
EXPERIMENTAL GROIN 112 N  
FIG. 8

(Figure 8) built of 0.547-inch steel had no holes up to March 1946 although holes were observed in April 1948. The dates when holes were first observed in the groins, the time elapsed, the approximate location of the center of the naturally perforated area, the number of years elapsed from installation until the holes were first observed and the annual reduction in web thickness of the steel on this basis are given in the lower portion of Table 2.

17. Protective Coatings. The commercial and government specified coatings used on Groins 139-N (Figure 4) and 112-N (Figure 8) disappeared from the exposed portion of the piles for all practical purposes in less than six months.
