TECHNICAL REPORT N-70-10

**SURVEY OF GULF COAST
STRUCTURAL DAMAGE RESULTING FROM
HURRICANE CAMILLE, AUGUST 1969**

Final Report

By U. S. Army Engineer Waterways Experiment Station, Vicksburg, Mississippi

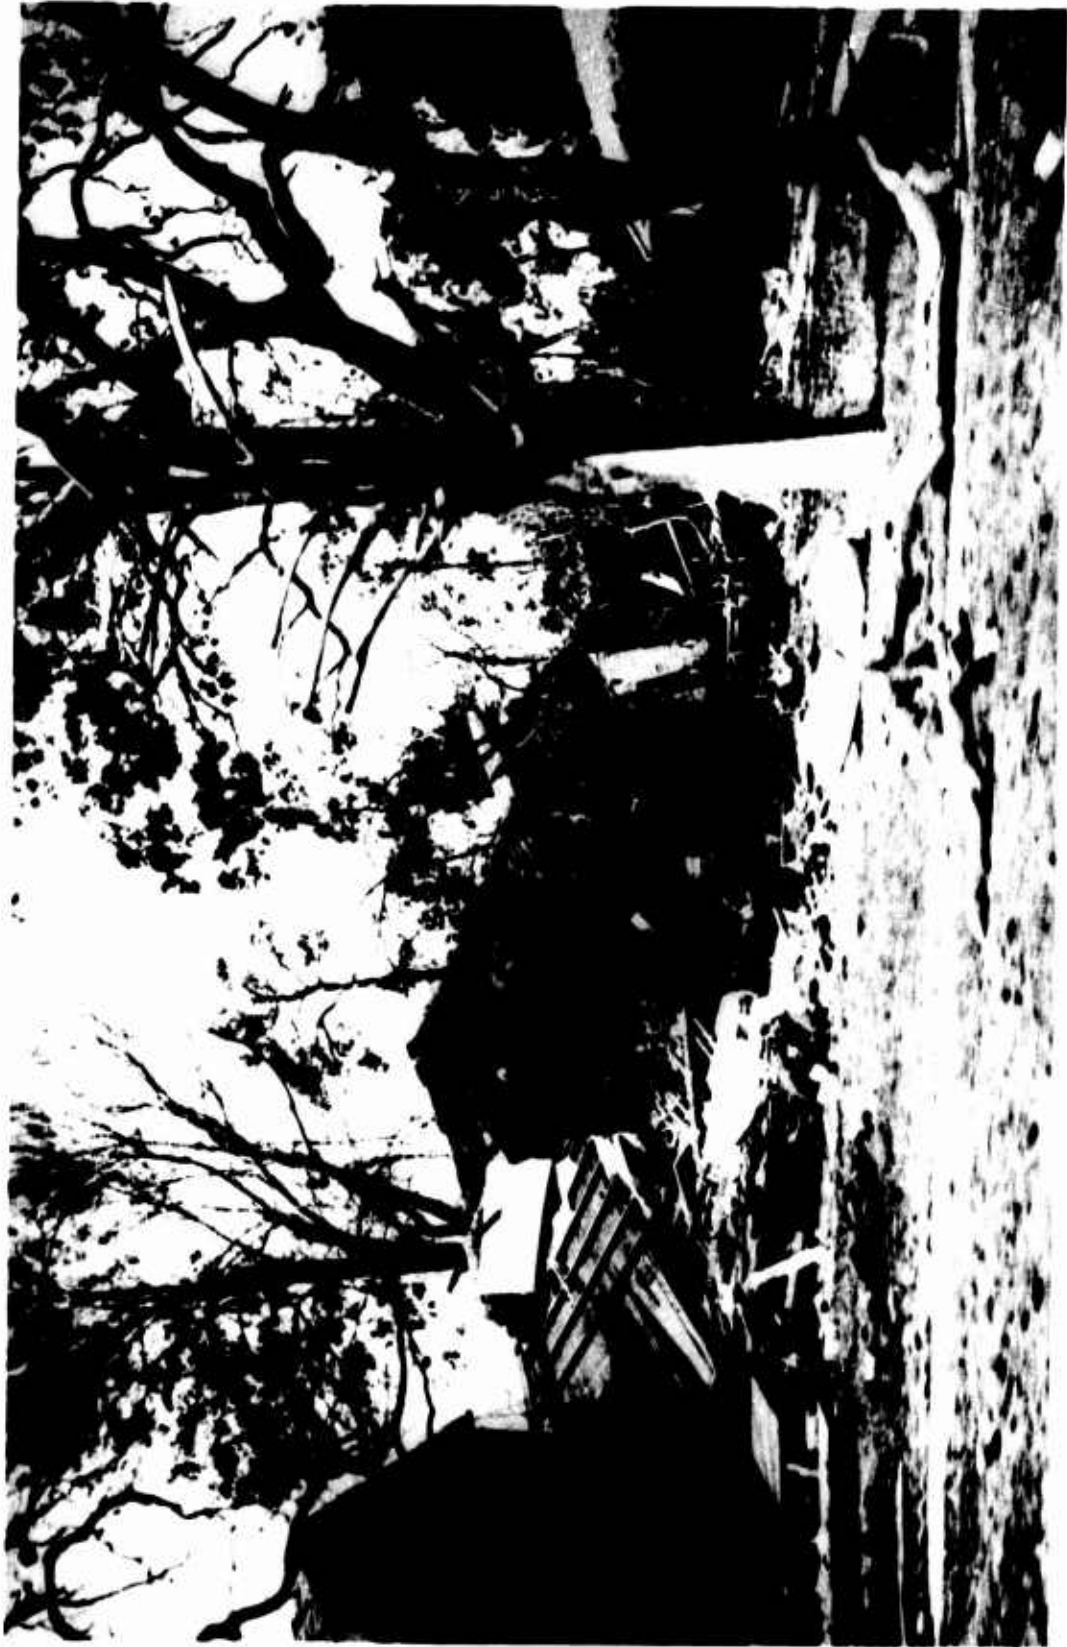
Figure 2.46 Service station, west Gulfport area.

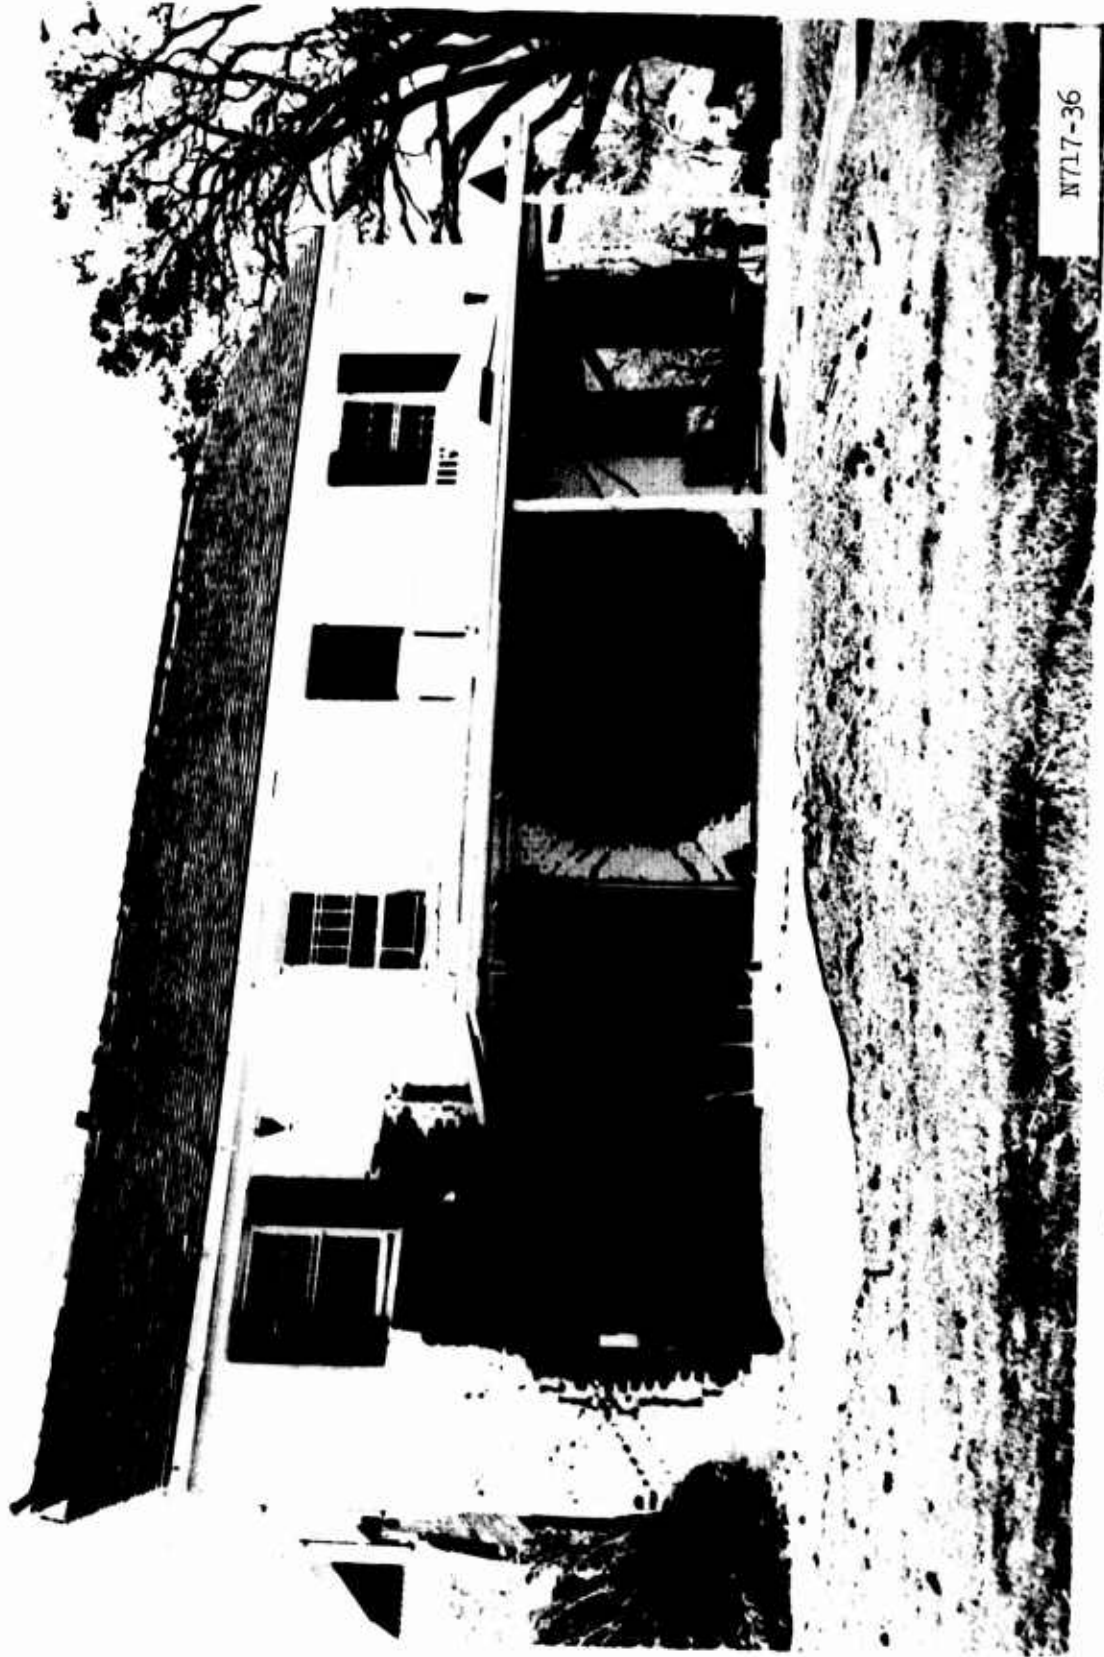
Figure 2.48 Collapsed frame house, Long Beach area.

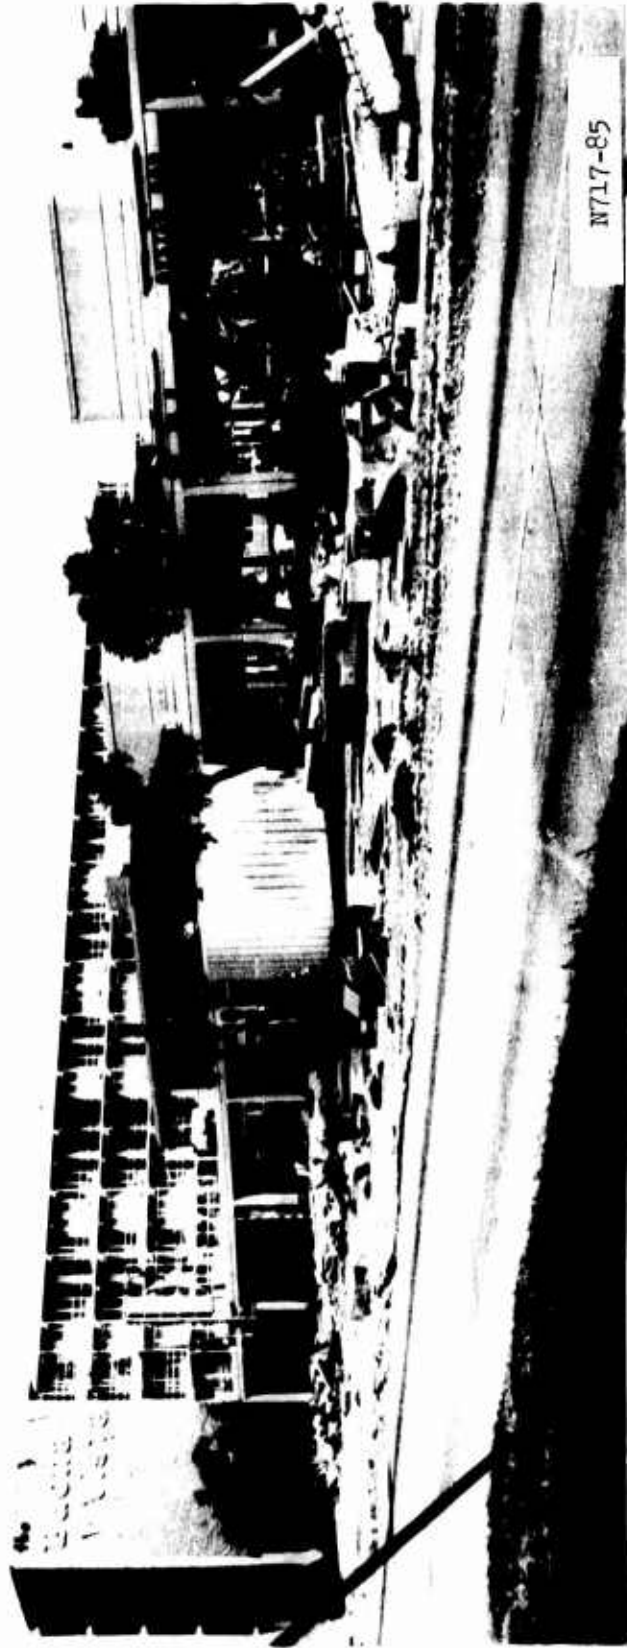
Figure 2.50 Steel frame recreation hall, Jones Memorial Park, Gulfport.

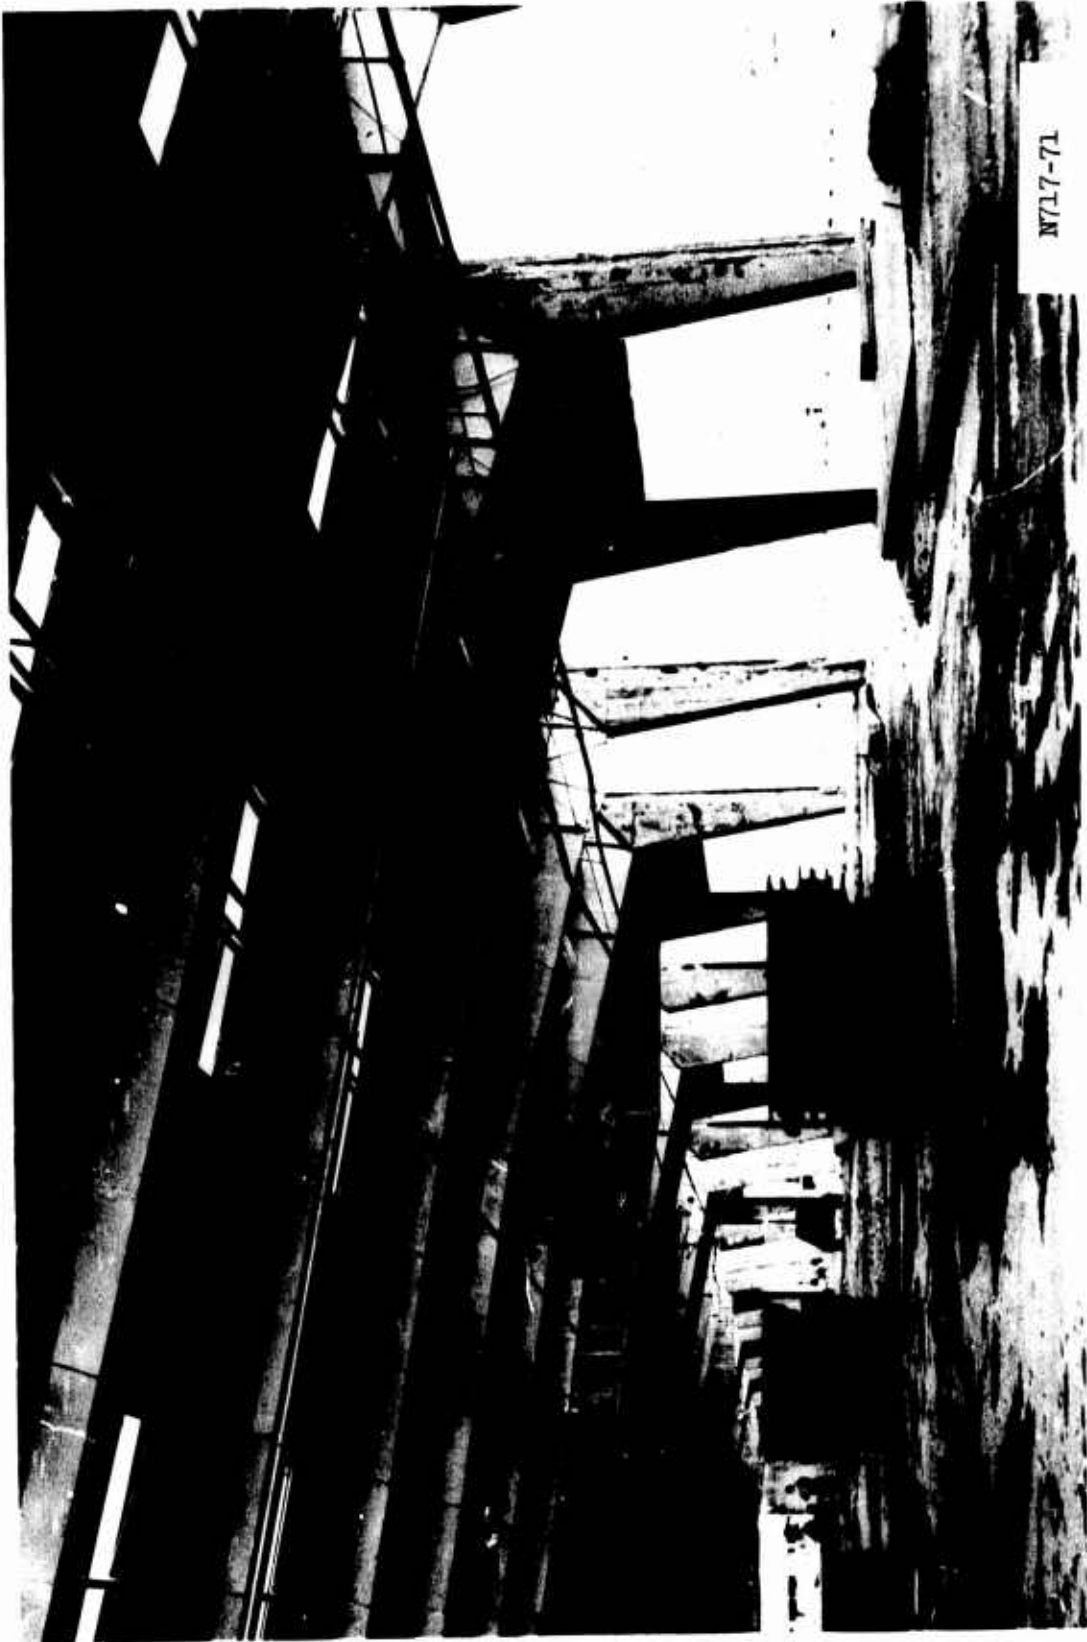
This building is a large clear span (span of about 125 feet) warehouse located at the southern tip of the Port of Gulfport. It is of rigid-frame construction with combination columns (steel sections encased in structural concrete) and with tilt-up concrete wall panels about 20 feet square by 6 inches thick and roll-up doors forming the walls. Light sheet metal purlins run along the length of the building and support a sheet metal roof. The columns appeared to have been cast in two steps, one to encase the steel section and the second to key in the tilt-up walls. The general construction is shown in Figures 3.1 and 3.2.

Figure 3.1 Close-up view of general construction of State Dock.

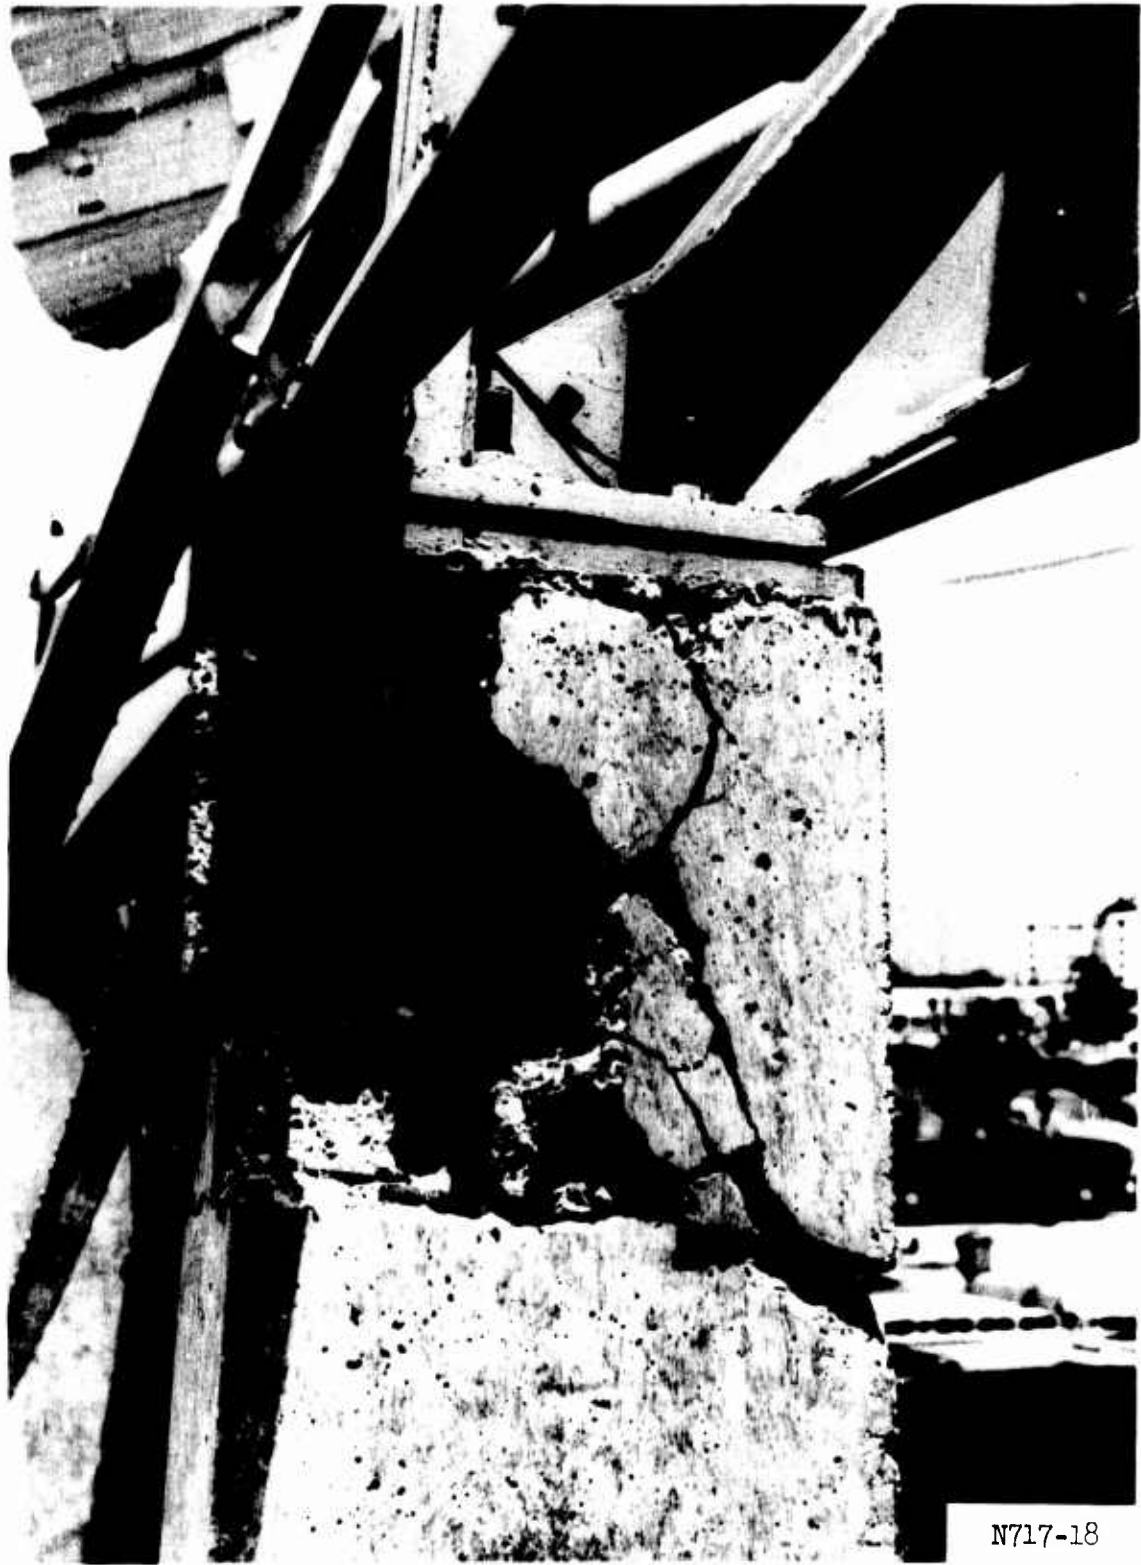
The steel arch remained standing despite the loss of two pipe column supports at the northeast corner (corner nearest the camera and to the left in Figure 3.13) and the dropping of the other three columns on the east side. Some roofing was torn off the west side of the arch (Figure 3.14). The middle pier supporting the west end of the arch was badly damaged

(Figure 3.15) and no doubt would have functioned better had more column ties been included near the top of the pier.

Figure 3.15 Center pier supporting west end of arch, Marine Life.

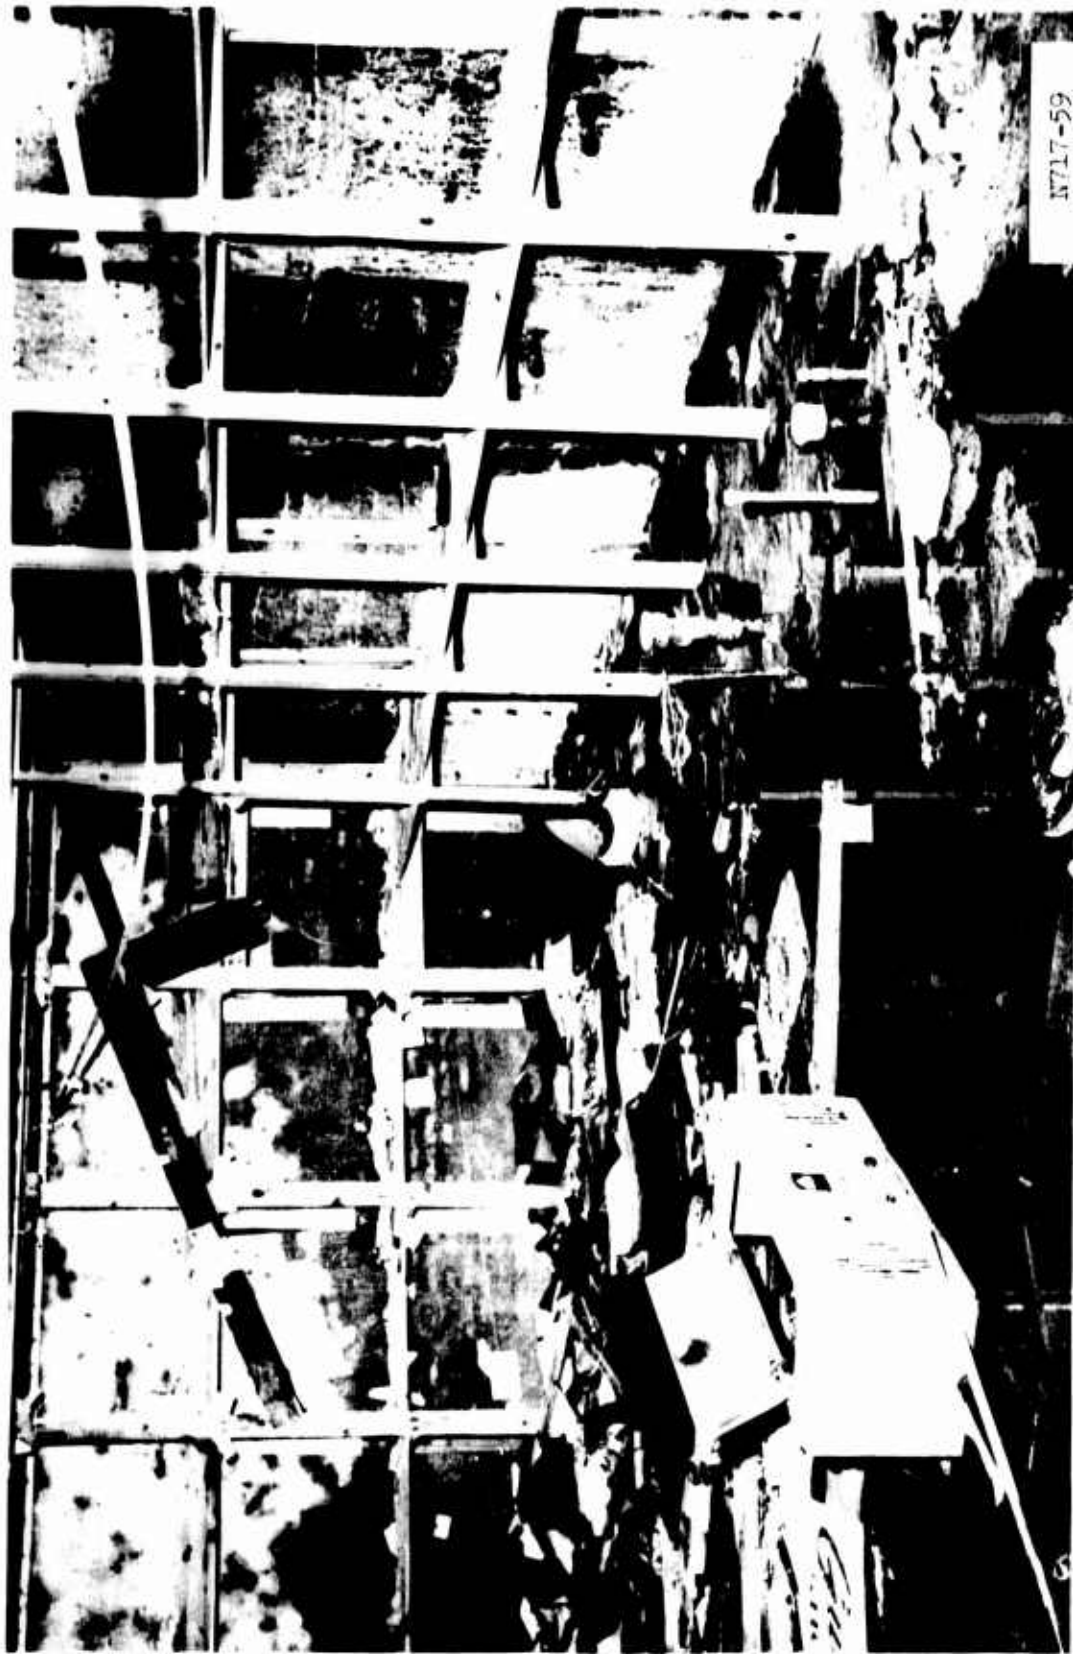
Figure 3.37 Emergency Operating Center, Pass Christian City Hall.

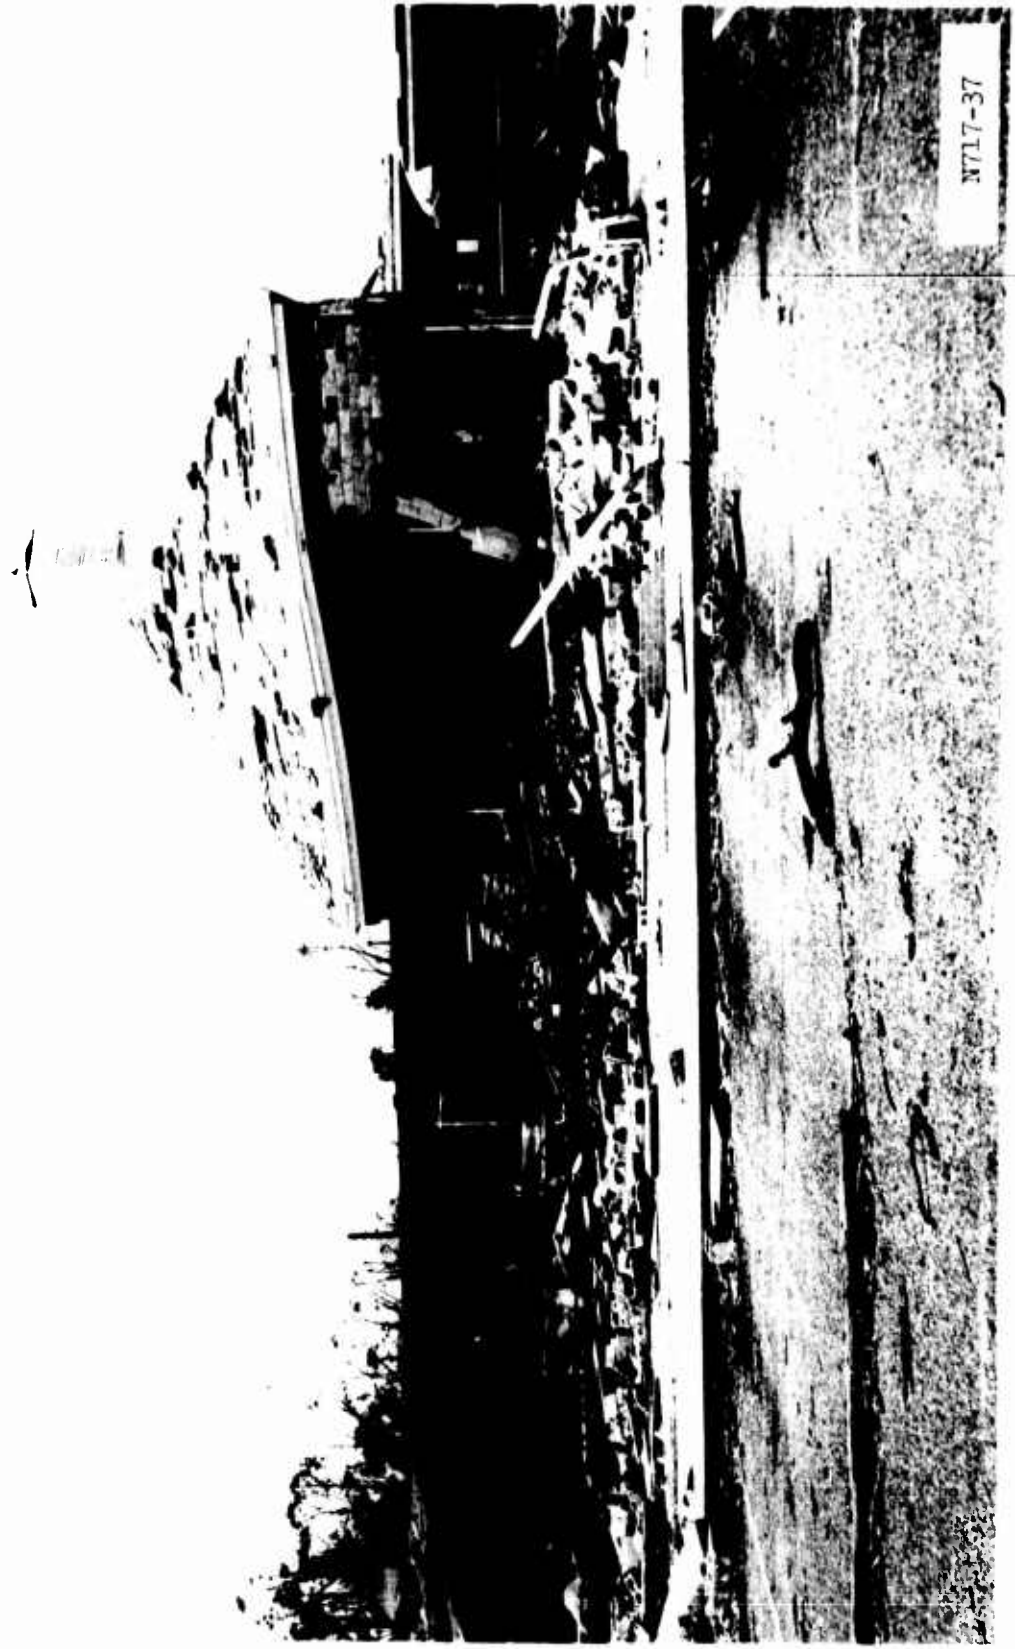
A Walgreen's store located on the seaward side of the A&P collapsed completely with much debris ending up in or behind the A&P (Figure 3.42). The angle trusses appeared to have been set into the block and brick exterior walls and fell with the wall. Small bulb angles placed atop the trusses and supporting the roofing panels spaced the trusses laterally.

Figure 3.42 Side view of A&P with remains of Walgreen's in foreground, Long Beach.

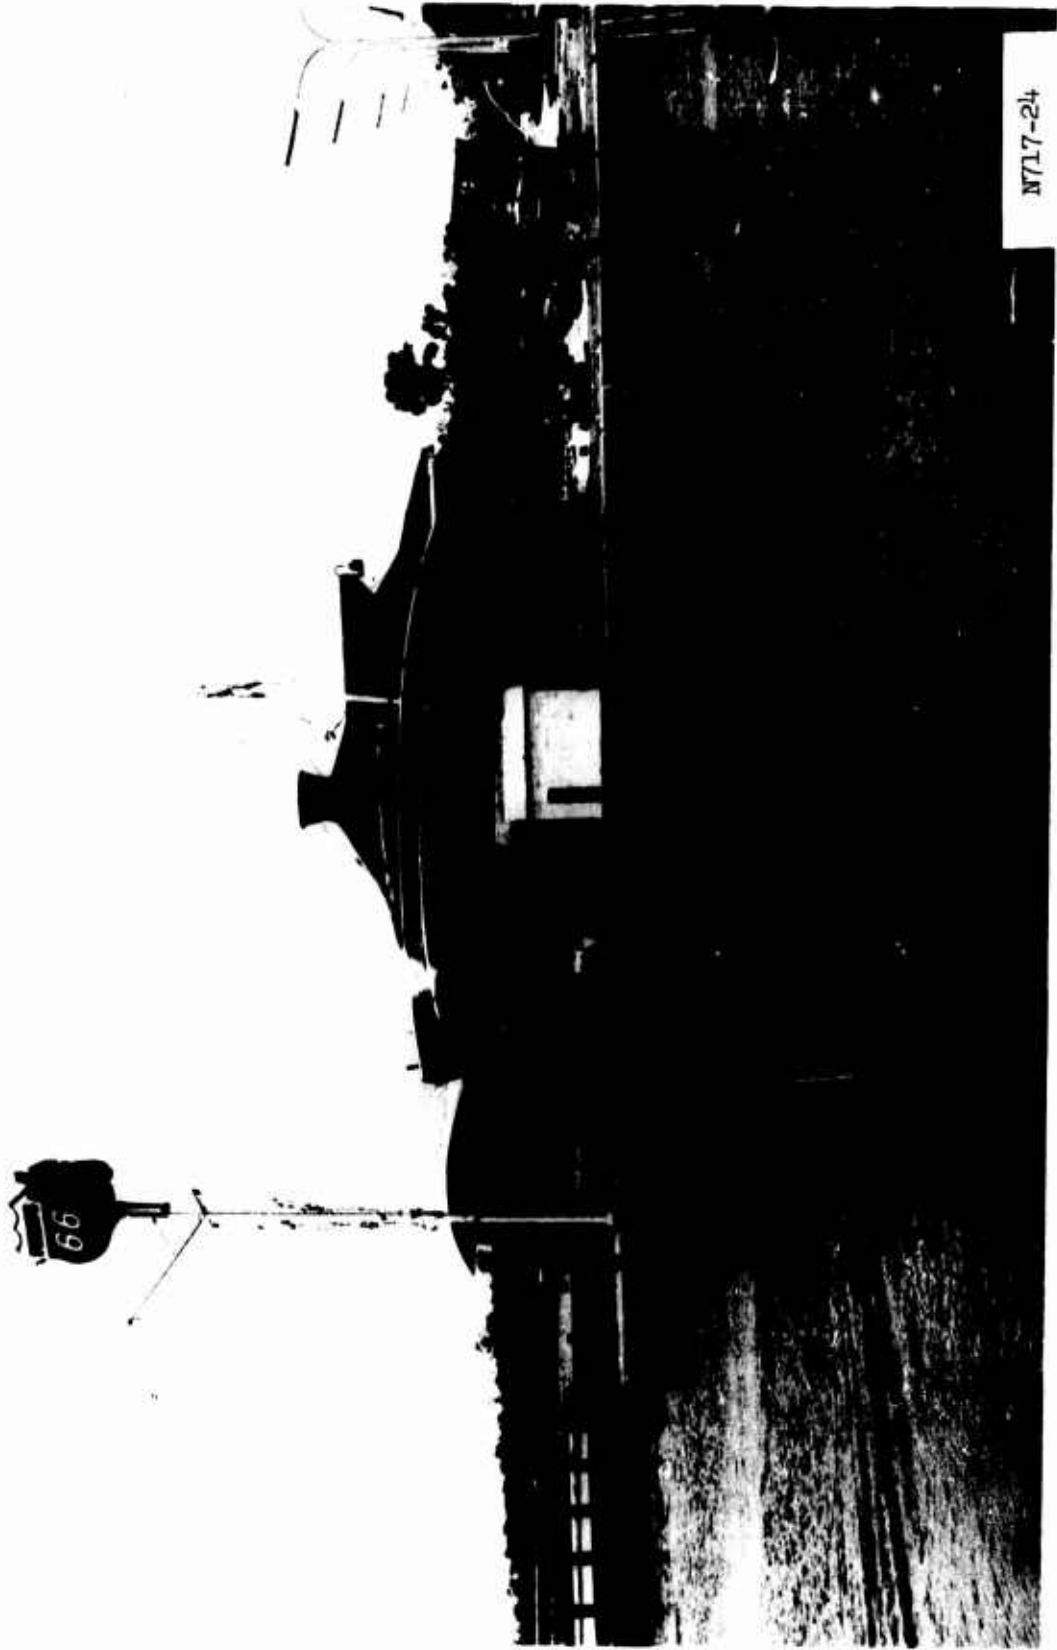
office area (Figure 3.51) indicates a lower bound on the water height in this area.

Figure 3.51 Sailboat on Edgewater Beach marina office area.

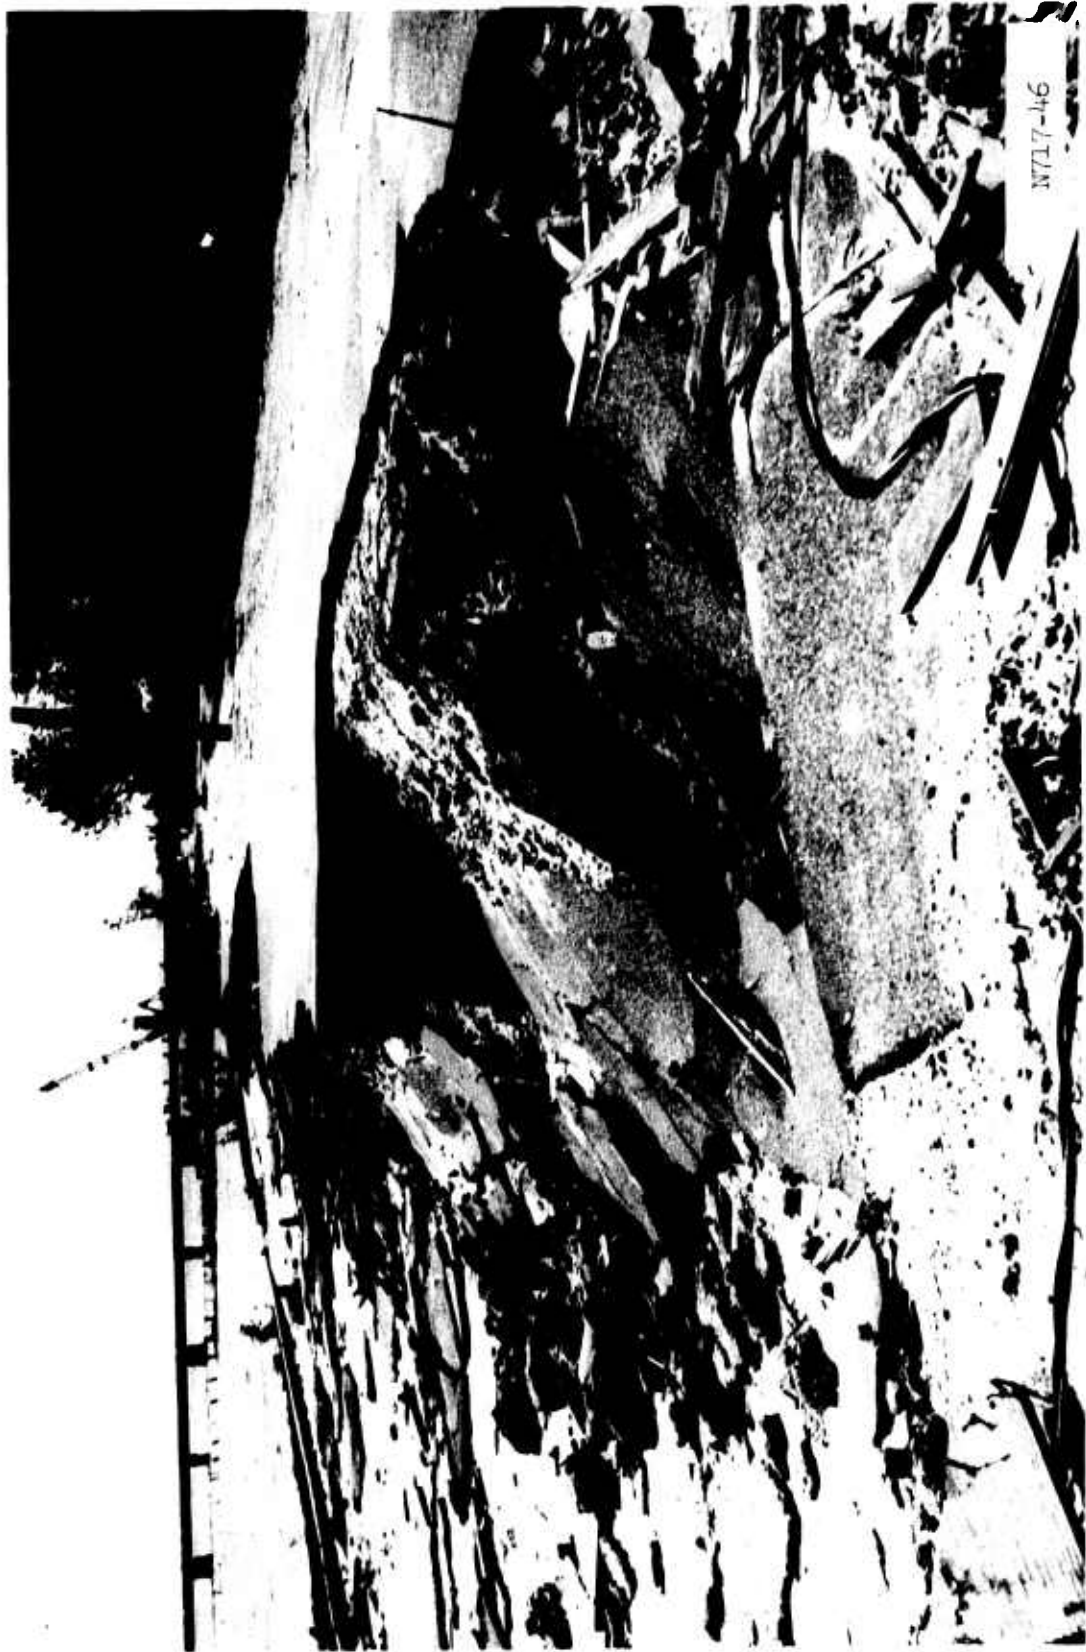
Highway 90 along the west side of Bay Saint Louis was seriously undercut by wave erosion and washed away in places (Figure 4.1) even though the highway was at an estimated elevation of 20 feet.

Figure 4.1 U. S. Highway 90 west of Bay Saint Louis.
