# TARGET RESPONSE TO EXPLOSIVE BLAST

Final Report  
By  
George H. Custard  
John R. Thayer  
Falcon Research and Development Company  
Denver, Colorado

September 1970

ARMED SERVICES EXPLOSIVE SAFETY BOARD  
FORRESTAL BUILDING  
WASHINGTON, D. C.  
Contract No. DAHC04-69-C-0095

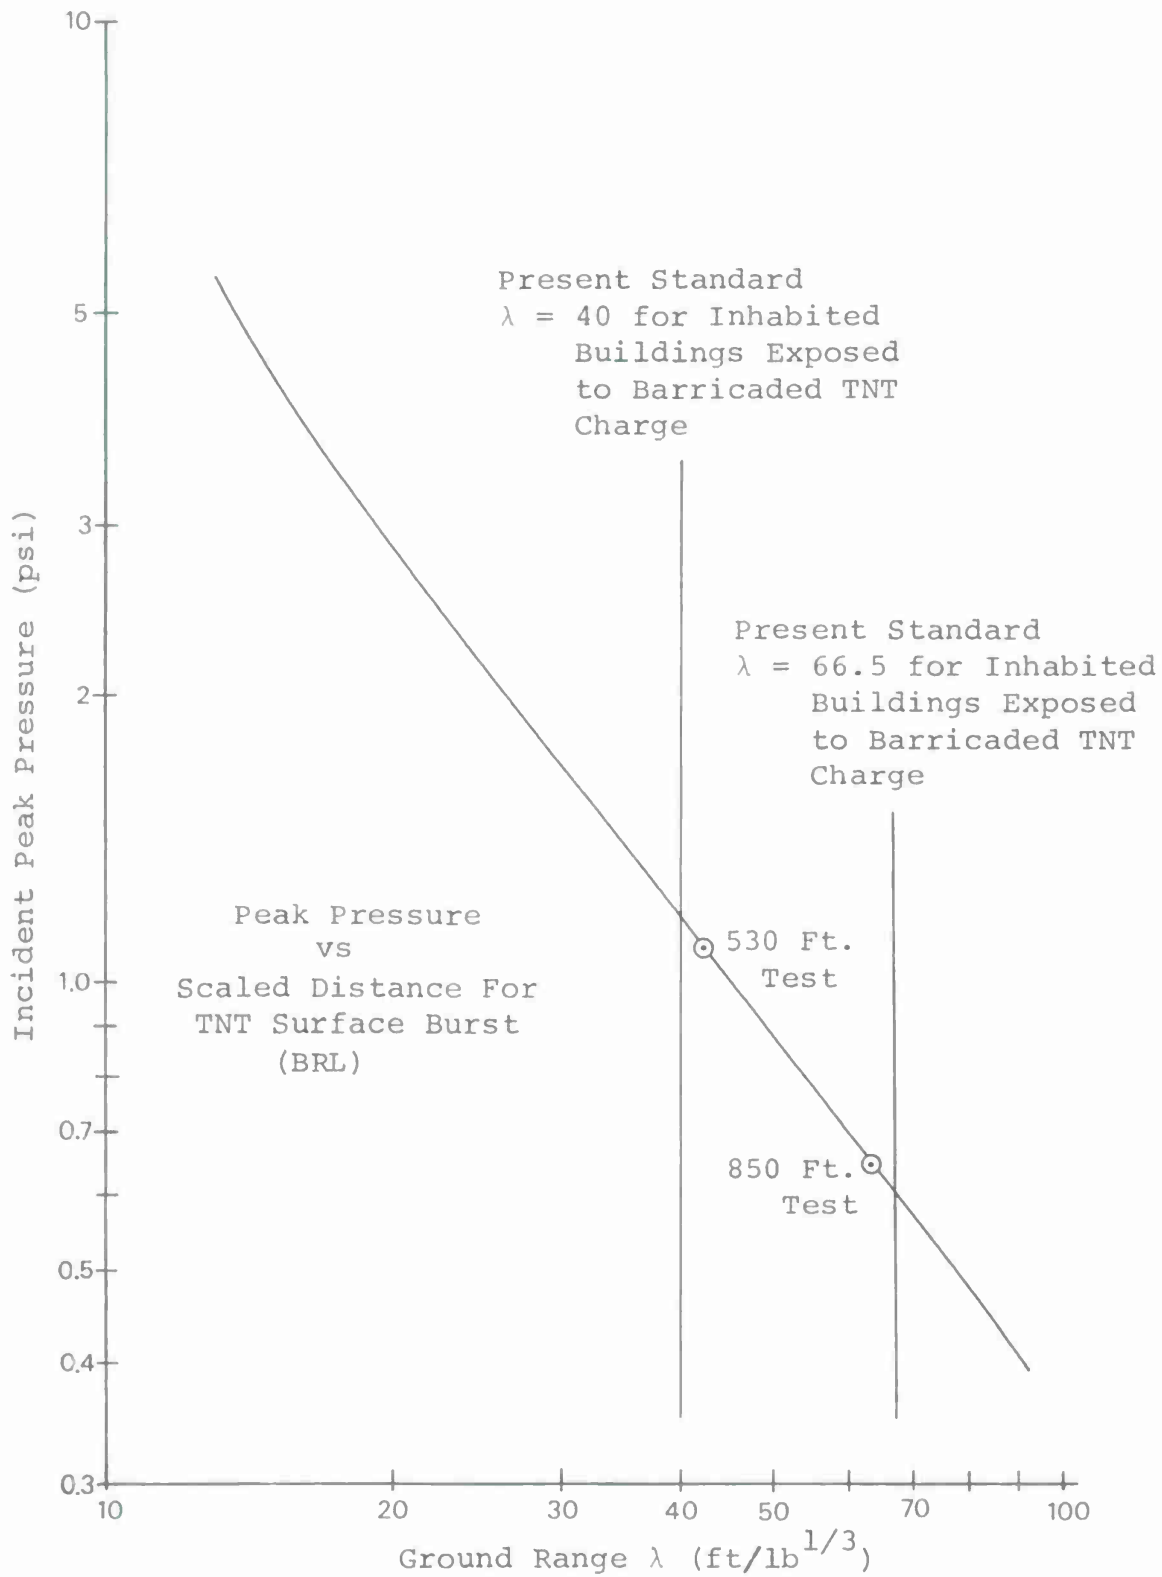
Figure 24. Plate Glass Window Exposures of the Dial Pack Directed Blast Test.

The incident peak pressure to which this window was subjected was determined to be 1.09 psi and the incident impulse 26.94 psi-ms. These data were secured from a BRL self recording gage located at the ground surface and to the side of the building. At the 850-foot location where the window was undamaged, the peak pressure was measured as 0.65 psi and the impulse was 18.46 psi-ms. The reflected pressure levels to which these windows were subjected were 2.26 psi and 1.33 psi respectively. Positive duration at the 530-foot site was 52 ms and at the 850-foot site, 65 ms. These window exposure are summarized in Figure 24.

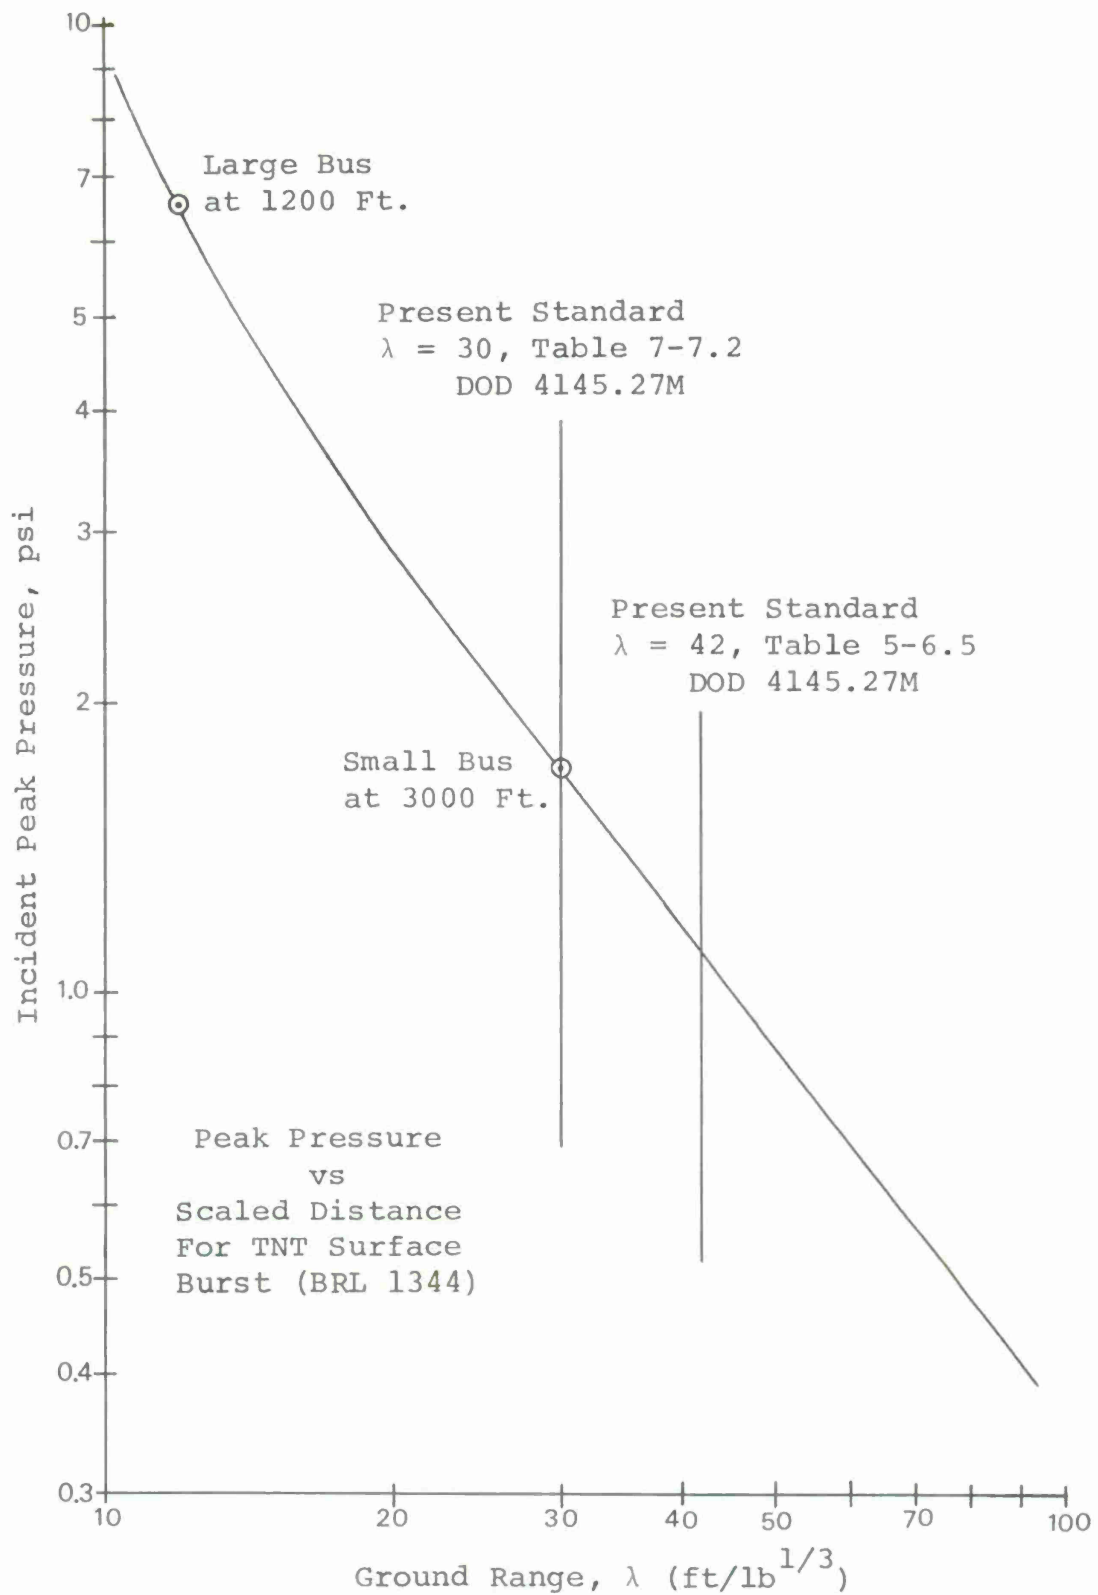
Figure 25. Bus Vehicle Exposures in the Dial Pack 500 Ton TNT test.

The results obtained in these tests of vehicle response to blast indicate that overturning is less of a hazard to large vehicles such as buses than had been predicted by early estimates. Overturning is still more of a threat, however, than a significant lateral motion. The exposure conditions for the buses in the Dial Pack 500 ton TNT test are summarized in Figure 25.

Two modifications to the model of blast interaction with a bus are needed to accurately reflect the behavior of the bus in response to blast loading. First the window area should be subtracted from the effective side area of the bus since the windows fail soon after shock arrival and do not transmit the energy they receive to the body of the bus effectively. The windows of the large bus were broken and moving out of their frames by 20 ms after shock arrival. The large windows of the small bus failed similarly. Second, some factor repre-

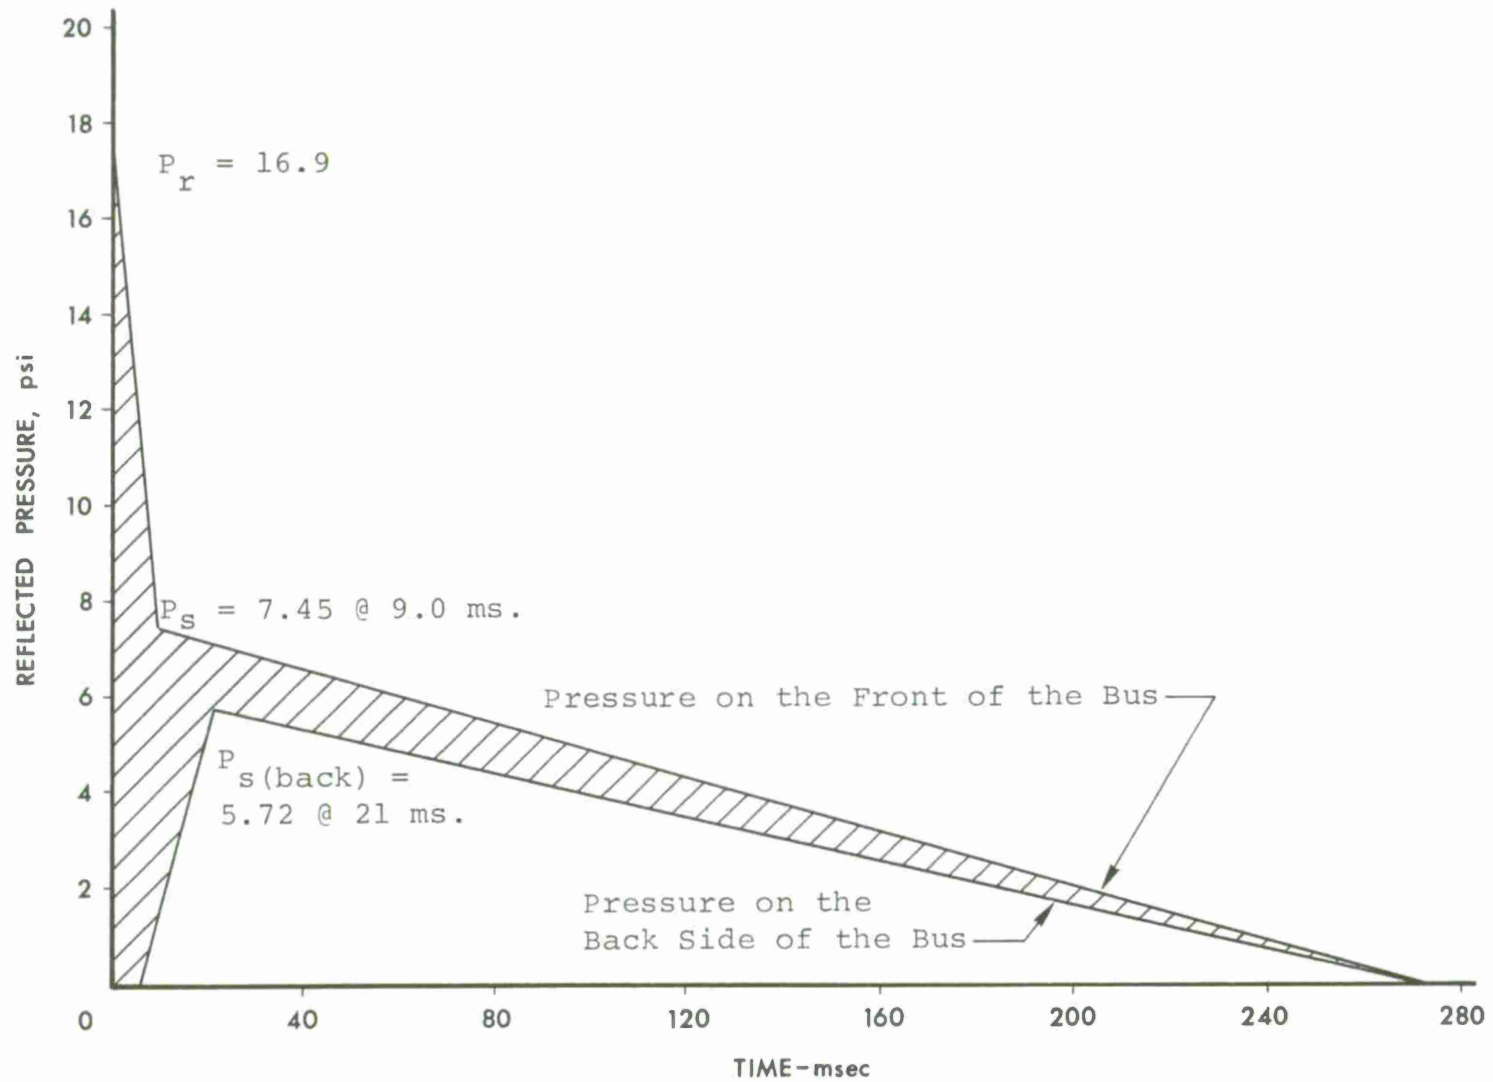
Figure 26. Loading Diagram for the Large Bus Exposed at 1200 Feet From the 500 Ton Charge.

A revised estimate of the impulse which was needed to overturn the large bus of the Dial Pack test, based upon the elimination of window areas from effective side surface, indicates that 250 psi-ms would be required if the bus overturned as a single unit. Figure 26 shows the assumed loading diagram for this vehicle. Only front and rear loading have been considered. This diagram does not include an influence for top and bottom pressure effects or for loading of internal surfaces through broken windows. The total net impulse derived from this loading diagram is 315 psi-ms. About half of this is available during the first 21 ms and the other half must be delivered during the remaining 250 ms where the pressure differential is quite low.

An examination of the rotation of the bus as shown in the high speed films (summarized in Figure 19) indicates that 60 to 30 percent of the work needed to overturn the bus was completed. The center of gravity was lifted approximately two thirds of the total rise needed for overturning. Thus one conclusion which might be drawn from these data would be that the suspension system of this bus absorbed about one third of the impulse delivered to it and consequently the estimate of impulse needed for overturning should have been proportionately higher. While these data may not be sufficient to accurately determine such a factor, they do clearly indicate that more impulse was needed to complete the overturning. The needed additional impulse must have been at least an additional 80 psi-ms since no more than 80 percent of the required work has been done at a time near the end of the loading curve when the maximum delivered impulse was 315 psi-ms. Similarly the additional impulse needed must be no more than 200 psi-ms since at least 60 percent of the required work was accomplished. The total required impulse for this vehicle is thus bracketed between approximately 400 and 500 psi-ms.

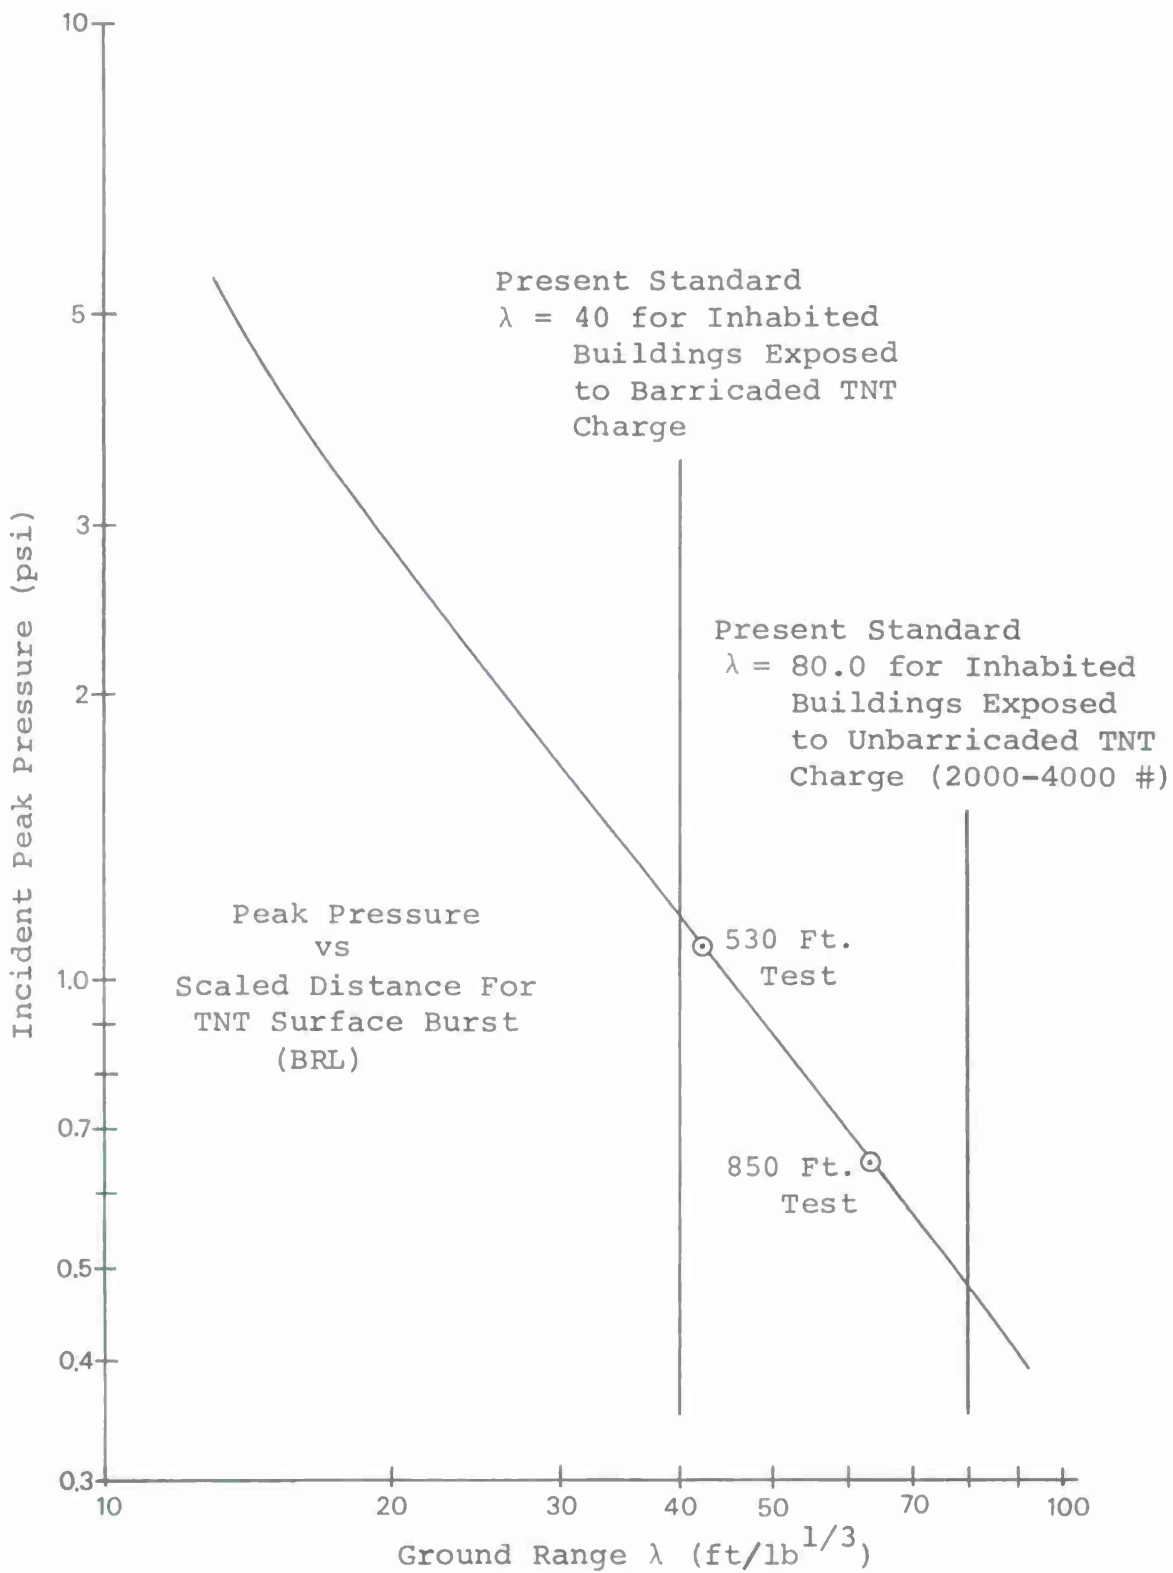
Figure 24. Plate Glass Window Exposures of the Dial Pack Directed Blast Test. (2200 lb. Effective Charge Size)

An errata sheet to the subject recent report which was distributed to you is enclosed. Figure 24 has been modified to indicate a  $\lambda$  value of 80 for unbarricaded charges. Table V has been modified by removing the distance values from the footnotes and adding asterisks to the measured impulse values in the table. There are no other changes. Please replace pages 45 and 46 with the revised sheet enclosed.
