Technical Note N-1130

IMPROVED TECHNIQUES FOR THE NON-DESTRUCTIVE TESTING  
OF DIESEL ENGINE PISTONS

NAVAL CIVIL ENGINEERING LABORATORY  
Port Hueneme, California 93041

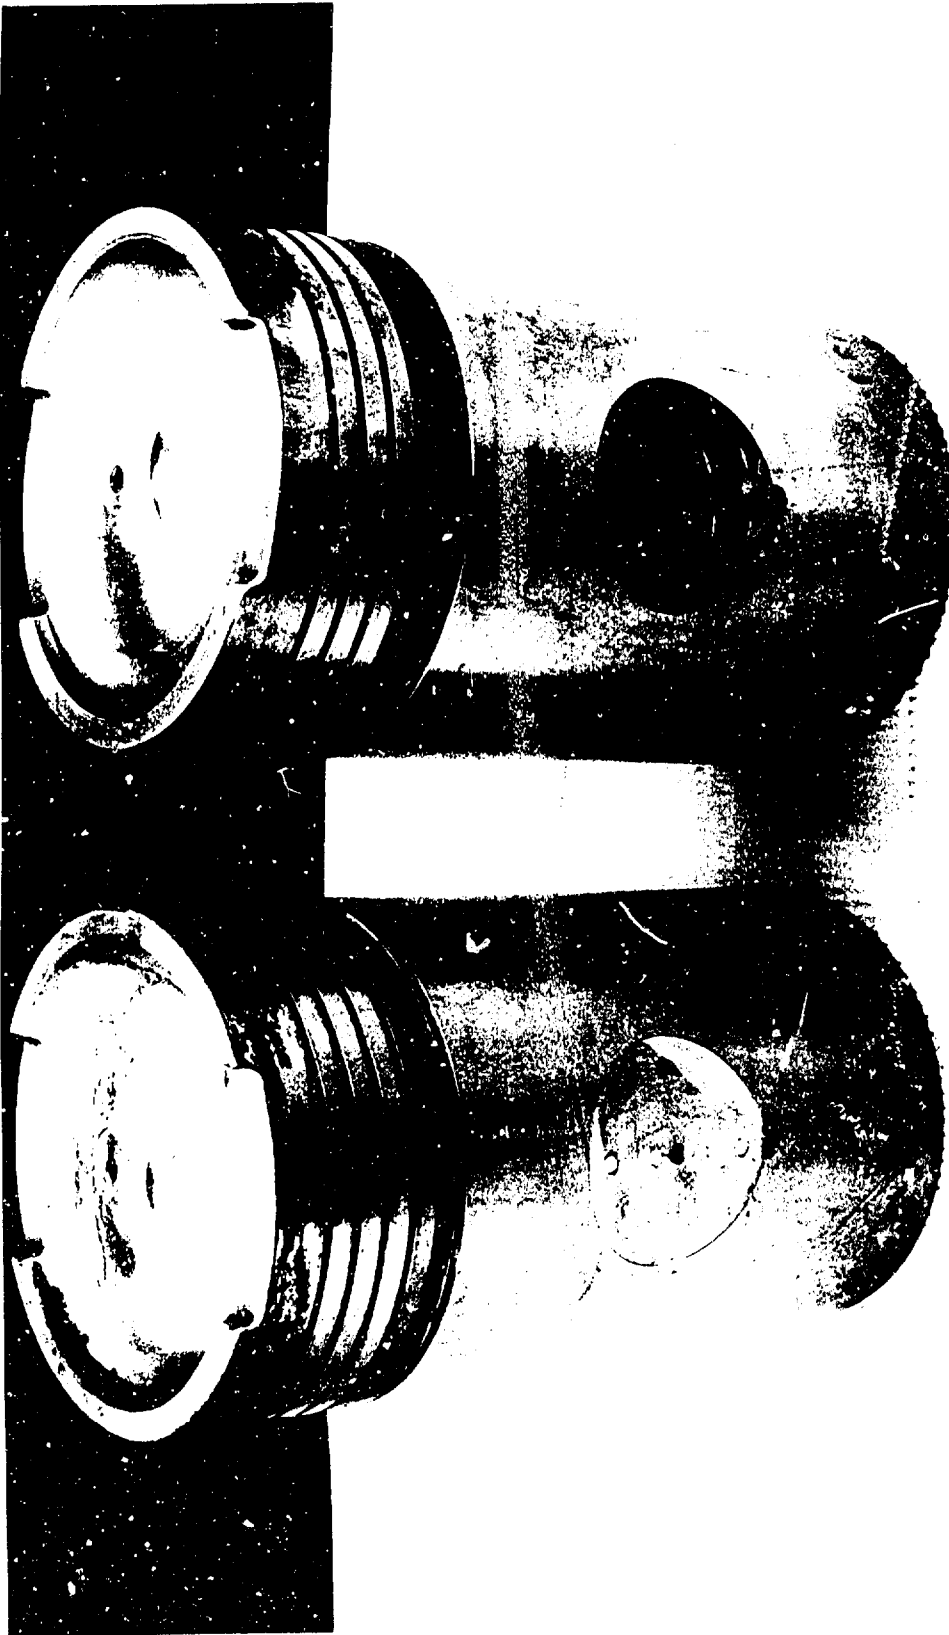
The first step in the development of the improved, non-destructive inspection technique was to conduct a thorough investigation and diagnosis of in-service piston failures. This involved an inspection and analysis of all defective pistons returned from Vietnam. See Figure 1 for an illustration of typical pistons as received. These pistons, manufacturer's part no. G-6924, are from Model DSG Enterprise diesel engines. The pistons are approximately 12 inches in diameter, by 20-3/8 inches high, and weigh between 185 and 188 pounds each. They are of one-piece construction, are machined from a ductile, nodular cast iron, and have a vertical-section configuration as indicated in Figure 2. Nodular cast iron is a relatively recent development in engineering materials. It is similar in some respects to gray (flake) iron, but is distinguished from it primarily because of the spheroidal shape of its graphite particles. The spheroidal graphite, in turn, results in improved mechanical properties in nodular cast iron, as compared to those of gray iron.

Figure 1. Enterprise Pistons. Part No. G-6924.

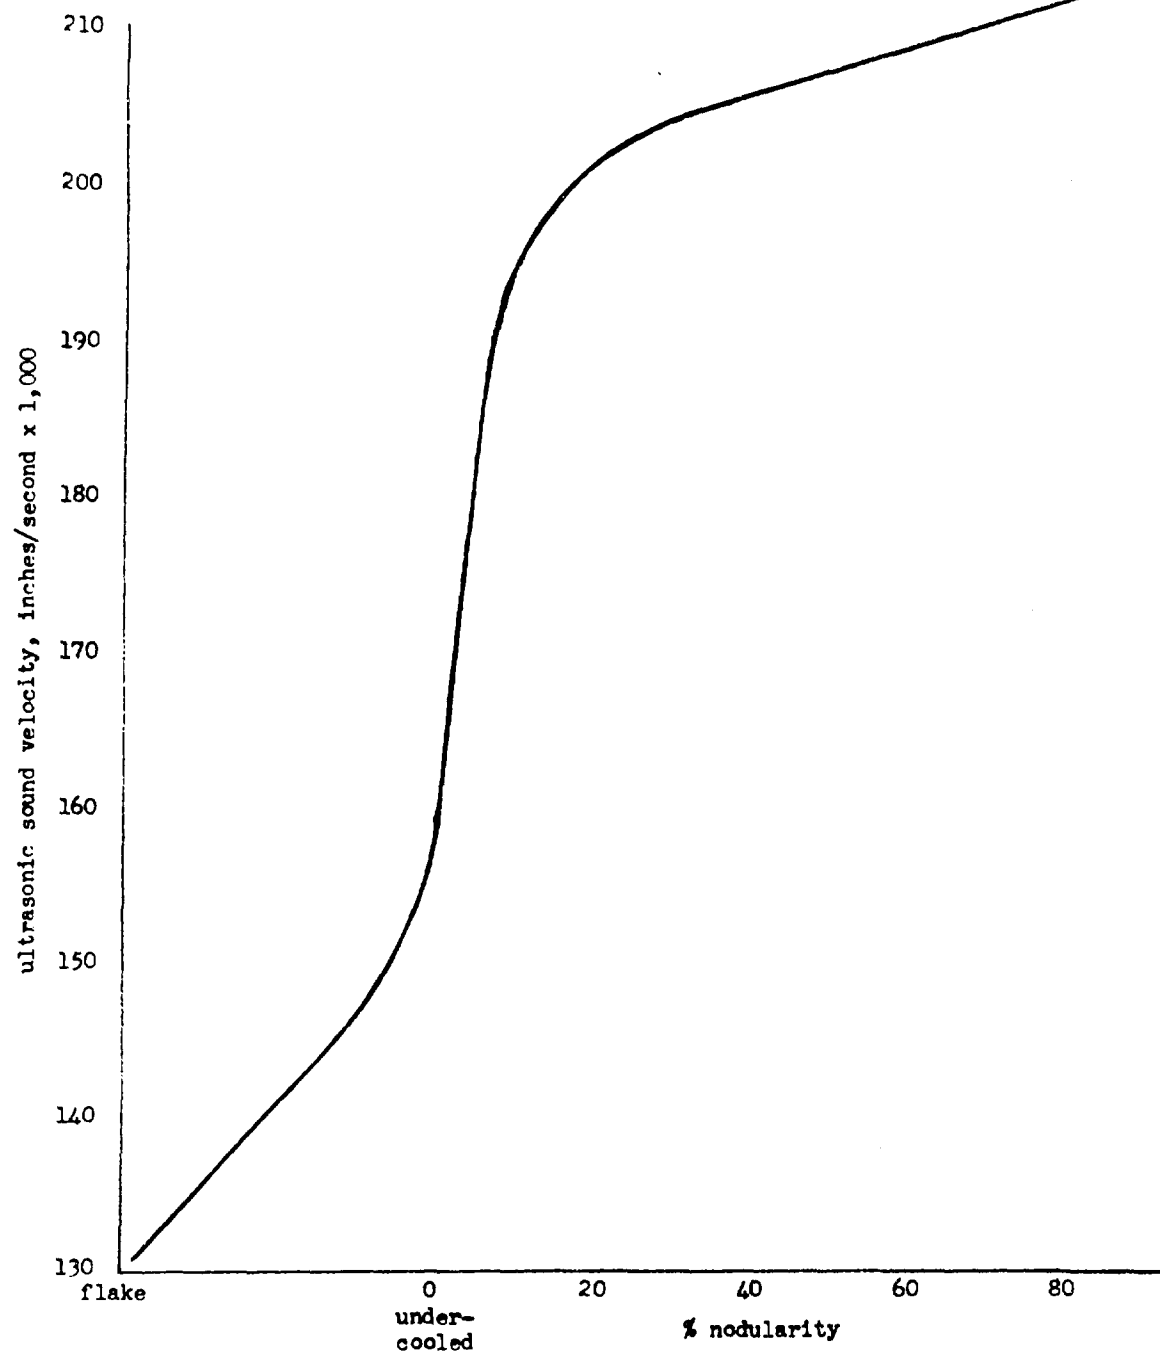
As the amount of undercooled graphite increases, sound velocity increases also, until an almost completely undercooled graphite structure exhibits a sound velocity of approximately 160,000 inches per second. Between a fully undercooled graphite structure and one that is 20 to 30% nodular, unobstructed sound transmission ability increases very rapidly to the area of 205,000 inches per second, wherein ultrasonic testing becomes most effective. As the percentage of nodularity increases still further, sound velocity continues slowly upward, until at 90% nodular, the velocity is within the vicinity of 215,000 inches per second (see Figure 4).

Figure 4. Sound velocity in typical cast irons.

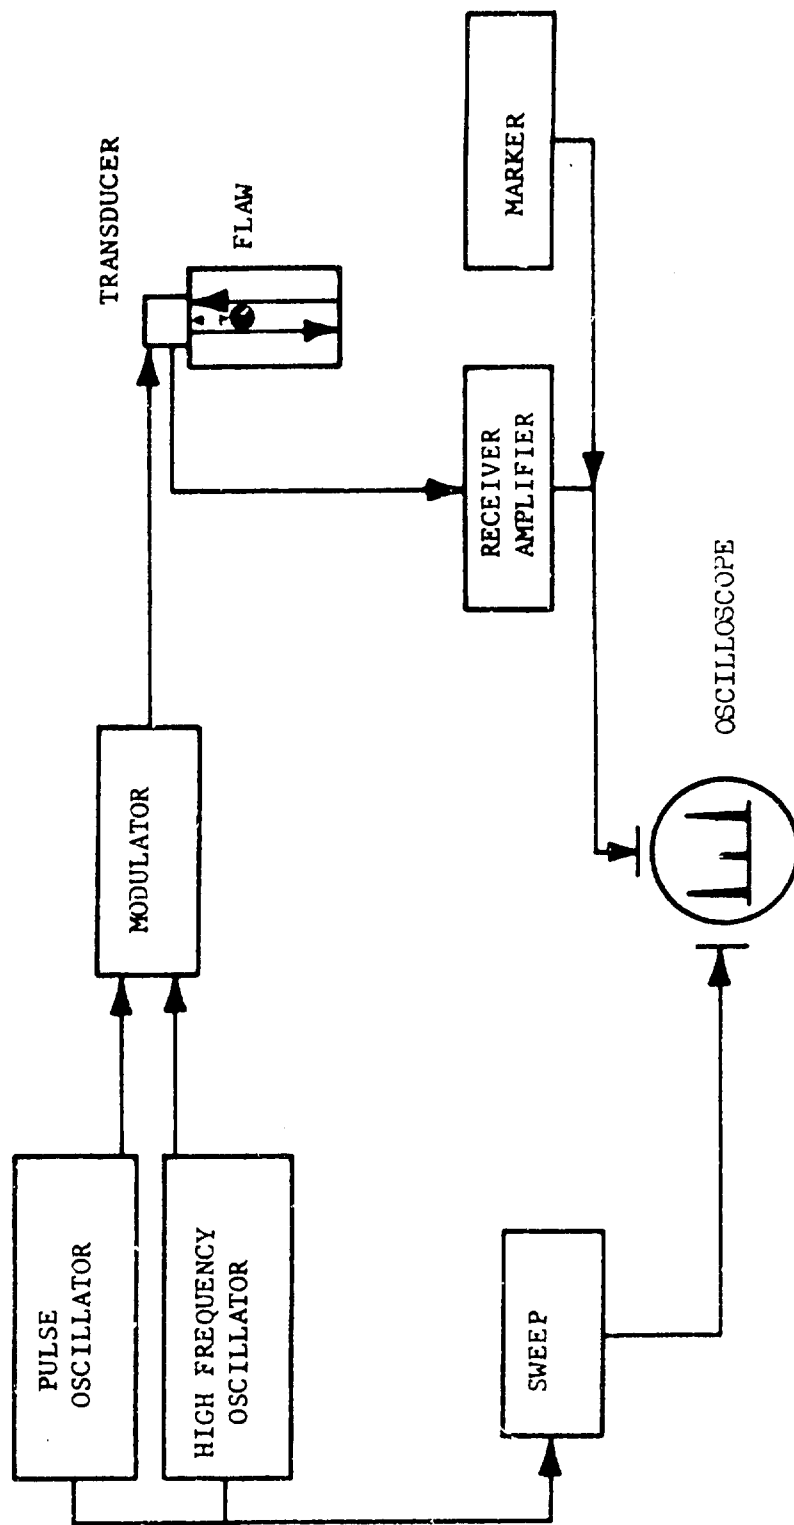
Instrumentation for this pulse-echo technique (the most commonly used ultrasonic system) comprises a pulse oscillator, a modulator, a transducer, a receiver-amplifier, a rectifier, a linear-sweep generator, and an oscilloscope (see Figure 5). When in operation, the output from the pulse generator is applied across the transducer, and conducted, via the liquid couplant, into the test item. When the ultrasonic wave strikes an interface, part of the energy is reflected. Receiver circuits then amplify the results of the reflection on the transducer to an amplitude suitable for operating the oscilloscope.

Figure 5. Ultrasonic pulse-echo flaw detection system.

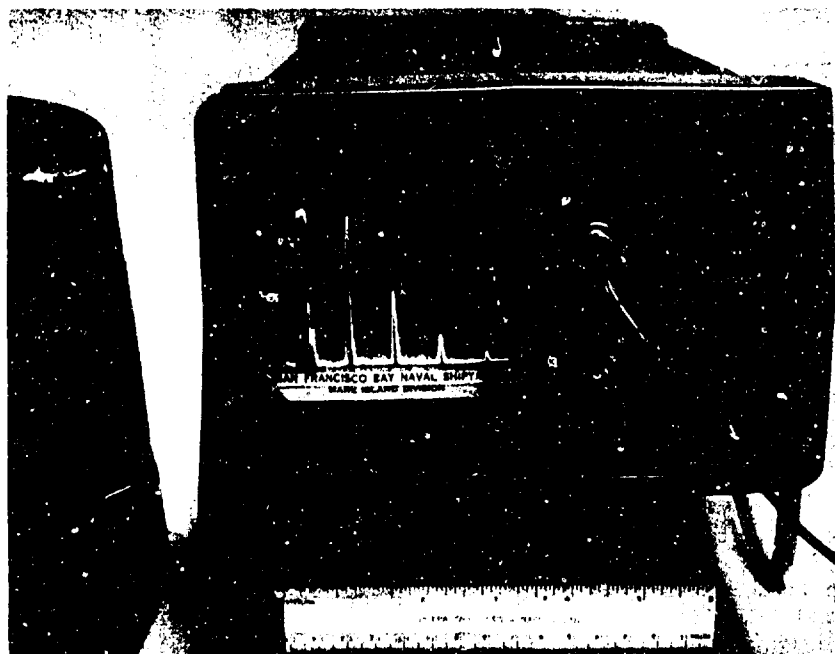
Figure 8. Depth measurement calibration.
