Report No. FAA-RD-71-3

# TITANIUM FUSELAGE ENVIRONMENTAL CONDITIONS IN POST-CRASH FIRES

Constantine P. Sarkos  
National Aviation Facilities Experimental Center  
Atlantic City, New Jersey 08405

MARCH 1971

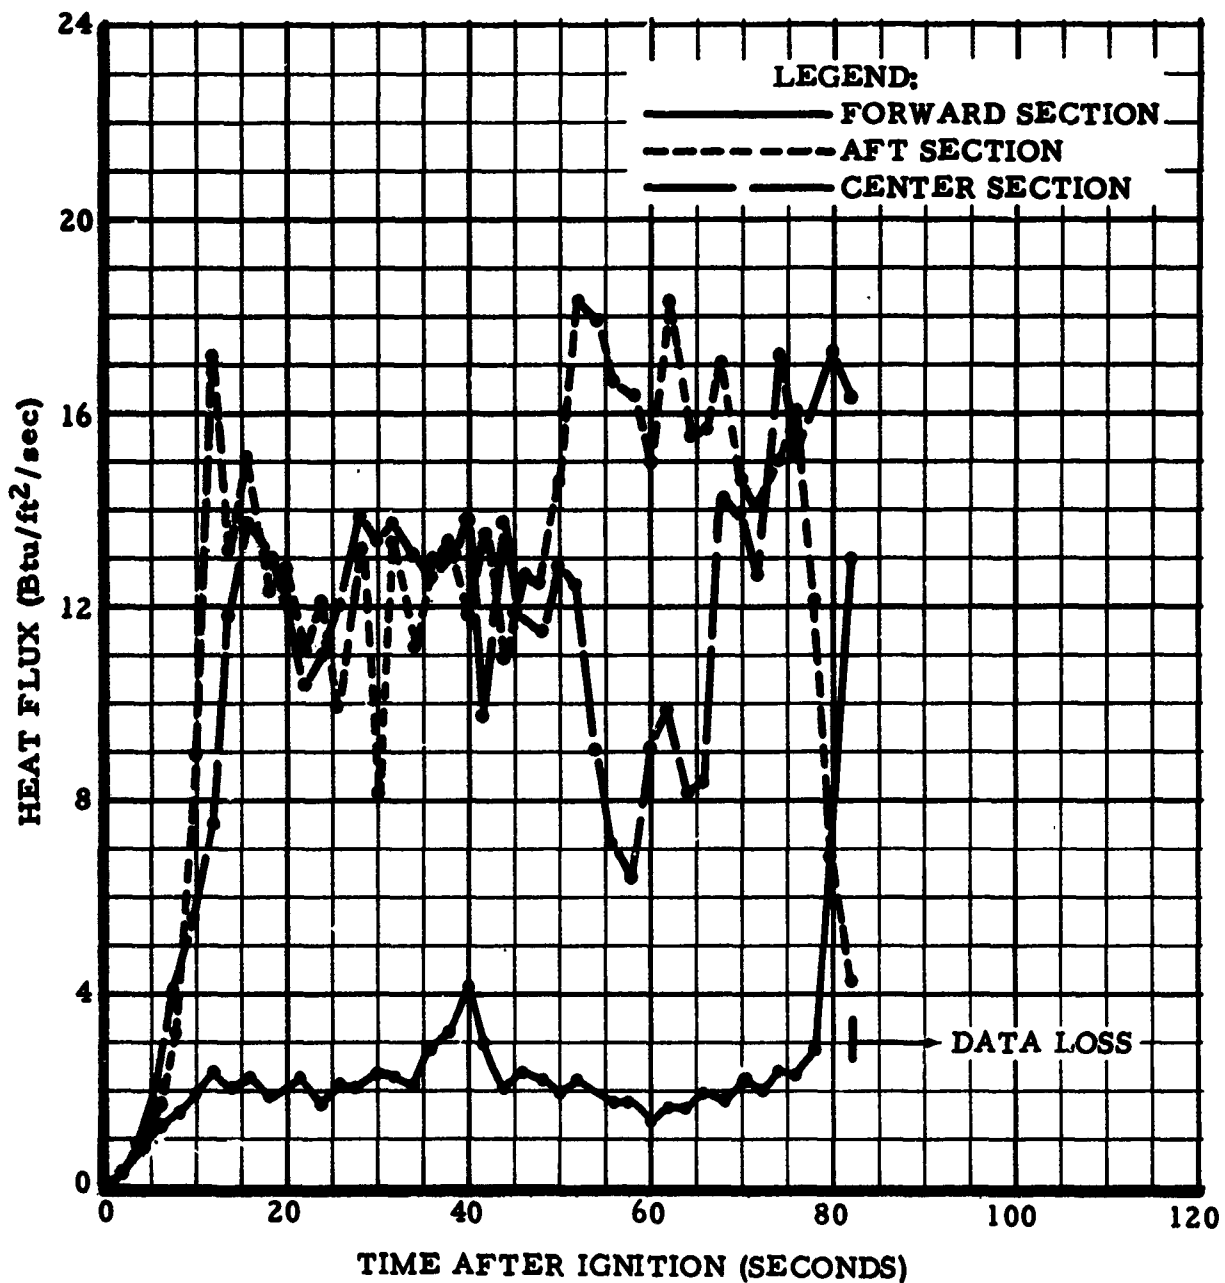
The intensity of the fuel fire was measured by three heat flux transducers and three thermocouples. Figure 21 compares the total heat flux impinging upon the fuselage at each instrumentation section. Each data point represents the average of five readings taken every one-half second. It was necessary to reduce the data by this procedure in order to eliminate the large, rapid fluctuations in heat flux characteristic of a turbulent fire of this size, thus making it possible to simultaneously compare the heat flux at each section. As was observed during the test, Figure 21 demonstrates that the fire did not reach full intensity until about 10-15 seconds after ignition. Also, it is apparent that the heat flux distribution was governed largely by the location of the firewhirl which, except for its movement at 80 seconds after ignition toward the forward end of the fuselage, was always adjacent to the fuselage near the aft end. Even though the center heat flux transducer was positioned at the center of the fire pit, the heat generated by the firewhirl was great enough to cause the aft total heat flux to exceed that at the center for most of the test. Convective flame bending toward the firewhirl caused the aft and forward heat flux, which were measured equidistant from the center of the fire pit, to differ by as much as a factor of ten. Data were abruptly terminated when the shielded cables connected to the heat flux transducers developed short circuits. Fortunately, temperature data were recorded throughout the test since all thermocouple wires were protected by asbestos insulation. Figure 22 shows the flame temperature at each instrumentation section. A comparison with the heat flux data revealed that the flame temperature closely followed the trends exhibited by

FIGURE 21 - HEAT FLUX UPON TITANIUM FUSELAGE DURING AN EXTERNAL FUEL FIRE

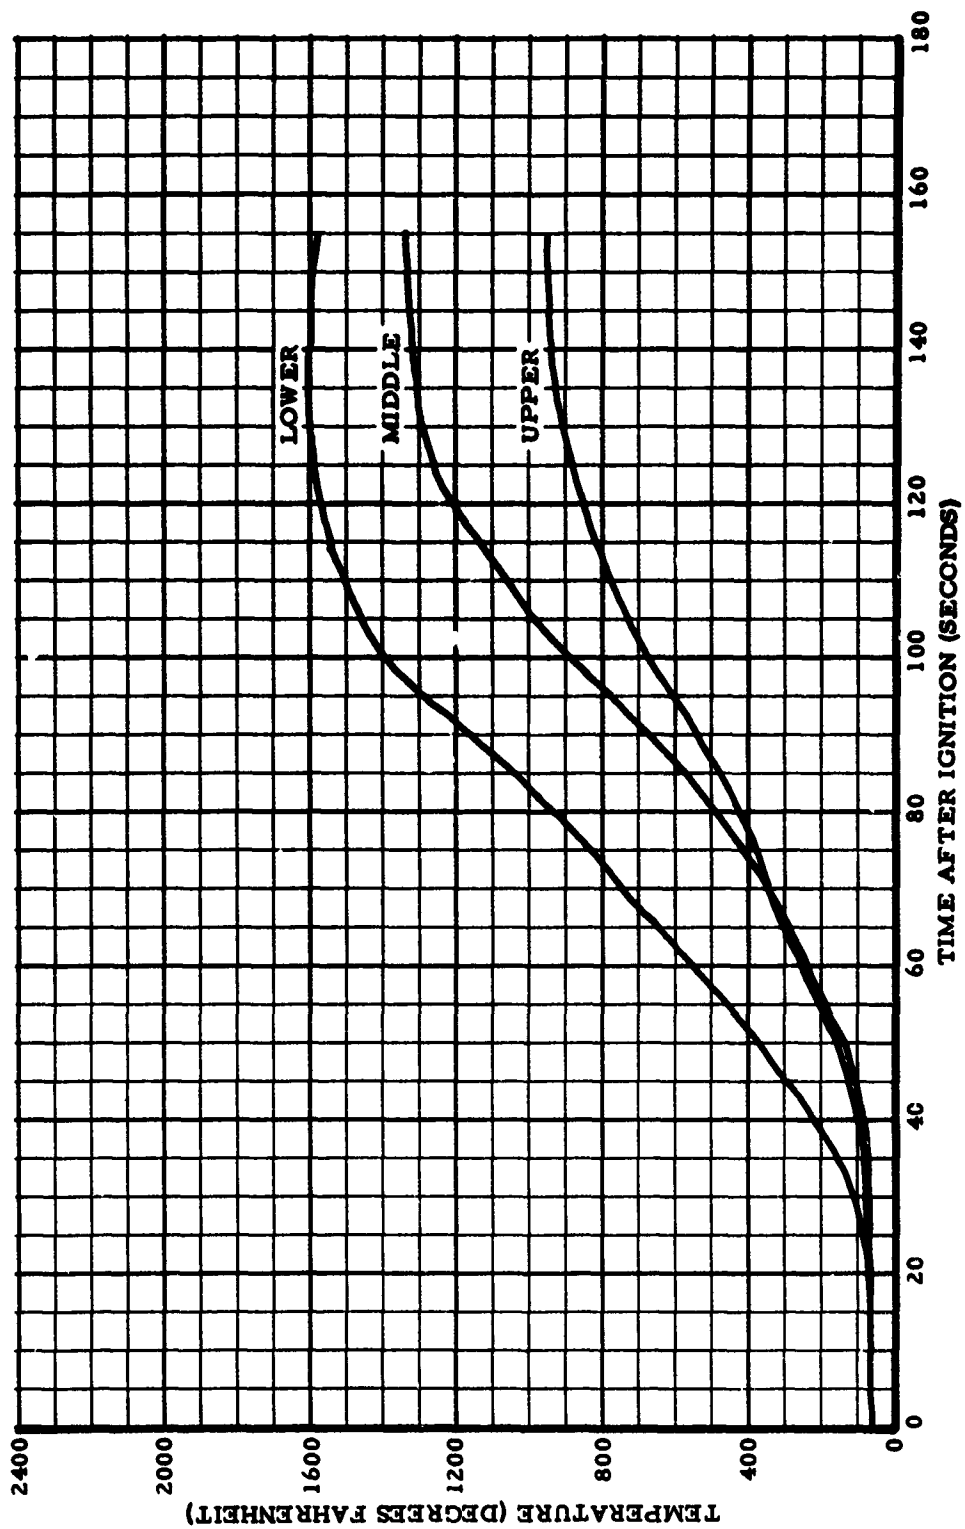
The structural members of the titanium fuselage did not heat up nearly as rapidly as the skin. In fact, the maximum increase in former temperature was only 30°F. This was due to the large heat capacity of the former and somewhat, perhaps, due to the location of the thermocouple on the inside flange of the former (Figure 7). Since the stringers were not nearly as massive as the formers, they were heated much more rapidly than the formers were, and the stringer temperatures eventually reached the titanium skin temperature by the end of the test. Figure 24 compares the measured stringer temperatures at the center section and is representative of the trend exhibited by the other two sections; i.e., the stringers located closest to the fire pit experienced the greatest heating. The temperatures of the three instrumented stringers increased towards the aft end of the fuselage, except for the upper stringer at the center section where the temperature exceeded that at the aft end. Since a comparison of the stringer temperatures gives a relative indication of the amount of heat transmitted through the titanium skin, it is not surprising that the location of the highest stringer temperatures coincided with the fuselage areas which experienced the most severe burning of RTV sealant and insulation.

FIGURE 24 - TITANIUM FUSELAGE STRINGER TEMPERATURE (CENTER SECTION) DURING AN EXTERNAL FUEL FIRE

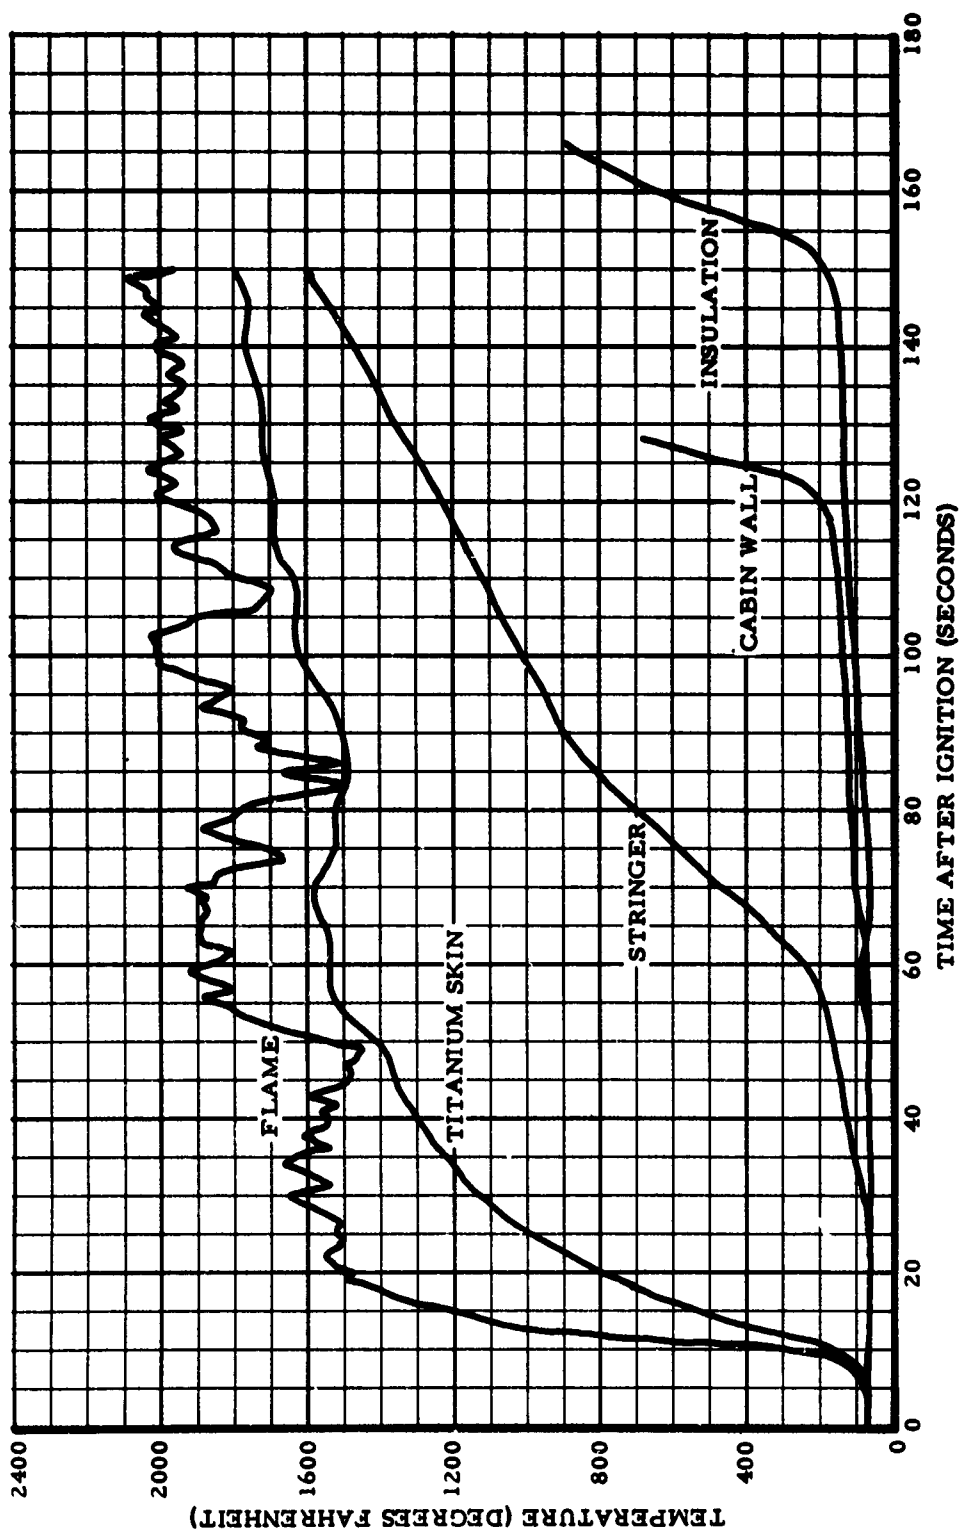
A better perspective of the heating of the titanium fuselage is provided by Figure 28 which shows temperature data from the middle group of thermocouples at the aft section. The titanium

FIGURE 28 - TITANIUM FUSELAGE TEMPERATURE (AFT SECTION, MIDDLE GROUP) DURING AN EXTERNAL FUEL FIRE

skin and stringer were heated by the external fuel fire, with the skin temperature always exceeding the stringer temperature. If the direction of heat transfer was uniformly from the fire to the cabin, it is obvious that the insulation temperature should have exceeded the cabin wall temperature for the duration of the test. Since the cabin wall and insulation temperatures exhibited just the opposite behavior--except for a short time increment about 60 seconds after ignition when the insulation thermocouple was apparently detecting the combustion of RTV silicone sealant--it is clear that heat transfer from the fuel fire did not directly cause the rapid cabin heating. Of course, the fuel fire was indirectly responsible because it heated the RTV silicone sealant and silicone-bonded insulation which decomposed and burned within the cabin environment. Figure 29 shows data from the upper group of thermocouples at the aft section. At this location the heat from the fuel fire was not nearly as severe as that experienced by the middle group of thermocouples. Note that the cabin air and wall temperatures eventually rose above the stringer temperature. Again the important relationship is that, throughout the test, the cabin air temperature exceeded the cabin wall temperature, which exceeded the insulation temperature, thus providing evidence for the deduced mechanism of early cabin heating.

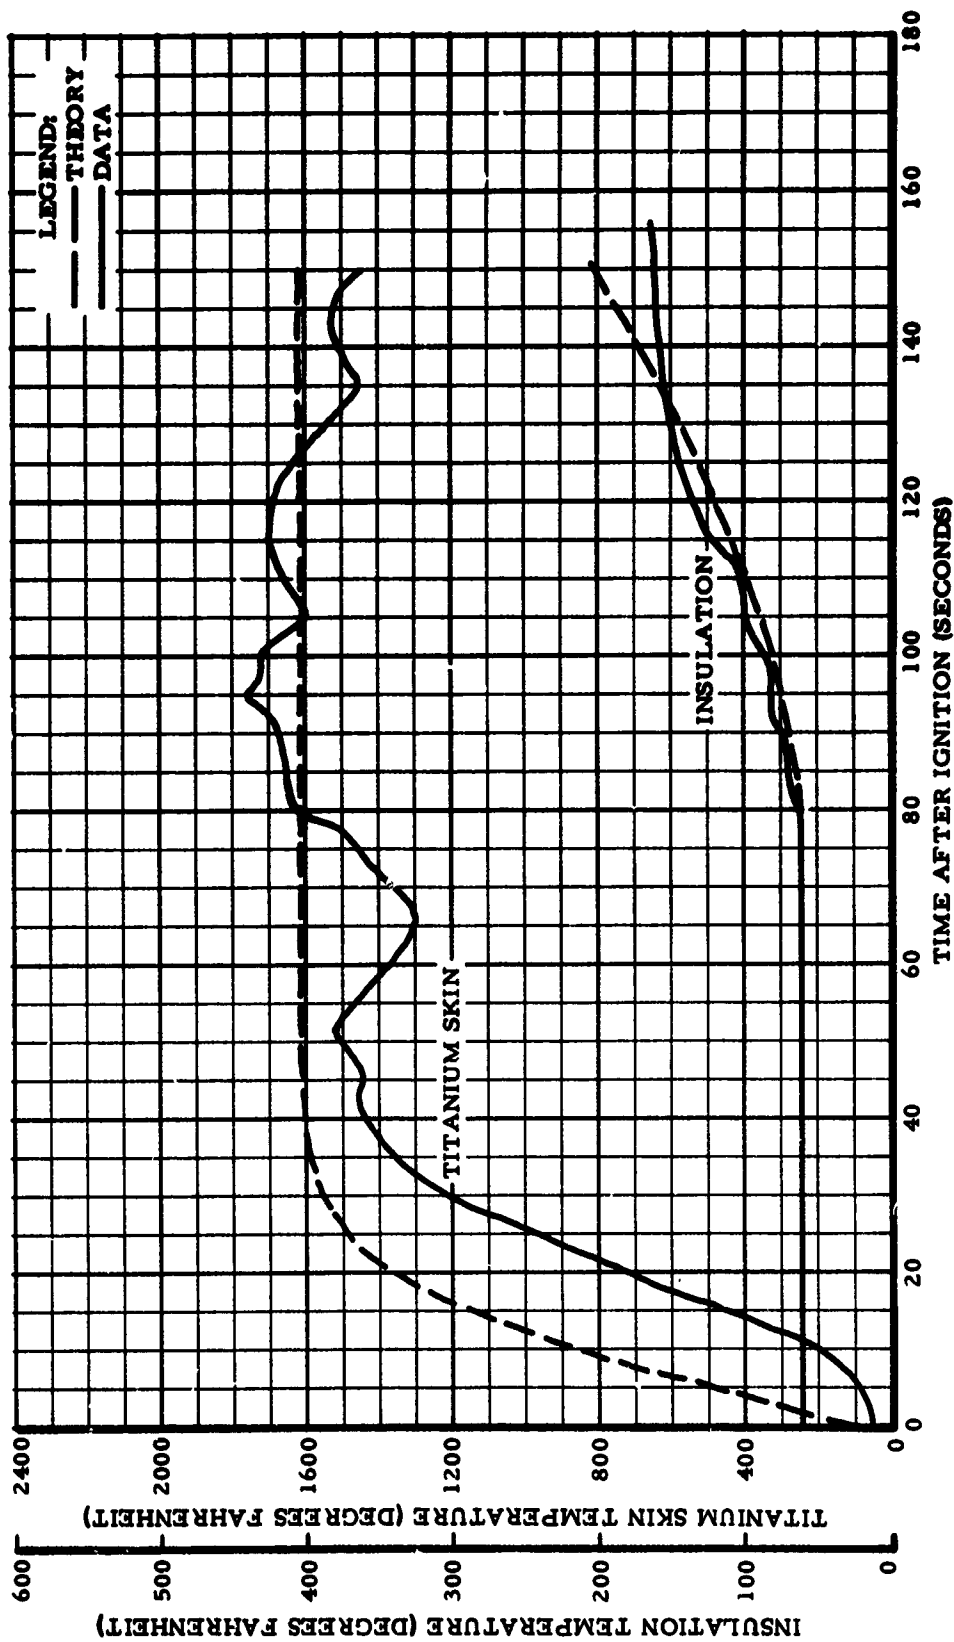
Before this test, considerable speculation was being expressed about the protection that could be provided to the passengers within a titanium fuselage during an external fuel fire. One estimate was that "the cabin will stay room-temperature comfortable for 30 minutes in a roaring fire" (Reference 12). However, this test demonstrated that the cabin pressure sealant and insulation, located adjacent to the titanium skin, were potential sources for the generation of smoke and volatile gases which would produce fatal conditions within the cabin in a matter of a few minutes. Actually, if the sealant and insulation were inert, the degree of protection could be considerable, as is explained below. Figure 30 compares the theoretical titanium skin and insulation temperatures (Appendix A) with the experimental data at the center section, middle group. The predicted skin temperature exceeded the data near the beginning of the test, since it was assumed that the radiative heat flux was at its steady-state value right at ignition; i.e., the fire buildup was not accounted for in the theoretical calculations. The steady-state skin temperature, which was a boundary condition for the calculation of the insulation heating, agreed reasonably well with the data. Therefore, any agreement between theory and data for the insulation temperature could be interpreted as signifying the validity of the calculation procedure. This agreement is amazingly evident in Figure 30, but

FIGURE 30 - TITANIUM FUSELAGE SKIN AND INSULATION TEMPERATURE DURING AN EXTERNAL FUEL FIRE COMPARED WITH THEORY

is misleading for several reasons. First of all, the insulation thermocouple, as was previously explained, was partially measuring heat from silicone combustion. Secondly, the predicted insulation temperature is conservative (high) since the theoretical model did not consider the heat sink capacity of the structural members, nor the heat transfer from the titanium skin to the reflective polyimide film which encapsulated the insulation. Therefore, the insulation temperature for a titanium fuselage constructed with inert insulation and sealant would be somewhere below either the theoretical or experimental curve shown in Figure 30. The cabin air temperature, assuming the prediction method to be valid, will thus be less than the prediction curve shown in Figure 1-6. It is apparent that a titanium fuselage without windows exposed to a roaring fire could provide a safe cabin environment for a significant time if the sealant and insulation are inert. The exact time can only be established by experiment, but is, at the very least, 5 minutes.

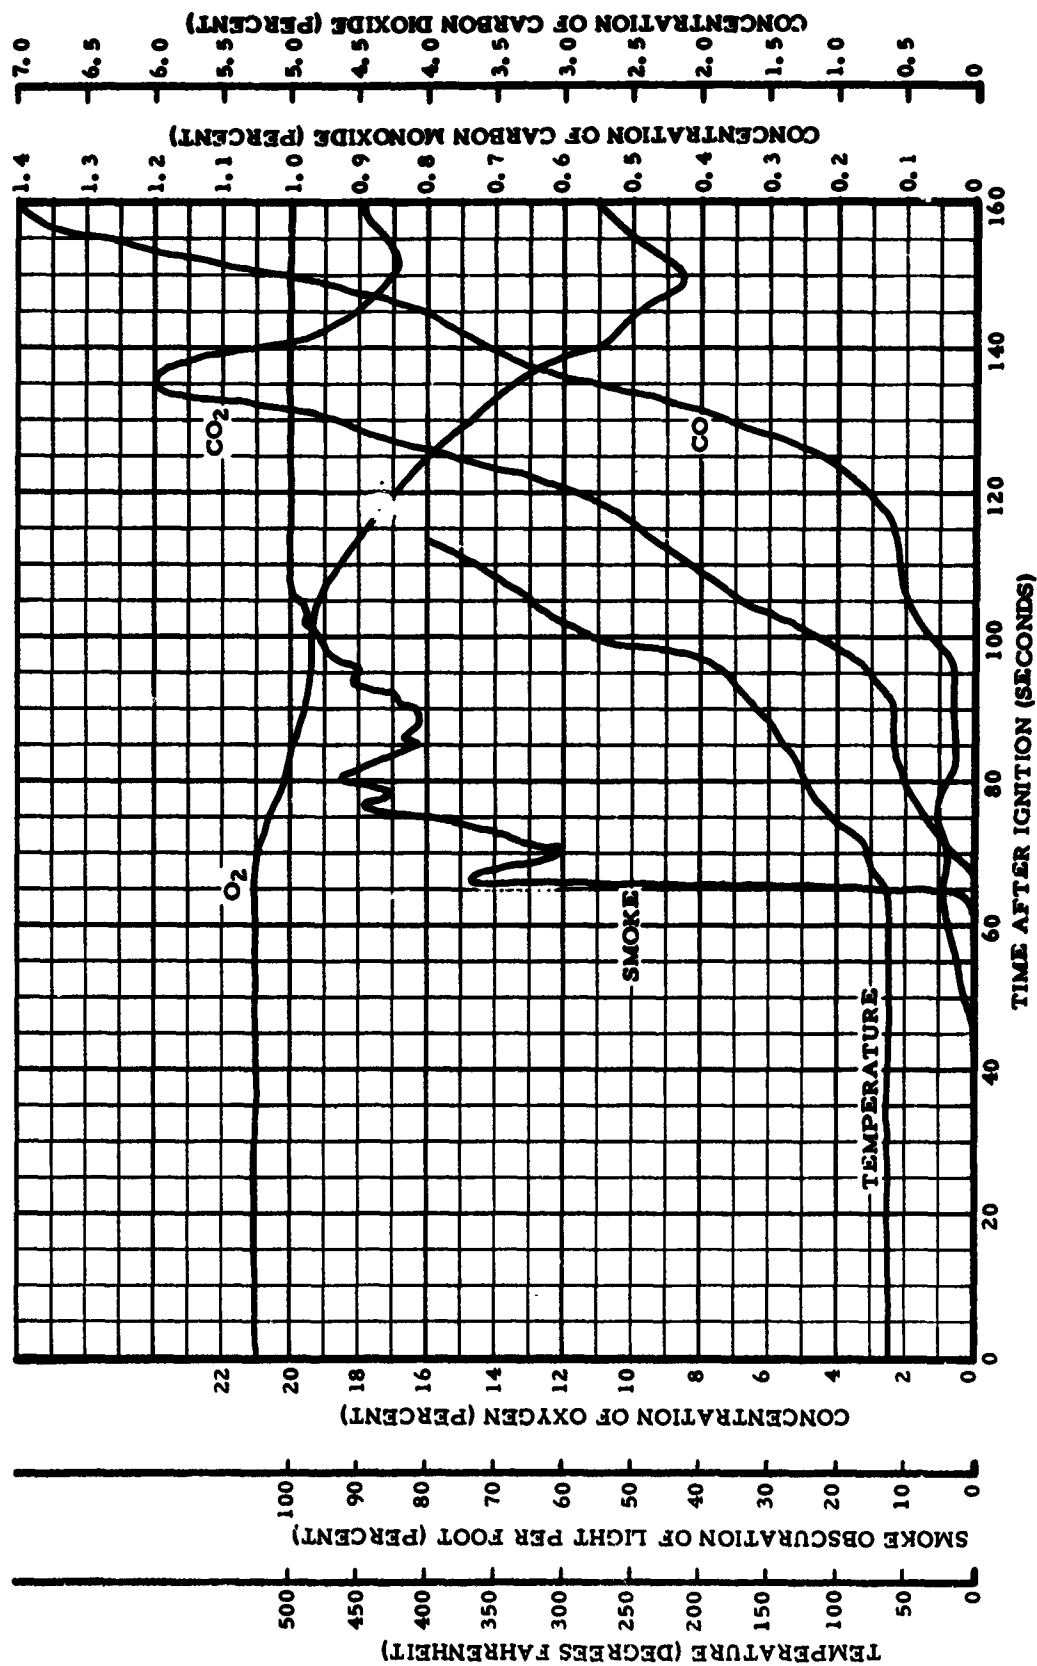
The environmental conditions at the two gas-sampling locations are shown in Figures 31 and 32. Both smoke near the window and carbon dioxide below the ceiling were detected before the cabin air showed any measurable increase in temperature. The density of smoke, as measured by the obscuration of light across a distance of 1 foot, showed the most drastic change, especially below the ceiling. Both smoke meters indicated total obscuration by shortly after 2 minutes. Generally, carbon monoxide and carbon dioxide increased significantly at both sampling locations shortly after 1 minute from ignition, and were accompanied by a decrease in oxygen. From a safety viewpoint, the presence of smoke offered the first obstacle against survivability. It would have been initially manifested by a decrease in visibility accompanied by an undeterminable amount of panic. Severe exposure to smoke also causes physiological effects which, similar to the psychological effects, have yet to be qualitatively or quantitatively defined. After the effects of smoke, a passenger would have next been hampered by the high cabin air temperatures. As indicated by the cabin wall temperature shown in Figure 26, the cabin air surpassed at least 800°F, and, judging by the slope of this curve, probably reached a considerably higher temperature. Tests at NAFEC showed cabin air temperatures reaching 1600°-1700°F during a flash fire (Reference 13). Exposure to temperatures of this level would cause unbearable pain and death in a matter of seconds (Reference 13). The concentrations of carbon monoxide, carbon dioxide and oxygen, each taken individually, would have only produced minor toxic effects (Reference 14) up to the fatality time governed by air temperature (approximately 2 minutes).

FIGURE 31 - TITANIUM FUSELAGE ENVIRONMENTAL CONDITIONS SIX INCHES BELOW CEILING DURING AN EXTERNAL FUEL FIRE
