TECHNICAL REPORT NO. 6-570

# DURABILITY AND BEHAVIOR OF PRESTRESSED CONCRETE BEAMS

## LABORATORY TESTS OF WEATHERED PRETENSIONED BEAMS

October 1971

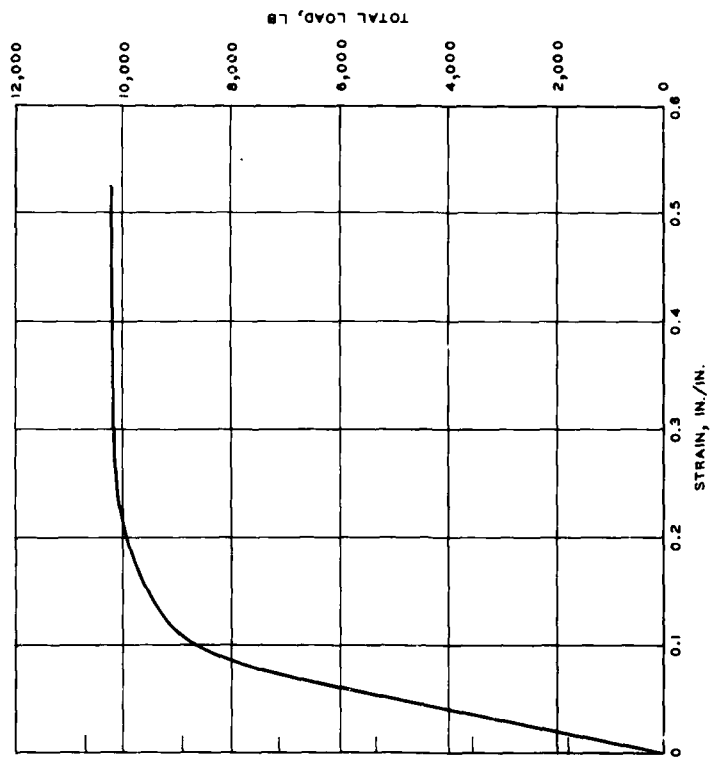
a. BEAM 8, STRAND 5  
(TREAT ISLAND)

# STRESS-STRAIN CURVES

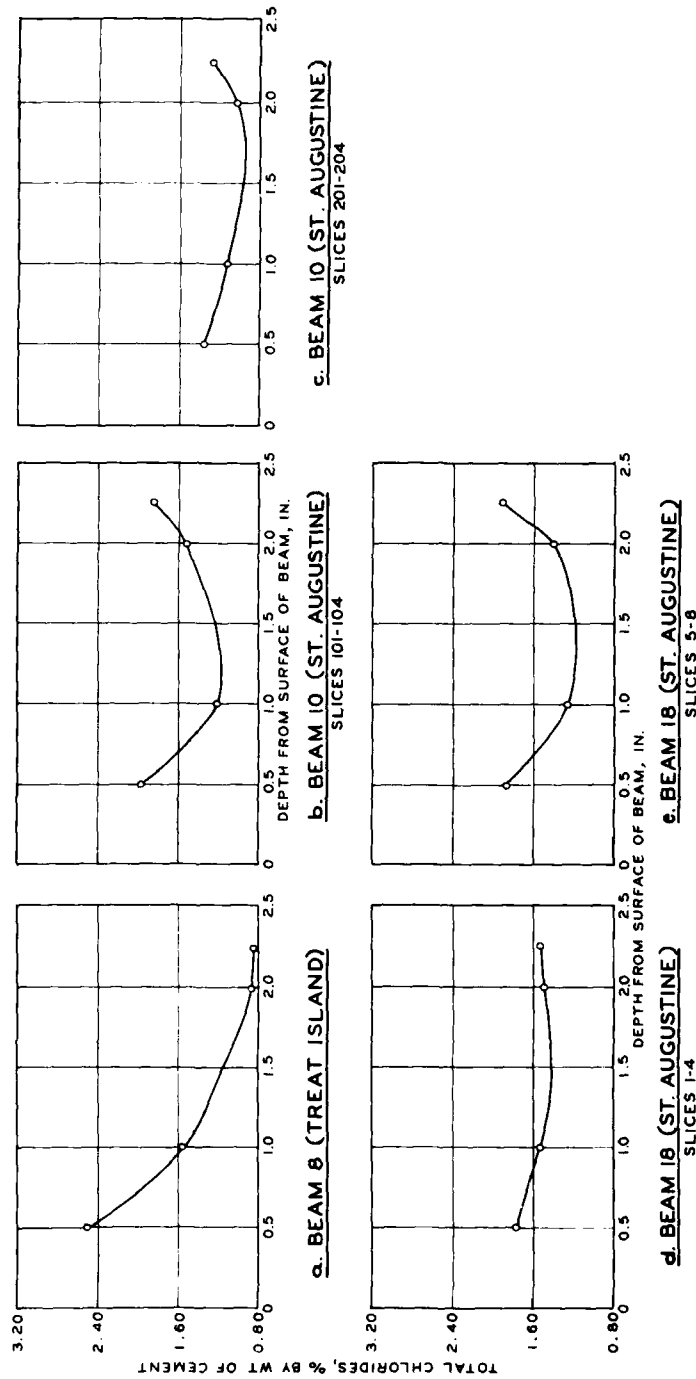
CHLORIDE CONTENT  
VS DEPTH

- d. Depth of carbonation tests indicated that carbonation was not a factor in the corrosion of the steel strands.
- e. Depth of chloride penetration tests revealed that sufficient chlorides were present in the test beams to cause corrosion on the prestressing strands.
