# EVALUATION OF THREE-PIECE AM2 ALUMINUM LANDING MAT

W. N. Brabston

April 1967

U. S. Army Engineer Waterways Experiment Station  
CORPS OF ENGINEERS  
Vicksburg, Mississippi

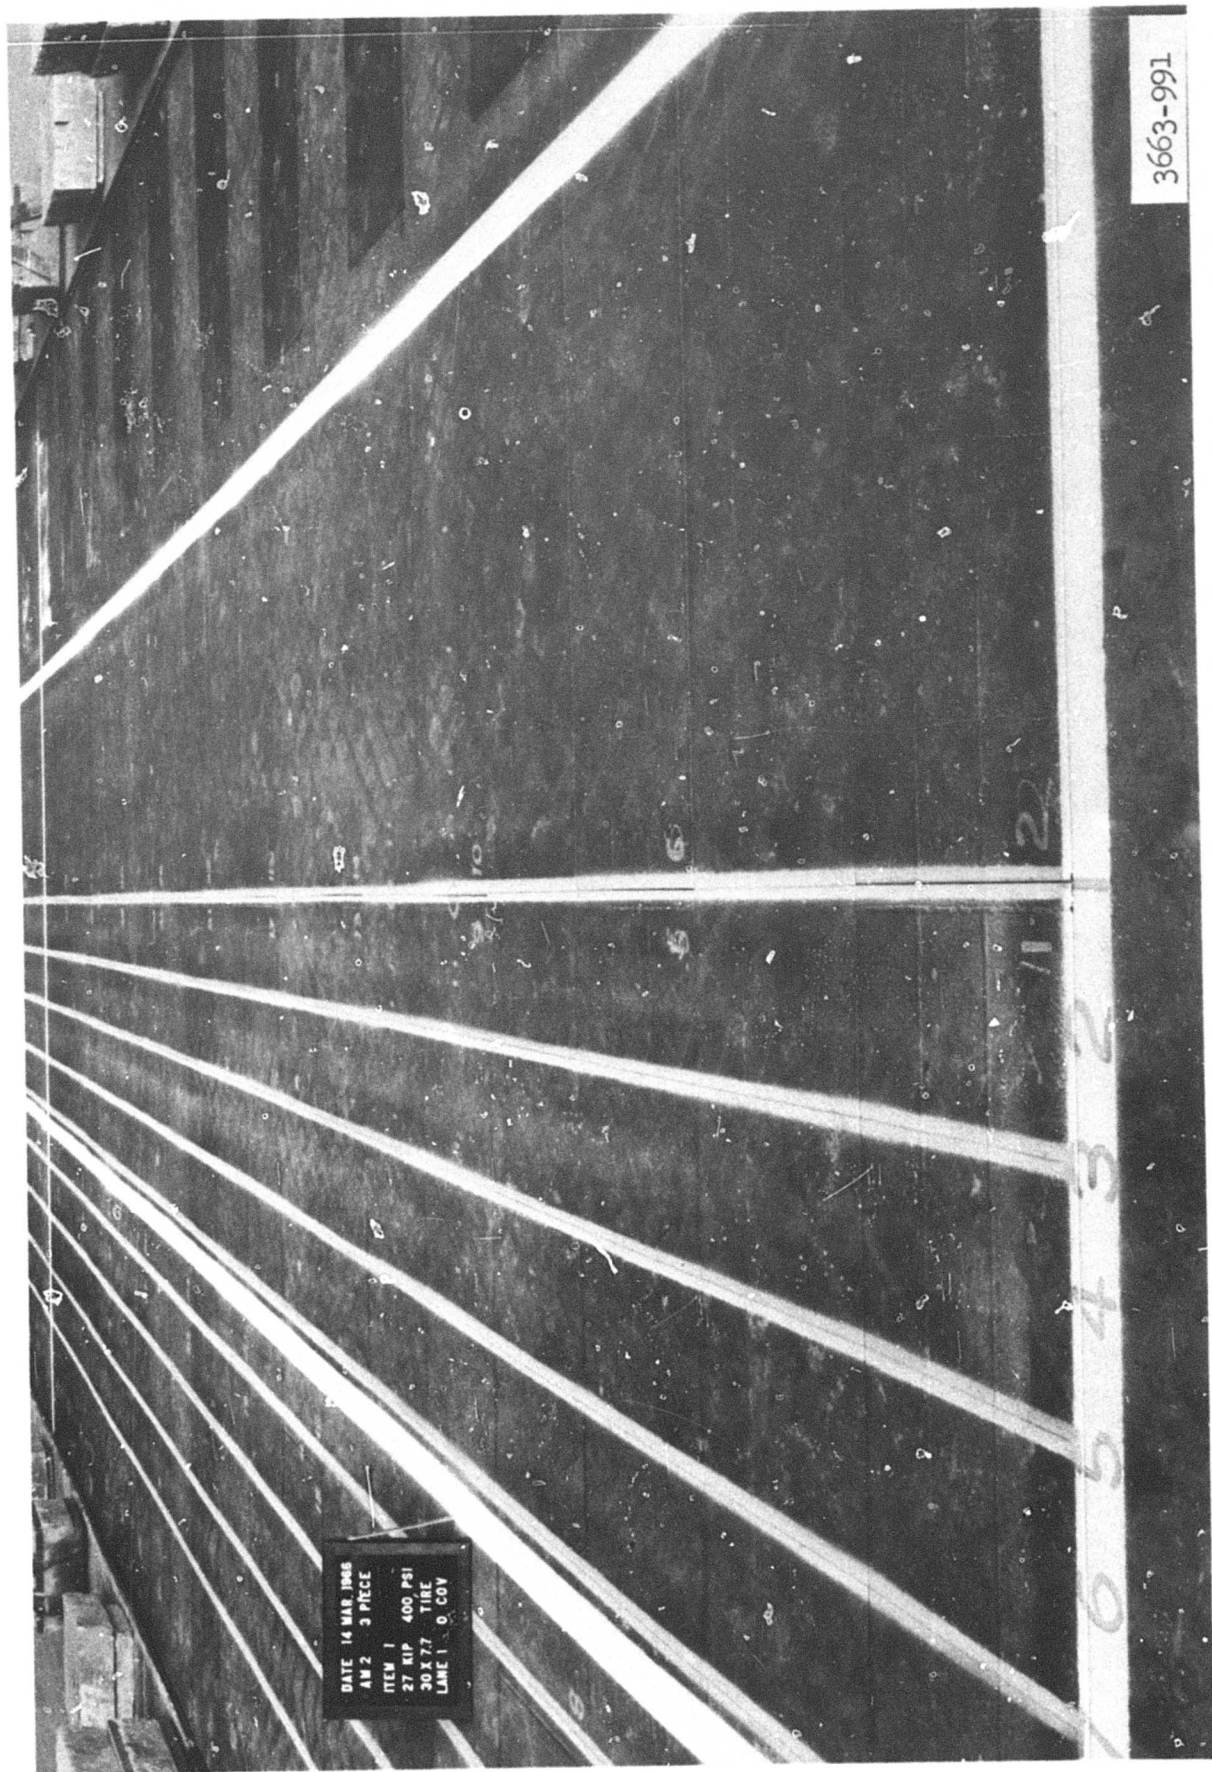
Photograph 1. Item 1, test lane 1, prior to traffic

21. Item 1. A general view of item 1 prior to traffic is shown in photograph 1. After four coverages, it was noticed that the ends of the

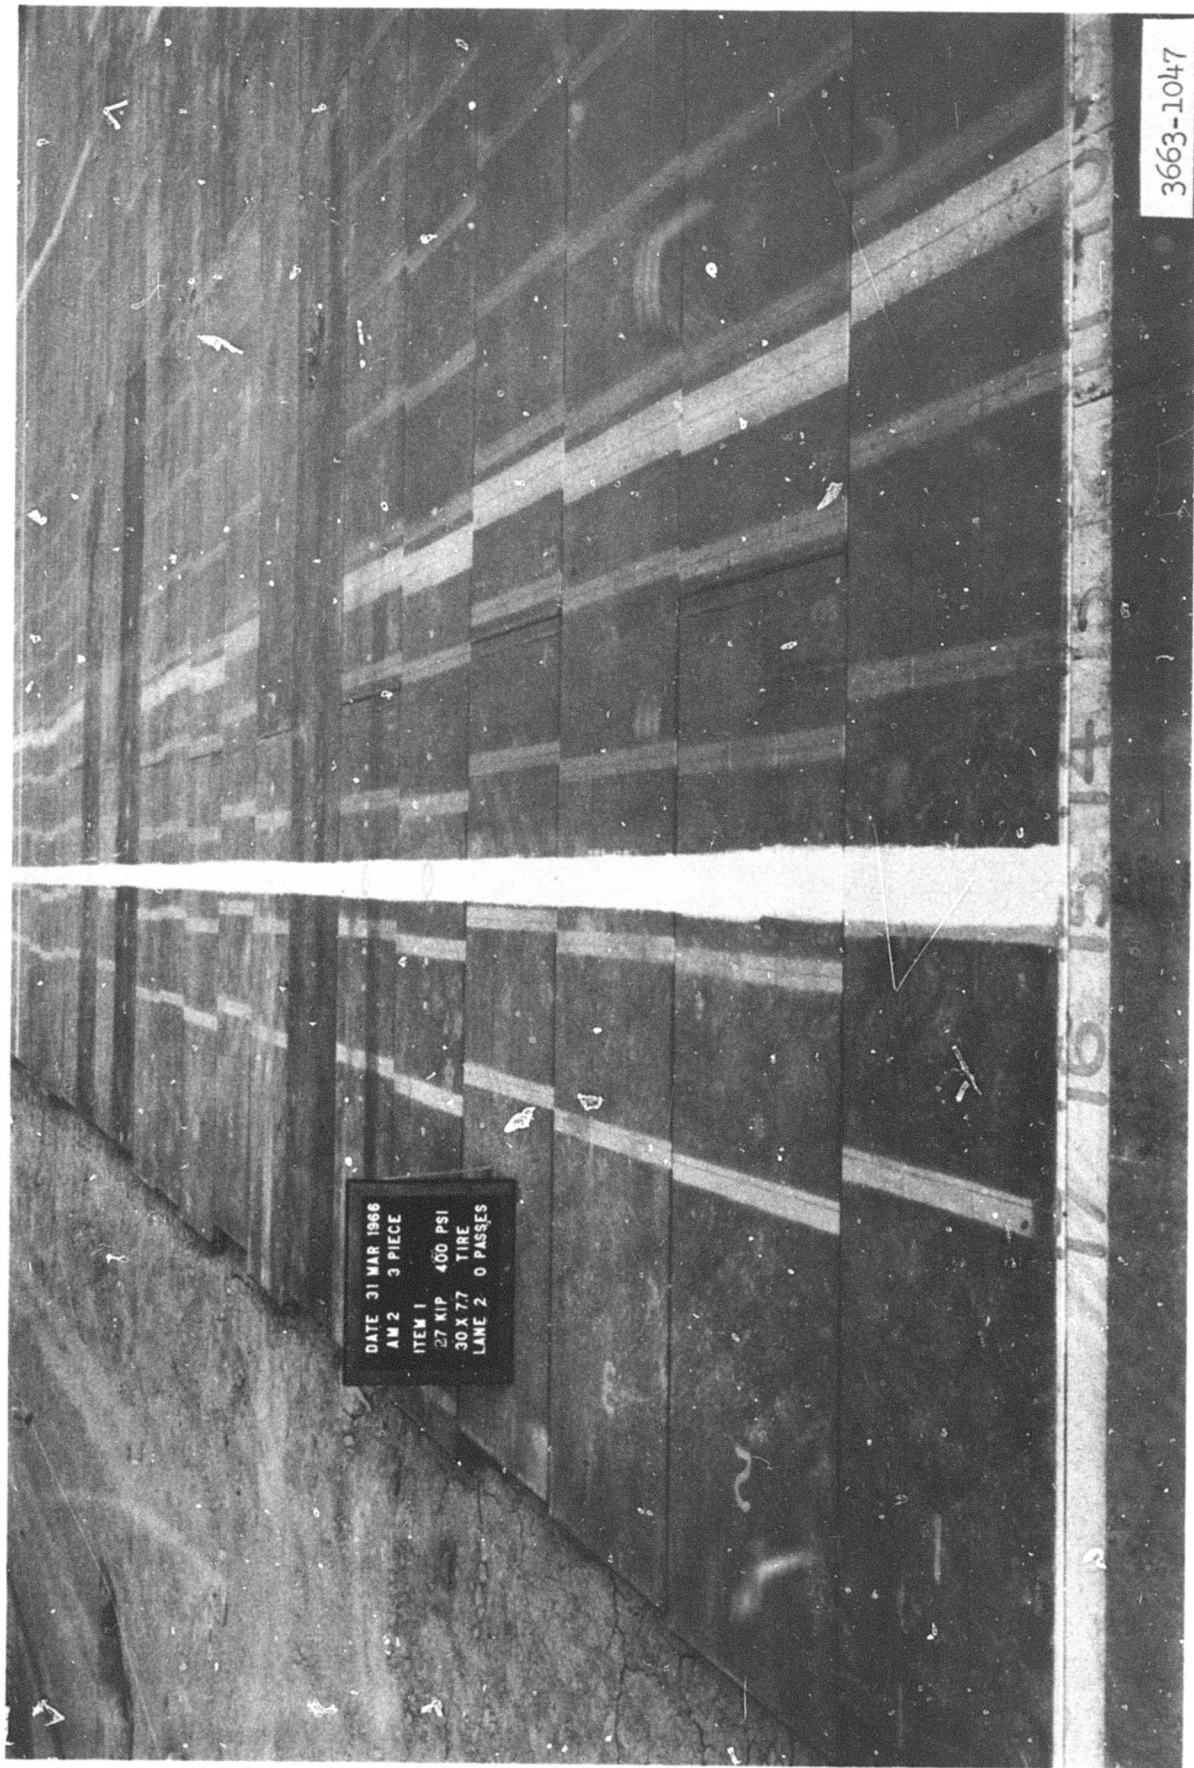
Photograph 17. Item 1, lane 2, prior to traffic

28. Item 1. When the weights were removed from the east edge of the mat, the mat ends sprang upward 2 to 3 in. as a result of deformation in test lane 1. Therefore, the mat was not in continuous contact with the subgrade. A general view of item 1 prior to traffic is shown in photograph 17. The effects of traffic were first noticed at 740 passes when a slight amount of dishing was observed in the individual extrusions of several planks (photograph 18). Dishing measurements were made in each of the three extrusions of each plank, but generally dishing was not noticeable until it progressed to about  $3/16$  in. deep. At about  $3/8$  in. dishing depth, an extrusion was considered to have a core failure which generally was indicated by an accompanying skin or weld break. The first mat break was noticed at 806 passes in plank 5. There was a  $1/4$ -in.-deep dish in the extrusion on the south side of the plank, and the adjacent longitudinal weld had a  $2-1/2$ -in. crack. At 1000 passes, a skin tear appeared in plank 5 adjacent to the longitudinal weld crack, as shown in photograph 19. In addition, on plank 3 a 5-in.-long crack had developed in the longitudinal weld on the south side of the plank, and there was a dish approximately  $1/4$  in. deep in the south extrusion. At this time, three additional planks with areas of apparent core damage were noted. The item was in good condition, generally, although there had been some lateral

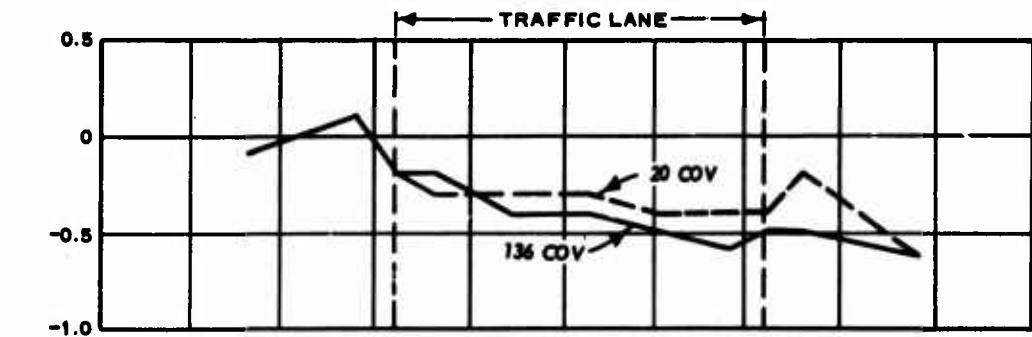
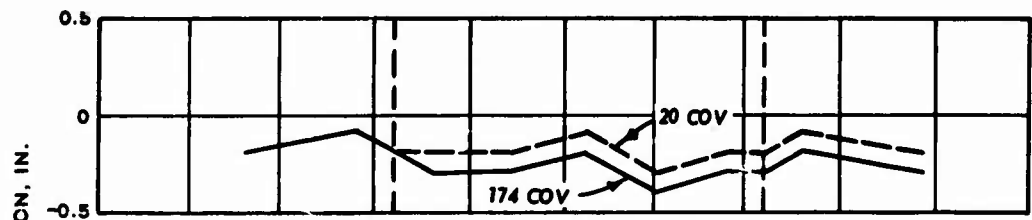
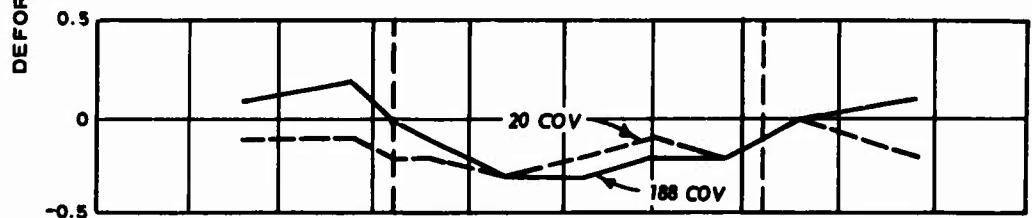
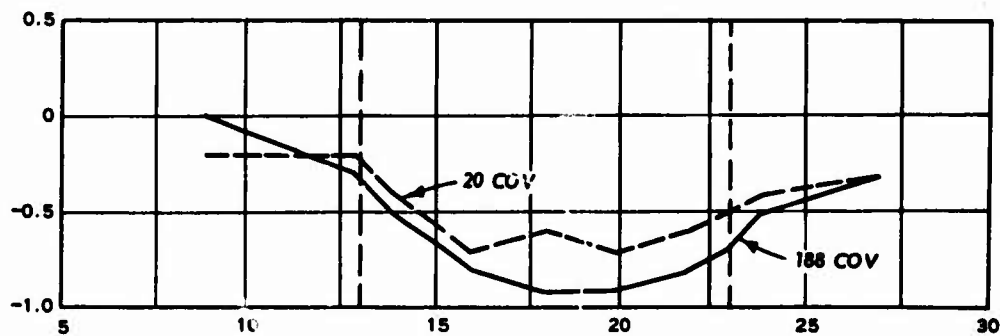
PERMANENT MAT DEFORMATION  
TEST LANE 1  
UNIFORM-COVERAGE TRAFFIC

25. Plots showing permanent mat deformation as determined from level readings taken prior to and at various levels of traffic coverage are shown in plate 3. These data indicate that the greatest deformation, about 0.9 in., occurred in item 4 after 188 coverages of traffic. Since this item had a loose sand subgrade, a large amount of consolidation resulting in mat deformation could be expected. Of the three items with a clay subgrade, the maximum deformation measured was about 0.6 in. in item 1 after 136 coverages of traffic. The maximum deformations measured in items 2 and 3 at end of traffic were 0.4 and 0.3 in., respectively. A plot of deformation along the center line of the traffic lane is shown in plate 4.
