MISCELLANEOUS PAPER NO. 4-852

# EVALUATION OF HARVEY TWO-PIECE LANDING MAT (AM2)

November 1966

U. S. Army Engineer Waterways Experiment Station  
CORPS OF ENGINEERS  
Vicksburg, Mississippi

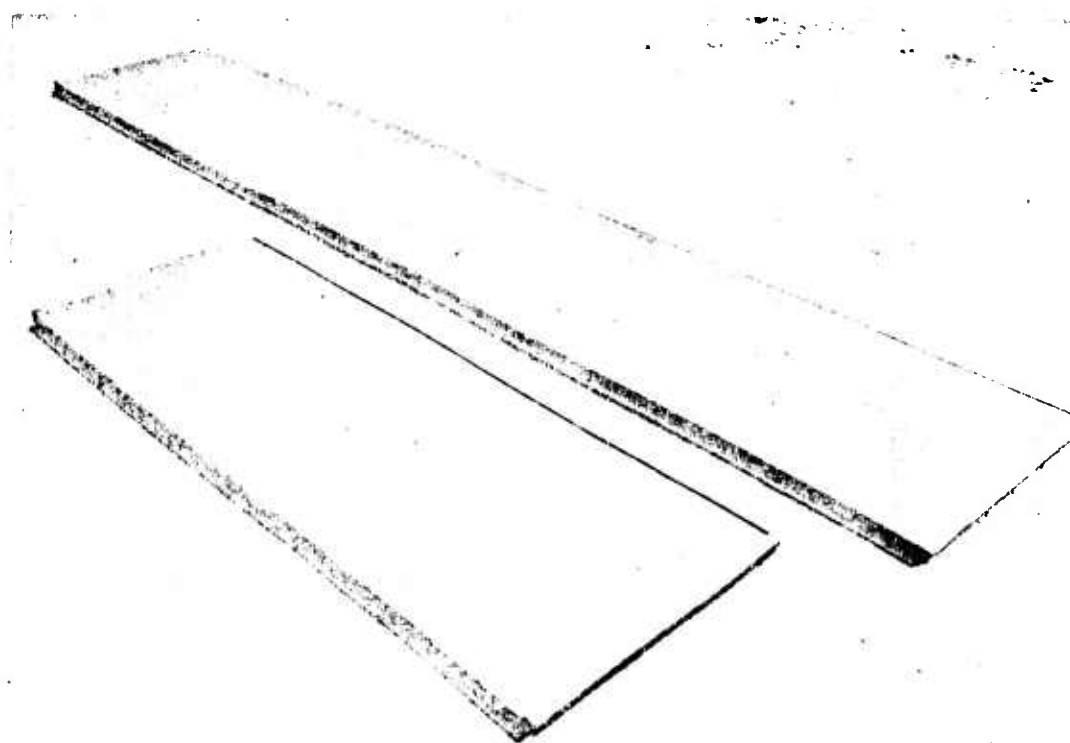
b. Full and half plank

Fig. 1. Bundle and planks of Harvey two-piece AM2

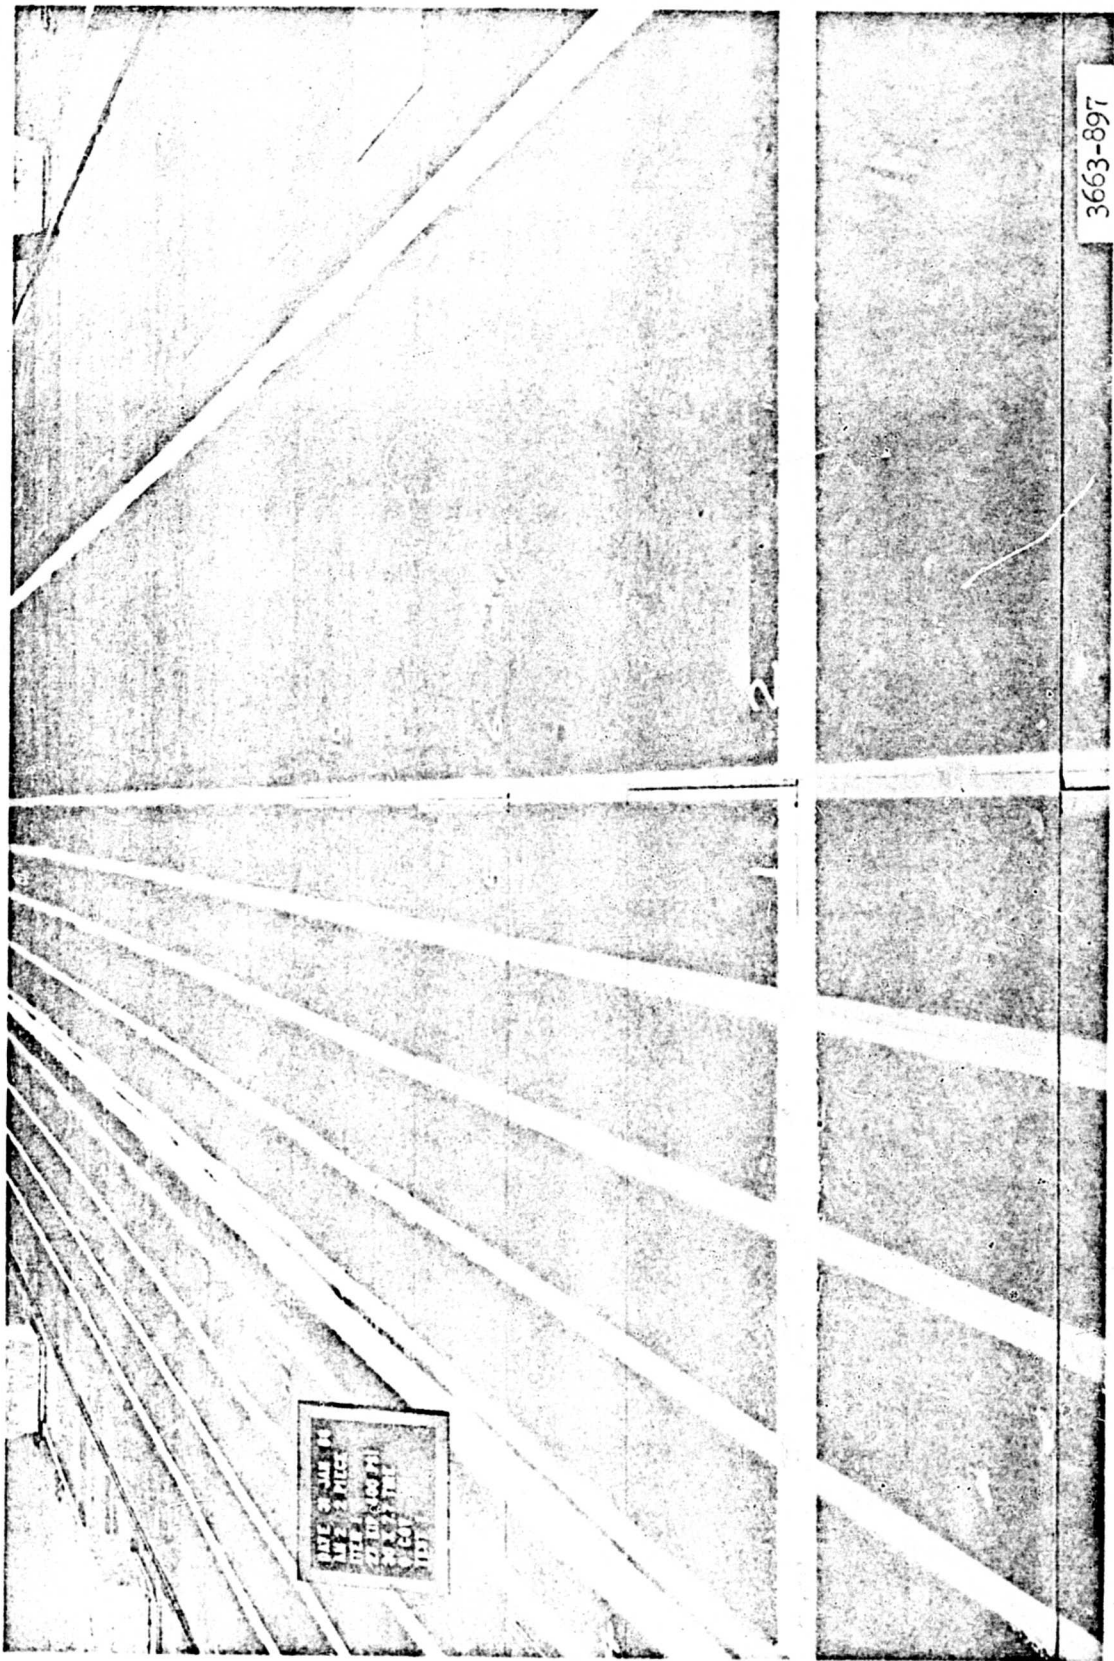
Photograph 1. Test section prior to traffic

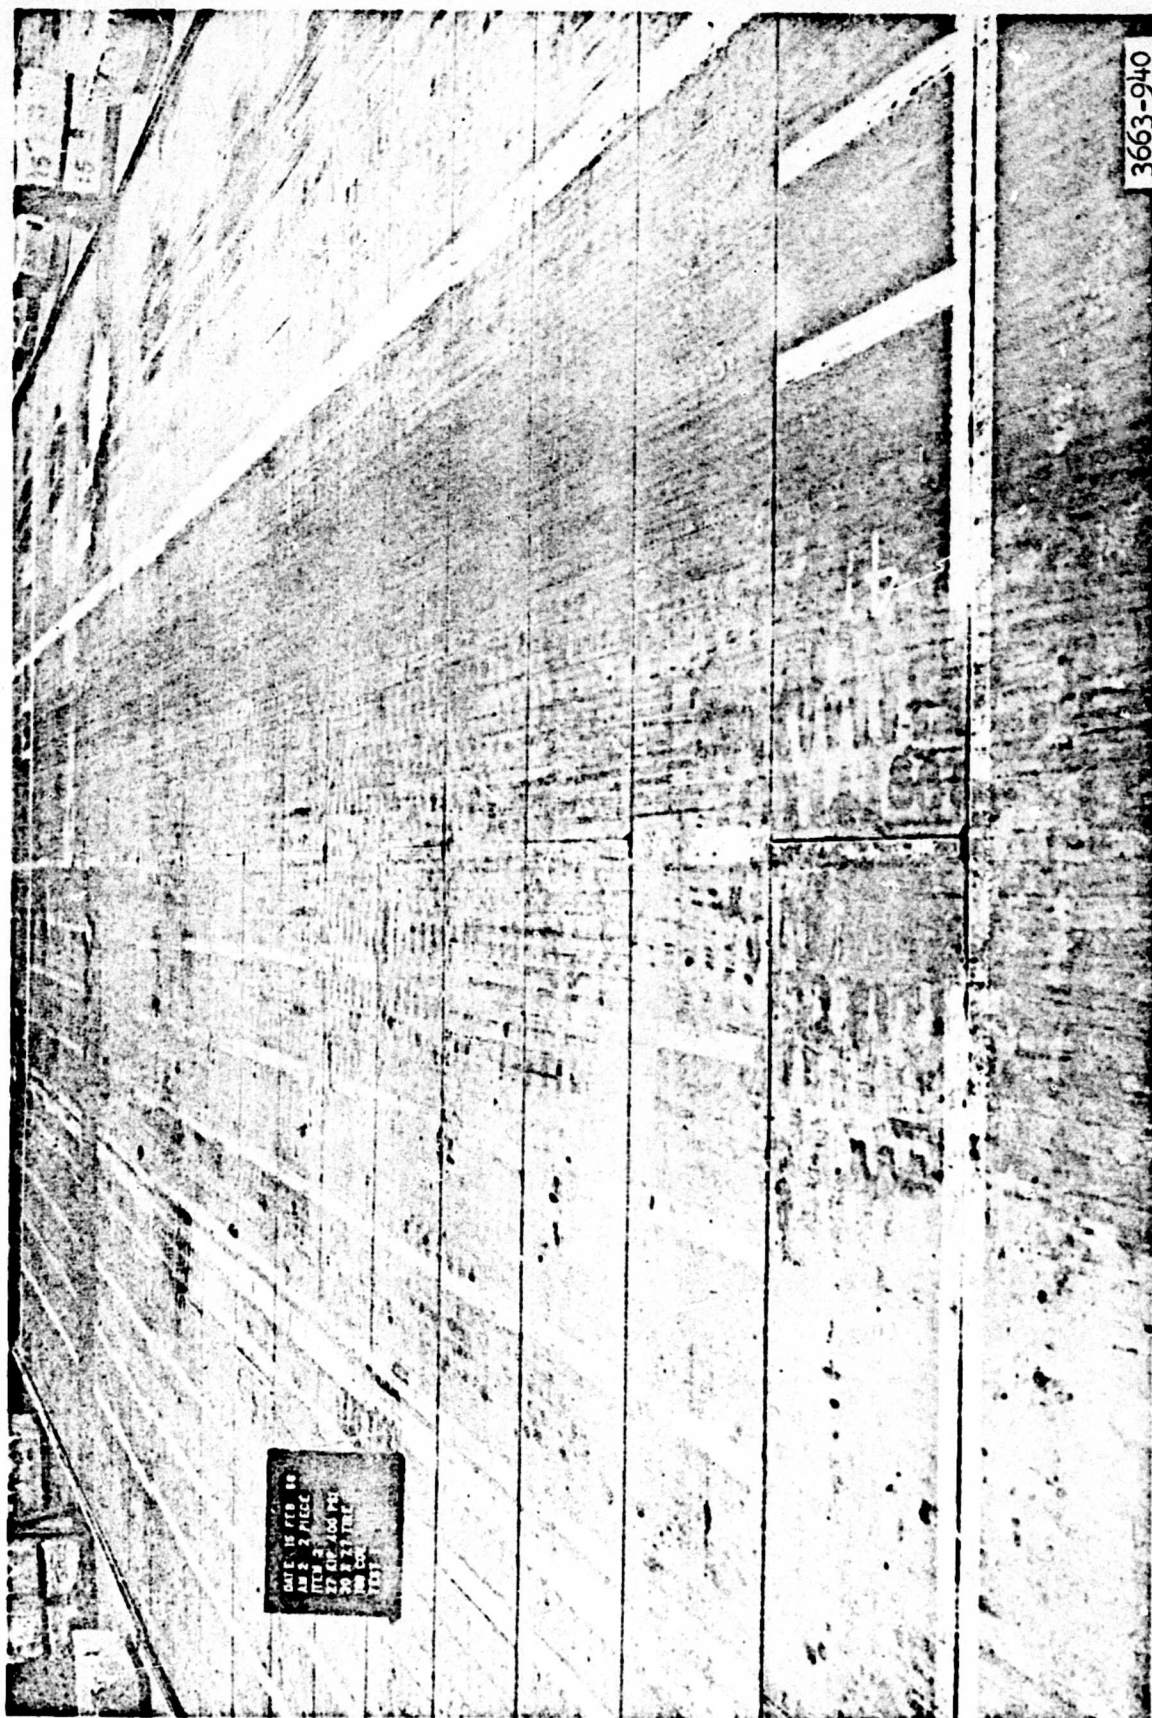
view of test item 2 at the end of 130 coverages is shown in photograph 4. All of the failures in item 2 were of the same type; the weld between the end connector strip and the body of the plank failed, allowing the end connector to separate from the plank.

Photograph 4. Lane 1, item 2, at failure after 130 coverages

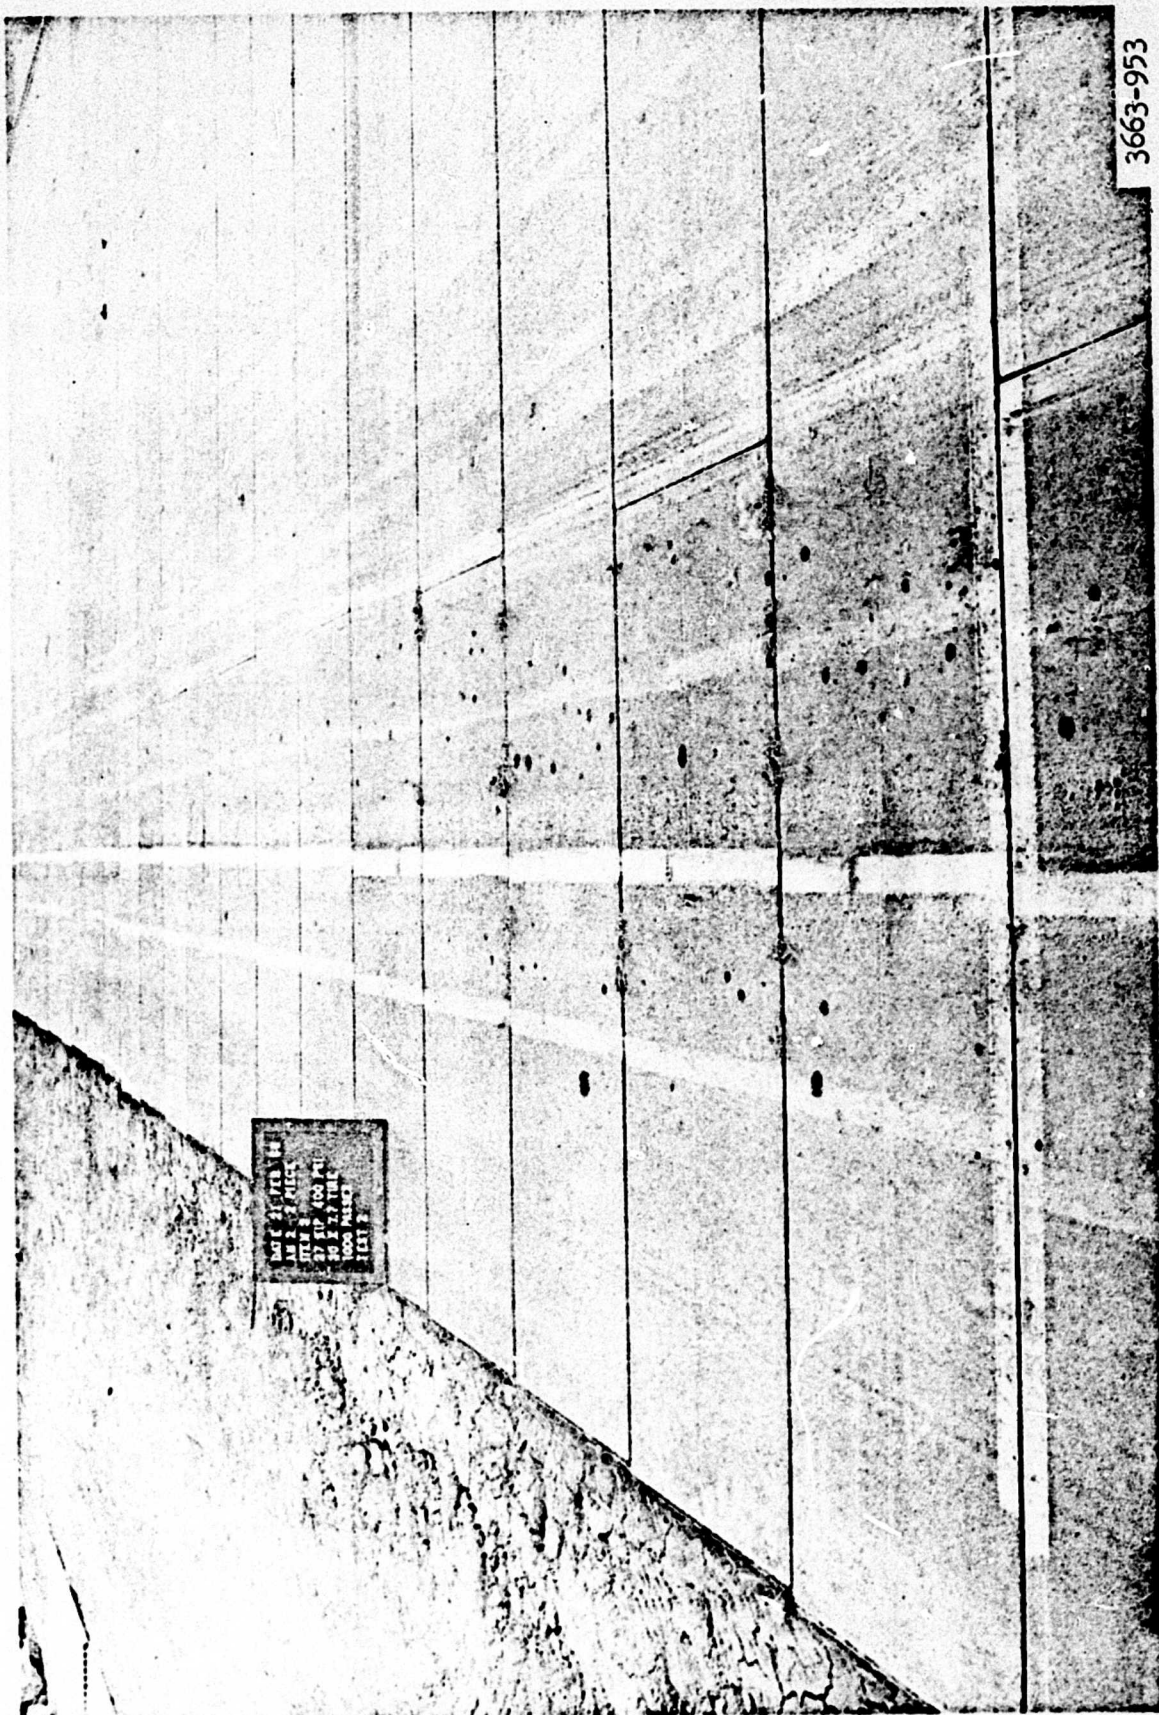
30. Some mat distress was noted in test items 2 and 4 at the end of 1000 passes, but little or no distress was noted in test item 3. Views of items 2, 3, and 4 at the end of 1000 passes of the load wheel are shown in photographs 11, 12, and 13, respectively. As traffic was continued, rapid deterioration of the mat in items 2 and 4 developed between 1200 and 1600 passes, and these items were considered failed after 1600 passes of traffic. The mat in item 3 was still in good condition when traffic was terminated. Test items 2, 3, and 4 at the end of traffic (1600 passes) are shown in photographs 14, 15, and 16, respectively. A typical longitudinal weld crack and dished planks indicating core failure are shown in fig. 5. One plank from each of the items was cut on the traffic lane center line. A cross-section view of each of these is shown in fig. 6. In the figure, planks 1, 2, 3, and 4 are from items 1, 2, 3, and 4, respectively, and are representative of the comparative damage suffered by each item by the end of traffic. It can be seen that the bottom weld had cracked in planks 2 and 4, whereas the top was still in good

Photograph 12. Lane 2, item 3, after 1000 passes

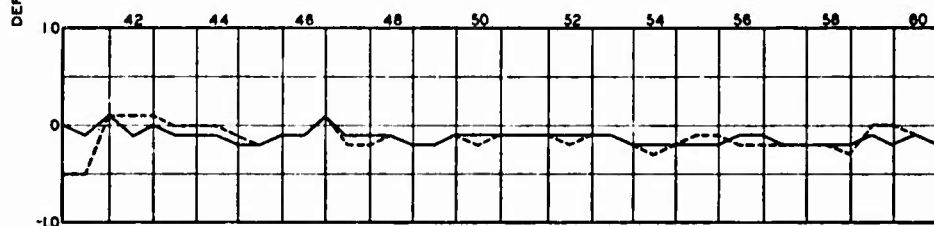
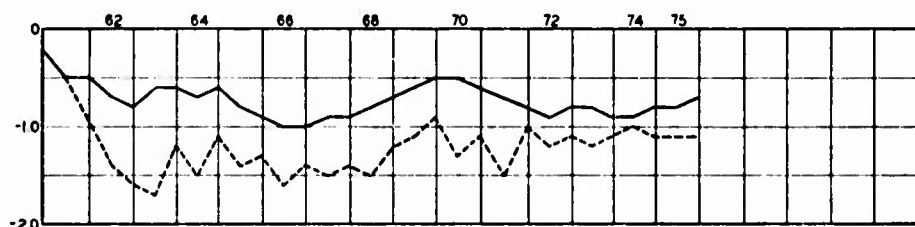
PERMANENT MAT  
DEFORMATION CROSS SECTIONS  
TEST LANE 2  
SINGLE-LINE TRAFFIC

32. Cross-section plots of permanent mat deformation across the traffic path at various traffic intervals are shown in plate 7. These plots indicate the severe bending and mat deformation that developed in test items 1, 2, and 4, as previously discussed (paragraphs 29, 30, 31), and also, the absence of deformation in test item 3.
