Assessments of House Damage from Event Dial Pack and 100 ton AN/FO Test

Interim Report

Prepared by: C. Wilton, URS Research Company

DEFENSE NUCLEAR AGENCY
WASHINGTON, D.C.

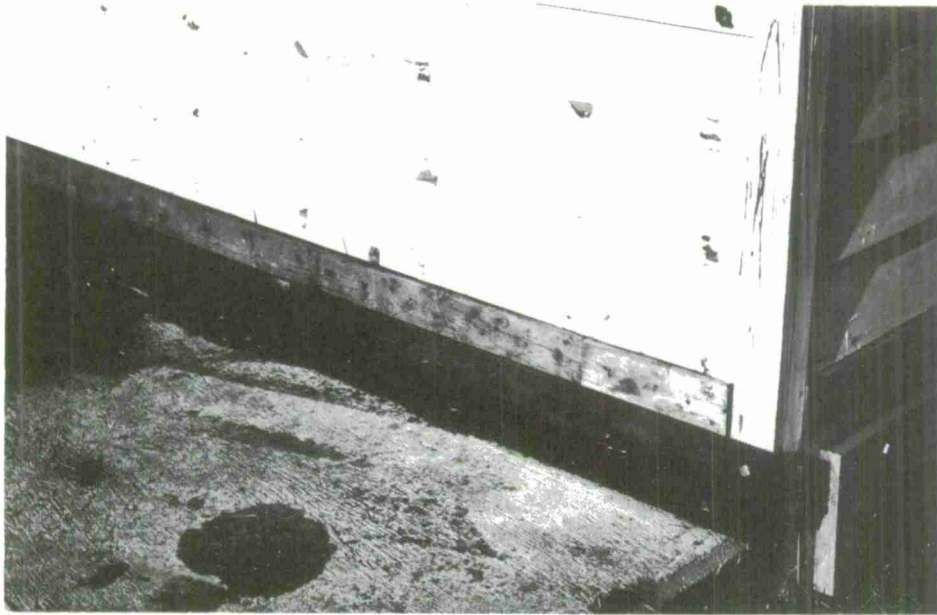
Fig. 6. Method of Fastening House to Concrete Pad,
East and West Sides of House

5. Fastening of house to concrete pad. At the sides of the house the concrete pad was approximately the same size as the house, so, 2 by 12 timbers were bolted to the concrete pad and lag bolted into the house as shown in Figure 6. At the front and back the concrete pad extended beyond the house and 4 in. by 6 in. steel angles 3/8 in. thick were bolted to the house and concrete pad as shown in Figure 7. This system worked very well since a posttest examination indicated no apparent movement of the house on the slab.

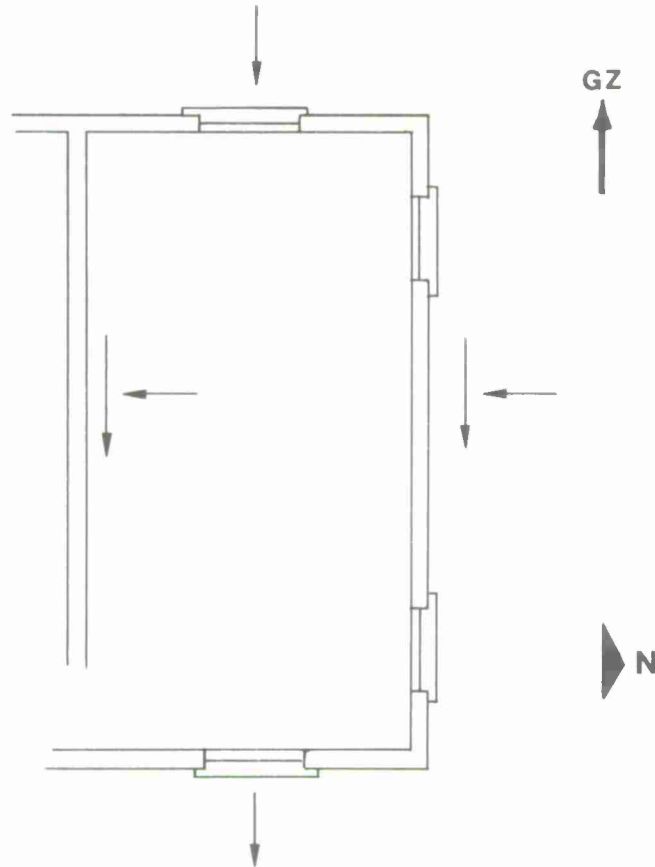
II. North Wall

A sketch of the living room is shown below and a description of the damage to each of the walls is given in the following paragraphs.

Both windows were blown inward. There was failure of eighteen 2 by 4 studs out of a total of 26, all in flexure and in the inward direction. About 40 percent of the sheetrock was removed and repair would require complete

replacement (see Figures B-1 and B-2). There was indication of shear motion in the wall; i.e., motion along the seams.

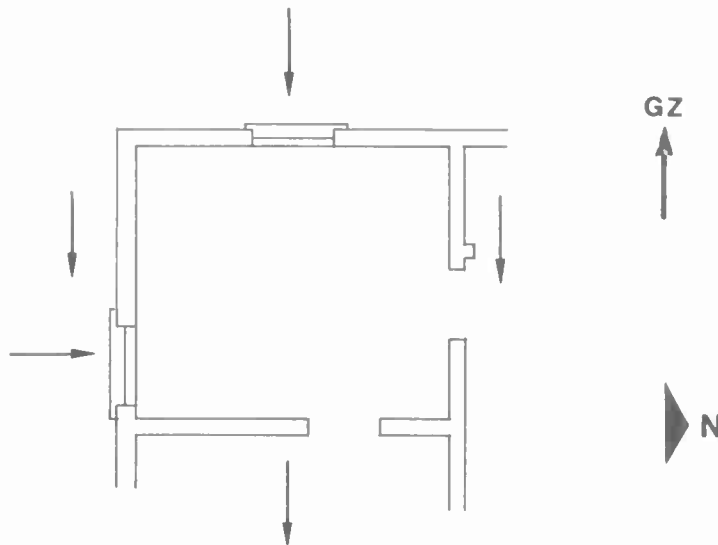
I. West Wall

Heavily damaged with window blown in, 90 percent of the sheetrock removal and six of seven studs were broken (Figure B-5).

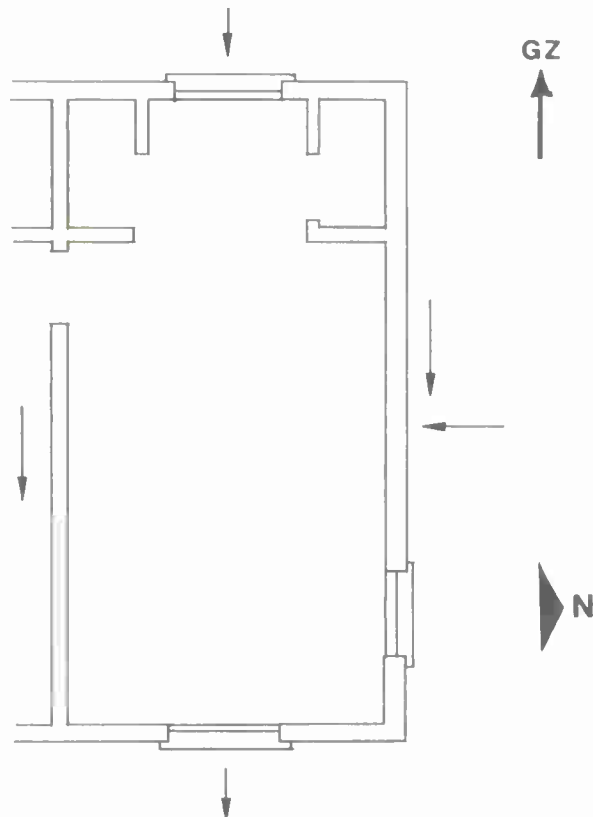
Master Bedroom

Sketched below is the master bedroom showing gross wall motion.

The window was blown inward. Twelve out of a total of 21 studs were broken inward in flexure. All sheetrock was damaged severely and 75 percent was blown inward (Figure B-7). There was also evidence of shear deformation in the remaining sheetrock.
