## **USAAMRDL TECHNICAL REPORT 71-47**

# **EVALUATION OF THE UH-1D/H HELICOPTER CRASHWORTHY FUEL SYSTEM IN A CRASH ENVIRONMENT**

**November 1971**

**CONTRACT DAAJ02-69-C-0030  
DYNAMIC SCIENCE ENGINEERING OPERATIONS  
A DIVISION OF MARSHALL INDUSTRIES  
PHOENIX, ARIZONA**

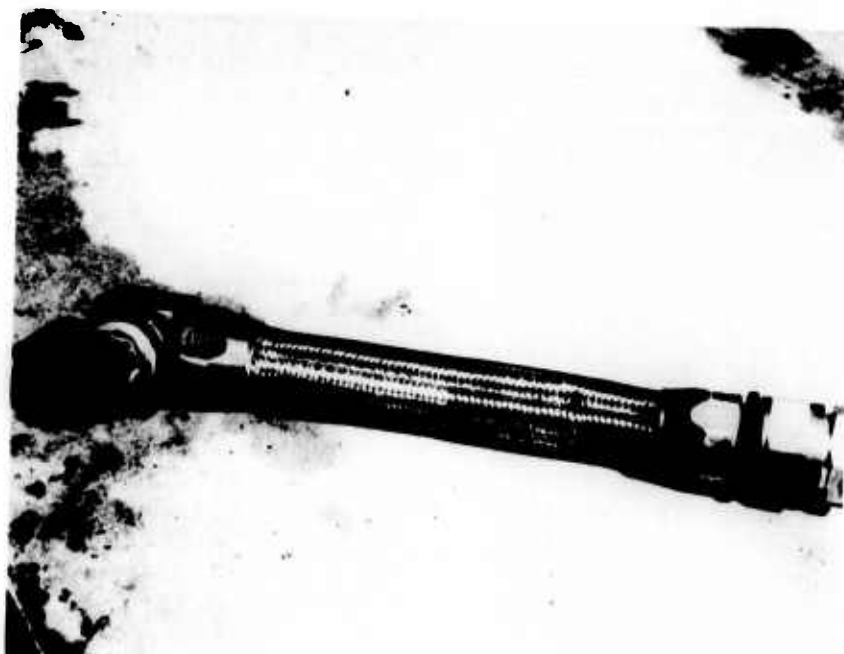
Figure 69. View of Line Half of -20 Valve After Dynamic Bending Test.

Figure 69 illustrates the line half of the -20 valve following load application. The entire boot portion of the -20 valve remained in the flange half of the valve. This boot was cut in two places prior to pulling free of the hose half of the valve (Figure 70).

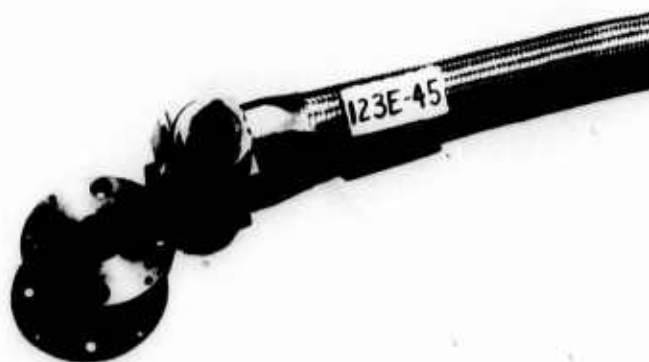
Figure 72. View of -20 Valve After Dynamic 45-Degree Impact Test.

The impact loads were applied through the impact mechanism at a rate of 68.4 feet per second for the -12 valve and 60.5 feet per second for the -20 valve. The loads recorded during impact were 817 pounds for the -12 valve and 1,270+ pounds for the -20 valve. The latter figure is not a peak load due to load cell failure at that value. Both valves functioned properly. Separations were made at the frangible sections, and no leakage was observed other than of the fluid entrapped in the boot during actuation. The -20 hose assembly and valve section were thrown over the impact barrier following impact. Figure 72 illustrates the -20 valve following dynamic impact.

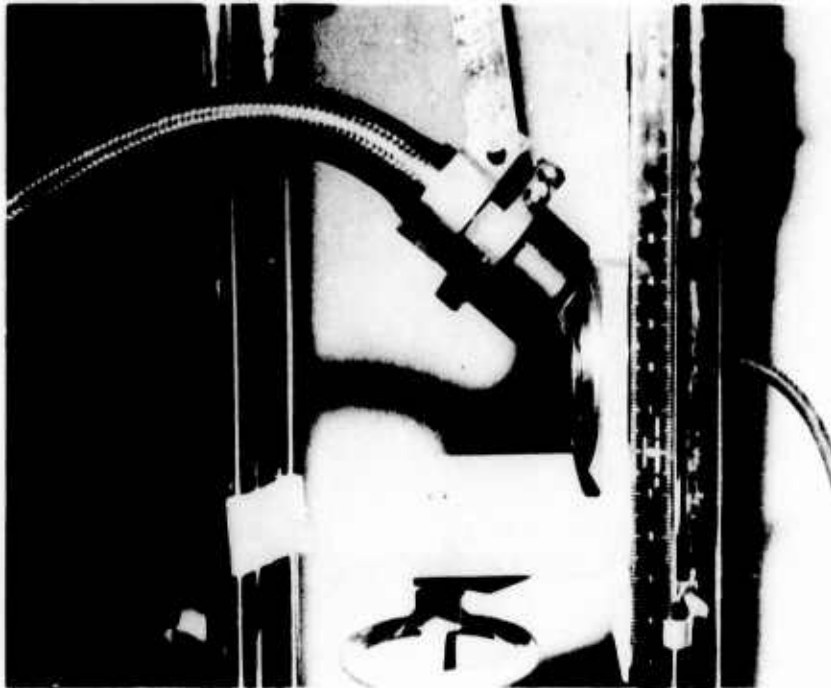
Figure 79. Valve Position at Time of Valve Closure During Static Bending Test.

fluid flow. The frangible section yielded at 1.3 inches travel, and the peak load recorded was 1,530 pounds. No seepage occurred. Figure 79 illustrates valve position at the time of flow stoppage. Figure 80 is a close-up of the valve body after removal from the test fixture.

As can be seen in Figure 79, the valve assembly bent approximately 45 degrees before closing. While the inner boot stretched and prevented fluid spillage during the valve displacement, an undesirably large amount of boot surface area was exposed. This exposed area could be cut by jagged metal or by the sharp edge of the torn frangible section.

The maximum allowable amount of exposed boot area was not previously specified; however, the need to do so is obvious. The valve manufacturer is studying the problem and is attempting to reduce the area.

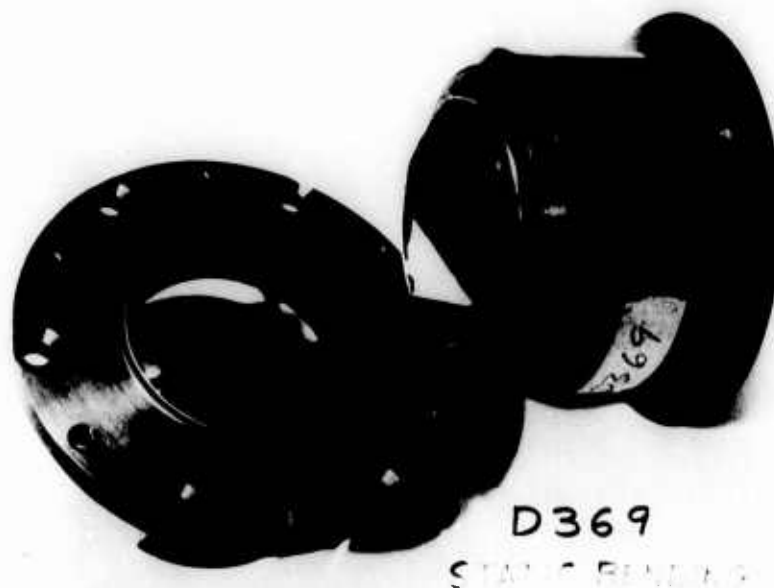
Figure 80. Valve Body After Removal From Test Fixture. (Note uncut portion of boot still holding valve halves together.)

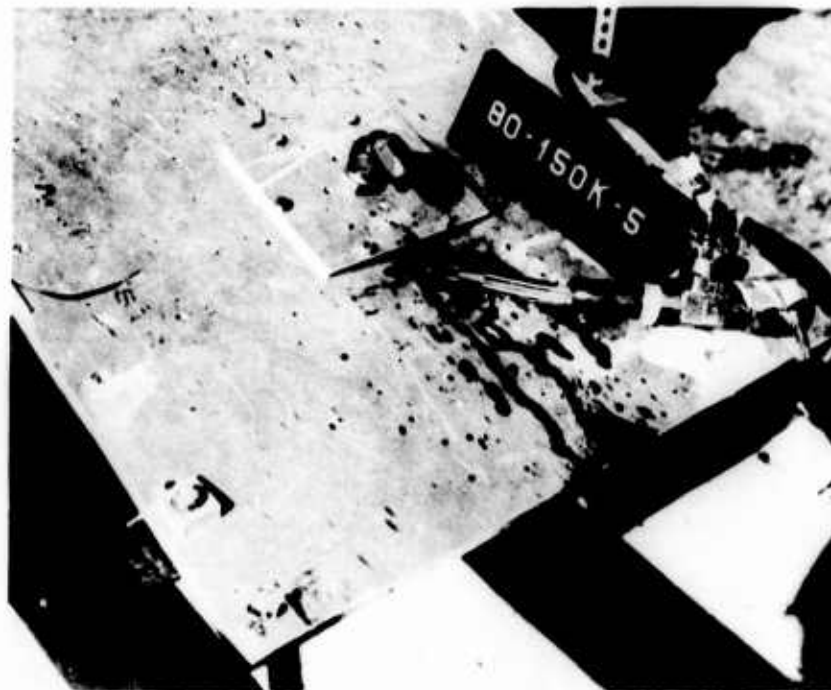
Figure 91. View of Valve A1-1/2 After Dynamic Bending Test.

Dynamic Bending - Test No. 80-150K-5: The valve and hose assembly were positioned on the sled as shown in Figure 90. A dynamic load was applied to the hose assembly at a rate of 65.5 feet per second. The force applied caused the hose to pull free of the elbow end fitting attachment at a peak load of 958 pounds. The valve was not damaged and performed properly following the test load application. A posttest view of this test may be seen in Figure 91.

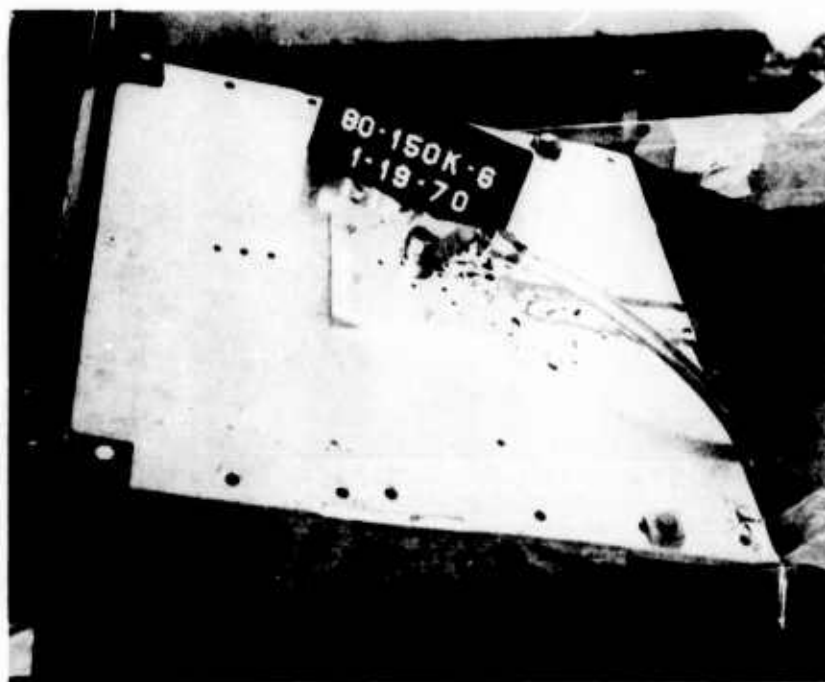
Figure 95. View of S.S.-1/2 Valve After Dynamic Bending Test.

Dynamic Bending - Test No. 80-150K-6: The valve and hose assembly were positioned on the sled in a manner similar to the setup shown in Figure 90. A dynamic load was applied to the hose assembly at a rate of 65.2 feet per second. The force applied caused the straight end fitting of the hose to fail at a peak load of 1,190 pounds. The snap ring in the "B" nut failed and permitted the remainder of the hose end fitting to pull free of the "B" nut and valve nipple. The valve was not damaged and performed normally following the test. A post-test view of the test setup is shown in Figure 95.

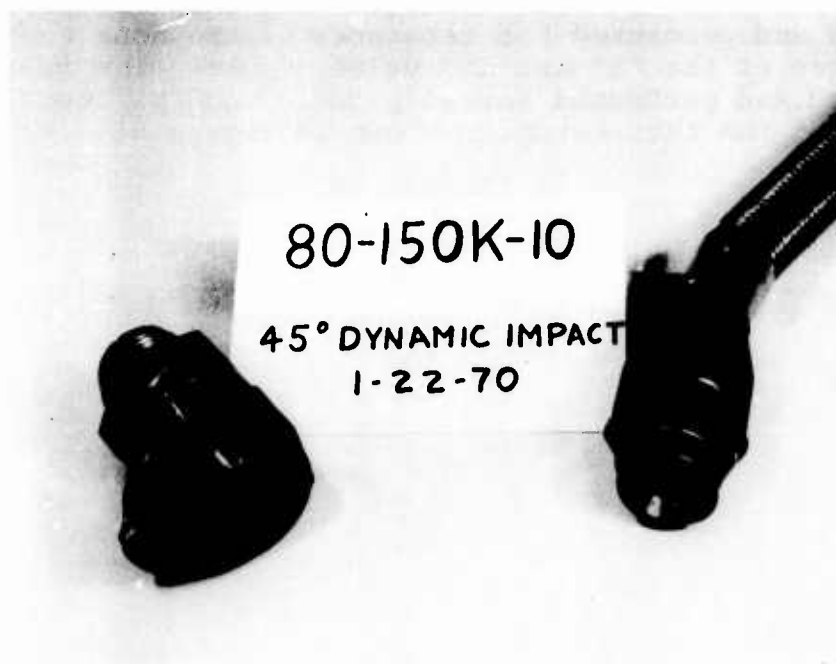
Figure 96. View of S.S.-1/2 Valve After Dynamic 45-Degree Impact Test.

45-Degree Dynamic Impact - Test No. 80-150K-10: The valve and hose assembly were positioned on the sled as shown in Figure 92. The straight hose end fitting installed on the valve nipple was impacted with a lead impact head at a rate of 66.2 feet per second. The "B" nut failed and permitted the remainder of the hose end fitting to break free of the "B" nut. A posttest pressure check of this valve indicated a fluid

leakage rate of approximately 100 cc/min. A view of the failed "B" nut is shown in Figure 96.

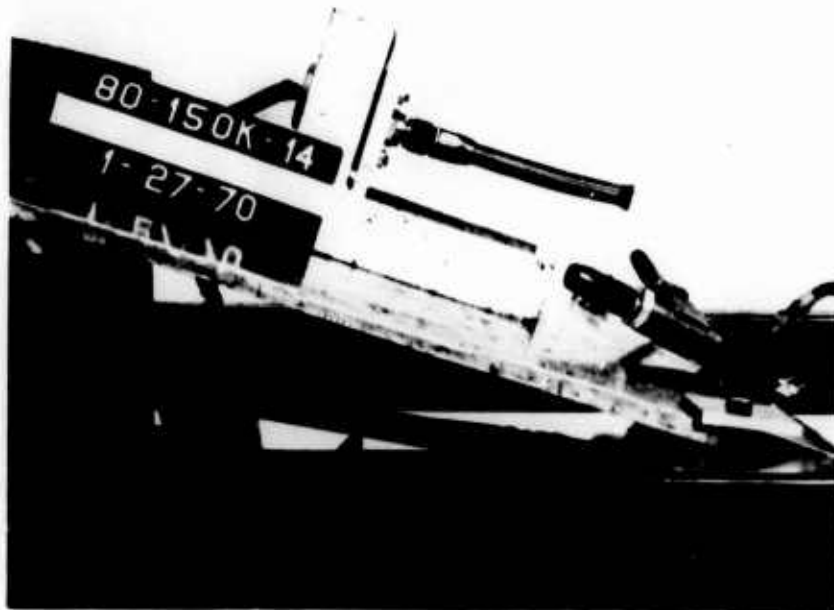
Figure 99. View of S.S.-1/2 Valve After Dynamic Tension Test.

The valve and hose assembly were subjected to dynamic loading at a velocity of 65.8 feet per second. The hose end fitting pulled off the hose at 846 pounds (Figure 99). The valve remained sealed and did not leak.

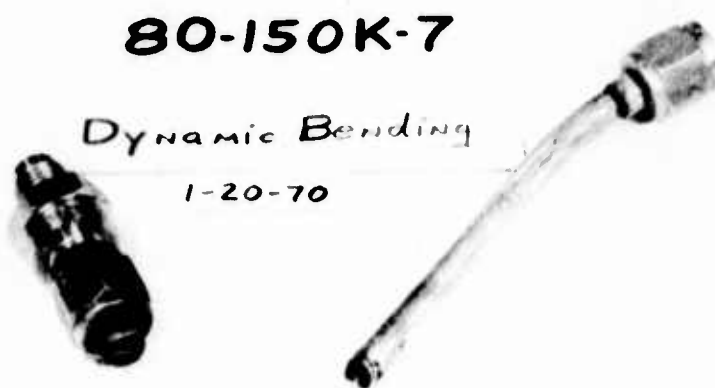
Figure 102. View of S.S.-1/4 Valve After Dynamic Bending Test.

Dynamic Bending - Test No. 80-150K-7: The mounting setup for the valve and tube assembly was similar to that shown in Figure 101. A load was applied to the 1/4-inch hose assembly at a rate of 65.2 feet per second. The force applied caused the tube to fail in tension at the top of the "B" nut as shown in Figure 102. The peak load recorded was 650 pounds. This dynamic load caused the valve to permit a leakage of 34 cc/min following the dynamic load application. The valve was then subjected to a flow in a normal direction and, when rechecked in the reverse direction, leakage still occurred. The direction of flow was again changed and, upon return to reverse direction, the valve sealed completely.

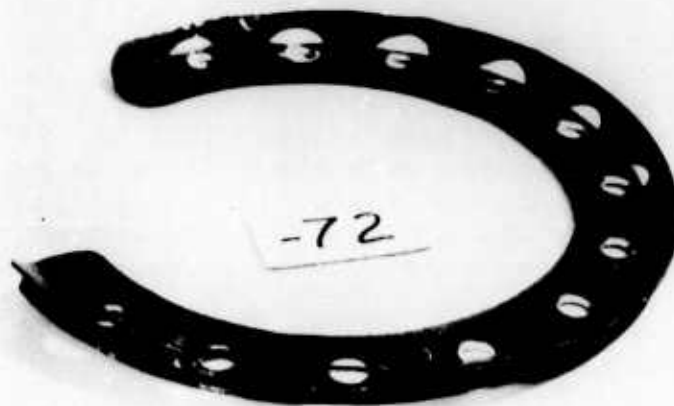
Figure 112. -669 Retainer After Tension Loading.

The six tension drops of the two retainer designs resulted in average values that were very close. The -648 retainer averaged release loads of 1,068 pounds, and the -669 retainer averaged release loads of 1,065 pounds. The tension values for the -648 retainer were more closely grouped than those of the -669 retainer. Figure 108 illustrates a typical tension setup immediately following release. Figure 111 illustrates a typical -648 retainer and Figure 112 illustrates a typical -669 retainer following tension loadings. Detailed test results are presented in Table XIII.

With the exception of the -669 fitting in tension, the results were very repeatable, with all data within  $\pm 5$  percent of the average load. The grossly larger deviation of the -669 tensile test results suggests that a factor was present in these tests which was not present in all the remaining tests. One possibility is the orientation of the open end of the horseshoe-shaped fitting. The clock position of this end was closely controlled during the bending and shear tests because it obviously would have a first-order effect on these tests. On the surface, this orientation would appear to be unimportant during the tensile tests; it was therefore not controlled. However, it is quite possible that the loading during the tensile tests was not exactly uniaxial, especially at the onset, and, therefore, the orientation may have been a factor.

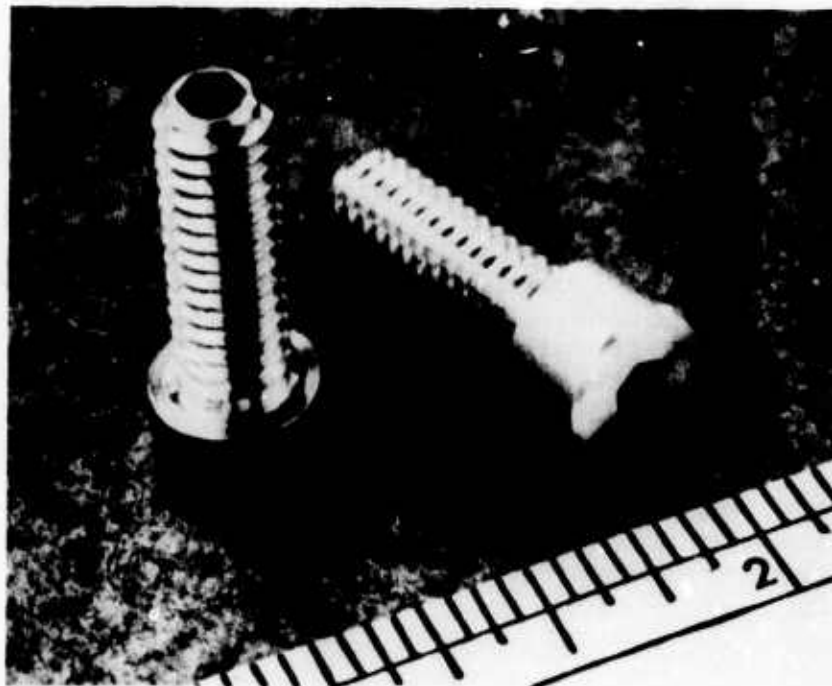
The frangible socket-head test screws (Figure 119) were 1/4-20 aluminum screws with a thread length of 0.70 inch. The outer surface of each screw head was a smooth cylinder. A 1/8-inch hexagonal section is broached lengthwise entirely through the screw. This feature serves two functions: (1) it permits the installation and/or removal of the screw with a 1/8-inch Allen wrench, and (2) it reduces the strength of the screw to a desired value. The use of an Allen wrench prevents the application of excessive torque, thereby reducing the opportunities for possible mishandling.

Figure 119. Allen Socket-Type Frangible Screws.

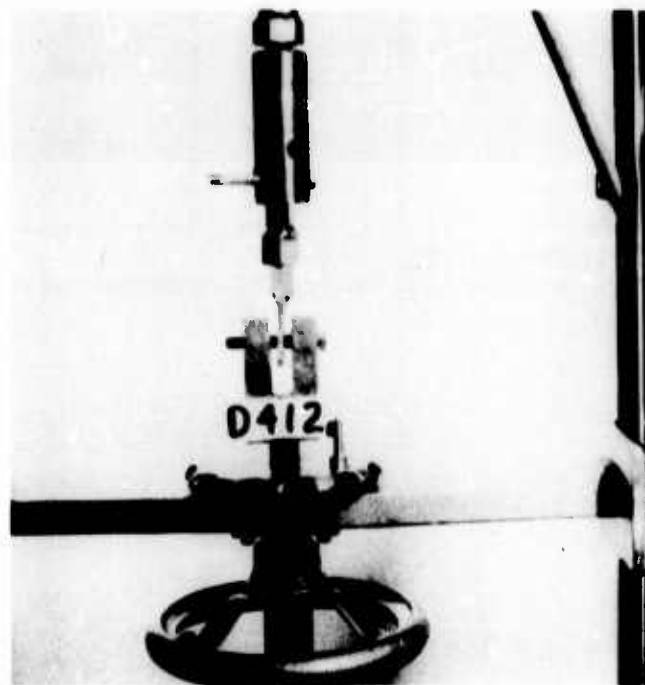
Figure 121. Static Tension Test Method Prior to Load Application.
