FAA-AM-72-7

## EVALUATION OF A FIBERGLASS INSTRUMENT GLARE SHIELD FOR PROTECTION AGAINST HEAD INJURY

February 1972

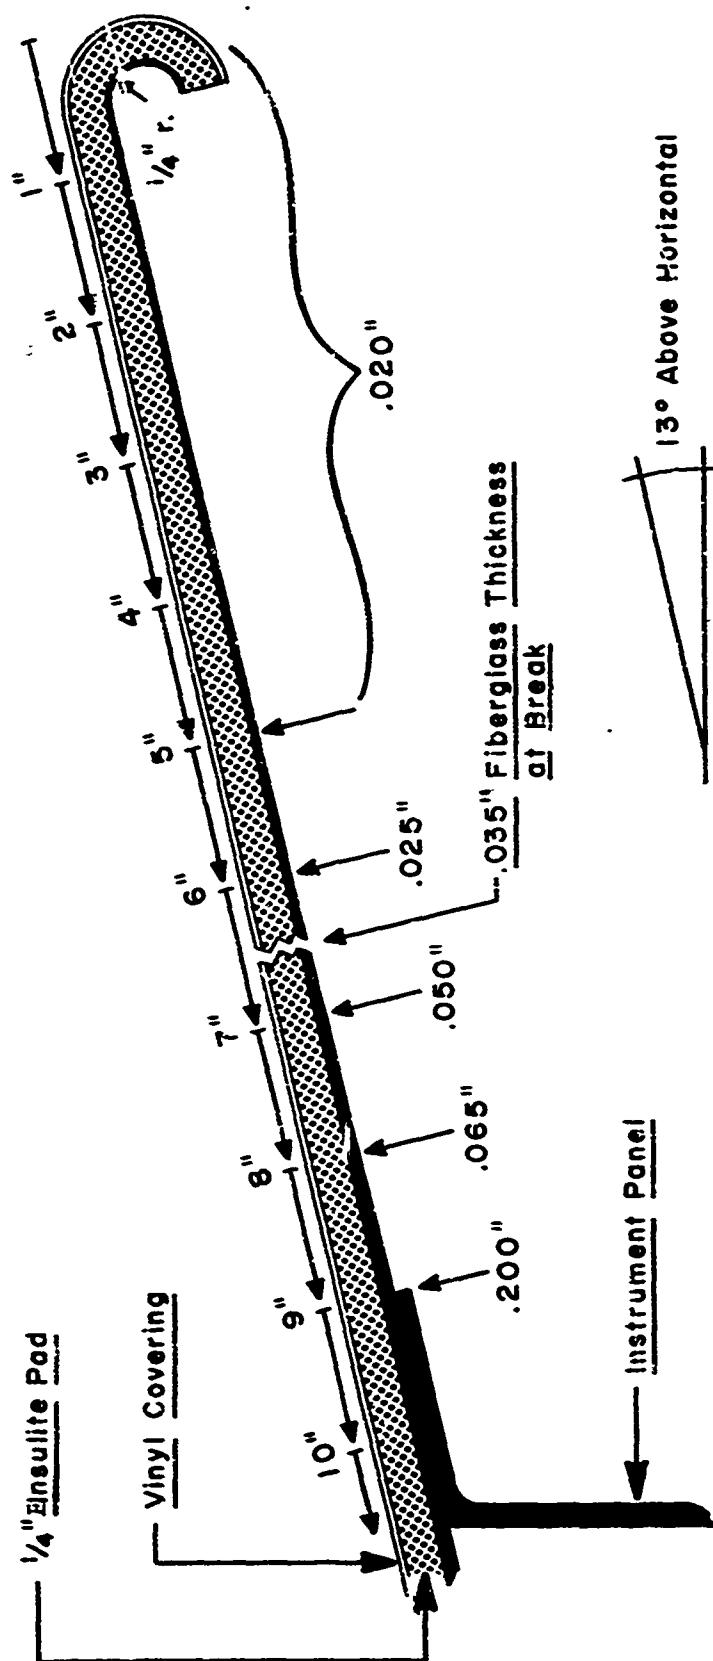
The glare shield shown in Figure 3 consisted of a basic structure of a thin fiberglass layer covered with a 1/4-inch thick layer of Ensolite and a thin layer of plastic vinyl. It extended 9 1/2 inches from the instrument panel toward the pilot and was elevated about 13 degrees above the horizontal. On the protruding edge nearest the pilot the shield was rolled down and under with an inside radius of curvature of approximately 1/4-inch. After impact testing had been completed, the covering was removed from a portion of the shield so that the thickness of the fiberglass could be measured. The first five inches (nearest the pilot) were of a uniform thickness of .020 inches, increasing to 0.025 inches at six inches, to .050 inches at seven inches, and .065 at eight. At nine inches the thickness abruptly increased to 0.200 inches due to the lap with the instrument panel.

FIGURE 3. Cross section of the glaro shield showing thicknesses at various points.
