FIRE TESTING OF INDEPENDENT FIBERGLASS  
FUEL TANKS WITH AND WITHOUT PROTECTIVE  
COATING OF FIRE RETARDANT PAINT

UNITED STATES COAST GUARD  
OFFICE OF RESEARCH AND DEVELOPMENT  
APPLIED TECHNOLOGY DIVISION

LTJG J. D. RICHART, USCG  
MERCHANT MARINE TECHNICAL DIVISION  
OFFICE OF MERCHANT MARINE SAFETY

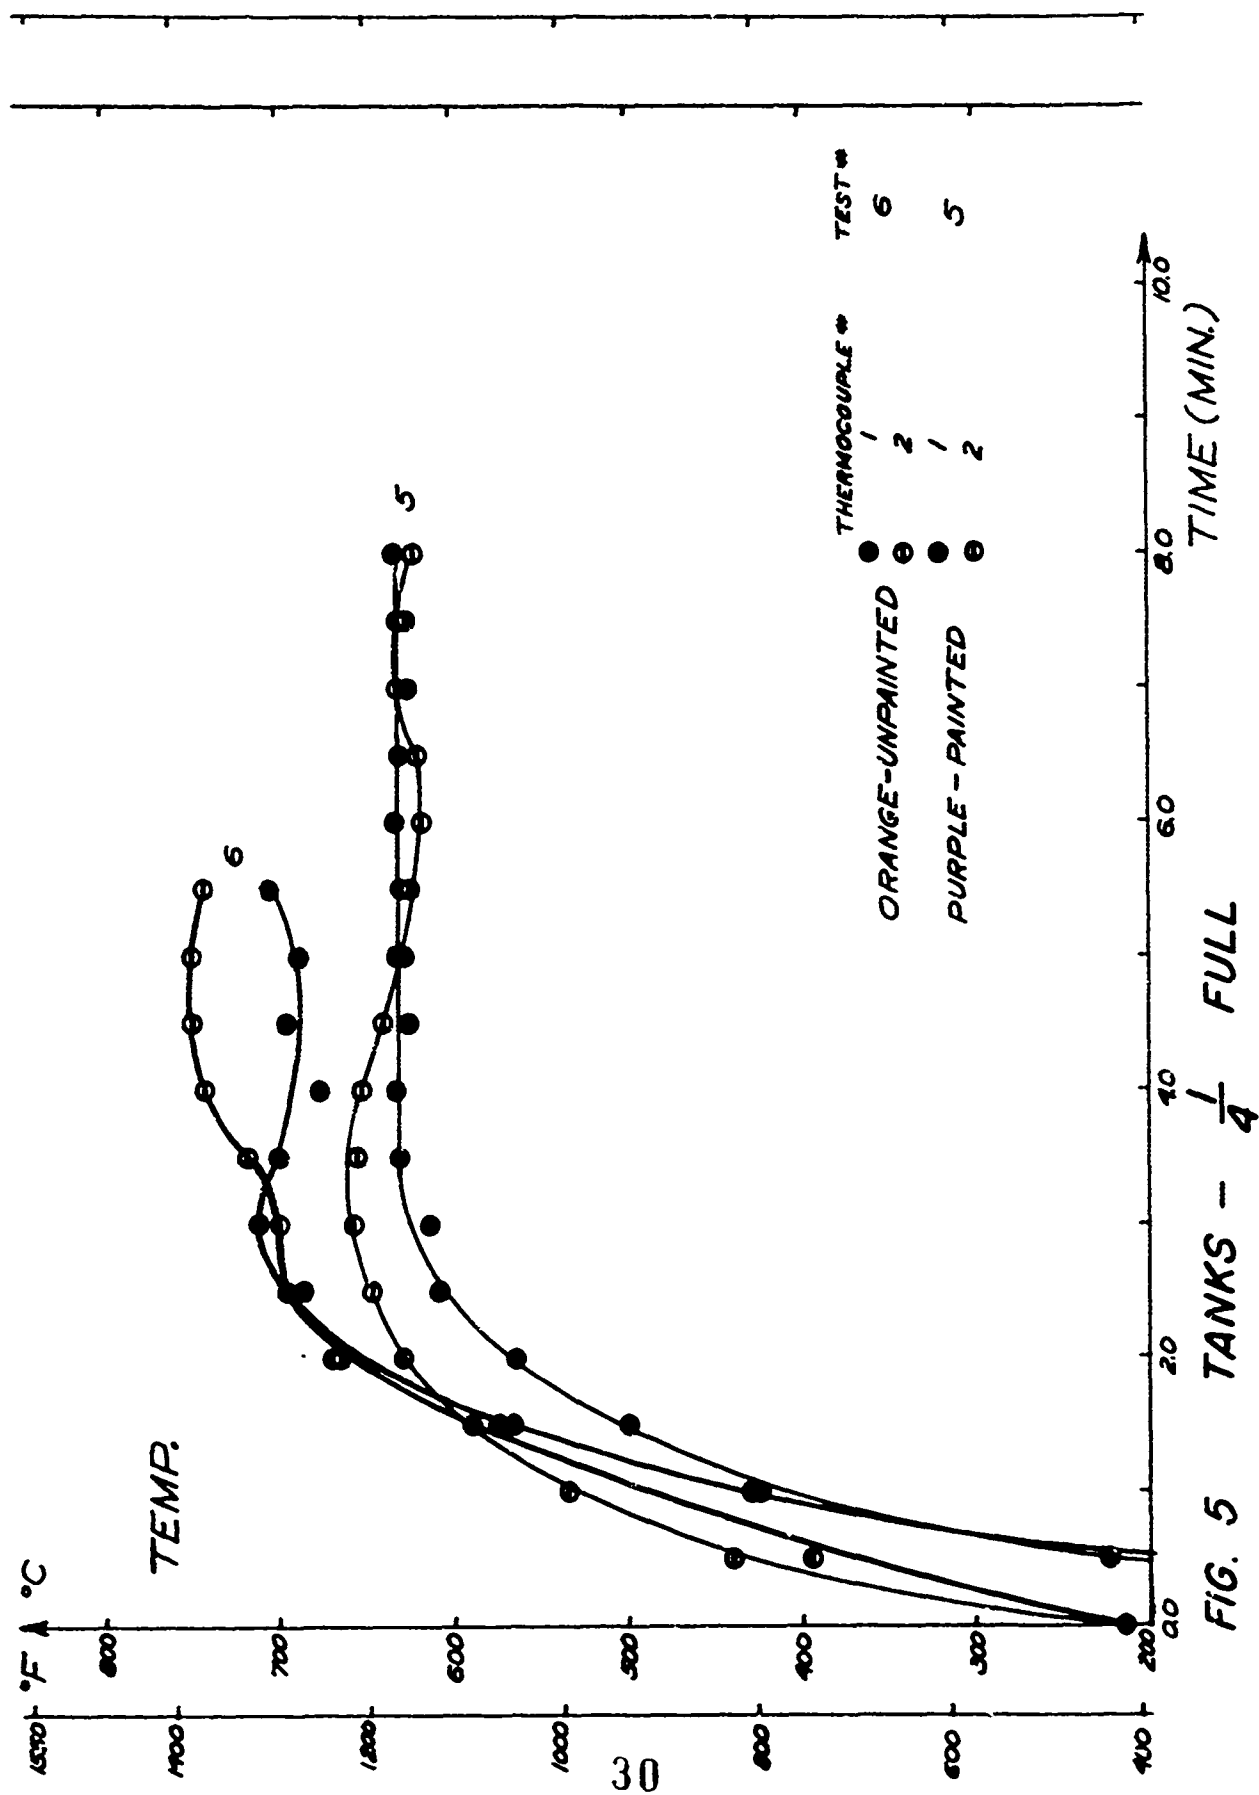
FIG. 5

FIG. 1 shows that Test #6 on the unpainted tank had temperatures which fell easily between the YSB's min.-max. curves for the 2m30s independent fuel tank fire test. Test #5 did not cross over the minimum curve, due to variables beyond control. As can be seen in FIG. 5, the unpainted tank was subjected to a fire about  $150^{\circ}\text{F}$  hotter than the painted tank. However, the painted tank lasted two minutes longer and still presented a better internal appearance. The internal temperatures depicted on FIG. 7 show the temperature in Test #6 to rise sharply after two minutes. The dip in the curve can be explained as follows: the thermocouple was positioned in the vapor space and when the fuel began to boil, a droplet of fuel hit the nickel bead, causing a sharp drop in temperature reading. As the liquid vaporized, the temperature again climbed rapidly.

TANKS -  $\frac{1}{4}$  FULL
