Report No. FAA-RD-72-25

# SONIC BOOM AND NATURAL DETERIORATION EFFECTS ON BUILDINGS: WHITE SANDS, N.M. STRUCTURE RESURVEY

J.H. WIGGINS, JR.

FEBRUARY 1972  
FINAL REPORT

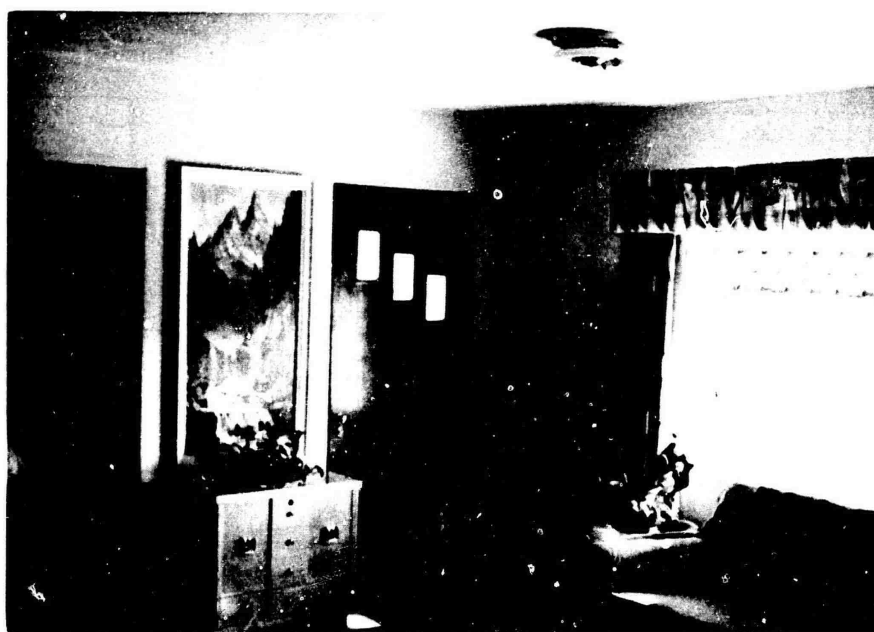
The Withers ranch (Fig. 5) is virtually in the same condition as it was seven years earlier (Note Fig. B2-3, SST 65-15, Vol. 2). It has been redecorated on the interior twice since the program and appears in excellent condition. Fig. 6 can be compared to Fig. B2-2, SST 65-15, Vol. 2.

Fig. 6 Interior of Wither's ranch house.

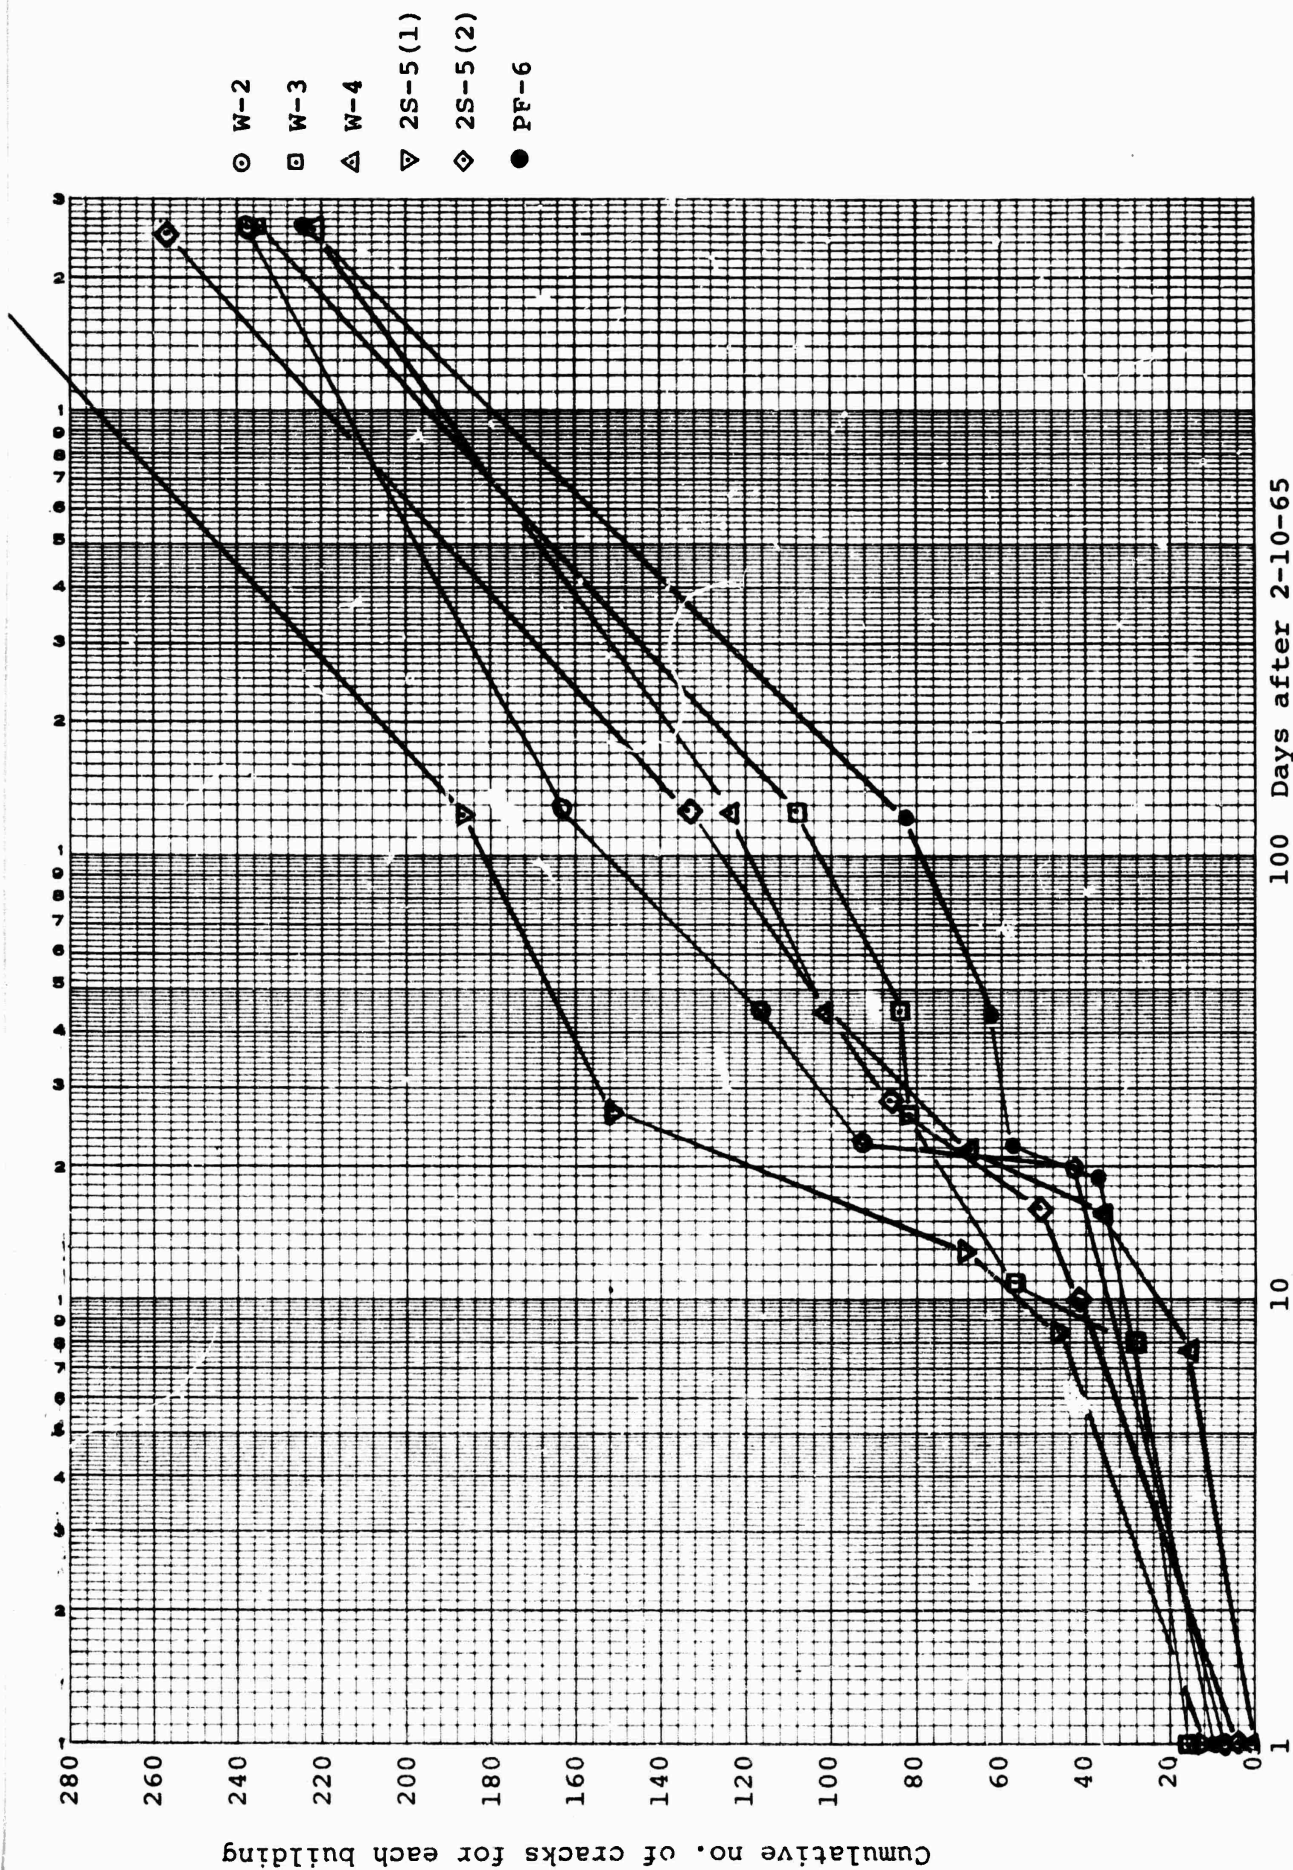
For the shrinkage type of process it has been found that  $\lambda(t) = \lambda/t$  is a good model. Based on this expression one would expect the rate,  $\lambda(t)$ , to plot as a straight line on log-log paper and the cumulative crack number to plot as a straight line on semi-log paper. This was demonstrated in SST 65-15 (Vol. 1). Figure 53 illustrates the data in Table 5.

Fig. 53 Cumulative Damage Plotted only for Inflection Points

cause further damage, one would expect at some over-pressure level the slope increase over and above that caused by the drying and settlement processes. This slope increase is obvious for each of the "buildings". However, in order to identify any real effects we plotted the average cumulative number of cracks for all the buildings along with temperature differential (Fig. 54). Slope increase is obvious on days of increasing temperature differential as well as over-pressure increase. These data infer that cumulative damage is indeed difficult to identify as a function of boom strength and number. However, the greater slope of the curve in the post-boom periods suggests strongly that natural deterioration conditions far outweigh boom influences regarding cumulative damage.

- 1) Further, in-depth analysis of the data is required to identify more closely the influence of sonic boom on cumulative damage.
- 2) A program conducted at the Oscura Range Camp with explosives, if not sonic booms, or similar new as well as these existing structures may be required in order to pinpoint cumulative damage effects on structures.

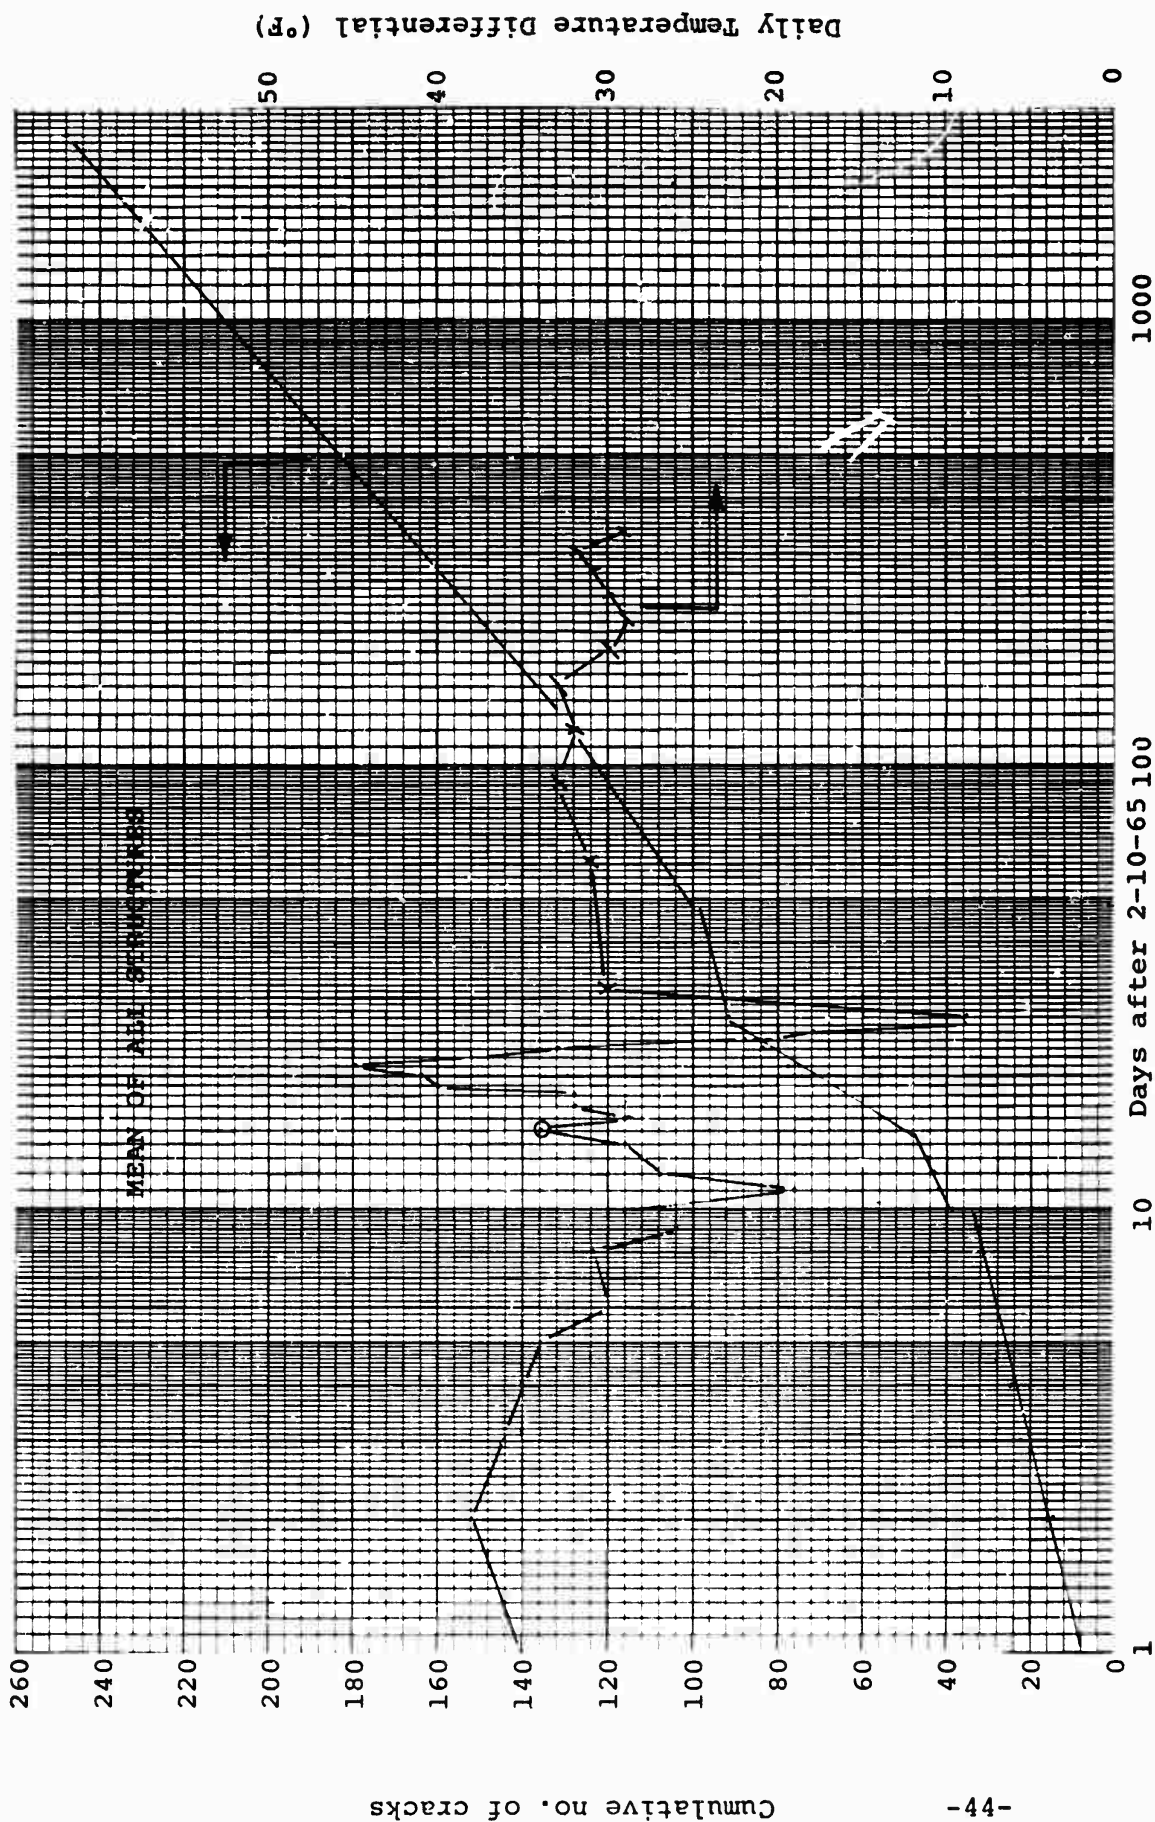
Fig. 54 Mean Crack Rate for All Structures Correlated with Temperature Differentials
