FIELD STUDY OF FENCING MATERIALS IN A MARINE-ATMOSPHERIC ENVIRONMENT -  
RESULTS OF UP TO THREE YEARS OF ATMOSPHERIC EXPOSURE AND CORROSION RATE  
DETERMINATION

Technical Note N-123

Eddy S. Matsui

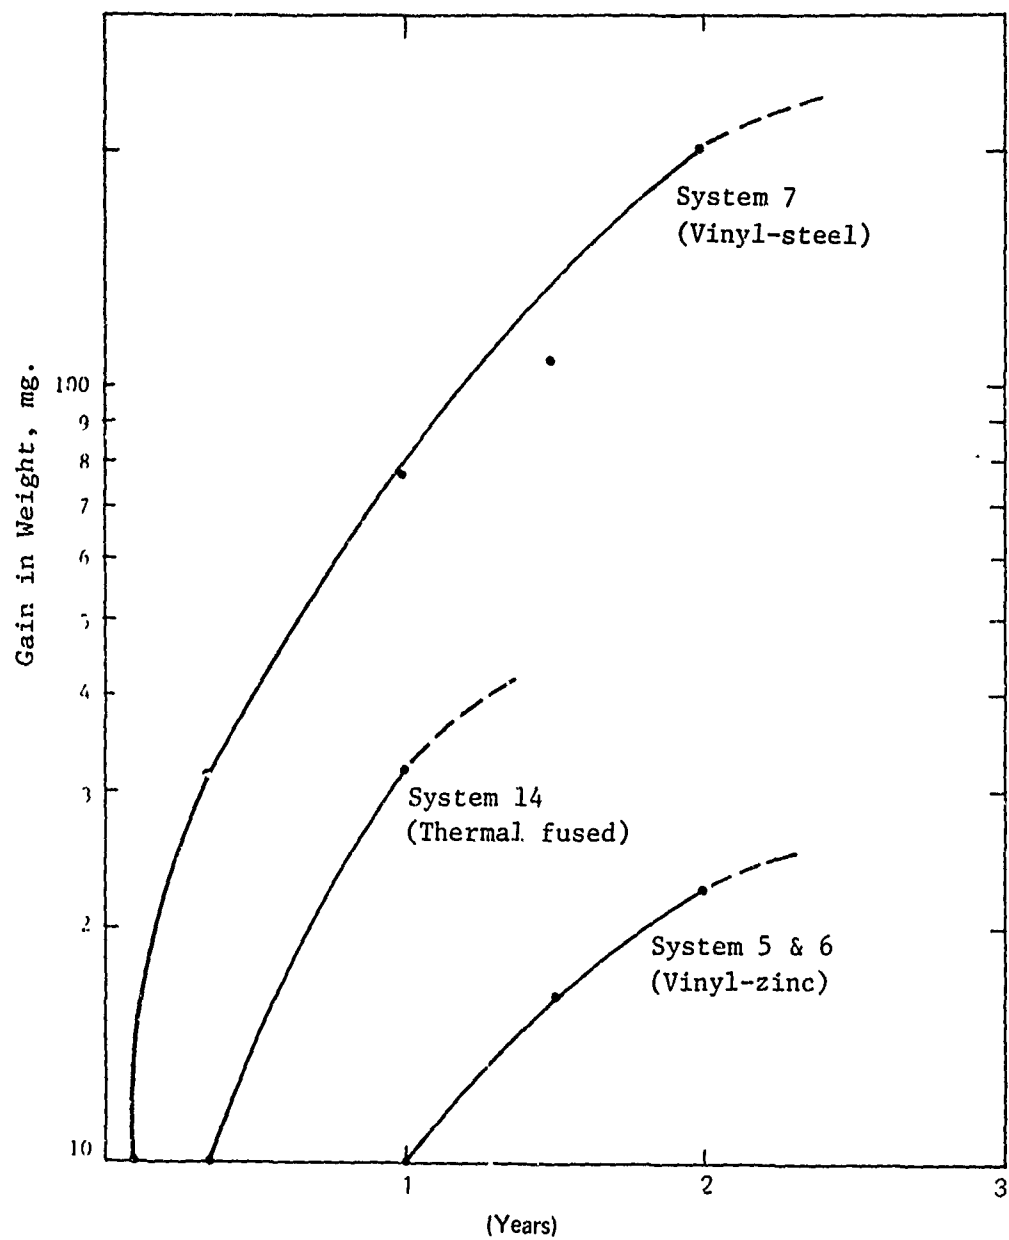
The corrosion rate of the vinyl-coated wires was determined by the weight gain method as described in an earlier section of the report. The results are listed in Table 6. A graphical illustration of the corrosion rate of vinyl-coated wires during the 24 months of atmospheric exposure is shown in Figure 33. Although visual inspection of the test fence did not reveal the condition of core wire, the graph shows that System 5 is the most corrosion-resistant system compared to Systems 7 and 14. System 7 appeared to be corroding faster than the other two systems. System 5 gained 7.1 mg while Systems 7 and 14 gained 76.2 and 31.6 mg of the corrosion product, respectively, during the 12 months of exposure. There was no apparent red-rust accumulation in the inter-space between the vinyl-coating and the core wire of System 5, except for the white corrosion product found near the cut end and scribed area, when the underlying core wire was examined after removing the vinyl coating (Figure 34). Most of the core wires of Systems 7 and 14 were also well protected from corrosion and maintained the original metallic appearance, except near the cut-ends and scribed areas (Figures 28 and 34).

Figure 33. Corrosion patterns of vinyl-coated fence wires in atmosphere.
