USAAVSCOM TECHNICAL REPORT 72-12

FATIGUE TEST OF  
THE MAIN ROTOR RETENTION COMPONENTS  
USED ON MODEL OH-58A/206A-1 HELICOPTER  
(P. I. P. TASK 69-29)

MODEL OH-58A/206A-1

REPORT NO. 206-098-164      DATE 4-30-71  
 FATIGUE TEST OF THE MAIN ROTOR  
 RETENTION COMPONENTS USED ON  
 MODEL OH-58A/206A-1 HELICOPTER

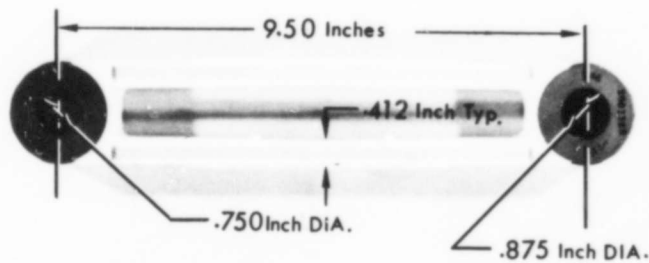
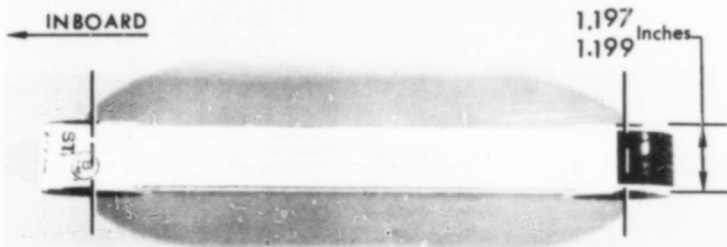
FIG. 1

The 206-010-105-3 strap assembly, Ref. 3, shown in Fig. 1, is made of AM-355 stainless steel wires of 0.0058 to 0.0062 inch in diameter wrapped around two end spools set at 9.50 inches apart. The spools are made out of stainless steel which are heat treated to a tensile strength of 180,000 to 200,000 psi. The wire material has a tensile strength of 440,000 psi and is wound in 46 layers with 179 wires per layer bonded with urethane rubber per Bendix ES-1170. The rubber impregnation is done such that the final belt and spool width is 1.199/1.197 inches and the depth of each belt at the center is 0.442/0.412 inch. At each spool a 0.005 inch thick teflon buffer is bonded between the spool and the bonded wire belt. The inboard spool has a pin hole of 0.7505/0.7500 inch in diameter. The outboard spool has a bolt hole of 0.8755/0.8750 inch in diameter.

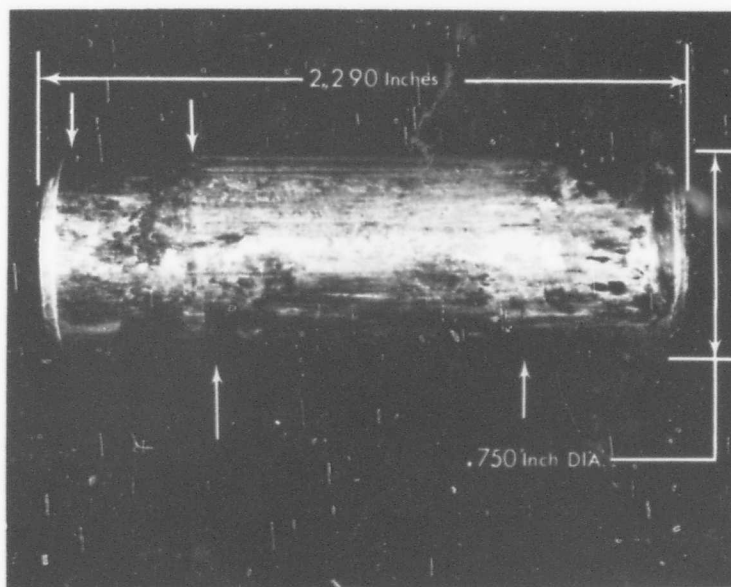
FIG. 2

The 206-010-123-1 pin, shown in Fig. 2, is made out of AISI 4140 steel and is heat treated to a tensile strength of 180,000 - 200,000 psi. The pin is 0.7495/0.7485 inch in diameter and is 2.290 inches long. The ends of the pin are chamfered to 0.060 X 45 degrees.

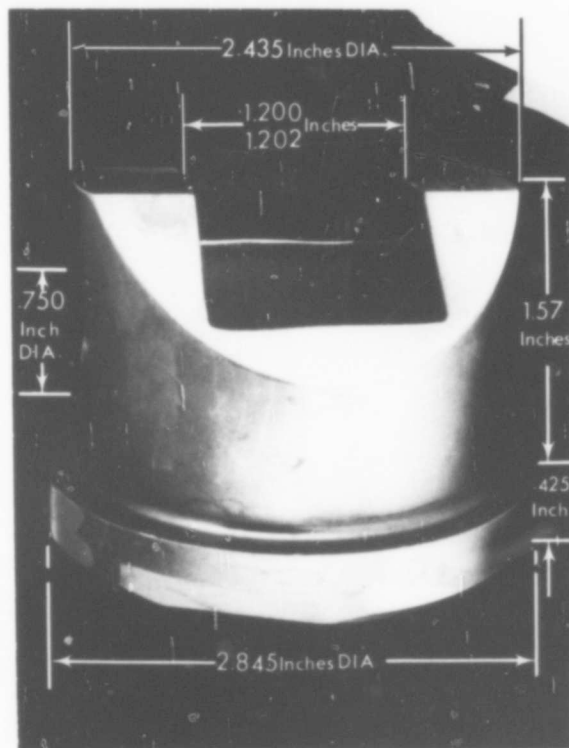
FIG. 3

The 206-010-155-7 strap fitting, shown in Fig. 3, is made out of SAE 4340 steel and heat treated to a tensile strength of 180,000 to 200,000 psi. The -155-7 fitting is essentially cylindrical in shape with a diameter of 2.435/2.438 inches, and has a length of 1.575 inches. At one end it has a flange 0.425 inch long and 2.845 inches in diameter. The outer edge of the flange is chamfered 0.100 x 45 degrees. At the opposite end, the fitting ends in a pair of tangs, which has sides at 45 degrees to the axis of the fitting and is 0.785/0.815 inches long. There is a rectangular cavity through the center of the fitting. At the tang-end of the fitting there is a 0.7500/0.7505 diameter pin hole at 0.785/0.815 inch from

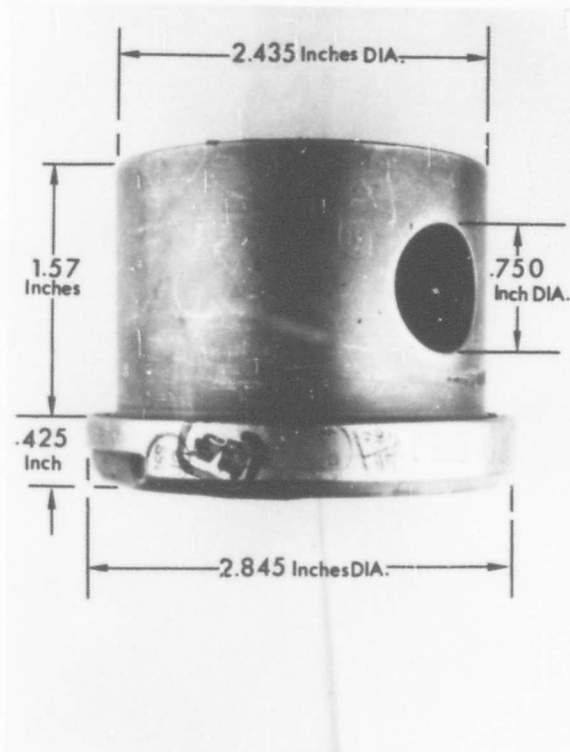
FIG. 4

The 206HA86-1 strap fitting, shown in Fig. 4, is essentially same as the -155-7 fitting except for the 45 degree sides of the tangs. These two cuts are eliminated to form a cylindrical fitting which is 1.575 inches long.

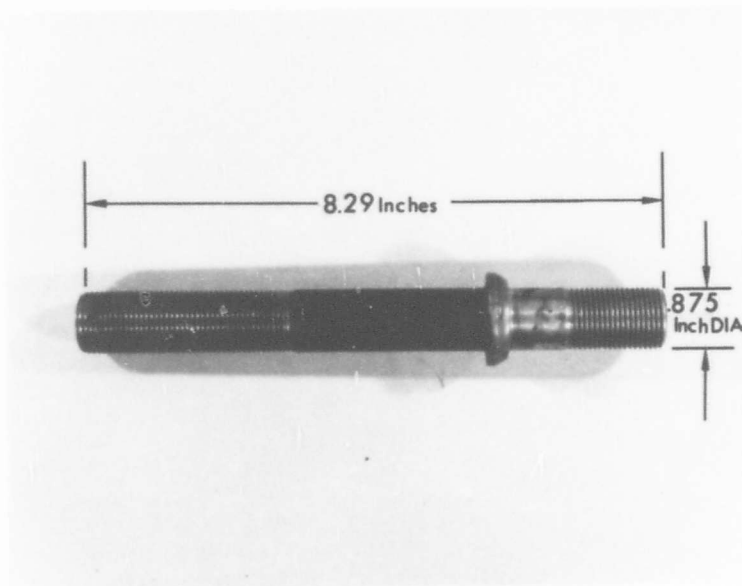
FIG. 5

One new 206-010-169-1 strap retaining bolt, Fig. 5, was used in each set of retention components as a supporting part. None of the -169-1 bolts used in the test indicated any failure. At the end of the test all the test parts were subjected to metallurgical examination. All the failed parts were checked and found to be within corresponding blueprint requirements except the -155-7 fitting, S/N J11-2070. The metallurgical examination results on this fitting are given under discussion of results of the -155-7 fitting.
