RADC-TR-72-148  
Technical Report  
July 1972

## ELECTRICAL OVERSTRESS FAILURES IN SILICON DEVICES

**ELECTRICAL OVERSTRESS FAILURES IN SILICON DEVICES**

**Clyde H. Lane**

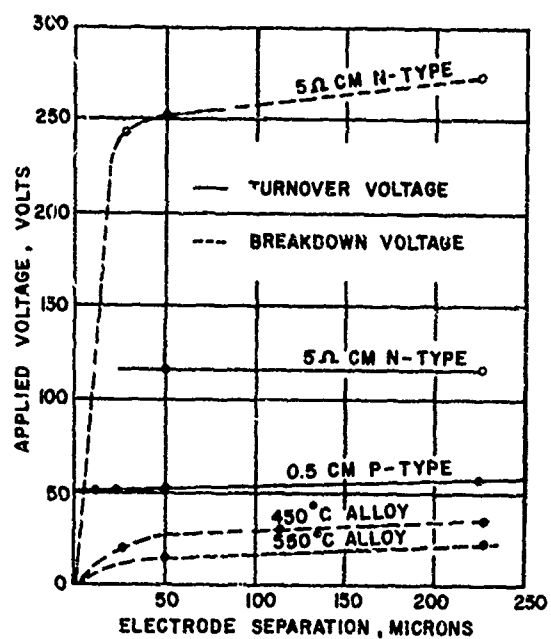
Two volts per micron equal a field strength of  $2 \times 10^4$  volts per centimeter. Peak field across the junction is about  $1 \times 10^6$  volts/cm, assuming a depletion region of  $1 \times 10^{-5}$  centimeters. The junction, however, is ill defined and any comparison with theoretical breakdown is of marginal value. More care was taken with Pattern D tests to note voltages and currents at critical points. The first group which was oxidized at  $1150^\circ\text{C}$ , alloyed at  $450^\circ\text{C}$ , overstressed and then alloyed again at  $550^\circ\text{C}$ , showed voltage versus electrode spacing variations depicted in Figure 16. For n-type material there was normal breakdown, microplasma formation and a continued increase in voltage and current until finally the zap occurred. The turnover voltage is the initial breakdown while the breakdown voltage is the voltage recorded when the zap occurred. Curves for n-type material were unaffected by the higher subsequent alloying. Contacts to the p-type material had very different I-V characteristics on the oscillograph display. Figure 17 gives a plot of power dissipation versus electrode spacing for the four combinations of conditions. Apparently there was a lower contact

Figure 16  
Variation in Turnover and Breakdown  
Voltages as Function of Electrode  
Separation for Aluminum Contacts

Figure 17  
Variation in Maximum Power Dissipation  
with Electrode Spacing for  
Aluminum Contacts

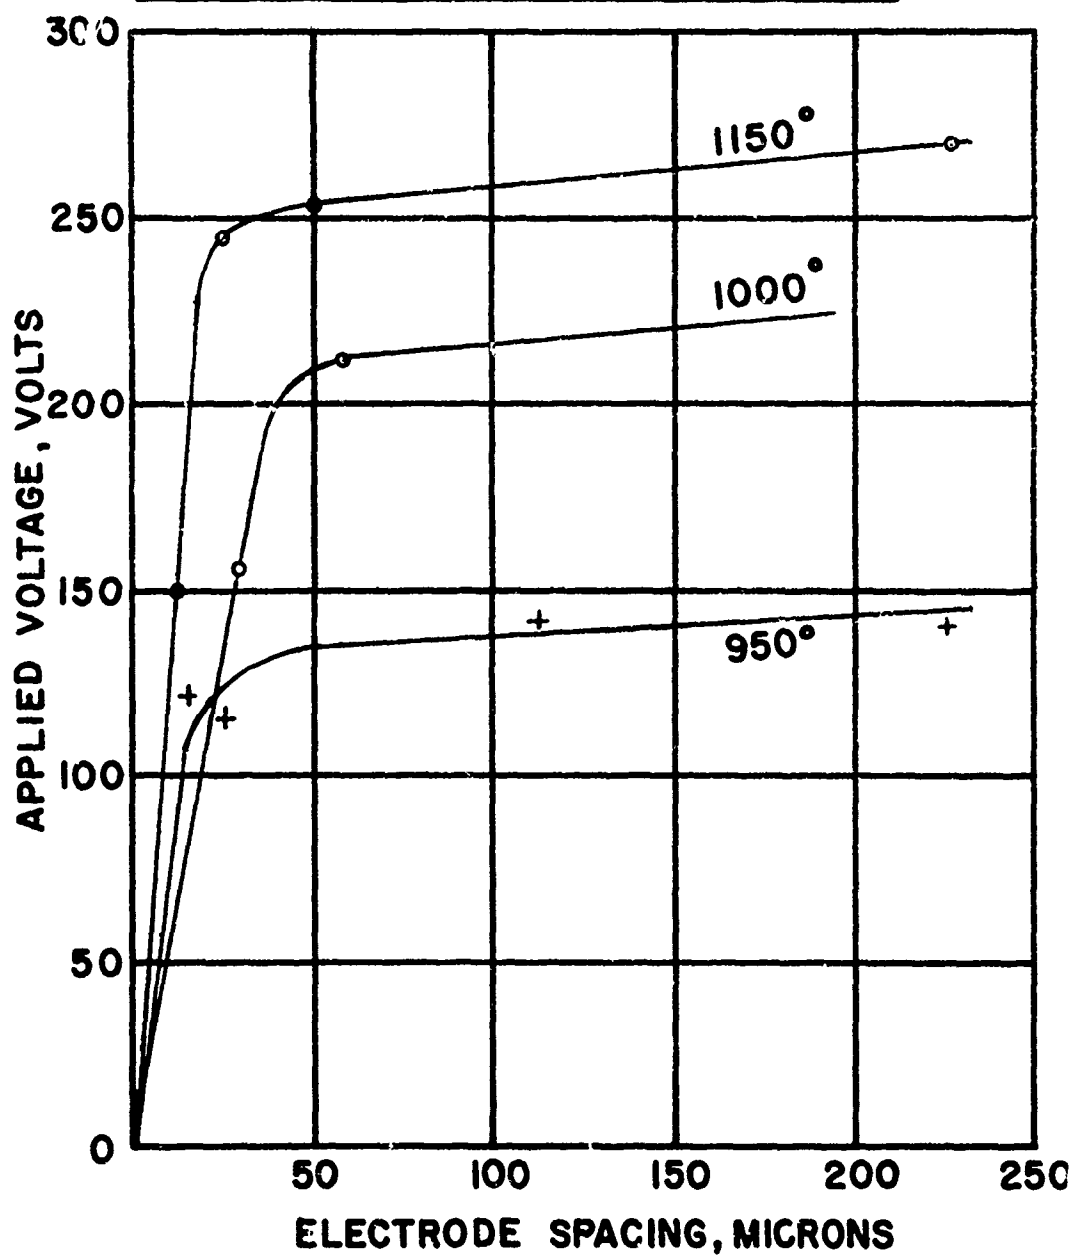
Only a faint hairline remained of the original aluminum path. This is due to a very narrow initial path which subsequently diffused away, or alloyed in because of the high temperature generated. It was also noted that when aluminum (in a zap path) melts back as a result of a second zap nearby, a black hazy line is left. This explains the double paths often seen in earlier work and shown in Figure 12. Perhaps the most important new information revealed by the lower oxidation temperature wafers was that the sensitivity to zap failures is increased by the lower oxidation temperature, particularly for 5 ohm - cm n-type wafers. This may seem surprising at first but the existence of more interface states at the Si-SiO<sub>2</sub> interface<sup>(6)</sup> when the oxide is grown at lower temperatures may explain why the surface zap susceptibility is increased. The graph of Figure 25 compares the zap voltage with electrode separation for aluminum metallization to 5 ohm - cm n-type wafers oxidized at various temperatures.

Figure 25  
Variation in Breakdown Voltage  
With Electrode Separation  
For Three Oxidation Temperatures
