AEDC-TR-72-161

**RESEARCH AND DEVELOPMENT TESTING  
OF YTTRIA/RARE EARTH  
STABILIZED ZIRCONIA MATRIX BRICKS  
IN THE PILOT TEST UNIT (PTU) AT AEDC**

**ARO, Inc.**

**November 1972**

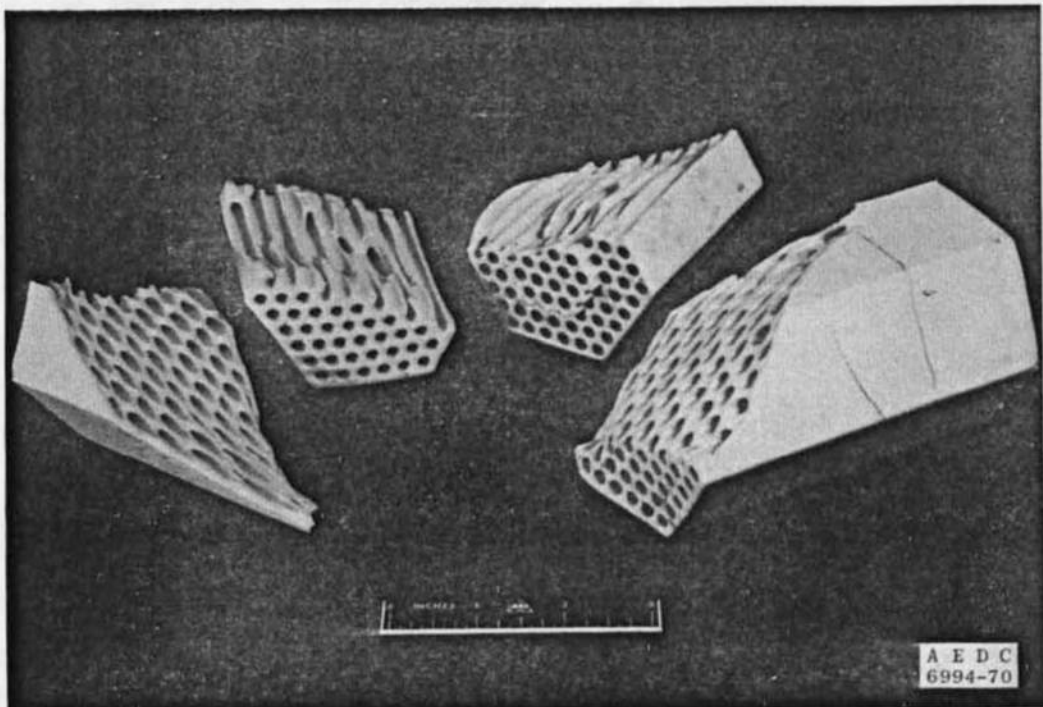
After runs 40 through 44, the top foot of the cored matrix was removed for the first major inspection. Laboratory analysis of selected bricks did not indicate destabilization. Pertinent photographs taken during the inspection are presented in Fig. 17. By referring to Fig. 14, all bricks shown in Fig. 17 can be identified as to location and number of runs that they remained in the matrix.

a. Column 10, 10.9 w/o, Coors

b. Column 8, 12.6 w/o, Coors  
Fig. 17 Post-Run 44 Matrix Inspection

c. Column 17, 12.6 w/o, Coors

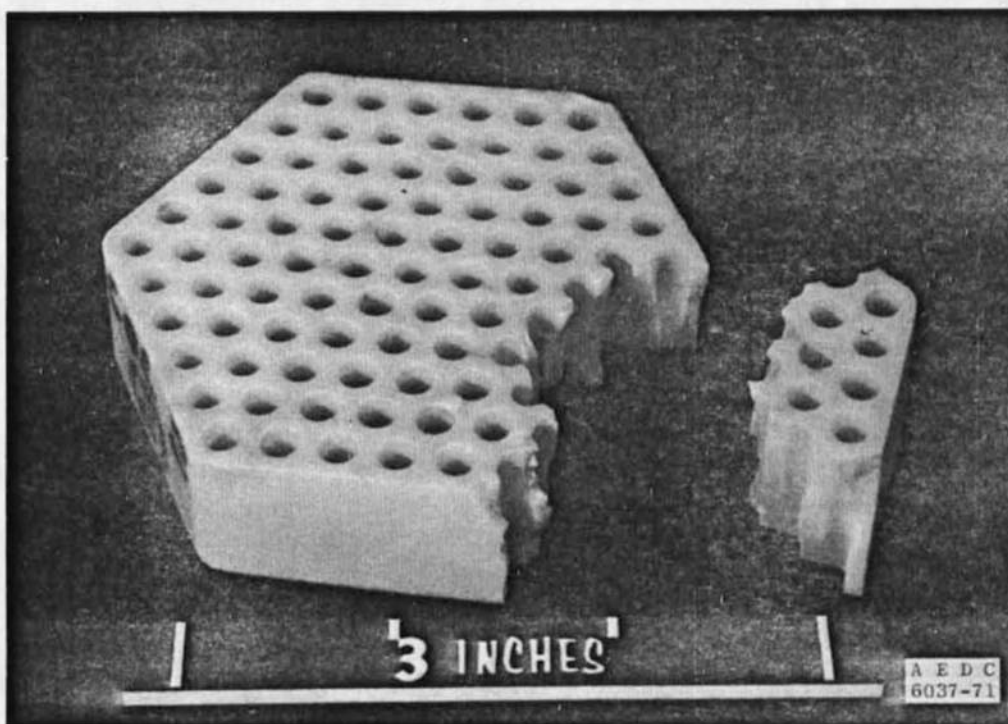
g. Zircoa, 16.5 w/o, Location 18-7

Throughout the pilot heater test program, fusion of the zirconia bricks has been noted. Occasionally, a small brick particle or chip was found fused inside a brick air passage, or a piece of one brick was sometimes found fused to the side of another brick, as illustrated in Fig. 23g. Also two or more bricks were sometimes found fused together. A sudden shock will usually separate the two. A typical example of this type of fusion is shown in Fig. 24d.

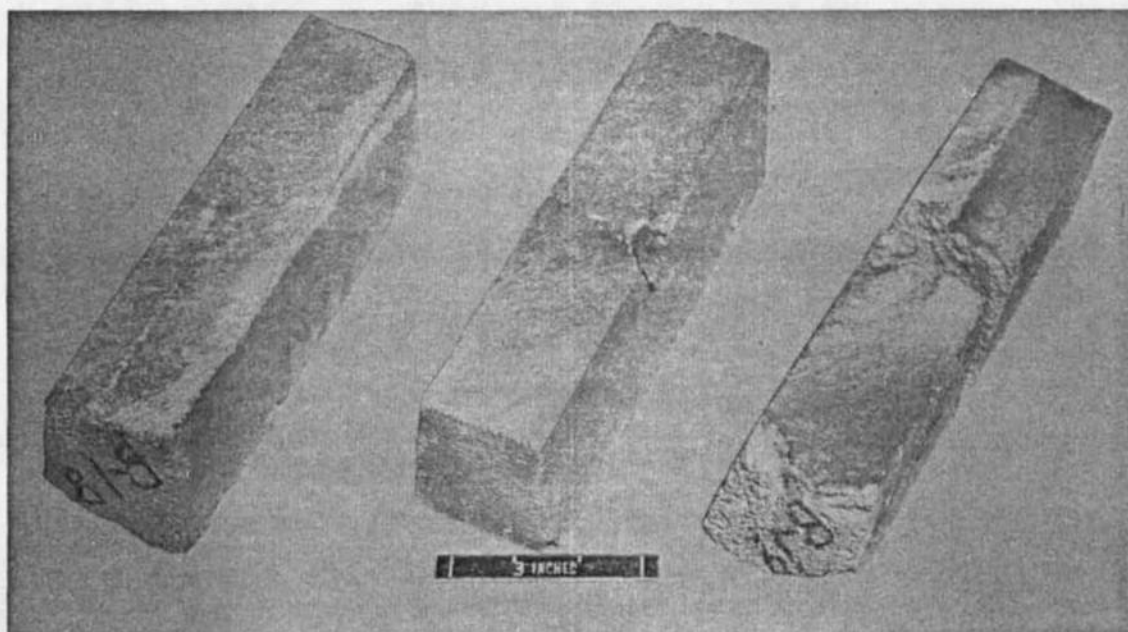
f. Outer Insulation Layer at the 15-1/2-ft Viewport, Lightweight Fully Stabilized Calcia Zirconia

Presented in Fig. 28 are photographs of various heater insulation refractories taken during the removal process. The condition of typical dome hot face refractories is illustrated in Fig. 28a. The steel shelf may be noted in Fig. 28b along with the bed liner bricks and the first layer of insulation. The outer layer of insulation cannot be seen in this photograph because of the heater shelf. Presented in Figs. 28c through h are photographs of various heater insulation and liner bricks. Crack and fracture patterns shown in these bricks are typical for the various types of insulation refractories.

5. The aluminum silicate firebrick insulation that gave evidence of melting was not fluxed by other impurities. The temperatures were evidently too high near the viewports, and higher temperature insulation is required in these areas.

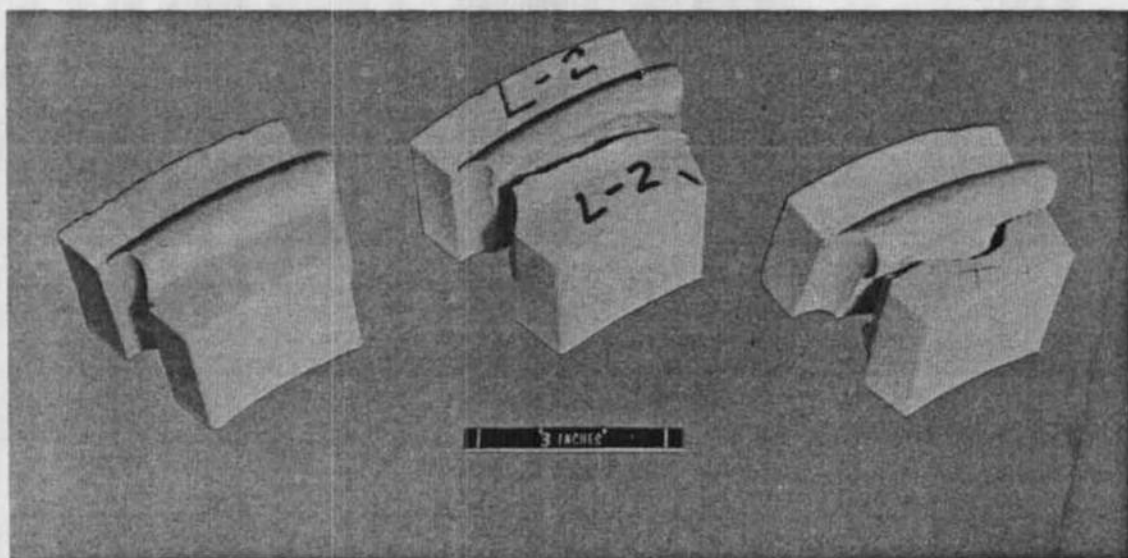
h. Typical Matrix Liner, Dense Fully Stabilized Yttria Zirconia  
Fig. 28 Concluded

4. The fractures in the tongue and groove sections of the  $\text{ZrO}_2$  insulation brick were not correlated with destabilization and thermal expansion stress discontinuities. Since many of the as-fabricated  $\text{ZrO}_2$  bed liner refractories contain visible cracks along the length of the tongue and groove area, it is possible that thermal gradient stresses during reheat and blowdown produce fractures in the bed liner above the matrix. Shear stress loading of the backup insulation probably contributes to the cracking in the tongue and groove region of the  $\text{ZrO}_2$  dome brick.

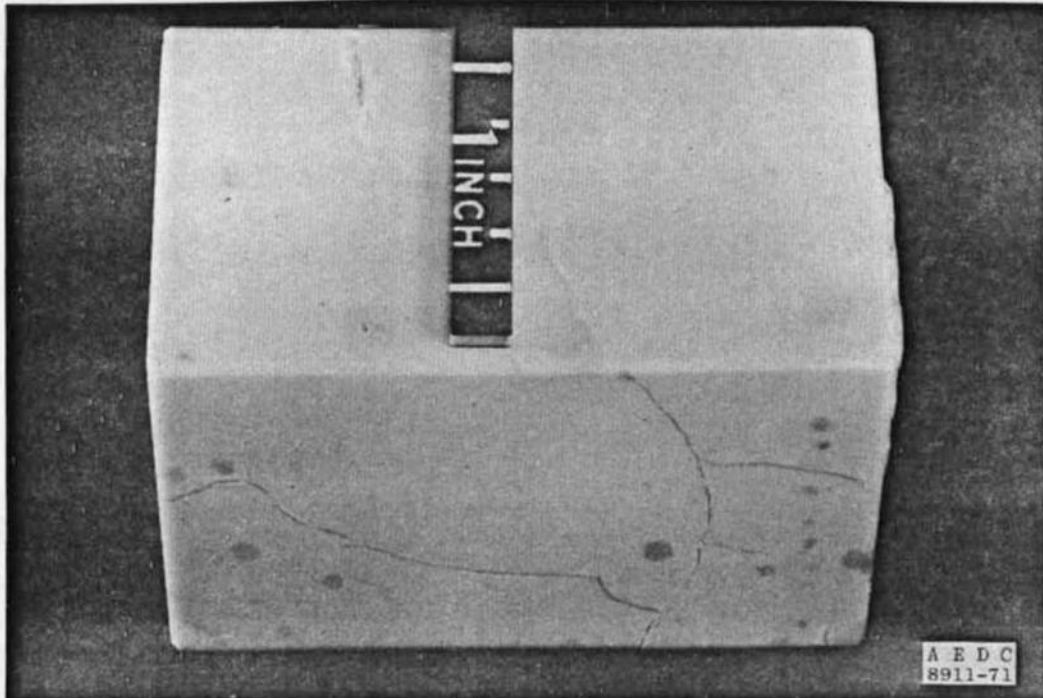
b. Side Opposite "A"

Occasionally stress marks will be discovered on the matrix bricks which are typical of those shown in Fig. 29. These horizontal indentations are caused by bricks becoming slightly misaligned as the matrix shifts with changing temperature. In cases of pronounced indentations such as these, the air passages in the brick adjacent to the surface and at the point of indentation remain slightly distorted, indicating that, because of elevated temperature, the brick was relatively soft at the time the indentation was made.

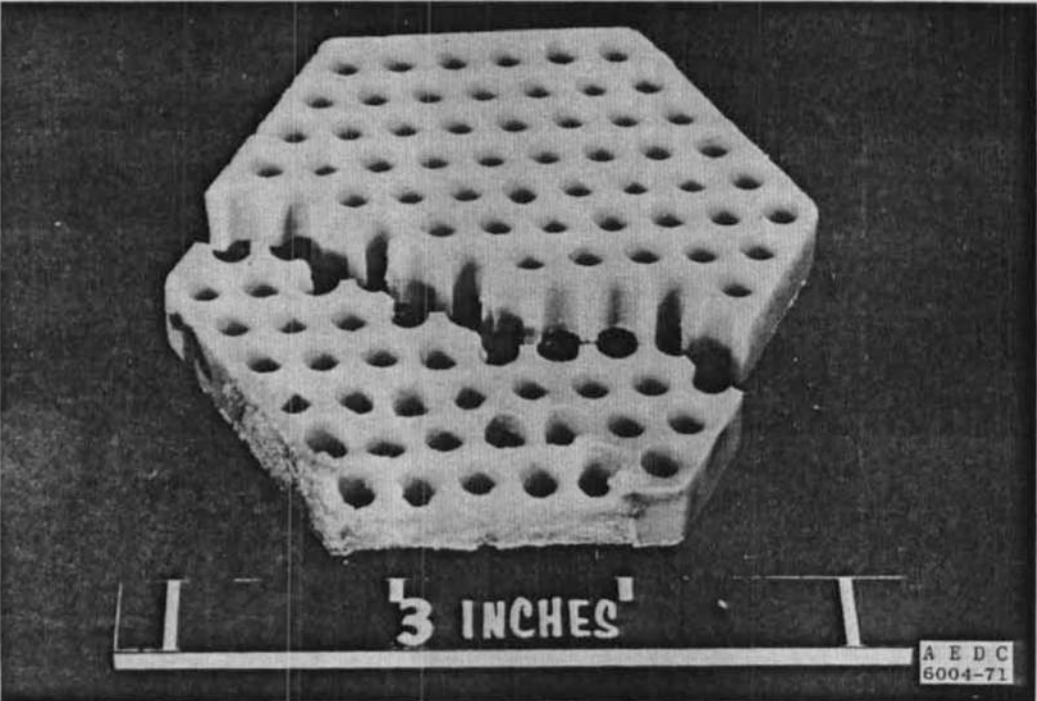
a. Coors, Buffer Brick, Column 10

Presented in Fig. 31 are matrix bricks, photographed during the post run 85 inspection, upon which material has been deposited and/or removed. The composition of material in these areas was analyzed and found to vary only slightly from the remainder of the bricks. Bricks which possessed this appearance were as follows: brick numbers 10-1, 10-2, 10-3, 12-2, 12-3, 13-5, 13-6, and 16-5. All of these bricks were situated in matrix columns adjacent to the bed liner. Brick 10-1 (Fig. 31a) appears to have experienced localized melting, resulting in the removal of material from the brick. To a lesser extent, this may also be observed of brick 13-6 (Fig. 31b). Presented in Fig. 31c are bricks 10-2 and 10-3 which are fused together. Again a localized area of the brick appears to have melted. In addition, deposits of yttria/zirconia material are fused to the bricks.
