WING LEADING EDGE FUEL TANK IMPACT TESTS

Federal Aviation Administration

Report No. FAA-RD-72-83

### FINAL REPORT

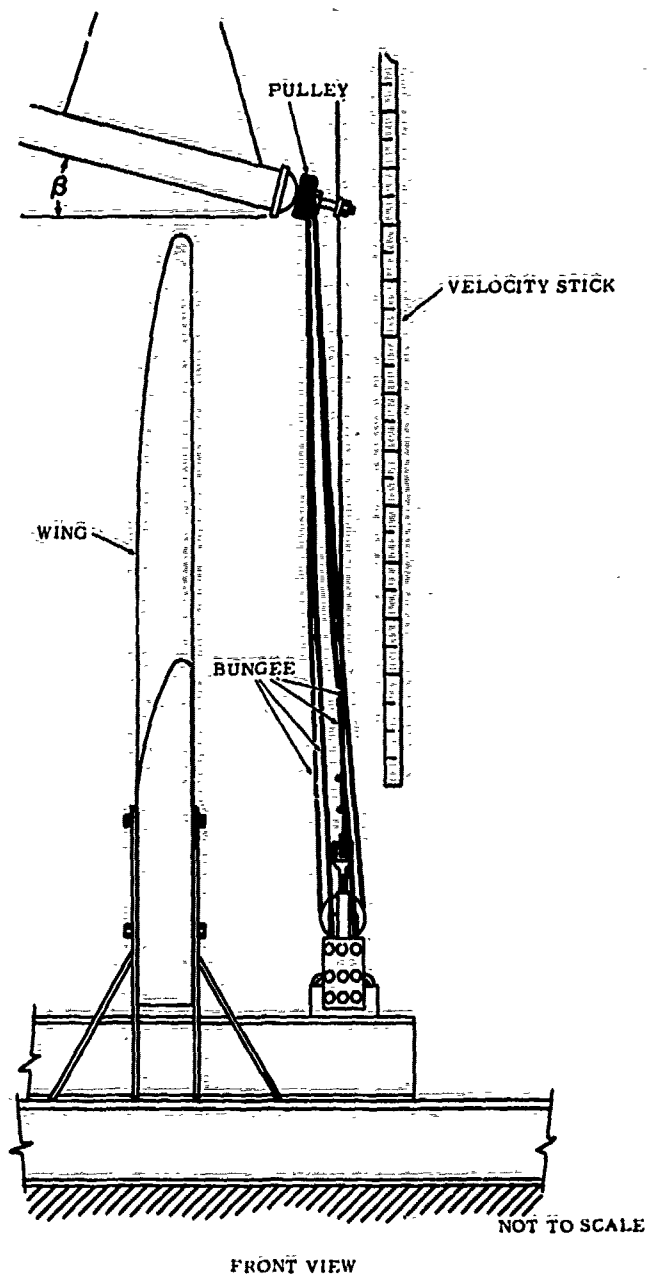
FIGURE 4. TEST OBSTACLE DURING ACCELERATION TOWARD WING

A relation of load (total downward force on obstacle at release) versus impact speed with the mass of the obstacle held constant was used to predict the impact speeds. This method of prediction was adversely affected by the tendency of the obstacle, as it accelerated toward the wing, to become other than horizontal causing the end fittings to bind with the guide cables which resulted in slower than predicted impact speeds. Table 2 (see page 10) shows the predicted impact speed and the actual impact speed. Figure 4 shows the obstacle in a position other than horizontal.

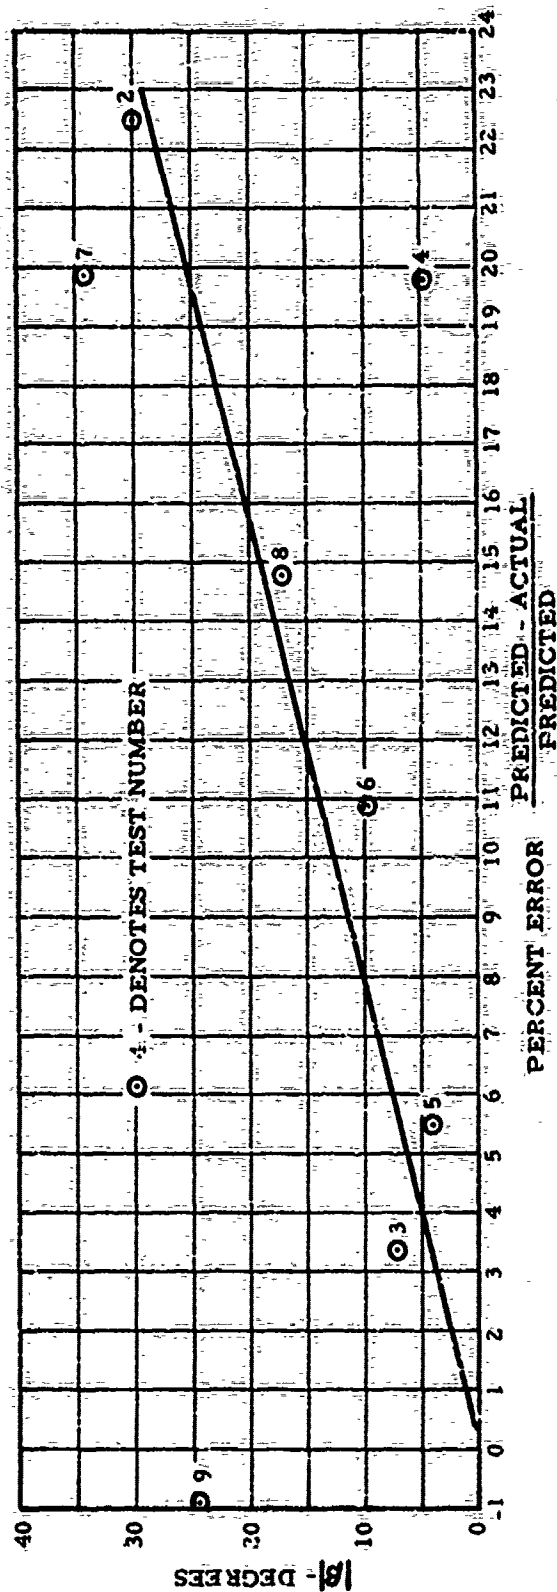
FIGURE 5: ANGLE OF IMPACT VS. PERCENT ERROR OF PREDICTED SPEED

Figure 5 was plotted using the high-speed film to determine the angle of the obstacle to the horizon ( $\beta$ ) and using the percentage error between the predicted and actual impact speeds. The two tests which are not consistent with the others are Test 4 and Test 9. A likely explanation for Test 4 is that during the obstacle acceleration toward the wing one of the guide cables broke, there was no obvious explanation for Test 9 being inconsistent.

Figure 5 shows a possible correlation between the Angle  $\beta$  and the amount of error between predicted and actual impact speeds. This correlation indicates that the problem of speed control could be reduced if not overcome completely by reduction of the physical contact between the obstacle and the equipment to control the path of the obstacle before and during impact. Future testing of this type will be difficult unless this problem is resolved, because the test cannot be conducted with any reasonable expectation of what the impact speed will be.
