MIGRATION OF SILVER THROUGH GOLD PLATING  
ON ELECTRICAL CONTACTS

Army Missile Command  
Redstone Arsenal, Alabama

19 December 1972

TECHNICAL REPORT  
RL-72-19

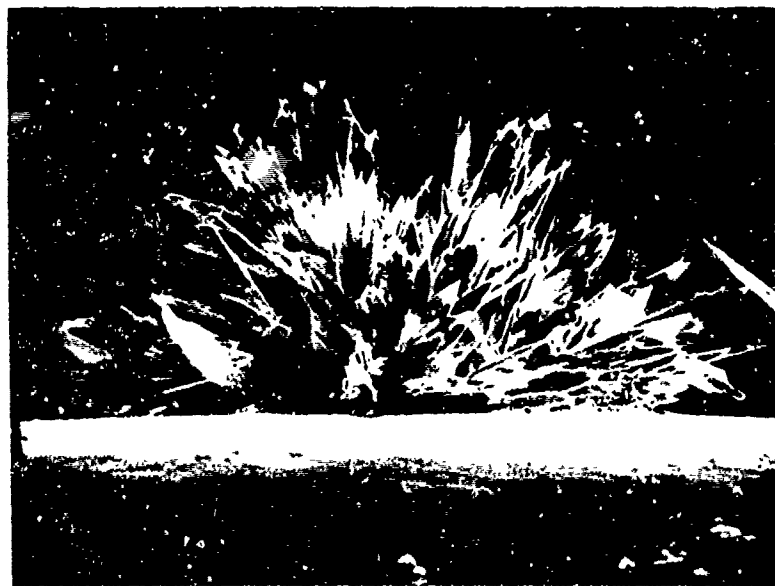
Another connector from the severely contaminated set of 12 was disassembled and a pin severed from the mounting. This pin was not as badly contaminated as the ones originally examined. Figure 49 depicts various crystalline protrusions of migrated silver. The caterpillar-like projection on the right side of the pin was enlarged to 350X magnification to show a flower-like appearance, Figure 50.

**FIGURE 50. ELECTRON MICROGRAPH. THE CATERPILLAR-LIKE GROWTH HAS TURNED INTO A FLOWER, WHEN MAGNIFIED TO 350X.**
