THE FEASIBILITY OF BURNER-CAN BURN-
THROUGH THERMAL DETECTION PRIOR TO
ENGINE CASE RUPTURE

Richard Hill

National Aviation Facilities Experimental Center

Report No. **FAA-RD-72-134**

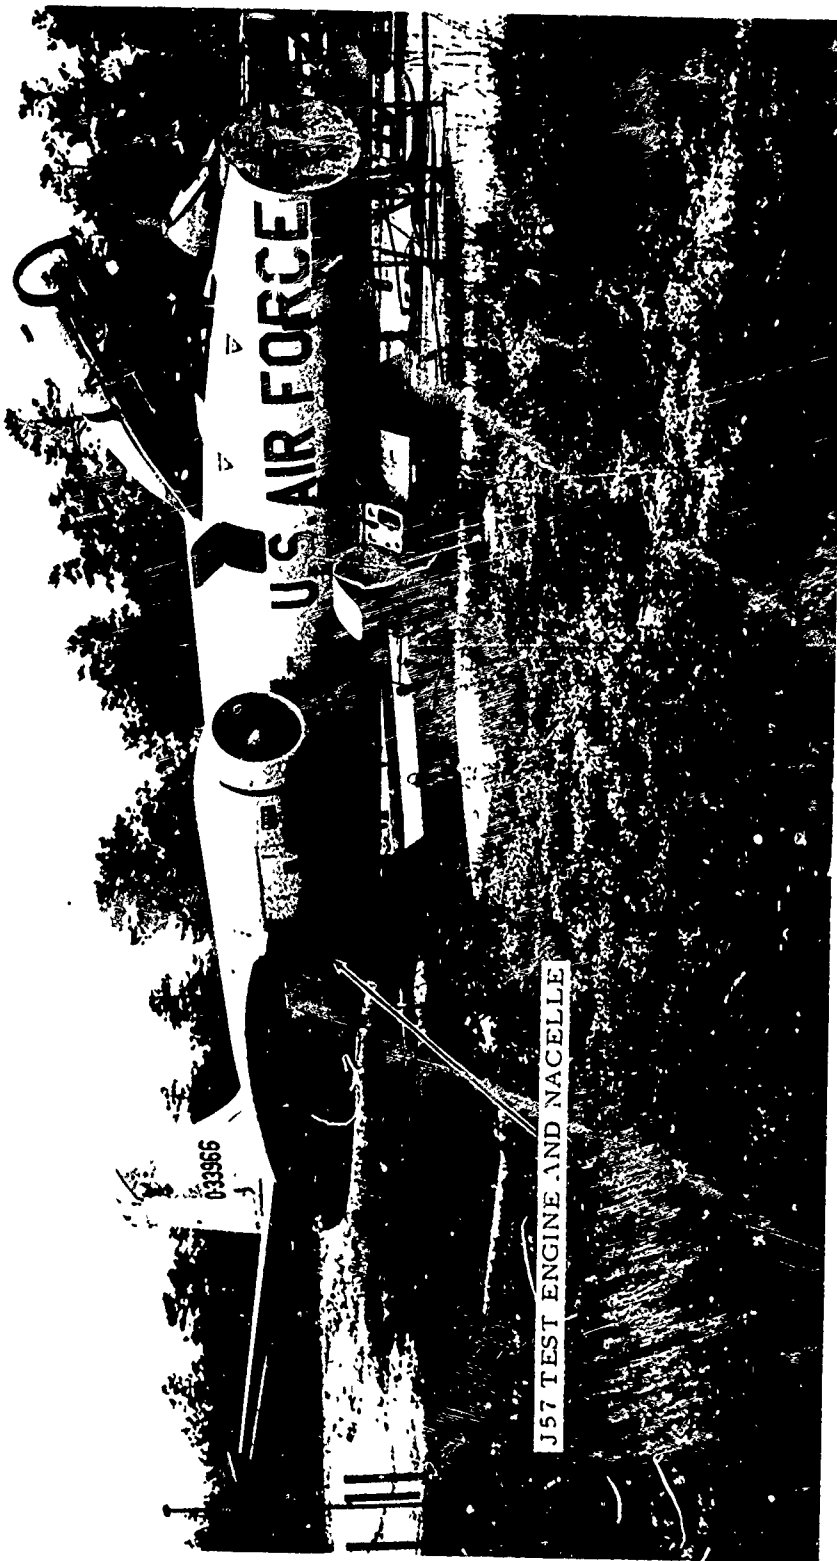
FIGURE 1. J57 TEST ENGINE

The test article used in this project was a Pratt and Whitney J57-P37 turbojet engine mounted in the right nacelle of a B57 airplane (see Figure 1). The engine was remotely controlled from a blockhouse located approximately 100 feet from the aircraft. Ten No. 28 gage Chromel-Alumel thermocouples were spot welded to the J57 engine and recorded on five Bristol Model-760 Strip-Chart Dynamaster two-pen recorders, located in the blockhouse.
