**NORWEGIAN SEISMIC ARRAY**

TECHNICAL REPORT

Field Maintenance Report

1 January - 30 September 1971

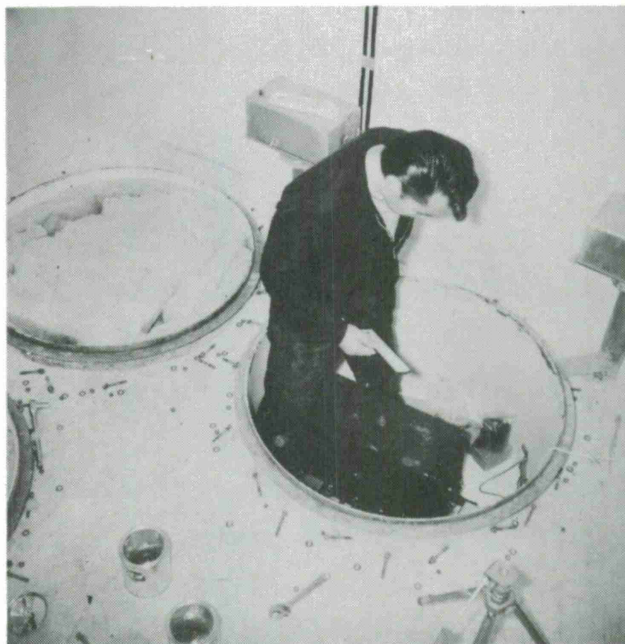
Figure 3.1 shows the NS and the EW tanks opened, the NS tank filled up with insulating pads around and on top of the seismometer, while the pads are removed from the EW tank. A bag of dehydrating substance can be seen beside the seismometer. The technician is returning the thermometer before the lids are put back on.

Figure 3.1 The NS and the EW tanks opened,  
the NS tank with insulating pads in.

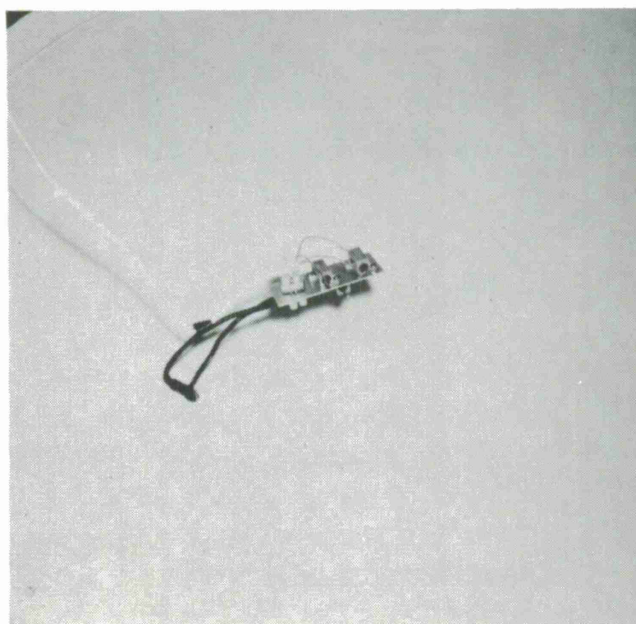
Figure 3.2 shows the heating element as it was placed underneath the lid.

Figure 3.2 The heating element as it was installed  
underneath the tank lid.

Based on information from the previous seismic station at Ringsaker, which utilized installations of somewhat the same kind as at NORSAR, we proposed to introduce an electric heating element in the LP tanks to increase the air temperature somewhat, in an effort to reduce the moisture in the tanks.

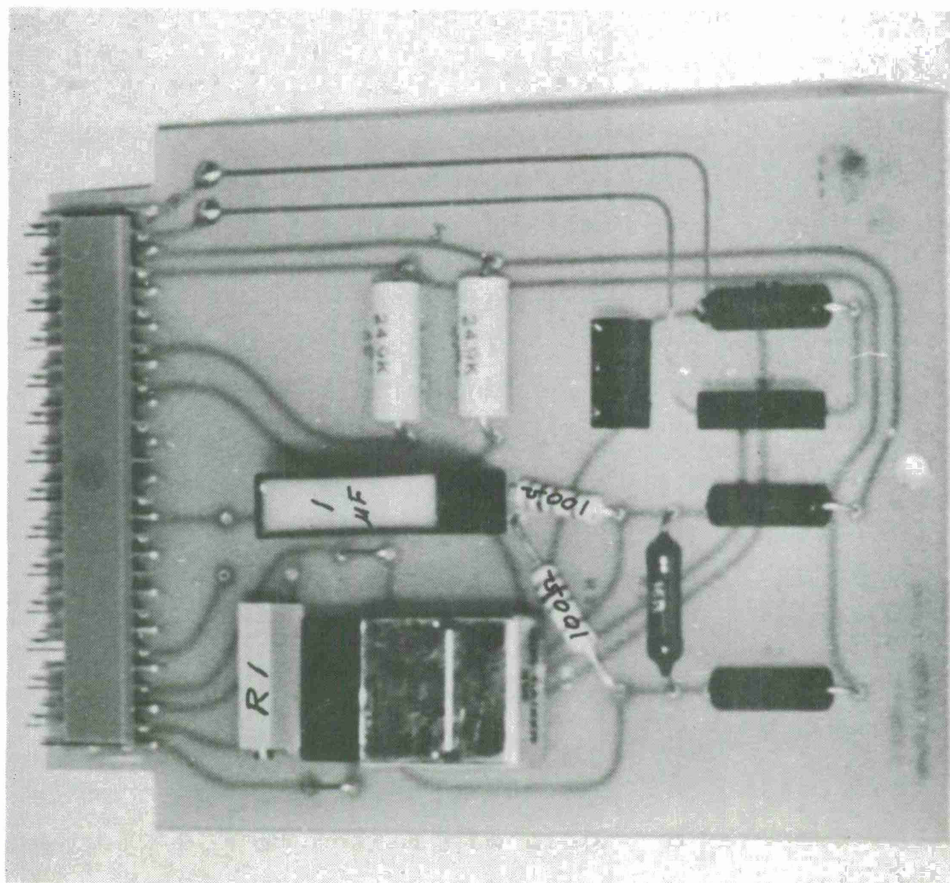
Figures 4.1 and 4.2 show modified RA5 Input Cards of respectively "Type used at 01C" and "Type used throughout the array except at 01C". Apart from the damping resistor R1 modification, the cards are also modified as earlier mentioned for suppression of 50 Hz noise in Cal.Amp. mode. The resistor R6 of 200 ohm is replaced by two resistors of 100 ohm in series and grounded over a 1 uF capacitor. Figure 4.3 shows a technician adjusting damping resistor at the WHV, while figure 4.4 shows the test setup in the CTV. By cooperation between WHV and CTV two technicians can now easily adjust the D to proper value.

Figure 4.1 Modified RA5 Input Card  
Type used at OIC.

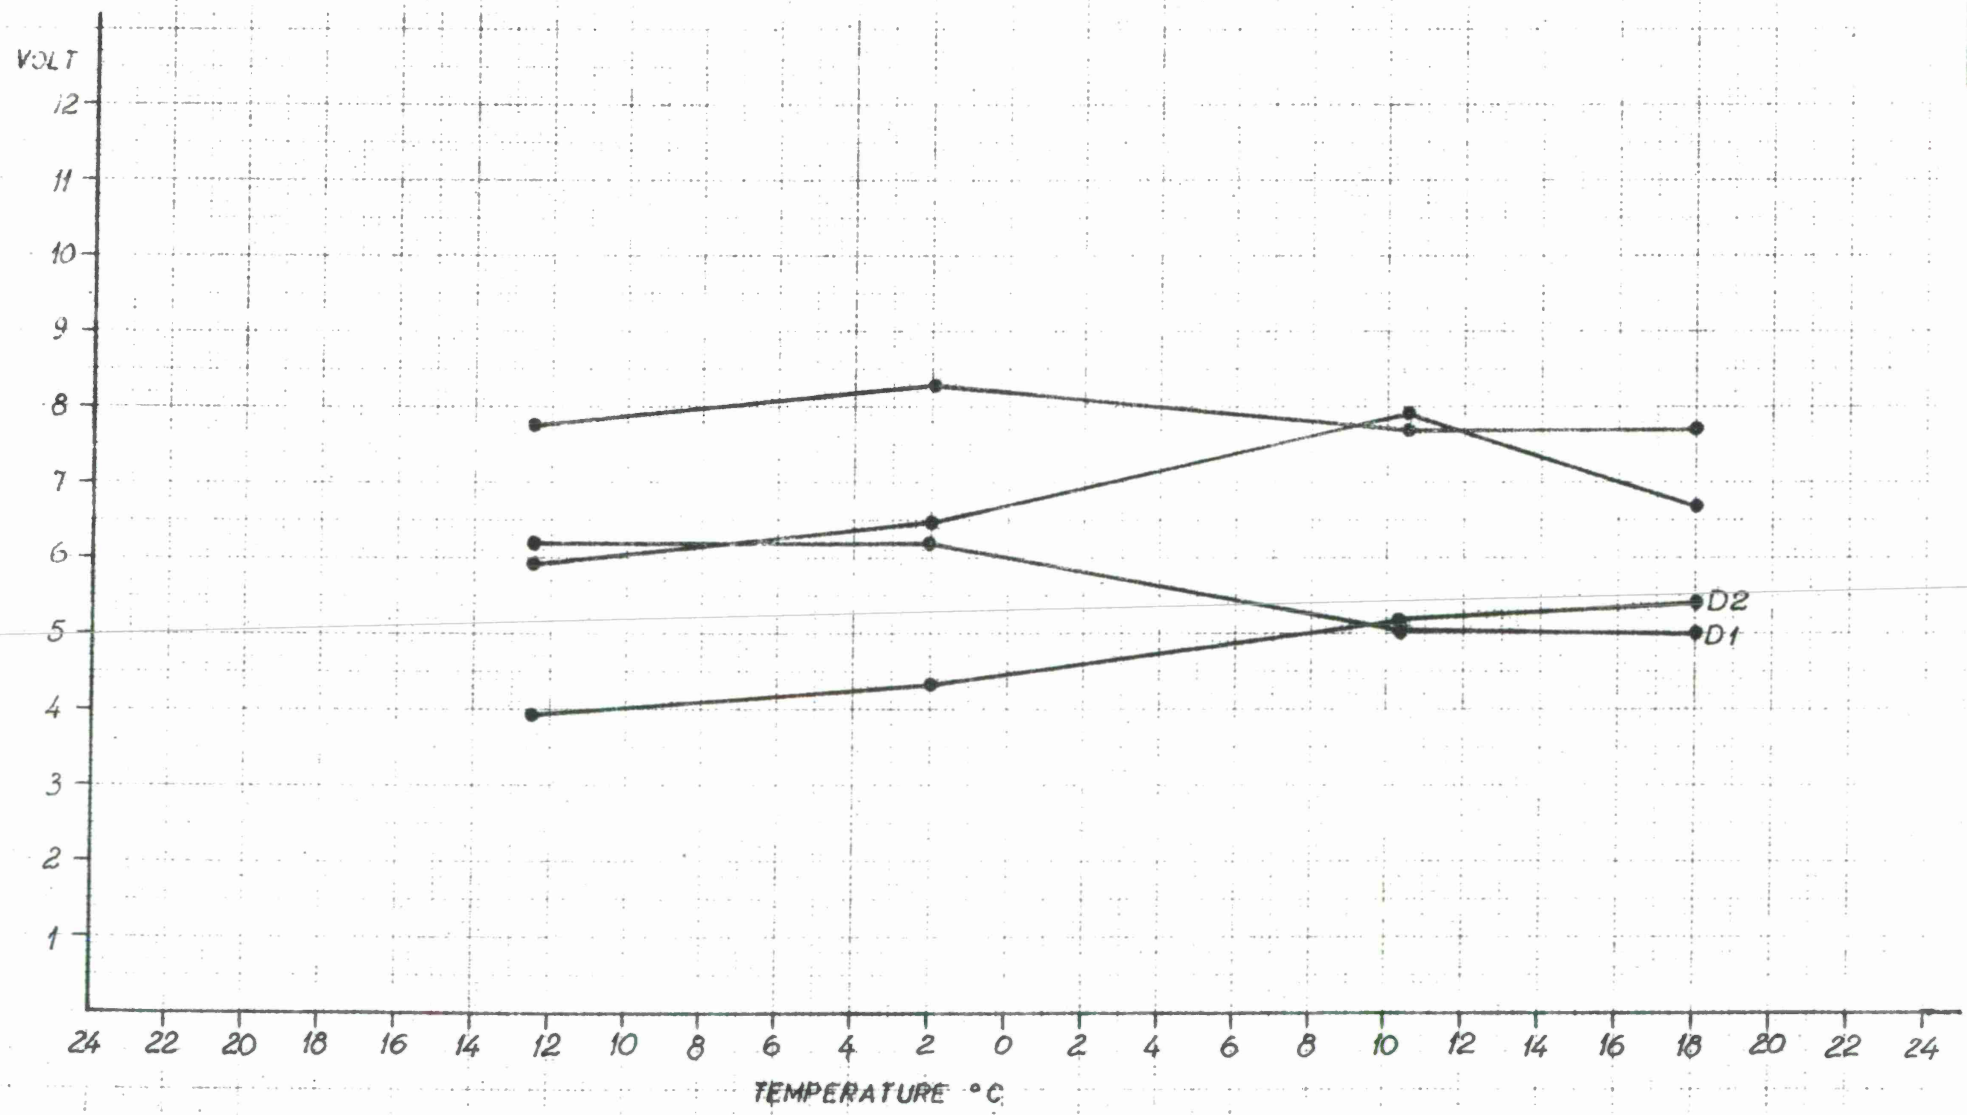
TEMPERATURE CHAMBER  
CHECK NO. 3 AMPLIFIERS ADJUSTED AT +12,5°C
