Naval Underwater Systems Center

Technical Note N-1284

ANALYSIS OF THE CONDITION OF ECHO TOWER,
AZORES FIXED ACOUSTIC RANGE, AFTER ONE
YEAR AT 1500 FEET OF DEPTH

Naval Civil Engineering Laboratory
Port Hueneme, California 93043

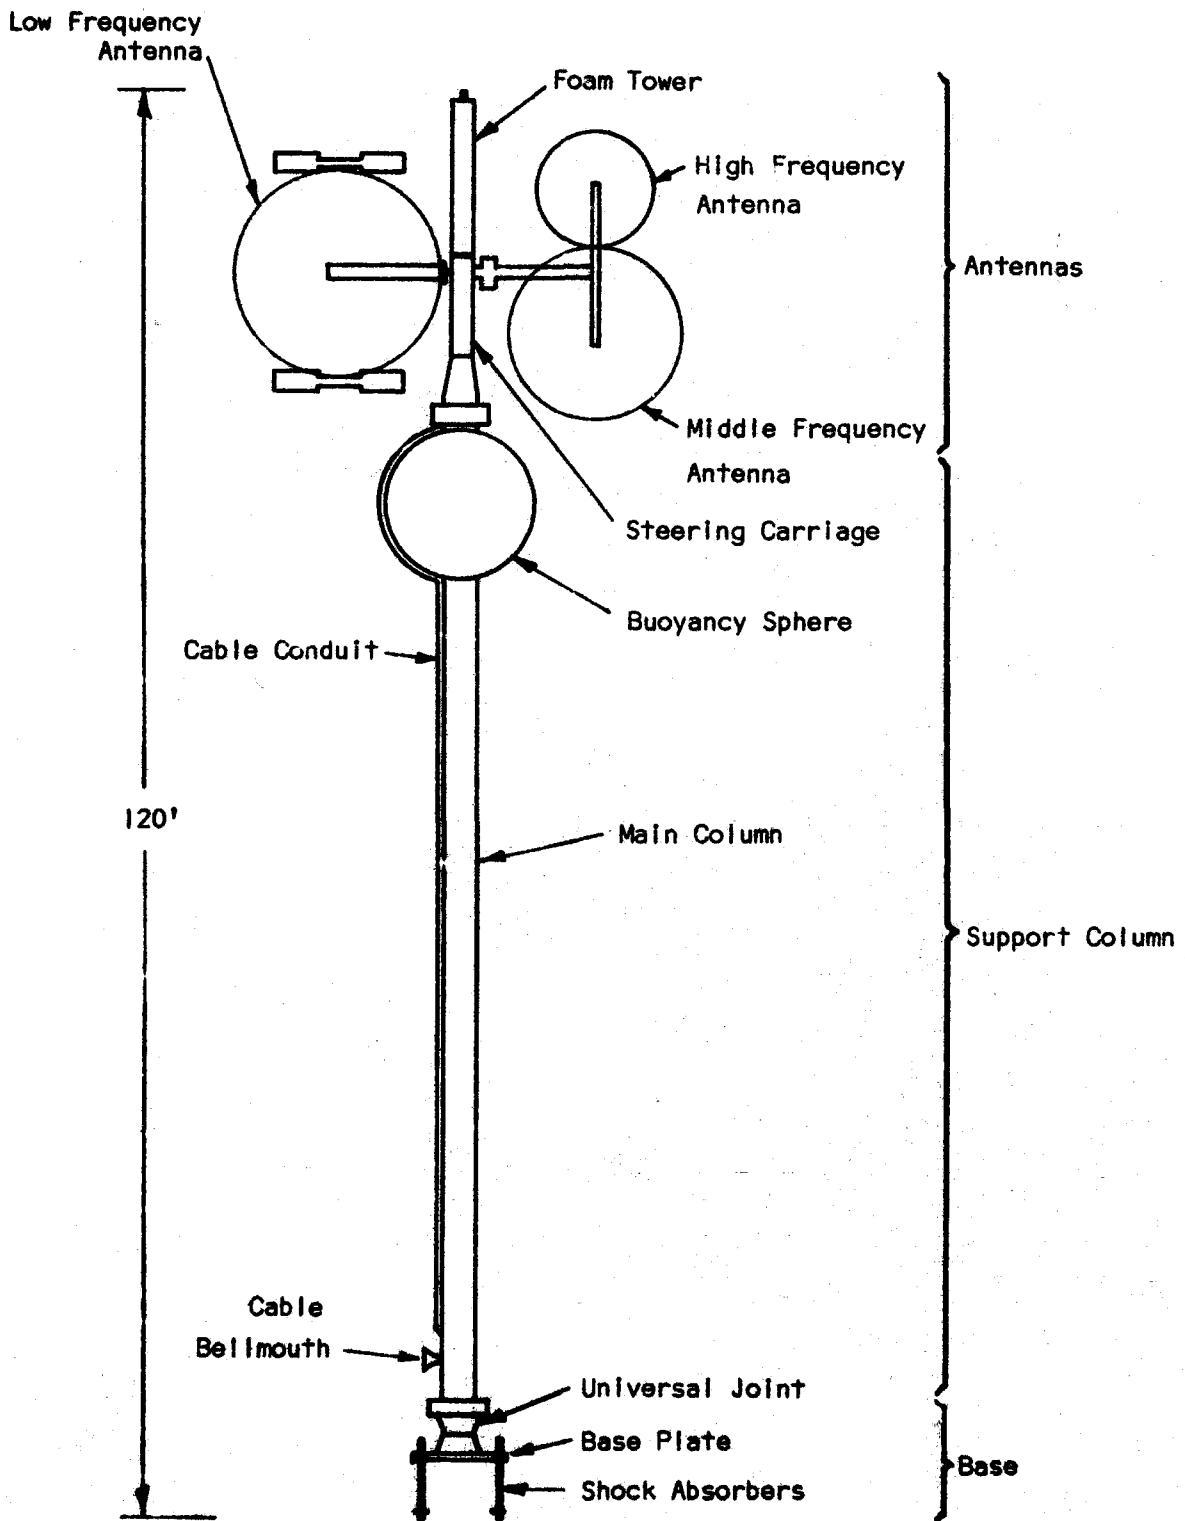
Figure 1. Sketch of Tower.

Approximately 12 hours after being retrieved from depth, an inspection of the upper portion of the tower was made while the tower was still completely submerged in seawater. A sketch of the tower is shown in Figure 1. Depth limitations limited this inspection to the portion of the tower above the center line of the sphere.
